# BLM Legacy Wells

Environmental Hazards  
&  
Eyesores

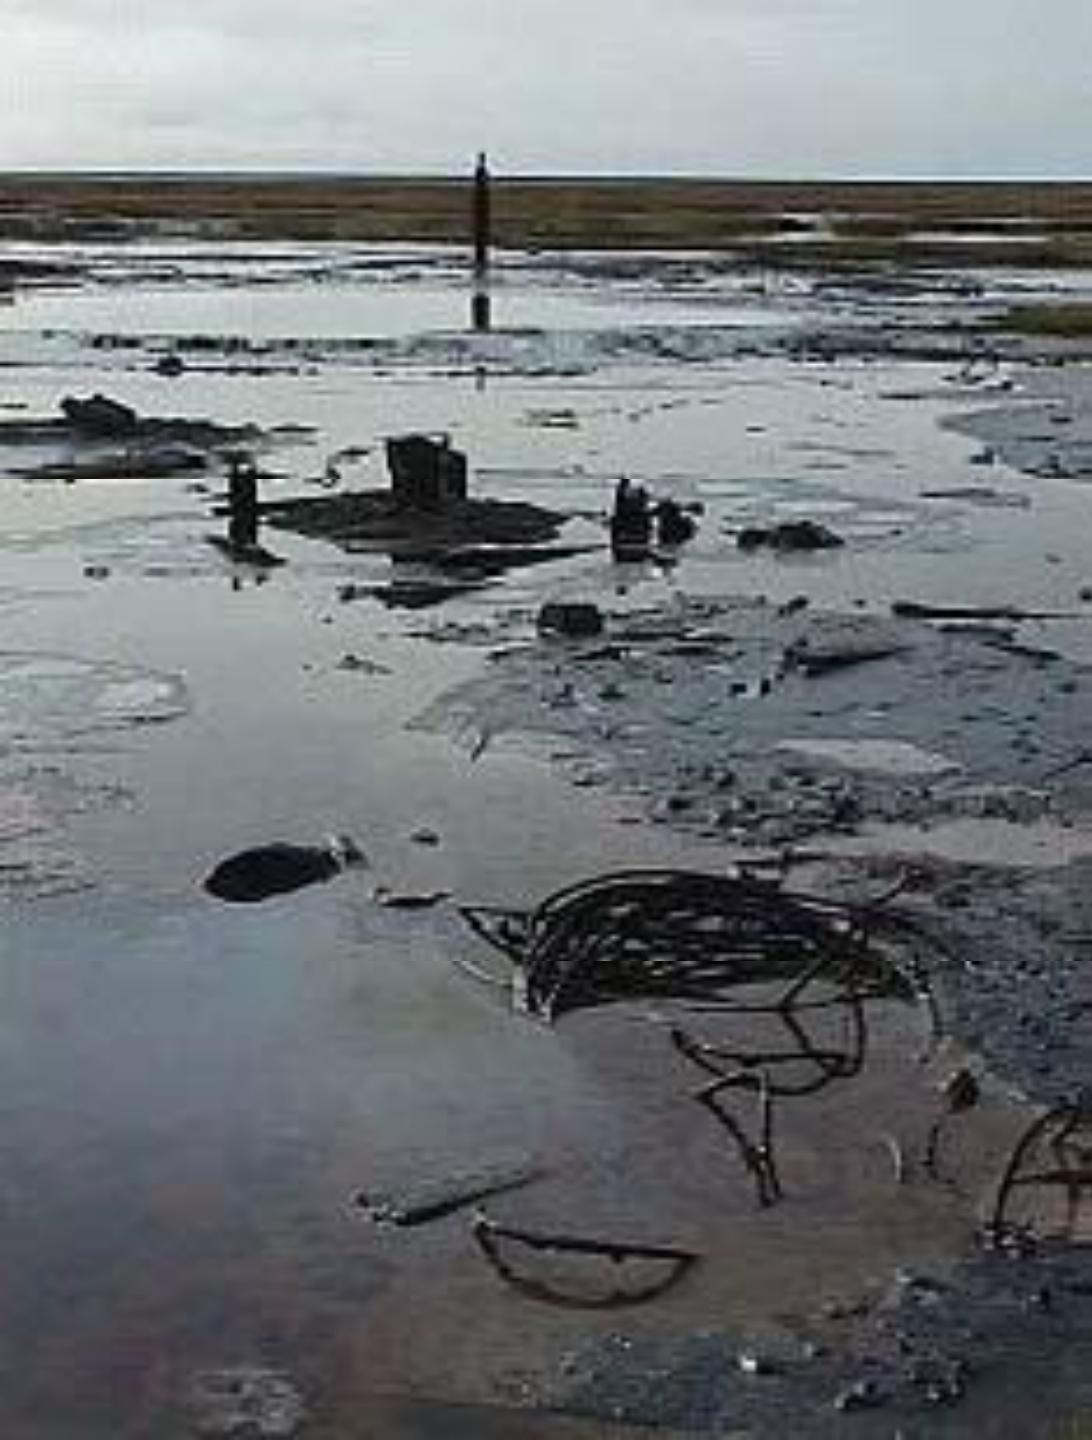
Wellhead along with  
wood and metal debris  
in a natural oil seep

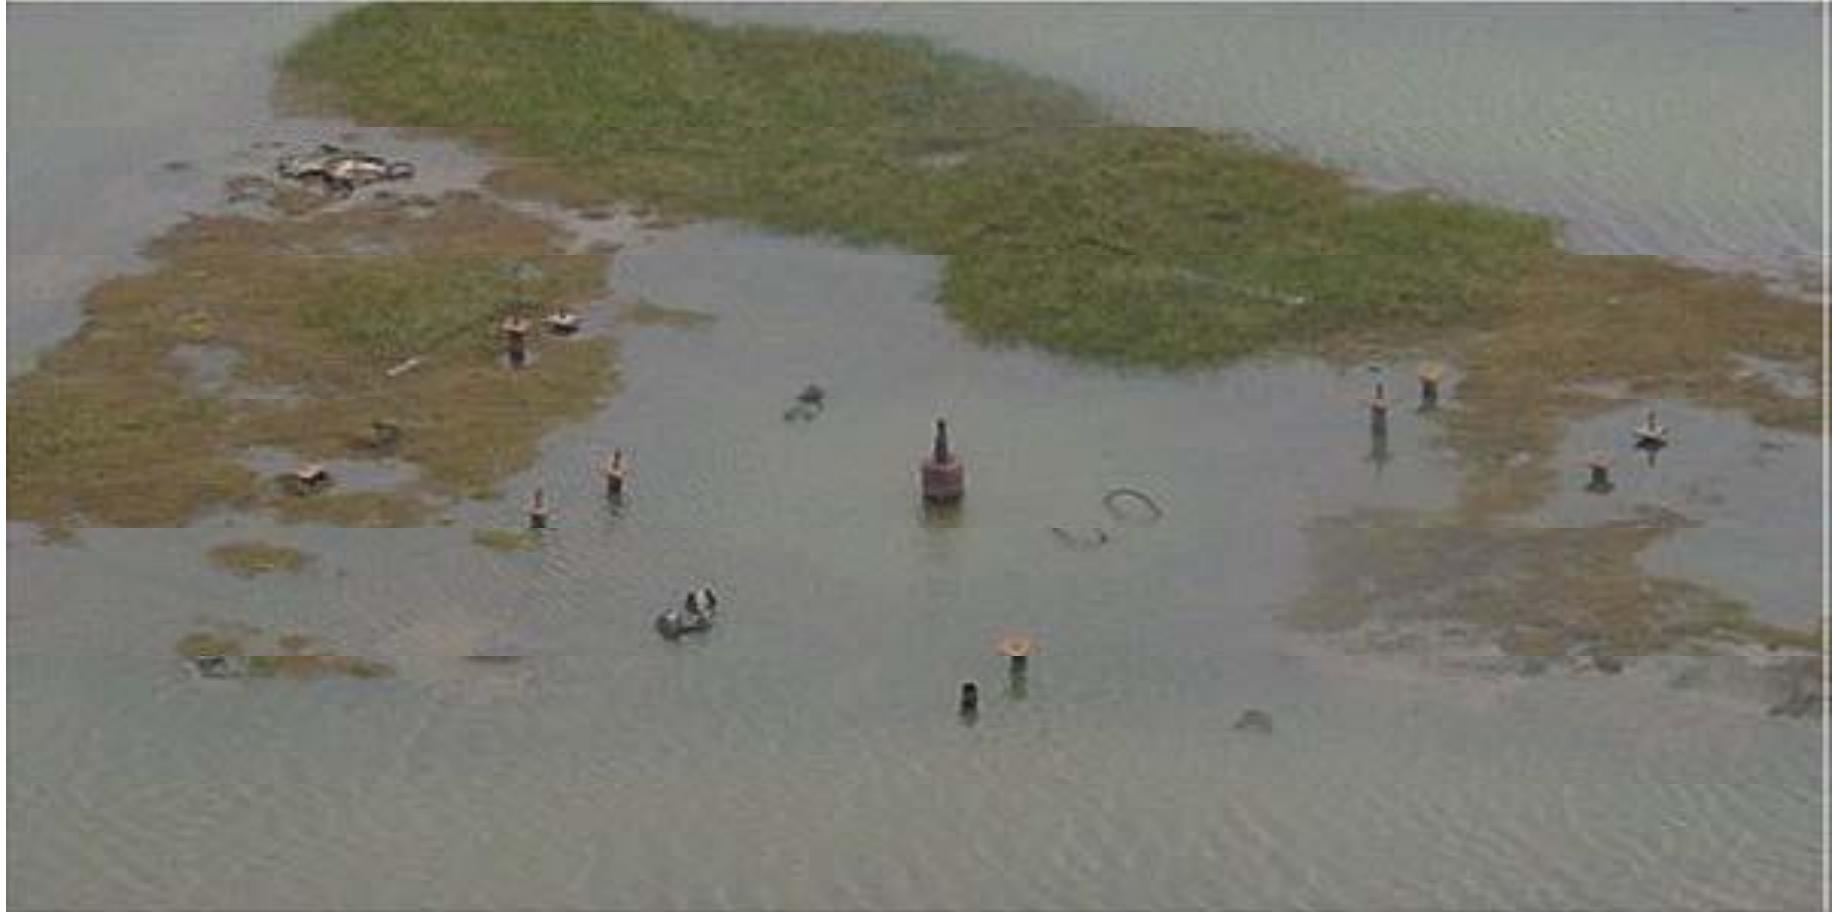
Natural subsidence and snowmelt have started to obscure this site.

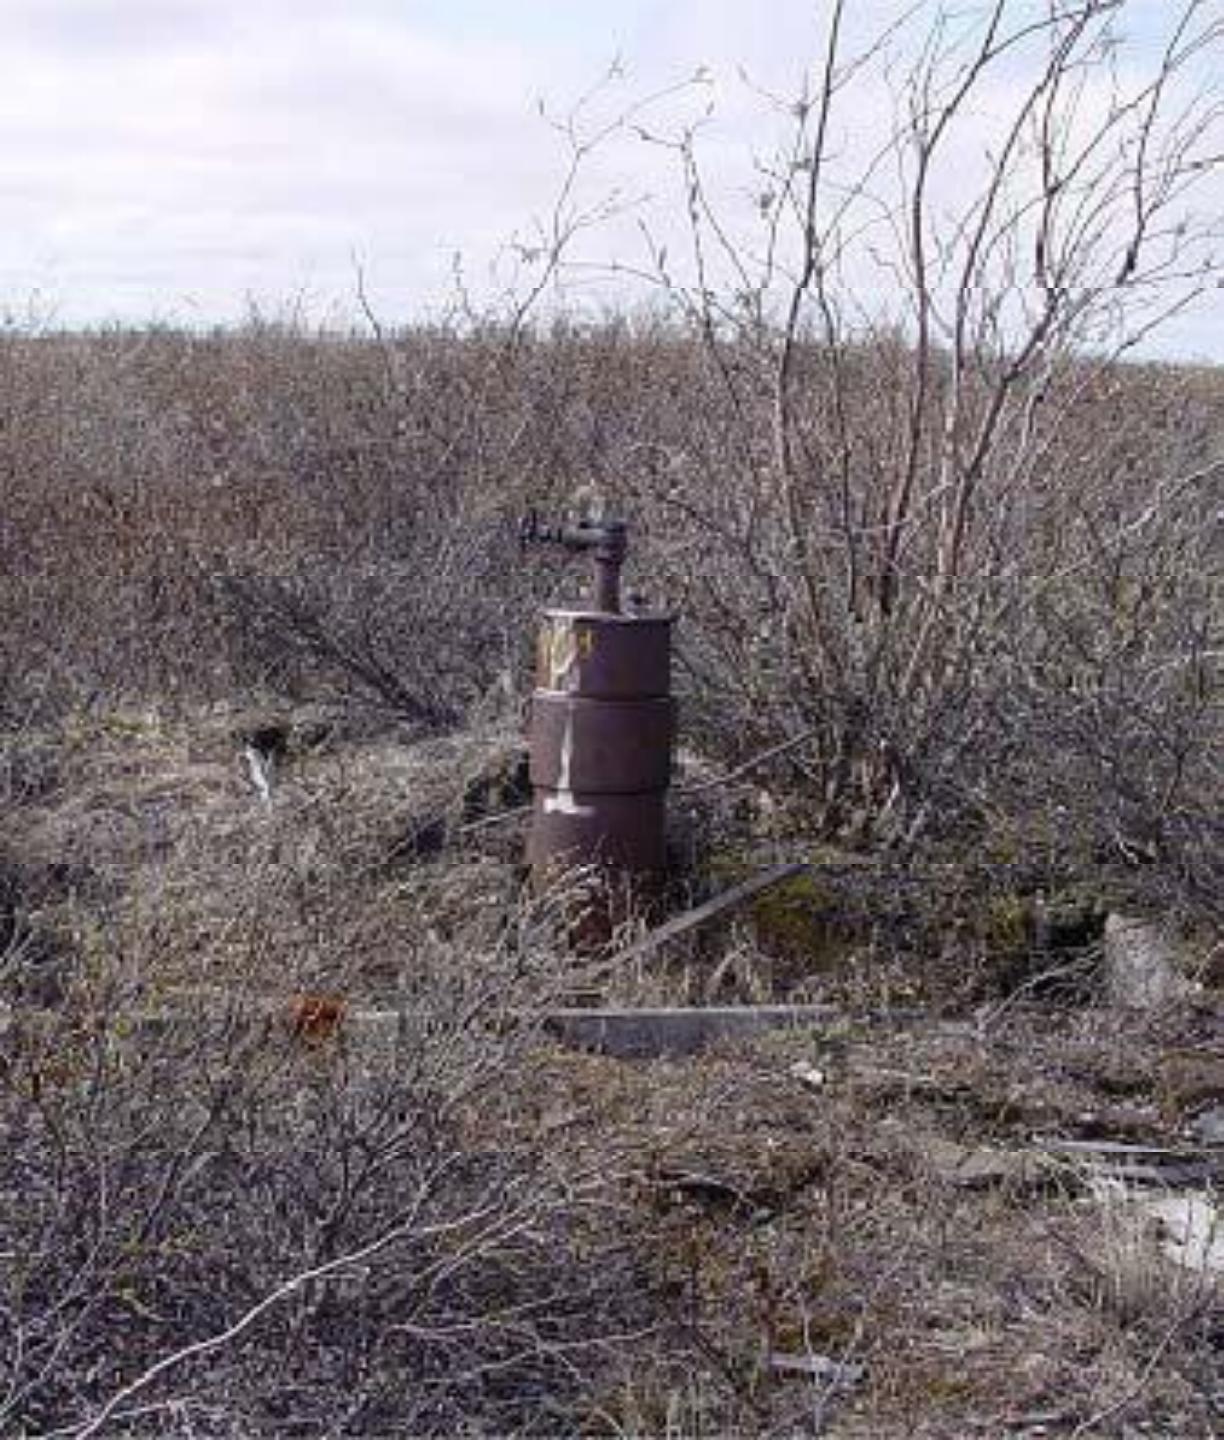
Primitive, rusting wellhead  
and wood debris
