APMA A20176118- FIELD SUMMARY REPORT

Annual Inspection and Follow-Up Compliance Inspection

The Pebble Project lies approximately 17 miles northwest of the communities of Iliamna and Newhalen. Located at the headwaters of Upper Talarik Creek, South Fork Koktuli River and adjacent to the headwaters of the North Fork Koktuli River, the Pebble Deposit is situated within the Nushagak/Mulchatna drainage system and Bristol Bay watershed. Topography varies from rolling hills to marshy lowlands and hosts several lake systems with dominant scrub coverage (*Salix*) or dwarf scrub tundra. The regional vegetation includes areas of forest, meadow, and scrub within riverine, lacustrine, lowland, upland, and alpine environments. Mammalian wildlife commonly observed in the operation area include *Ursus arctos*, *Alces alces*, *Rangifer tarandus*, *Castor canadensis* and *Spermophilus parryii* among others.^{1,2} Raptors, waterbirds, shorebirds, and landbirds are also commonly observed. The Pebble Deposit consists of two known contiguous hydrothermally altered sulfide copper-gold-molybdenum porphyry deposits hosted in the Kahiltna Terrane Batholith (Cretaceous); one near-surface (Deposit West), an

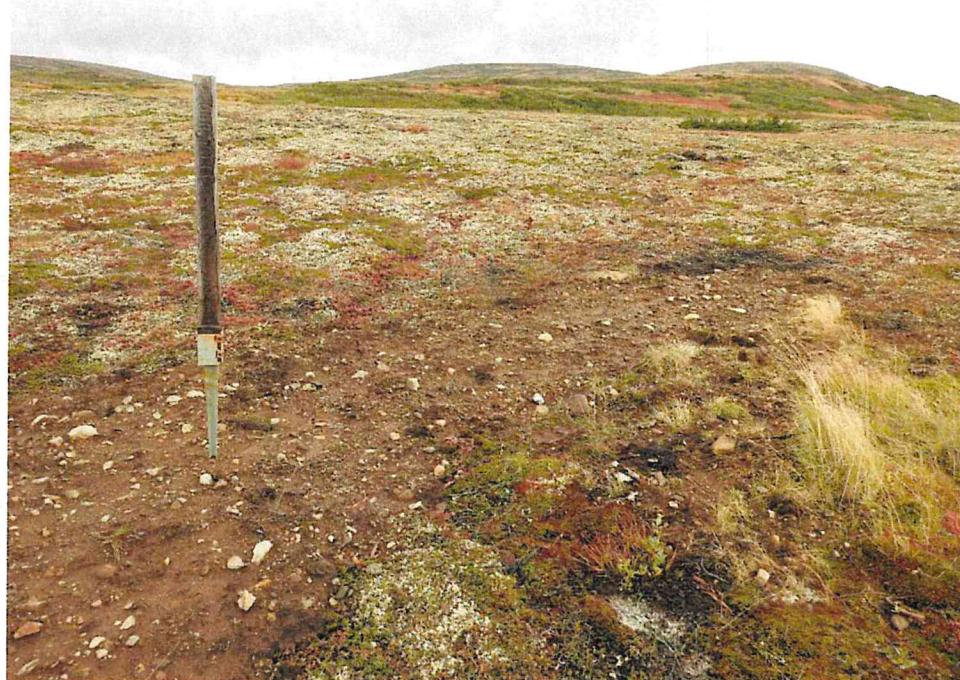
1. Borehole 8433M
15 Sept 2017

Exploration borehole 8433M exhibited ponded water near the borehole with an unknown source in 2016. Attempts to stop water flow in spring of 2016 were unsuccessful. On August 20, 2017, the operator re-drilled, grouted and reclaimed the site successfully as reported in PLP's 2017 Reclamation Activity Report⁶ submitted November 30, 2017. At the time of inspection, the site was found to be in an acceptable stable condition. DNR recommends seeding this site in spring of 2018 but it is not a requirement under AS 27.19, 11 AAC 97.200 or terms of MLUP A20176118. The borehole rating for this location has been modified to 3-D⁴.

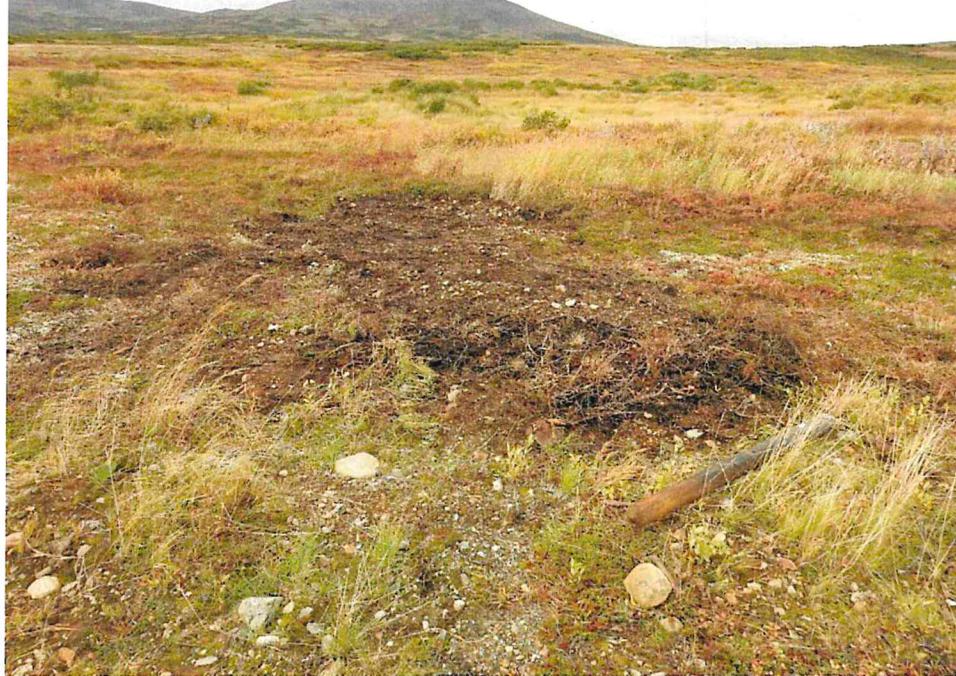
2. Borehole 3132
15 Sept 2017

Exploration borehole 3132 exhibited a minor weep upon inspection in 2016. Borehole 3131, located in close proximity to borehole 3132, was repaired in 2015 by drilling and regROUTING, but the repair was unsuccessful. Borehole 3132 was re-drilled, grouted and reclaimed on August 10th, 2017⁶. It appears that borehole 3131 and 3132 exhibit some influence on one another. Borehole 3132 was not exhibiting instability at the time of inspection and is also grouted and plugged. DNR recommends seeding this site in spring of 2018 but it is not a requirement under AS 27.19, 11 AAC 97.200 or terms of MLUP A20176118. The borehole rating for this location has been modified to 3-D⁴.

Borehole 3131
also pictured (nearest stake).

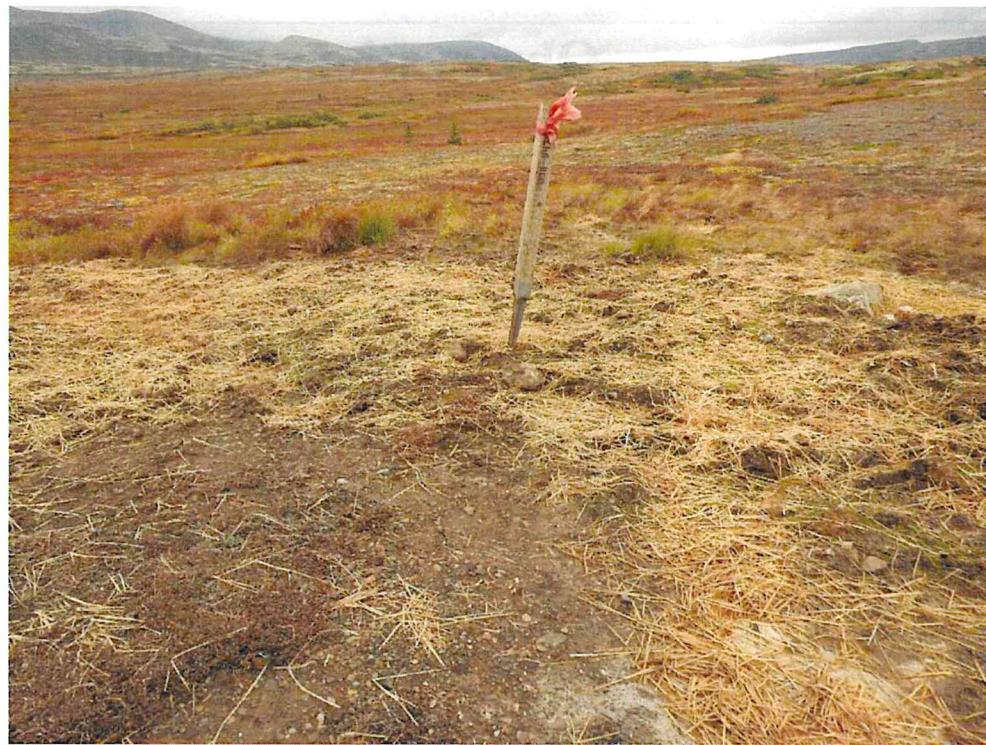
3. Borehole 9475
15 Sept 2017

Borehole 9475 was re-drilled, grouted and reclaimed in August 2017⁶ after a history of water production and unsuccessful repair. Reclamation efforts began after closure in August and will continue to be monitored for revegetation in 2018. The borehole rating for this location has been modified to 3-D⁴.

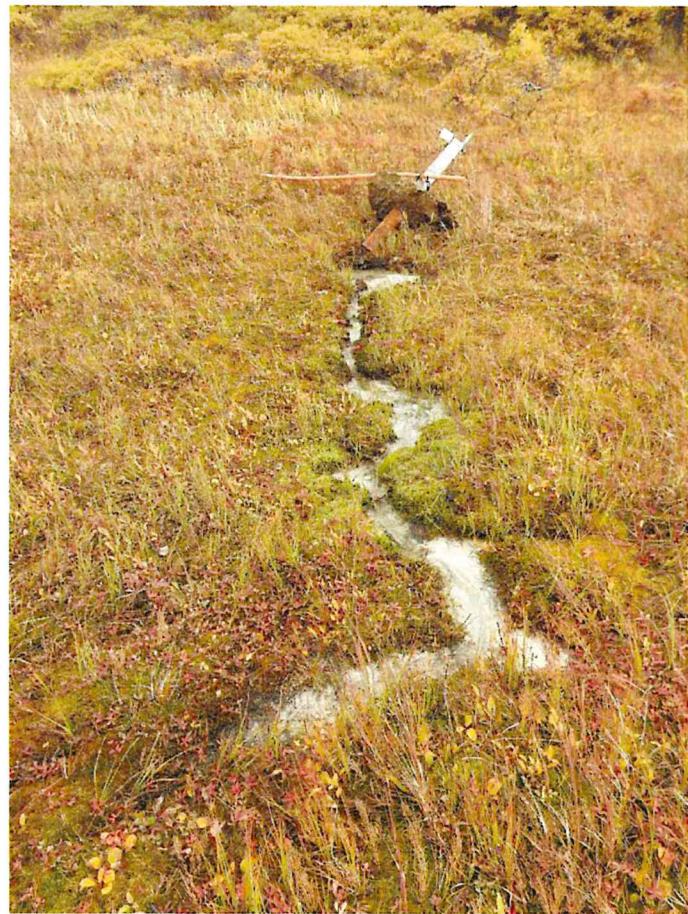
**4. Borehole
GH08-156**
15 Sept 2017

In 2016, DNR requested the operator investigate the origins of a small upwelling at the base of borehole GH08-156. In 2017, the operator determined the water presence was from surface flow originating upgradient from the borehole, collecting at the borehole casing and continuing downgradient in an outflow channel⁶. To confirm this, the operator removed the above ground casing and packed the borehole with bentonite pellets. At the time of inspection, just a short time after the repair was made, an approximate 3" wide by 3" deep and 15' long channel outflow was observed. The outflow channel includes bentonite clay particles suspended after water contact from surface flow. Remediation of the outflow channel is scheduled for the 2018 field season. DNR requests the operator continue monitoring and reclamation efforts as scheduled. The borehole rating for this location has been retained at 1-B⁴.

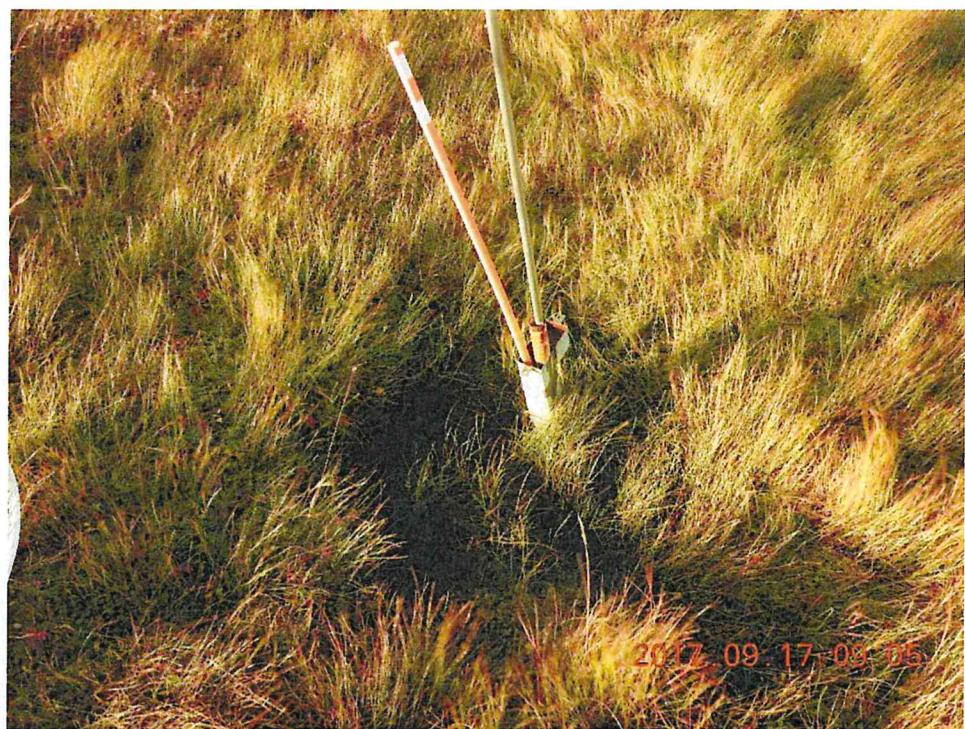
**5. Borehole
GH06-072
17 Sept 2017**

Borehole GH06-072 was observed producing a small amount of water inside the casing in 2017. The Margo plug installed at the time was rusted and likely the cause of the condition. In 2016, DNR requested the operator install a new Margo plug and determine if that repair adequately stopped water flow. The installation of a new Margo plug and the cessation of flow was observed during inspection in 2017. The borehole rating for this location has been revised to 1-D⁴.

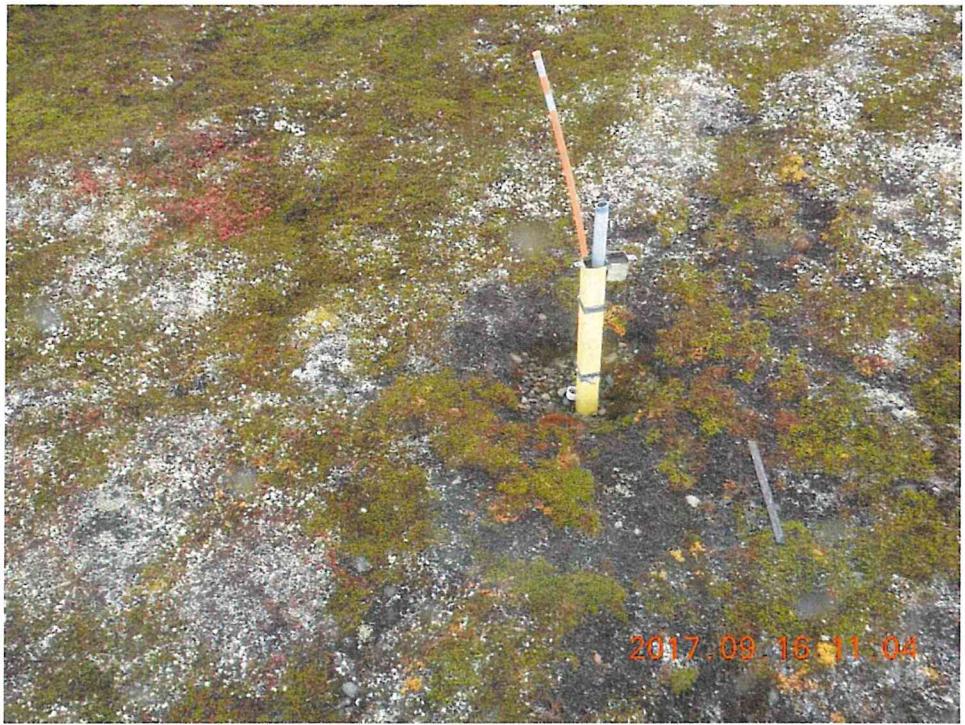
**6. Borehole
GH11-236
17 Sept 2017**

In 2016, DNR observed a depression surrounding the casing of this monitoring well. DNR requested the operator observe and measure the depression to determine if the site was experiencing subsidence. Upon inspection, the site appears to be in similar condition with no notable change in depression dimensions. If no subsidence has been measured, the operator should fill the depression and complete reclamation. The borehole rating for this location has been retained at 1-D⁴.

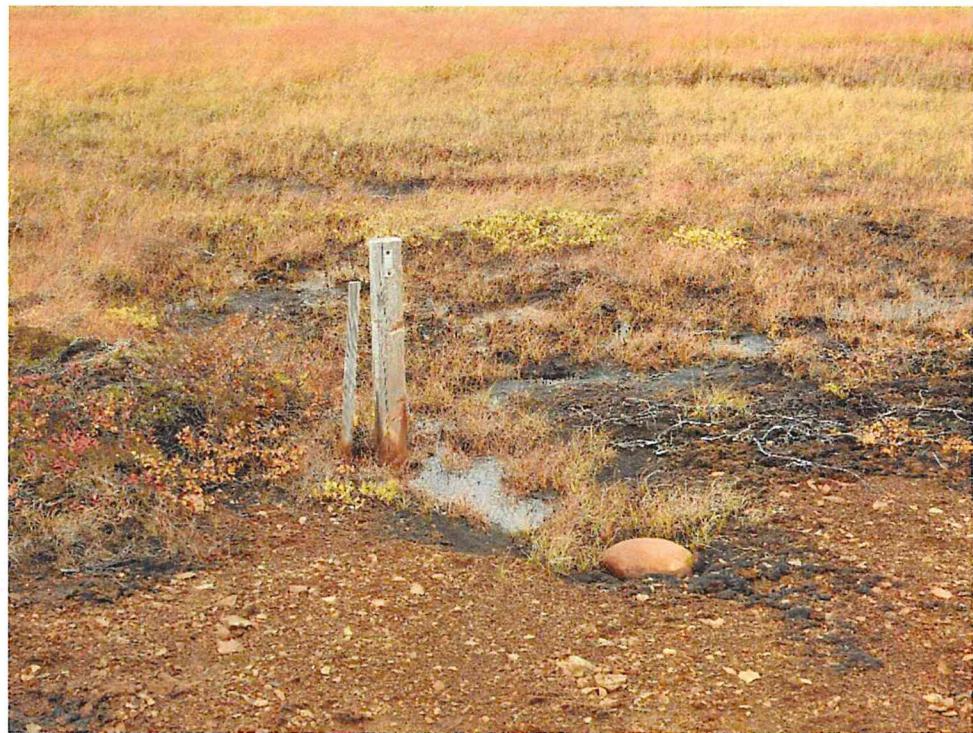
7. Borehole 4279
15 Sept 2017

Borehole 4279 has been documented with ponded water near the borehole since 2015. In 2016, DNR requested the operator confirm the standing water was not produced from the borehole location. The operator has made multiple inspections and determined the ponded water is not a result of influence from the borehole. In 2017, DNR observed standing water across the surrounding low lying, flat area and noted no substantial change from years past. The borehole rating for this location has been retained at 3-D⁴ and no additional action is requested at this time.

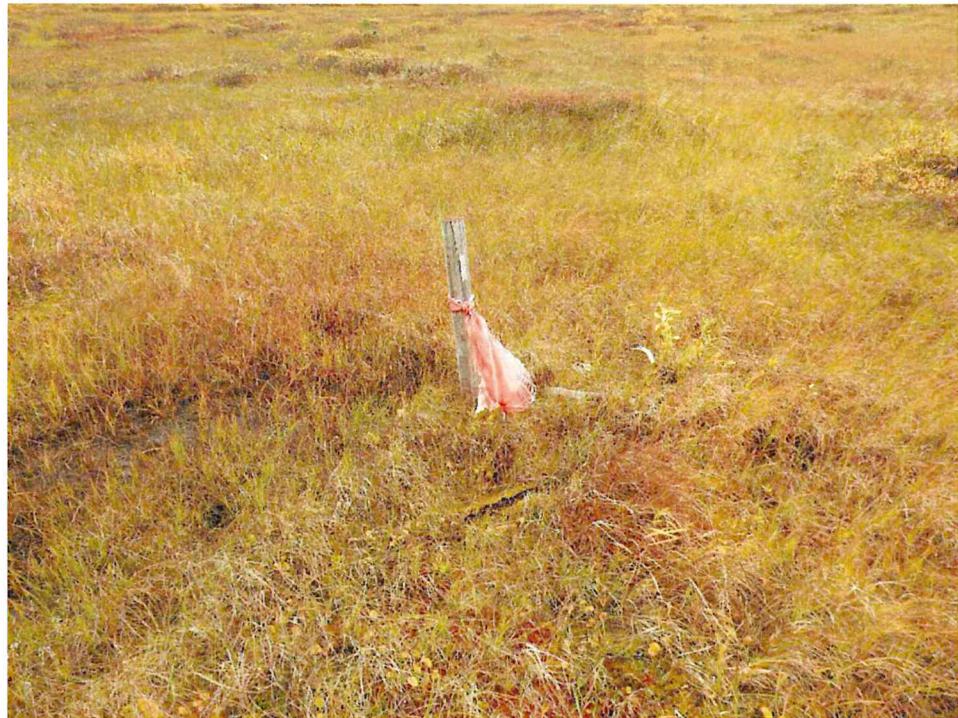
8. Borehole 5332
15 Sept 2017

Borehole 5332 was observed with nominal amounts of ponded surface water. Surface water appears to flow through the surrounding low-lying area and past the borehole location. The ponded water was observed clear and without a sheen or smell. The borehole has been plugged, reclaimed and abandoned. The borehole rating for this location has been retained at 3-D⁴.

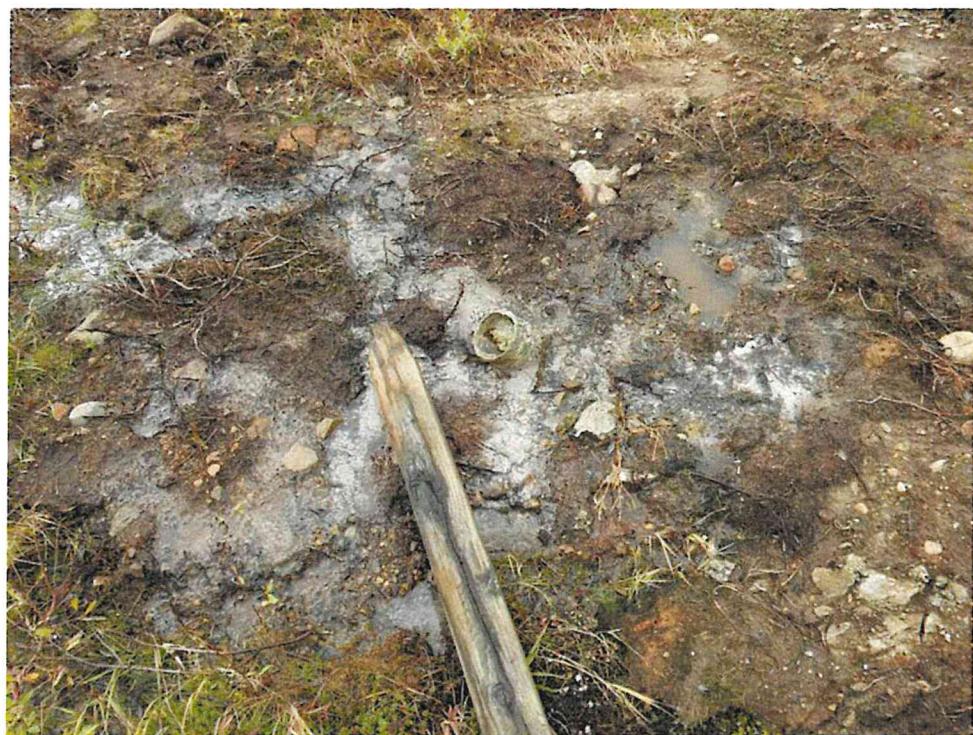
9. Borehole 3127
16 Sept 2017

This borehole exhibited minor water production despite efforts to re-drill and grout to stop water flow in August 2017. Water produced from this borehole dissipated in a disseminated fashion to surrounding

vegetation several feet from the borehole. The operator indicated the need for a more specialized drill to successfully complete repairs. Repairs are scheduled for Spring 2018. DNR requests the operator continue monitoring site conditions and report repair activities as soon as practicable. Borehole rating has been modified to 3-B⁴.

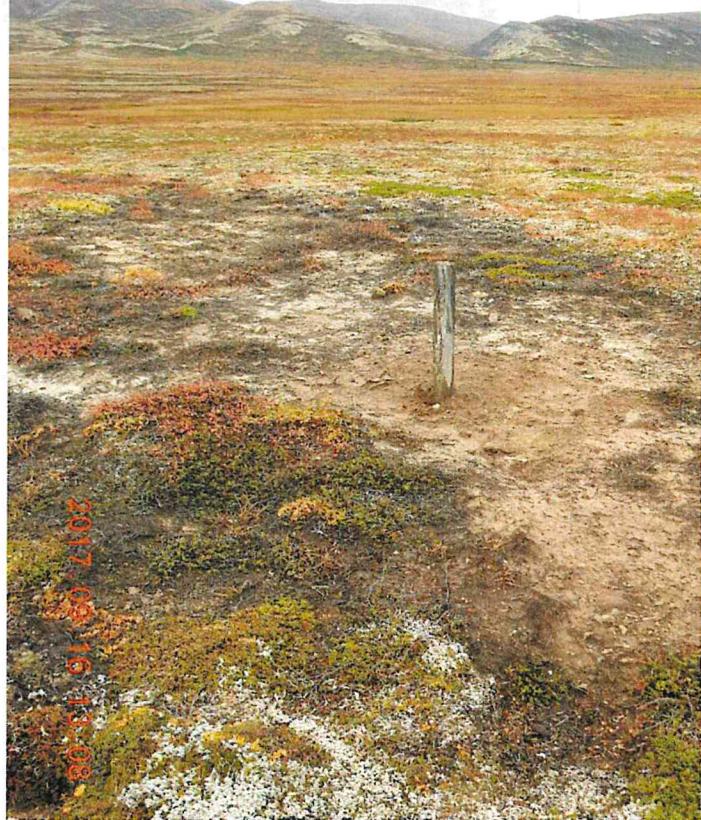
10. Borehole 3134
16 Sept 2017

Borehole 3134 was abandoned and reclaimed in 2017. Vegetative regrowth since drilling has been slow and may be due to the minimal organic layer naturally occurring in the surrounding area. DNR requests the operator amend the soil and reseed as necessary to encourage regrowth. Borehole rating has been modified to 3-B⁴.

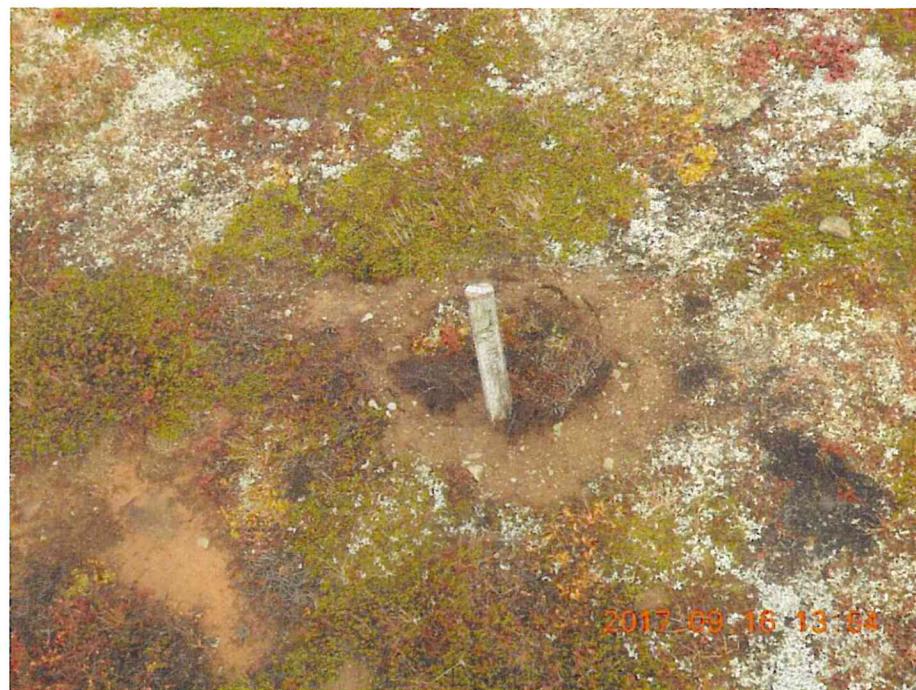
11. Boreholes 4153
16 Sept 2017

Borehole 4153 appears to be experiencing a small amount of subsidence surrounding the casing. The subsidence is estimated at approximately 4" deep by 3' wide encircling the borehole location. In 2017, the operator removed the casing above ground and may have instigated this condition during reclamation efforts. DNR requests the operator to monitor the site in 2018 for further subsidence or monitor to verify the site is in fact subsiding. If the site is subsiding, complete a repair to prevent further subsidence. The borehole rating for this site has been modified to 3-D⁴.

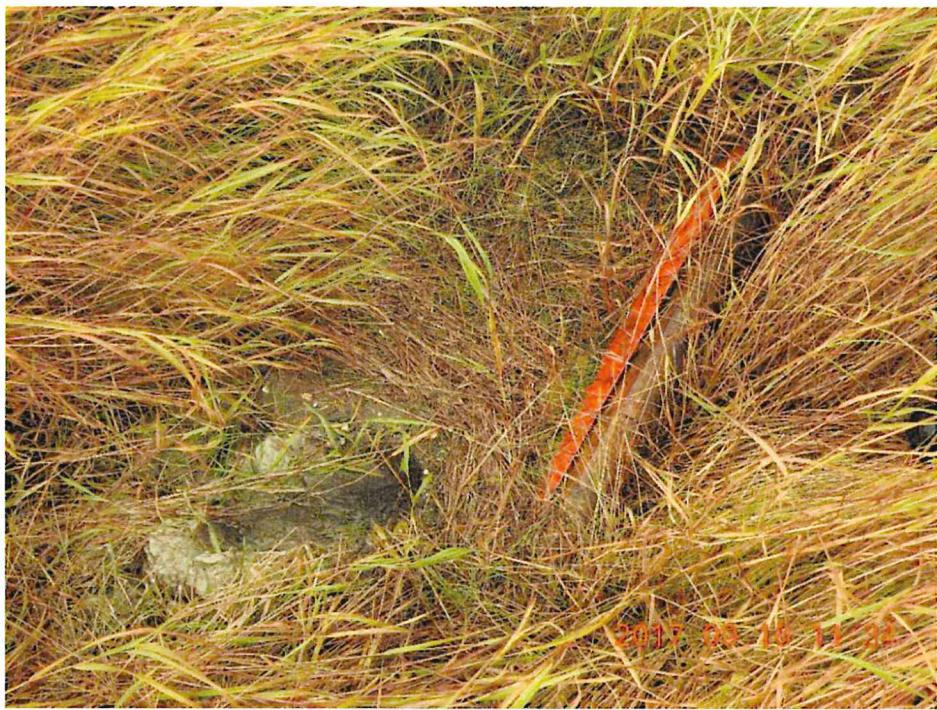
12. Borehole 4224
16 Sept 2017

Borehole 4224 had an attempted repair but the repair was not successful. Surface water flow from the hillside appears to be affecting this borehole though water does not run from the borehole itself. DNR requests the operator to complete repairs in the 2018 season and to backhaul the cut casing from the field. The borehole rating has been modified to 3-C⁴.

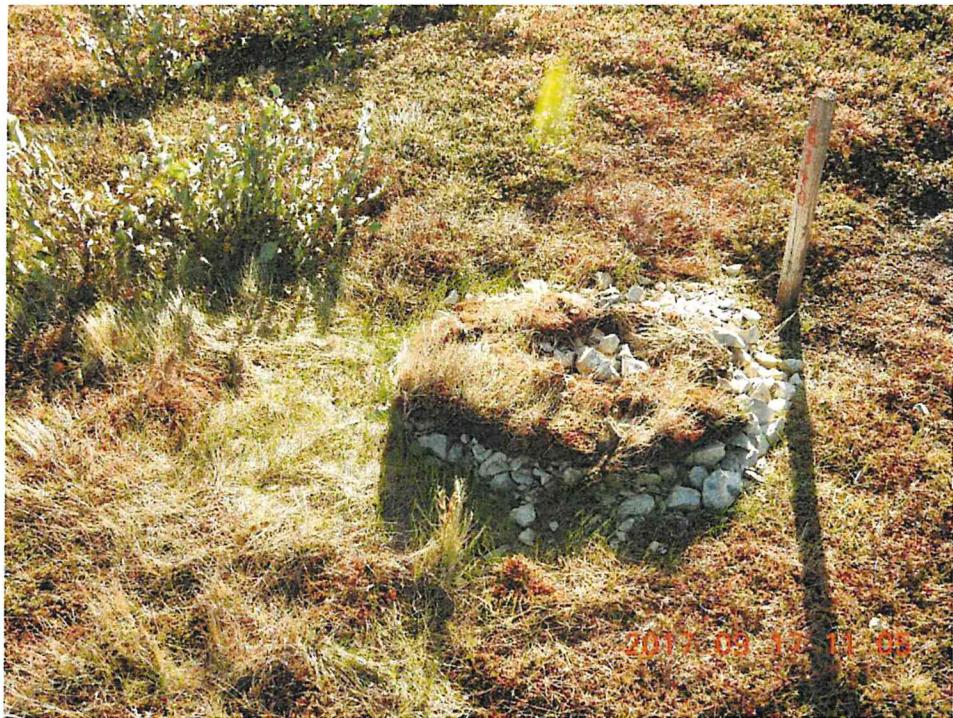
13. Borehole 6340
17 Sept 2017

Borehole 6340 has a pile of mounded rock at the borehole location. This borehole was abandoned by cutting off the casing structure in 2017. DNR requests the operator place additional organic cover to promote revegetation. The borehole rating has been modified to 3-D⁴.

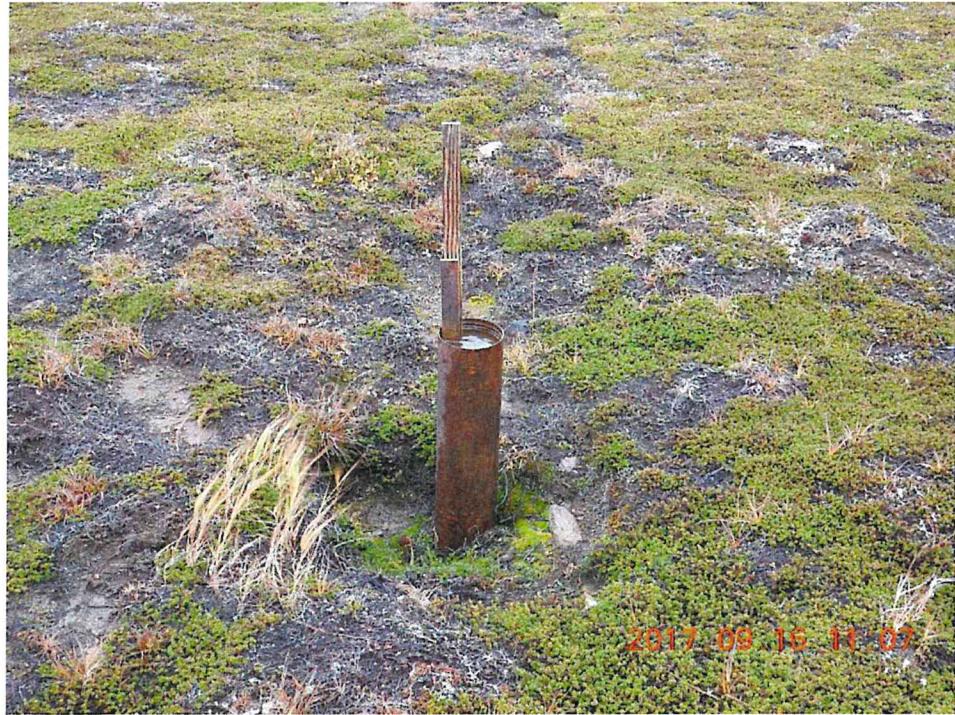
**14. Borehole
GH11-247**
16 Sept 2017

This borehole has been grouted, plugged and reclaimed but not abandoned (an above ground casing remains). DNR inquired as to why the borehole casing was not capped and was informed there is a PVC pipe structure within the borehole casing which is properly capped. The rating for this borehole has been modified to 2-D⁴.

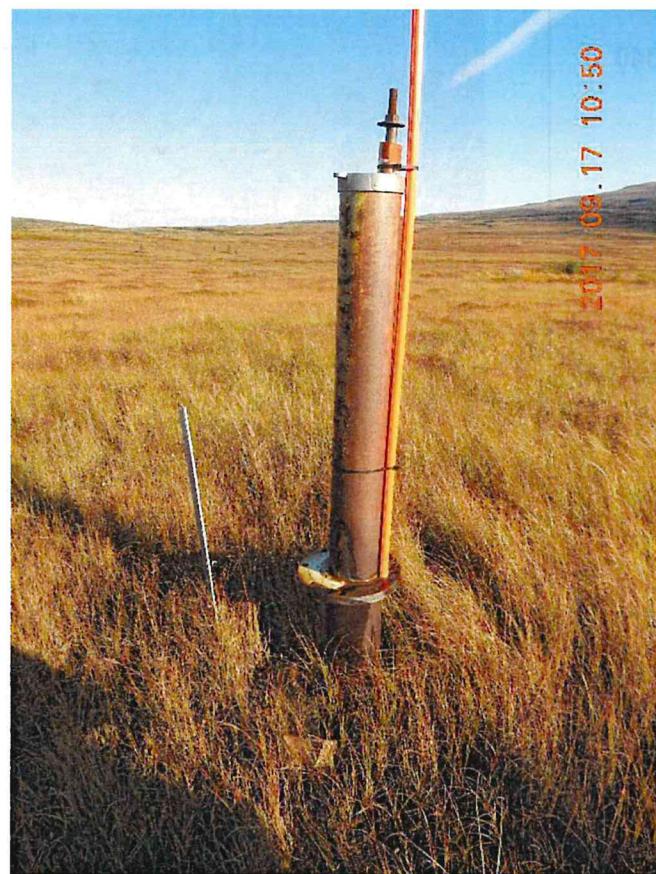
15. Borehole GH11-272S
17 Sept 2017

This monitoring well has a pin hole in the casing approximately 6" above the lower casing collar. A very small amount of rainwater is dripping and running outside the casing. A small amount of algae growth was observed. This well has a Margo plug installed which prevents capping. This notification is a matter of courtesy only as the condition does not pose a compliance risk or environmental degradation. DNR advises the operator to repair at the operator's convenience.

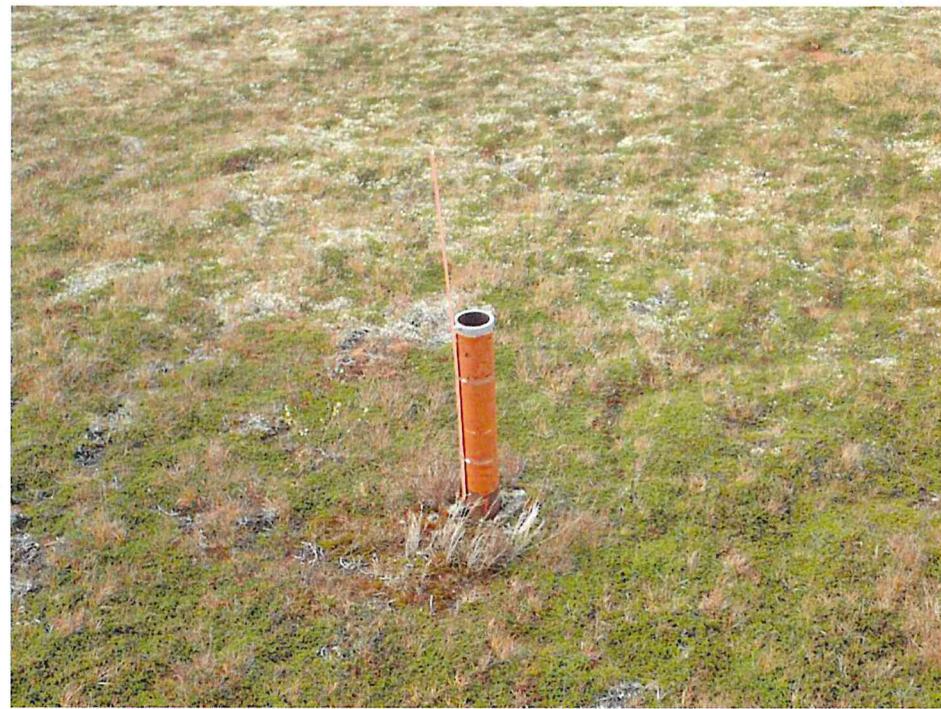
16. Borehole P-04-02M
16 Sept. 2017

Site P-04-02M was observed to be lacking a cap on the monitoring well. The cap was observed onsite but was not affixed. It does not appear the condition of this monitoring well would prevent capping. The operator notified DNR that the casing was successfully capped on October 6th, 2017. The rating for this location has been modified to 1-E⁴.

Three boreholes were observed missing caps (GH06-078, P-04-02M, and P-04-03), in violation of MLUP A20176118 reclamation stipulation 1g. The requirement for borehole capping is a new permit stipulation and requires the operator to cap approved boreholes or monitoring wells where practicable, in a manner which prevents water infiltration, contamination of groundwater, artesian conditions or tampering. Site GH06-078 is plugged but not abandoned (an above ground casing remains). The operator should consider removing the above ground structure and fully abandon the site or request approval to retain the site for future use. The presence of the material plug satisfies the spirit of the capping requirement at this site. Site P-04-02M was observed with a cap present, but not affixed. The operator was notified during the inspection. Borehole P-04-03 was observed with a cap present but not affixed. Site P-04-03 is otherwise in stable condition and is not producing a surface water expression.

ADNR was subsequently notified by the operator that all sites were successfully capped on 5 October 2017 (GH06-078), 6 October 2017 (P-04-02M), and 18 January 2018 (P-04-03). As a result, the infractions mentioned above have been adequately addressed and no further action is required

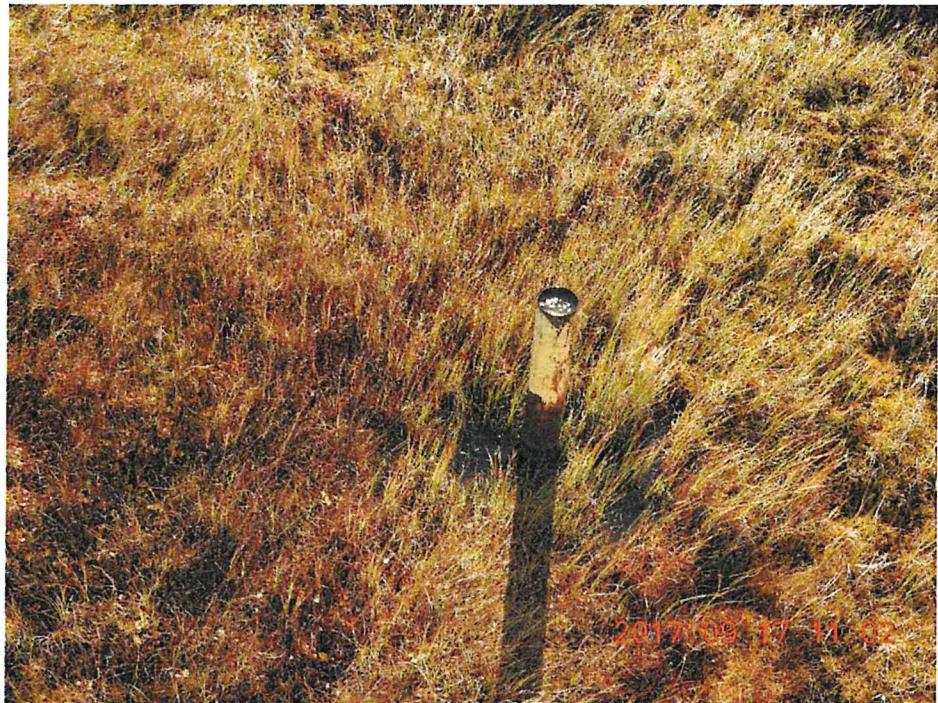
17. Borehole GH06-078
17 Sept 2017

Site GH06-078 was observed to be lacking a cap on the casing. There was no cap observed onsite at the time of inspection and no structures were identified that would reasonable prevent capping. This monitoring well has been grouted and plugged. The operator subsequently reported successful capping at borehole GH06-078 on October 5th, 2017. The rating for this location has been modified to 2-E⁴.

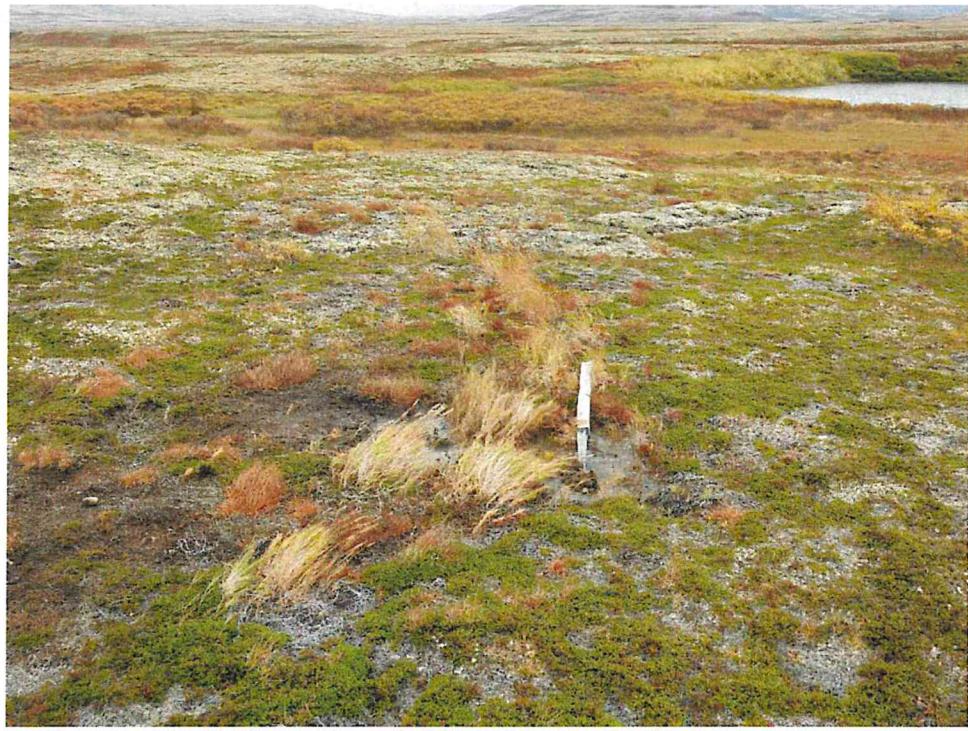
18. Borehole 11538
15 Sept 2017

Borehole 11538 exhibits pooled surface water at the borehole location. The site is located on a dry bench above a small kettle pond and does not appear to be under the direct influence of a surface water source. The outflow channel observed in previous inspections was not observed in 2017. The operator informed DNR that a drilling contractor investigated the site and determined water was precipitation resurfacing after rain events or snow melt. The drill contractor did not advise re-drilling. DNR requests the operator to continue monitoring at this site. The rating for this location has been modified to 3-C⁴.

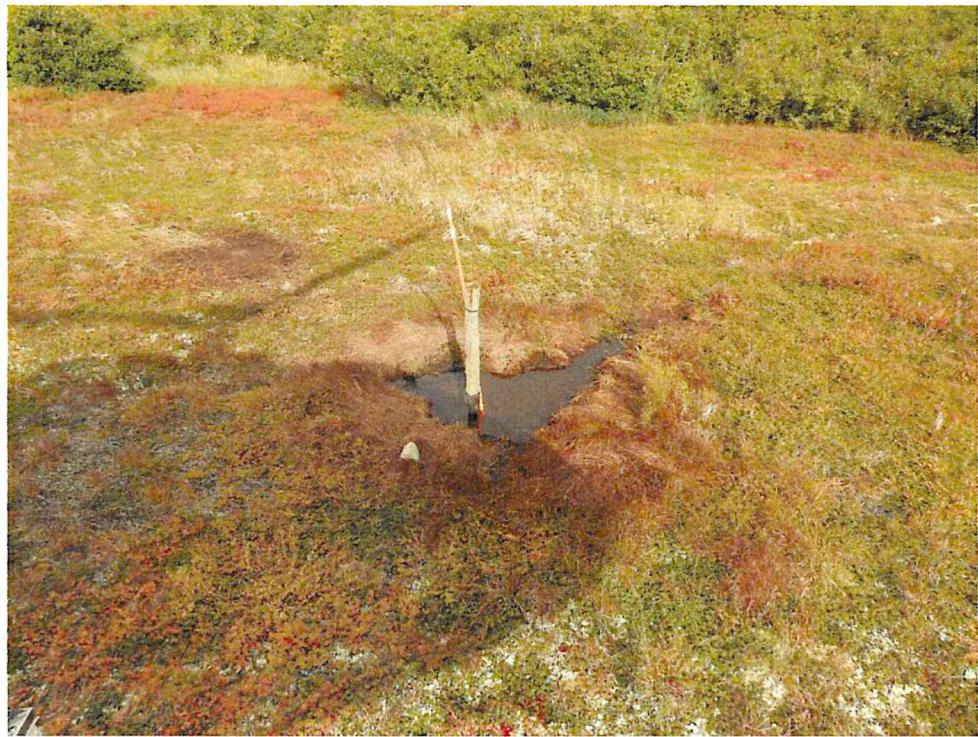
19. Borehole 12550
15 Sept 2017

Borehole 12550 exhibits continued pooling of water at the casing. The standing water is clear and approximately 6-8" deep in a triangular shape (approximately 4' wide by 6' long) surrounding the borehole. Vegetative growth surrounding the pool of water suggests its continued presence. The outflow channel downgradient from the borehole observed in previous years was dry at the time of inspection. DNR requests the operator continue to monitor this site and conduct any repairs as necessary. The borehole rating for this location is retained at 3-C⁴.

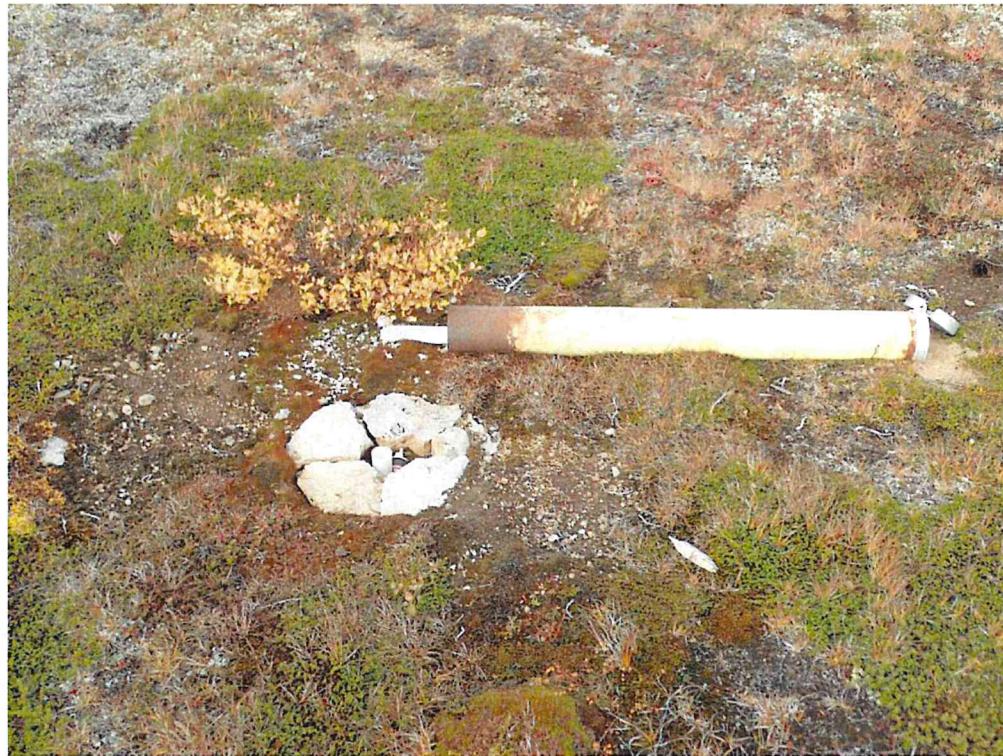
20. Borehole P-04-03
16 Sept 2017

Borehole P-04-03 was observed with the casing and a PVC pipe structure removed from the main PVC pipe stem. The borehole stem is a PVC structure and appears to have been capped at one time. The PVC pipe was not observed with a cap at the time of inspection as is required under MLUP A20176118. DNR requests the operator place a cap as soon as practicable. The borehole rating for this location has been established as 1-C.

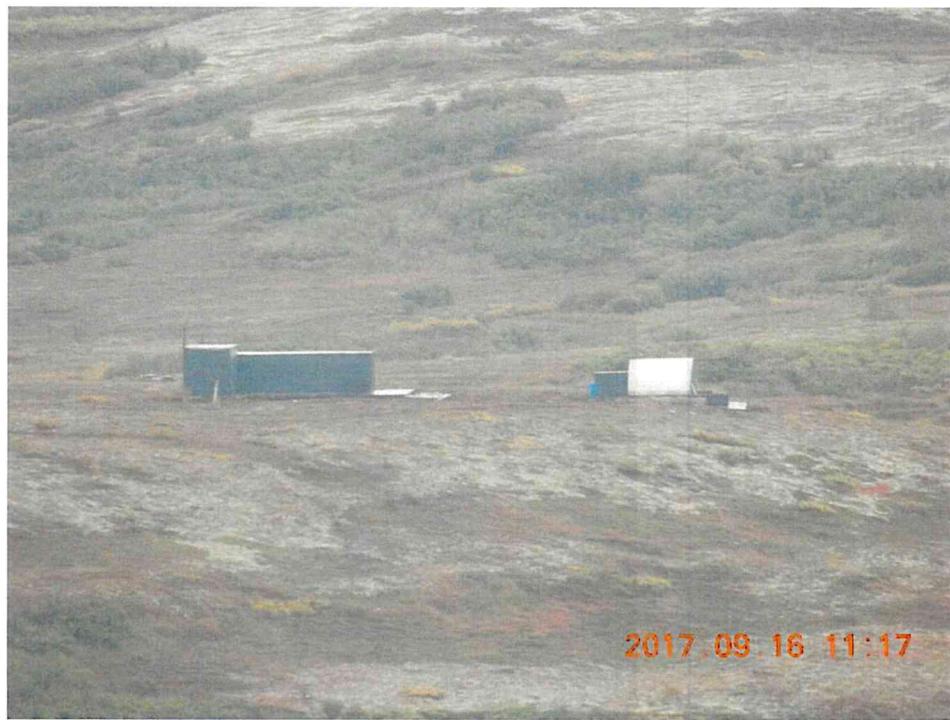
23. Watershed
16 Sept 2017

The Watershed site is in good condition and houses remediation and emergency response supplies. A fuel tank with aluminum containment is present. The fuel container was empty at time of inspection. Secondary containment rainwater collection should be decanted regularly if the tank is put into operation.

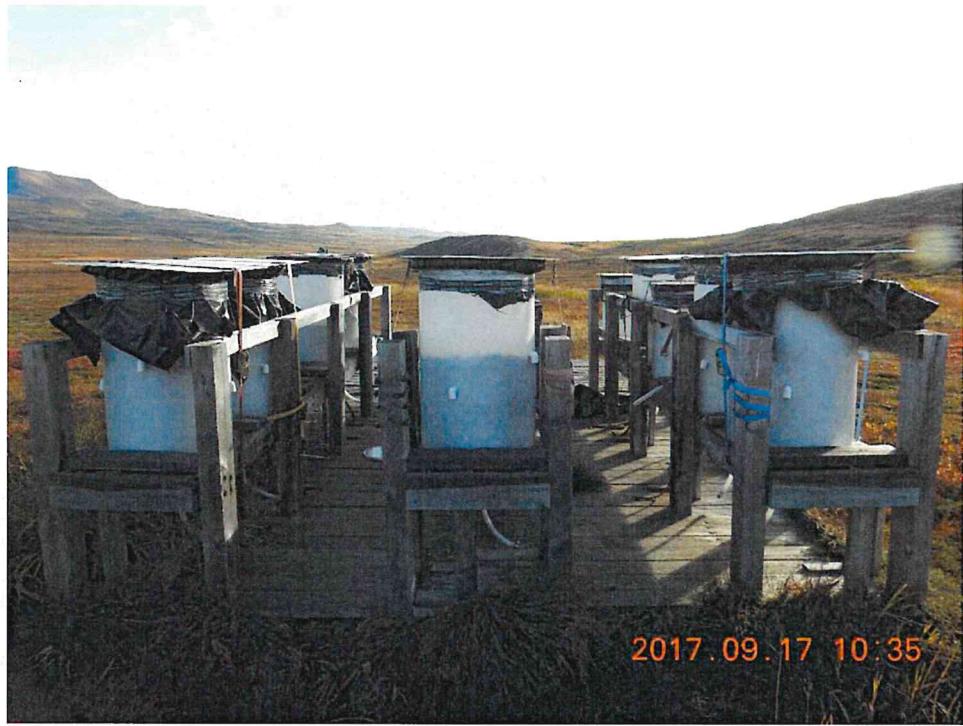
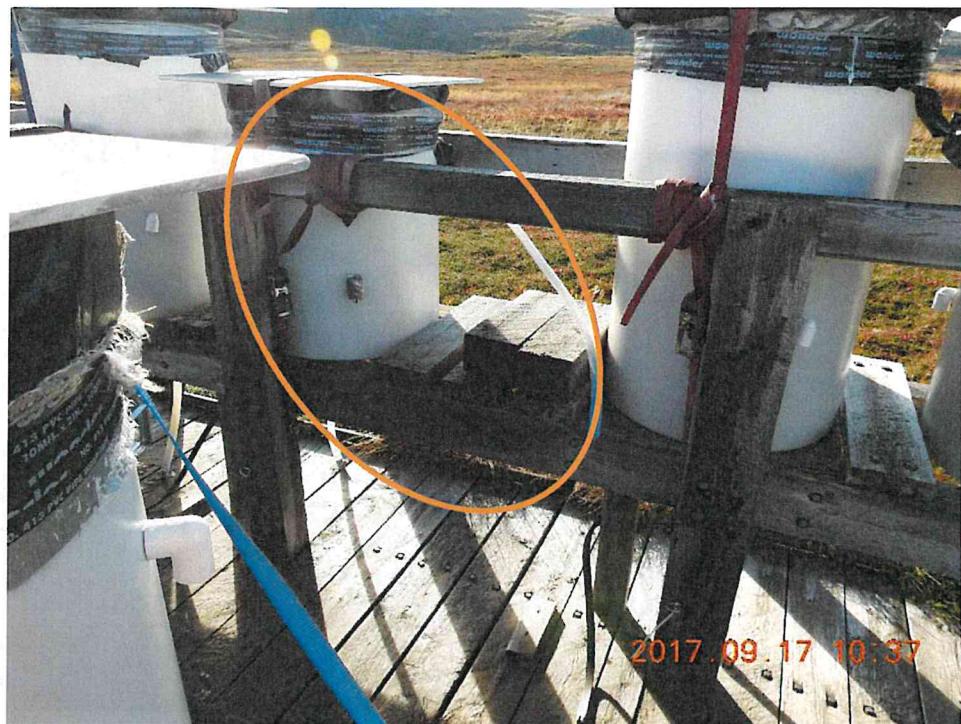
The ARD Test Site is comprised of twelve poly drums containing rock material. All inlets and outlets to the drums are adequately sealed with exception of one hose outlet (middle drum, most southeasterly row). The hose inlet is approximately 6" above rock level with no water observed in the container. Notification was given to PLP during the inspection to reseal the outlet. PLP described having trouble with avian wildlife disrupting the tops of the barrels in the 2016 inspection. PLP replaced all lids with substantial metal lids appropriately affixed to the barrels. All drums are located on a tundra pad and no water was present onsite. No discoloration or other indicators of leakage were present. ADNR requests PLP continue to monitor regularly. Any repairs or modifications should be detailed in the annual reclamation report.

Orange colored circle identifies
hose without outlet
plug. See Section
4.3.

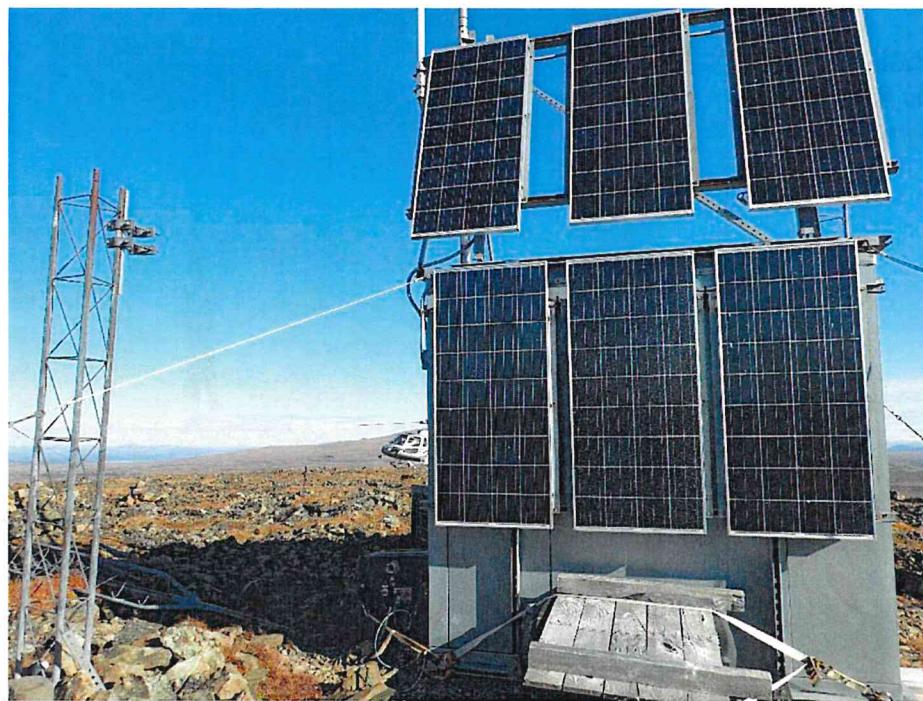
**31. Koktuli
Mountain Radio
Repeater
Damage**
17 July 2017

ADNR visited the Koktuli Mountain Repeater Station and found facilities to be in acceptable condition. PLP noted vandalism to solar panel and tower equipment in the winter of 2016-2017. The operator subsequently reported cable and tower replacement in the 2017 field season⁷.
