# **INVESTIGATION OF RECLAIMED DRILL SITES, PEBBLE PROSPECT, 2016**

**Center for Science in Public Participation  
*for*  
United Tribes of Bristol Bay  
304 Main Street  
Dillingham, AK 99576  
November 3, 2016**

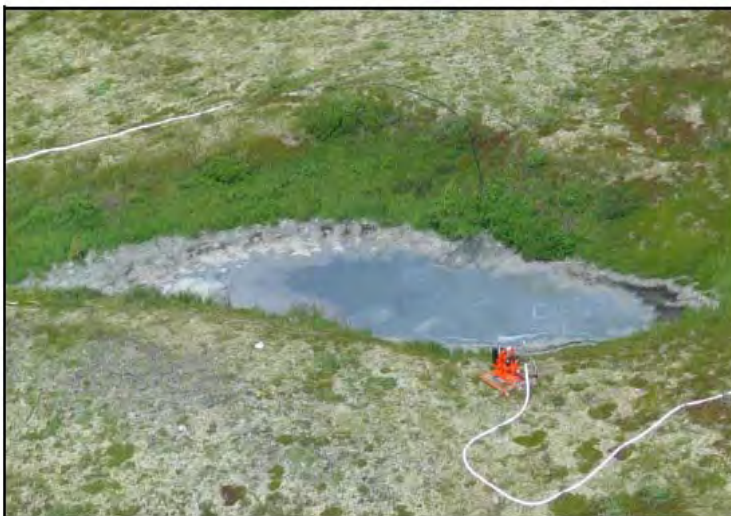
Photo #14. Clay deposited in a dry depression by discharged drilling fluids.

***Figure 1. Drilling waste discharged to land.*** Kettle ponds are small bodies of water in depressions; some are connected to groundwater while others are not. Large pumps move water uphill from the sump approximately 1000 feet to upland ponds (DNR inspection report June 2005), such as the one shown in this photo (DNR inspection report July 2007).

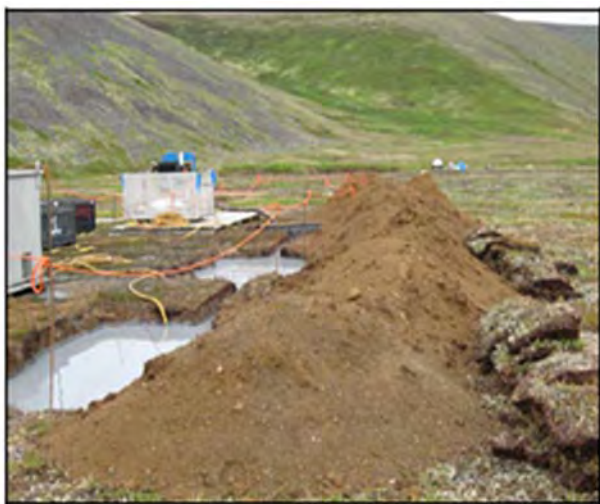
Figure 3. Sump pits (on left) and tundra stock pile being saved for reclamation (on right).

***Figure 2. Drill waste sumps in use.*** From DNR inspection report June 2010

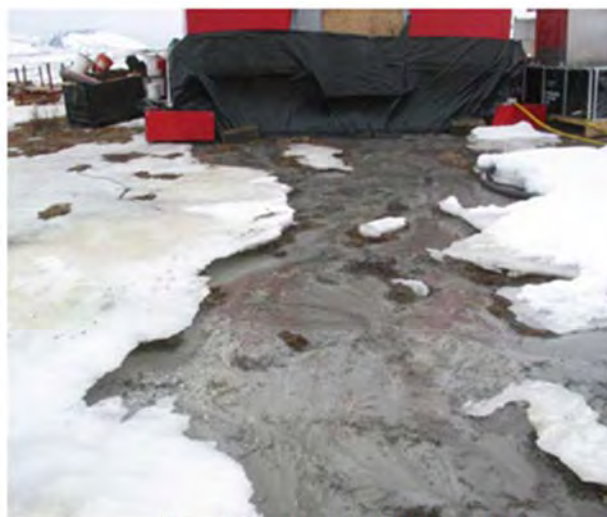
Figure 4. Water and cuttings discharge on uplands.

***Figure 3. Water and sediment from the drill cuttings was discharged as permitted onto the uplands directly from the drill rigs.*** During ice free months a sump pit will be dug to retain drill cuttings. (DNR inspection report, April 5 2007)

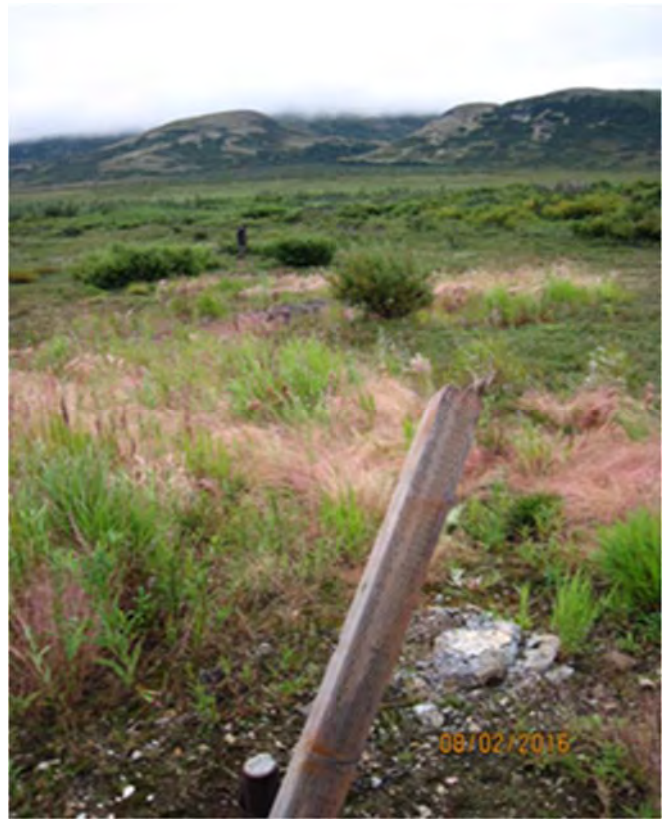
Dead vegetation was one of the most common sightings. Additionally some sites had “squirrel grass” (species not known) identified by a local resident as not native to the area (Figure 7). At site DDH 11533 it appears to be spreading downwind from the original site of application. These sites also had areas of dead vegetation, indicating that non-natives were applied when natural vegetation failed to re-establish. There is also a note in the August 2010 Field Inspection report that Kentucky Bluegrass was seeded at DDH 8417 to control erosion.<sup>7</sup>

**Figure 7. Squirrel grass.** Reddish-colored grasses in foreground and center.

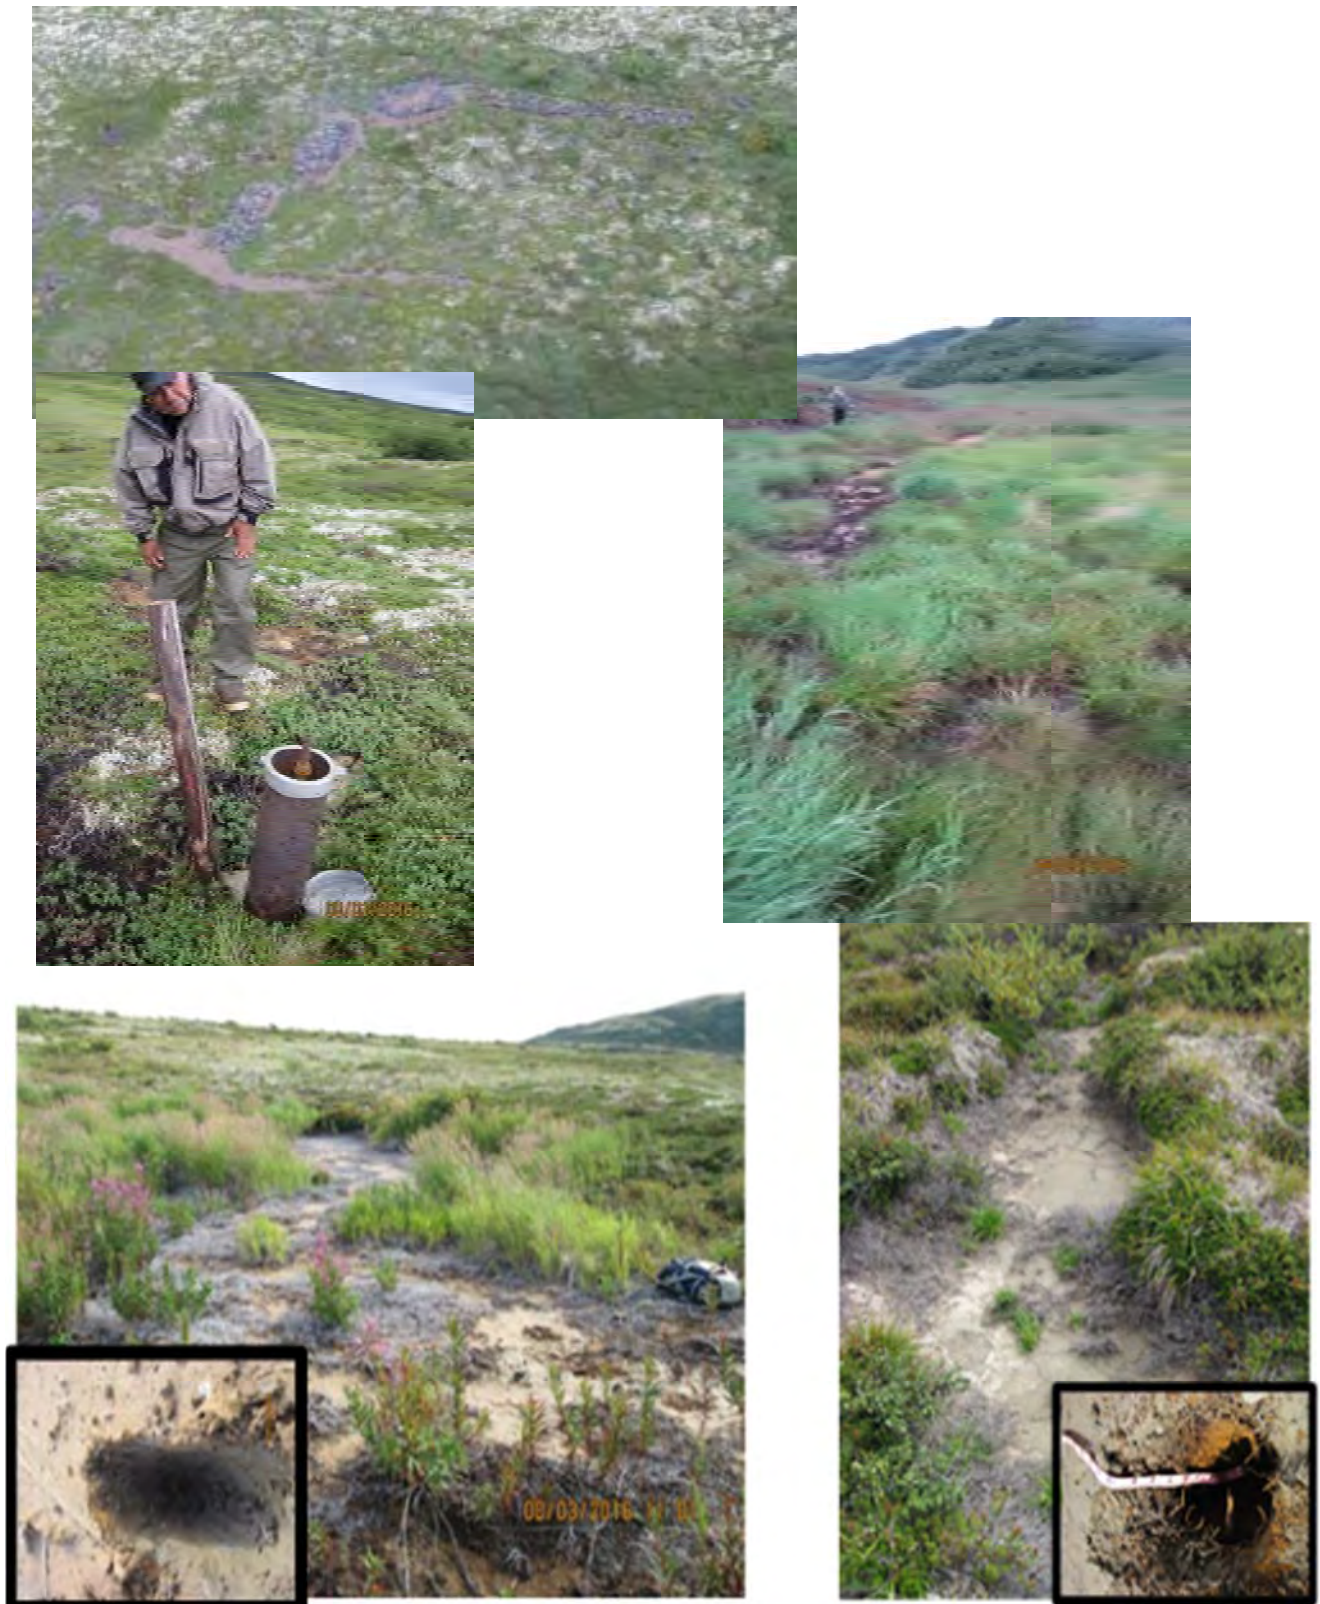
At several sites tundra mats placed on sump pits failed to grow, vegetation did not establish on overburden on sumps (Figure 8), or vegetation was failing to thrive as evidenced by dead patches. The October 2012 field inspection report by ADFG noted that “*stockpiled squares of tundra mat on-site were desiccated, overturned, broken and flaking apart, and scattered by the wind with no apparent effort to cover or protect them*”. Tundra mats may be failing to thrive due to poor handling, soil quality, or a combination.

Drill casings had been, and potentially still are, periodically flushing material onto the surface. At these sites, fine-grained orange-yellow or grey material presumed to be drill cuttings were present in a trail leading from the casing downgradient. Cuttings directly covered vegetation (tundra mats) and killed vegetation in the path of the trails. In some areas, drill cuttings had been apparently discharged over a wide area, and were evident as patches of cuttings and dead vegetation, particularly in depressions. Impacts from cuttings are distinct from locations where vegetation did not re-establish on drill sumps and trenches (Figure 8).

**Figure 8. Vegetation impacts.** (Top) Vegetation failing to grow on sumps at DDH 11540. (Middle) Drill cuttings flushed from open casings at GH05-60 (left) and DDH 7392 (right). (Bottom) Landscape and soil profiles of drill cuttings where drilling waste has been discharged over large areas near DDH 6355 (left) and DDH 12548 (right).

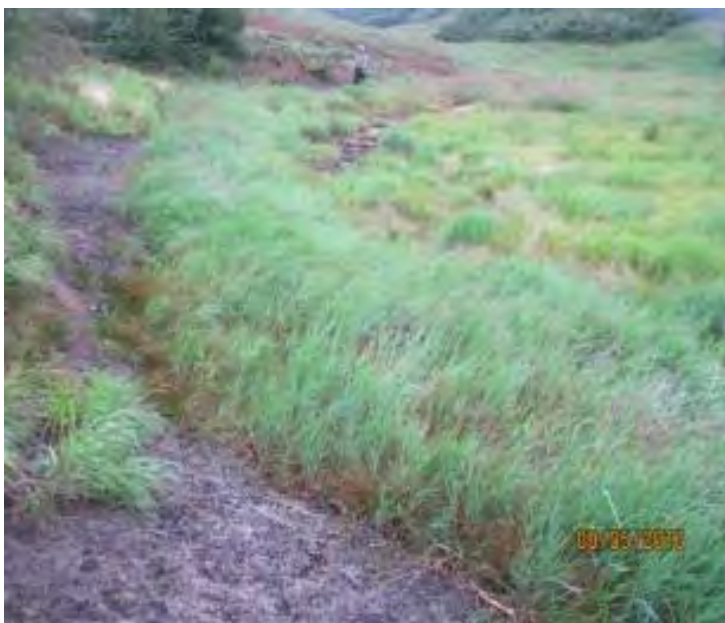
There is also a ring of dead vegetation several feet above the floor of the gulley (Figure 10). There is no obvious explanation for this, but it is possible that several drill sites disposed of waste in the gulley, affecting vegetation. Based on mapped information, a stream was

**Figure 10. Dead vegetation along hillside in gulley.** Acid drill cutting can be seen in the background in the bottom of the gulley, where they have flushed from DDH 7392.

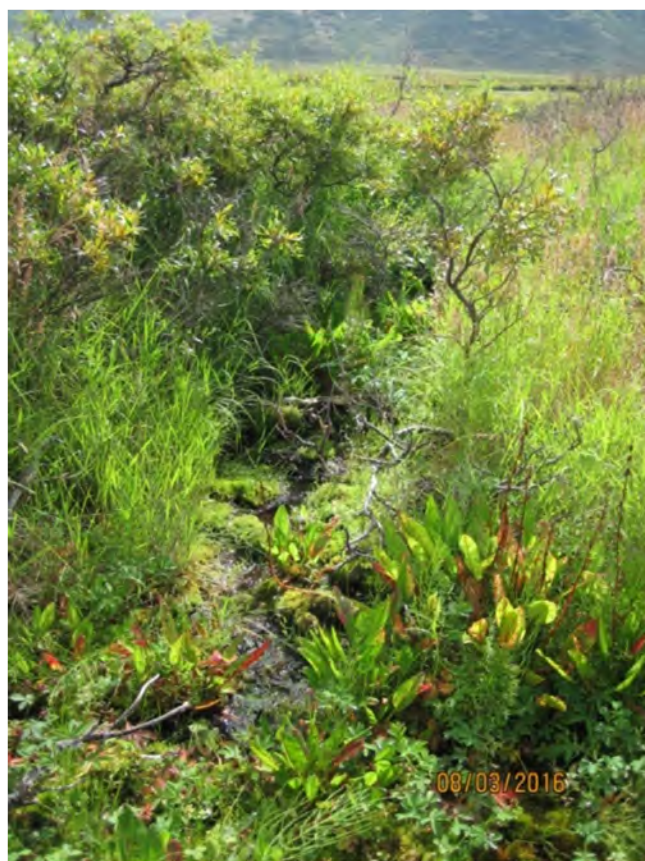
The wetland spring in 2016 had the same pH and conductivity as the 2011 sample, but was elevated in minor and trace elements relative to the 2011 sample, although lower in concentrations than the 2011 wetland pool sample. Concentrations of cadmium (not shown), barium (not shown), and zinc were similar to 2011, but copper, molybdenum, aluminum, iron, manganese were higher than in the 2011 spring sample and higher than ponds 715' and 915' upgradient (USGS 2008) (Table 10).

Figure 11. Wetland spring sampled in 2016.

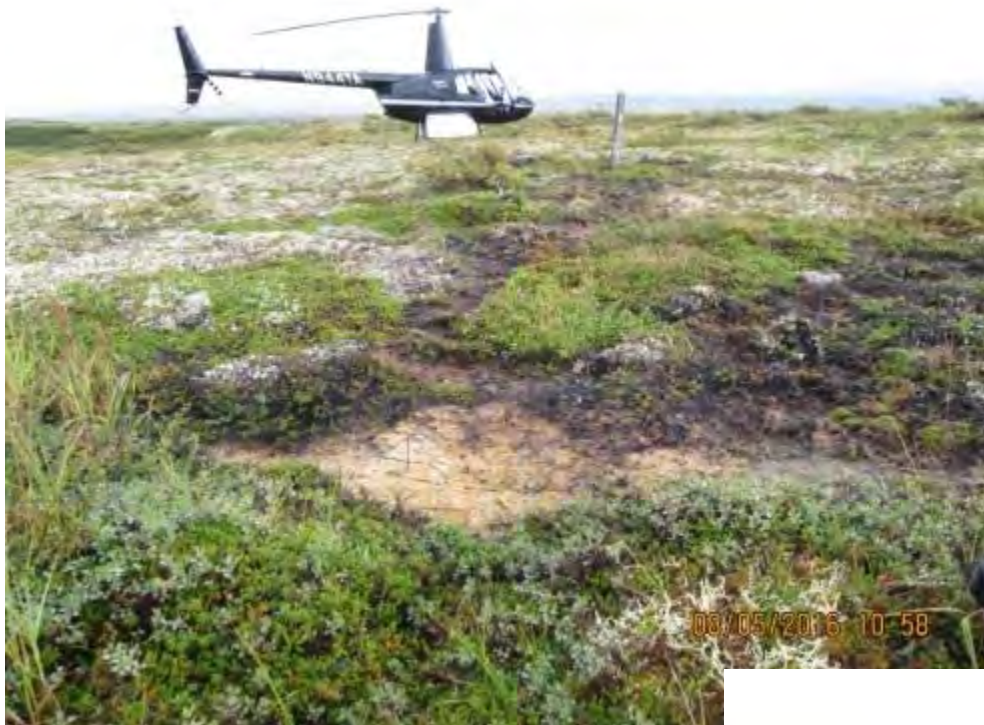
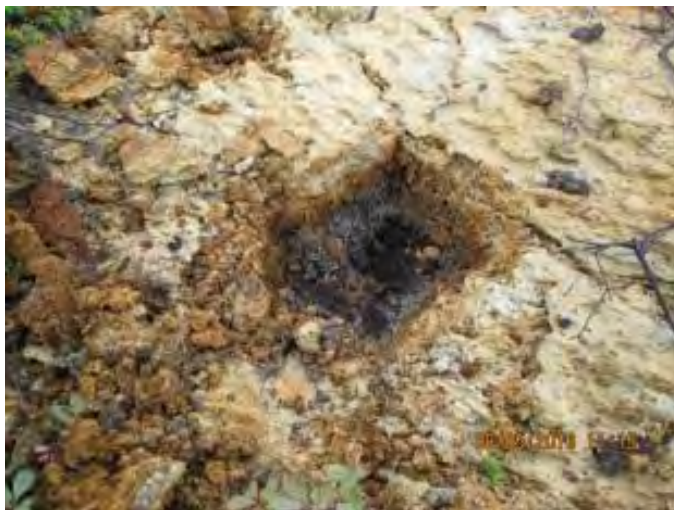
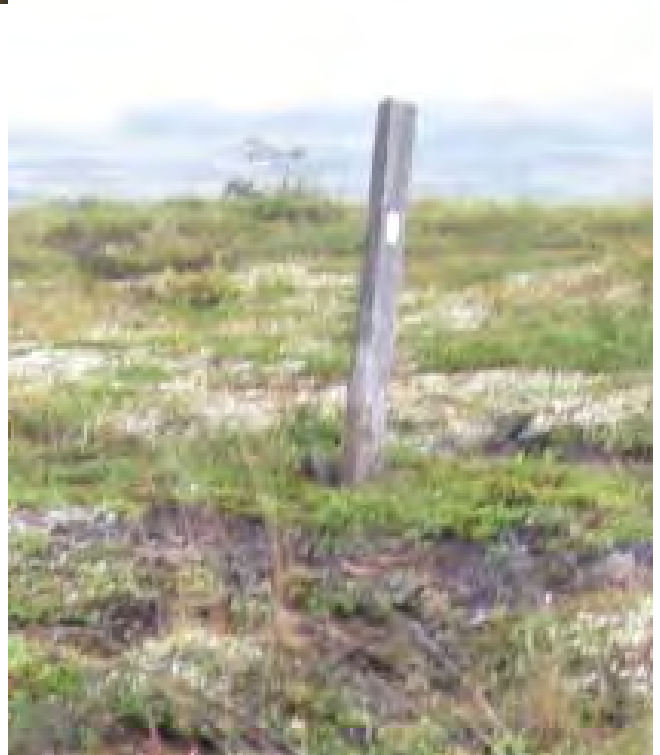
**DDH 3129**

**Drill cuttings flushed from this low, cut off, open casing towards a pond. A thick layer of cuttings is shown in the photos. Cuttings were acidic with elevated sulfate, arsenic, copper, and molybdenum. Pond water did not have high concentrations of analytes; pond sediment was not collected.**

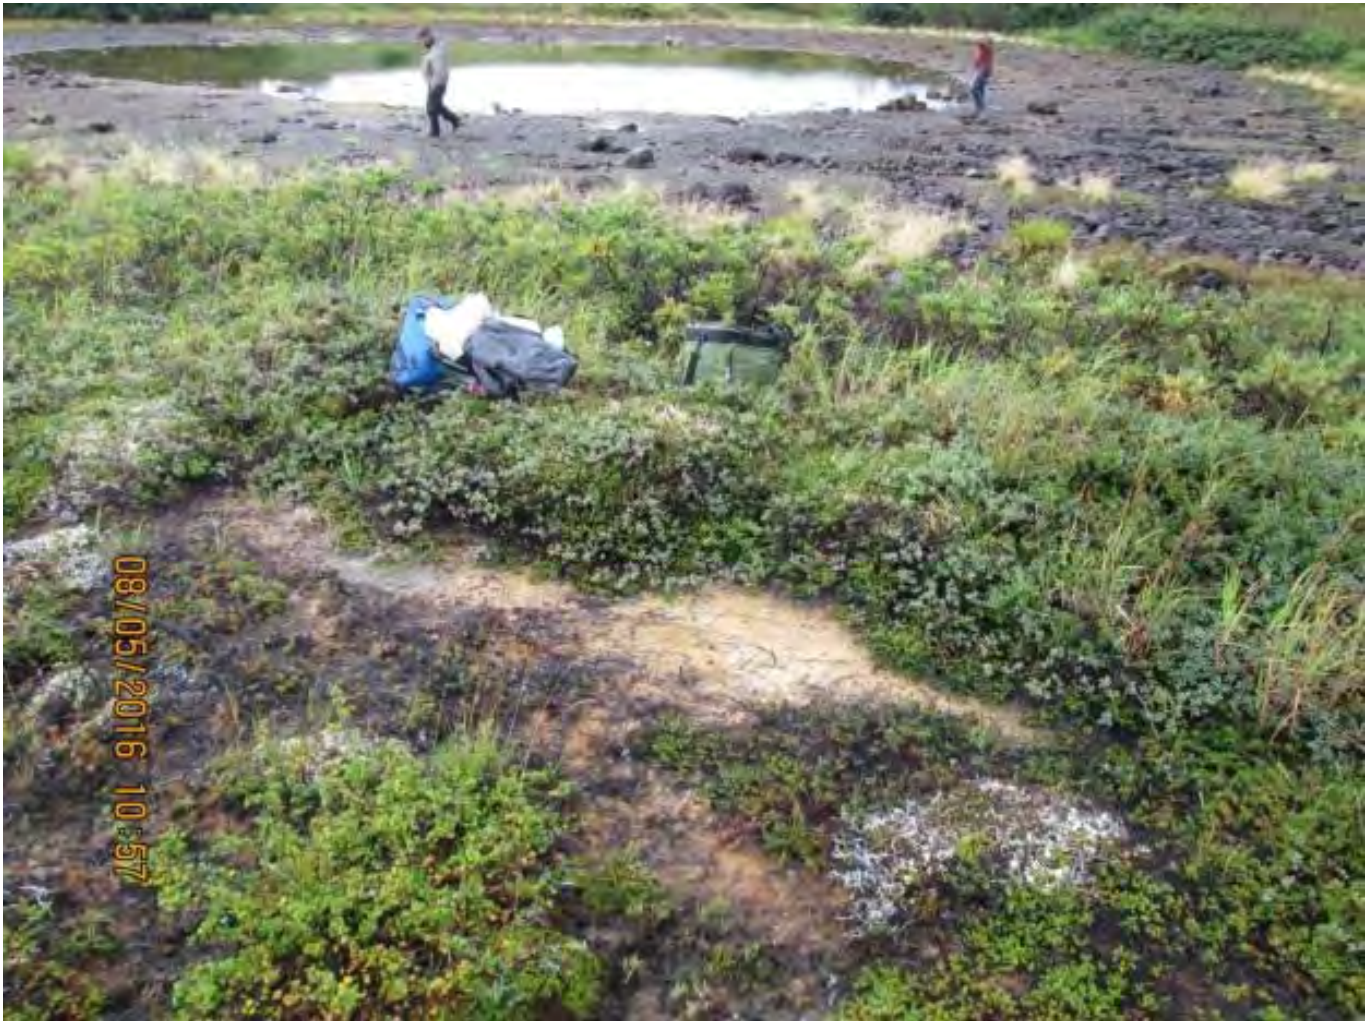
**The pond downgradient from DDH 3129 did not have elevated metal concentrations, with the exception of slightly elevated aluminum. Sediment was not collected.**

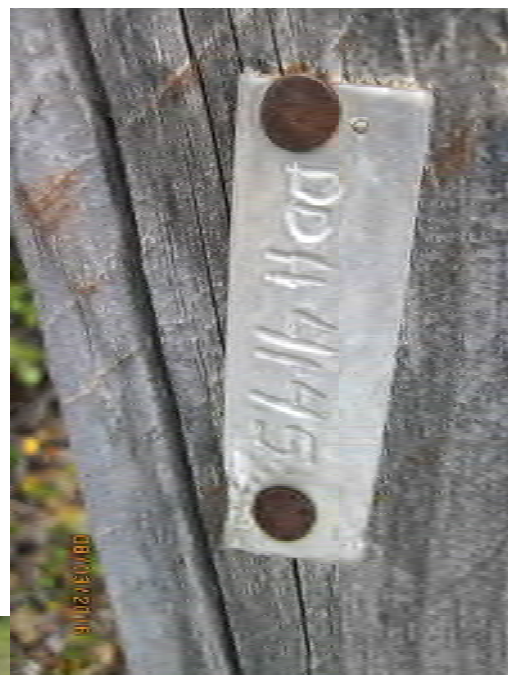
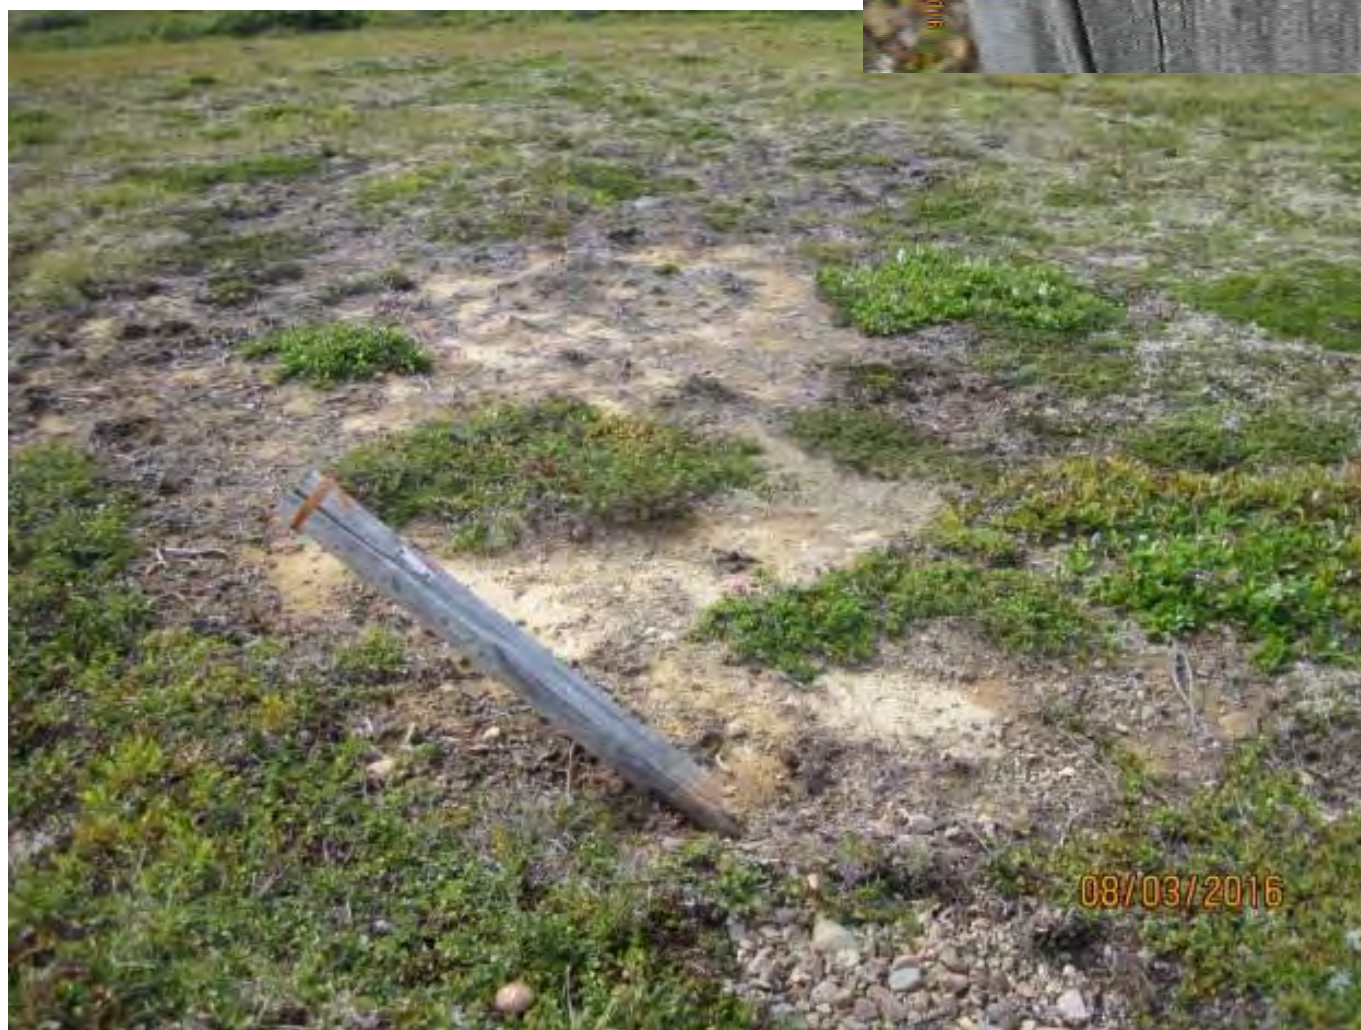
**DDH 4145**

**This site is one of at least six within walking distance of each other. It is a good example of cuttings flushed from a drill casing.**

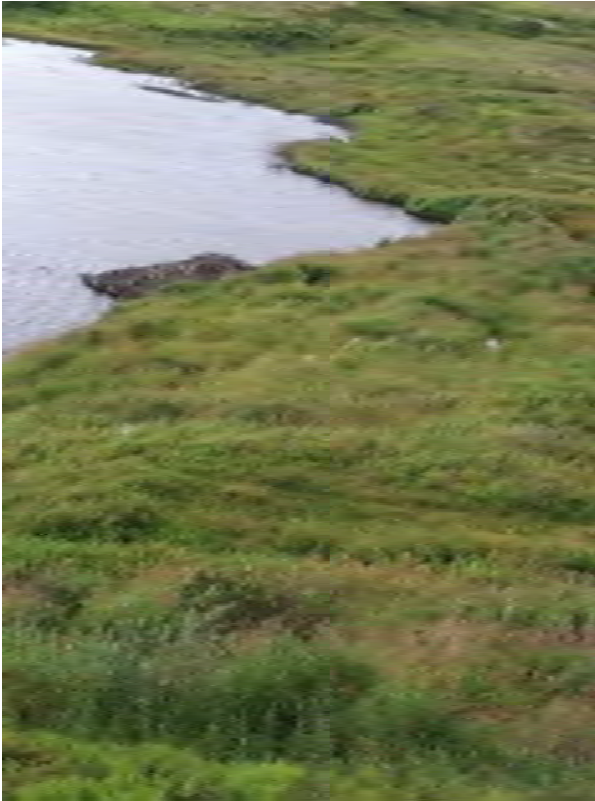
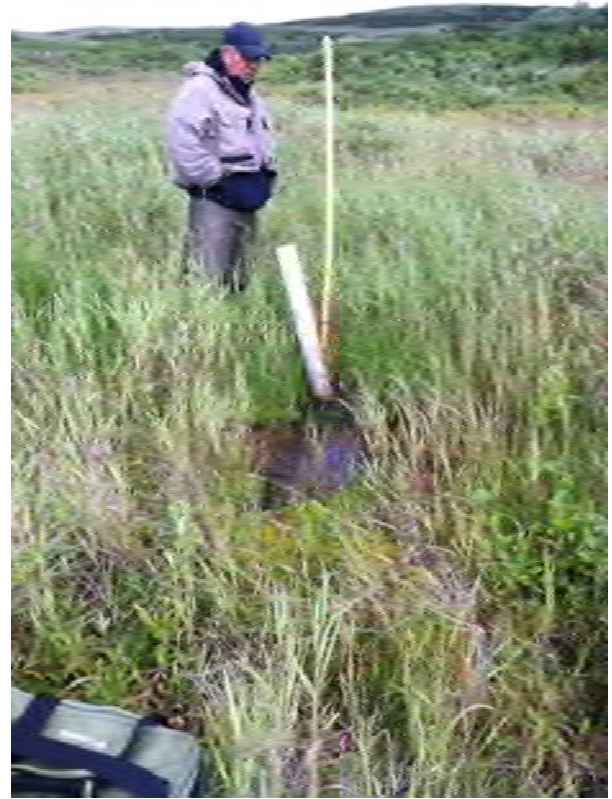
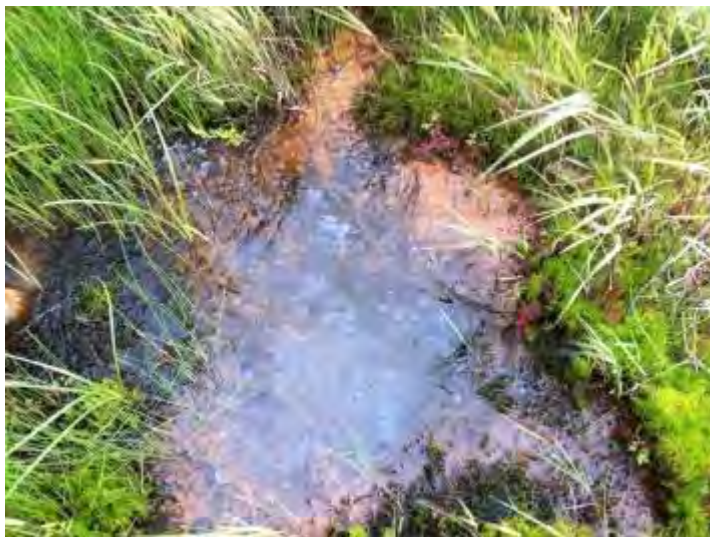
**This site is located in a wetland on the edge of a beaver pond. You can see the weathered orange snowpole marking the site in the picture on the left. To the right, outside of the picture, is a wetland pond that had iron staining. Water directly around the drill casing at DDH 4202 also had iron-stained water and a sheen. This is not uncommon in wetlands, so we collected water and sediment samples at the base of the casing. Iron and sulfate were elevated in water samples above water quality criteria and above water samples collected in the pond in 2008 (sulfate at 35 mg/L vs 11 mg/L and iron at 2.7 mg/L vs 0.6 mg/L). Sediment was very high in copper (1,892 mg/kg) and molybdenum (246 mg/kg). This information suggests that the standing water around the drill casing is artesian flow from water passing over mineralized ore in the drill hole, rather than natural wetland water.**

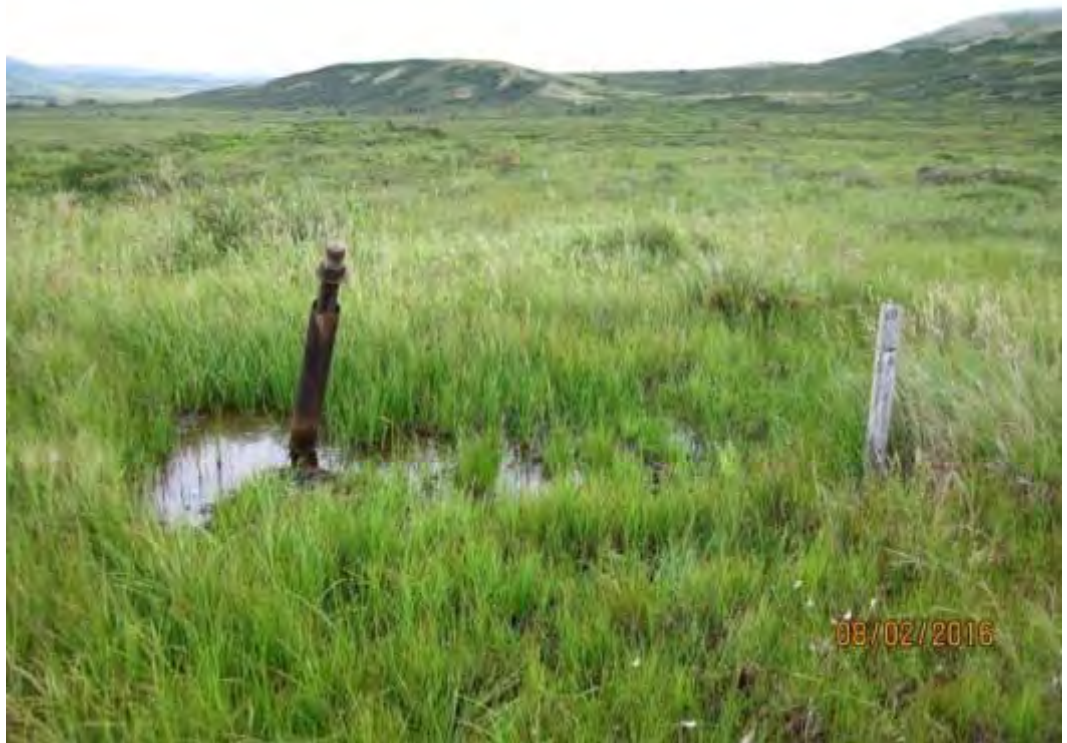
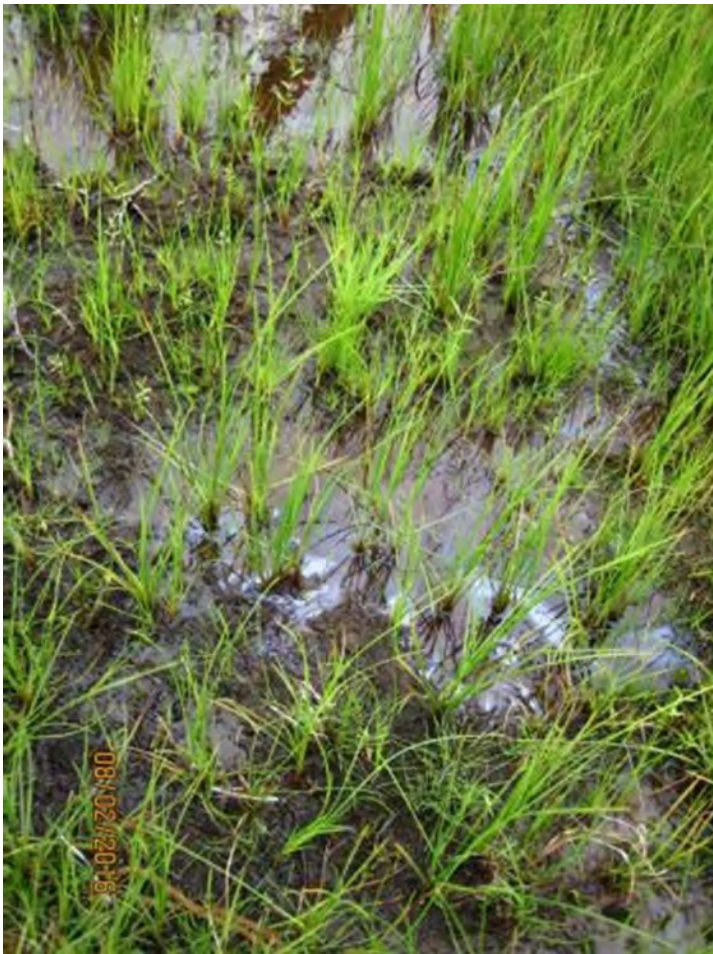
**DDH 5330 is in a wetland and surrounded by standing water. Water and sediment samples indicated that water is coming up from the casing. Although water was low in copper, sediment had elevated copper at 621 mg/kg; the highest background sediment copper in the mine area was 200 mg/kg, with nearby sites less than 20 mg/kg. Sediment was also enriched in molybdenum (98 mg/kg vs a maximum of 22 mg/kg in mine area sediment). This site was listed as a drillhole “converted to active” well although there are no indications that it could be used as a water source.**

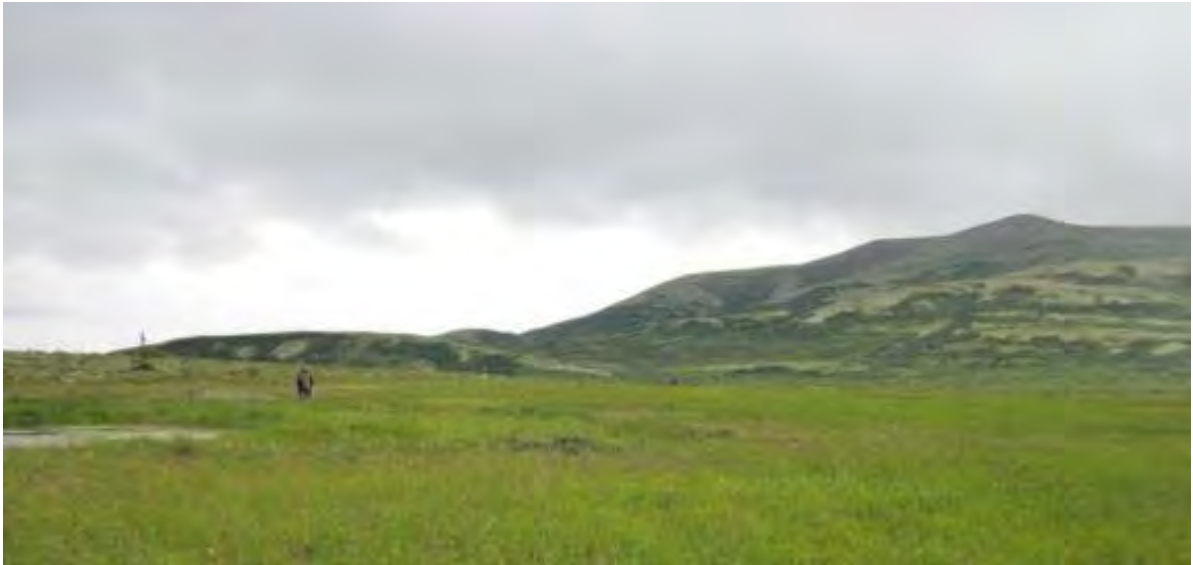
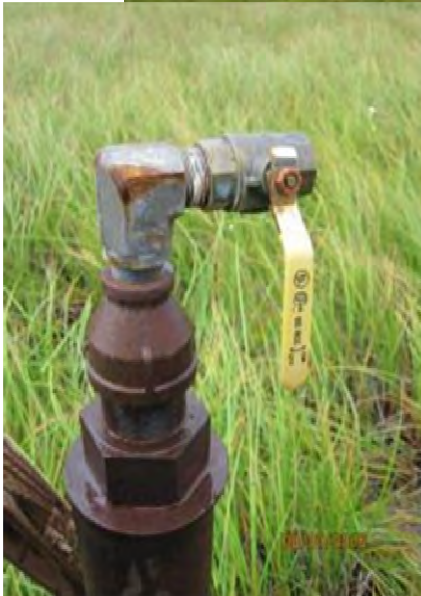
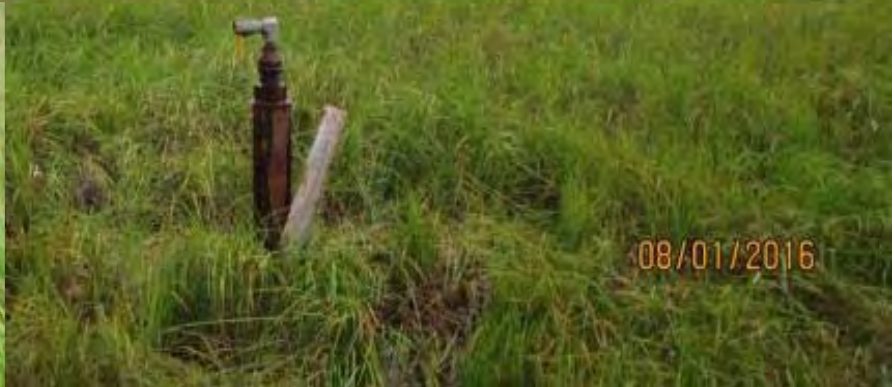
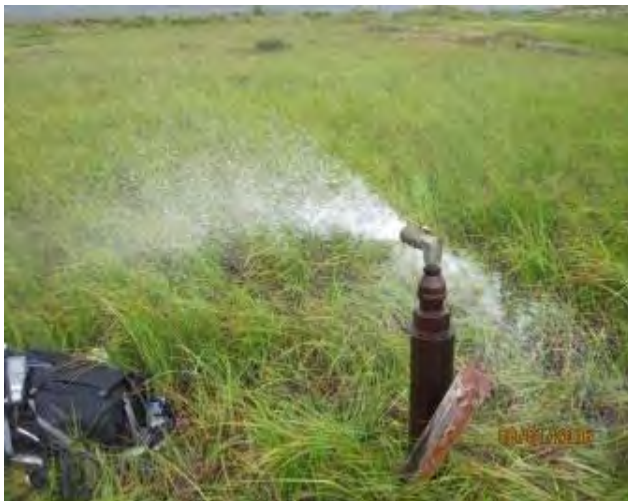
The entire plateau where this drill site is located is wet with springs. The drill site has a history of artesian conditions; USGS observed free-flowing water from the drill stem – and collected a sample – in 2008. The casing currently has a valve on it, but this will require regular maintenance. A similar site, DDH 7379, had a broken valve and artesian water. DDH 7365 is near a pond (to the middle left of the photo). Standpipe (also called drill stem) water was collected by opening the valve. It is elevated in sulfate, sodium, copper, iron, manganese, and lead (report Table 11 and unpublished).

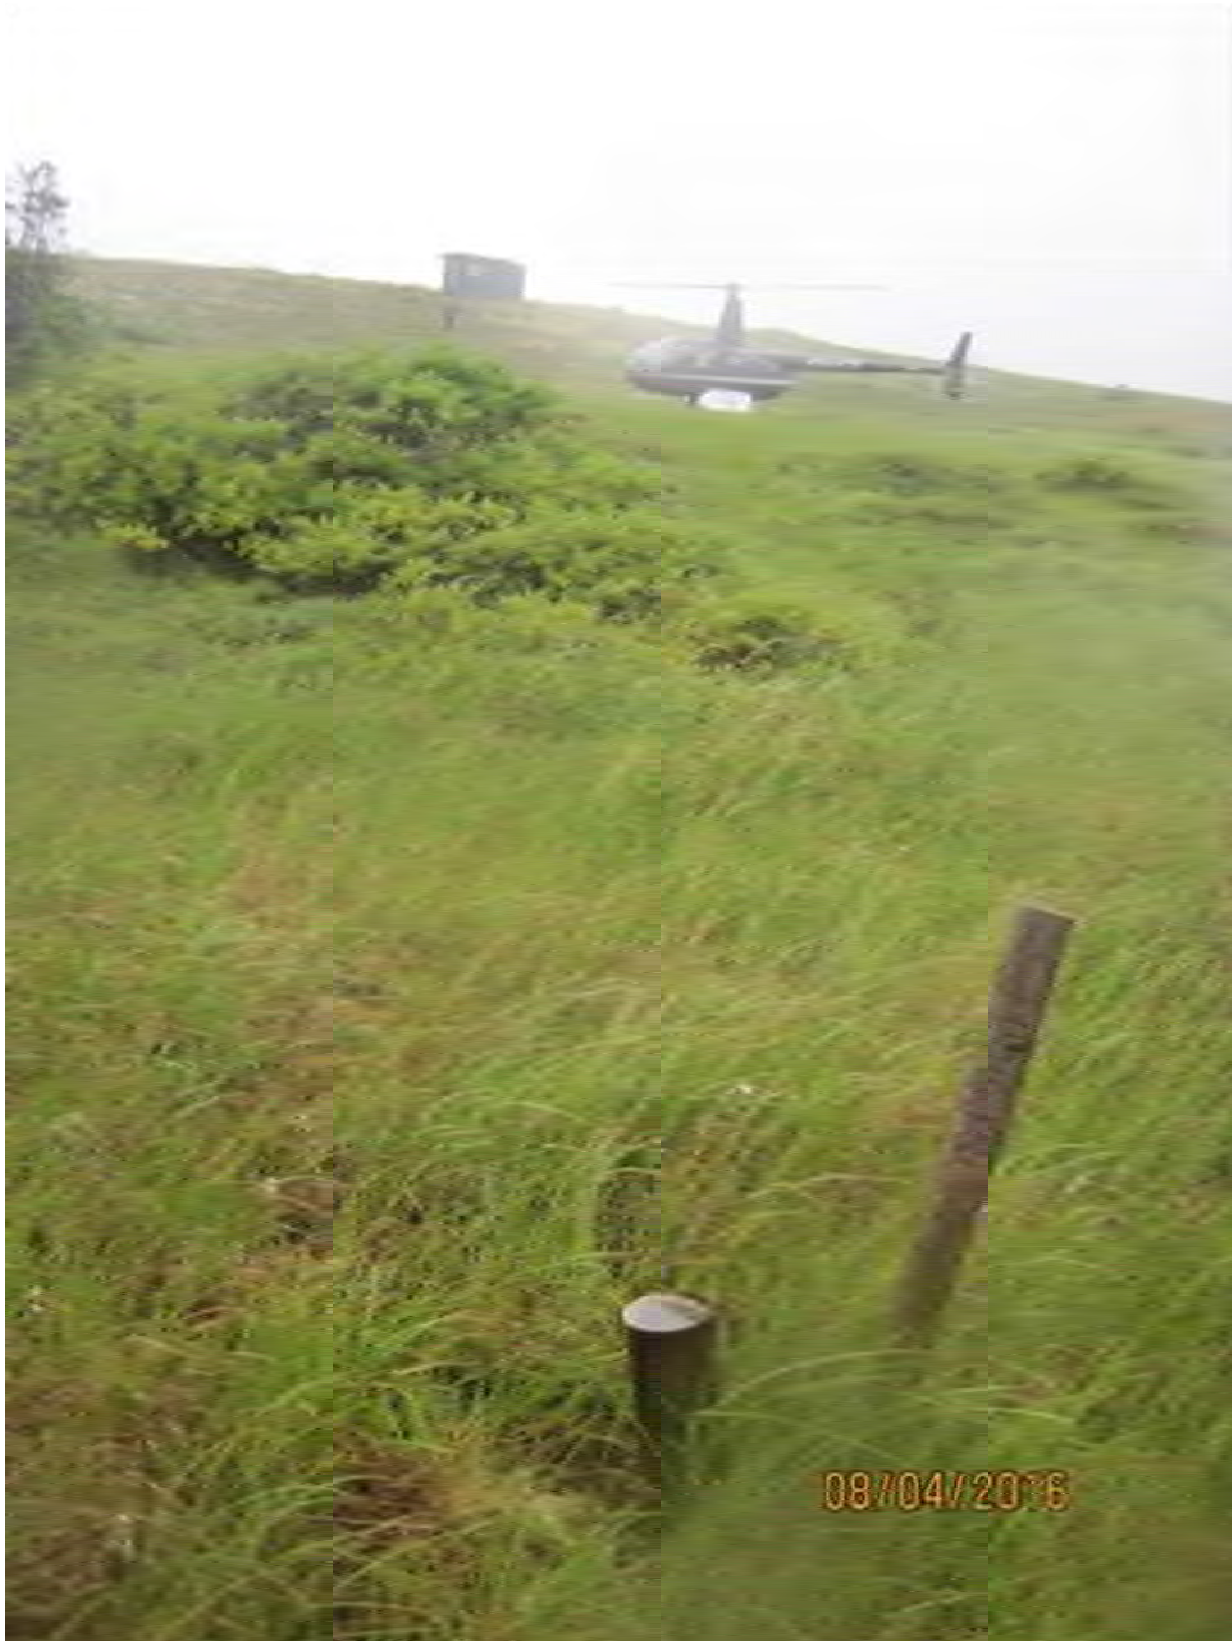
**DDH 7367**

**One of many examples of an open casing.**

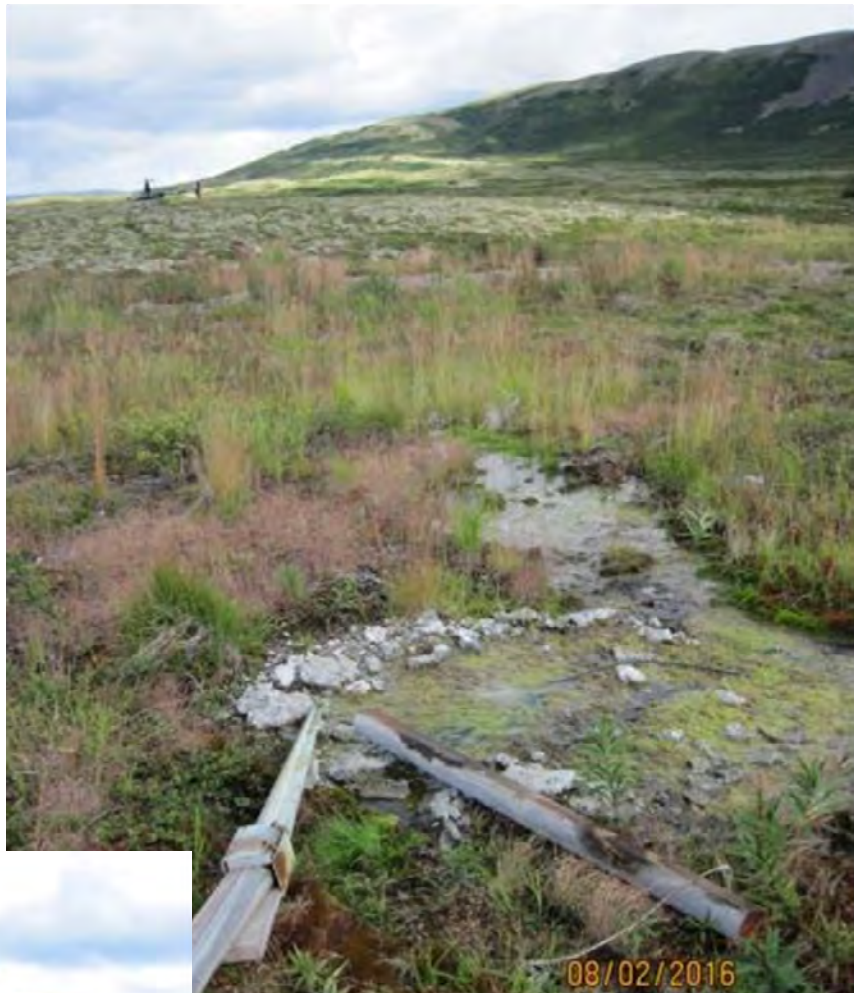
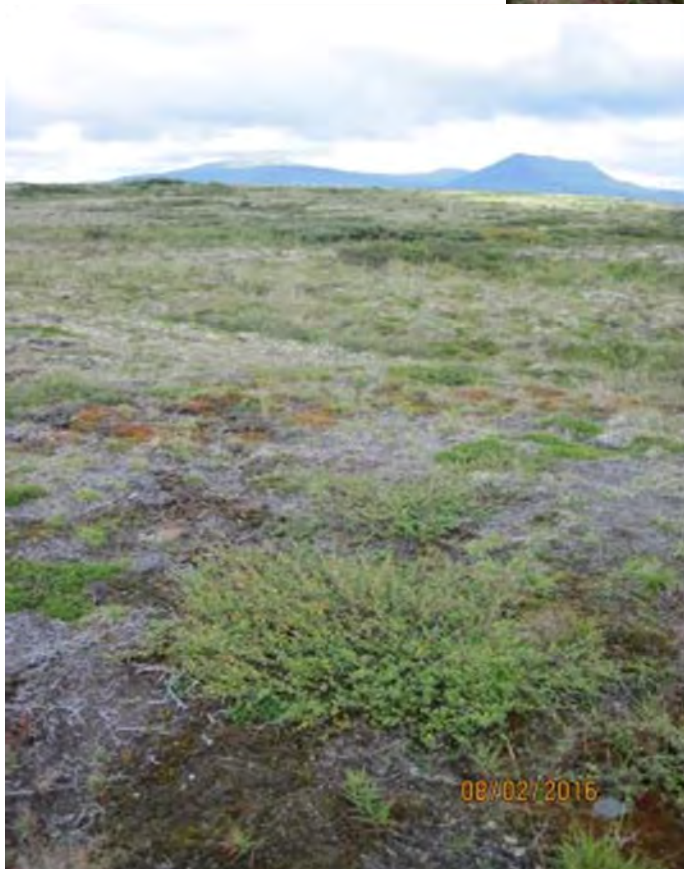
## ***DDH 7380 & DDH 7386***

This site is an example of wetland contamination and of the need to inspect and correctly classify drill sites.

These should be separate locations, and have two different reclamation classifications. DDH 7380 is classified as fully reclaimed and stable (3E) and DDH 7386 is classified as inactive and stable (2E). Monument markers for both posts were lying next to an artesian flow upwelling from where a drill casing had been removed. There is no record of DDH 7380 having been inspected by the State, and DDH 7386 appears to have been last inspected in October 2007.

At this site, clear water bubbled up through milky material, possibly cement. The site had a slightly alkaline pH (7.8) and was elevated in copper, aluminum, iron, and manganese, and several other elements, including thorium and uranium (report Table 6). Only DDH 7382 and DDH 7380/7386 are elevated in thorium and uranium; it is possible that both are moving through alkaline material. There were several patches of dead vegetation in the general area.

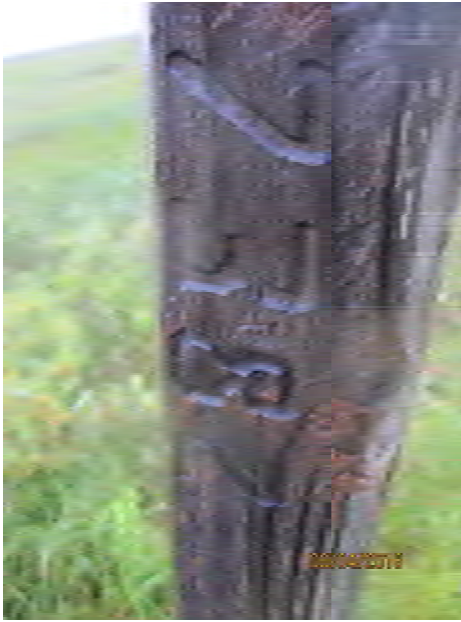
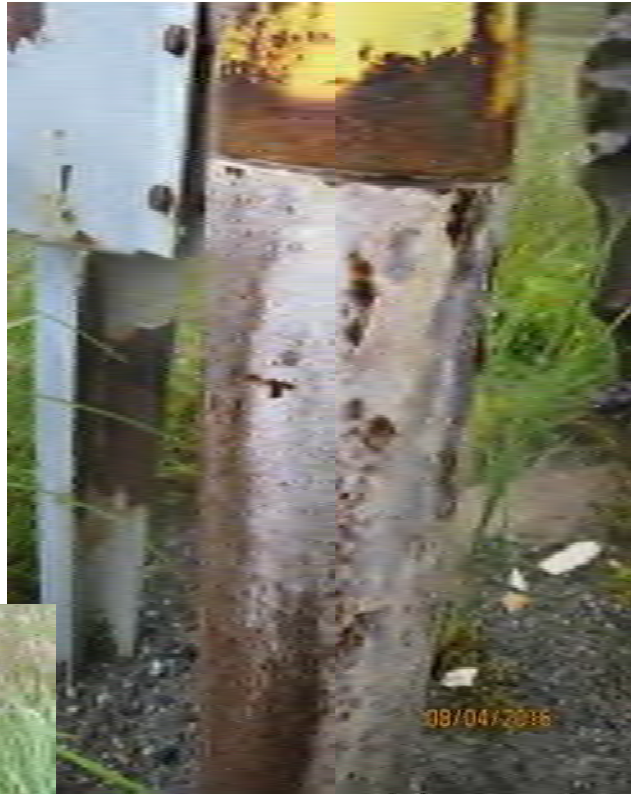
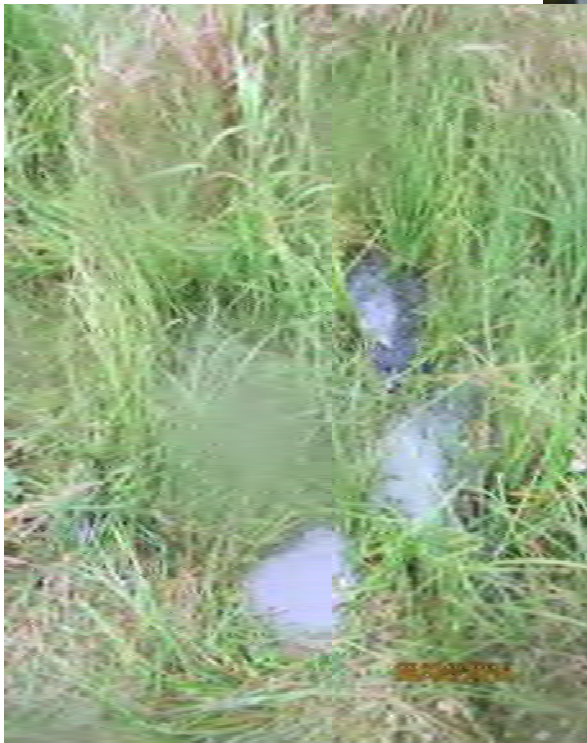
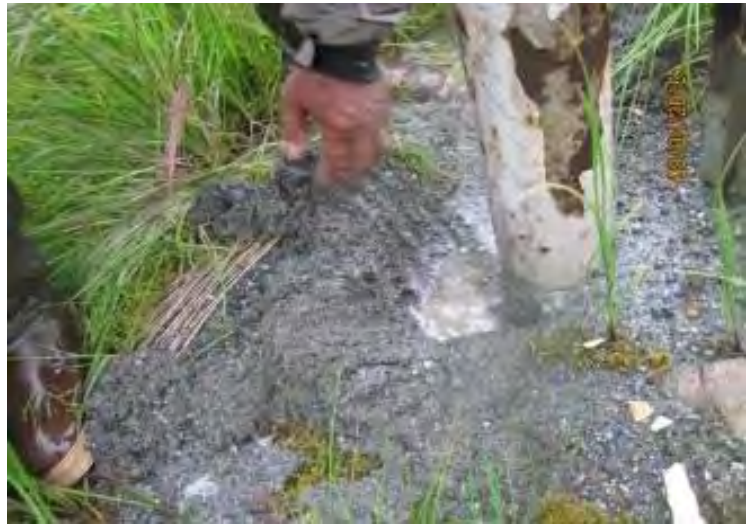
**This site was visited during a rainstorm. Gravel was packed around the casing, which was unusual, and a milky fluid was welling up from around the casing in the gravel. It was observed moving into a wetland. Samples from material around the casing, wetland water, and wetland sediment were submitted for laboratory analysis. The wetland sediment was contaminated with petroleum; it was one of only two samples that had petroleum contamination. Possibly the petroleum came from the material packing around the casing. Wetland water and sediment were elevated in copper; water was also elevated in several different metals (report, Table 11). Photos show the casing and the trail into the wetland.**
