# **INVESTIGATION OF RECLAIMED DRILL SITES, PEBBLE PROSPECT, 2016**

**Center for Science in Public Participation  
*for*  
United Tribes of Bristol Bay  
304 Main Street  
Dillingham, AK 99576  
November 3, 2016**

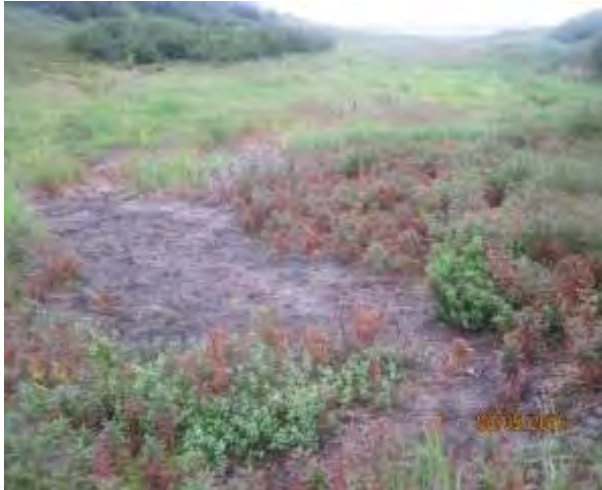
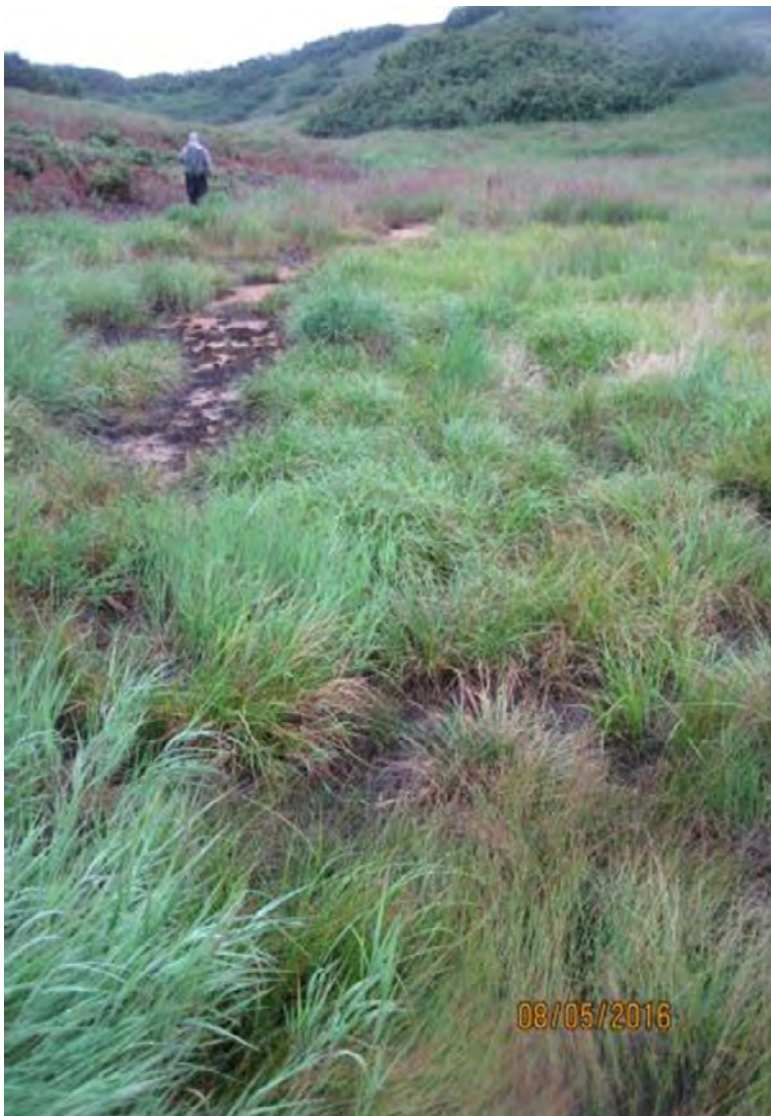
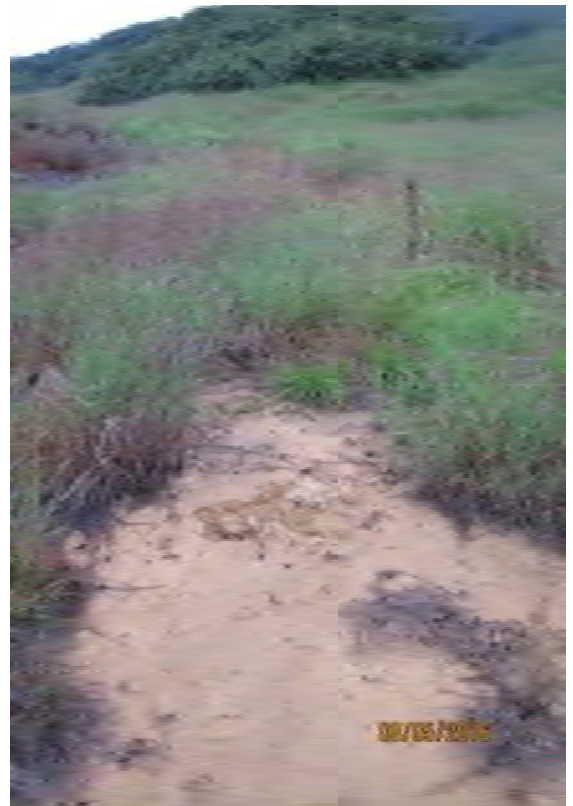
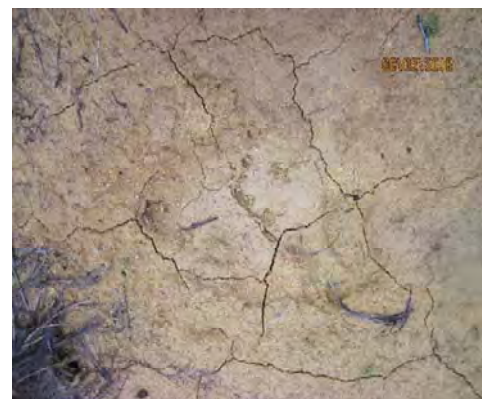
## DDH 7392

To the west of the discovery outcrop is a horseshoe-shaped rim of hills around a gulley. Around the rim are several old drill sites, with sites DDH 3071 and DDH 7392 in the gulley about 20 feet apart. A thick layer of drill cuttings (bottom right) ran from the open casing at DDH 7392 for well over 100' (bottom left). No water was present at the site, but given the path of the cuttings it is feasible that rainwater or snowmelt is moving the cuttings. The cuttings were light colored and about 4 inches deep, covering vegetative mat. The material was acidic (pH 3.0), with elevated specific conductance, sulfate, copper, and molybdenum (Report Table 8).

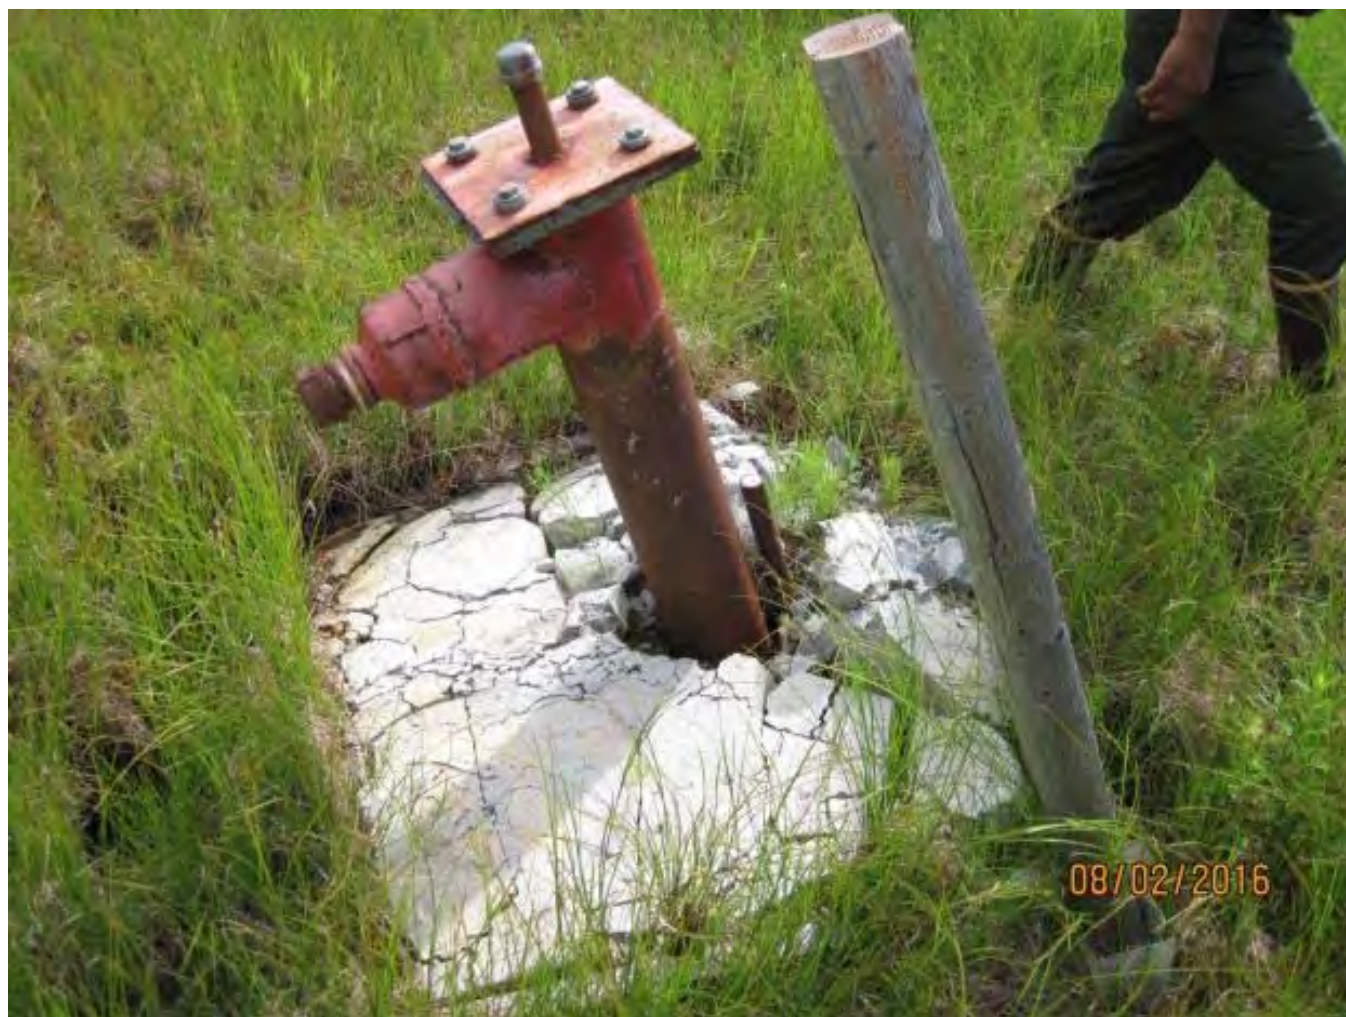
**This site represents one of several casings with a variety of bolts and plugs, possibly to contain artesian conditions.**

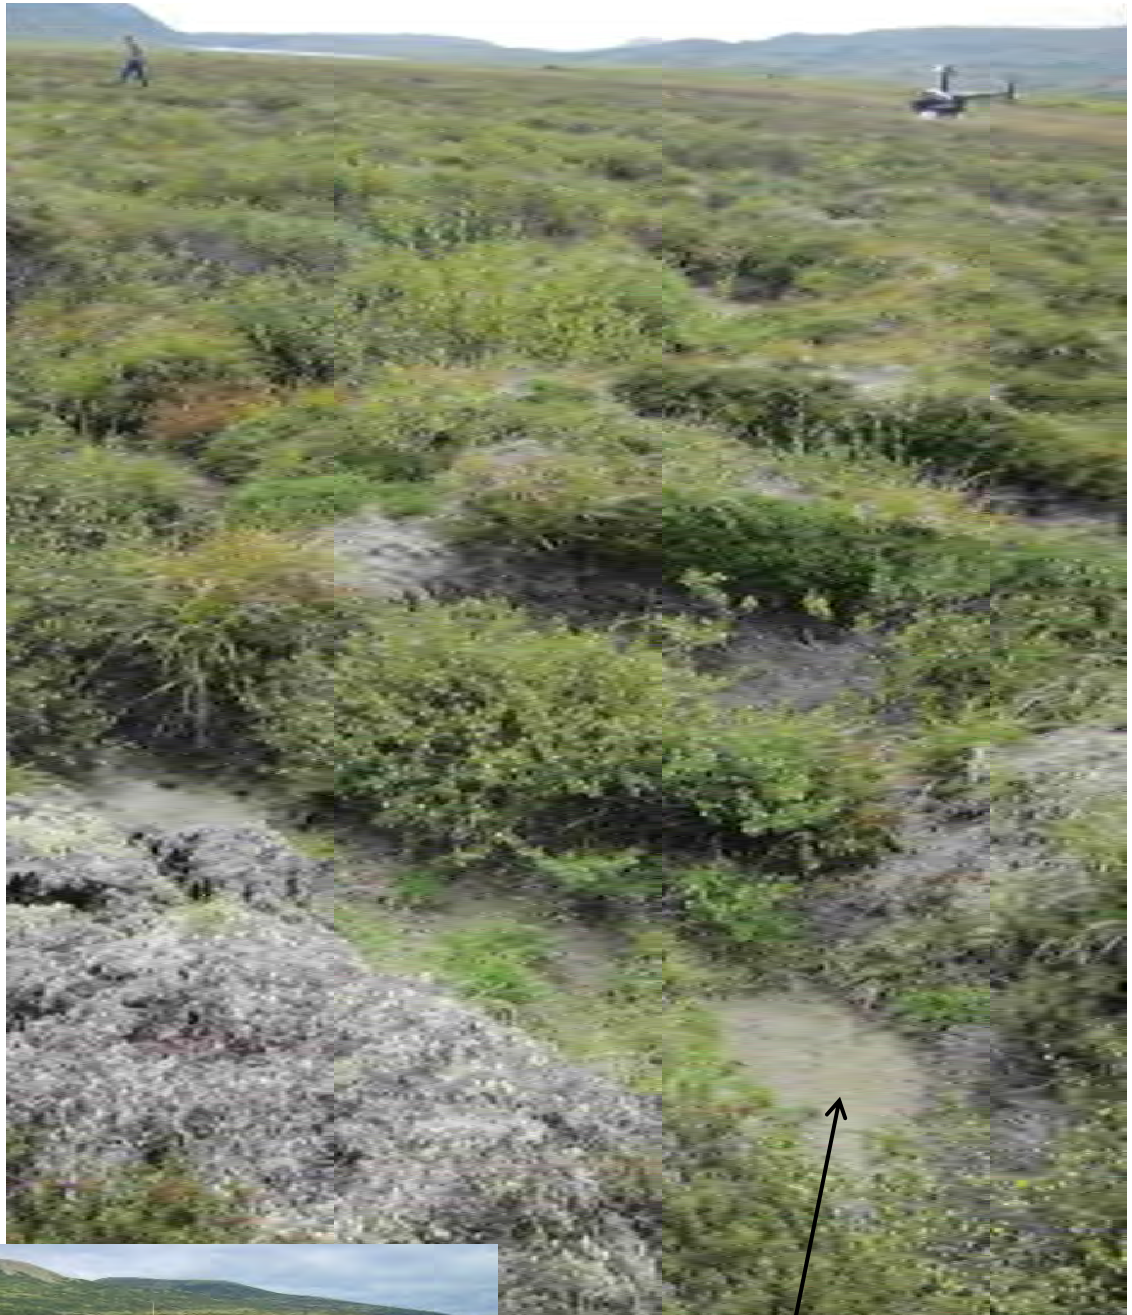
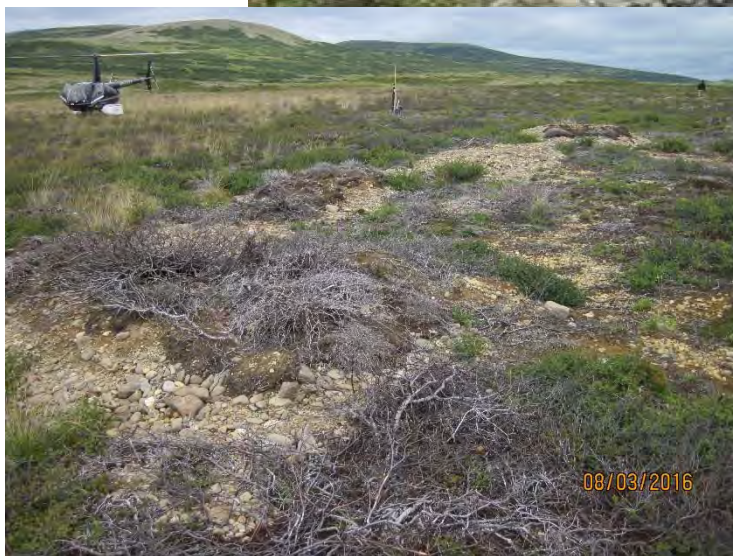
**Patches of drill waste in small depressions**

**This is an example of one of three sites where drilling waste was disposed of over a large area in the past. Patches were located between DDH 12548 and DDH 4171. Vegetation was not growing on the drill sump pits at DDH 12548. Samples of soil with drill waste material were neutral pH but elevated in sulfate, copper, molybdenum and zinc (report Table 8).**
