# CENTER for SCIENCE in PUBLIC PARTICIPATION

Sept 20, 2016

Re: DNR July 2016 Pebble site visit report  
Cc: Dave Chambers, [dchambers@csp2.org](mailto:dchambers@csp2.org)

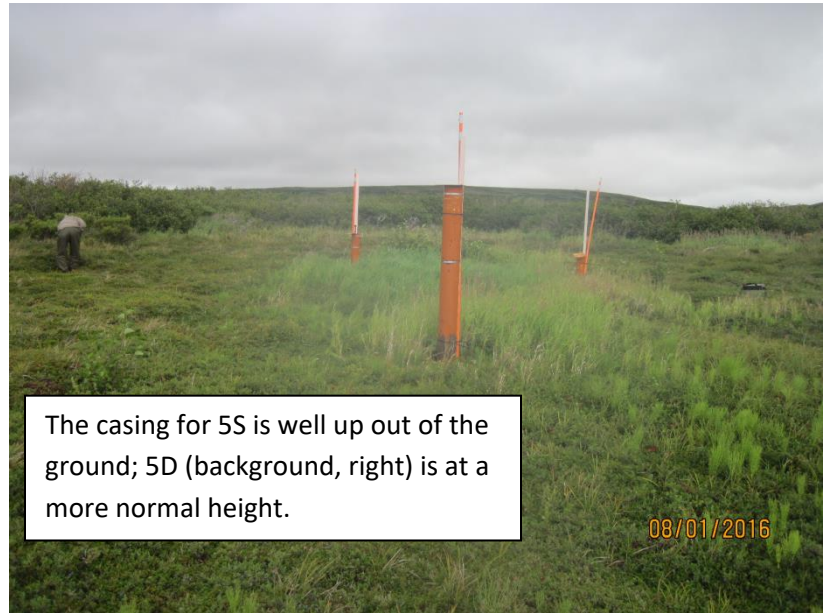
**SRK5D, M, S.** This is a set of three wells in the same location. DNR visited all three, but only discussed 5D (with aerial photo). CSP2 noted that 5S was jacked well out of the ground. However, we did not see any signs of contamination or any standing water.

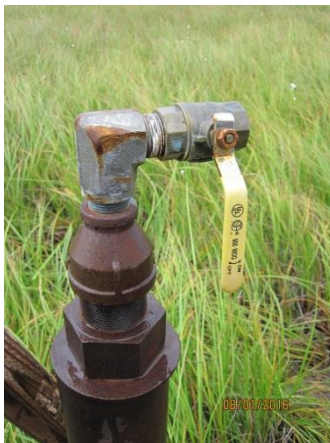
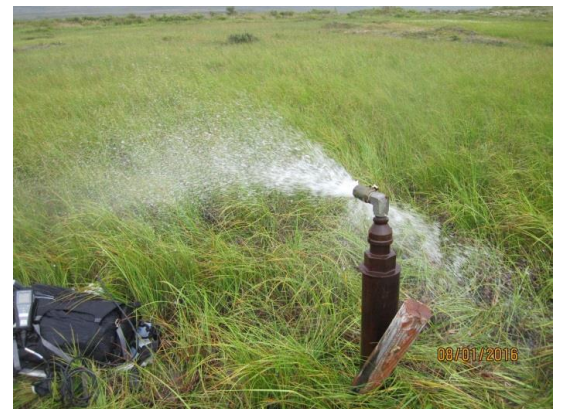
**DDH 7365.** DNR visited this site but did not have any notes about it in their report. CSP2 noted that this well had a ball valve on it, which if turned produced a firehose spray of water; there was a sulfide smell when the valve was opened. This site is not far (50 feet?) from a pond that USGS sampled in 2008.

We took a sample of the borehole water and of the nearby pond for general chemistry (awaiting results). The pH of borehole water (collected from spray when valve opened) was neutral (pH 6.7-7.8, differed with the meter used) and water was cold (6C). The pond pH was also neutral (pH 6.4-7.3) but warmer (13-15C).

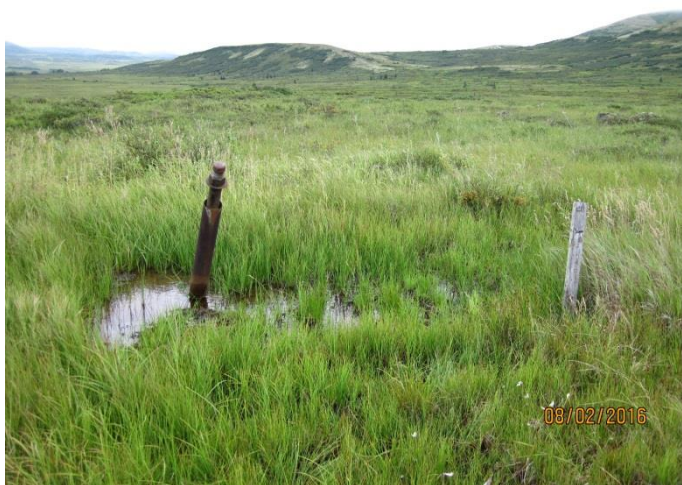
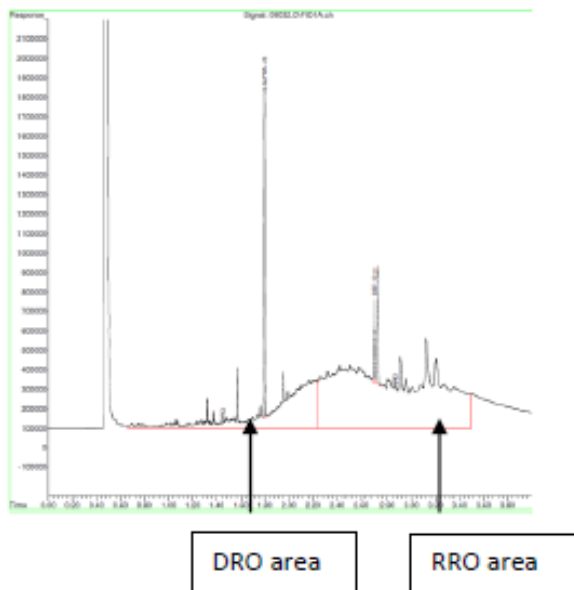
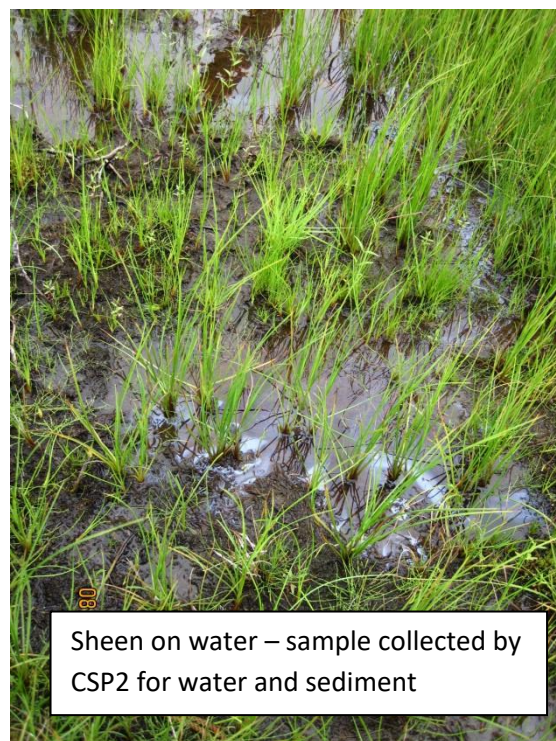
**DDH 5330.** DNR took a photo and said the 2015 repairs were successful, although there was some water ponded at the base of the casing. It is not clear if DNR landed at the site. This is listed as an “active well”.

We noted that there was water pooled at the base of the old rusted open casing with iron staining and a sheet, although we could not determine if there were artesian conditions that caused the water pool or not. About 100 feet away was another borehole (DDH 7366) in a swampy area but plugged and without water pooled around it. There was no evidence of drill mud waste pits at DDH 5330.

The soil was pH 7.2 and water was pH 6.4, temp 11-13C, and specific conductance around 215 uS/cm. The sediment around the standpipe had a “red fluffy” texture, with black (sulfide smell) below that, then gray about 6 inches lower.

We took samples of water and sediment for fuels analysis and general chemistry. The soil showed evidence of fuels contamination by heavy hydrocarbons (RRO at 2,680 ppm) but the water did not (<1 ppm of DRO or RRO). We do not know whether this is from drilling mud or some other material.

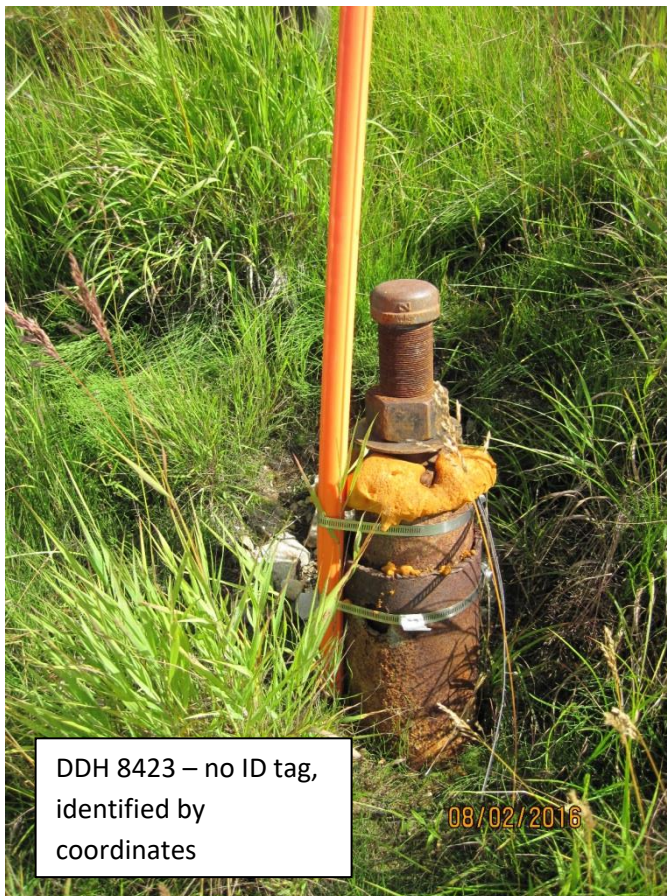
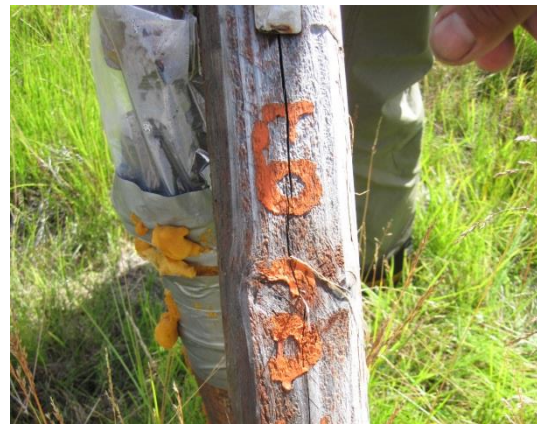
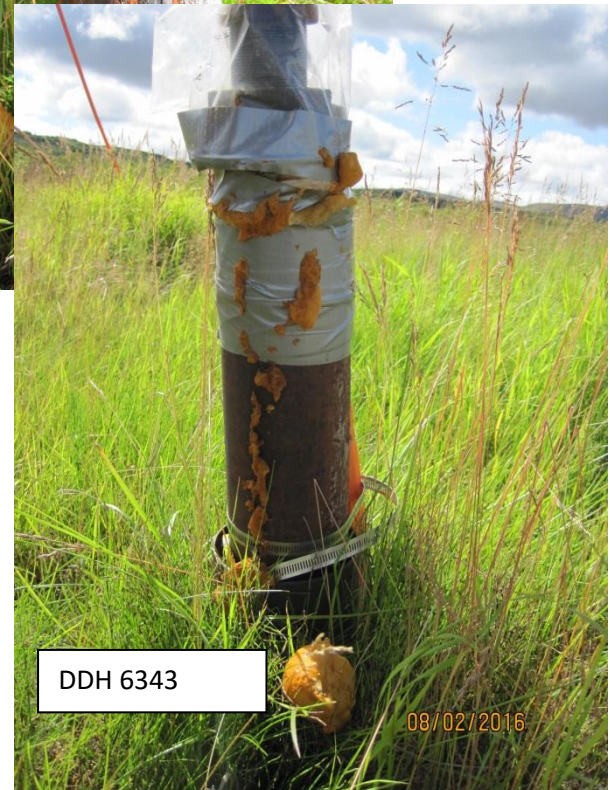
**DDH 6343 and 8423.** These two wells were about 15' apart. DNR and CSP2 each visited both of them. DNR noted that the former problems at both drill holes in 2015 had been repaired, with the casing at DDH 6343 "sealed and wrapped" and DDH 8423 was "spray foamed to prevent water penetration". CSP2 noted that a ziploc had been duct-taped over the casing head. The casing was not leaking, there was no water at the site and CSP2 did not collect field data. DNR took photos of both sites, but they are aerial photos and it is not clear if they landed. They did not mention that there was no identification marker for DDH 8423.

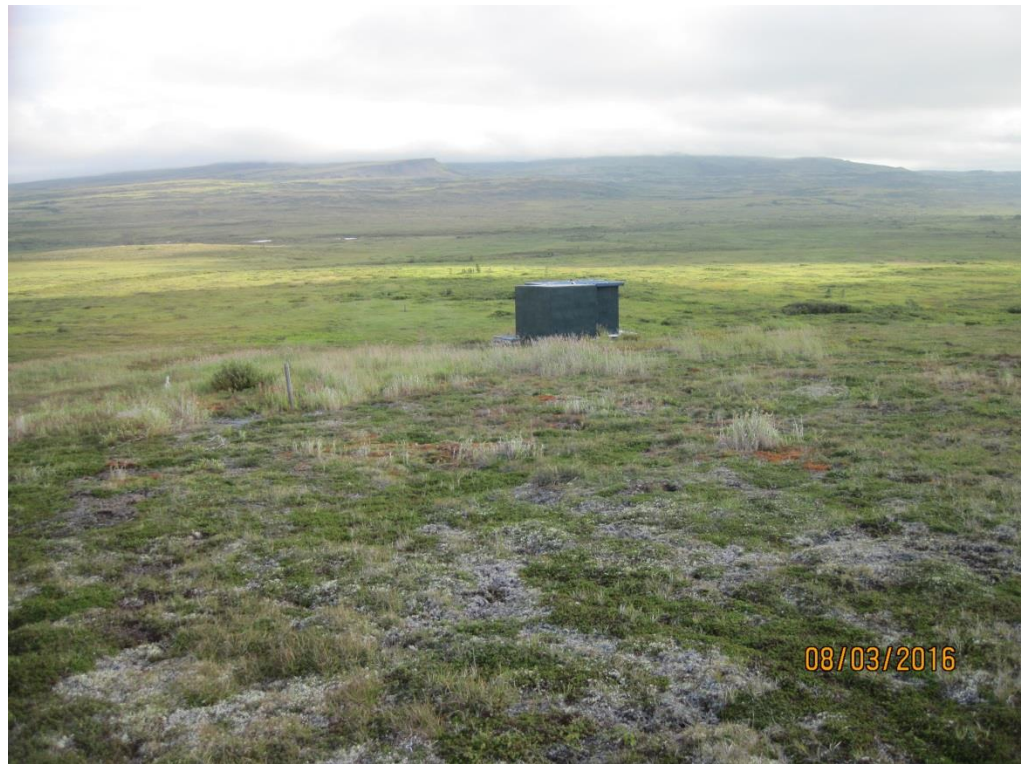
**DDH 8417.** This was a fully reclaimed site with no casing remaining. DNR did not write up notes for this site; CSP2 did not collect field data. CSP2 noted that there were mud pits, with some living and some dead vegetation on the pits.

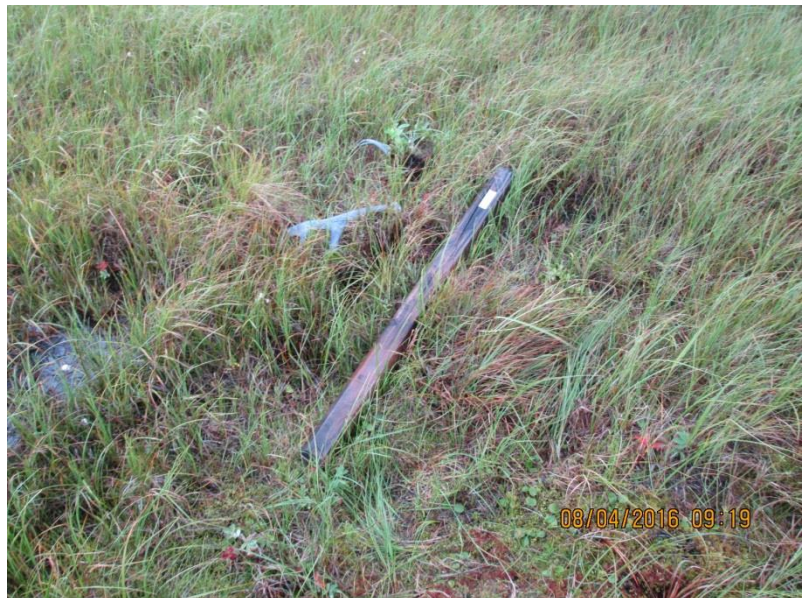
**DDH 5332.** This is a reclaimed site with no casing. DNR has a photograph (aerial) and notes that the well was producing a small flow but it was not near a water body and there was no iron staining. CSP2 noted it was a wet area with no sign of drill sumps but did not collect field data.

There was no sign of a well casing – only the post laying in the grass next to water. Does DNR think the water could be coming from the casing, even though it is cut off below ground and plugged? They only note that it is a wet area and the source of water is unclear. They asked PLP to investigate the cause and submit a work plan.

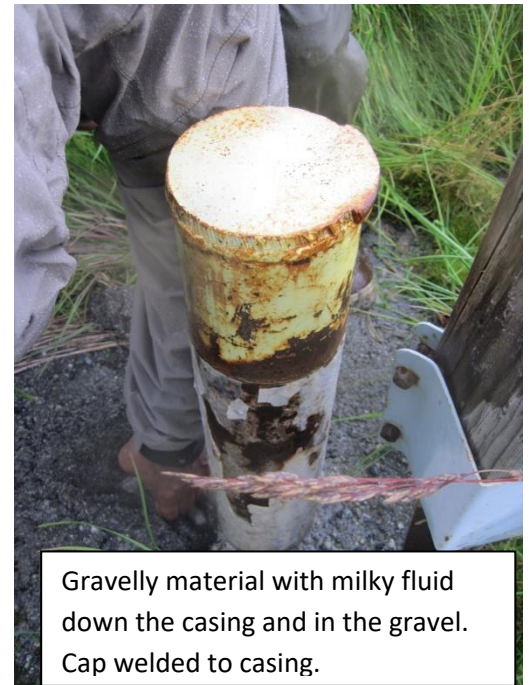
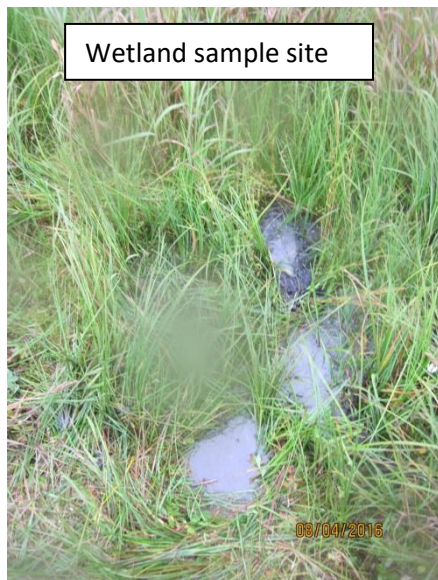
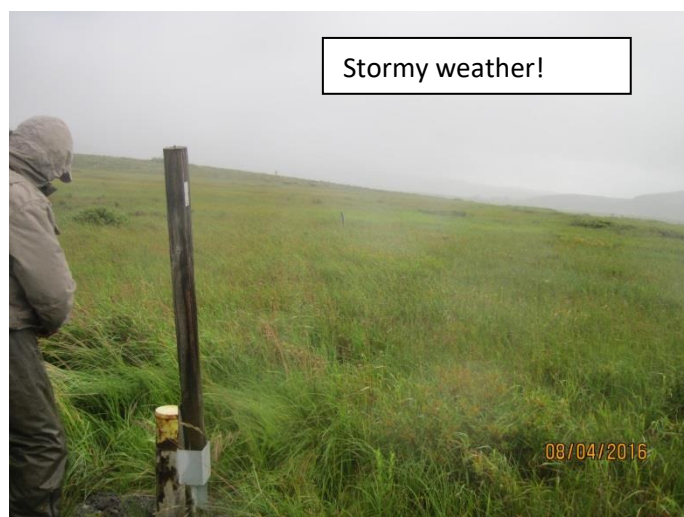
**DDH 7382.** DNR had no photos or notes, other than their pre-visit notes that a new cap had been installed in 2015 to control a minor leak. We visited this site in a rainstorm, which may have affected the material we saw. It had a gravelly material around the casing – the only site where we saw that – and was leaking some sort of milky fluid. I rolled up my sleeve and stuck my arm down in the gravel and could feel that the material was present at least 12” down, and it was running at least 10’ away from the casing into the tundra. The cap was welded onto the casing. I wonder if the material only flows up during rains? It’s too bad there is no picture from DNR, when it was not raining.

The soil pH was 6.5, water at the base of the drill casing was pH 7.2, wetland water downgradient was pH 5.2 (which can be normal for a wetland). Water at the casing had specific conductance of 289 uS/cm and in the spring about 10’ downgradient (following the mud trail) the specific conductance was 209 uS/cm; both had temperatures about 10C. There was no sign of acid drainage and the conductivity could be normal for wetlands.

We took samples for fuels analysis and found that the wetland sediment (collected along the mud trail about 10’ downgradient of the casing) was contaminated with diesel-like hydrocarbons and heavier hydrocarbons (DRO at 2,890 mg/kg, RRO at 6, 470 mg/kg) but the wetland water overlying the sediment was not contaminated, nor was the gravelly material at the base of the casing. This is a site that deserves further attention.

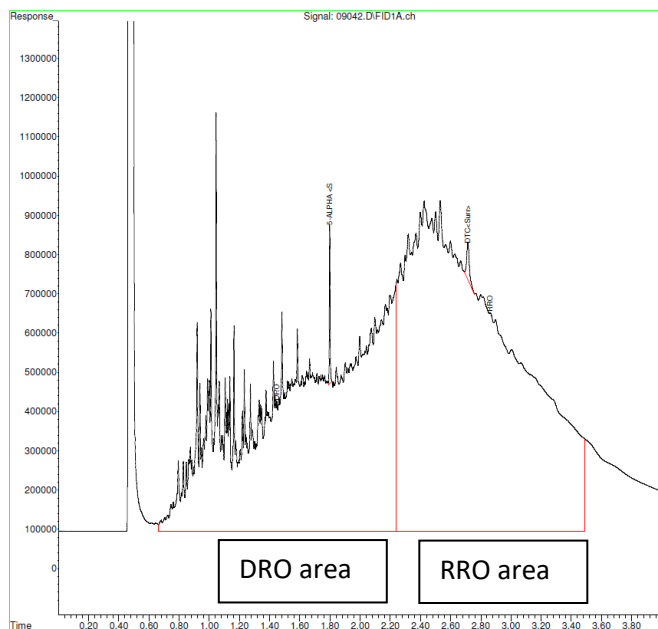
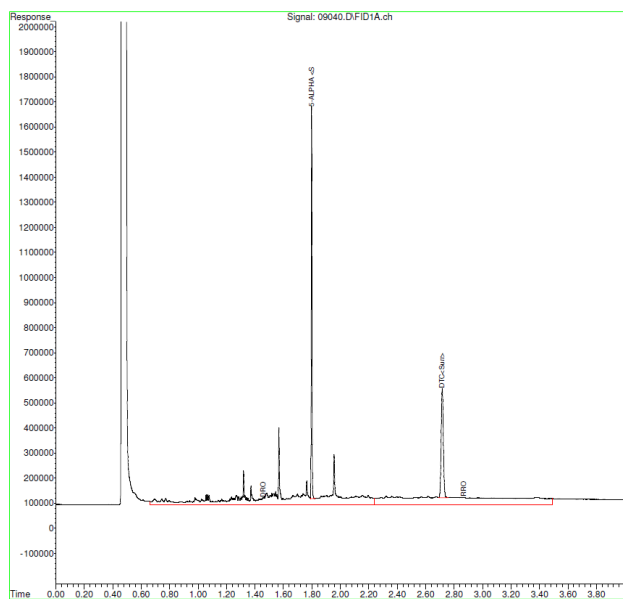
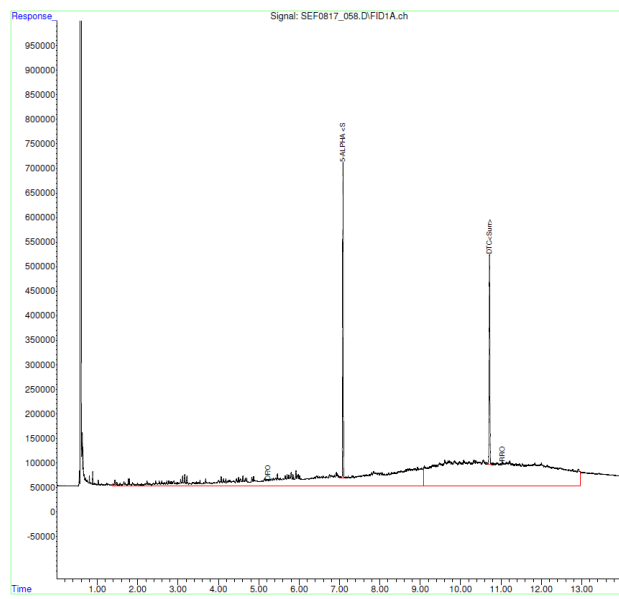
Wetland sediment downgradient of borehole had fuels contamination (right). The material around the borehole (below) and wetland water (below right) did not have fuels contamination.

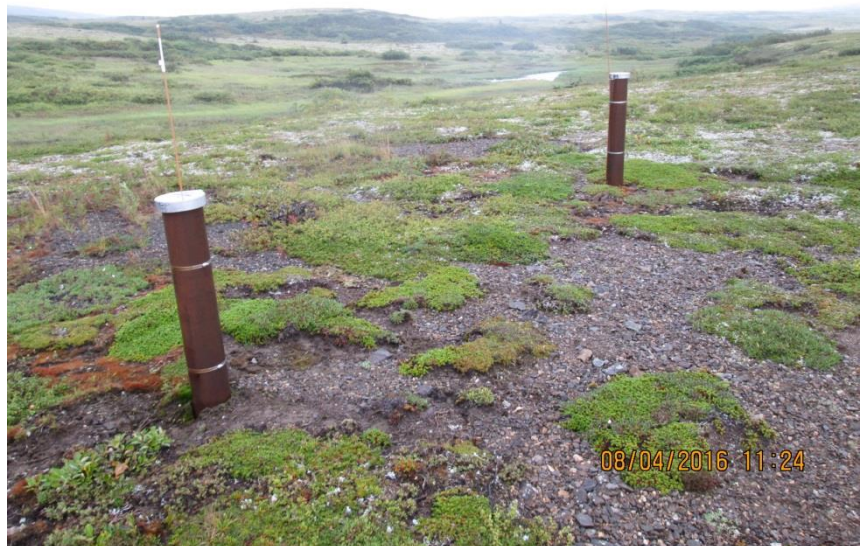
**P05-30D, 30S.** DNR has no notes or photos of this site. CSP2 noted that it was a pair of capped wells with bare ground between but took no field data.

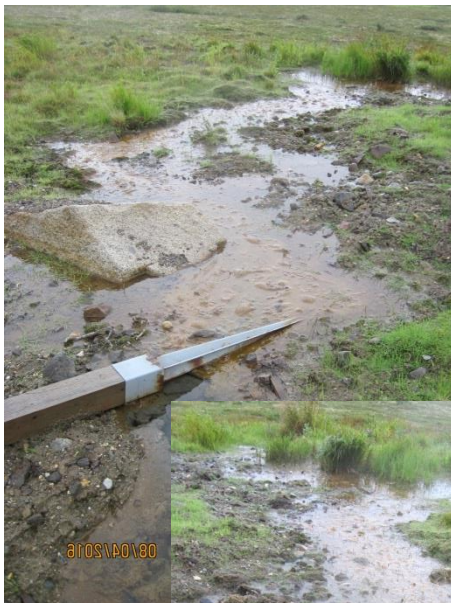
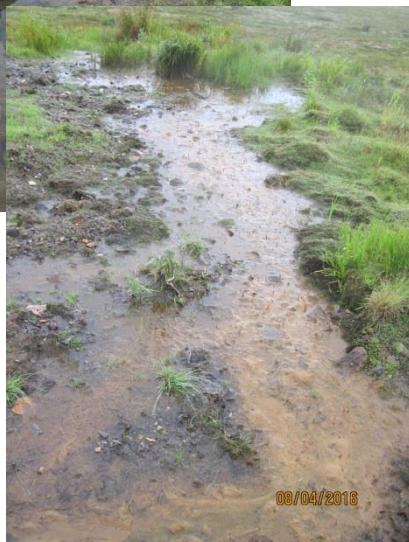
**DDH 9475.** DNR noted that water was being produced outside the casing, despite grouting in 2015 to 40' deep on one side and 80' deep on the other with sand, cement, and bentonite, and that water was flowing 132' downhill. CSP2 noted that the identification post was on the ground and a spring was bubbling red mud and gray sand, with a trail of red (iron-stained) mud going downhill.

We took samples for general chemistry (metals, salts, etc – results not back yet) but not for fuels analysis. We did take the water pH and conductivity, but upon returning to base camp saw that the meter was not reading correctly, therefore we cannot be sure that the data is valid. The measurements we had were

At the spring (drill hole), the water temperature was 7.4C with a specific conductance was 1,221 uS/cm; about 12' downgradient the water was pH 4.9, temp 9C, specific conductance 1,360 uS/cm. If the readings were correct, these indicate some possible acid drainage.

We saw no casing, only the downed post, which suggests the artesian flow is occurring despite the casing being plugged and cut off below ground. Also, this location, if I

recall, was on the top of a hill, so unsure what is driving artesian conditions.

DNR asked PLP to “investigate a resolution” and monitor vegetation.

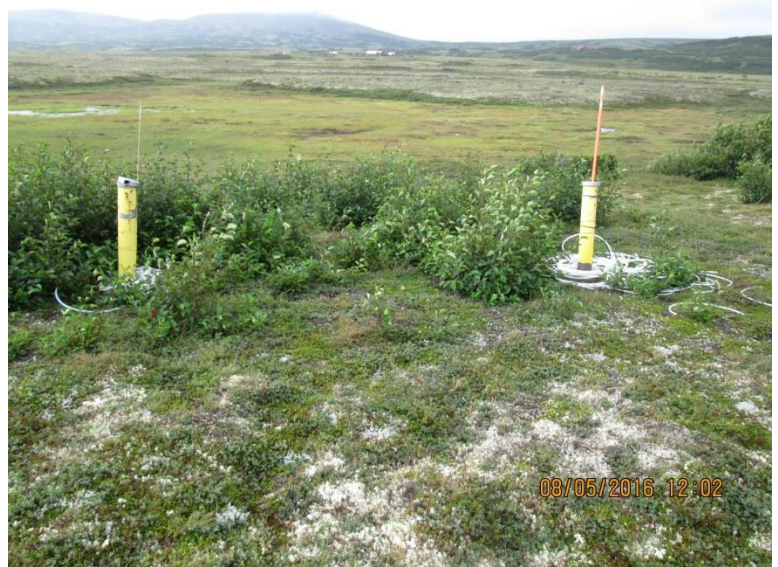
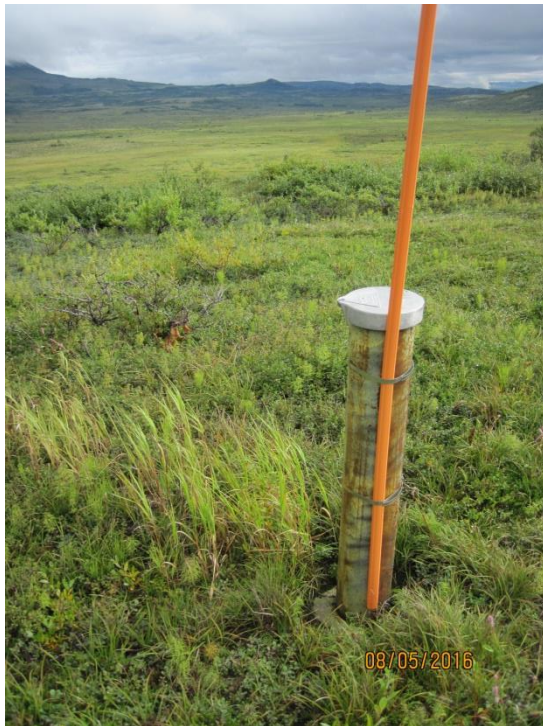
**P05-36D, 36M, 36S.** DNR has no notes or photos. CSP2 notes that the site is a nest of 3 wells with caps unlocked and plastic tubing trash around them. We did not collect field data.

**GH11-270S.** DNR has no photos or notes for this site. CSP2 did not take field samples. There was a closed cap on this well.

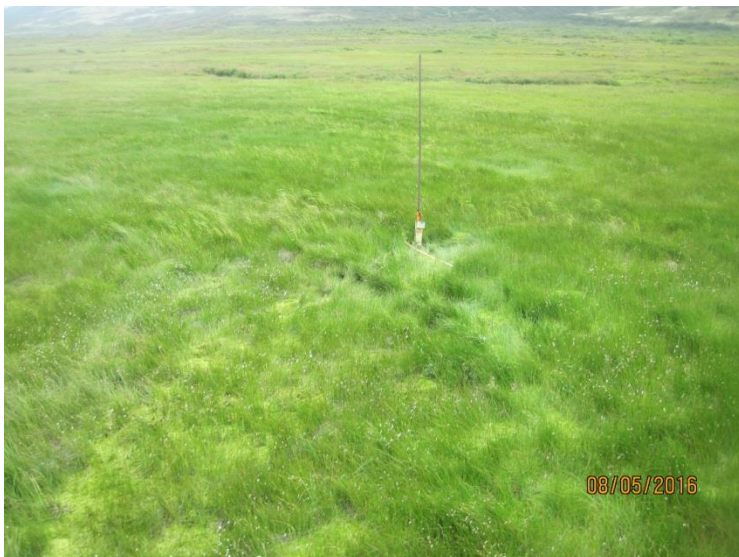
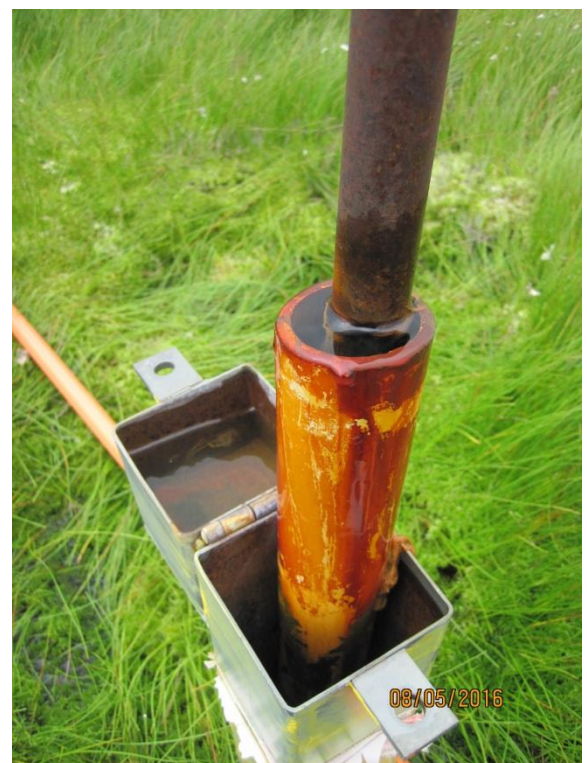
**GH06-72.** DNR notes a minor upwelling with a rusty plug on the casing and a sheen – likely from bacteria – in water pooled at the base. Both CSP2 and DNR have photos from ground level. CSP2 noted the artesian flow, with PVC and metal rod pushed up out of the casing, but the location was the soggiest we had been to and the helicopter was unable to land or to shut down – I could only duck out and get a photo while the heli hovered.

Footprints filled with water when you walked.

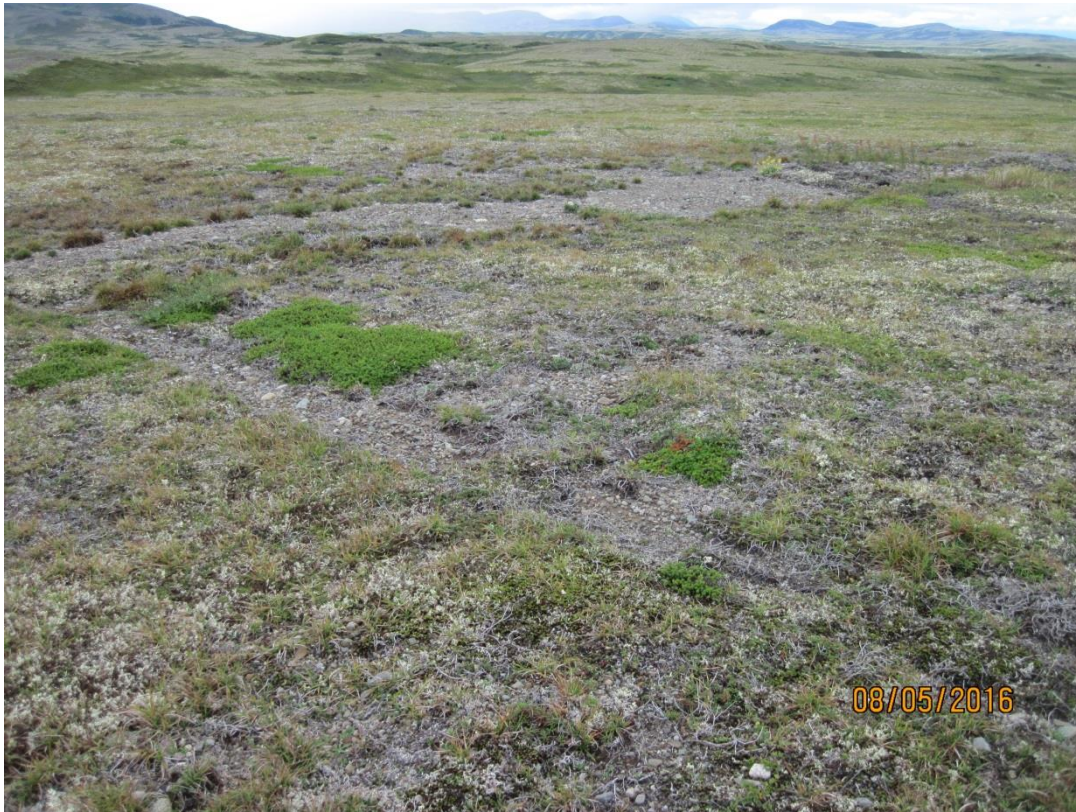
**DDH 10481.** This was a fully reclaimed site with no casing. Long mud pits were present. There was a trail, bare of vegetation, to the pits and on top of the pits was dead tundra that was not rooting to the soil. DNR has no notes or photos. CSP2 did not collect field samples.

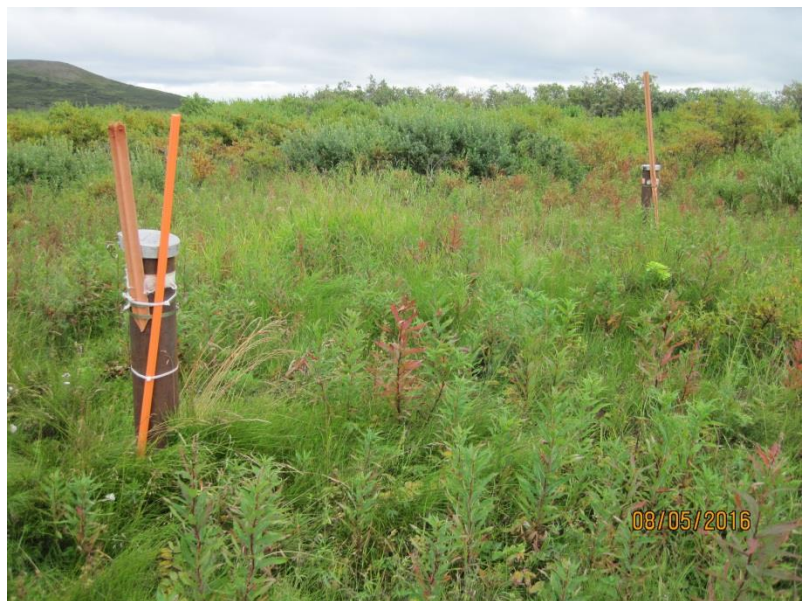
**MW05-13D, 13S.** This is a set of monitoring wells that is actively available to monitor groundwater, and caps were closed on top of the casings. There did not appear to be any problems at the site. DNR took no photos or notes, and CSP2 did not collect samples.
