SURVEY FINDINGS – Problems in 4 General Areas:

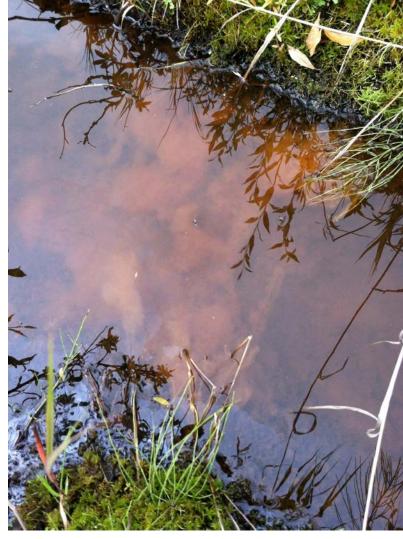
DDH 4202 1Aug16

Petroleum contamination

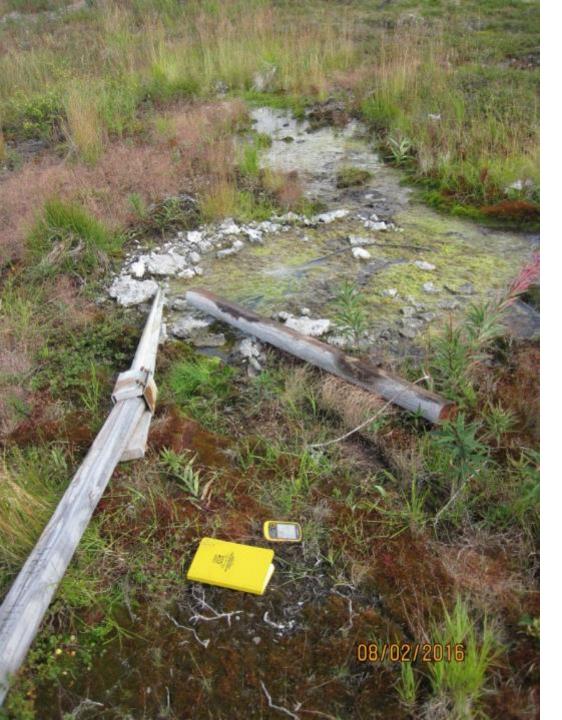
Artesian dill holes with elevated levels of sulfate, copper, and other heavy metals

Artesian Flow DDH 7386 2Aug16

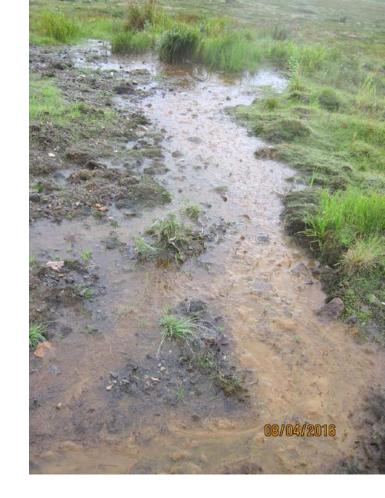
Artesian Flow with drill cuttings DDH 9475 4Aug16

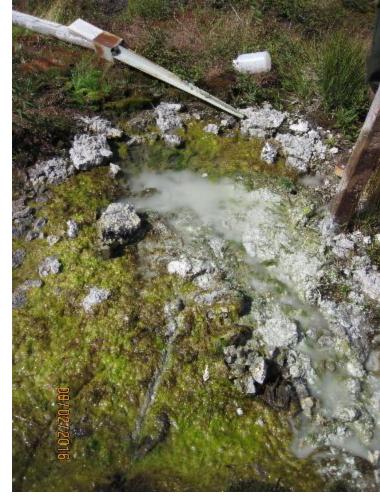
Artesian Flow with Drill Mud DDH 7380 2Aug16

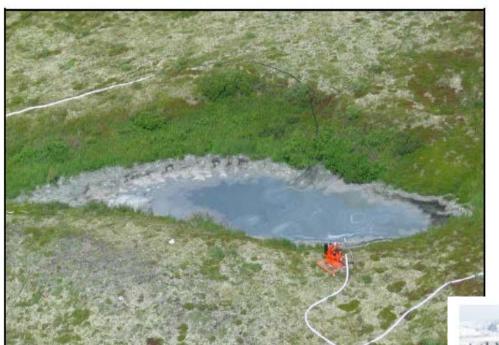
Photo #14. Clay deposited in a dry depression by discharged drilling fluids.

*Drilling waste discharged to land. (ADNR inspection report June 2005)

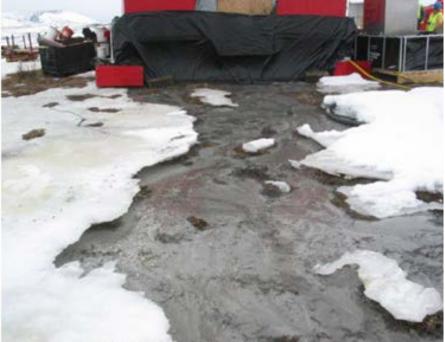
Figure 4. Water and cuttings discharge on uplands.

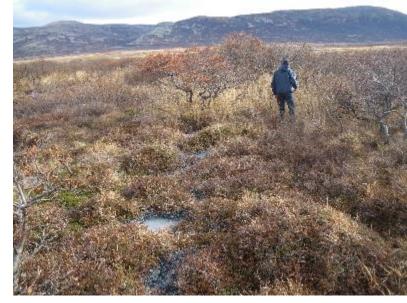
Drill Waste Sumps
DDH 11540
220ct11
