State of Alaska 30th Legislature House Resources Committee

RE: Cook Inlet Offshore Update

Middle Ground Shoal - "A" Pipeline

Anna Platform & Pipeline

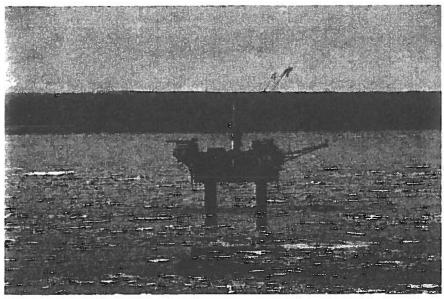
Hilcorp's Anna Platform in Upper Cook Inlet, where workers felt an impact before observing several oil sheens on Saturday. (Photo courtesy Cook Inletkeeper)
