REPORT SUMMARY:¹
INVESTIGATION OF RECLAIMED DRILL SITES, PEBBLE PROSPECT,
AUGUST 2016

Center for Science in Public Participation²
for
United Tribes of Bristol Bay
304 Main Street
Dillingham, AK 99576

November 3, 2016

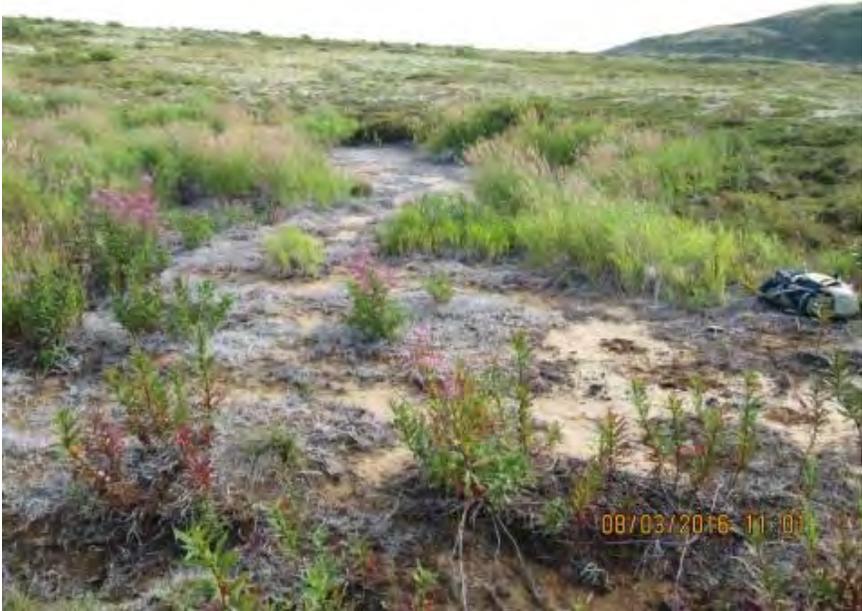
Remnants of direct discharge from drilling are still evident on the landscape as oxidized or grey fine-grained material accompanied by dead brush and tundra (Figure 2). Exploration drilling targeted sulfide ore with copper, gold, and molybdenum, and sampling by CSP2 determined sites with remaining drill waste discharge to be very high in copper and molybdenum. Some samples were acidic, and may be continuing to impact vegetation. Five areas with discharge were located. The nearest sites to these discharges were drilled in 2004, 2006, 2007, and 2012, indicating that the waste may have been impacting vegetation and soil for anywhere from 4 to 12 years.

Figure 2: Dead vegetation and acidic drill cuttings (light-colored material in foreground) remain years after the hole was drilled. Soil was over 100 times higher in copper and molybdenum than background. The nearest hole (DDH 6355) was drilled in 2006.

Allowing drill waste to be placed directly on the tundra, where it is exposed to oxygen and water, has led to acid generation in the waste. This is not only a demonstrated source of contamination at Pebble, but it should be obvious that allowing this practice to continue at any mineralized drilling site could result in similar contamination. DNR should not allow drill waste to be placed on the ground surface.

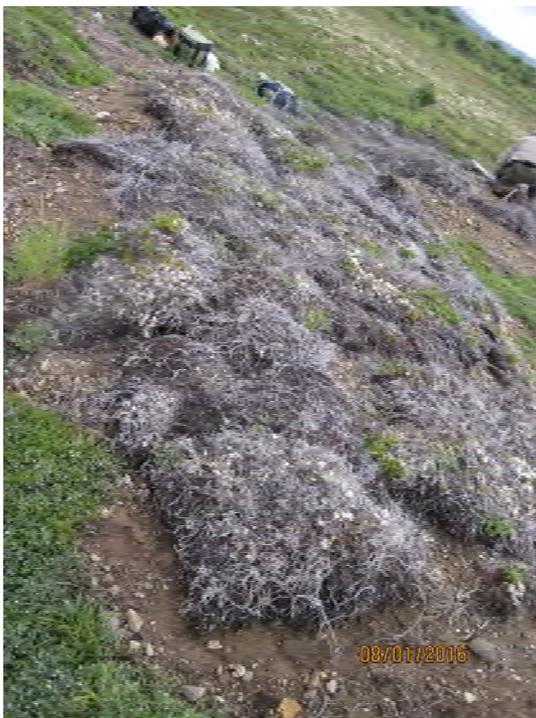
Figure 3: Dead vegetation on reclaimed drill waste sump DDH 11540, drilled in 2011.

Vegetation fails to grow on some of the drill sumps established to contain drill waste (Figure 3). After drilling is complete, drill sumps are covered with soil removed from the sump, and tundra mats or other vegetation placed on top. CSP2 sampling determined that the soil on top of the sump is not toxic. Therefore, vegetation should grow on sump covers if tundra and other vegetation are handled correctly.

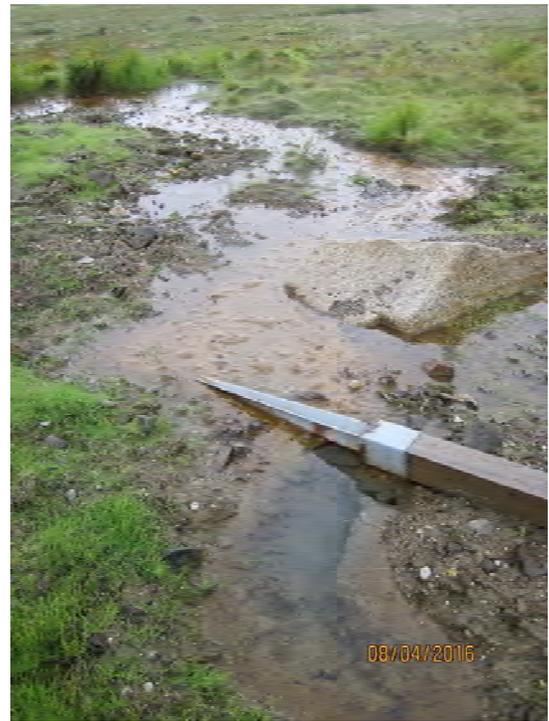
Figure 4: Artesian flow at DDH 9475, drilled in 2009.

- Re-plug wells with free-flowing artesian water and from which drill cuttings have flushed out onto the landscape.

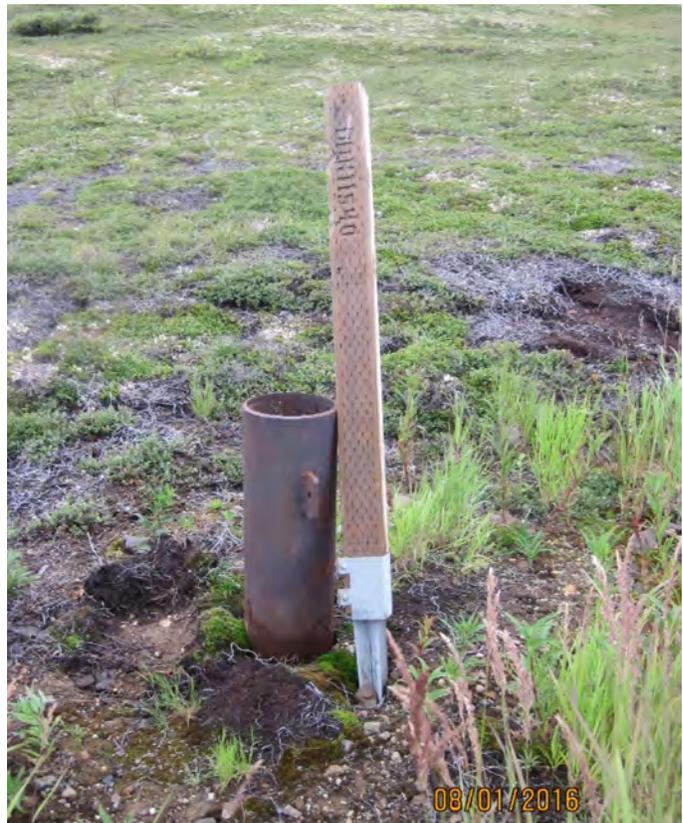
Approximately 25% of the sites visited had steel drill casings extending above the surface. These drill casings can pose a risk to snow machine operators when fully or partially covered with snow. The Multiple Land Use Permit that DNR issued to allow Pebble mine exploration on State land requires specific reclamation actions, including cutting abandoned drill casings off below ground surface, filling drill holes with a minimum of 10 feet of cement, removing equipment and buildings, and submitting an annual reclamation statement.

There were sites that had open drill casings (Figure 5), and sites where drill casings had been removed but artesian water appeared to flow from the old drill hole.

Figure 5: Steel drill casing at reclaimed drill site DDH 11540, drilled in 2011.

- Remove drill waste that is leaching metals and/or acid, or is not revegetating;
- Identify all wells with remaining drill casings, and cut off all well casings at wells that are not being actively used. Properly mark remaining drill casings so they can be avoided by snowmachines in the winter; and,
