## **PEBBLE PROJECT**

**2017 Reclamation Report**

**MLUP No. 6118**

**DECEMBER 31, 2017**

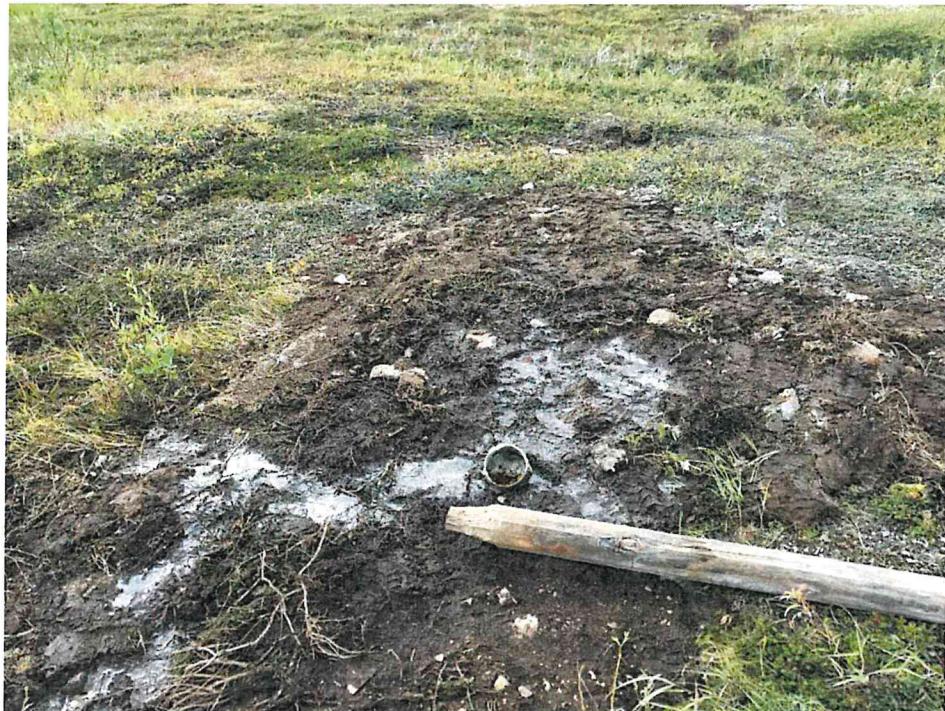
1. Borehole 3127

This site was first repaired in 2016 by backfilling with bentonite pellets (see 2016 Annual Reclamation Report). These repairs were initially successful but subsequent inspection in spring 2017 showed that minor upwelling (approximately 1 gallon per minute [gpm]) had recurred. Water quickly dissipates into the surrounding tundra.

PLP's drilling contractor (Foundex Pacific) made two attempts to re-drill and grout the site in 2017, with limited success. Water flow was reduced but not completely cut off. Foundex advised that the site would be better addressed with an alternate rig configuration that can more accurately adjust to the borehole's initial drilling angle (-49°). After consultation with DNR, PLP decided to forgo a third attempt in 2017 and instead plans to implement the contractor's recommendation in 2018.

*Minor upwelling shown following second repair attempt.*

Approximately 160 square feet were disturbed during repair efforts. The site was reclaimed and stabilized to minimize erosion, but was not reseeded in anticipation of additional repair work in 2018. PLP will continue to monitor the site and report changes to DNR.

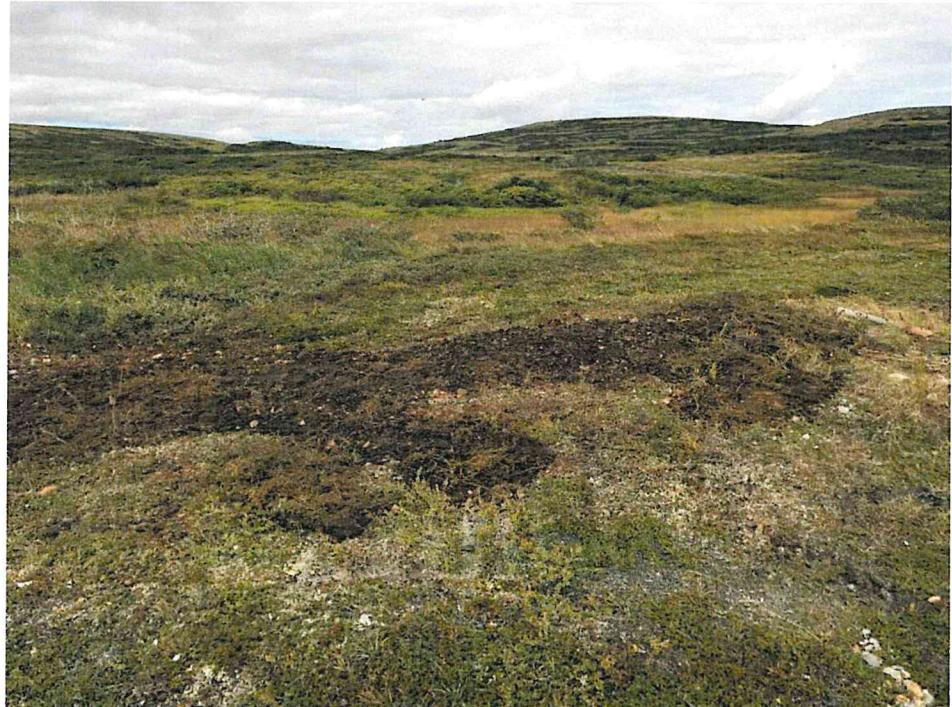
2. Borehole 3132

Borehole 3132 is co-located with Borehole 3131, which was successfully re-drilled, grouted, and closed in 2015. Inspection in 2016 showed a small, diffuse upwelling that quickly dissipated into the surrounding ground. The water volume was too small to quantify, but appeared consistent. The exact source or point of origin could not be determined.

*Work site after repair and reclamation complete.*

The original borehole was drilled to a depth of 71.5 feet and grouted to the surface with approximately 60.8 cubic feet of grout mix (dry volume). All water flow was successfully cut off. No casing or surface structures were left in place.

All heavy equipment and materials were set on tundra pads. A small area of approximately 120 square feet, including a small sump to manage excess water, was excavated to complete repairs. Disturbed areas were then reclaimed and regraded to minimize erosion. The site will be re-inspected in 2018 to verify repair success and seeded with an approved seed mixture if appropriate.

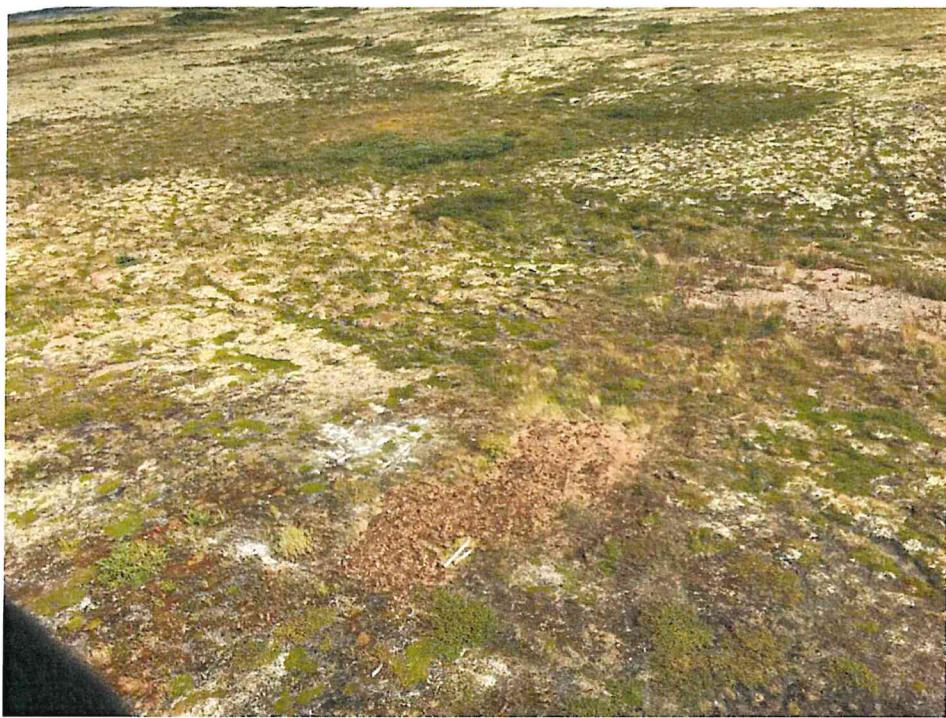
3. Borehole 7386

This site is located in the West Deposit area and is co-located with Borehole 7380. A clear, consistent upwelling (less than 1 gpm) was observed in 2016. Water flowed downhill in a discrete channel before dissipating into the surrounding ground.

*Aerial photo of work site after repair and reclamation complete.*

The original borehole was drilled to a depth of 162.67 feet and grouted to the surface with approximately 65.8 cubic feet of grout mix (dry volume). All water flow was successfully cut off. No casing or surface structures were left in place.

All heavy equipment and materials were set on tundra pads. A small area of approximately 160 square feet, including a small sump to manage excess water, was excavated to complete repairs. Where present, existing vegetation was preserved for re-use. Disturbed areas were then reclaimed and regraded to minimize erosion. The site will be re-inspected in 2018 to verify repair success and seeded with an approved seed mixture if appropriate.

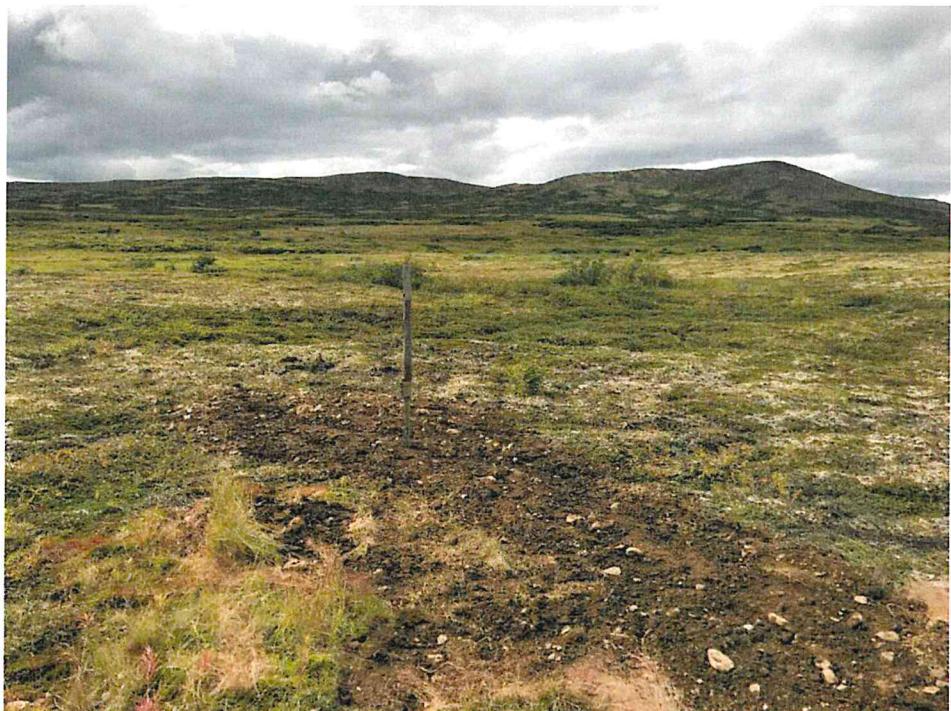
4. Borehole 8433M

This site is located approximately 800 feet southwest of the MSD in the West Deposit. No surface structures are present. The 2016 inspection observed water flowing consistently at a rate of 1-2 gpm and before dissipating into surrounding ground. A previous attempt to cut off water flow using bentonite pellets in 2016 was unsuccessful.

*Work site after repair and reclamation complete.*

The original borehole was drilled to a depth of 51.5 feet and grouted to the surface with approximately 21 cubic feet of grout mix (dry volume). All water flow was successfully cut off. No casing or surface structures were left in place.

All heavy equipment and materials were set on tundra pads. A small area of approximately 60 square feet, including a small sump to manage excess water, was excavated to complete repairs. Where present, existing vegetation was preserved for re-use. Disturbed areas were then reclaimed and regraded to minimize erosion. The site will be re-inspected in 2018 to verify repair success and seeded with an approved seed mixture if appropriate.

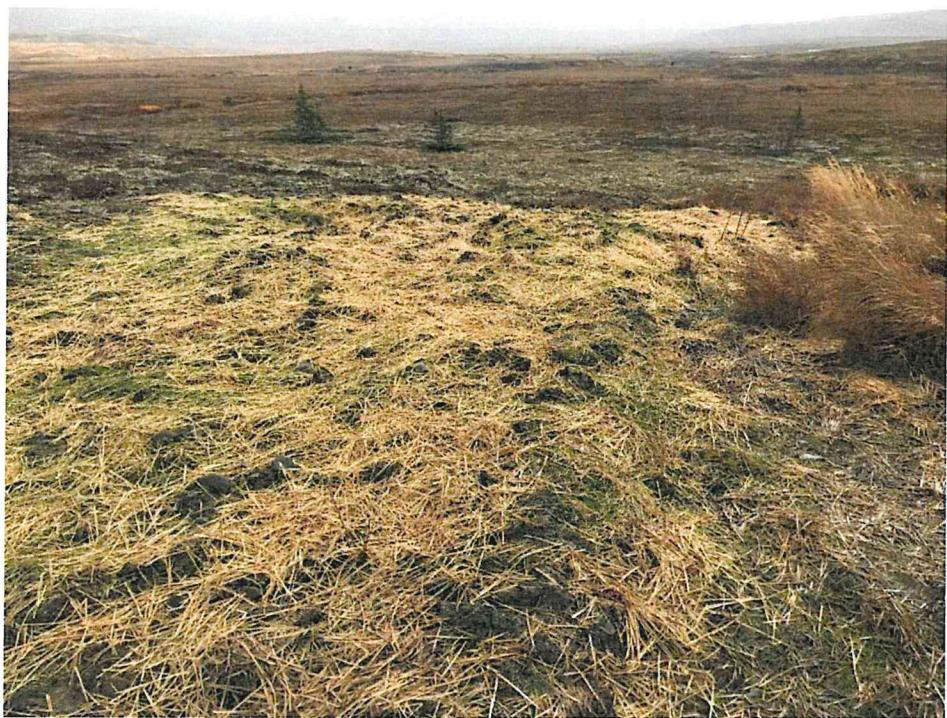
### 5. Borehole 9475

This site is located in the East Deposit area and was previously used for long-term monitoring. Upwelling was first observed in 2014, with an initial repair attempt made in fall 2015. Repairs at that time were unsuccessful, as upwelling had resumed by spring 2016. Prior to 2017 repairs, water was observed flowing at a rate of approximately 2-3 gpm before dissipating into the ground approximately 130 feet downgradient.

*Work site after repair  
and reclamation  
complete.*

The original borehole was drilled to a depth of 102.33 feet and grouted to the surface with approximately 160 cubic feet of grout mix (dry volume). All water flow was successfully cut off. The existing casing was removed.

All heavy equipment and materials were set on tundra pads. An area of approximately 1000 square feet, including a two-stage sump to manage excess water, was excavated to complete repairs. Existing vegetation from a portion of the site was preserved for re-use. Disturbed areas were then reclaimed by regrading, re-seeding with an approved seed mixture and covering with straw to minimize erosion.

The site will be re-inspected in 2018 to verify repair success and determine the need for additional reclamation measures, if any.
