ALASKA STATE CAPITOL SEISMIC RETROFIT & EXTERIOR RENOVATION

Legislative Council - October 30, 2013

Phase I Components:

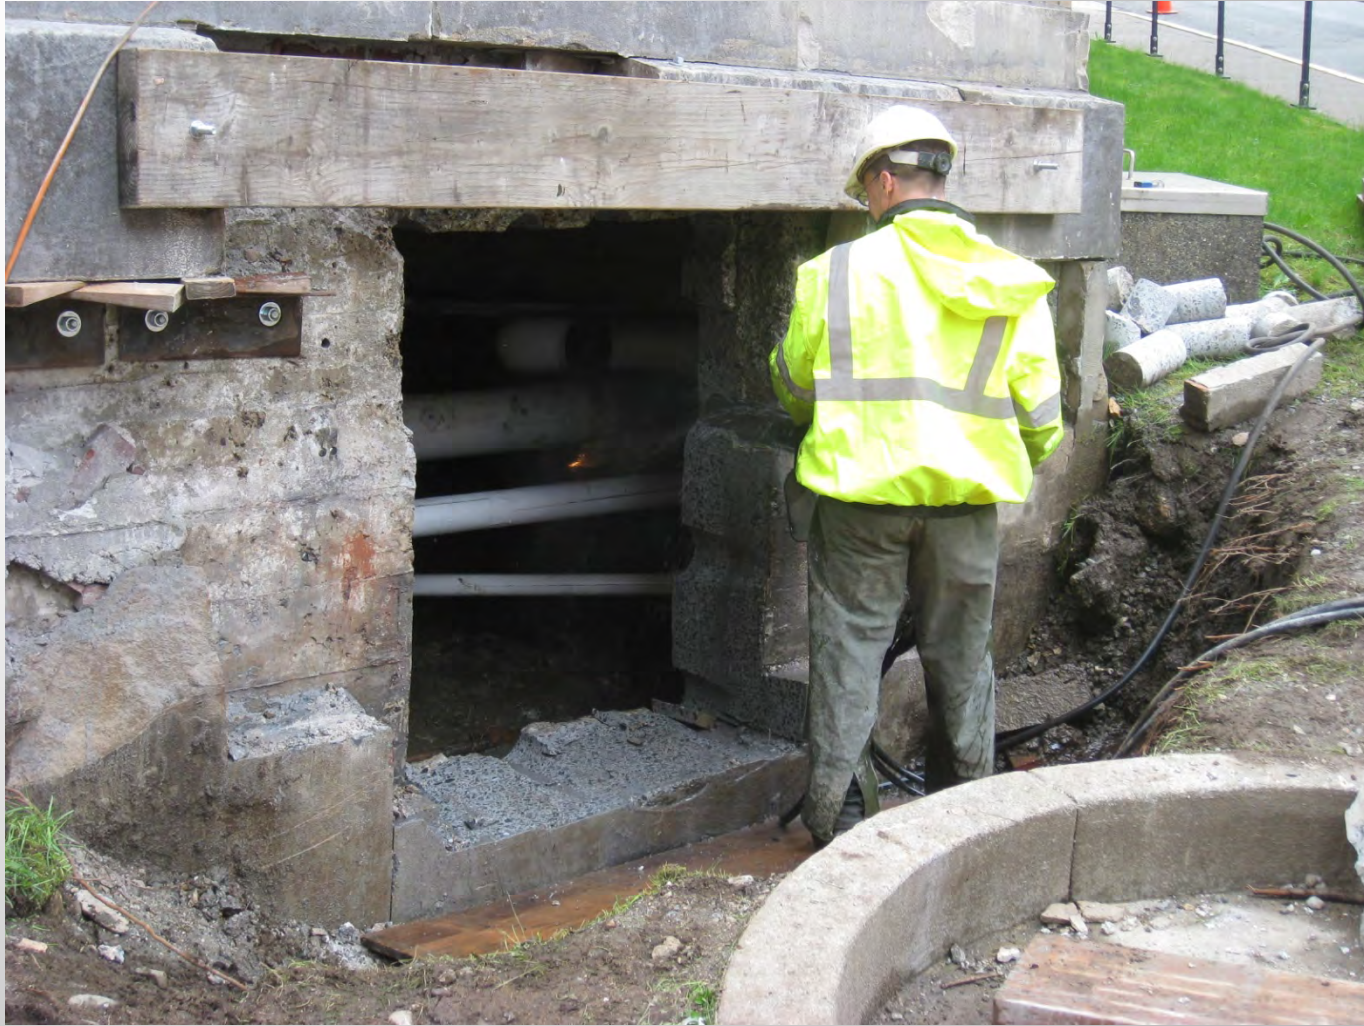
Crawl Space Prior to Construction

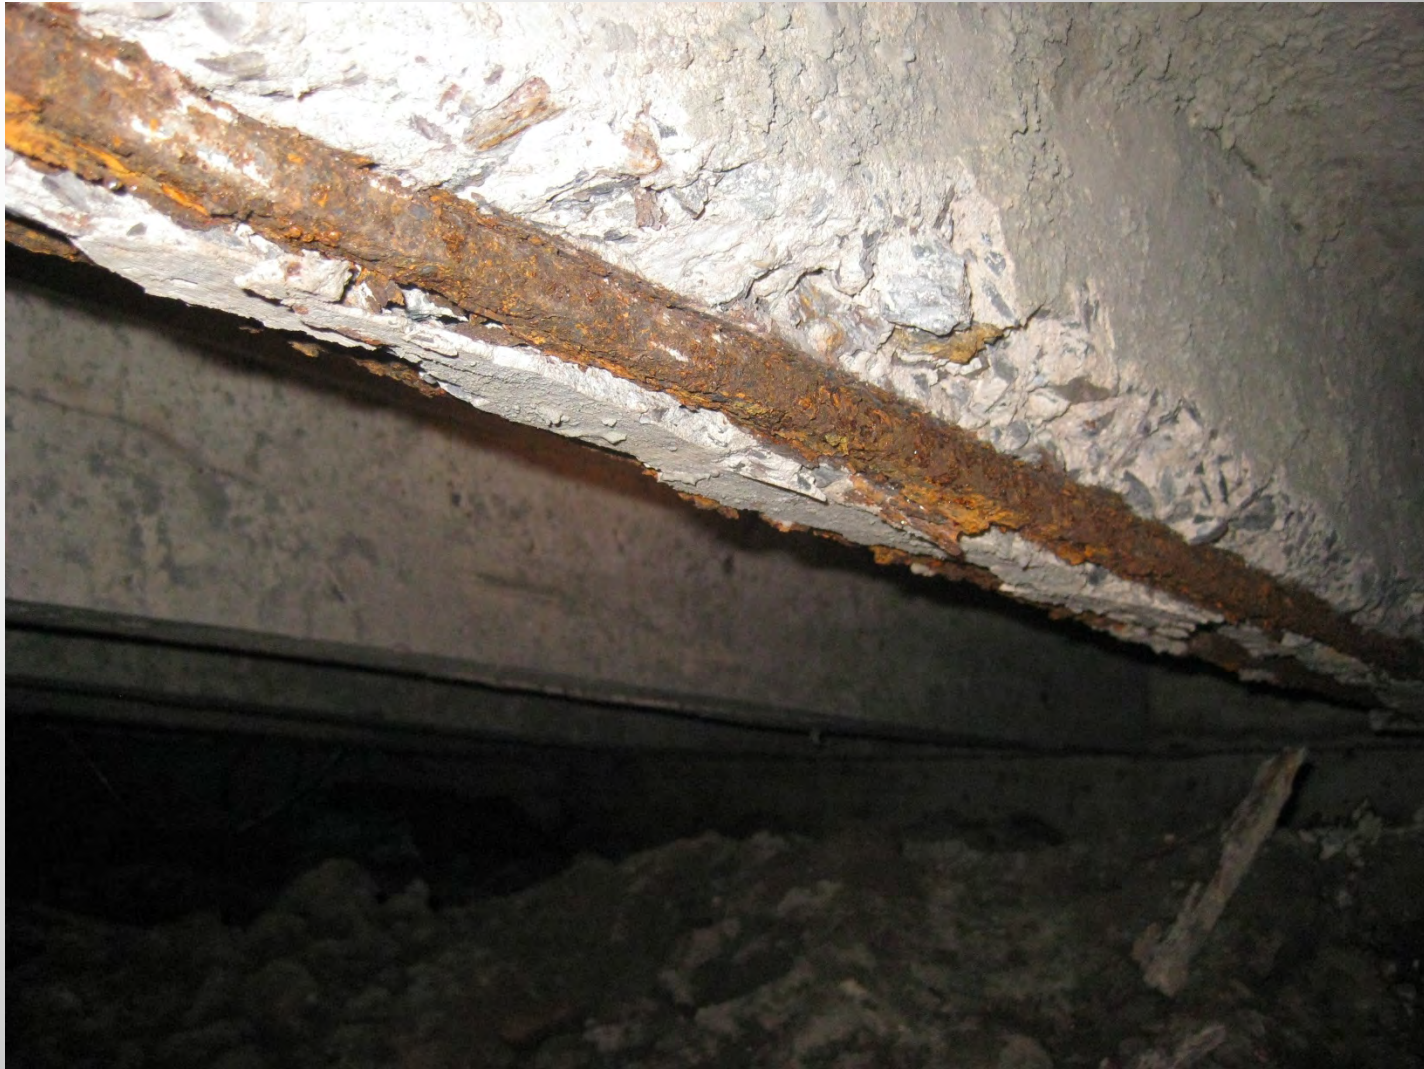
Corroded Reinforcing in Floor Joist

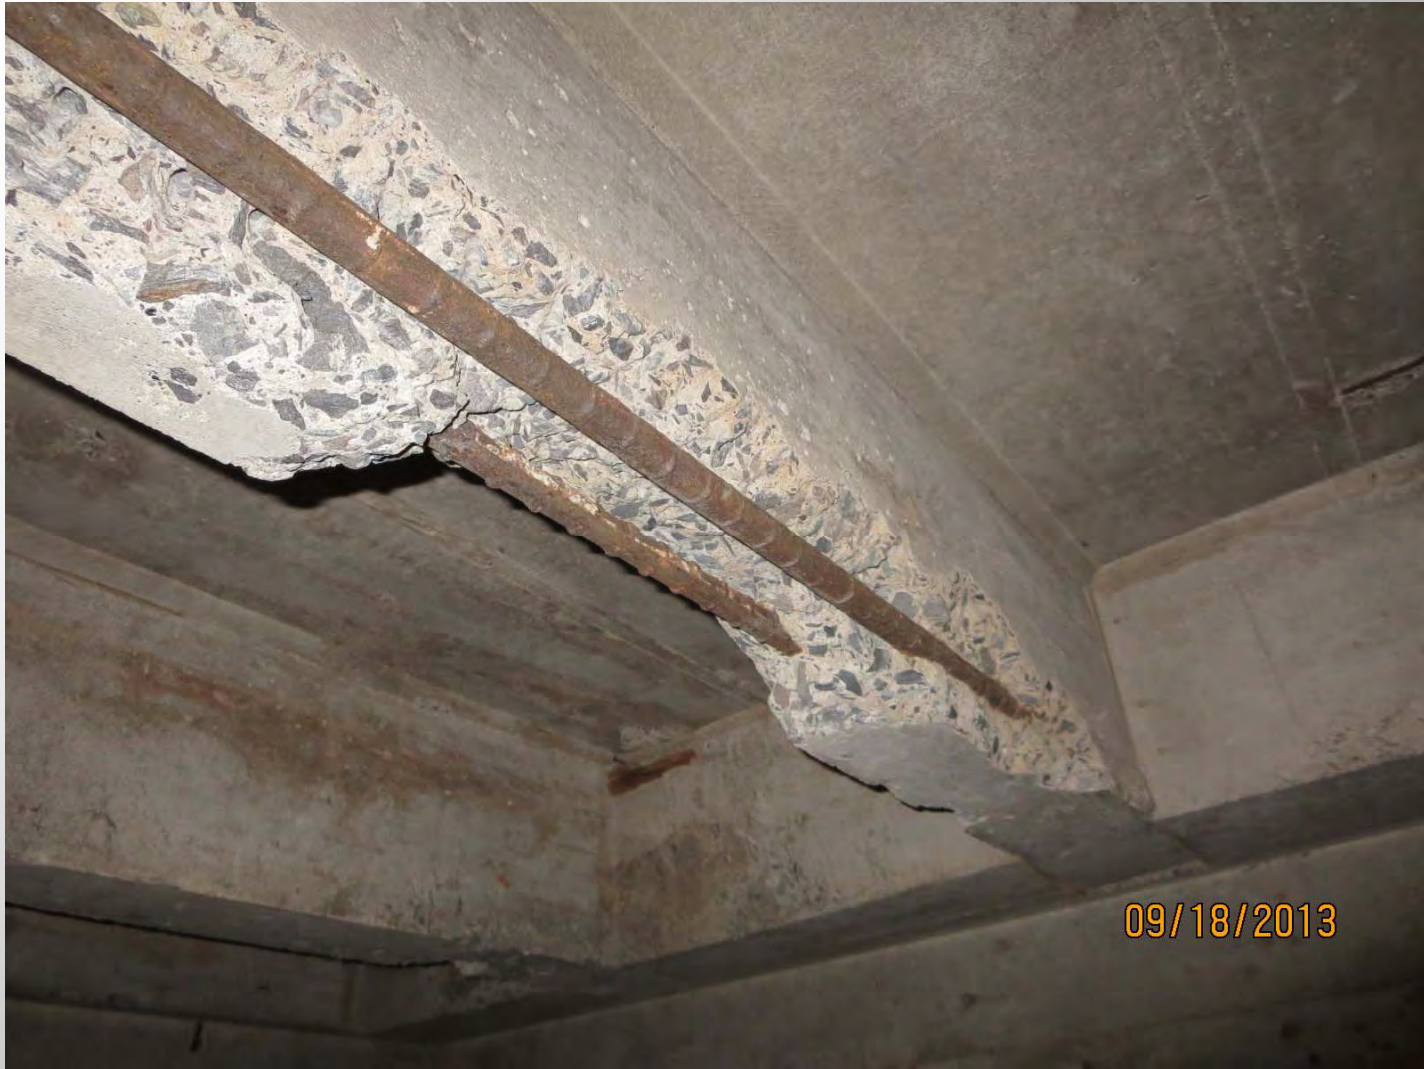
Loose Concrete and Rust removed from Joist

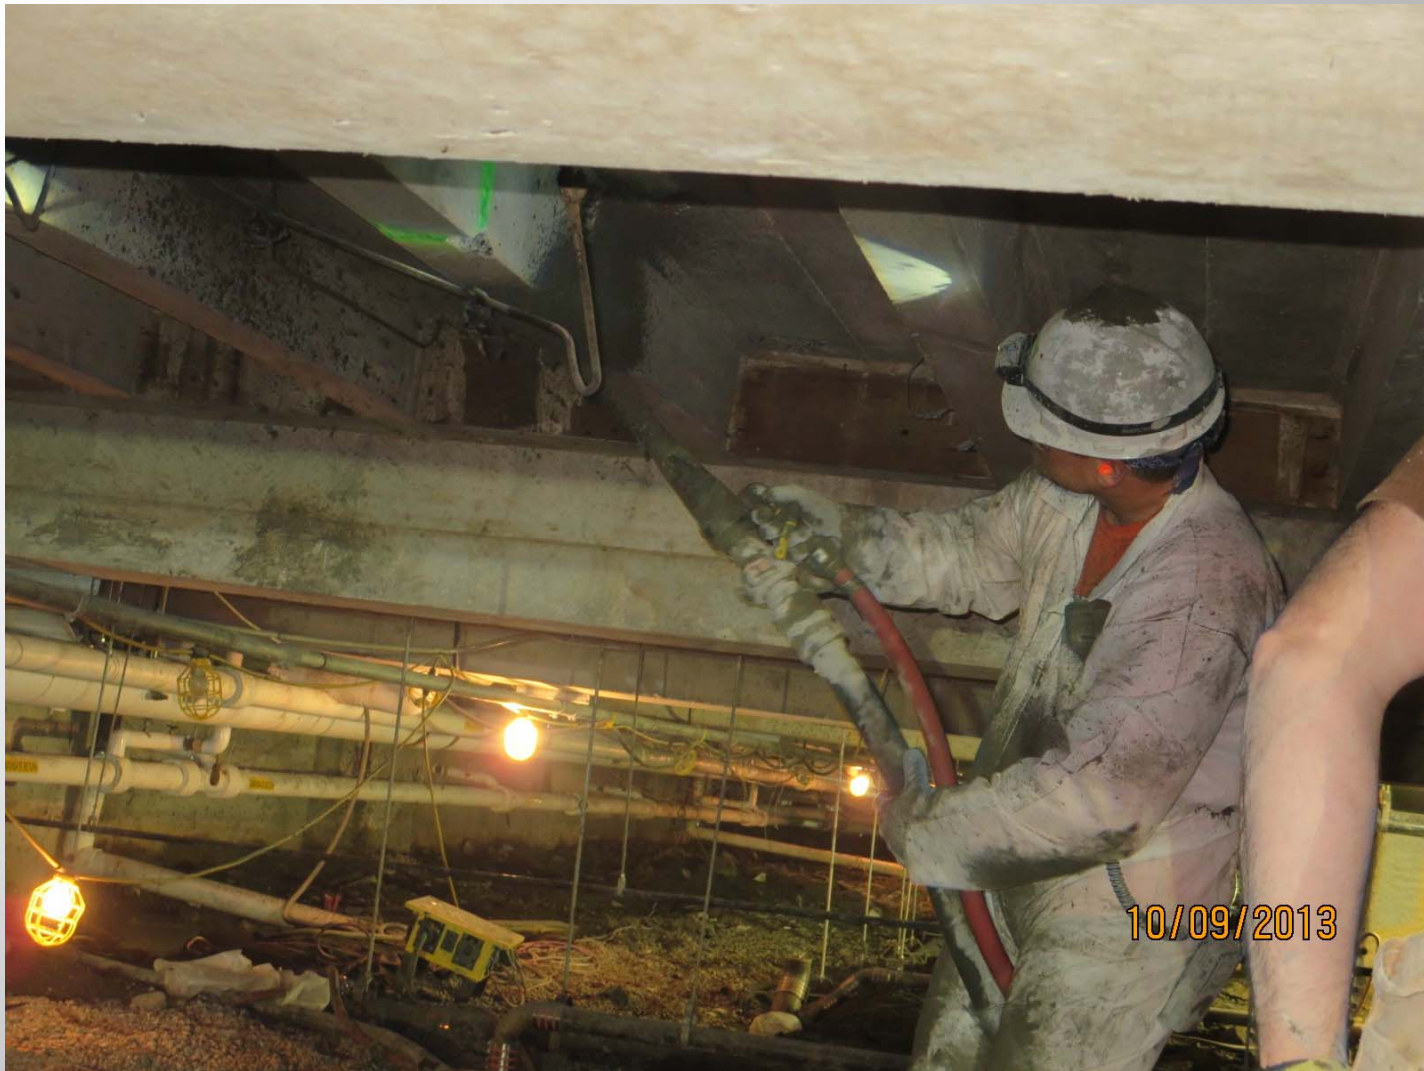
Shotcrete being Applied to Joists

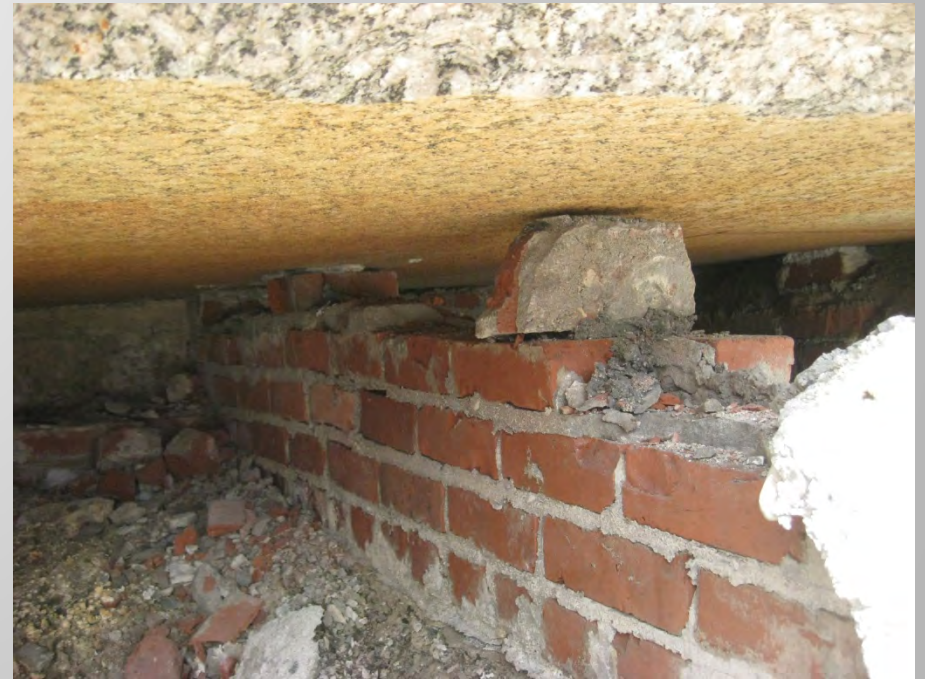
Condition of Foundation under Entry Stairs

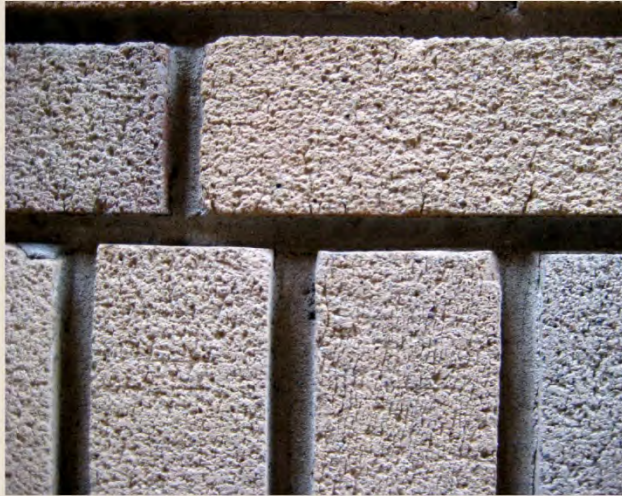
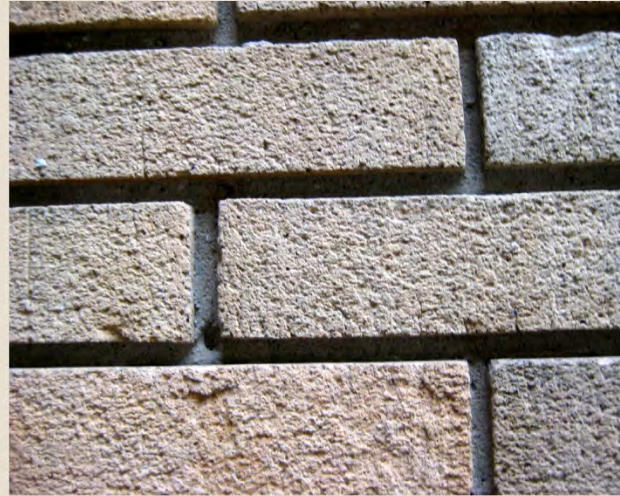
2.6 Sandblasting exacerbates water intrusion and seriously damaged brick.

- Exterior brick has been irretrievably damaged by sandblasting, which removed outer crust.
- Resulting spalling can be retarded, but not stopped, by application of consolidating & water-repellent agent.

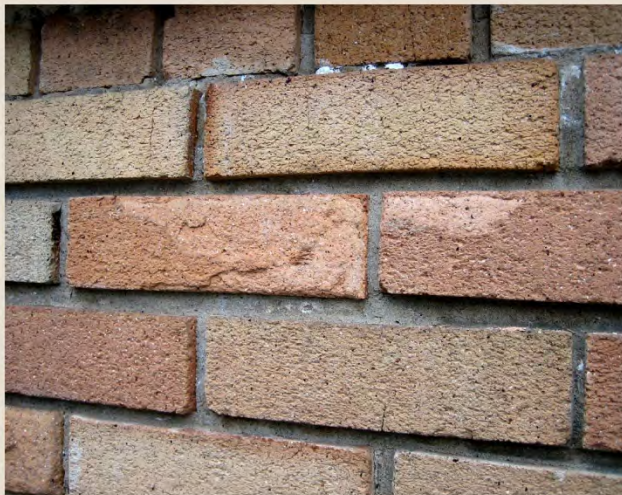
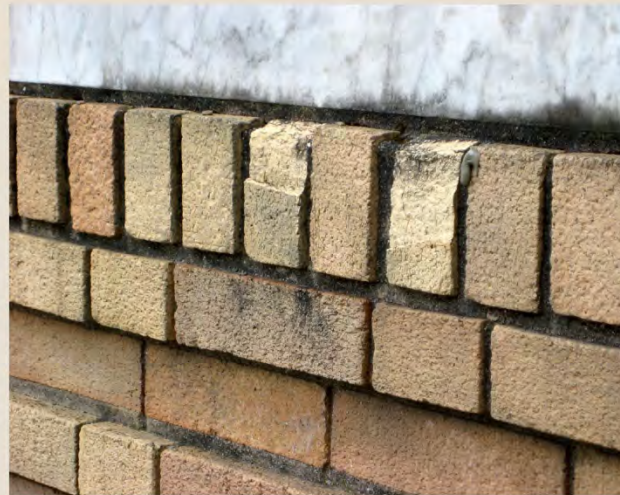
- Brick will continue to spall and crumble.
- This may be a significant consideration.

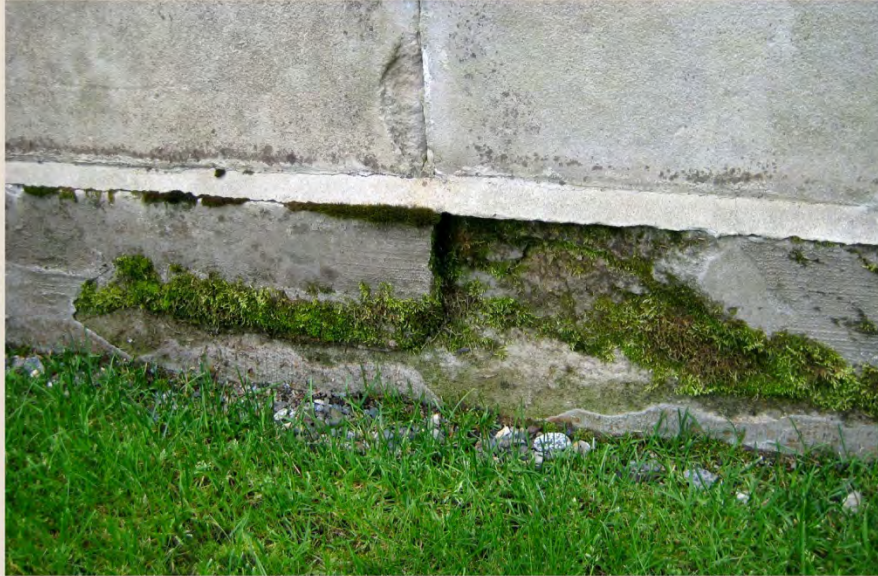
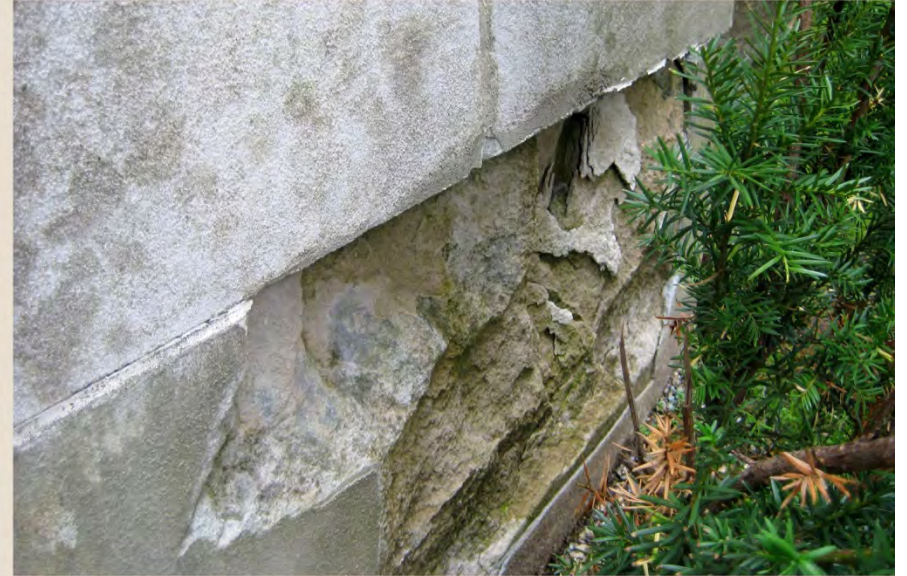
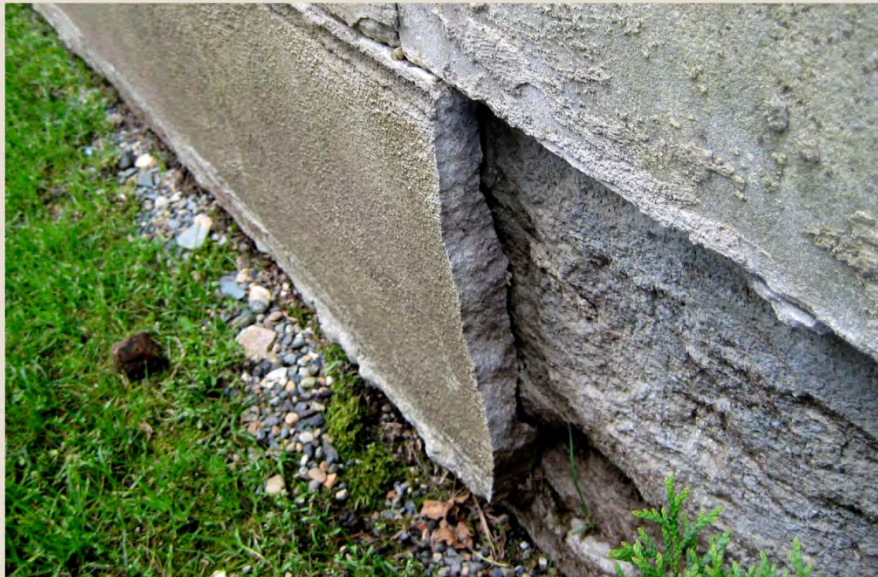
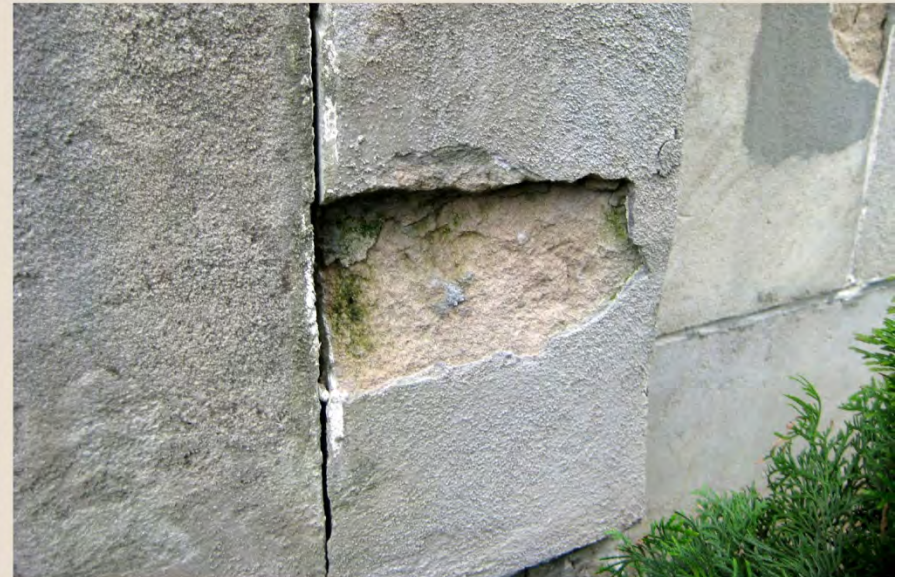
Destruction of Stone Base Along Grade

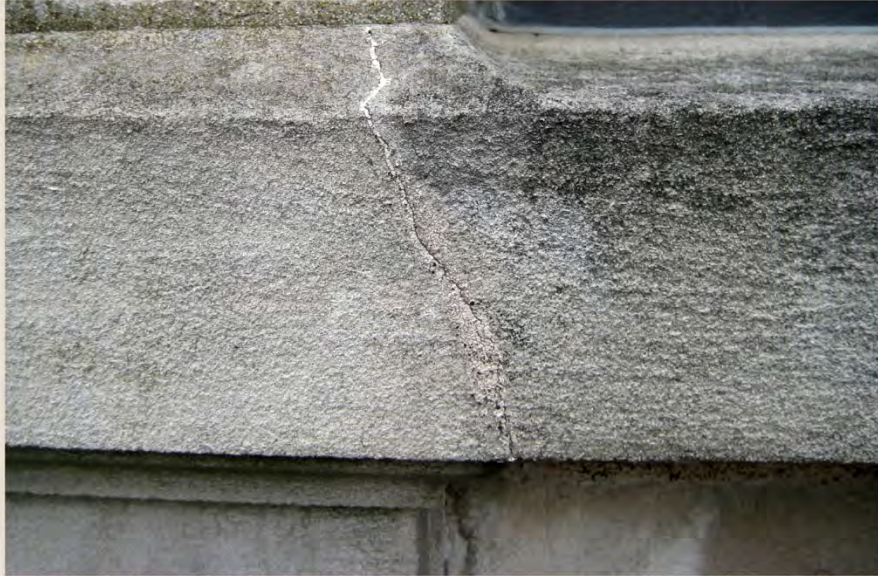
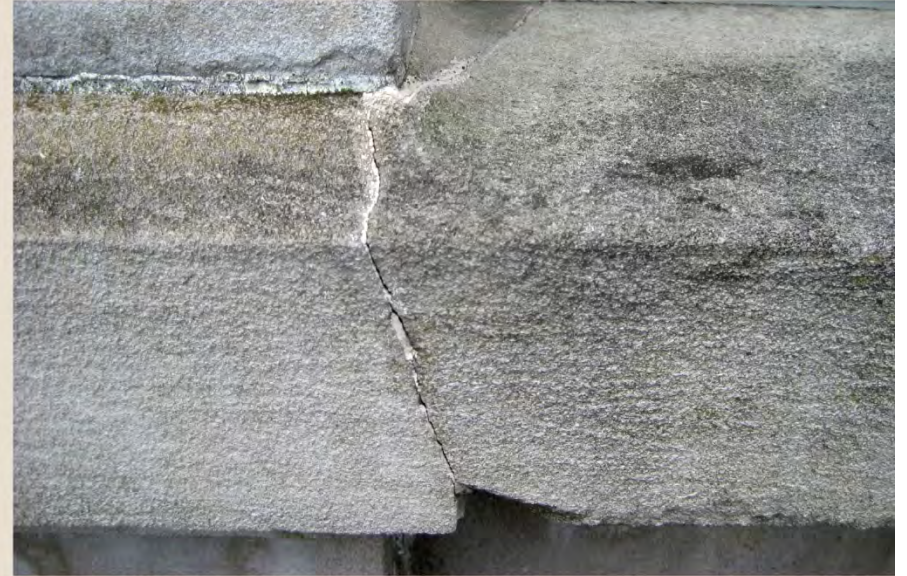
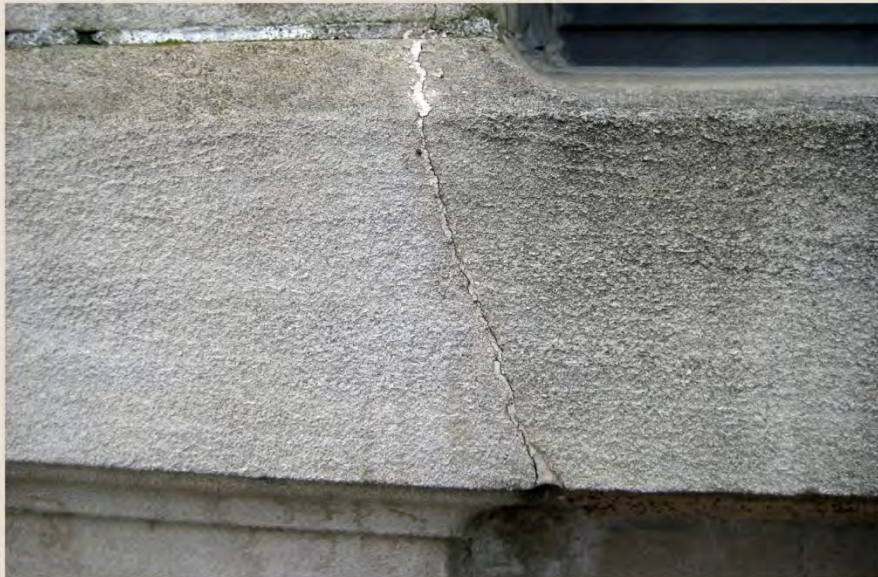
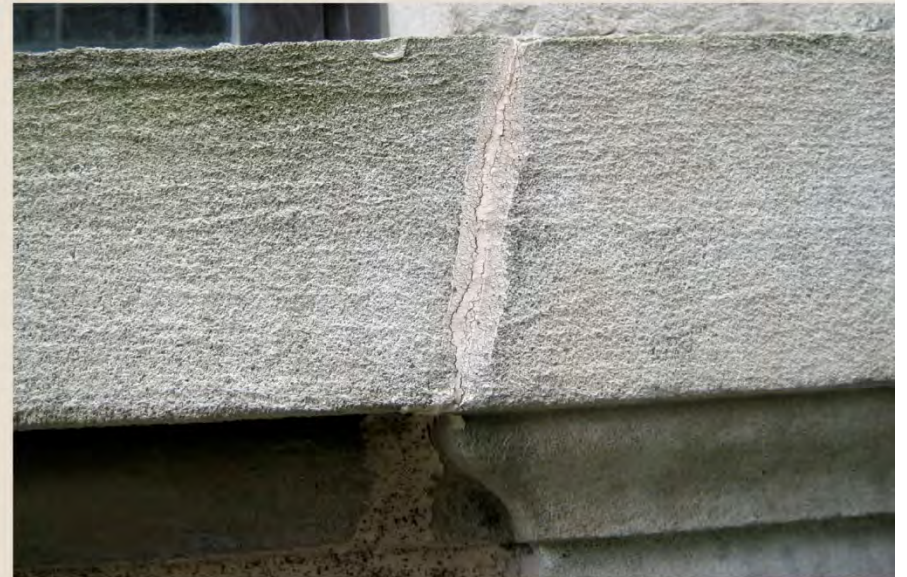
Seismic Cracking of All Stone Window Sills

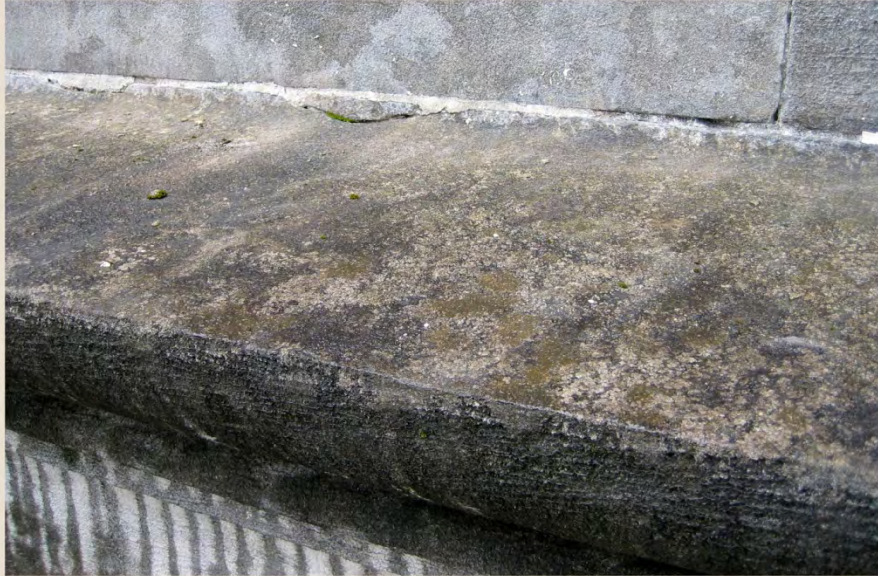
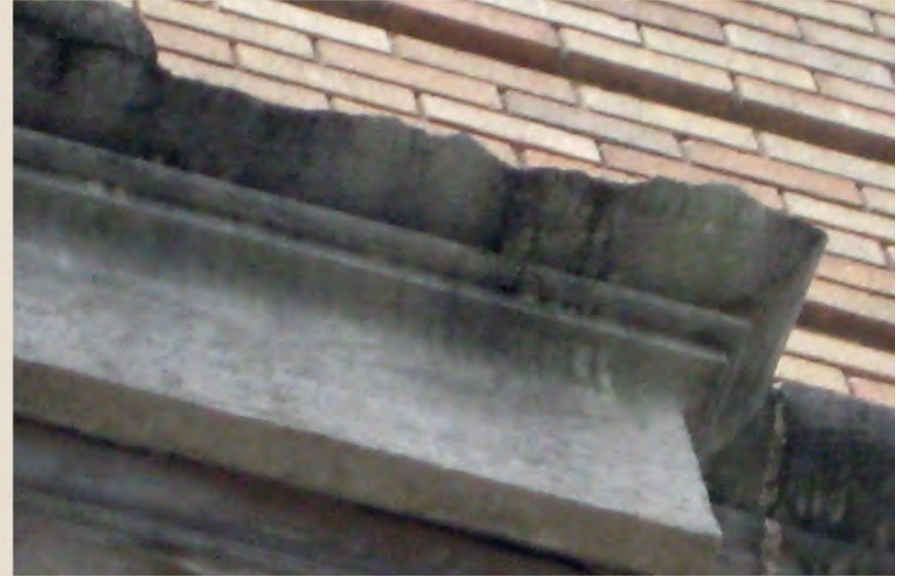
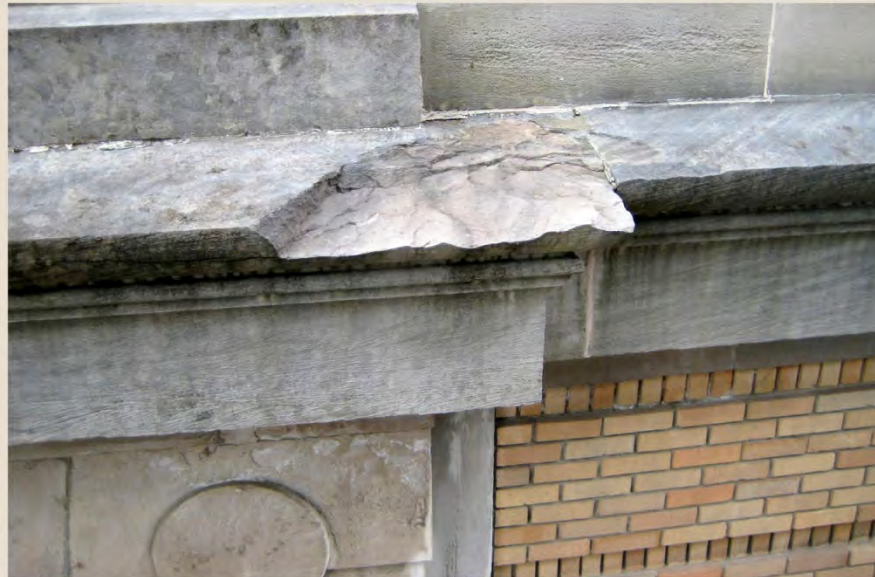
Degradation of Stone Water-Table

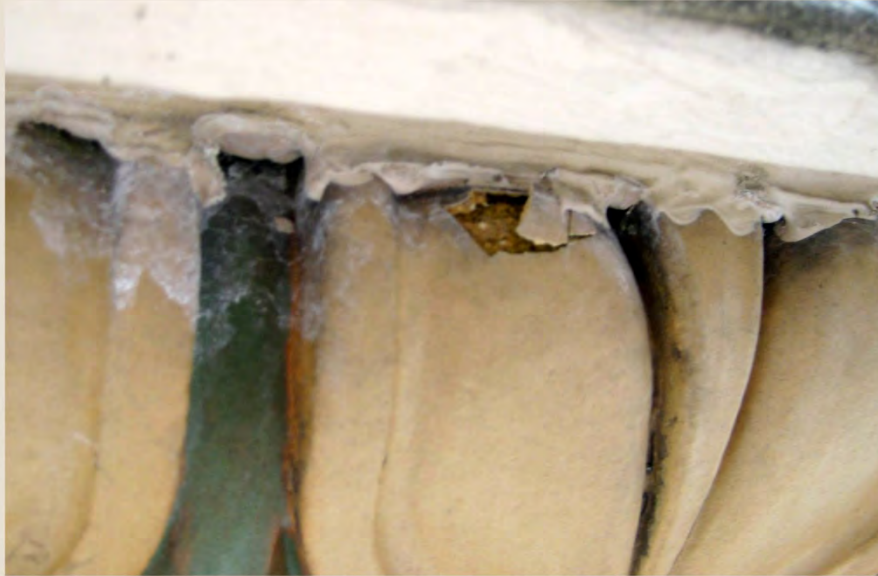
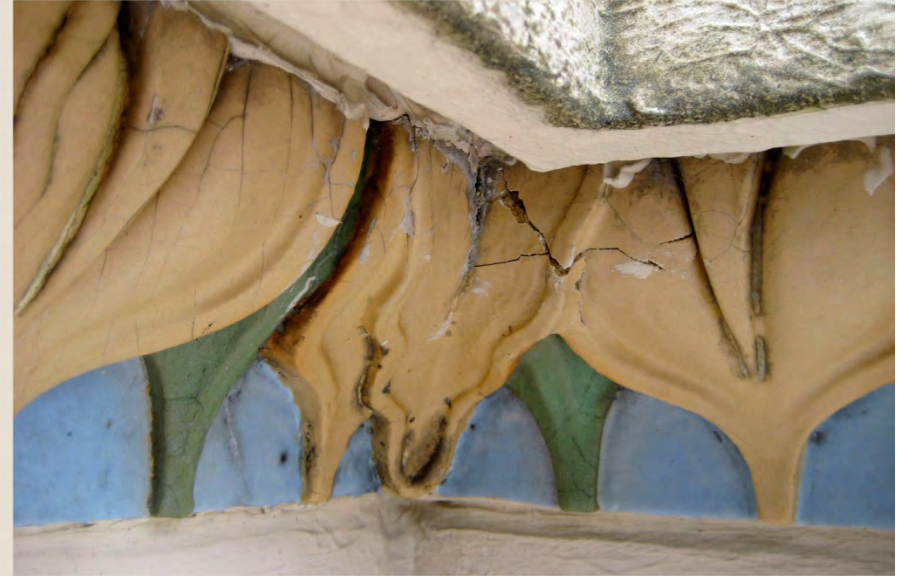
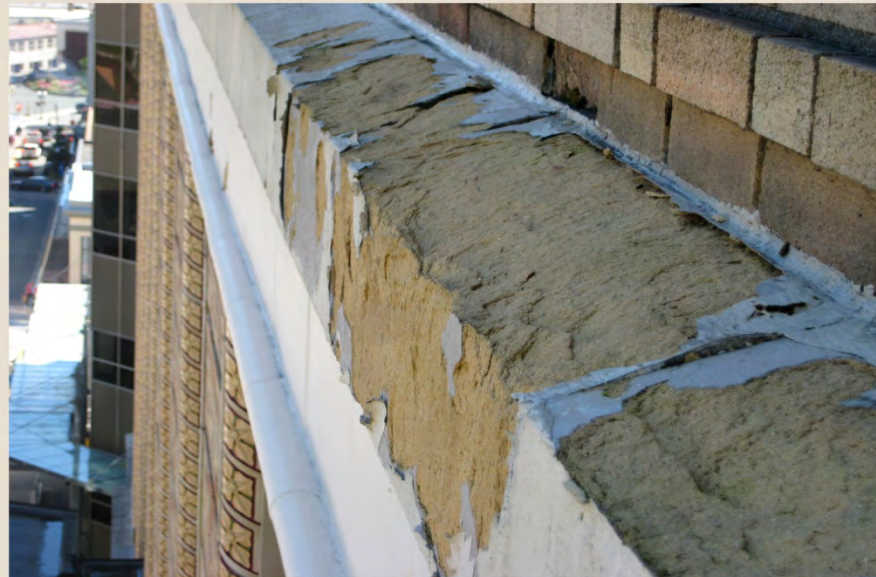
Degradation of Terra-Cotta Water-Table

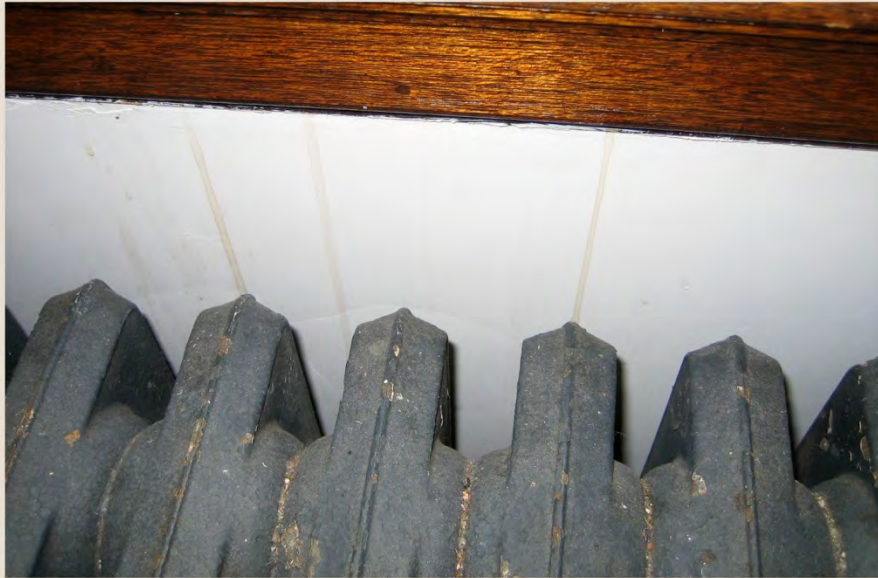
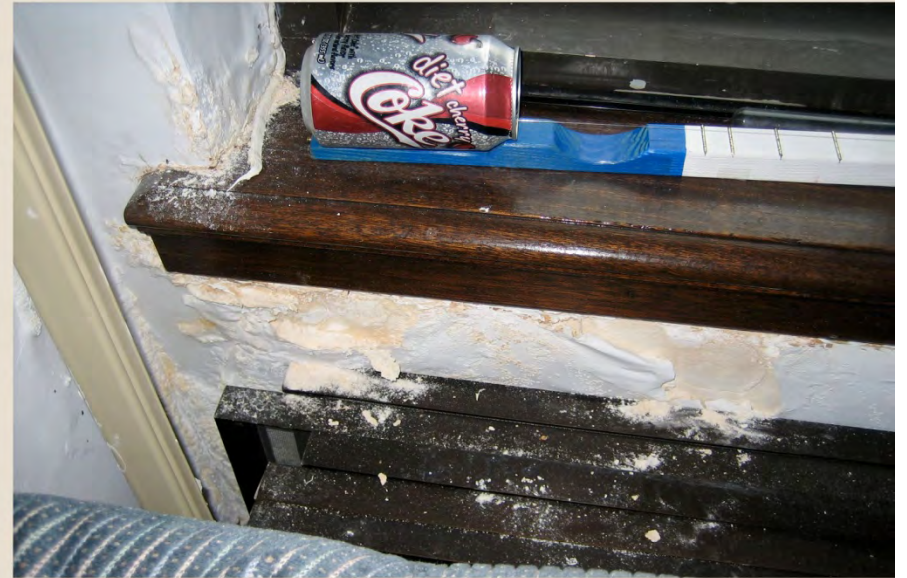
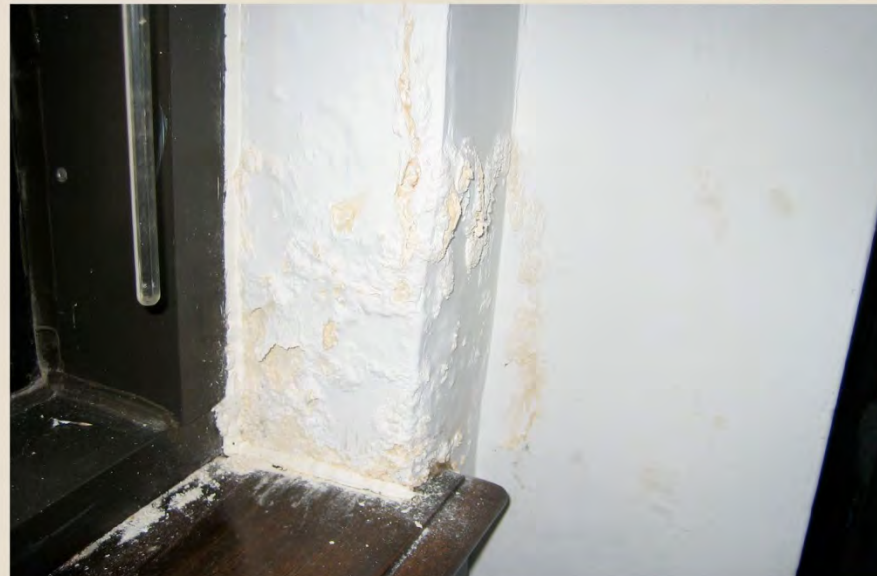
Leak Symptoms at Windows
