# Alaska State Legislature

SUBJECT: Terry Miller Legislative Office Building Retaining Wall Cap and Rail

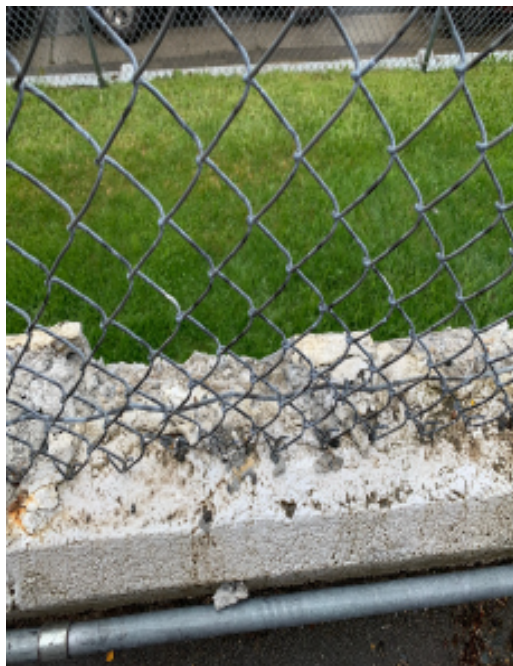
Crumbling Concrete

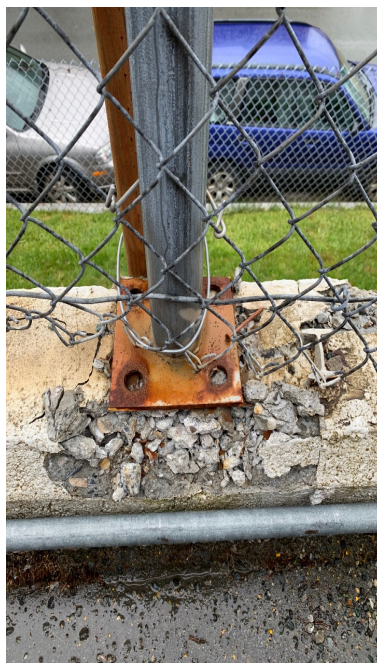
Rusted Bolts

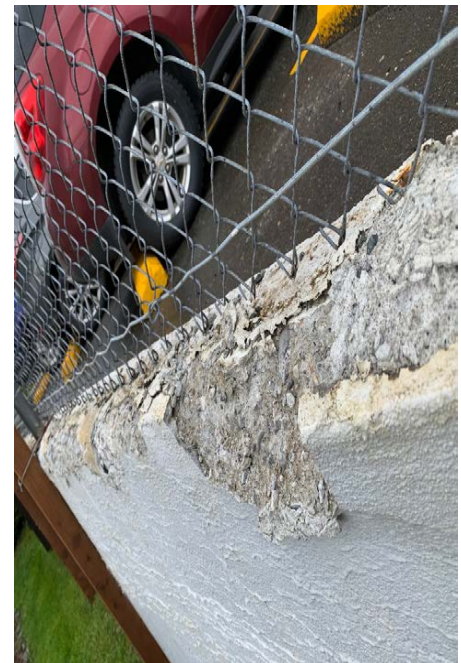
Crumbling Concrete

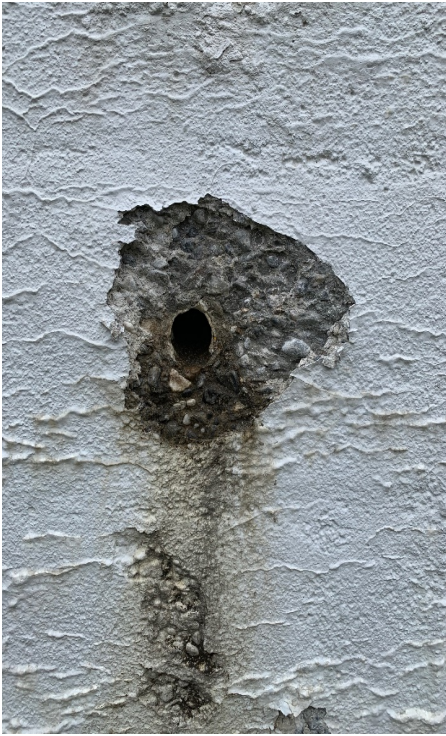
Existing Drain Holes

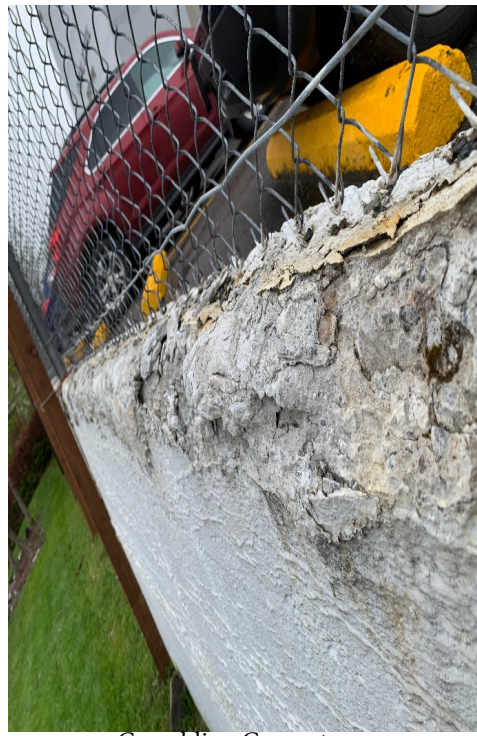
Crumbling Concrete

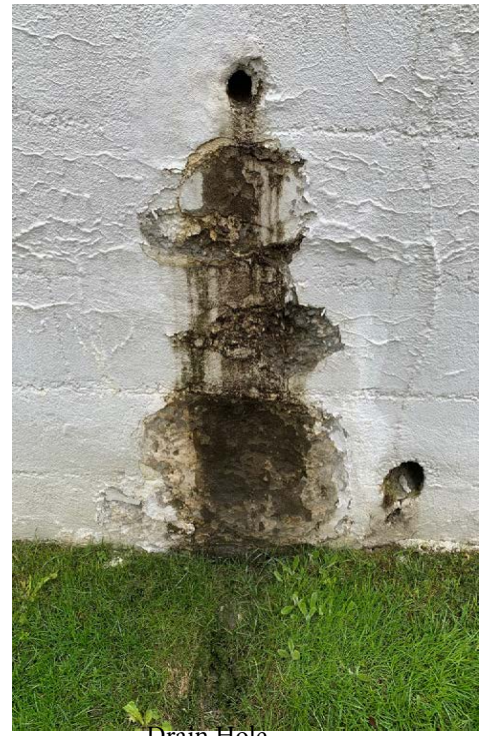
Drain Hole

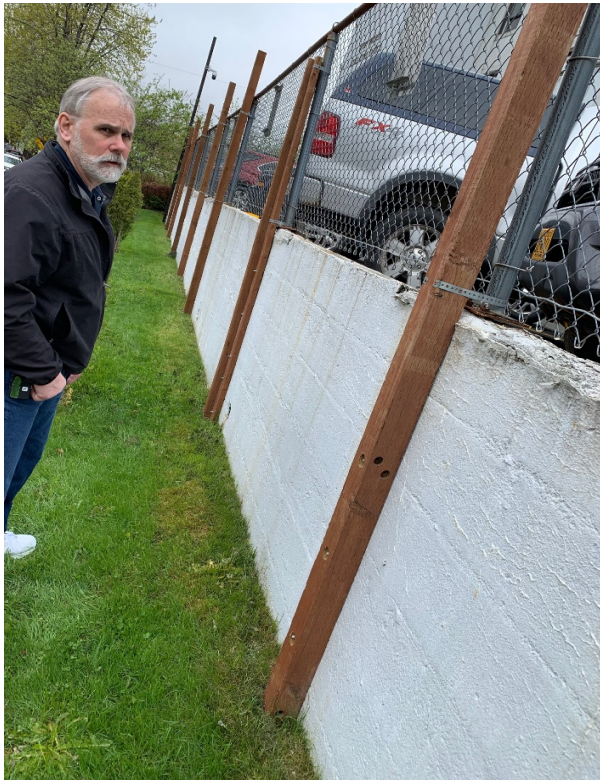
Temporary Fence Anchors

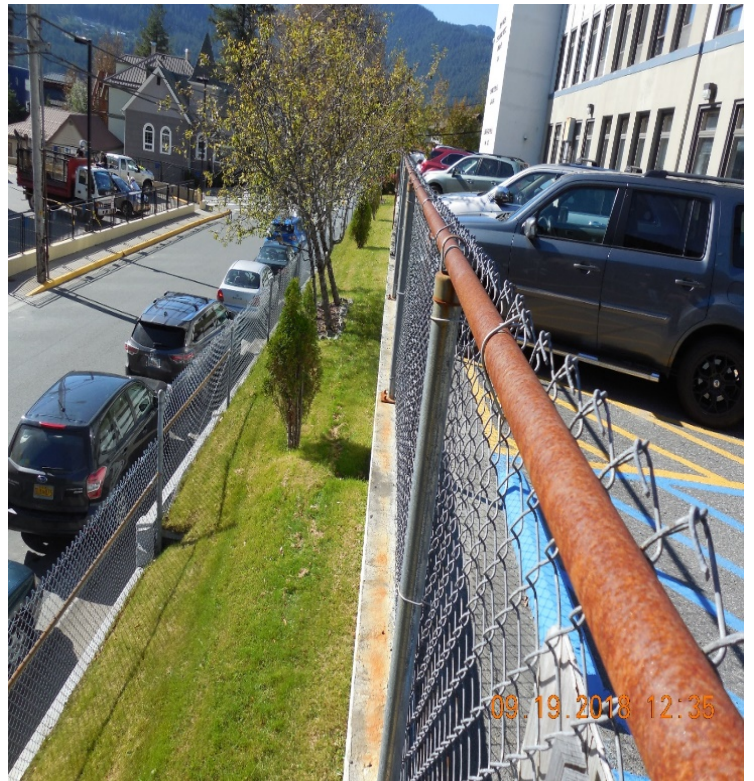
Rusted Railing
