SUBJECT: Terry Miller Building Windows & Siding Change Order 5

Project (ITB or RFP) Title: Terry Miller Legislative Office Building Window and Exterior Renovation

## North and West Wall - Window Wood Grounds at Jambs and Grout at Sill

RFP 007 Construction Images:

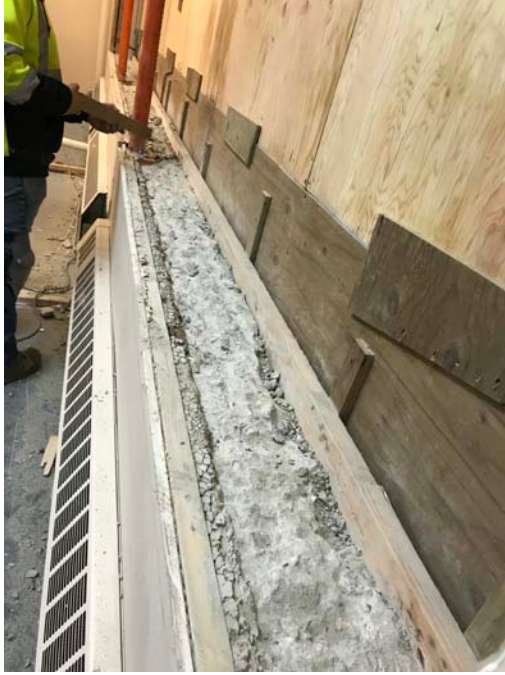
View of typical West addition sills along Main Street. Sills require grouting to fill voids for proper window receiver shimming and form smooth transition to support scheduled exterior sill flashing.

The windows on the north and west side of the building will require new wood grounds and grouted sills to replace wood grounds removed as part of HZMT RFP 005. The placement of new wood grounds and grouted level sill is required for proper window installation and structural securement of window receivers to the concrete structure.

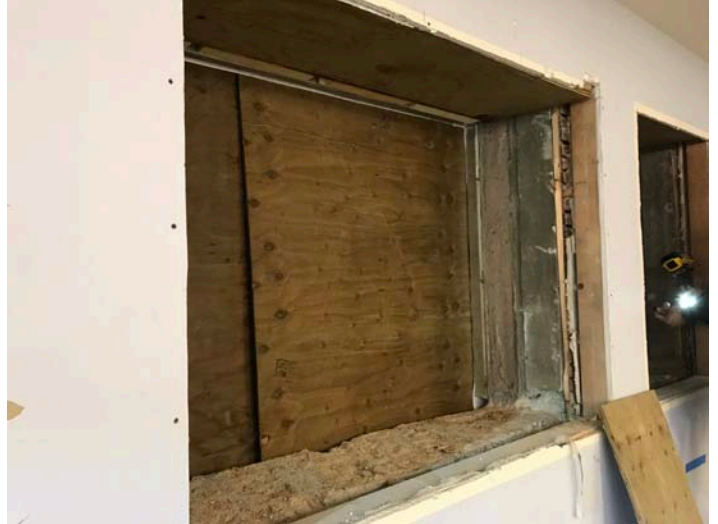
View of typical window sill in Library. Sills require grouting to fill voids for proper window receiver shimming and form smooth transition to support scheduled exterior and interior sill and flashing.

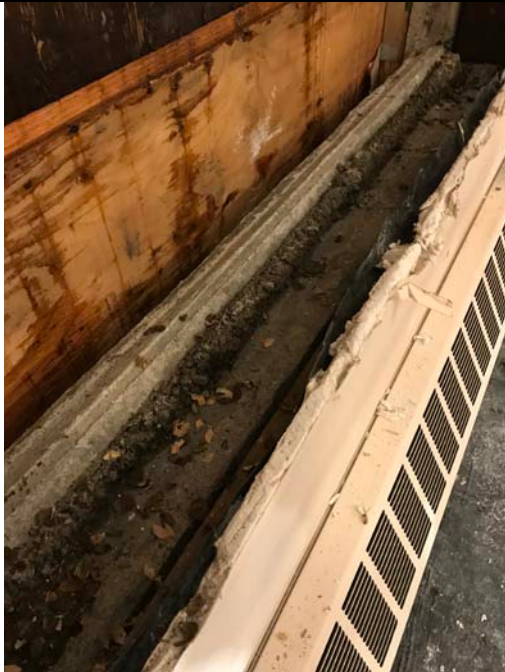
It appears when the exterior walls were formed, concrete was allowed to flow around the blocked-out "window buck" rough openings at sill, jamb and heads. Due to large aggregate encountered in the project, unknown concrete placement methods and small batches of concrete placed at a time, the concrete appears to not have flowed and consolidate adequately under the wood window buck sills. The un-consolidated concrete formed air pockets due to the difficulty to move or have concrete flow sideways under the wood window bucks, which resulted in the large voids, air pockets and uneven concrete described.

View of typical north and south window sills under abated wood window bucks that became the wood grounds for original wood window rough opening. Sills are heavily impacted by air pockets, unconsolidated concrete and concave voids. Sills throughout the 1927 and 1961 work require grouting to fill voids for proper window receiver shimming and form smooth transition to support scheduled exterior and interior sill and flashing.

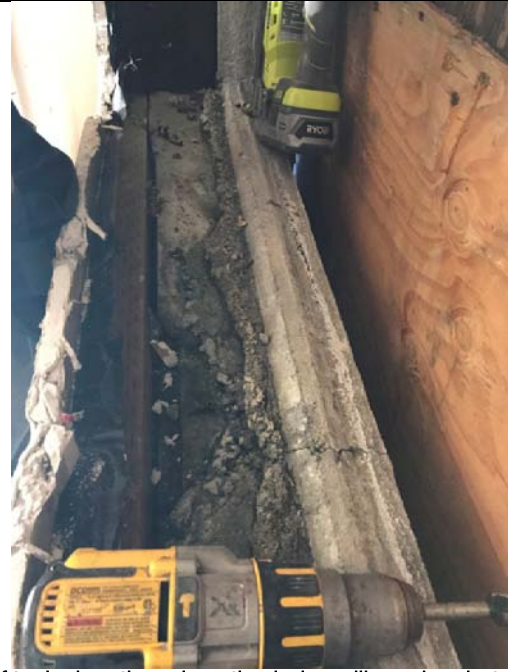
View of typical north and south window sills under abated wood window bucks. This condition of unconsolidated concrete under the window bucks (wood grounds) is present at all floors and window openings that have been demolished.

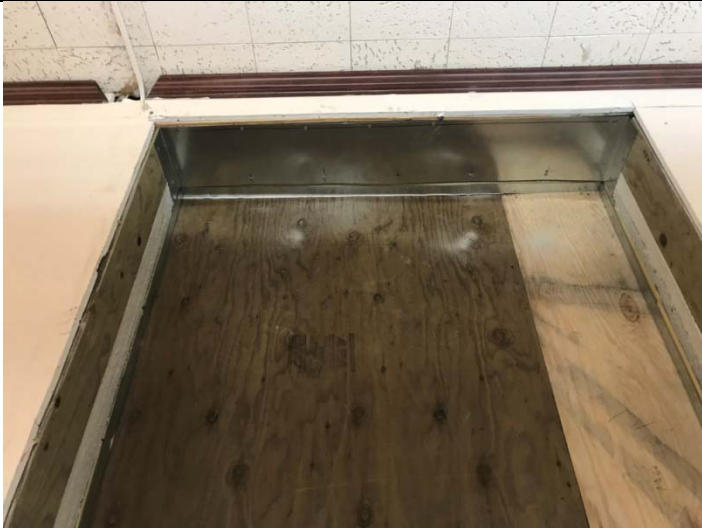
View of typical window head repair anchored into concrete at window heads and jambs.

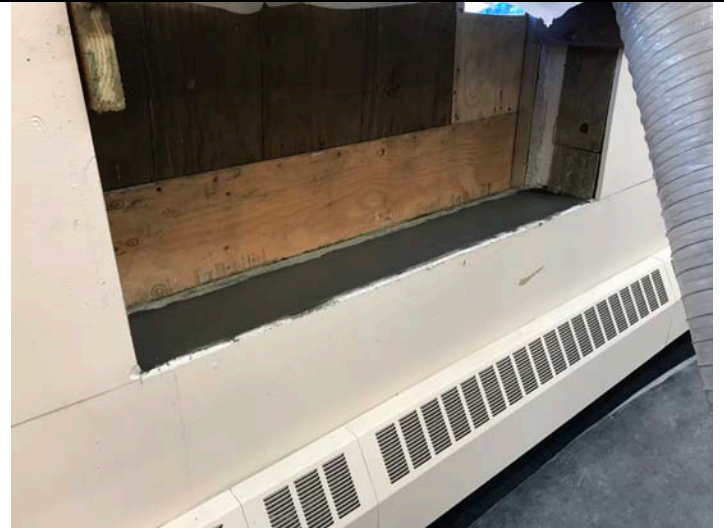
View of typical window sill grout repair.

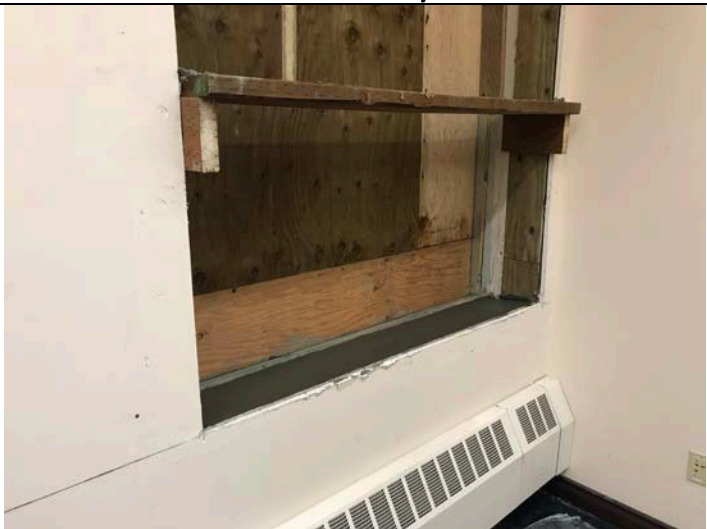
View of typical window sill grout repair.

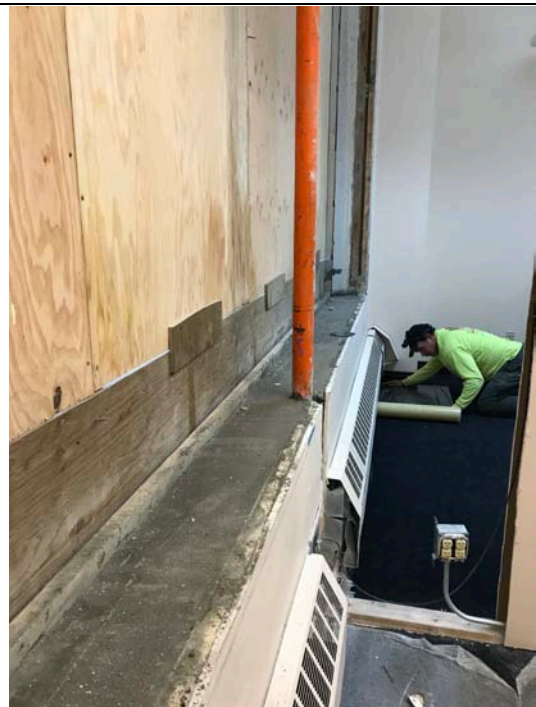
View of typical window sill grout repair.

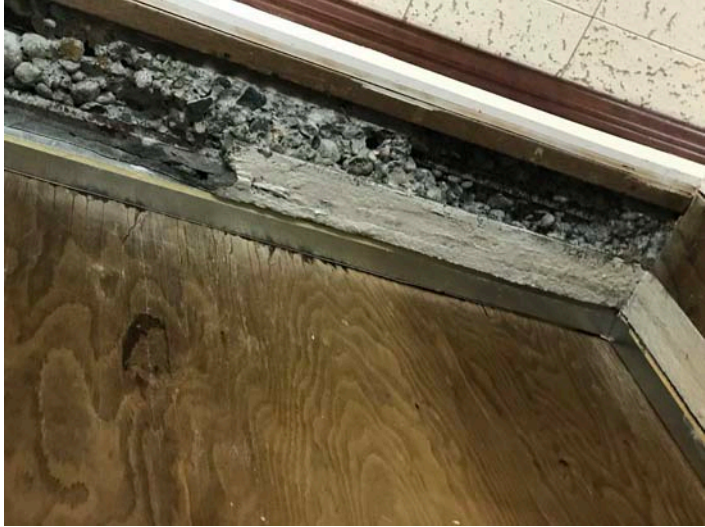
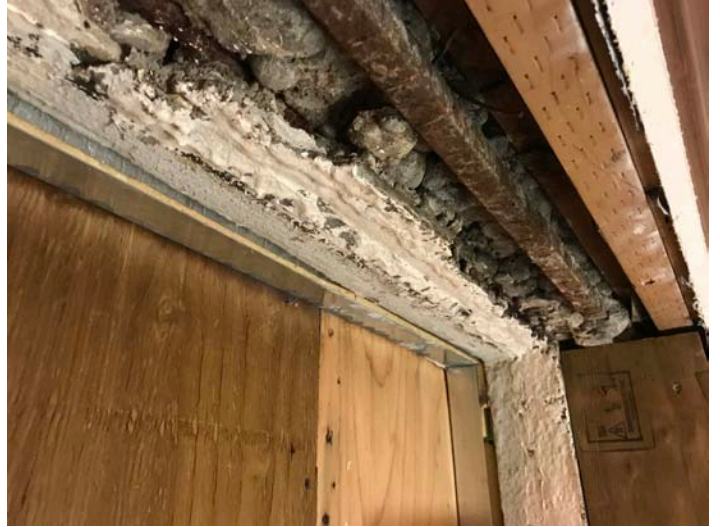
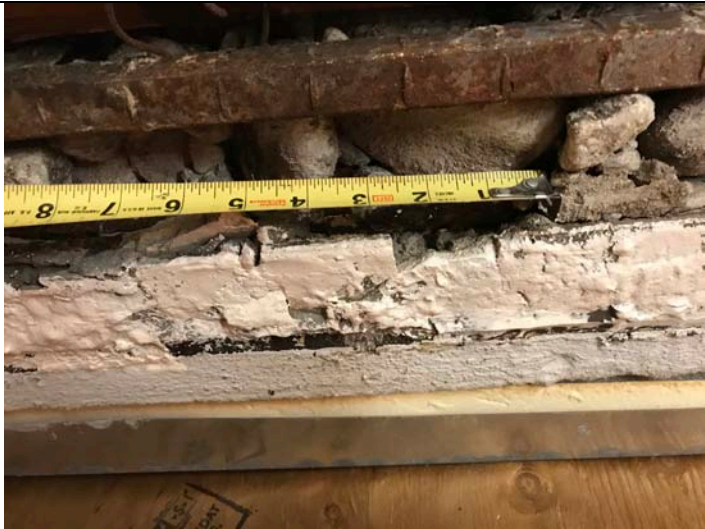
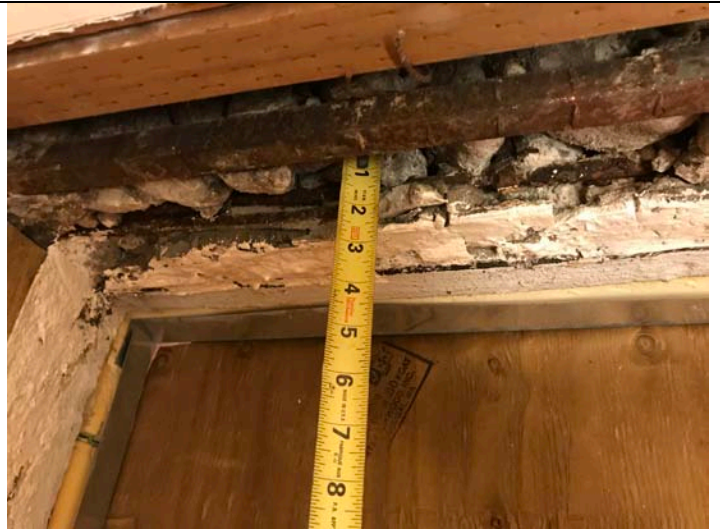
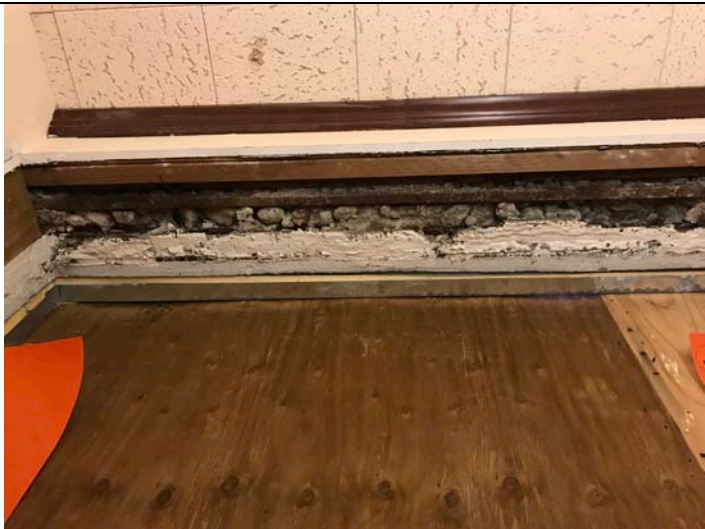
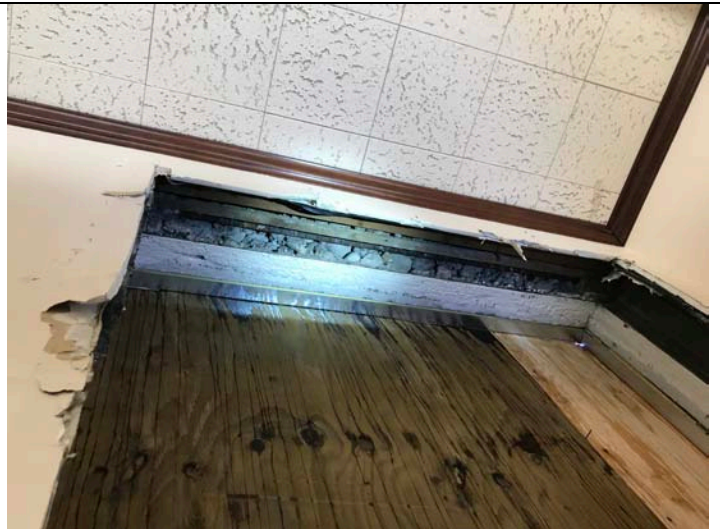
View of third floor heads.
