2 HOUSE CS FOR CS FOR SENATE BILL NO. 364 (Finance)

6 For an Act entitled: "An Act making special appropriations to certain  
7 communities and municipalities for erosion control  
8 projects; and providing for an effective date."

Subject: Seldovia Slope Protection

EVALUATION OF DESIGN ALTERNATIVES FOR  
BEACH EROSION CONTROL FOR THE  
SELDOVIA SMALL BOAT HARBOR

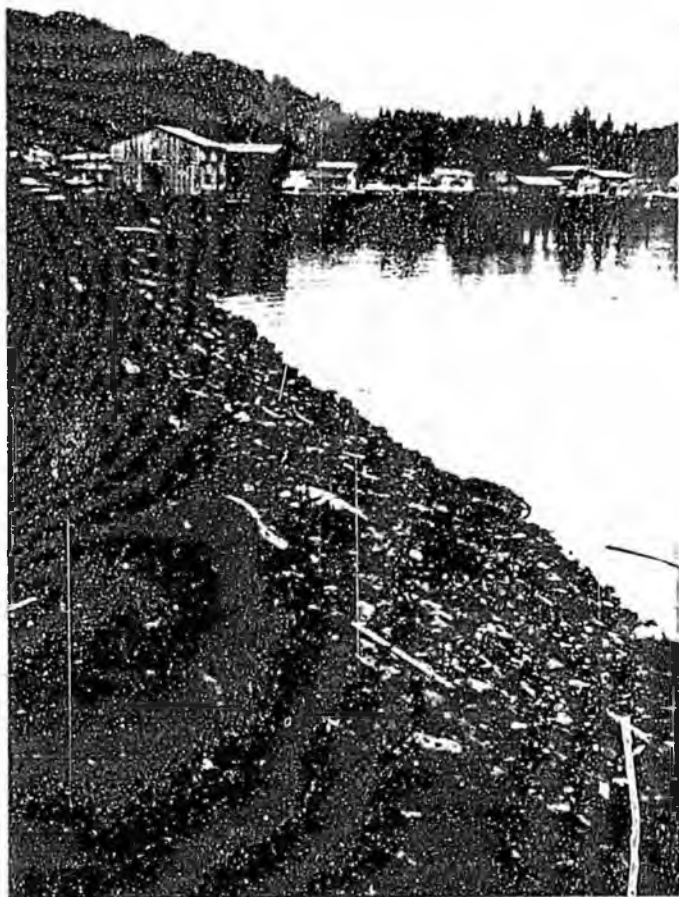
a. Rock present on beach above an elevation of approximately + 6 ft. MLLW.

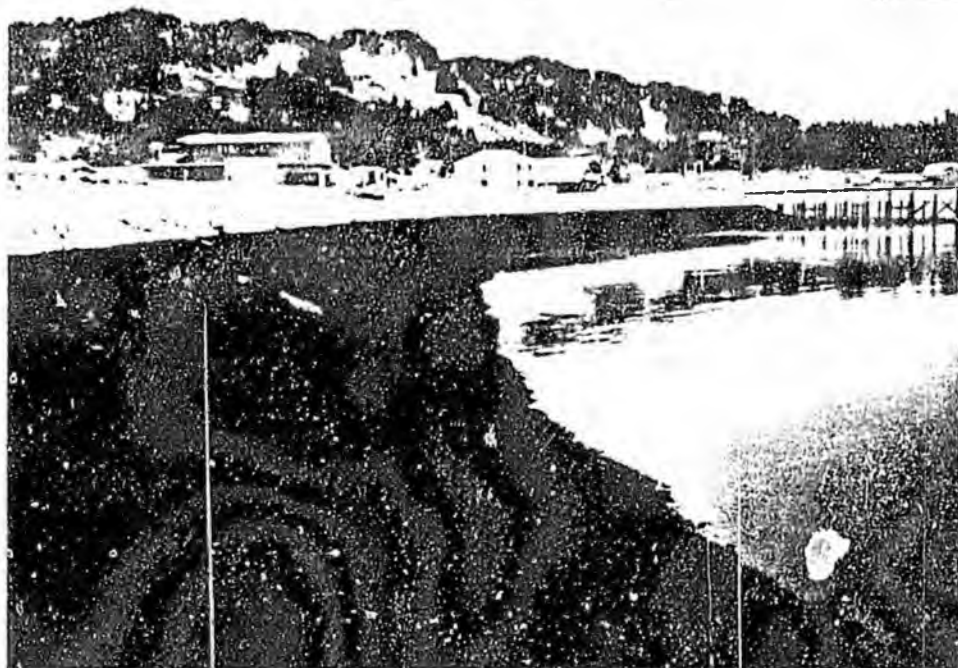
Figure 2. Photographs of the existing shoreline along the northeast side of the Seldovia Small Boat Harbor.

b. View of beach from the northeast corner of the small boat harbor. Materials on the lower portions of the slope consist primarily of silts, sands and gravels.

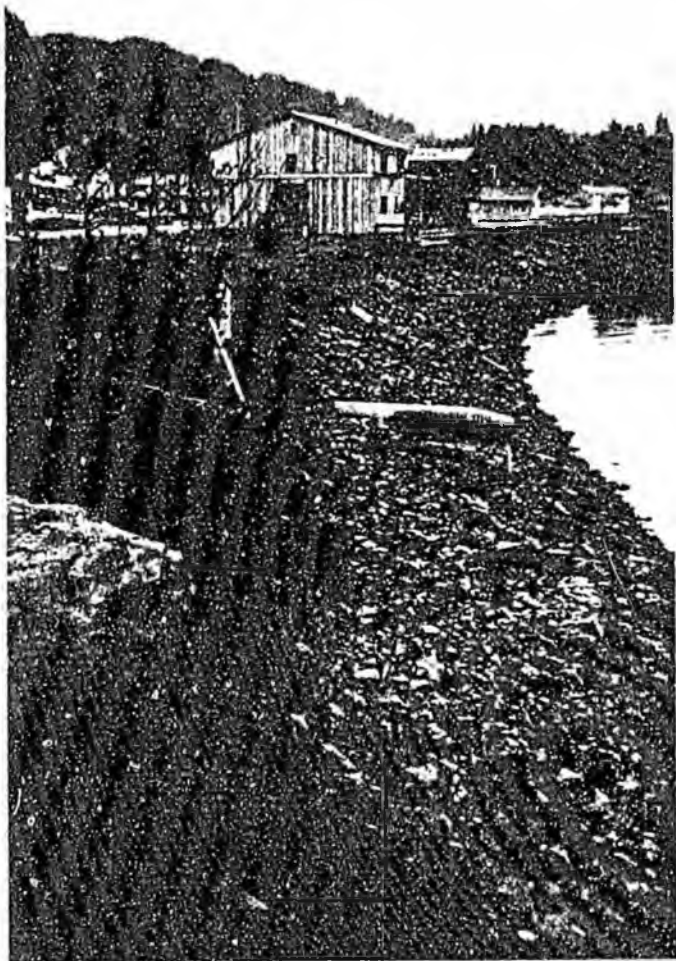
- Zone 1 - A 400 foot stretch of shoreline extending southward from approximately the north side of the "Linwood Bar" to "The Shop",
- Zone 2 - An area 50 to 75 ft on either side of the approach to the small boat harbor floats, and
- Zone 3 - An area extending from approximately 50 ft north to 100 ft south of the old approach to the small boat harbor.

Indications are that since 1970 up to 10 or 11 ft of shoreline erosion has occurred in both Zones 1 and 3 while 5 to 6 ft has occurred at Zone 2. Figure 3 depicts general conditions at Zones 1 and 3.

a. View of eroded shoreline at Zone 1.

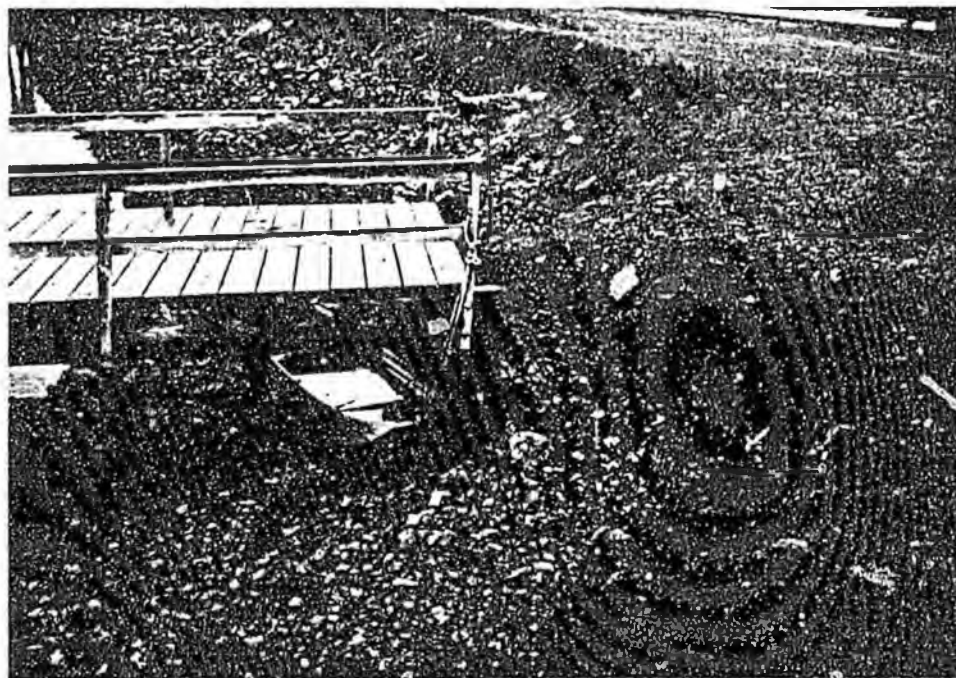
Figure 3. Photograph of the eroded shoreline in the Seldovia Small Boat Harbor.

b. View of eroded shoreline at Zone 3.

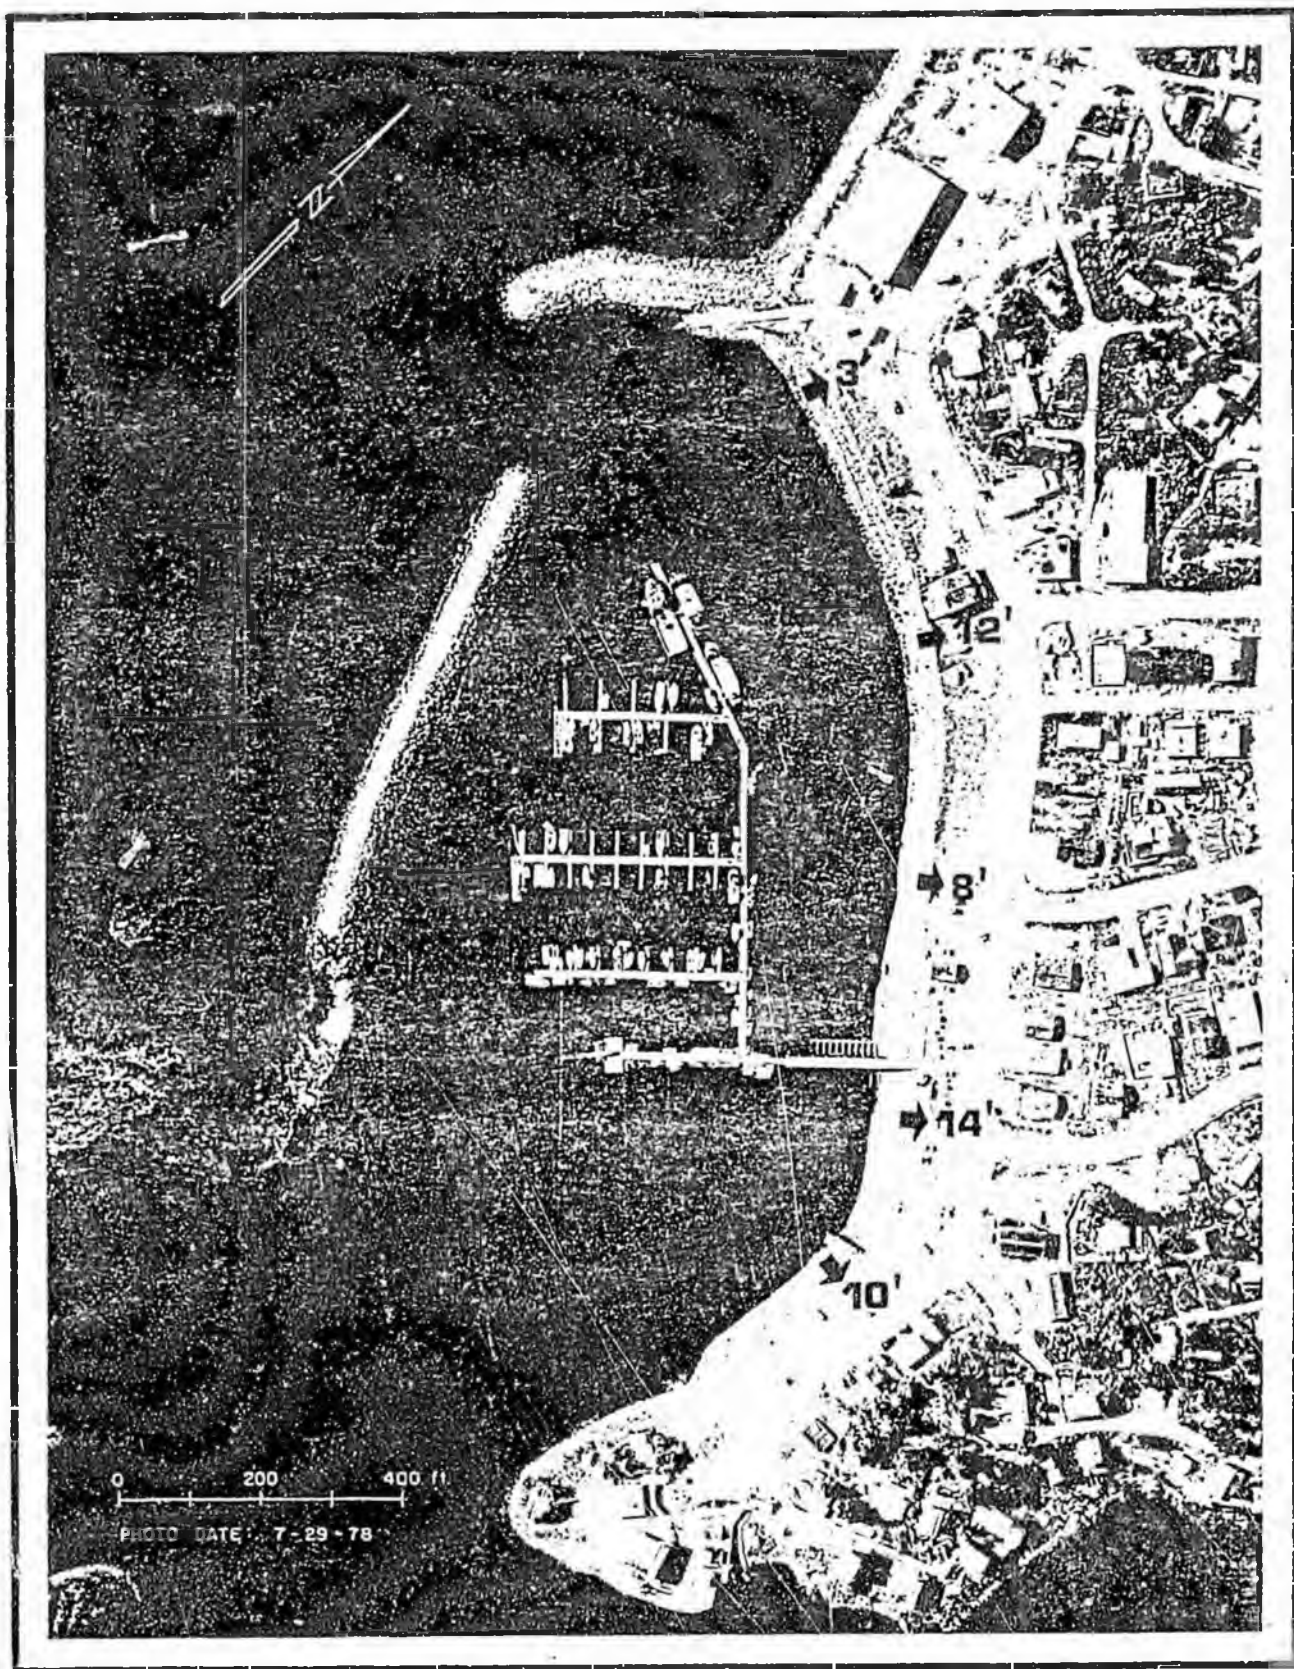
Figure 4. Summary of erosion in the Seldovia Small Boat Harbor for the period 1965 to 1981.

In our study, we have determined that fill material along the northeastern shore of the Seldovia Small Boat Harbor has eroded along its entire length since the fill was placed in 1965. Maximum erosion up to 14 or 15 ft has occurred locally.

The amount of shoreline erosion which has occurred to date is depicted on Figure 4 (on the 1978 aerial photograph). These observations and measurements indicate the general shoreline erosion ranged from 3 to 14 feet since 1965. For purposes of comparison, aerial photography for 1965 and 1970 are provided in the Appendix to this report.
