PB90-916405  
NTSB/MAR-90/04

# NATIONAL TRANSPORTATION SAFETY BOARD

## MARINE ACCIDENT REPORT

GROUNDING OF  
THE U.S. TANKSHIP EXXON VALDEZ  
ON BLIGH REEF, PRINCE WILLIAM SOUND  
NEAR VALDEZ, ALASKA  
MARCH 24, 1989

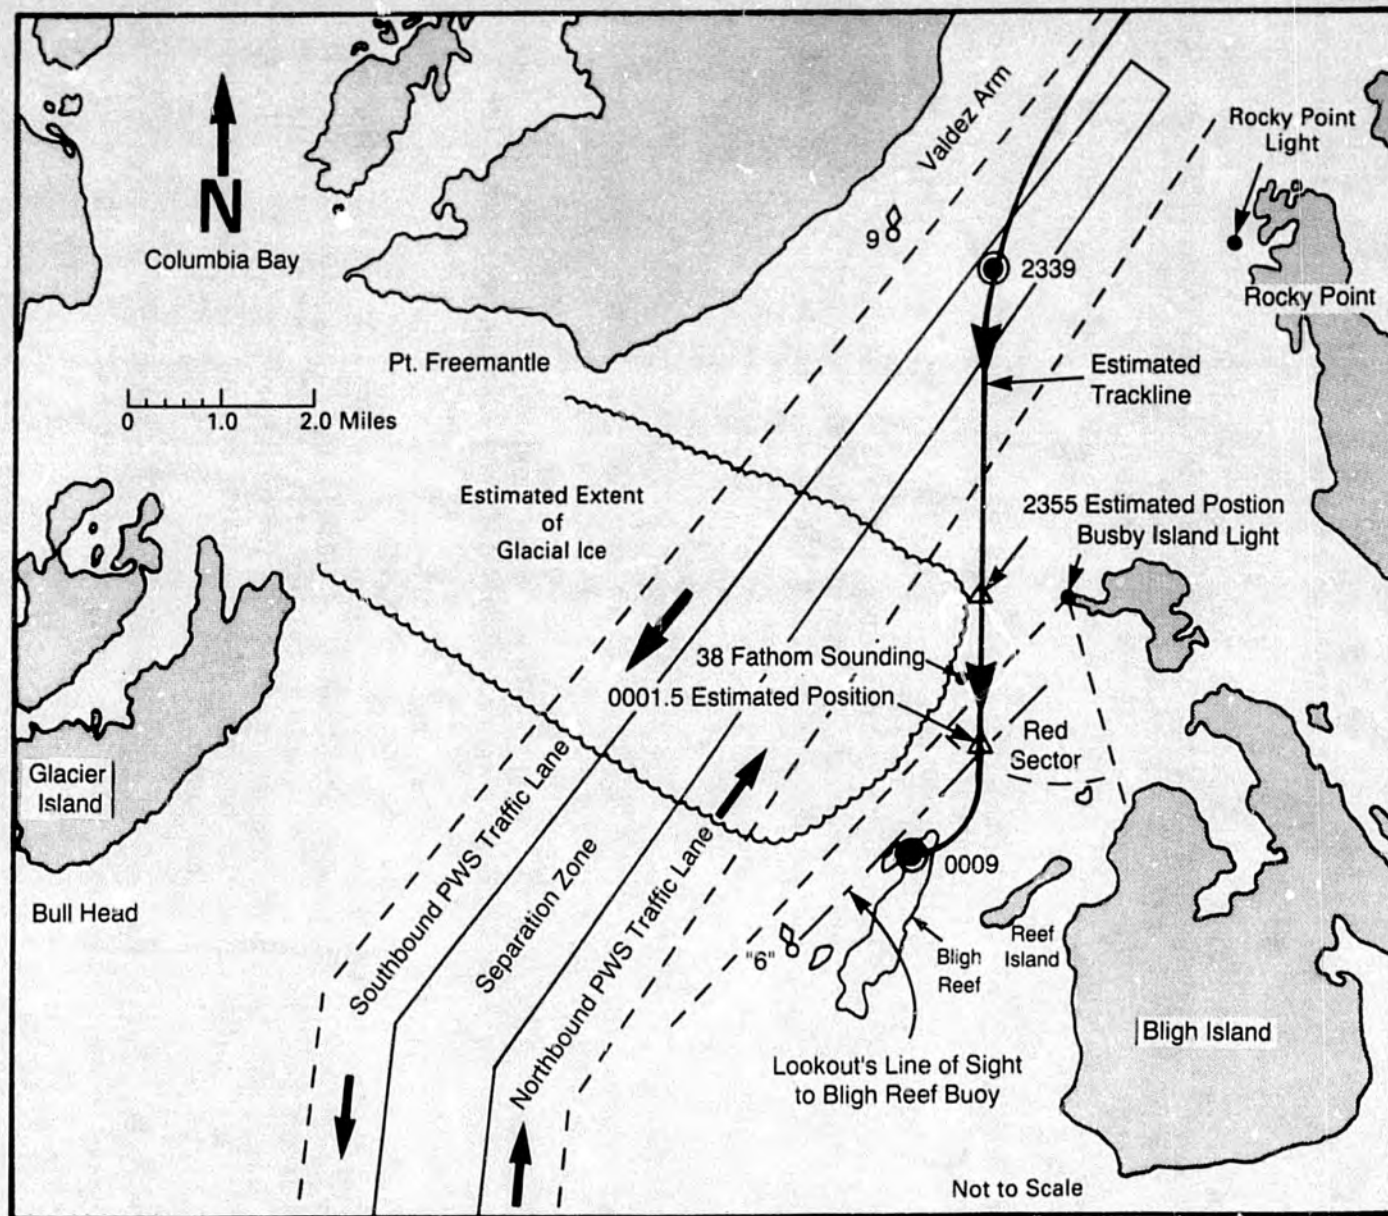
Figure 3.--Trackline of EXXON VALDEZ.

Light and Buoy No. 9 and a radar range to the land adjacent to Buoy No. 9. The third mate stated that the vessel was turning while he was taking the bearings. When plotted, his fix showed that the vessel's 2339 position was in the middle of the separation zone and approximately 2 miles west of Rocky Point Light. By about 2343, according to the course recorder, the vessel was steady on a course of 180°.

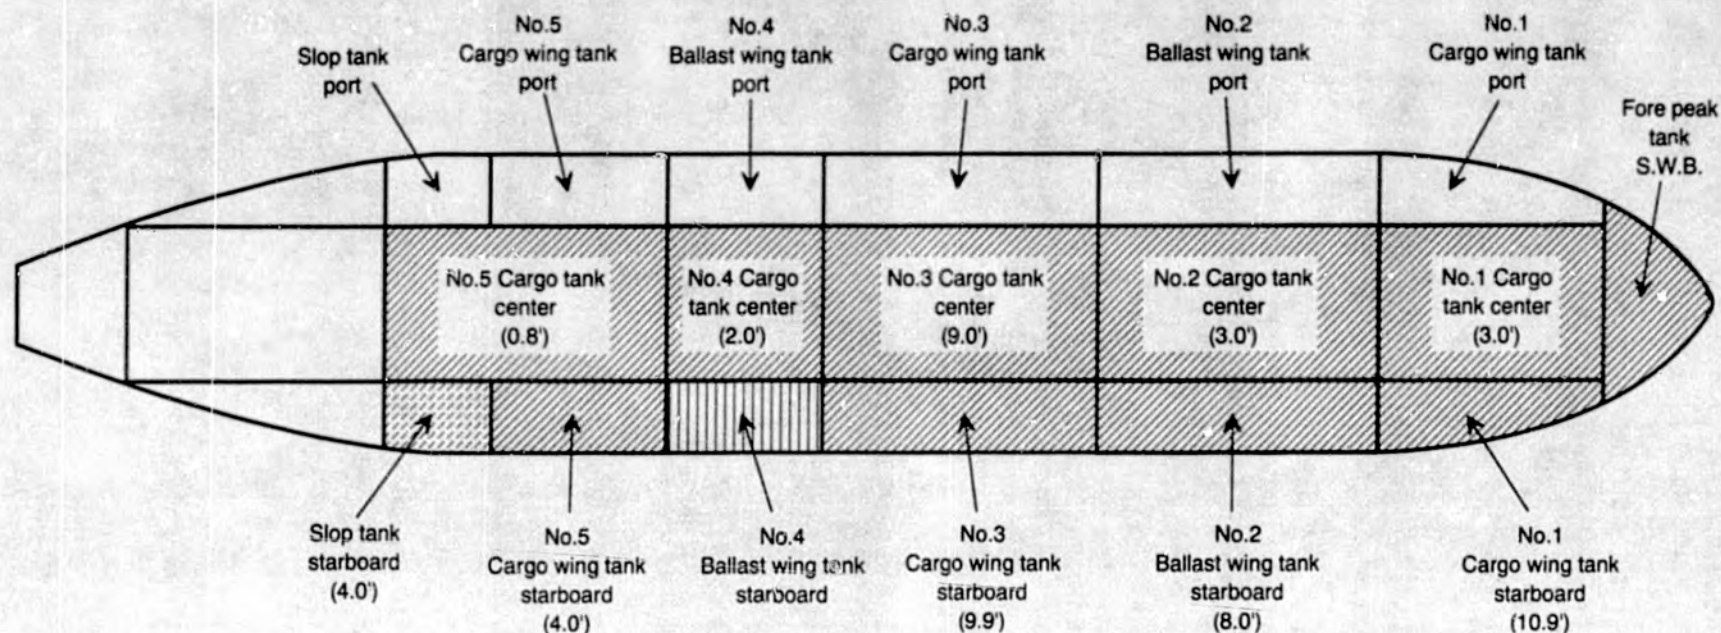
Figure 8.--Plan view showing damaged tanks.

An inspection of the vessel in drydock at the National Steel and Shipbuilding Company shipyard in San Diego was conducted on August 29, 30, and 31 and September 1, 1989. The inspection revealed that the forepeak tank was severely holed and that center cargo tanks Nos. 1, 2, 3, and 4 were ripped open over almost their entire lengths. Although holed, center cargo tank No. 5 sustained the least damage. Starboard cargo tanks Nos. 1, 3, and 5 also were severely holed, as was starboard ballast tank No. 2. Starboard ballast tank No. 4 sustained minor damage, resulting in a small opening at

the bottom of the forward bulkhead near the turn of the bilge caused by a separation of the bulkhead from the bottom plating. The void (double bottom) below the starboard slop tank was also ripped open. (See figure 8.)

The Safety Board found that the maximum vertical damage was 10.9 feet above the bottom of the vessel at two locations in the after half of starboard cargo tank No. 1. The most forward of the two locations was between frames Nos. 10 and 11, where a large boulder had lodged in the ship's hull structure, causing a longitudinal to break loose at frame No. 11 and curve upward to a height of 10.9 feet. The highest point of the boulder was about 8 feet. Upward bending and breaking of longitudinals near the after end of the tank between frames Nos. 12 and 13 resulted in the second 10.9 feet of vertical damage. In starboard ballast tank No. 2, frames Nos. 15 and 17 near the middle of the tank sustained deformation up to about 15 feet. There were two locations in the forward part of starboard cargo tank No. 3, between frames Nos. 23 and 24 and Nos. 24 and 25, where the vertical damage reached 9.9 feet. The maximum vertical damage in center cargo tank No. 3 was 9 feet in the forward part of the tank between frames Nos. 23 and 24 and Nos. 24 and 25. The vertical damage in the other cargo tanks ranged from less than 1 foot to 8 feet in a few locations.

The center vertical keel had broken loose from the after bulkhead of center cargo tank No. 2 from the tank bottom to a height of about 9 feet, and a small crack in the weld extended to a height of about 11 feet. On the other side of this bulkhead, which was the forward bulkhead of center cargo tank No. 3, the center vertical keel had broken loose from the bulkhead from the tank bottom to a height of about 9 feet.

There was no damage to the port tanks and except for the after part of the void under the starboard slop tank, which is outboard of the pumproom, all damage occurred forward of the pumproom.

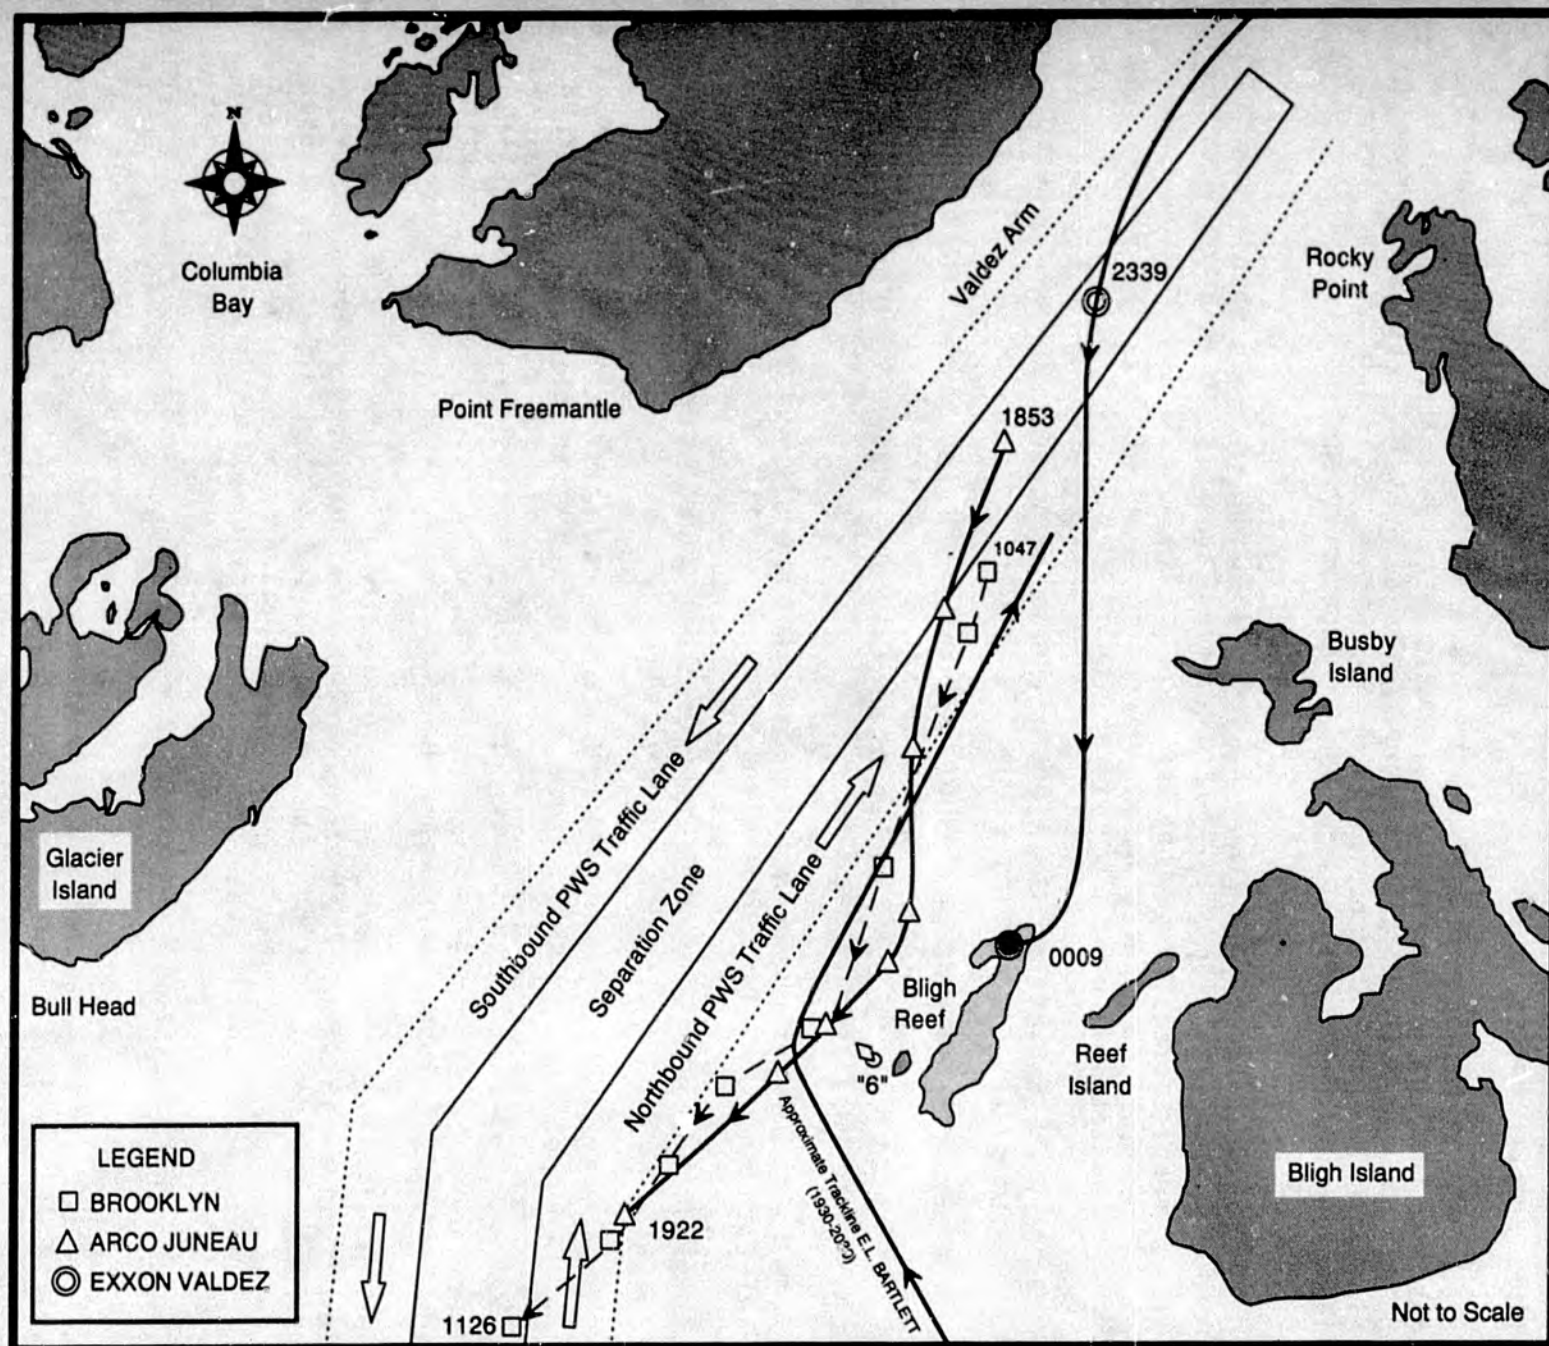
Figure 9.--Vessels departing the TSS.

(about 2,400 feet) west of Bligh Reef buoy before returning to the TSS about 1922.

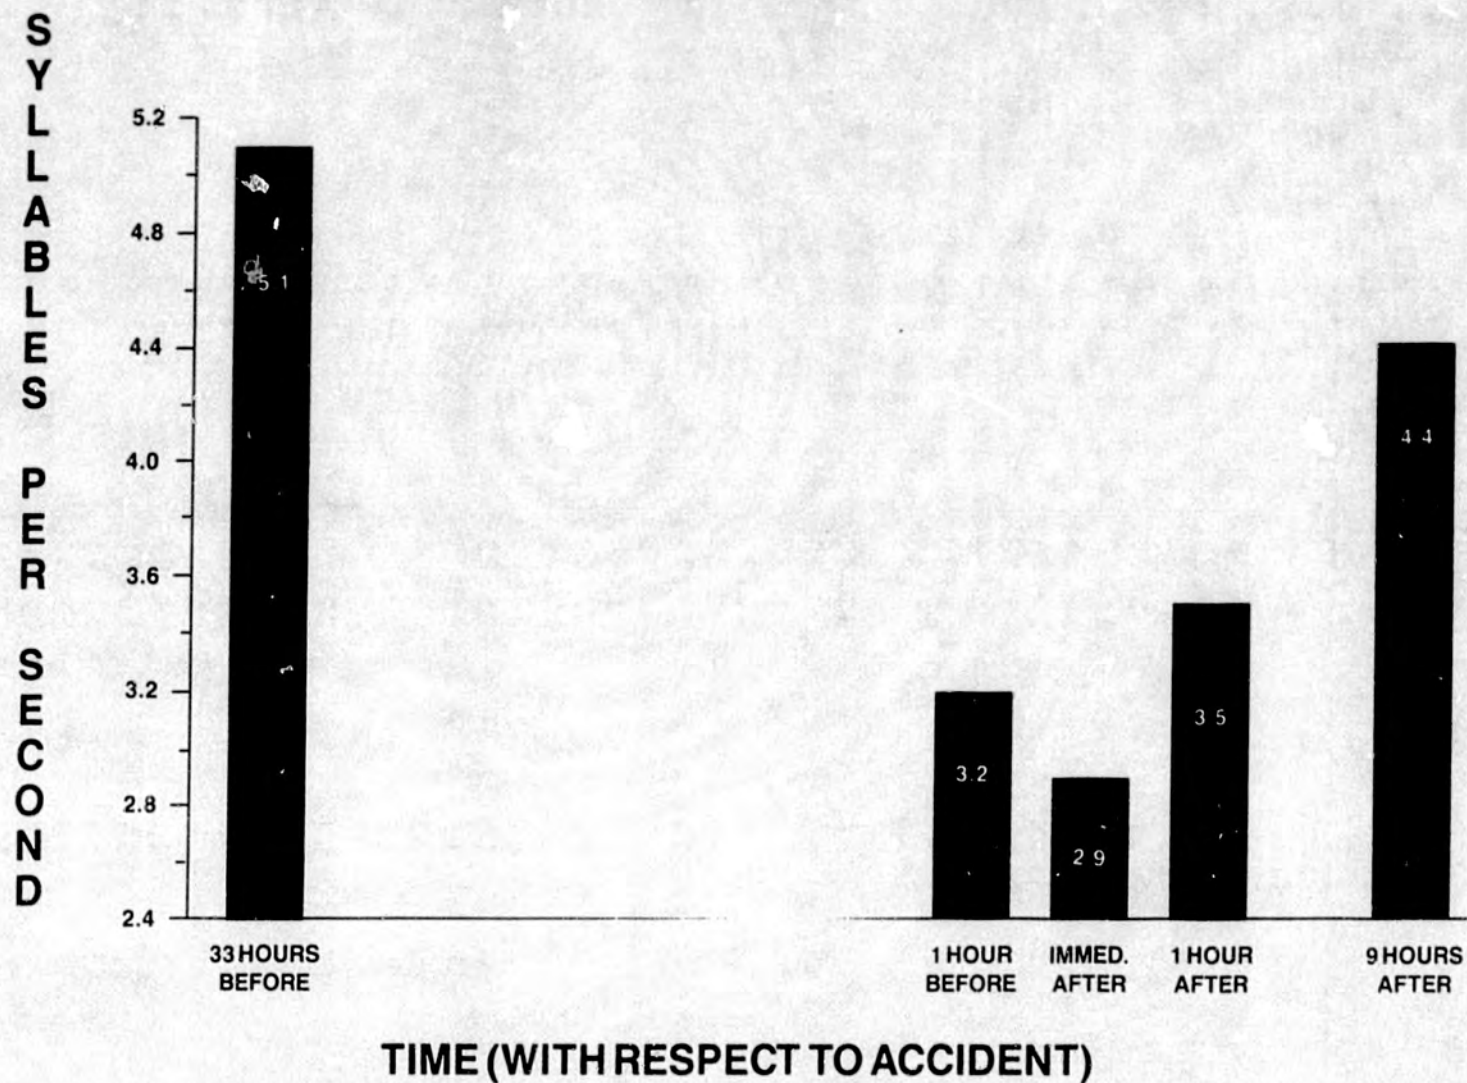
Figure 15.--Graph summarizing speaking rate.

speech 9 hours after the accident and that it was significantly slower than his speech 33 hours before the accident.

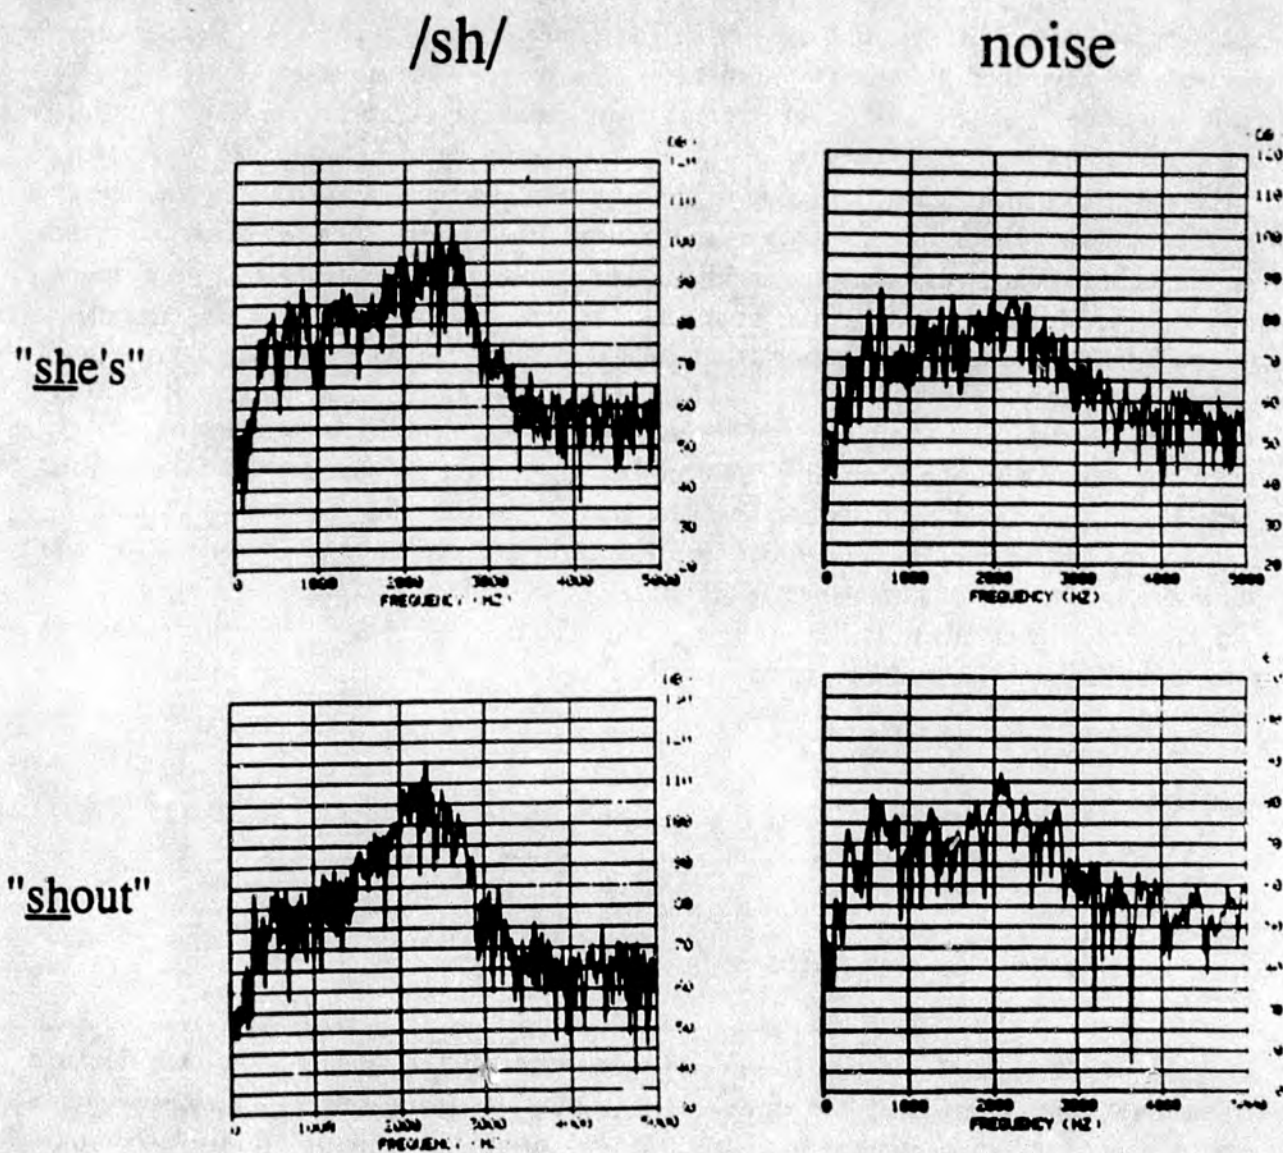
Figure 2. Power spectra of /sh/ produced by Captain Hazelwood in the words *she's* and *shout* recorded 33 hours before the accident. Each spectrum is paired with a spectrum of the background noise from a nearby open-mike pause.

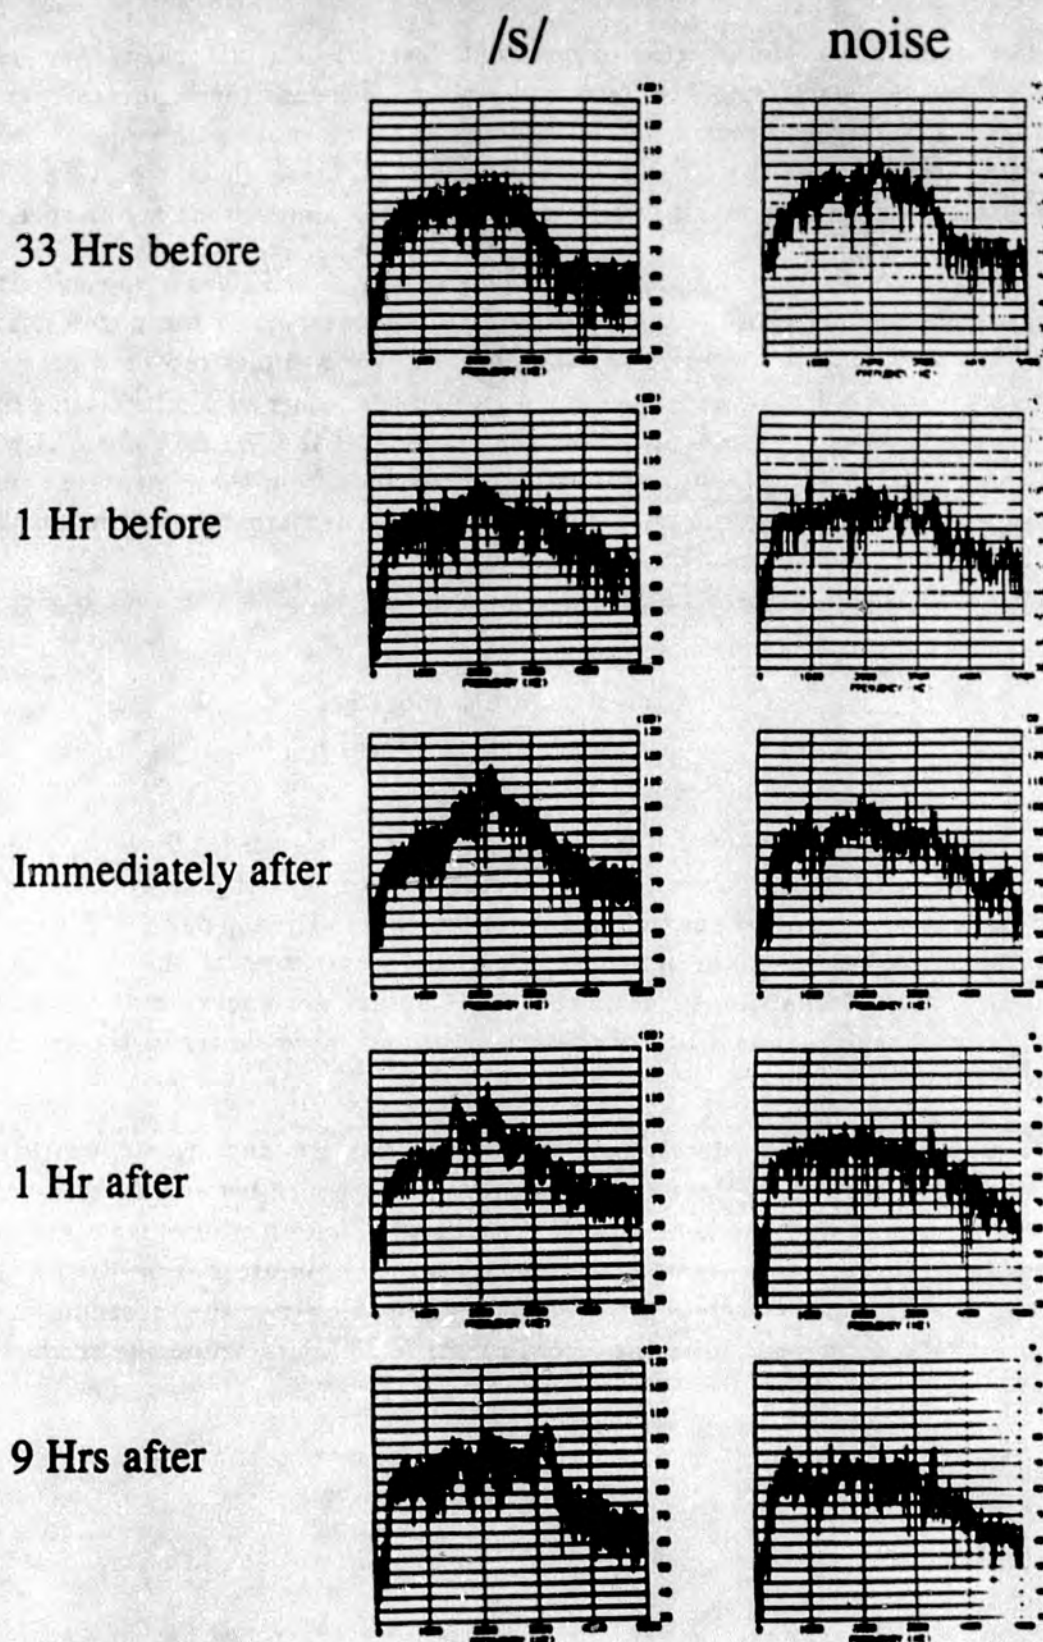
Figure 3. Power spectra of /s/ paired with spectra of nearby open-mike pauses from each of the NTSB recordings.

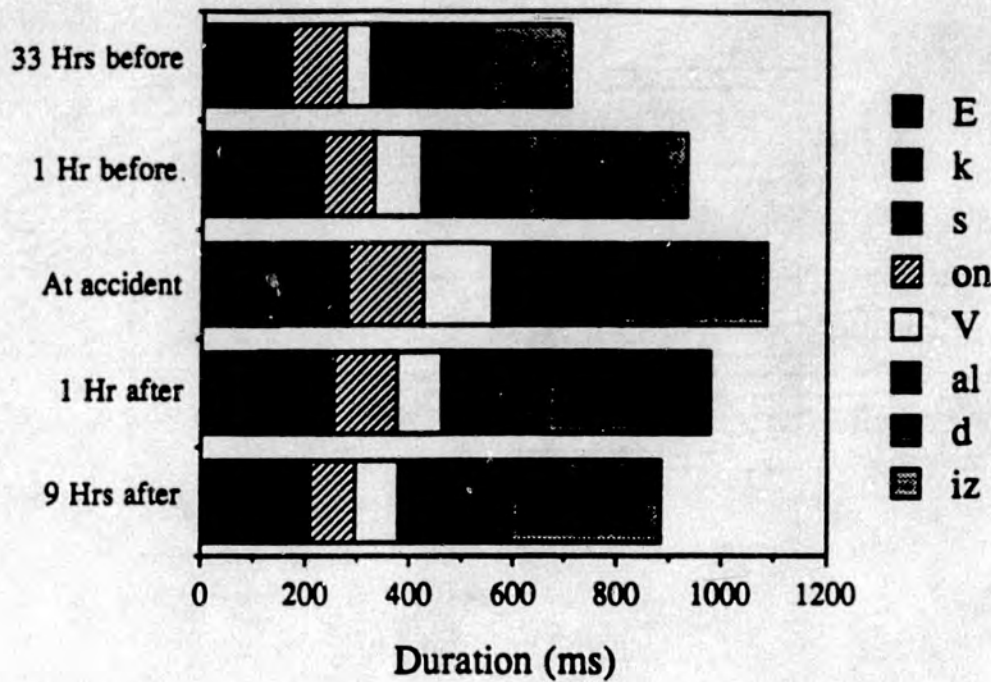
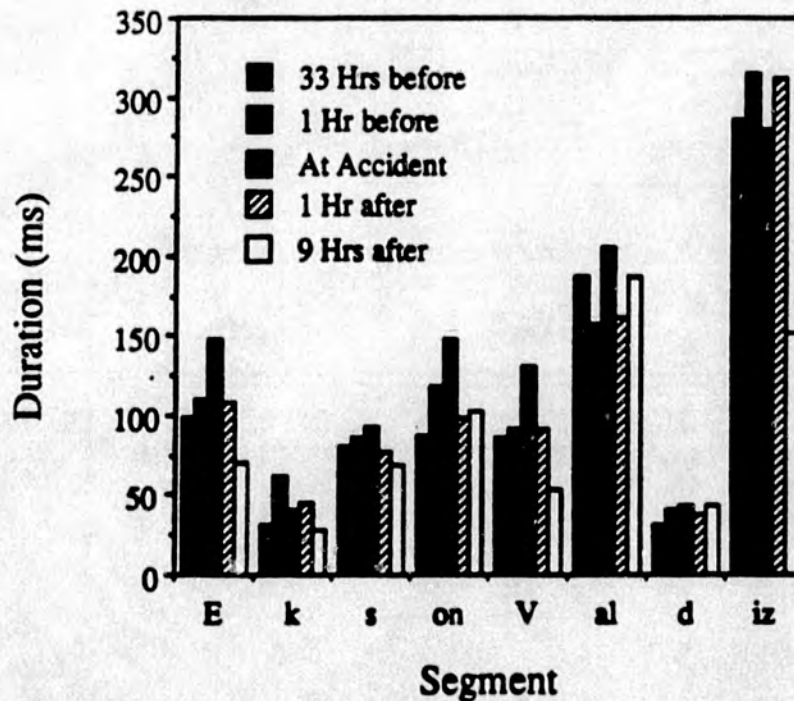
Durational changes are perhaps the most reliable effects we have found in the NTSB recordings and they suggest that Captain Hazelwood was speaking more slowly than normal around the time of the accident. These changes in duration are consistent with the laboratory

**Figure 4.** Durations of speech segments in the phrase, *Exxon Valdez* at the different times of recording. Top panel: cumulative durations indicating the overall increase in duration. Bottom panel: durations grouped by segments showing which segments had increased duration around the time of the accident.

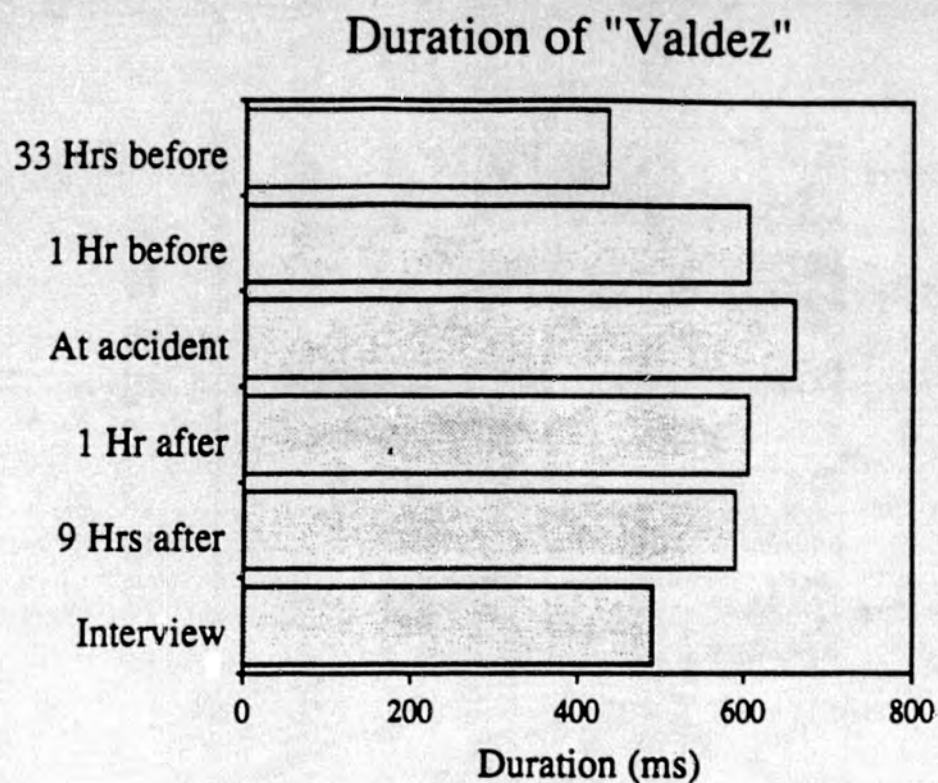
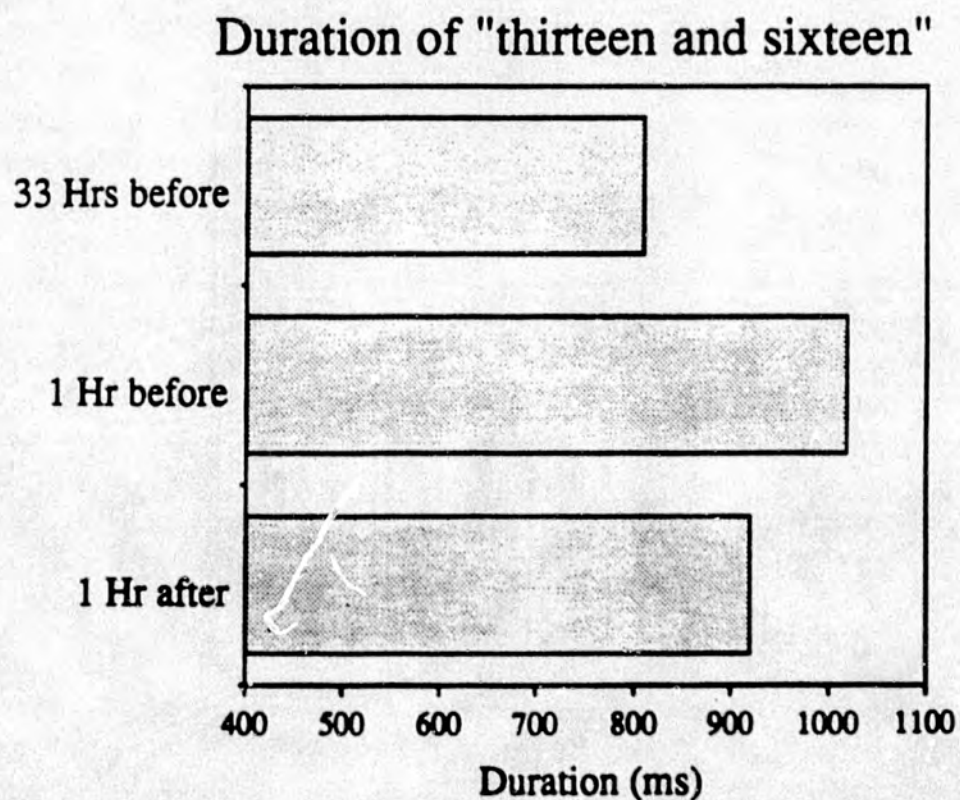
Figure 5. Top panel: Duration of the word *Valdez* from the NTSB tapes (data is the same as that in Figure 4) compared with the same word produced in a similar discourse position in the televised interview. Bottom panel: Duration of the phrase *thirteen and sixteen* from recordings made at three times around the time of the accident.

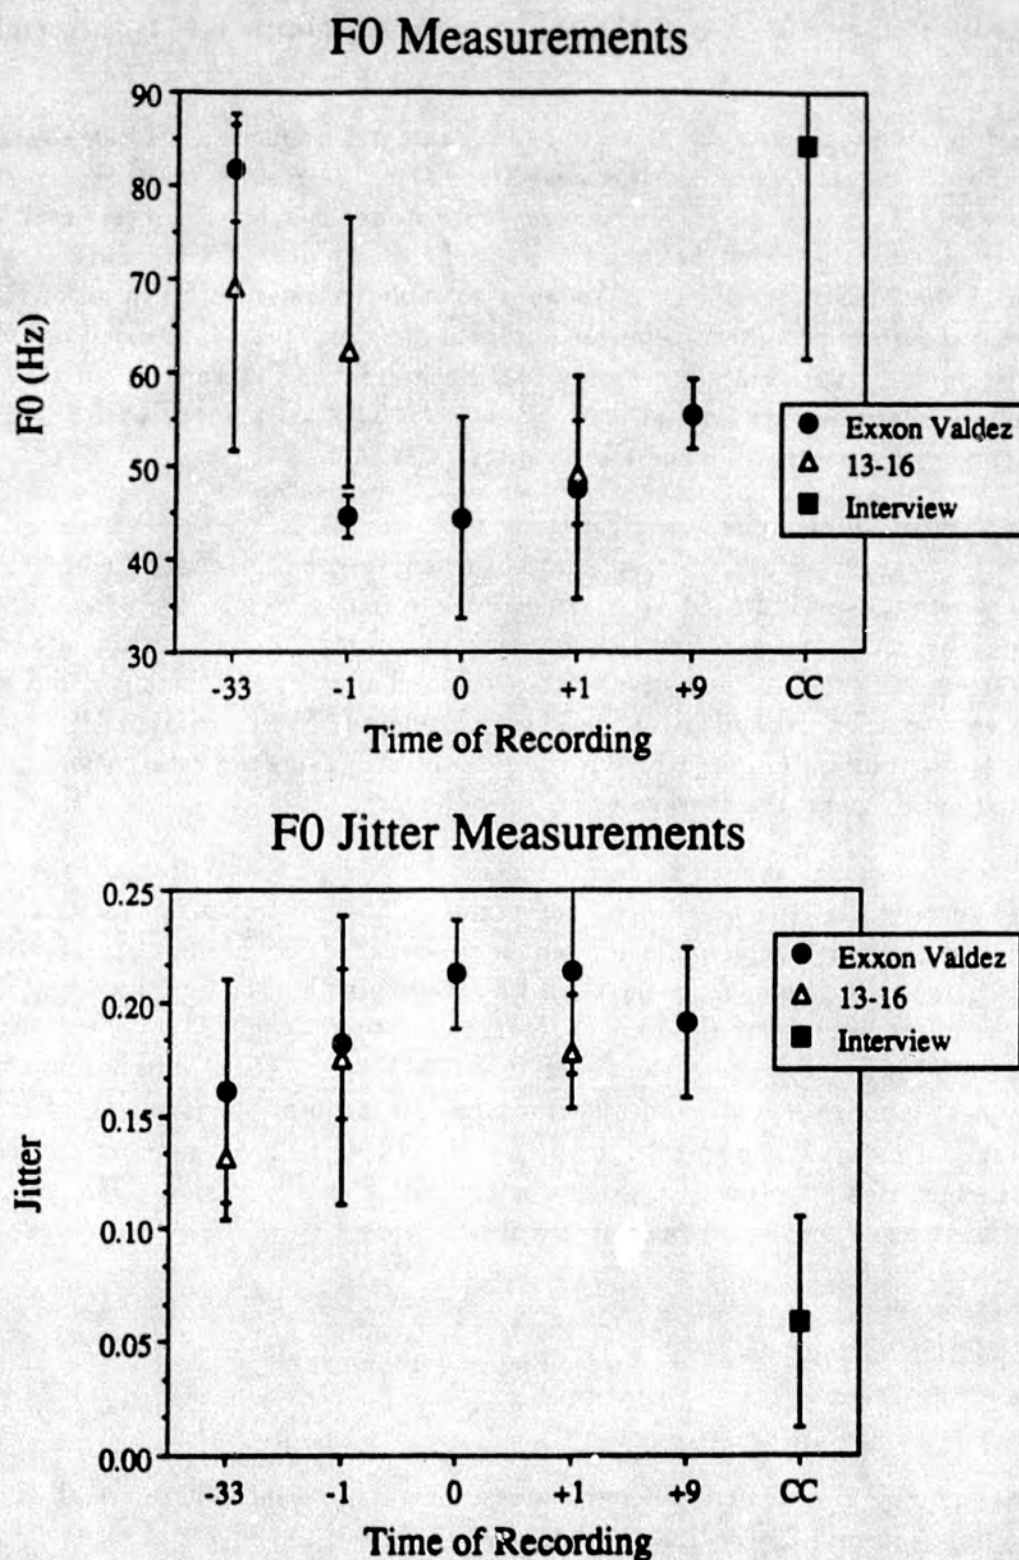
Figure 6. Top panel: Average fundamental frequency (pitch of voice) in *Exxon Valdez*, thirteen and sixteen and from one sentence in the televised interview as a function of time of recording. Bottom panel: F0 jitter measurements from the same speech samples.
