**PRUDHOE  
BAY  
CORROSION  
CRISIS,  
8/18/06  
(FILE 9)**

**ConocoPhillips Alaska  
Commitment to Corrosion Monitoring  
Annual Reports 2000 – 2005**

# **Greater Kuparuk Area (GKA) Corrosion Programs Overview**

***Commitment to Corrosion Monitoring***  
***1<sup>st</sup> Annual Report to the Alaska Department of Environmental Conservation***

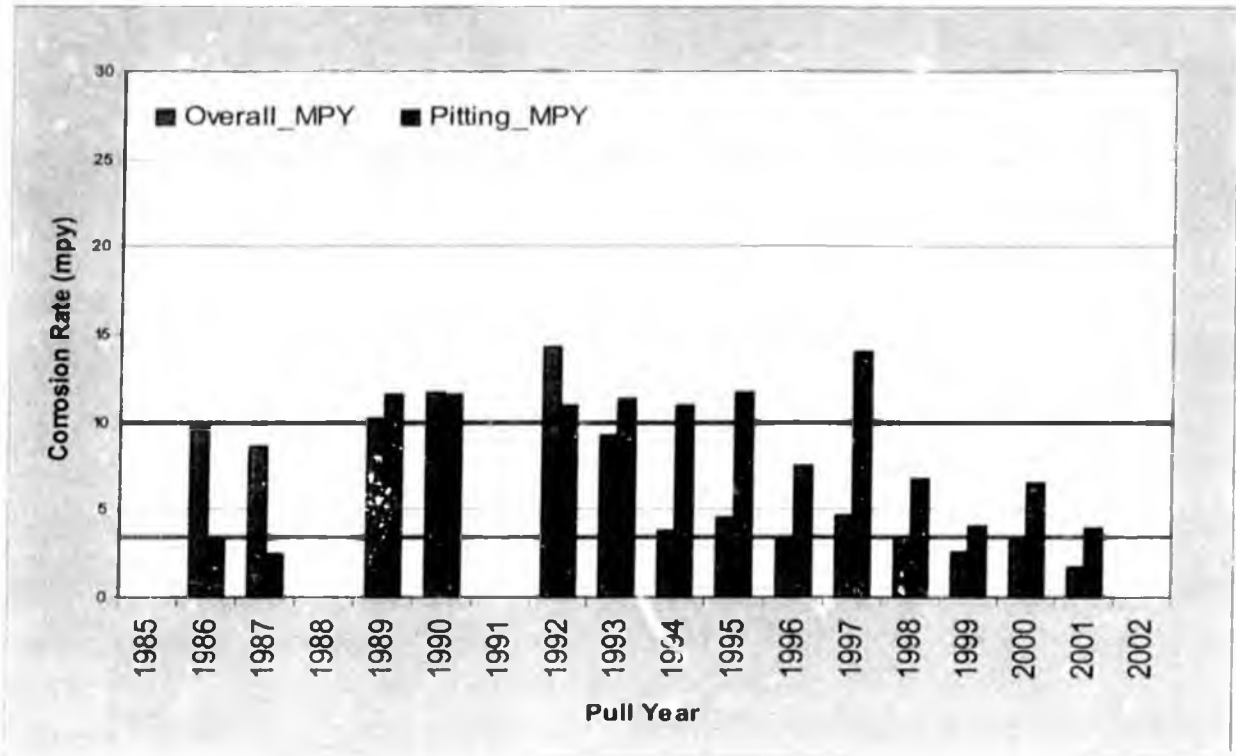
Figure 2. Seawater Cross-Country Line Coupons – general and pitting corrosion rates as a function of time.

*Sea Water Cross-Country Lines:* The monitoring data summarized in Tables 1 and 2 and presented in Figure 2 above, suggest that although the two sea water cross-country lines had some coupon corrosion rates above target thresholds in 2001, the average corrosion rates have remained low, and well under the targets. Inspection data suggest that, in seawater service, corrosion tends to manifest itself in un-piggable, relatively stagnant sections of line (such as dead legs and headers).

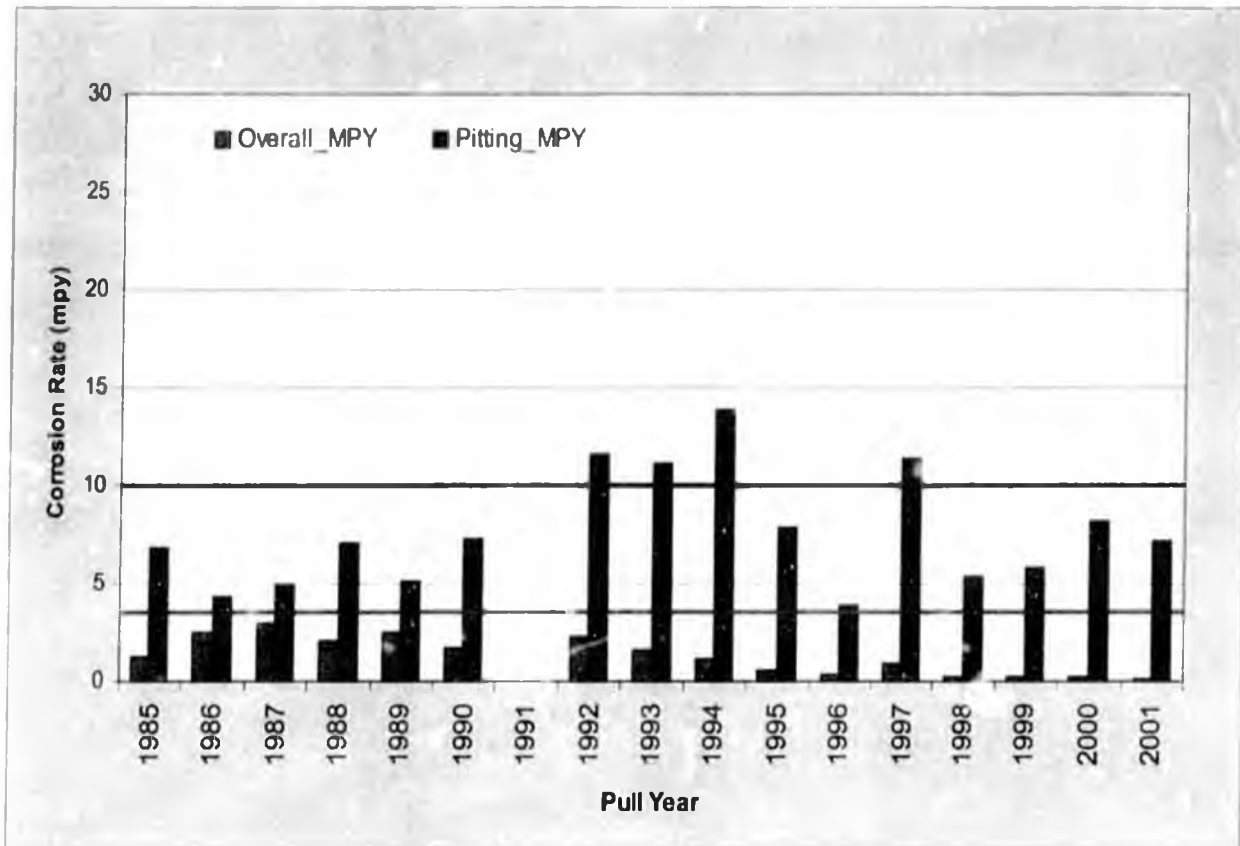
**Figure 3. Water Injection Cross-Country Line Coupons – general and pitting corrosion rates as a function of time.**

*Mixed Water Injection Cross-Country Lines:* The monitoring data summarized in Tables 1 and 2 and presented in Figure 3 suggest that pitting and general corrosion coupon rates are under control; however, inspection data suggest that, in this service, corrosion tends to manifest itself primarily in un-piggable, relatively stagnant sections of line (such as on well lines verses common lines, dead-legs verses mainline segments, etc.). This information helps to prioritize ongoing inspection efforts. General corrosion rates have improved steadily over the last 15 years, and are within the target range, while the pitting rates remain below target levels, and at approximately the historical average.

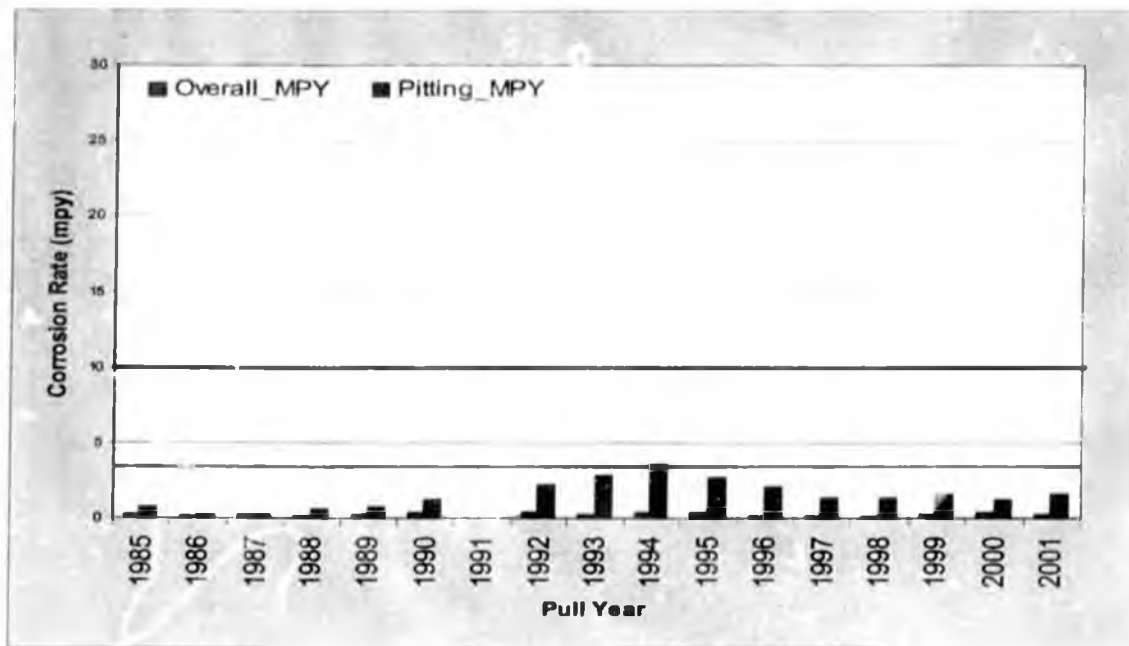
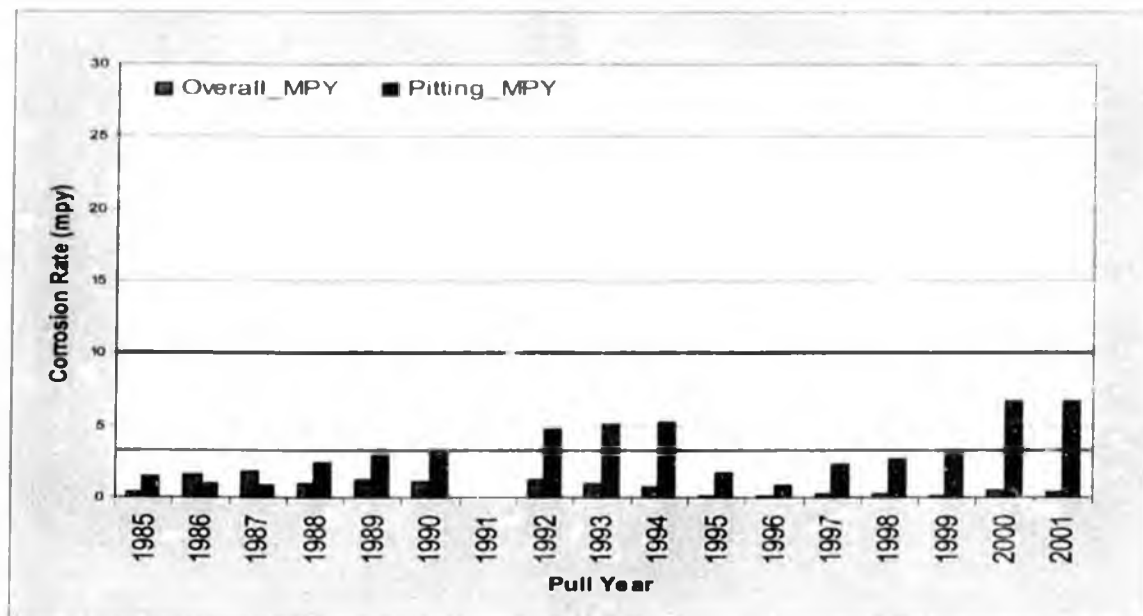
*Three-phase Production and Mixed Water Injection Well Flow Lines:* While the monitoring data summarized in Tables 1 and 2 and presented in Figures 4 and 5 suggest that corrosion rates are below targets, inspection data indicates that higher rates are actually being experienced. The well line inspection data are discussed in section 3.1.b below, and are a good example of why monitoring data alone cannot be relied upon to characterize corrosion in a given system.

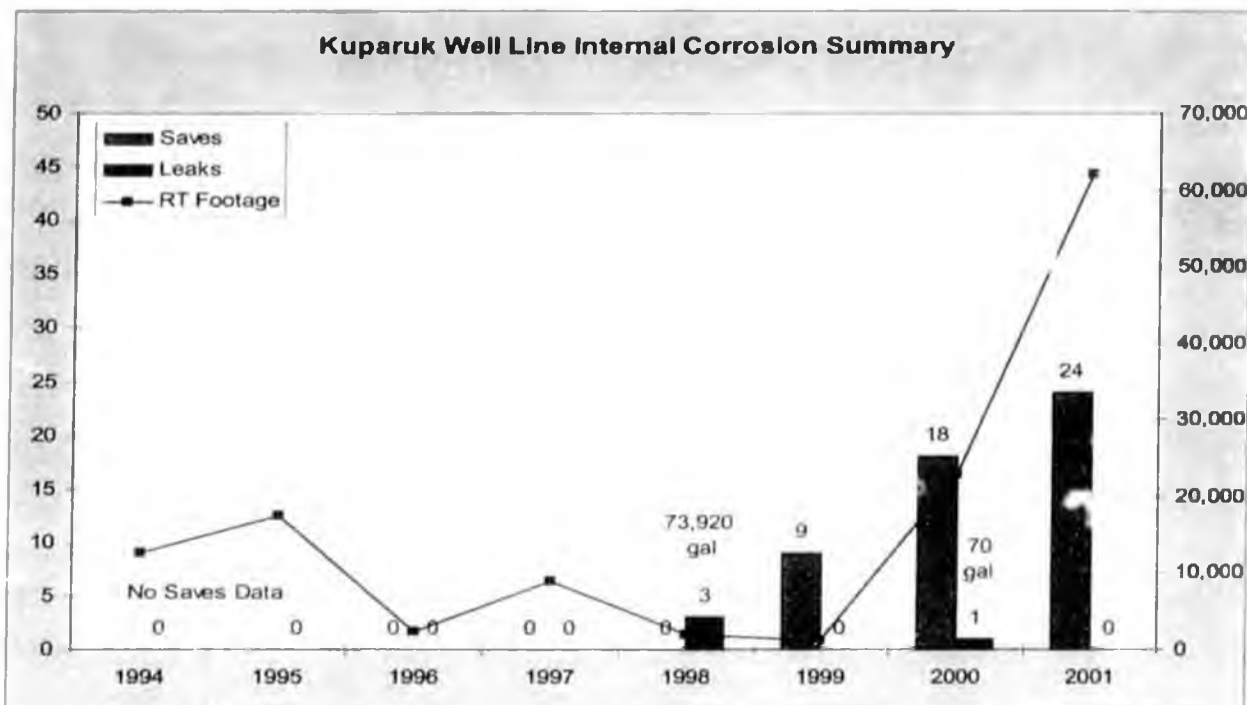
**Figure 8. Summary of Well Line Internal Corrosion Inspections – RT footage, leaks, and saves as a function of time.**

As indicated in Figure 8 below, repair recommendations were initiated on 24 lines (17 injection, 7 production) in 2001 because of internal corrosion damage. Repairs typically consist of either sleeves or replacement of the de-rated section of line. Figure 8 also shows that the number of inspections on the well lines has increased dramatically since 1999, but the number of repair recommendations has increased at a lower rate.

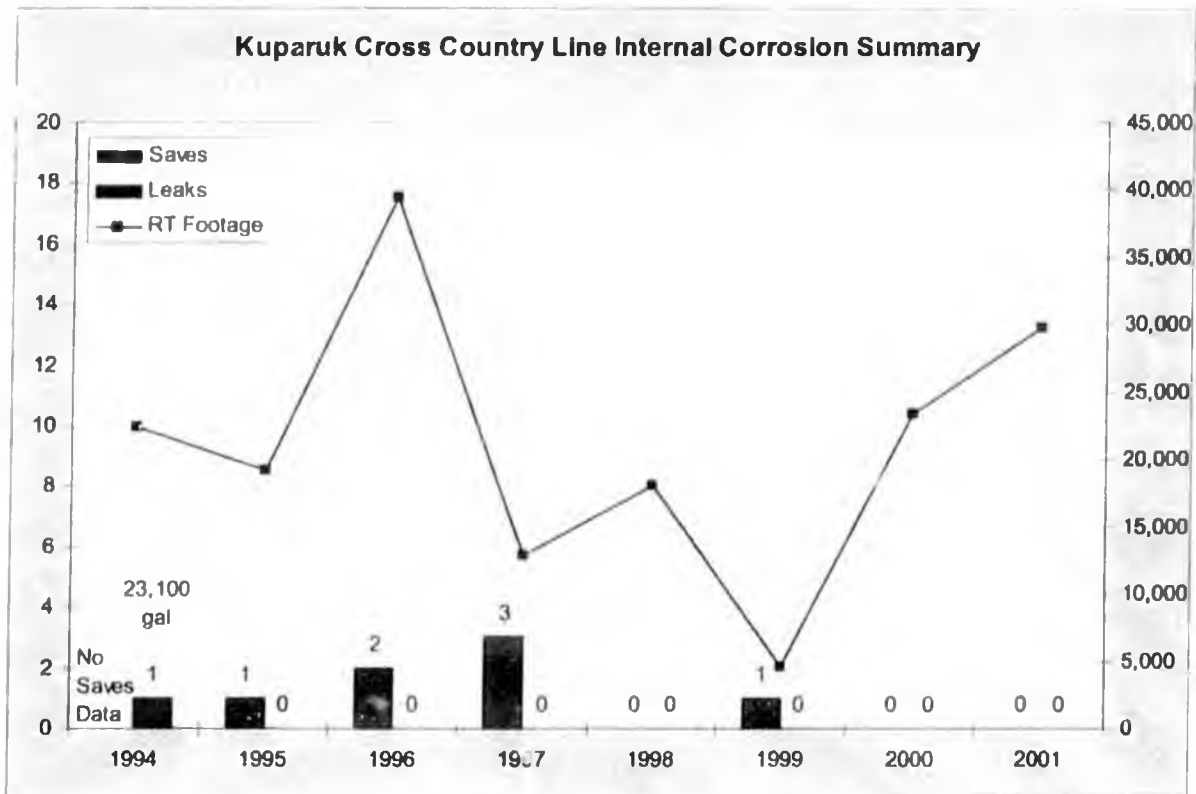
Figure 9. Summary of Cross-Country Line Internal Corrosion Inspections – RT footage, leaks, and saves as a function of time.

As indicated in Figure 9, no (0) repair recommendations were initiated on cross-country lines because of internal corrosion damage in 2001. Inspection results in Figure 9 show that the corrosion mitigation programs are adequately protecting the three-phase lines and the water injection lines.

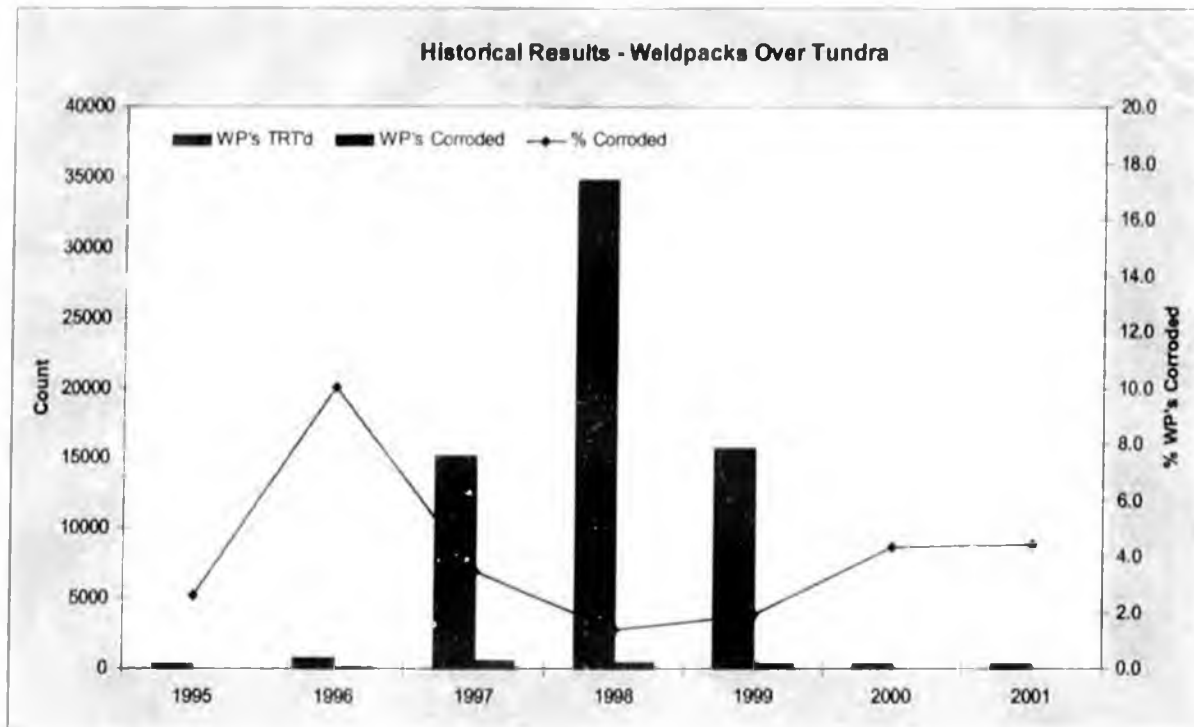
Figure 10. Summary of Weld Packs on Cross-Country Lines over Tundra (off-pad) – number of weld packs inspected, number of weld packs corroded, and percent of weld packs corroded.

Figure 10 illustrates the most-mature external corrosion inspection program of the three external corrosion programs. By the end of 2001, all weld packs on cross-country lines over tundra had received their first, baseline TRT inspection. A prioritized recur inspection program for these weld packs is scheduled to begin in 2003.

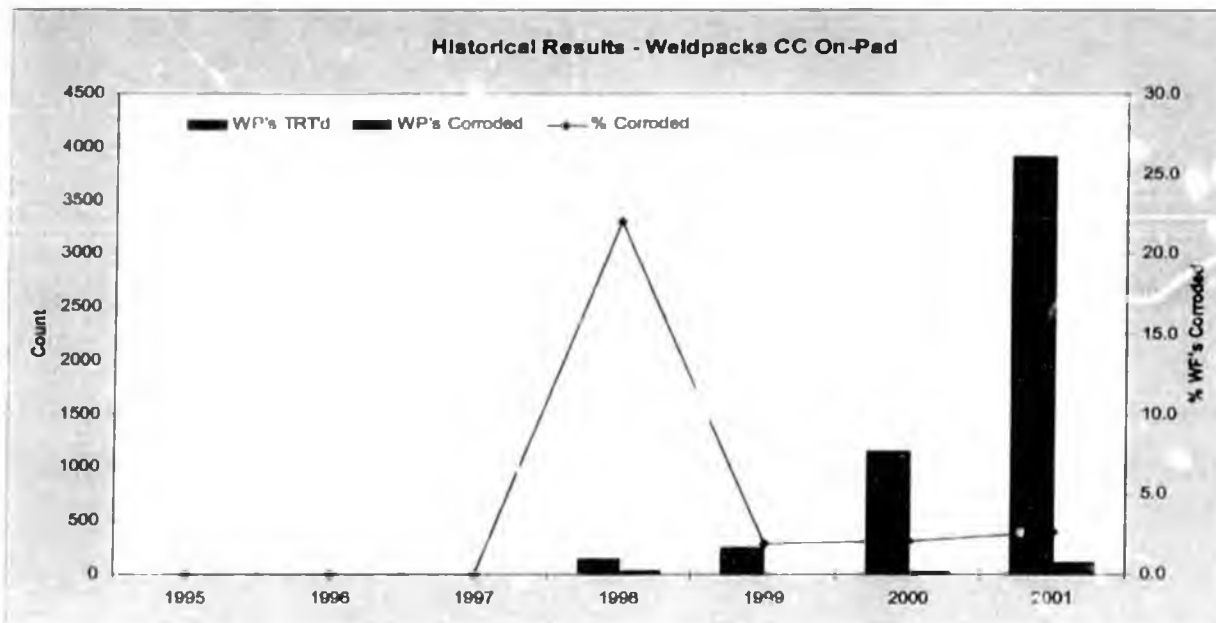
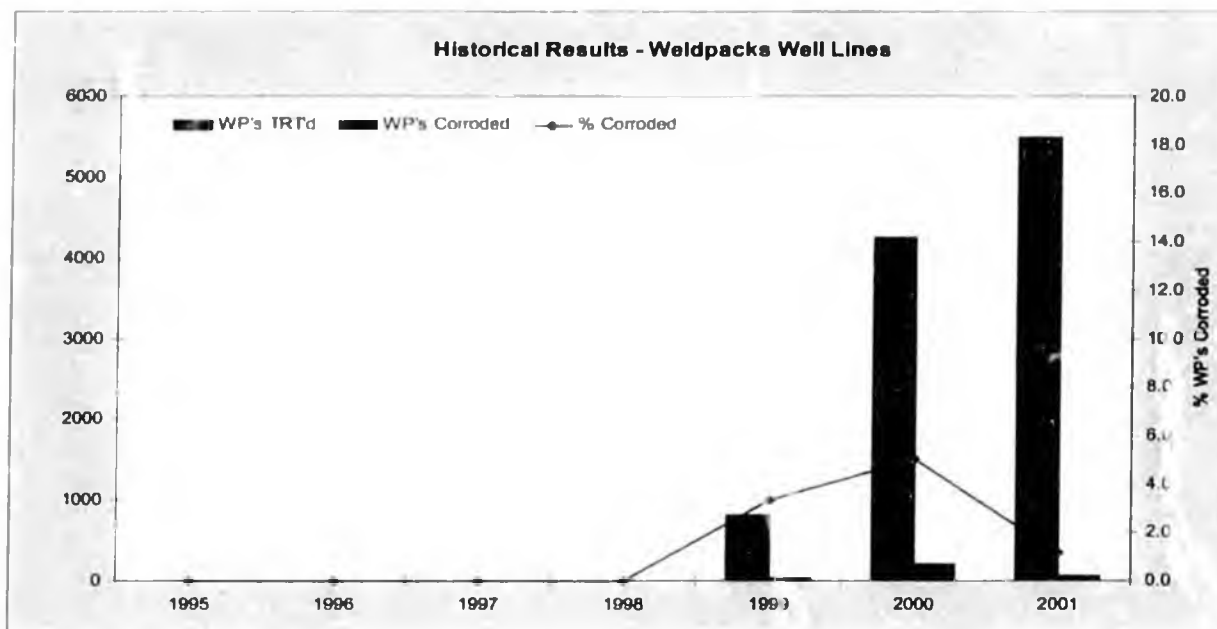
Figures 11 and 12 depict the results of the major focus of the external weld pack inspection program in 2001. The cross-country on-pad weld packs were inspected using a prioritization scheme based on the historical corroded to wet ratios of the over-tundra portions of the cross-country lines. The well line weld packs were inspected using a prioritization scheme that examined the oldest, the hottest, and thinnest-walled lines first. Based on the results in Figure 12, it appears that the worst weld packs have been inspected and the risk of a future leak has been minimized. Continued inspections in 2002 will confirm if this hypothesis is correct. As of Year-End 2001, 61% of the cross-country on-pad weld packs and 43% of the well line weld packs have received their baseline TRT inspection.

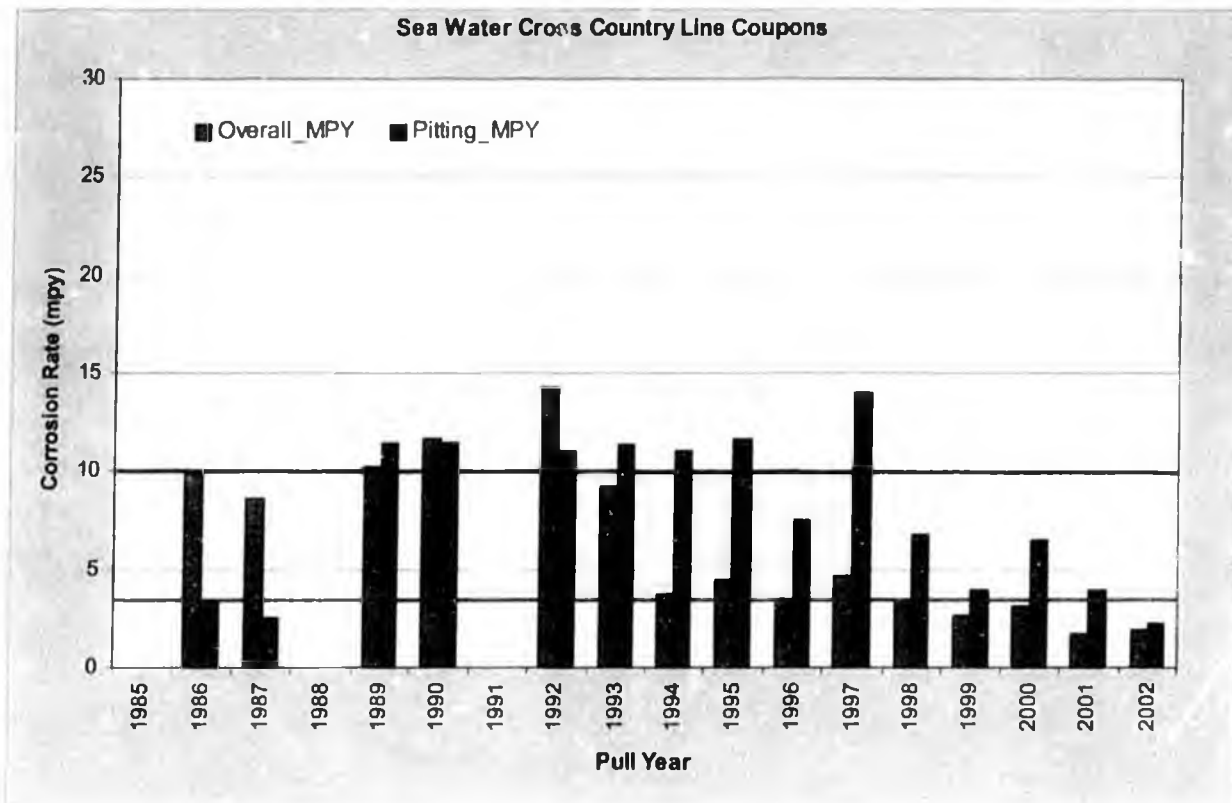
Figure 2. Seawater Cross-Country Line Coupons – general and pitting corrosion rates as a function of time.

*Sea Water Cross-Country Lines:* The monitoring data summarized in Kuparuk Tables 1 and 2 and presented in Figure 2 above, shows the average corrosion rates for the sea water cross-country line coupons remained under thresholds in 2002. UT inspections were conducted in the area of the coupons with the high general corrosion rates and no increases to existing minor damage were found. An ER probe has been installed in the same area with no appreciable corrosion rate noted.

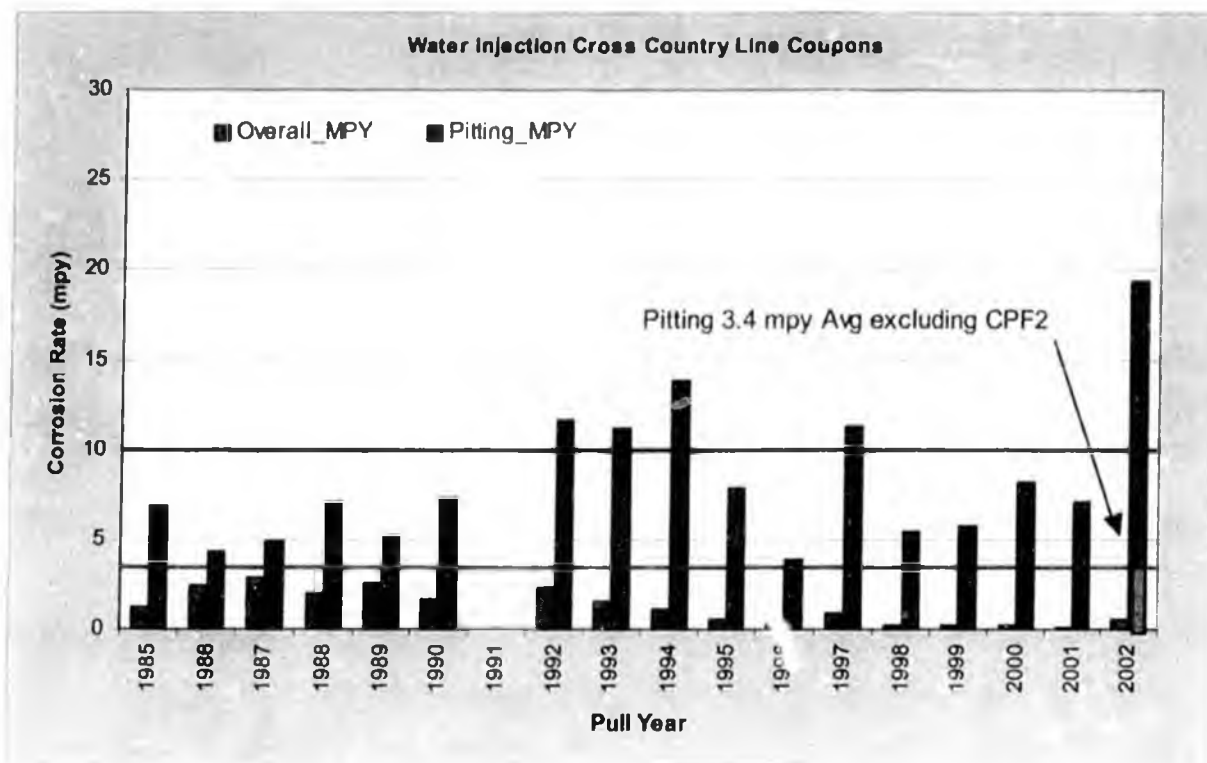
**Figure 3. Water Injection Cross-Country Line Coupons – general and pitting corrosion rates as a function of time.**

*Mixed Water Injection Cross-Country Lines:* The monitoring data summarized in Kuparuk Tables 1 and 2 and presented in Figure 3 show that average general corrosion rates are below the threshold, but that pitting rates for the field are above the threshold. Closer analysis of the data shows that the average pitting rate excluding CPF2 locations is well under the threshold. Recent inspection data from the CPF2 lines show some damage on three lines. This information, along with coupon results, was used to prioritize 2003 inspection efforts. RTR inspection work for 2003 will target 15,000 feet of cross-country water injection lines.
