CSSB 450am cont. 1368

REPORT OF DAMAGE

Subject: Kodiak Container Wharf (Pier 3)

Investigation of the Storm Damage to the Kodiak City Dock Facility

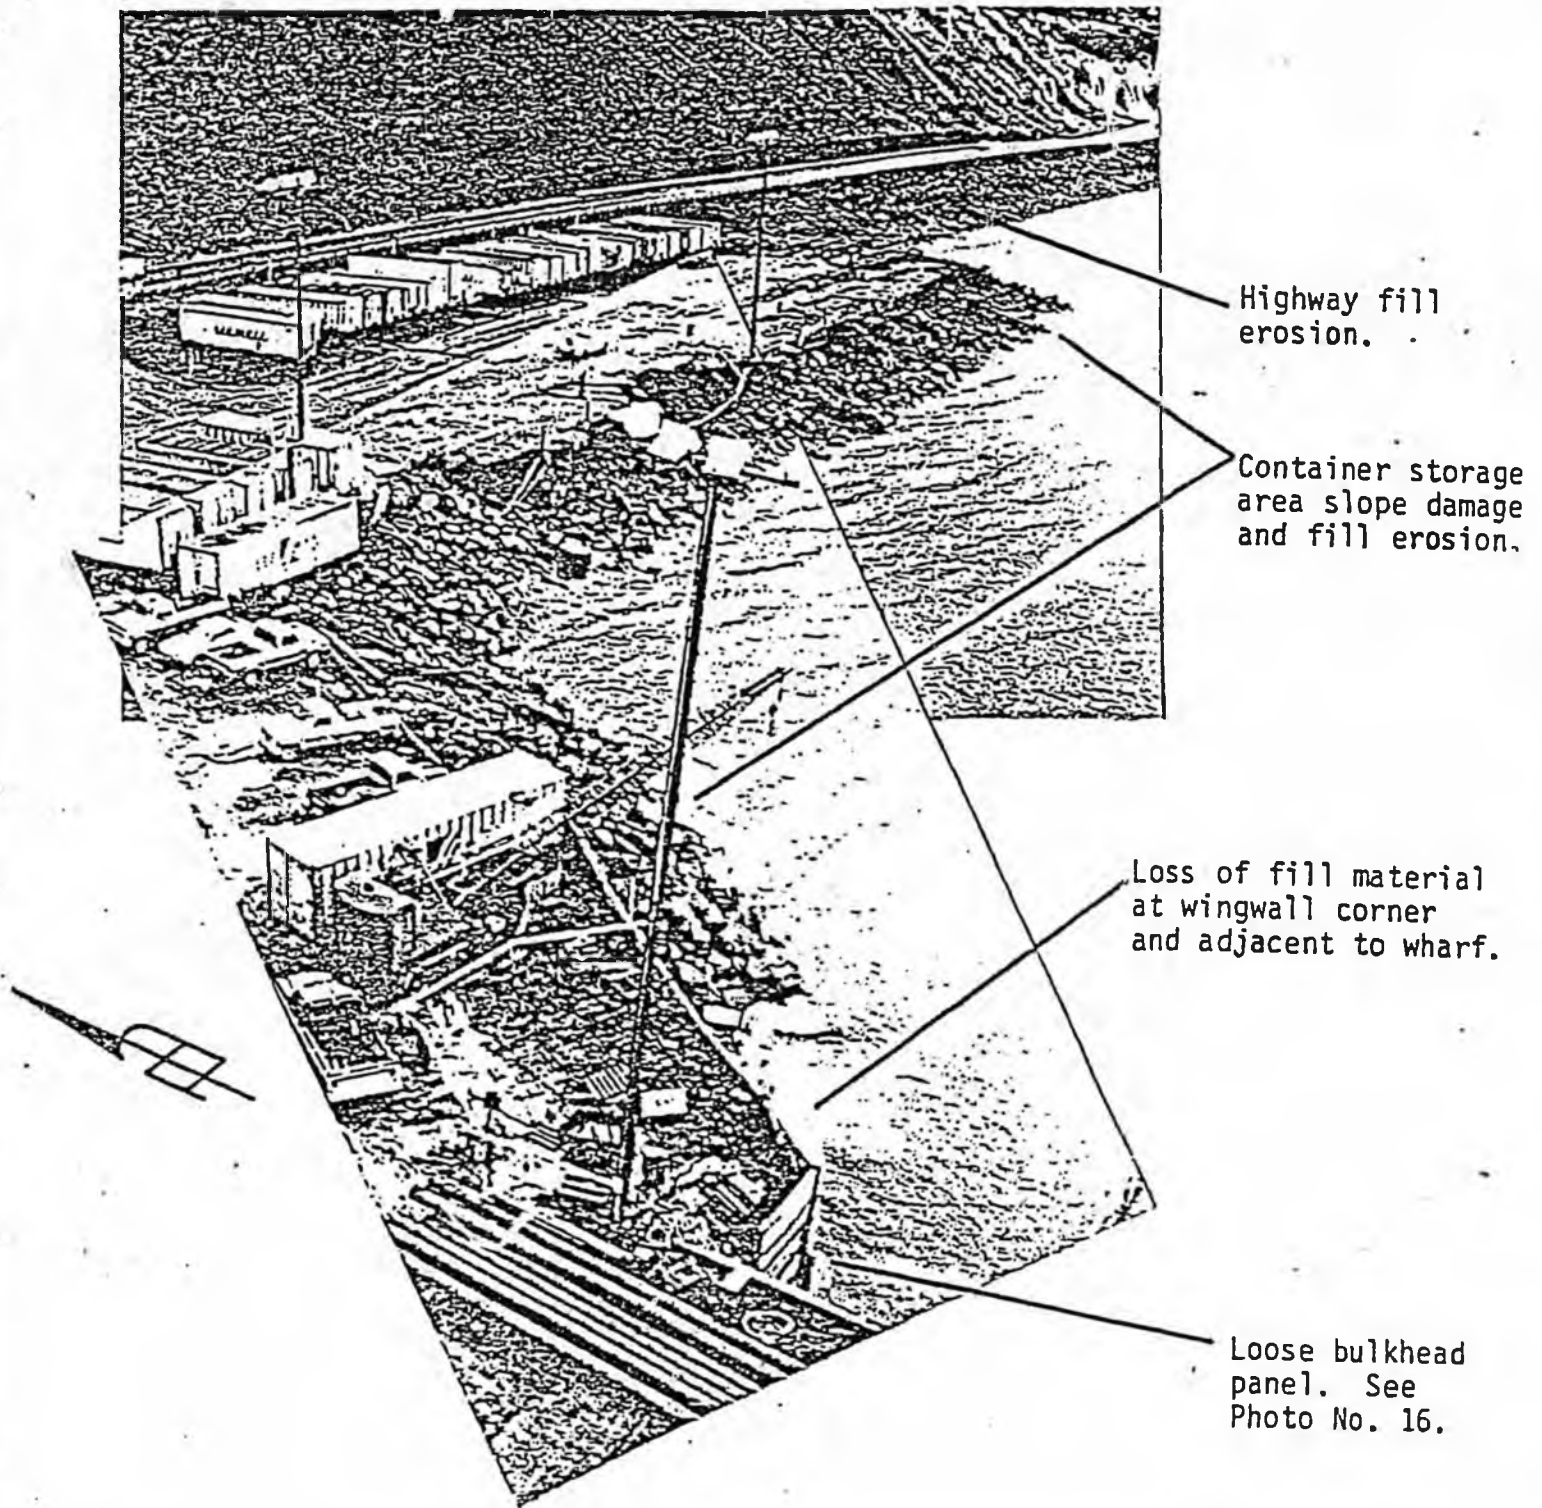
Photo No. 1: Overhead view of the easterly wingwall and of the easterly container storage area. Deterioration by storm wave erosion of the bankline along the container storage area is clearly visible as is erosion of the adjoining highway fill.

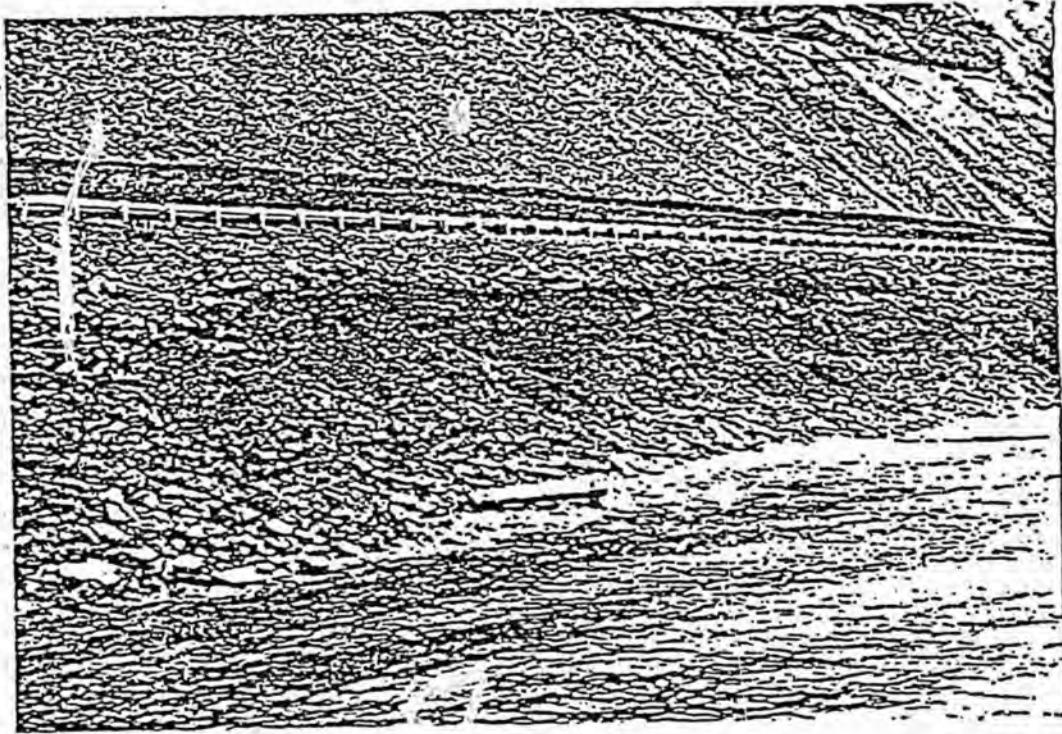
Photo No. 2: Erosion of highway fill adjacent to container storage area.

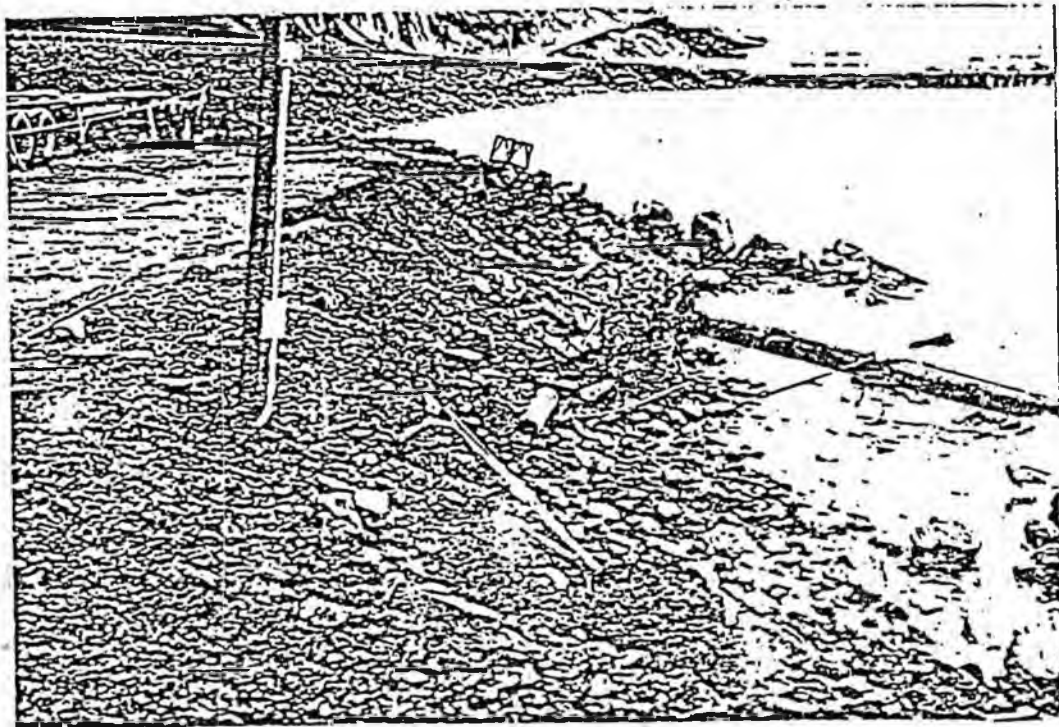
Photo No. 3: View of easterly corner of container storage area. Fallen lightpole visible at right of photo. Note location of concrete curbing relative to eroded bankline.

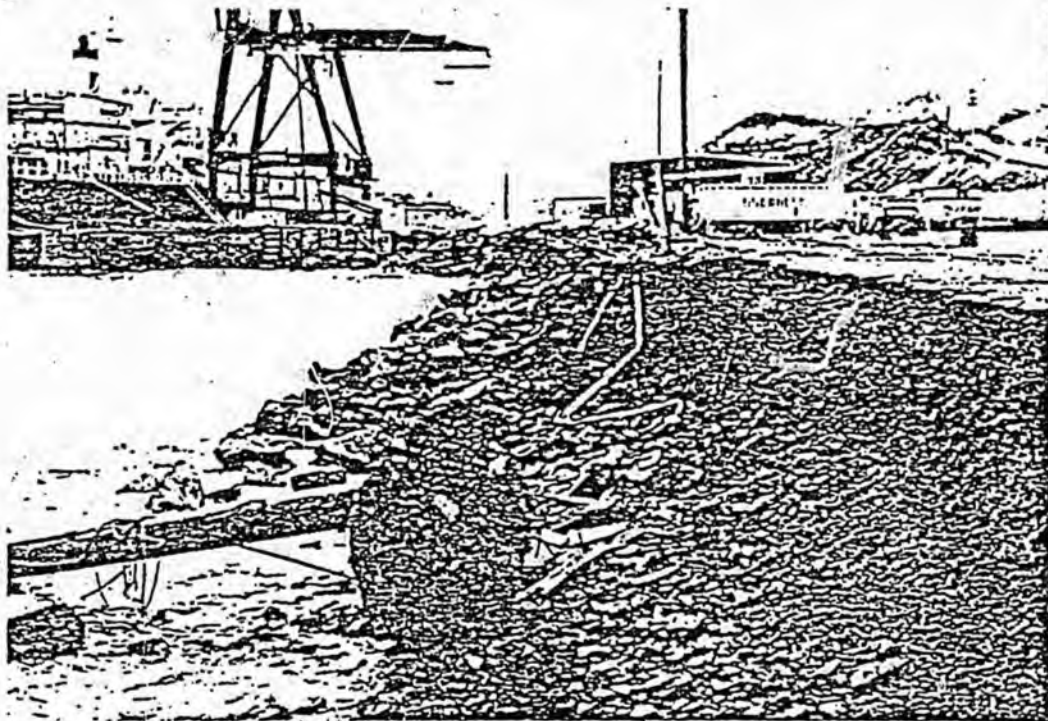
Photo No. 4: View from east end of container storage area looking west. Butt of lightpole visible in center of photo would indicate relatively little initial installation penetration.

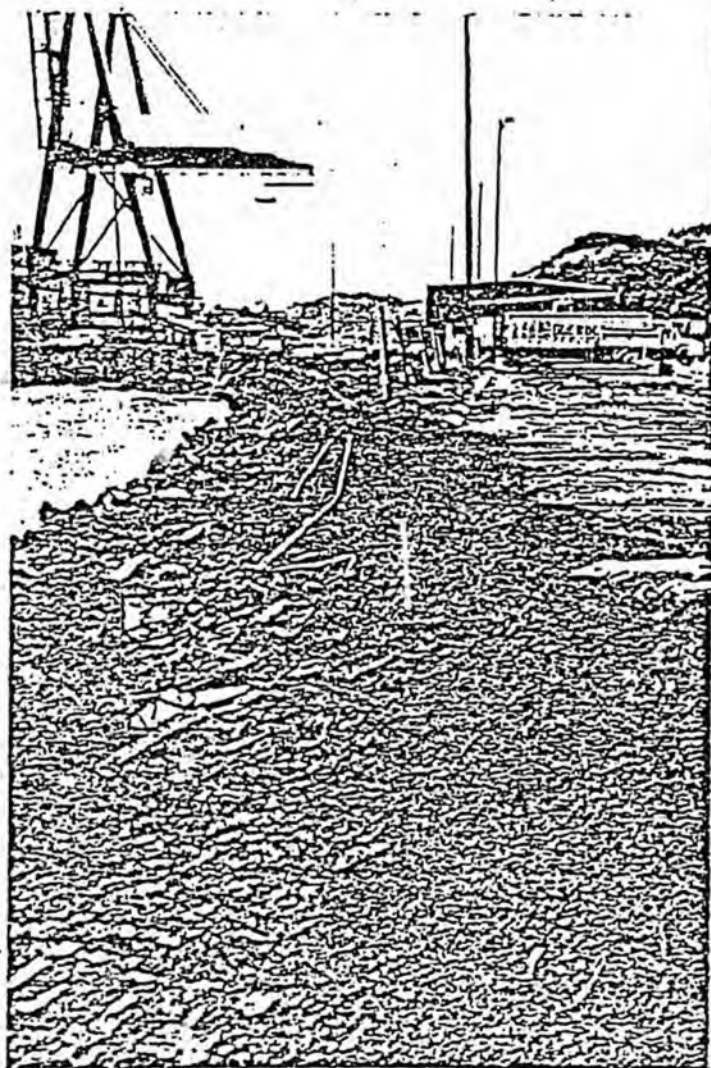
Photo No. 5: View as per Photo No. 4.

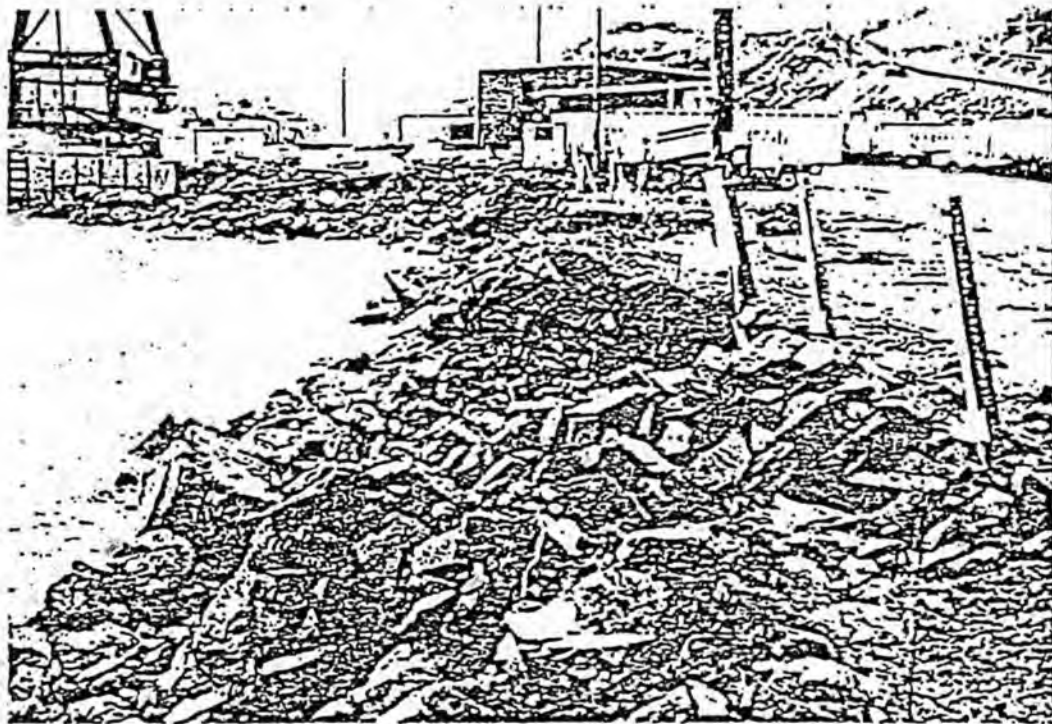
Photo No. 6: View looking west from east-central portion of container storage area. Lean of electrical receptacle posts initially caused by contact with parked container vans.

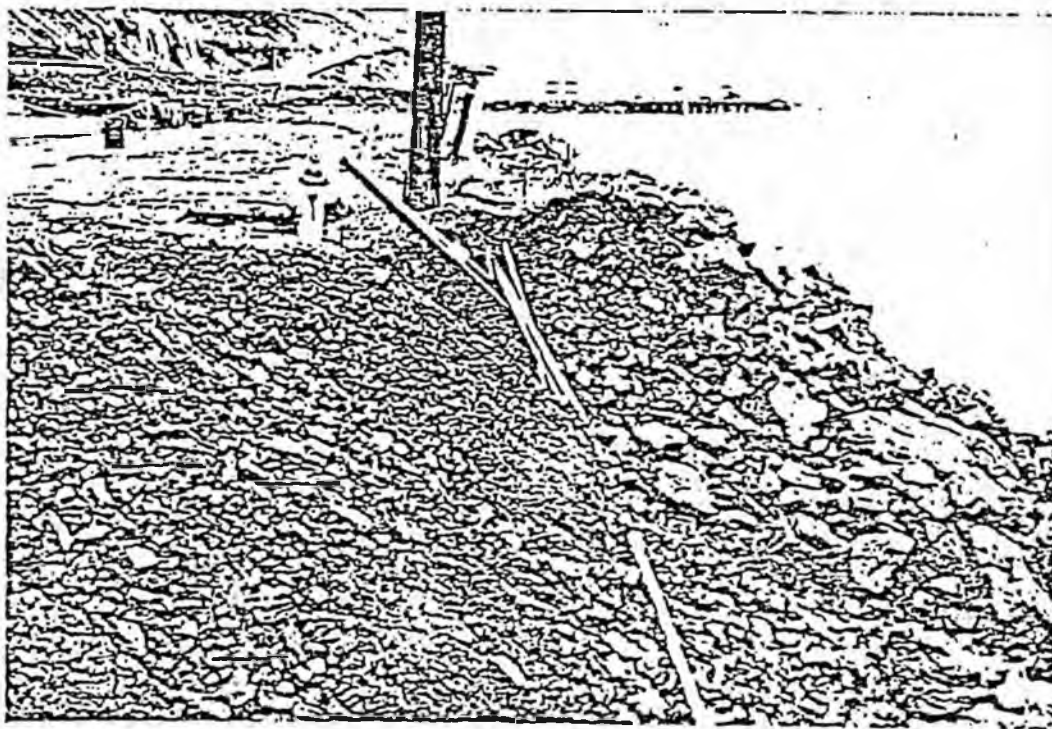
Photo No. 7: View looking east from west-central portion of container storage area. Fill in foreground placed by City of Kodiak.

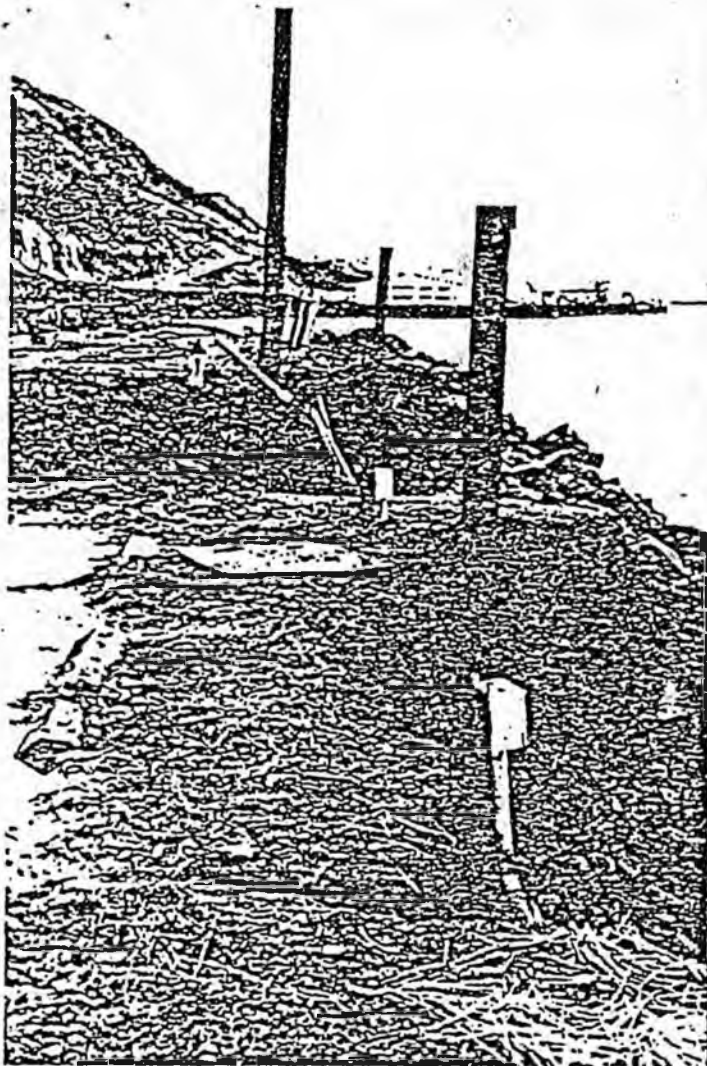
Photo No. 8: View looking east from west-central portion of container storage area.

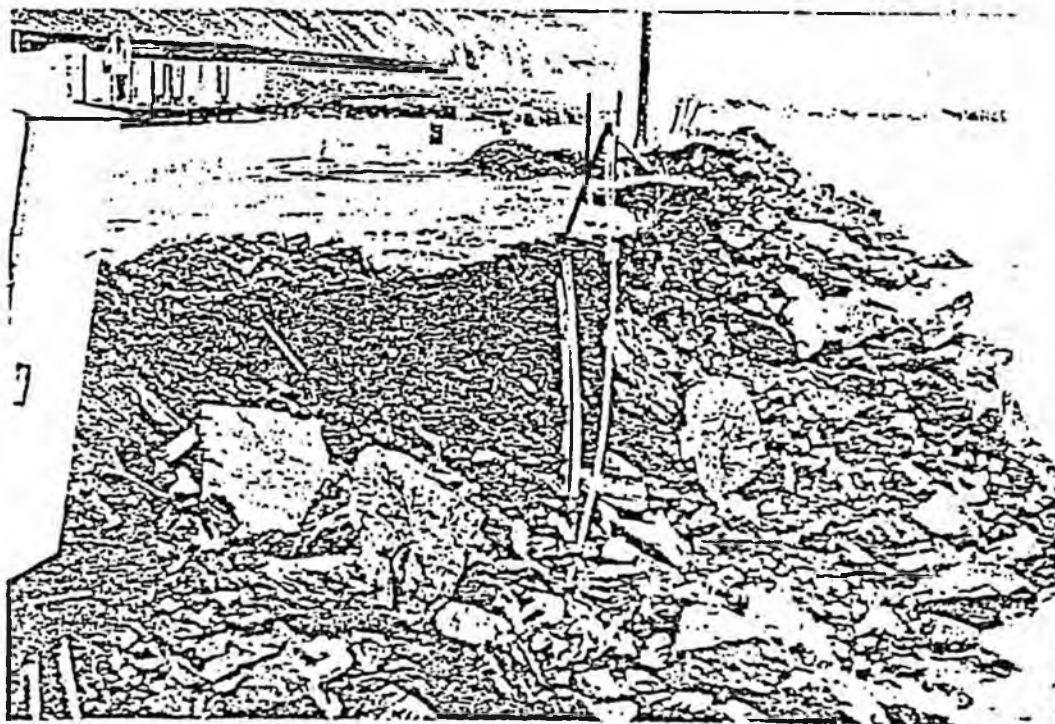
Photo No. 9: View as per Photo No. 8 above. Large riprap rock displaced downslope.

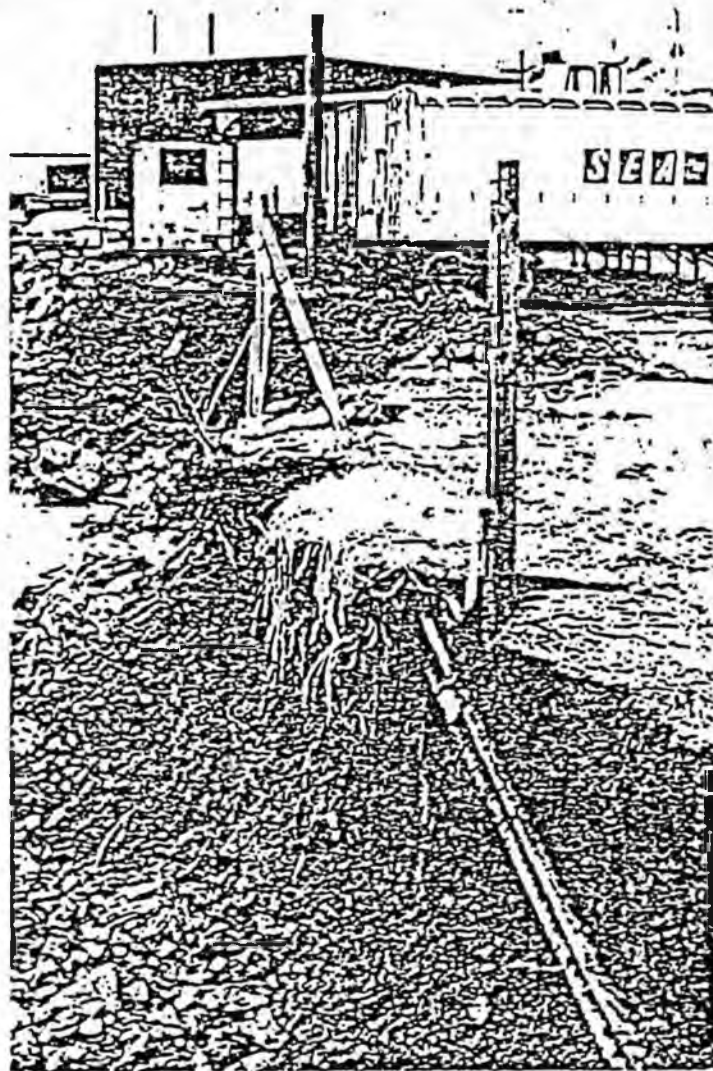
Photo No. 10: View looking west toward intersection of wingwall fill and container storage area. Waterline leak in vicinity of nearest container van in upper right of photo, not visible.

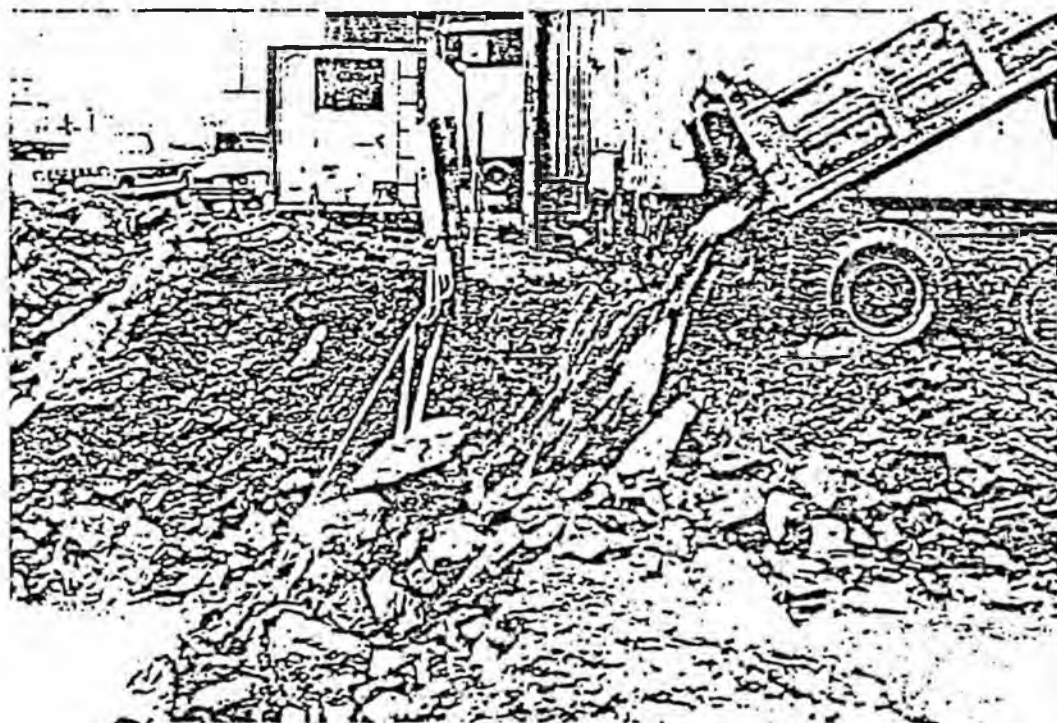
Emergency repair had begun during my visit to the site with several truck-loads of rockfill dumped into the more severely eroded areas (Photo No. 11). The method of repair proposed by the City Engineer (Contract Specifications for Pier 2 & 3 Storm Damage Emergency Repair) was reviewed and found appropriate to bring the container storage area back into operational use.

Photo No. 11: View as per Photo No. 10 above. Emergency rock fill being placed to prevent further spalling of bank.

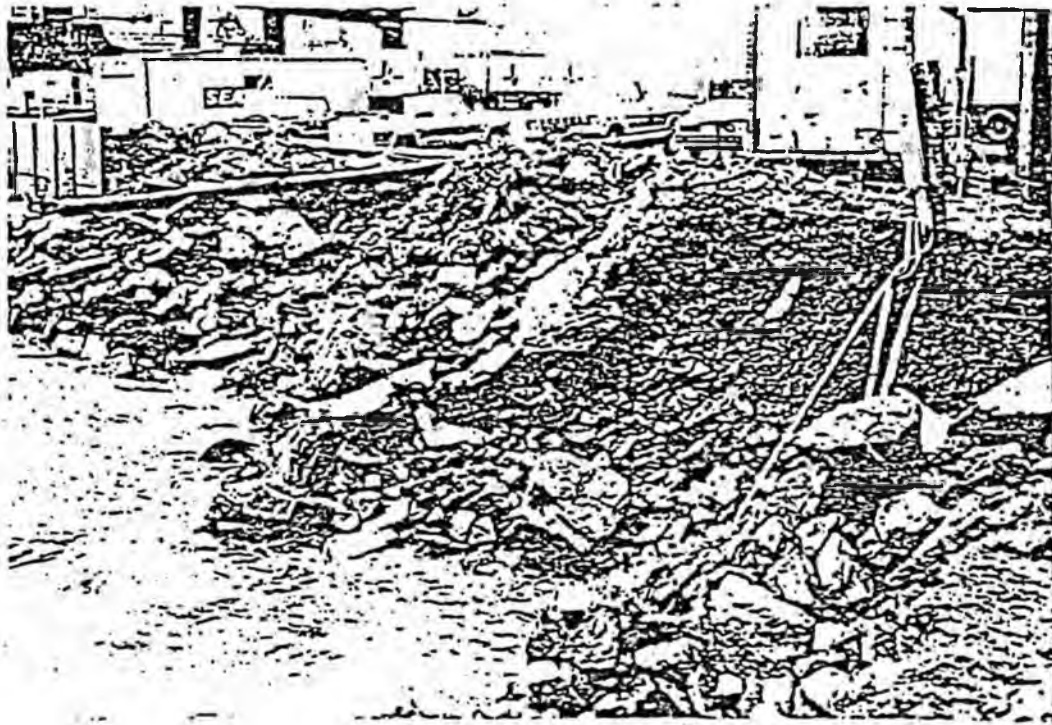
Photo No. 12: Slope erosion northerly of east wingwall. Note location of creosoted piling originally stored on top of bank.

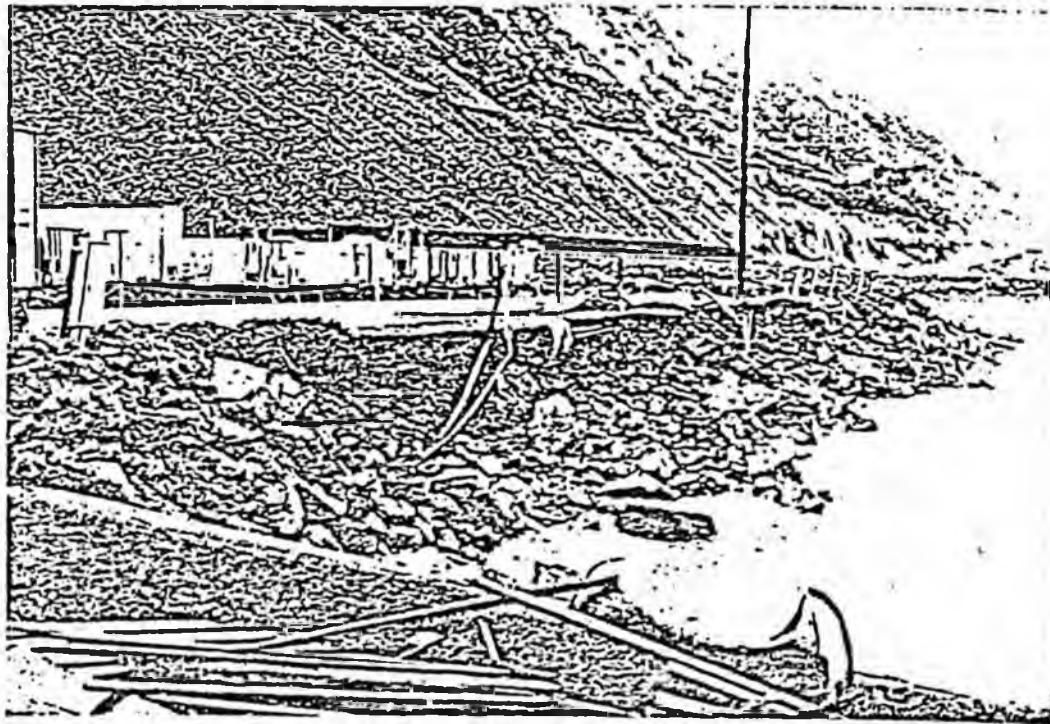
Photo No. 13: Overall view looking east of slope erosion along container storage area.

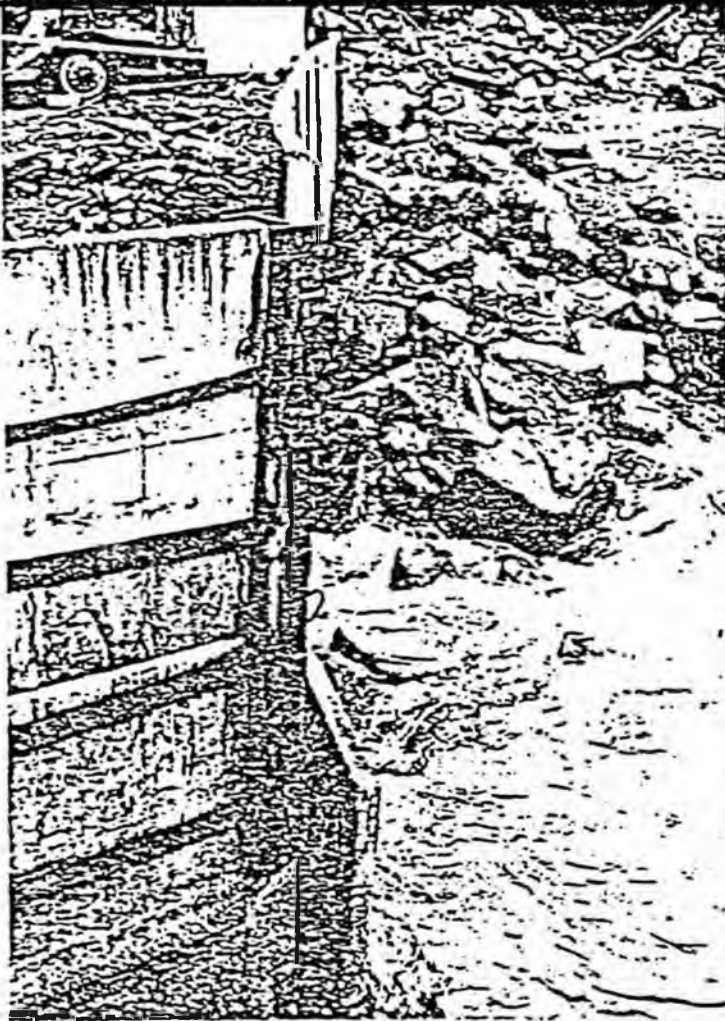
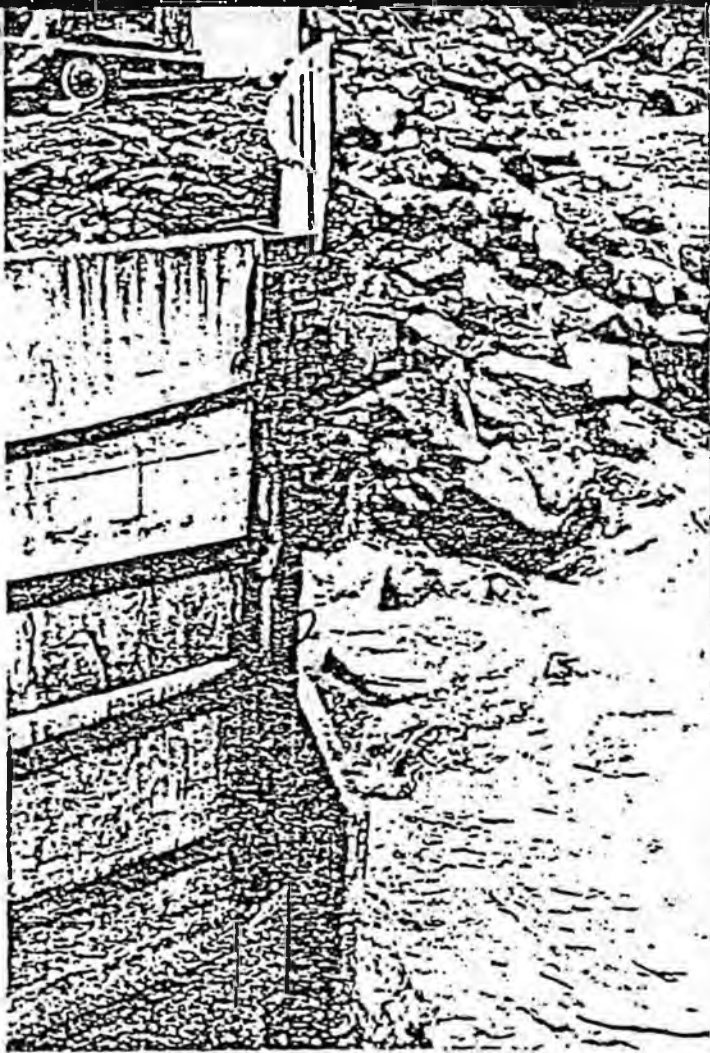
Photo No. 14: View looking northeasterly along top of east wingwall. Note irregular alignment of wall top.

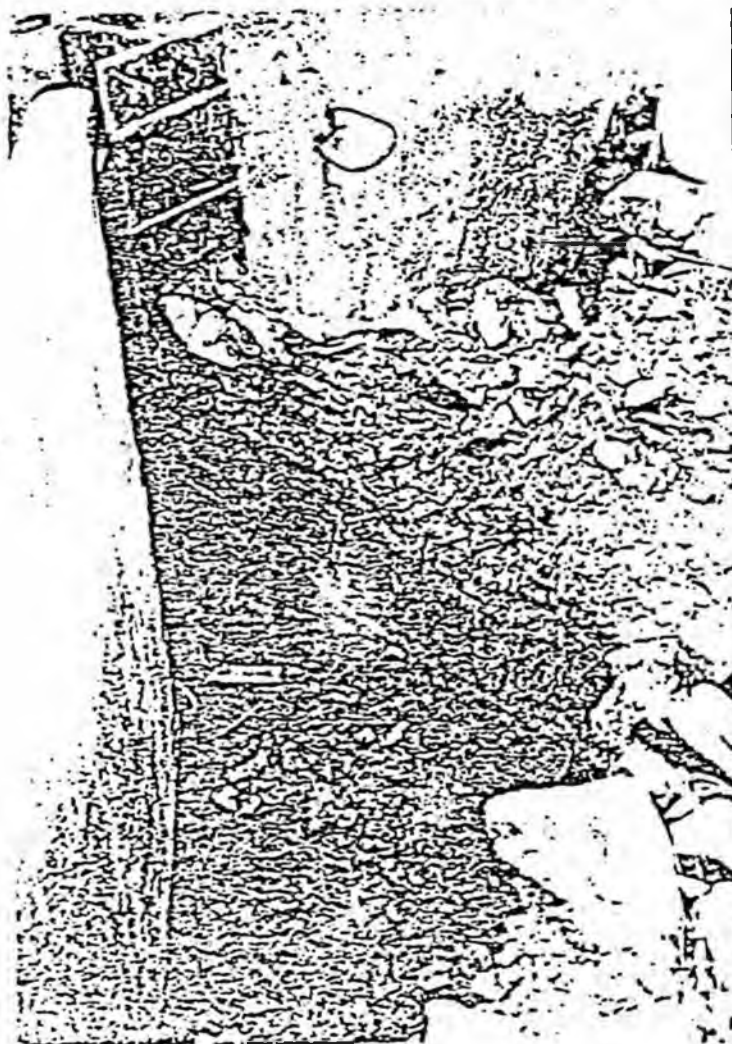
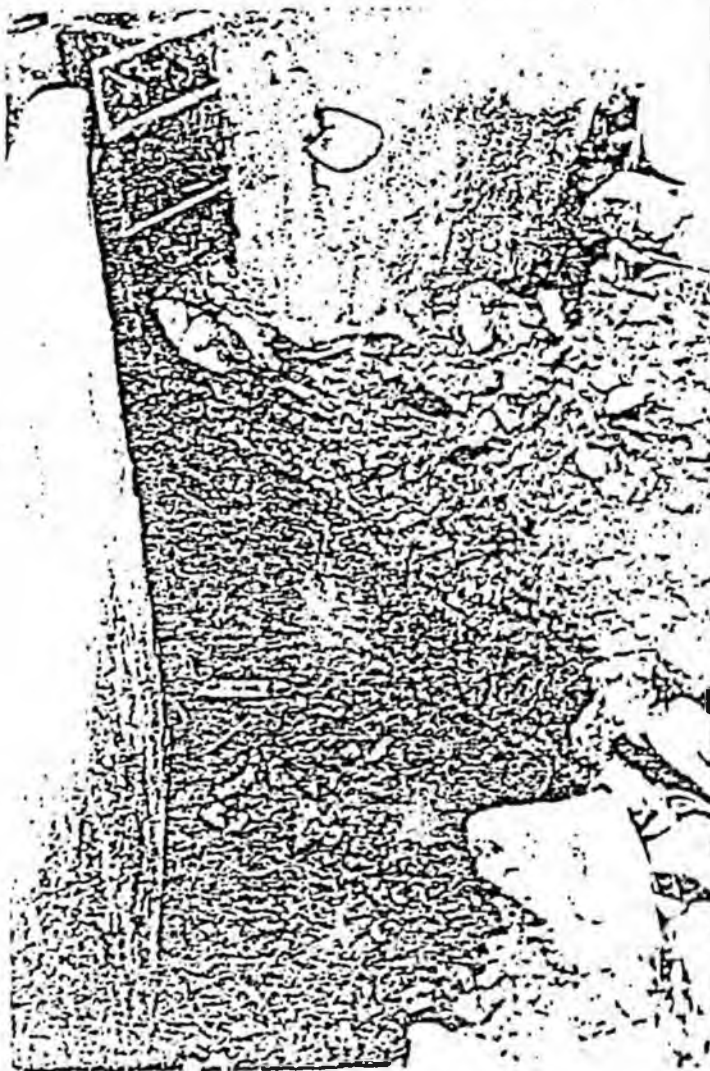
Photo No. 15: View at corner pile, inside of east wingwall. Due to broken tierods, pile is retained in place by buried steel tension beam installed by City of Kodiak. Loss of fill material caused by wave action through loose panel below.

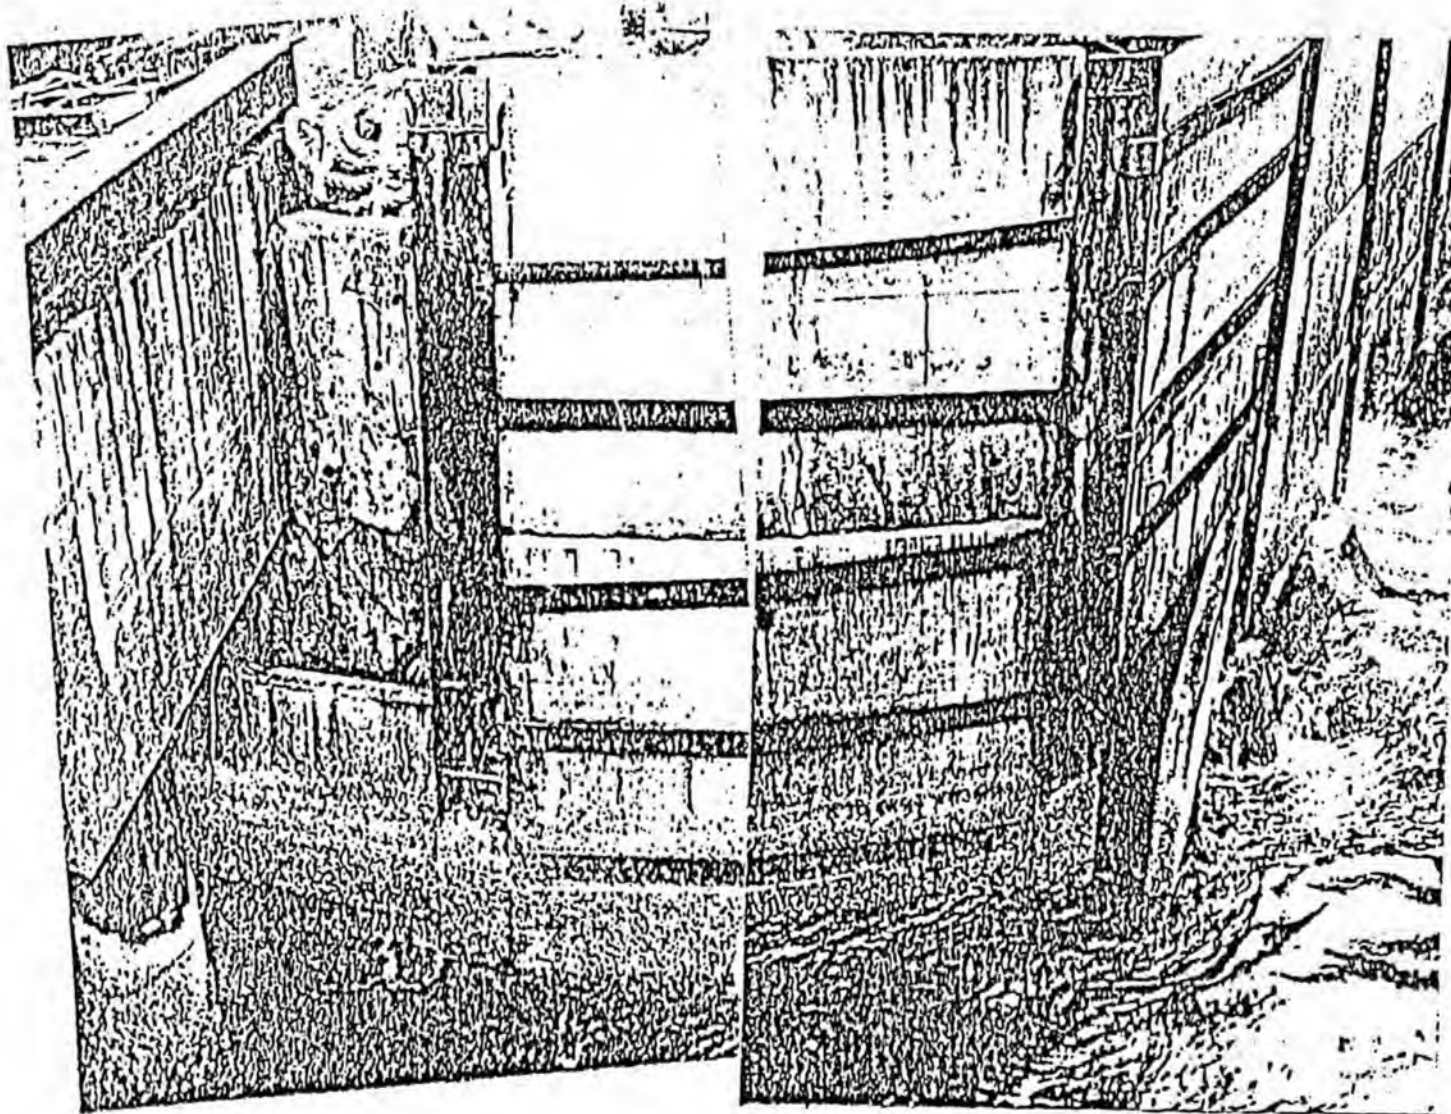
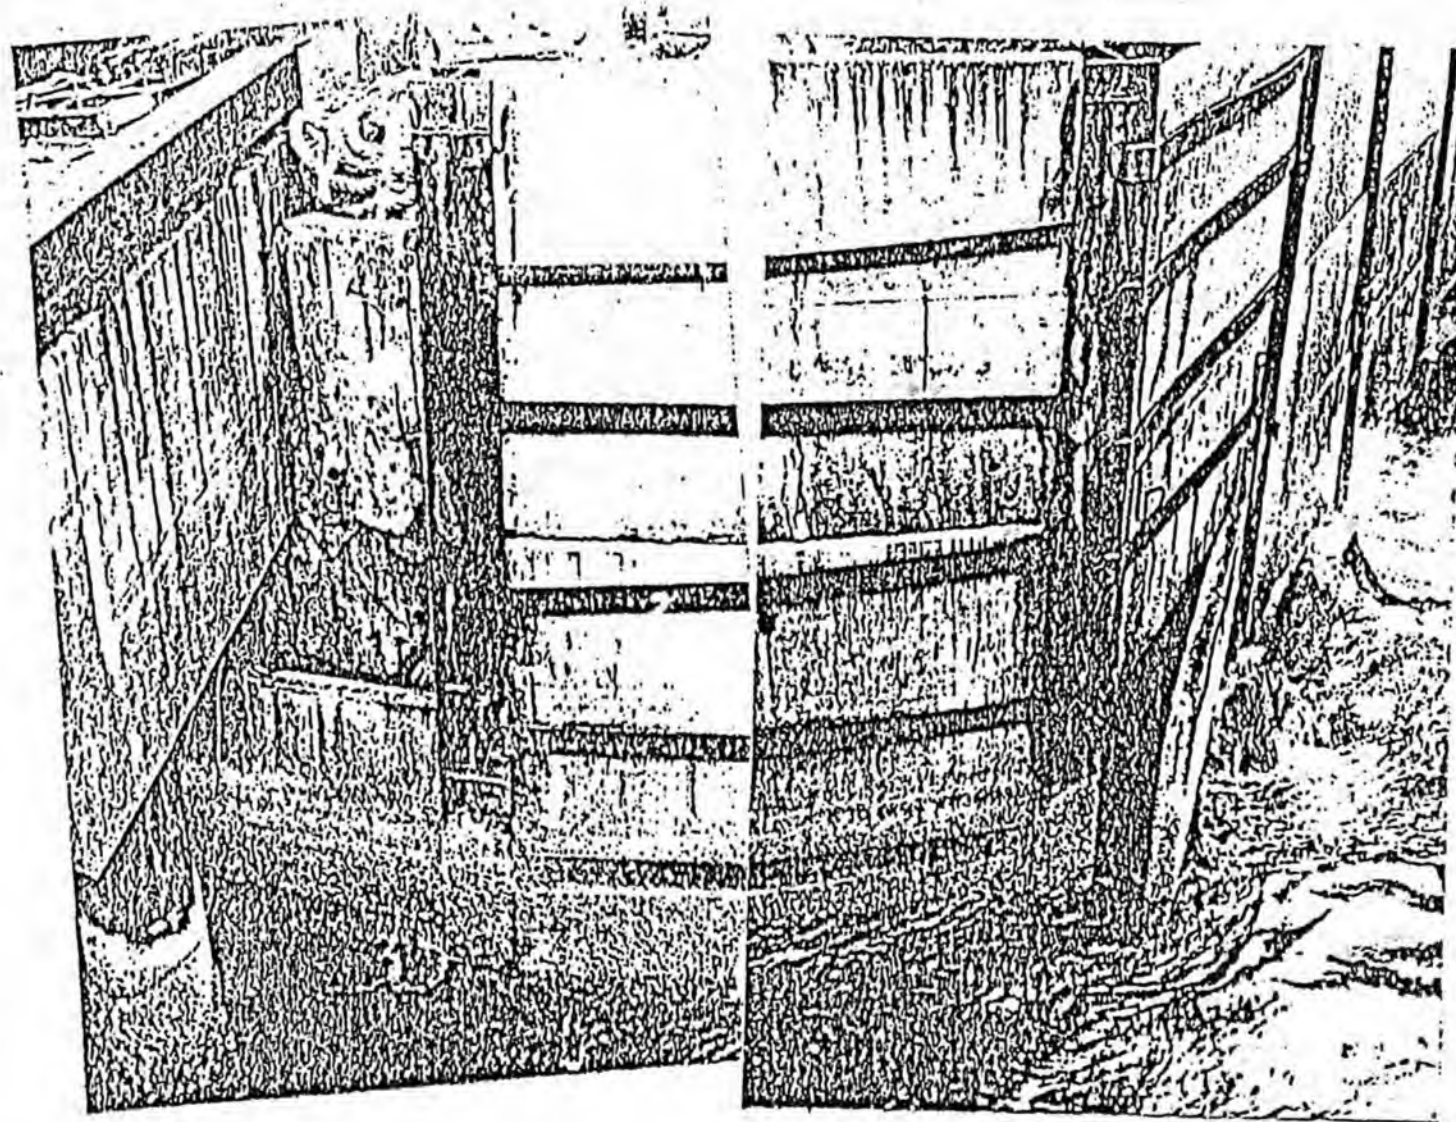
Photo No. 16: View of east end of main wharf bulkhead at junction with east wingwall
Movement of soldier pile adjacent to wharf structure (at left of photo) has broken
cast-in-place concrete panel section. Steel straps keep soldier piles from spreading.
Steel tierrod ends are broken, first three soldier piles.

Photo No. 16: View of east end of main wharf bulkhead at junction with east wingwall. Movement of soldier pile adjacent to wharf structure (at left of photo) has broken cast-in-place concrete panel section. Steel straps keep soldier piles from spreading. Steel tierod ends are broken, first three soldier piles.

Temporary repair work on the bulkhead must continue where piles have translated or moved sufficiently to endanger loss of supported concrete wall panels (Photo No. 18). Repair should be in the manner established and shown in Photo No. 16 wherein tension straps maintain both the relative positions of adjacent piling and act as bearing plates for the wall panels.

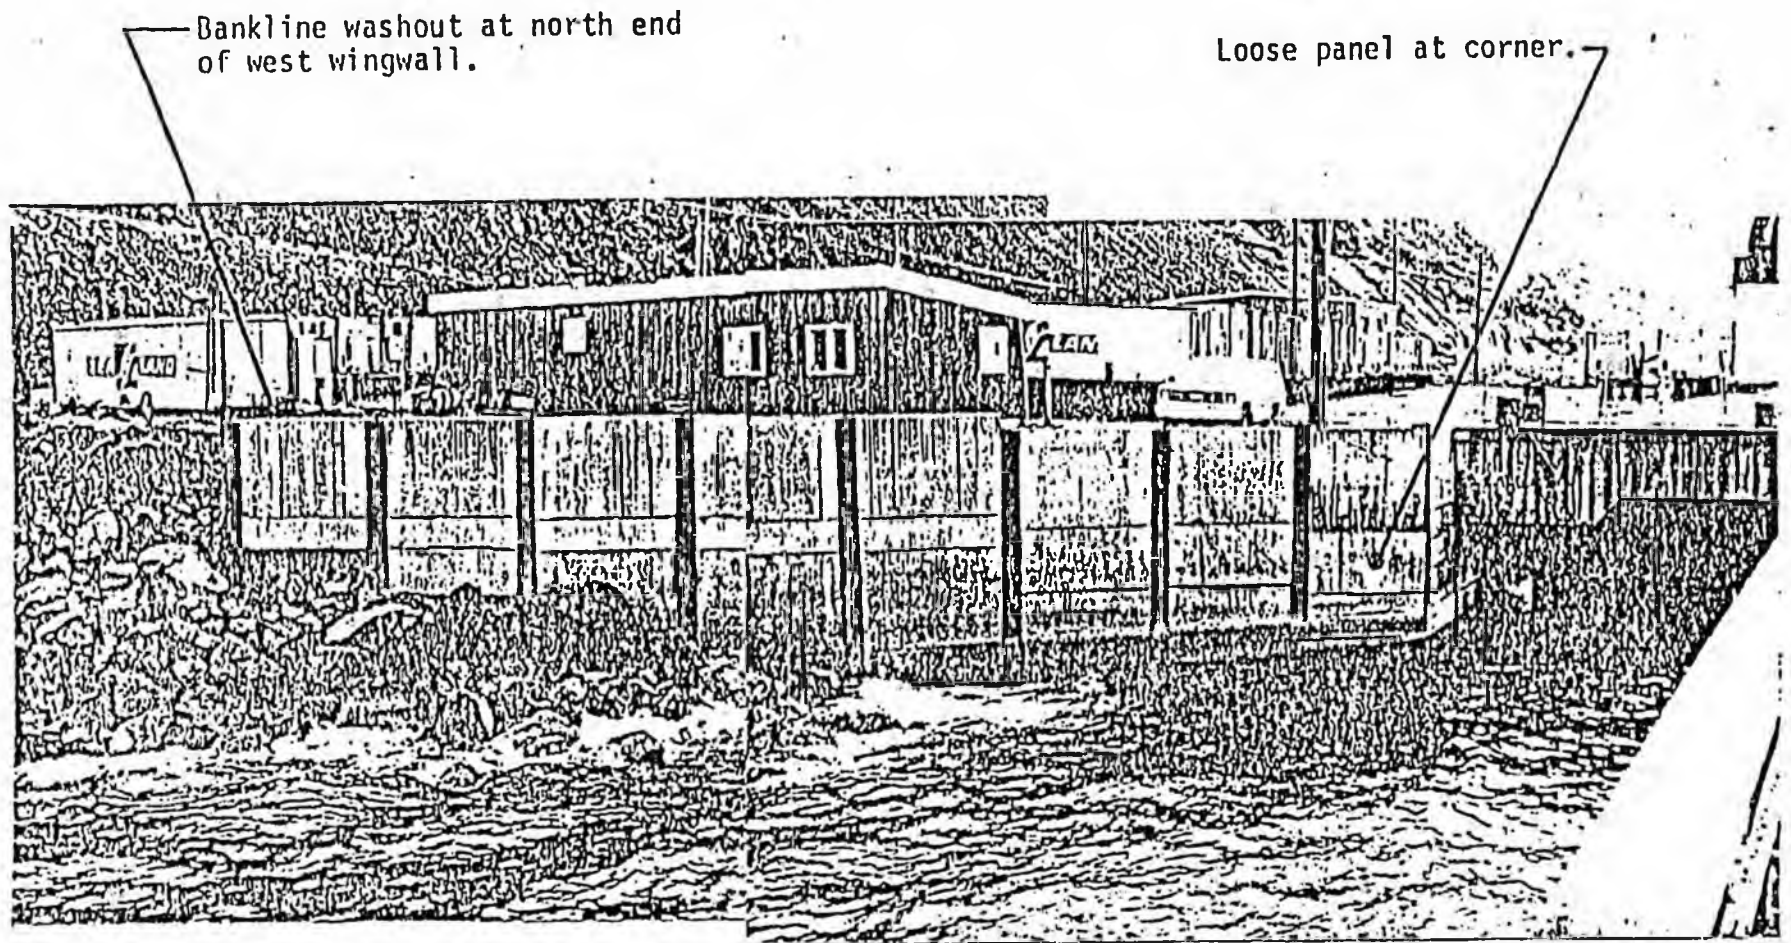
Photo No. 17: Overall view of west wingwall. Storm damage relatively minor in comparison to east container storage area and east wingwall.

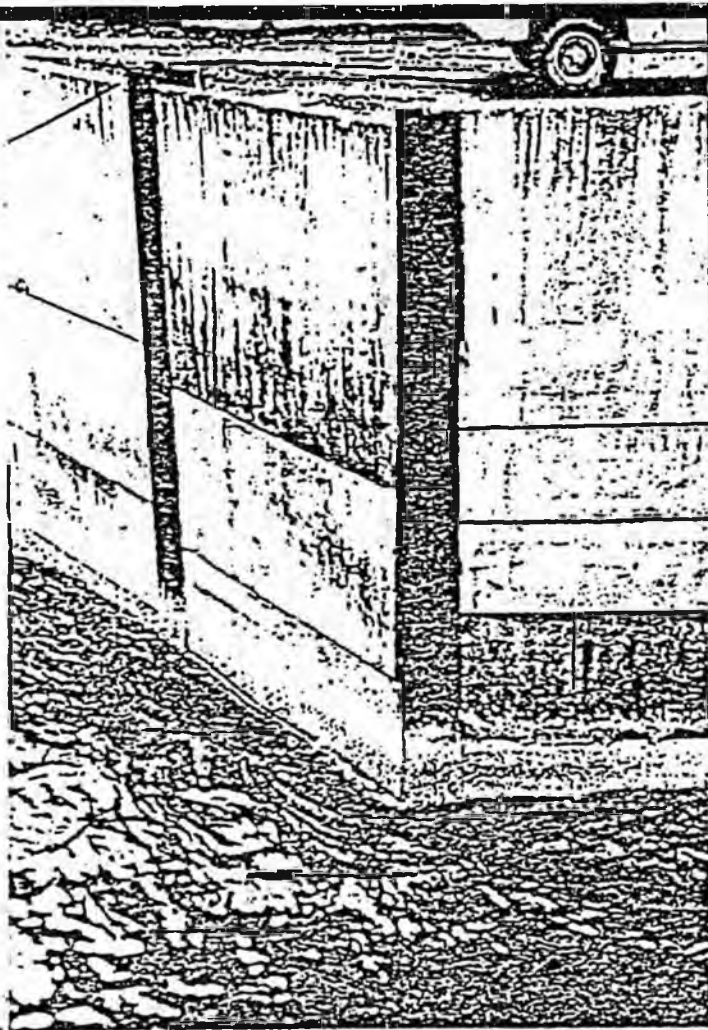
Photo No. 18: View of west wingwall corner. Concrete panel framing into flange of corner soldier pile in danger of falling out in fashion similar to that shown in Photos No. 14 and 16.

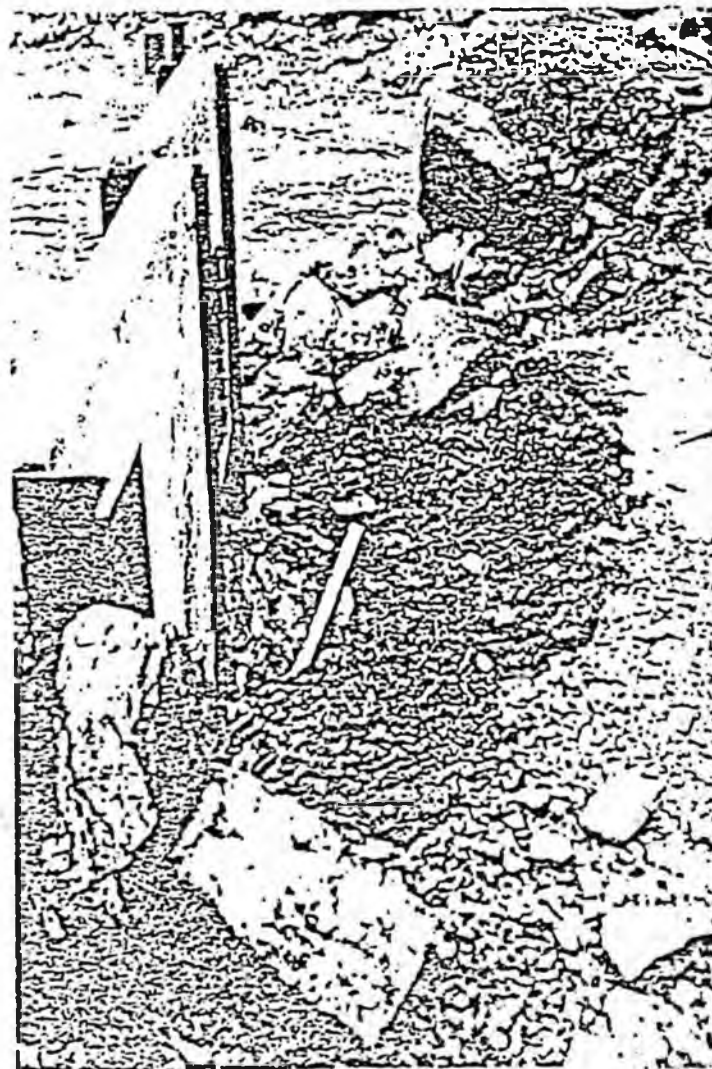
Photo No. 19: View of northern end of west wingwall looking north. Fill washed out from behind wall by storm waves.

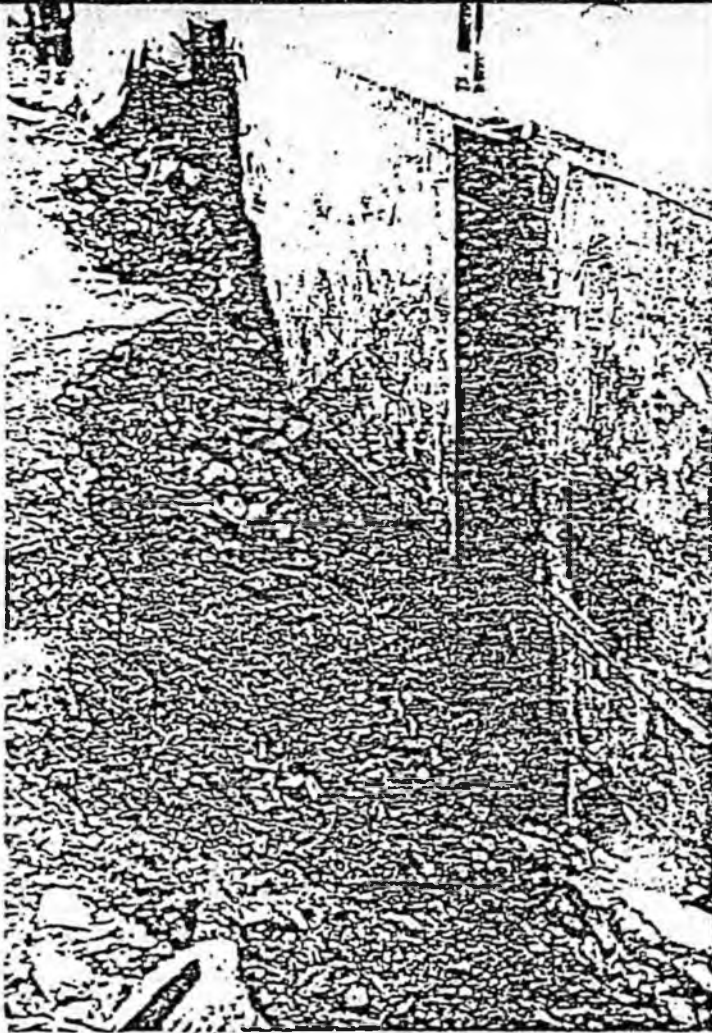
Photo No. 20: View of north end of west wingwall looking south. Eroded fill is daylighted under concrete panel.
