CSSB 450am cont. 1368

REPORT OF DAMAGE

Subject: Kodiak Container Wharf (Pier 3)

Investigation of the Storm Damage to the Kodiak City Dock Facility

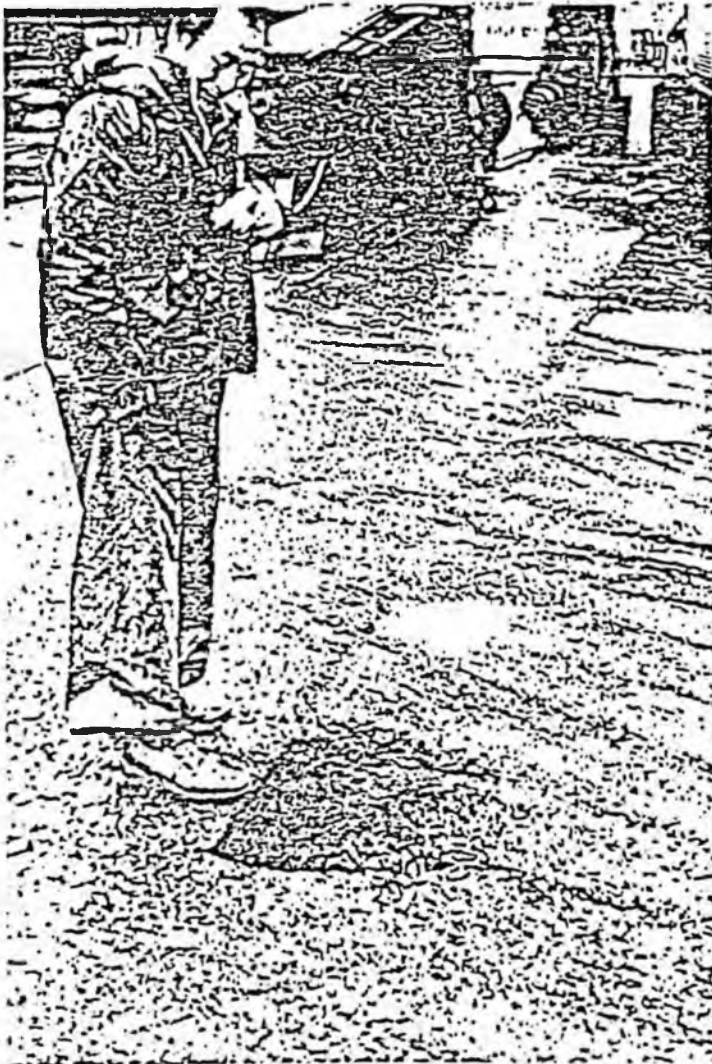
Photo No. 21: Sinkhole in rockfill in back of wharf. Typical three places along easterly third of wharf.
