LEG. FINANCE - BILLS 1983 - 1984 1840

HB 151 cont.

Summary of Building Modifications

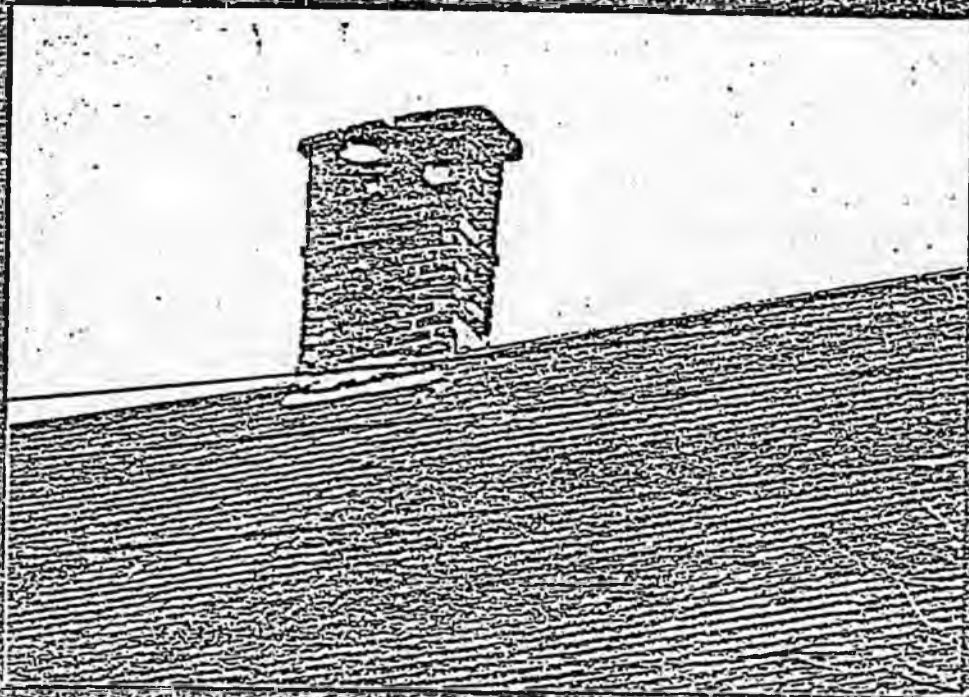
61

The roof consists of square-butt, mineral-surfaced asphalt shingles, laid approximately 5 inches to the weather on a wood substrate with 12:12 pitch. The roofing is deteriorated as indicated in photos #61 & 69, and requires complete replacement with best grade fire retardant shingles of same appearance. All flashings need replacement at that time also, and such work should not be done until all foundation stabilization and framing realignments are completed.

Brick chimney is deteriorated and needs attention. See photos #61 & 69.

Loose or rotten brick should be reset or replaced with matching material as appropriate. Flue liner needs to be thoroughly inspected, cleaned, and repaired if required.

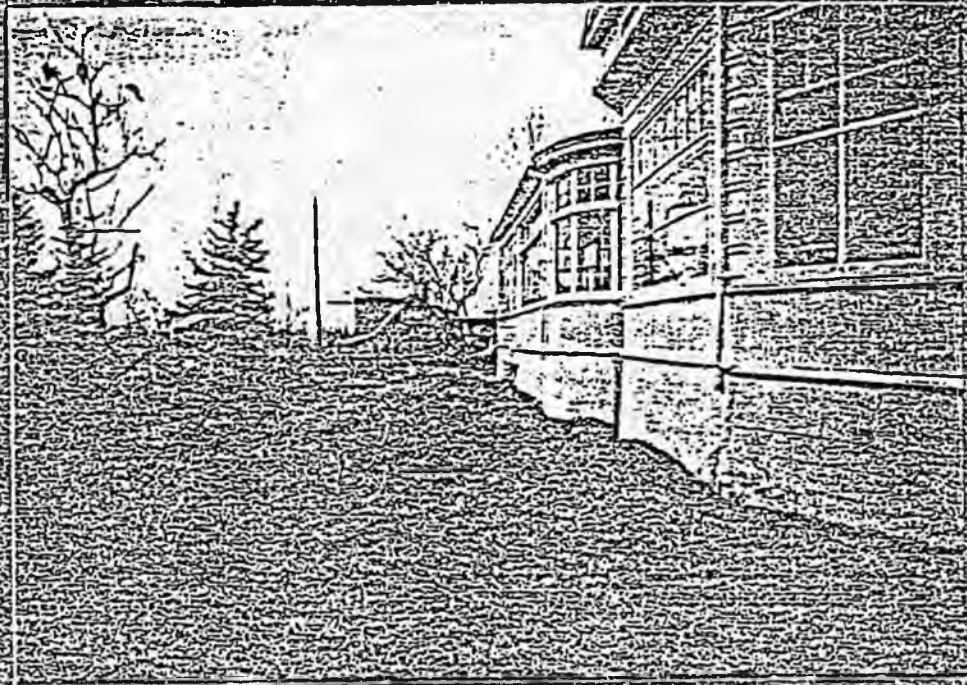
63

There are no readily apparent problems with the principal foundation line, although the inner foundation under porch #112 and under the bay window group #115-117 of study #109 will require detailed examination when the outer foundations are opened. Severe settlement problems have occurred affecting the outer foundation under porch #112 and under the bay window. See photos #63-66, 73, 74. It is not known whether this set-

tlement is due to inadequate footing design, improper preparation of the soil bearing surface when footings were installed, or whether due to possible soil drift or subsidence down the slope to the south.

Analysis of soil stability in the south third of this property should be obtained, and the outer foundations of the porch and bay window removed and reconstructed. It will be necessary to examine the inner foundation wall line at that time to confirm condition. Levelling of first floor over the crawl space and rework of piers on that area should take place after soil analysis is obtained. Crawl space minimum clearance is about 1½ feet. It may prove desirable to excavate the crawl space to full basement depth and develop full finished basement at that time.
