## DEFERRED MAINTENANCE TASK FORCE

Public Hearing

October 14, 1997

# **FAIRBANKS COURTHOUSE FEASIBILITY STUDY**

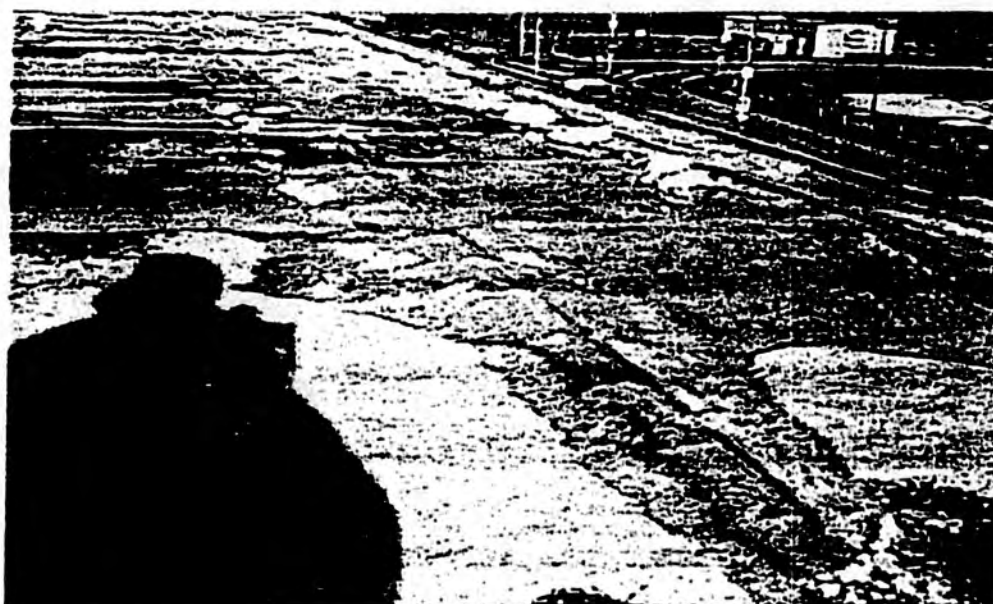
**Figure 6**  
Main building roof: Line of fasteners backing out

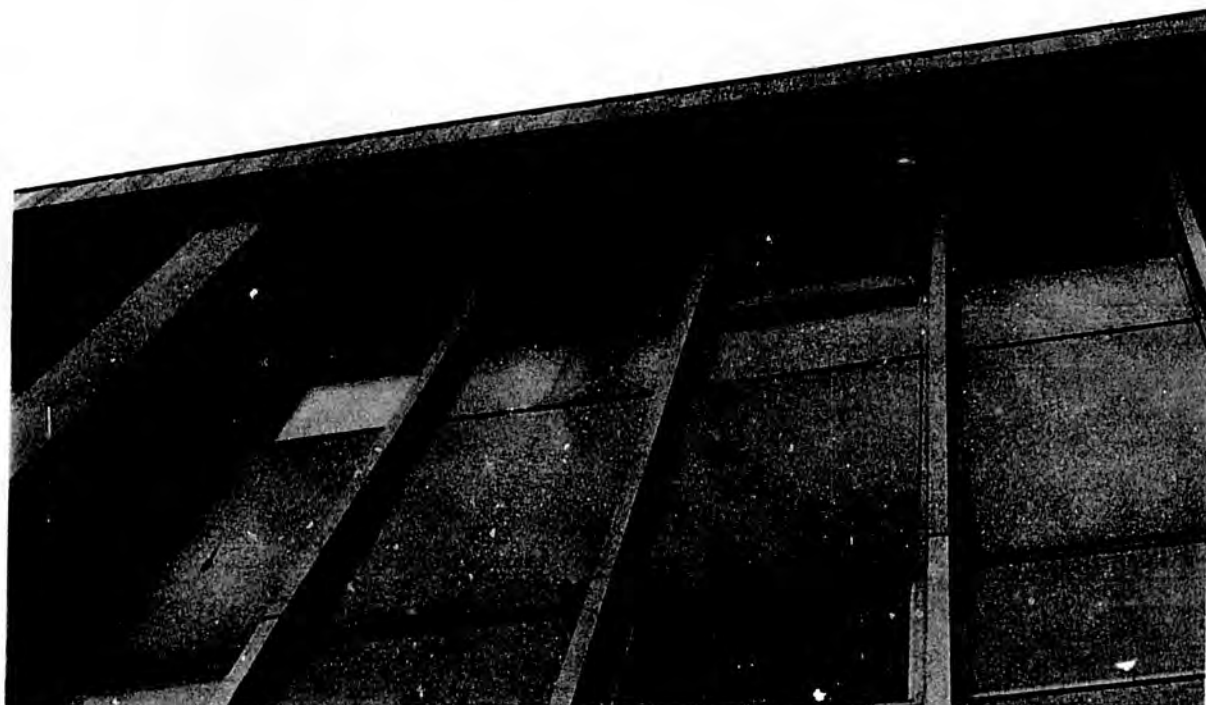
Photo #6

Delaminating Exterior Panels

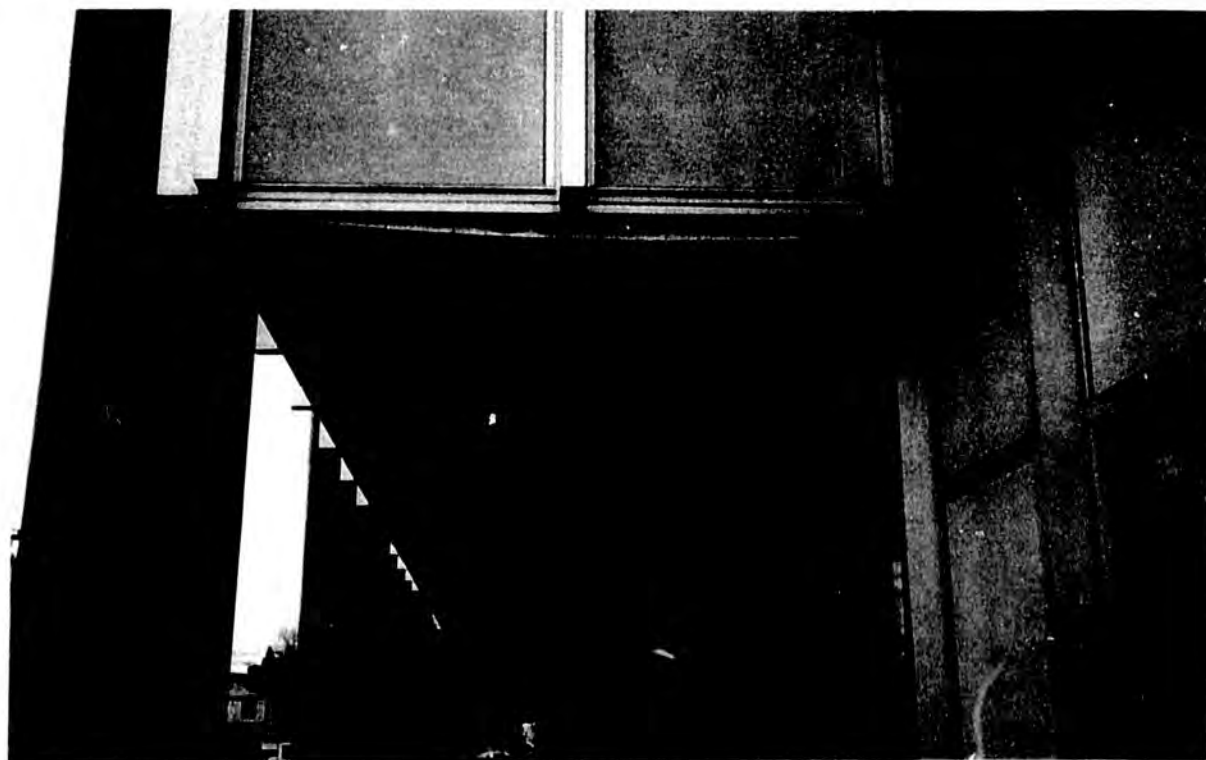
Photo #7

Failing South Soffit

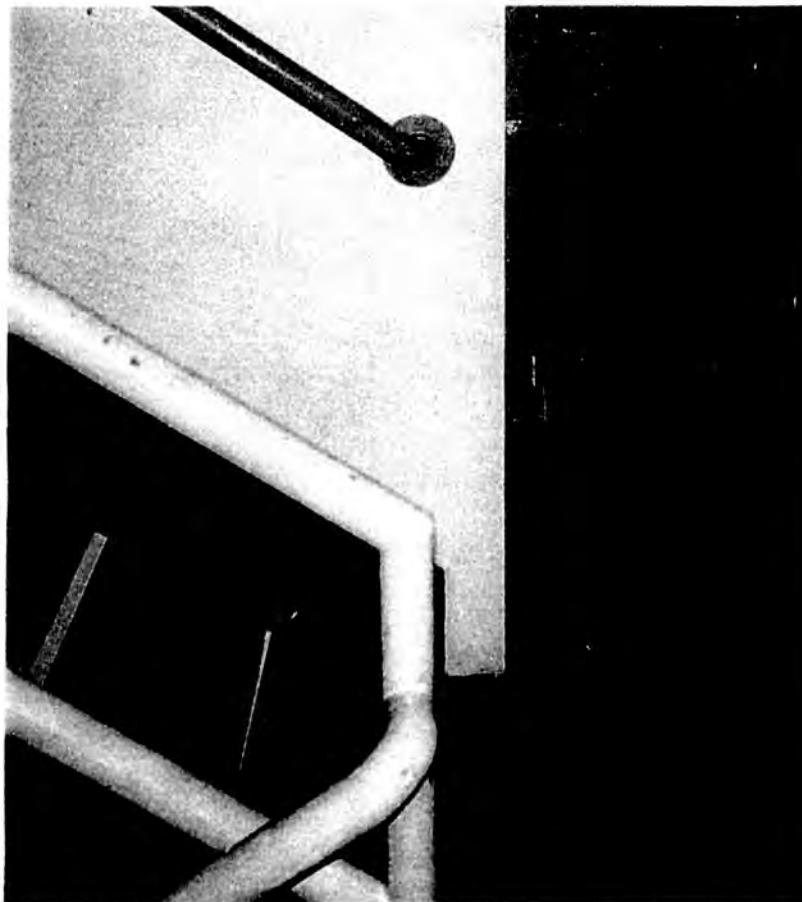
Photo #33  
Non-compliant  
Handrails  
at Exit Stairs

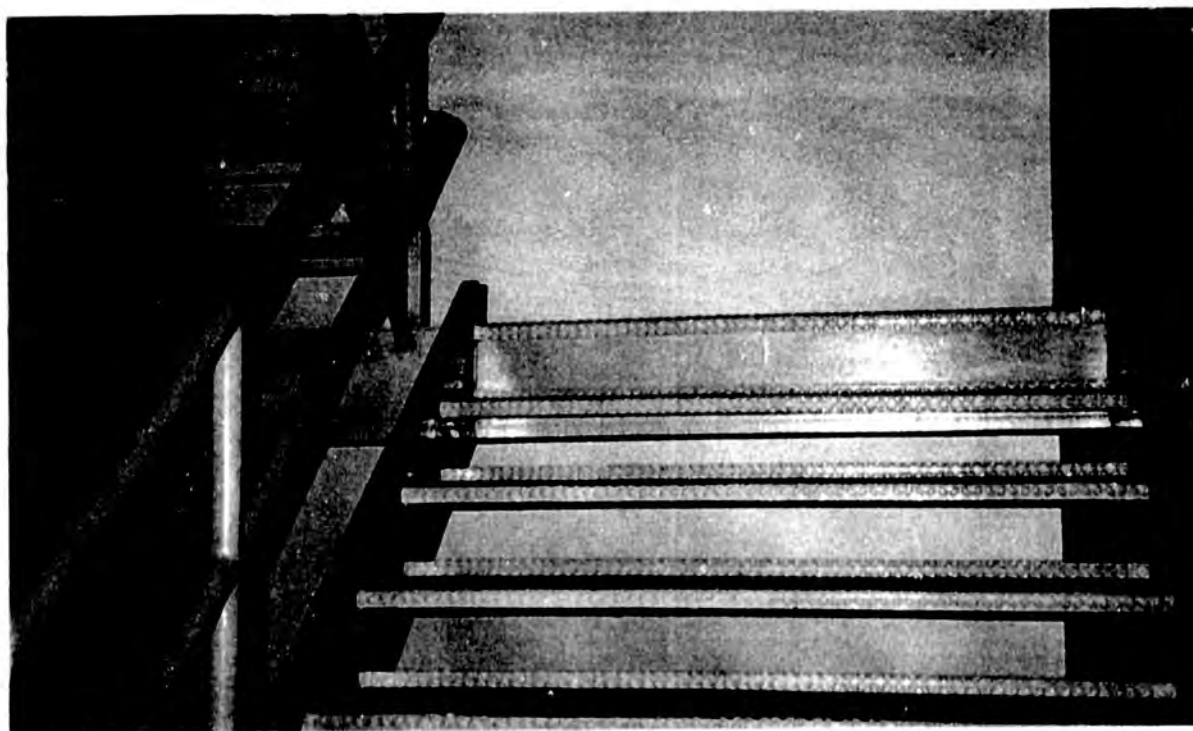
Photo #34

Open Risers at Exit Stairs

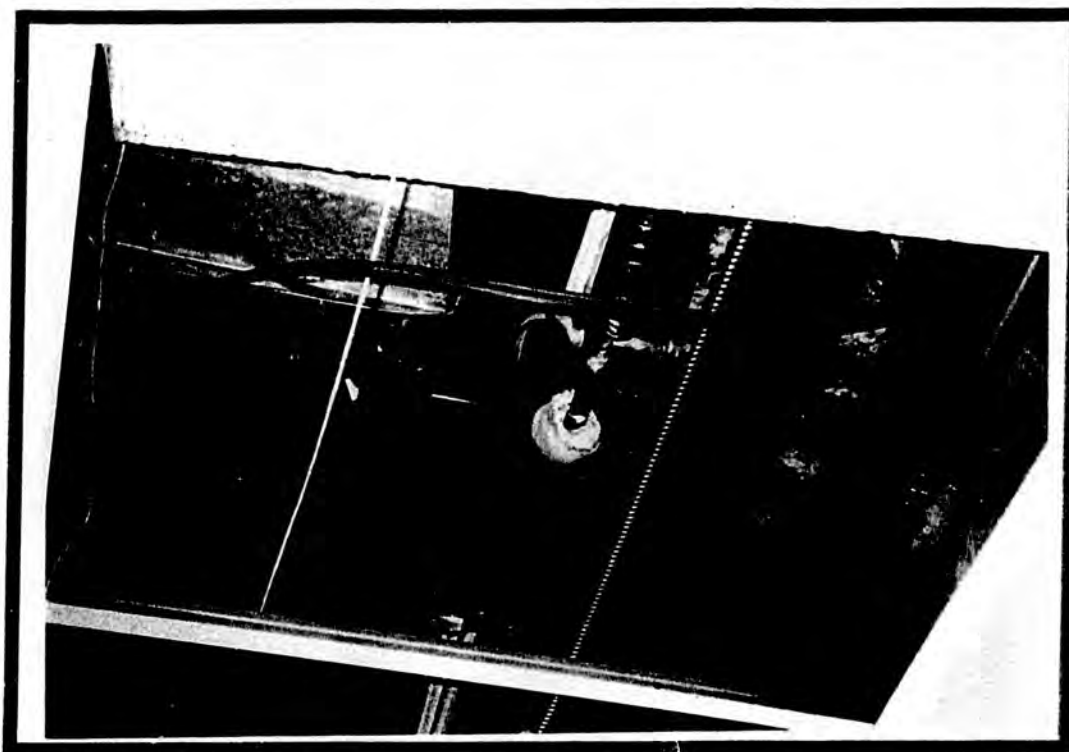
**Description of Photo: Friable asbestos, north hallway ceiling, 3rd floor.**

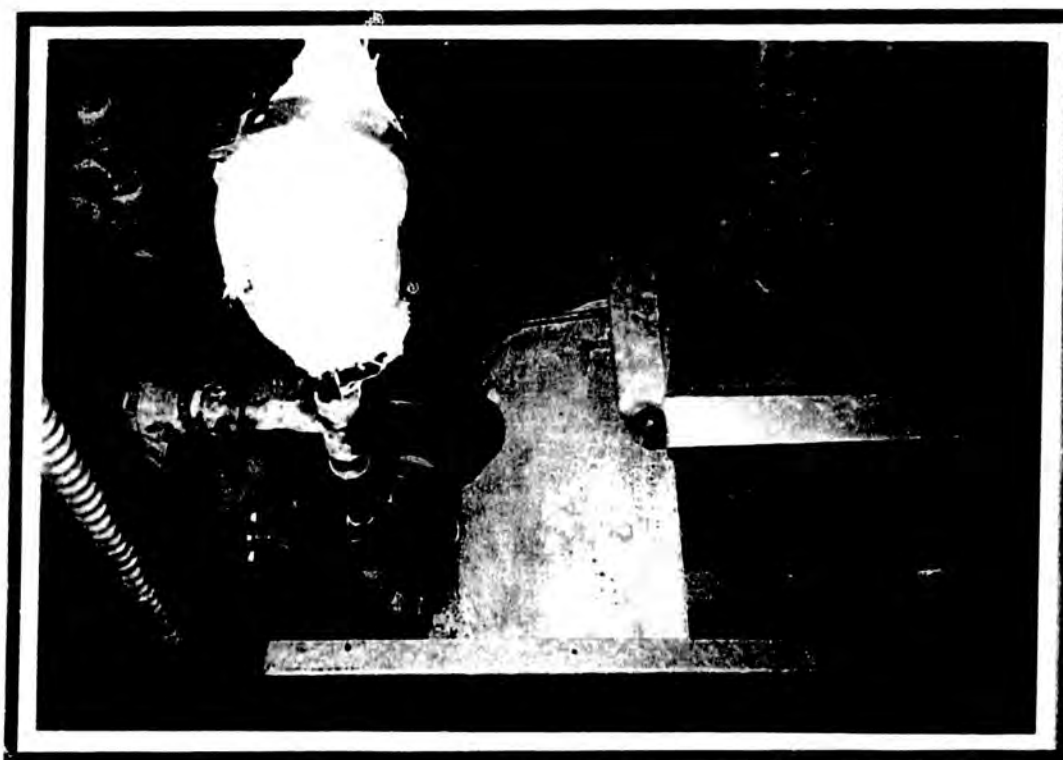
**Description of Photo: Friable asbestos, north hall ceiling, 3rd floor.**
