Northwest Arctic Borough  
School District

*Current Capital  
Improvement Project Needs*

**BUCKLAND**

## ENGINEER'S CERTIFICATE OF INSPECTION

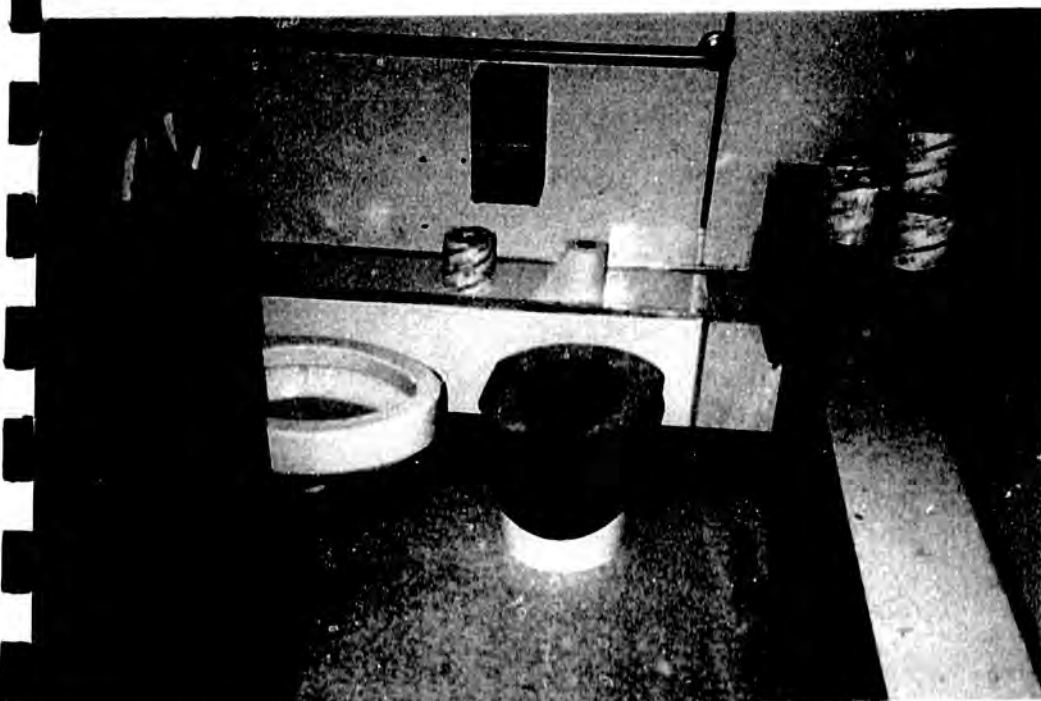
**PHOTO 3**

Because the preschool and the shop are separate structures from the main building, utilities must be run to these structures. This causes the water supply and sewage disposal function to be somewhat tenuous. Lines routinely freeze, requiring the use of honey buckets for extended periods.

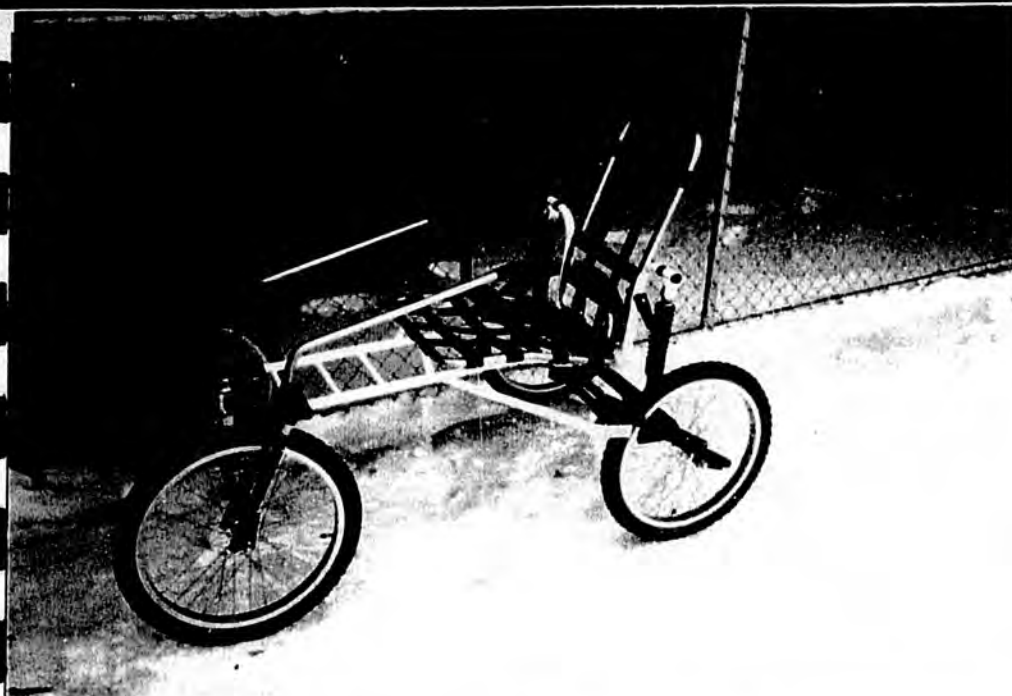
**PHOTO 4**

This cart is used by a handicapped student to access the school building.

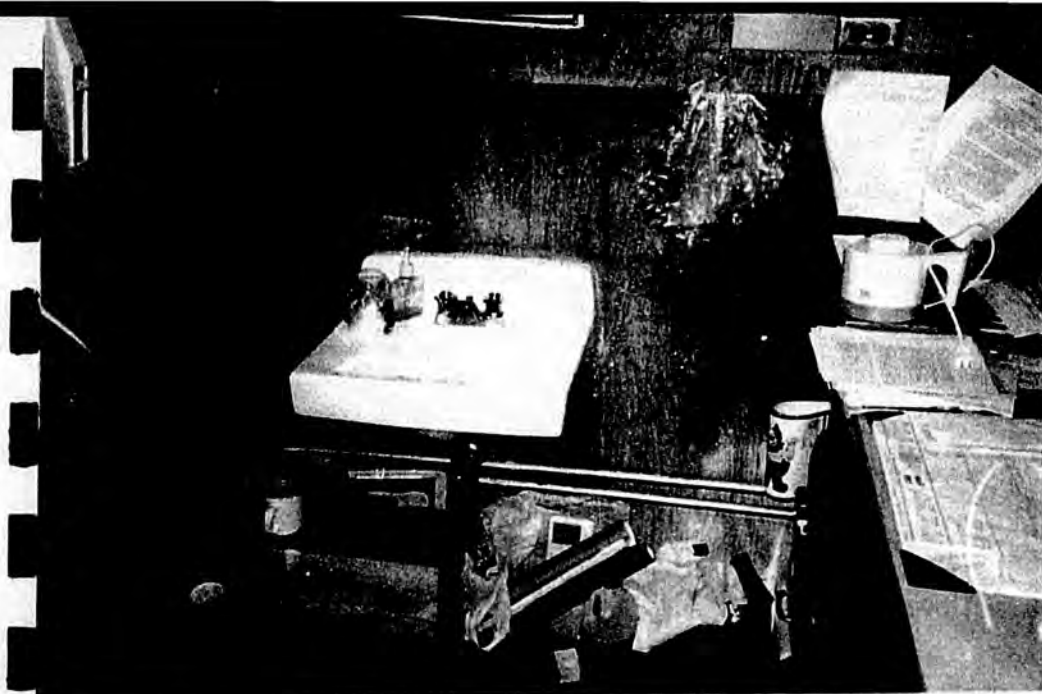
**PHOTO 13**

Lavatory in the special education room that has been reprogrammed from a shop. Notice the conduit and the electrical panel. Storage, panel, and conduit are hazardous to students. Also notice the steps to accommodate sink height. This area also houses the instructor's desk.

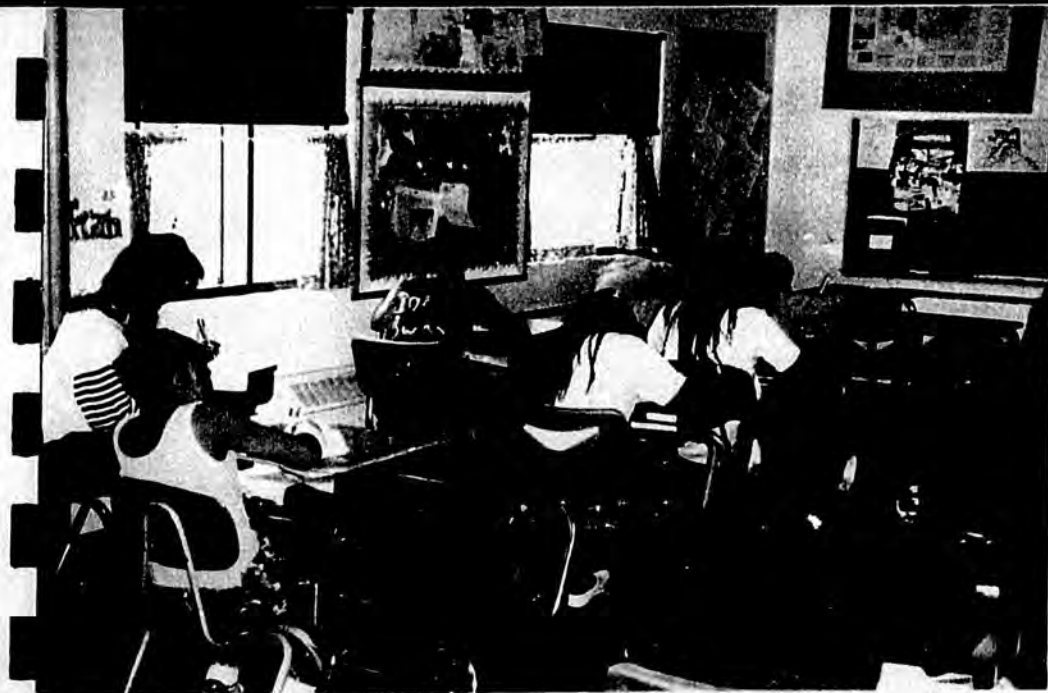
**PHOTO 10**

Crowding conditions have caused the media space to be taken over and used as a classroom, precluding access by other student groups.

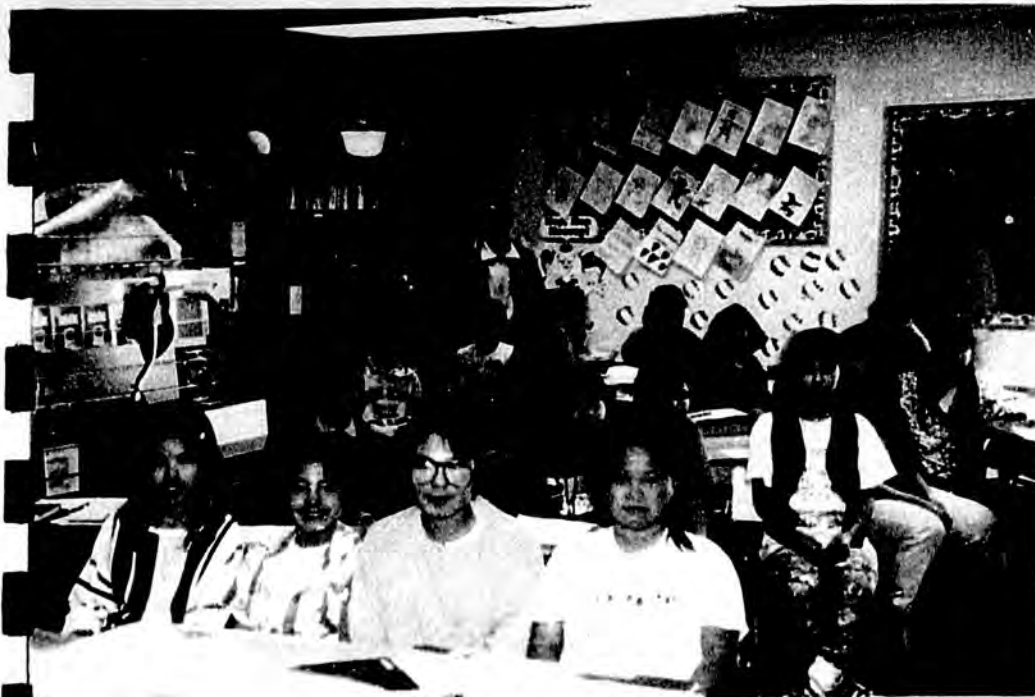
**PHOTO 11**

A crowded classroom filled above capacity with students. This condition is further complicated by excess storage required to be in the room because no other space is available.

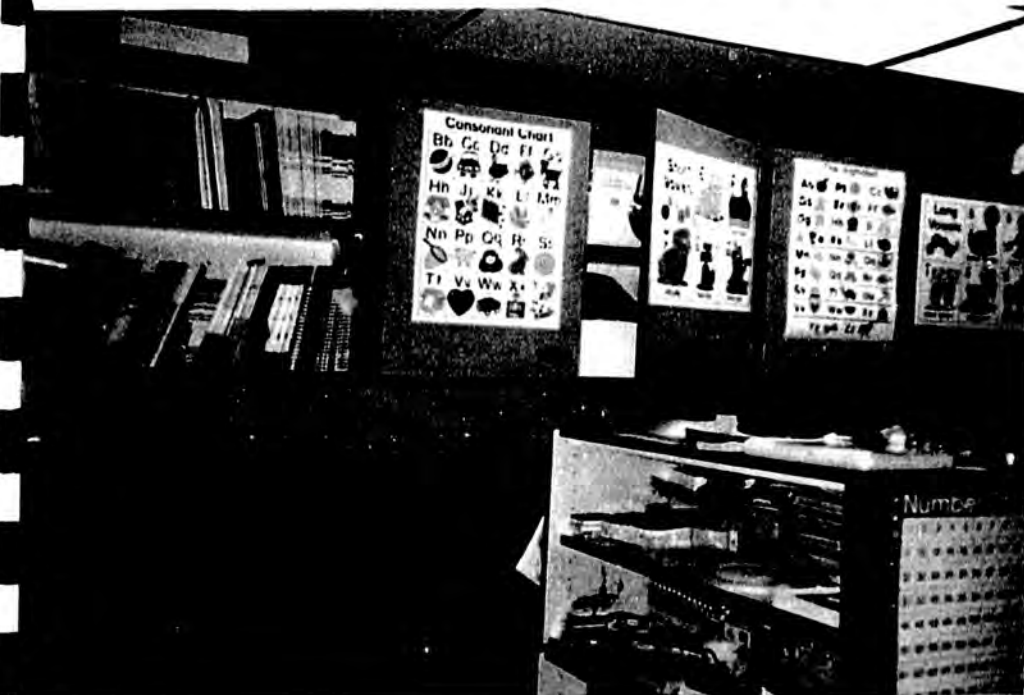
**PHOTO 12**

Elementary special education room that was originally designed and used as a shop. Notice the outlet strip is at industrial height.

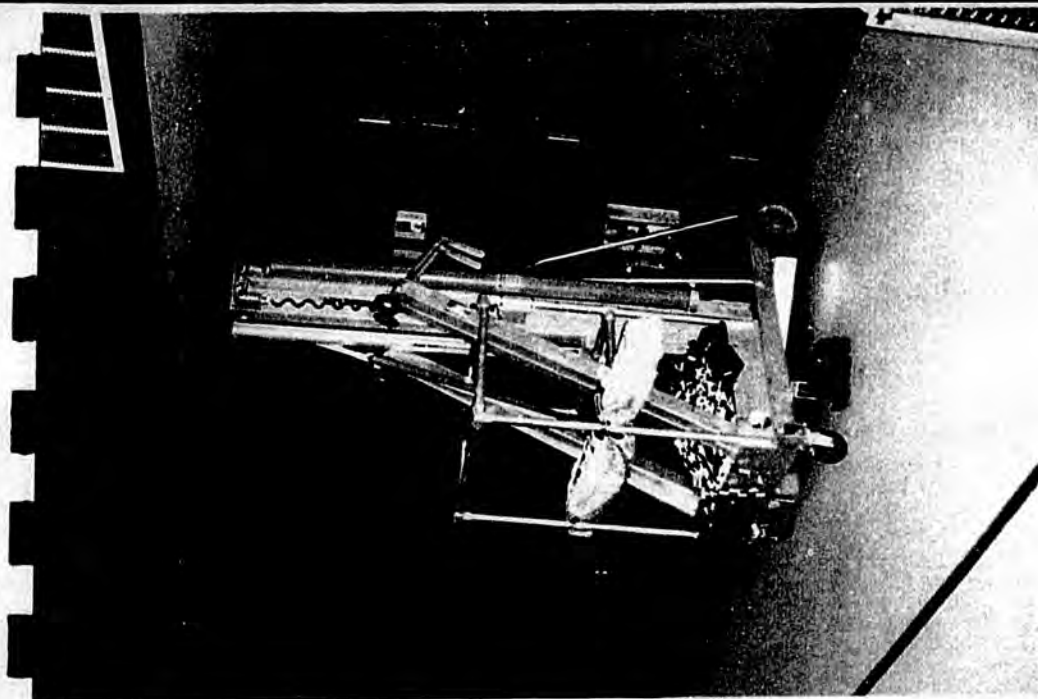
**PHOTO 7**

Hoist is used to reach the ceiling light fixtures in the gymnasium. Because there is no storage area available for this device, it is being kept in the gym. Notice it is being used as a rack for custodial tools and PE equipment. Storage of this device in the gym constitutes an egress hazard and an impact hazard to students.

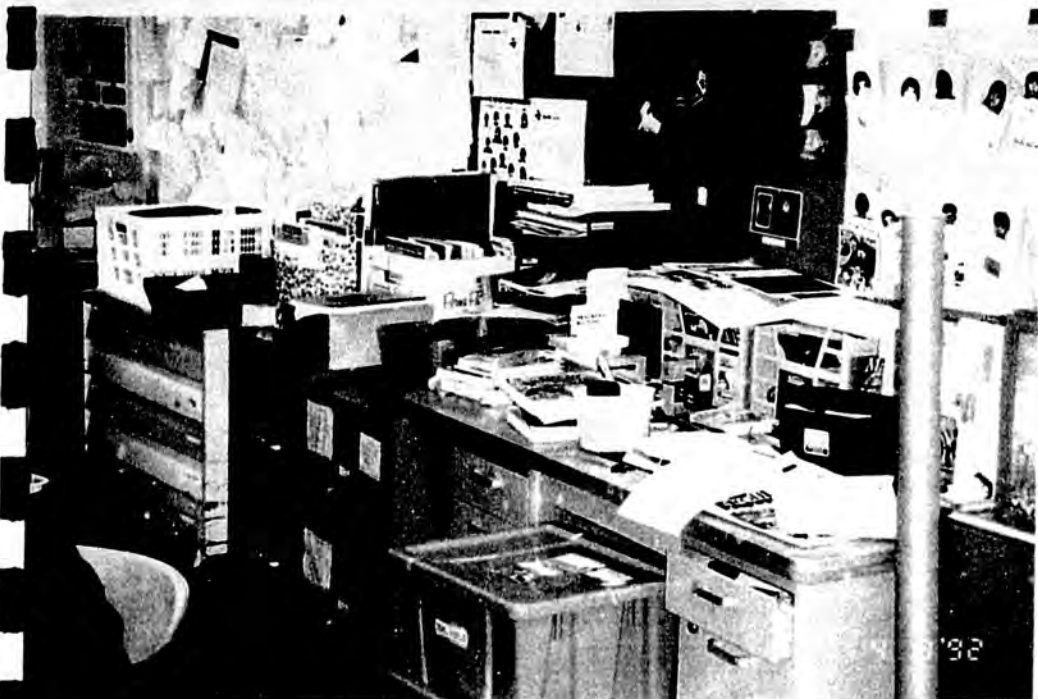
**PHOTO 8**

This shows an administrative area being overcome by storage. The area is completely dysfunctional; there is no room for a teacher's desk.

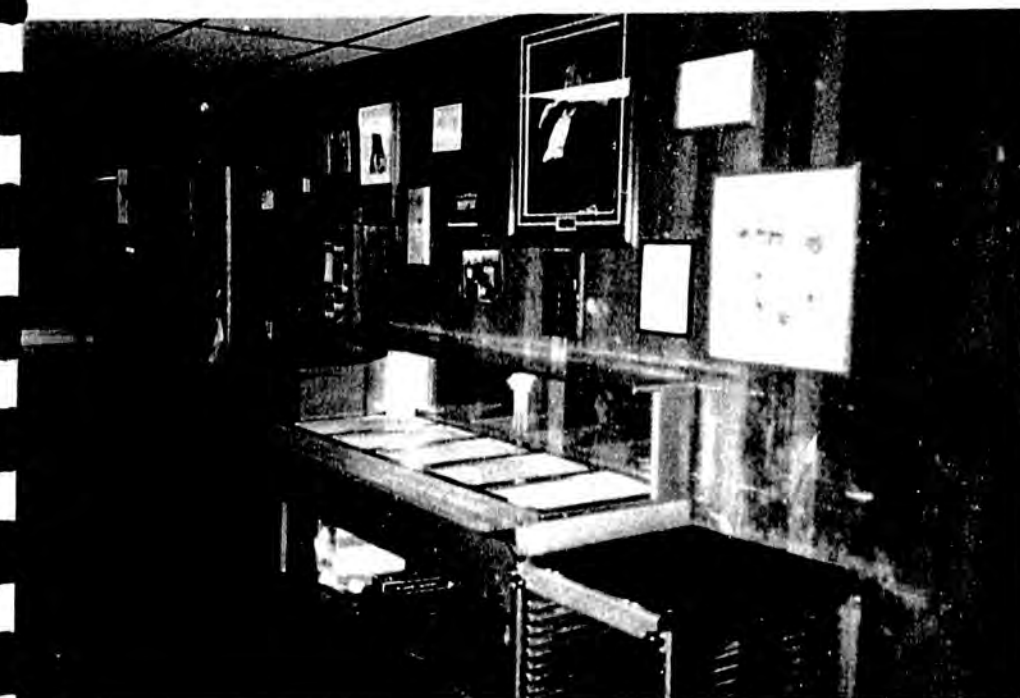
**PHOTO 9**

Food service steam table and serving line are in the corridor. TV and cabinet are stored in the same area. This situation creates an impact and egress hazard. It also complicates logistics of serving lunch and breakfast.

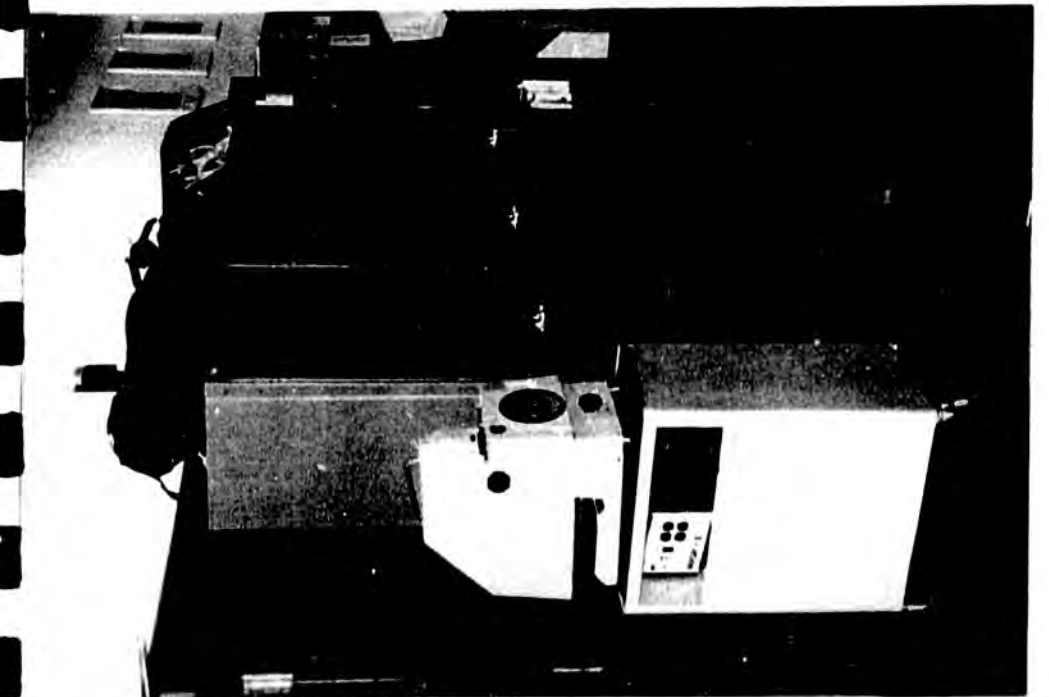
**PHOTO 21**

Video equipment that should be properly housed in a media center storage area is being stored in the classroom. As the student population increases, crowded conditions cause items to be moved from the classroom to the hallway.

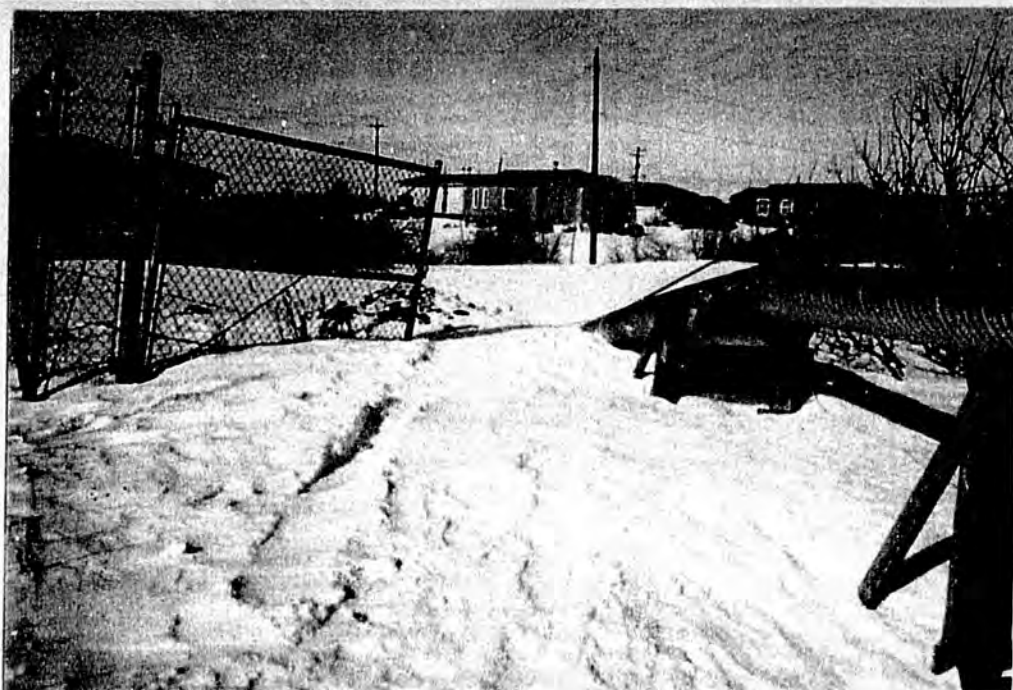
**PHOTO 1**

Sewage lagoon and sewage out-flow from school complex. Note failed system. Fencing and flow-line are also in poor condition.

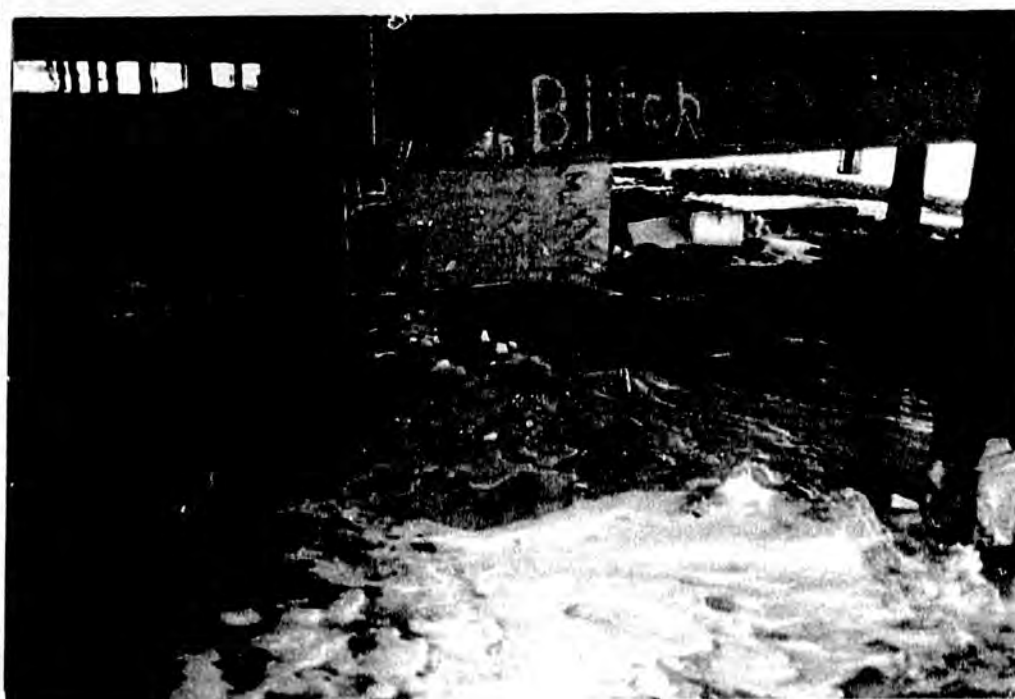
**PHOTO 3**

Effluent from broken sewer line under the building.

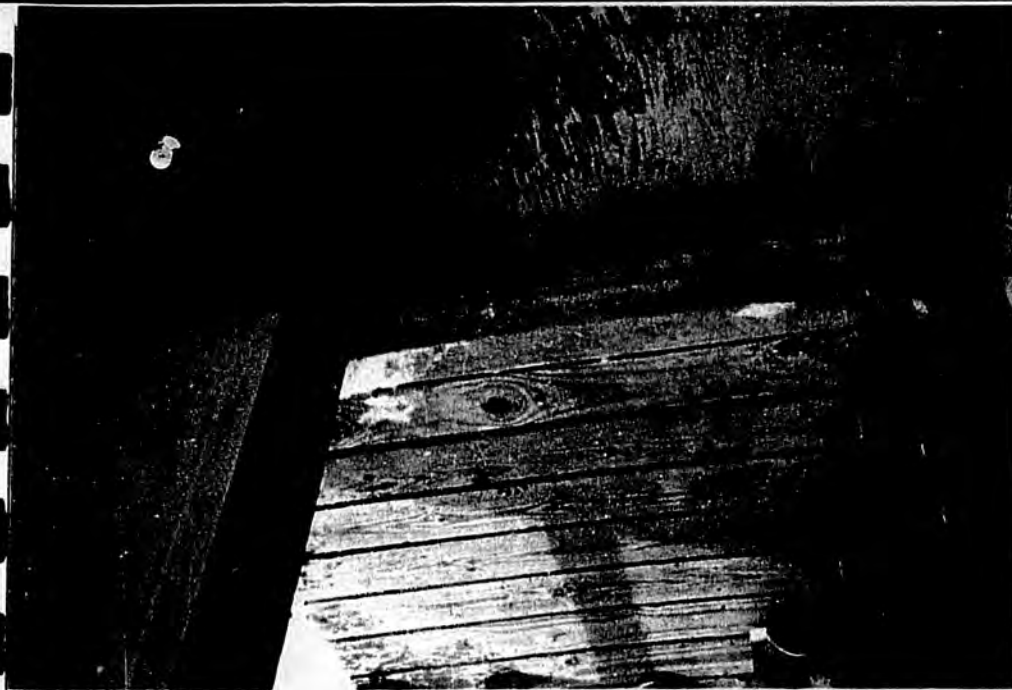
**PHOTO 22**

This change in elevation does not meet UBC exit requirements. Notice a fuel container is being stored in the exit vestibule. Also notice the overall dilapidated condition of the building.

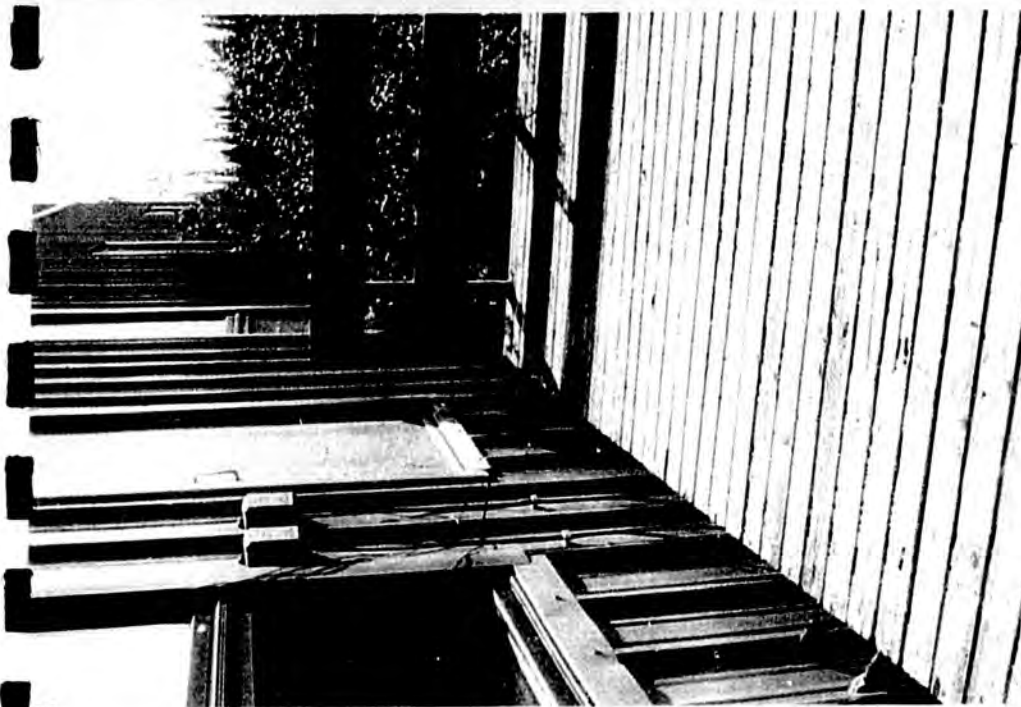
| <u>CODE VIOLATION</u> | <u>DESCRIPTION OF PROBLEM(S)</u> | <u>CODE No.</u> | <u>PHOTO No.</u> |
|---|---|---|---|
| | J-Box cover missing in ceiling cavity | 1 | |

| <u>CODE VIOLATION</u> | <u>DESCRIPTION OF PROBLEM(S)</u> | <u>CODE No.</u> | <u>PHOTO No.</u> |
|---|---|---|---|
| | <b>GYMNASIUM:</b> | 1 | |

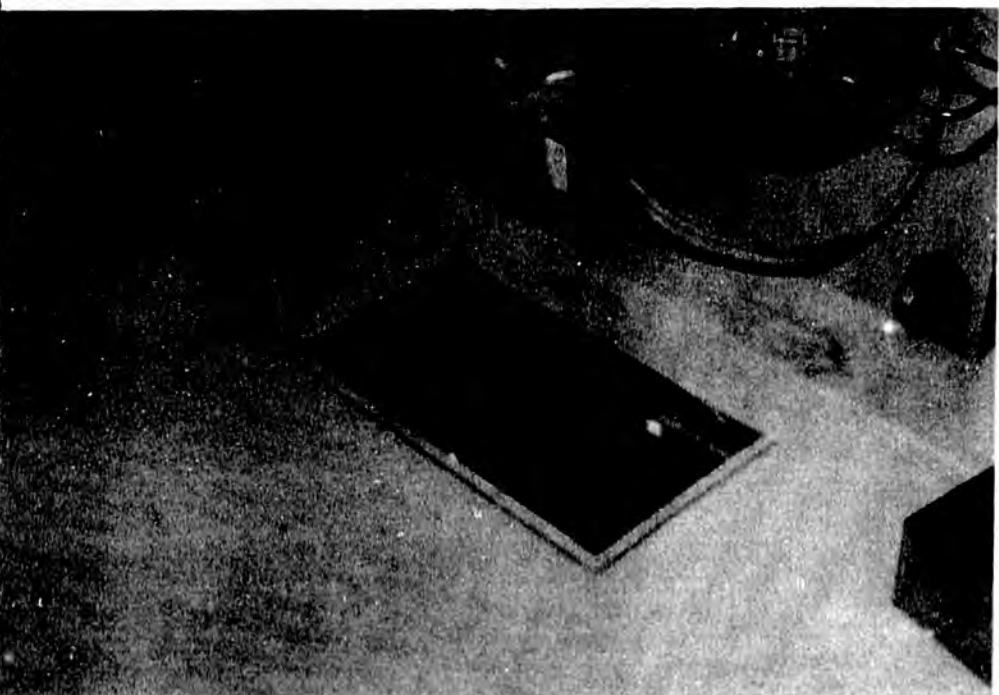
| <u>CODE VIOLATION</u> | <u>DESCRIPTION OF PROBLEM(S)</u> | <u>CODE No.</u> | <u>PHOTO No.</u> |
|---|---|---|---|
| | Inadequate water pressure at drinking fountains | 1 | |

# BUCKLAND SCHOOL

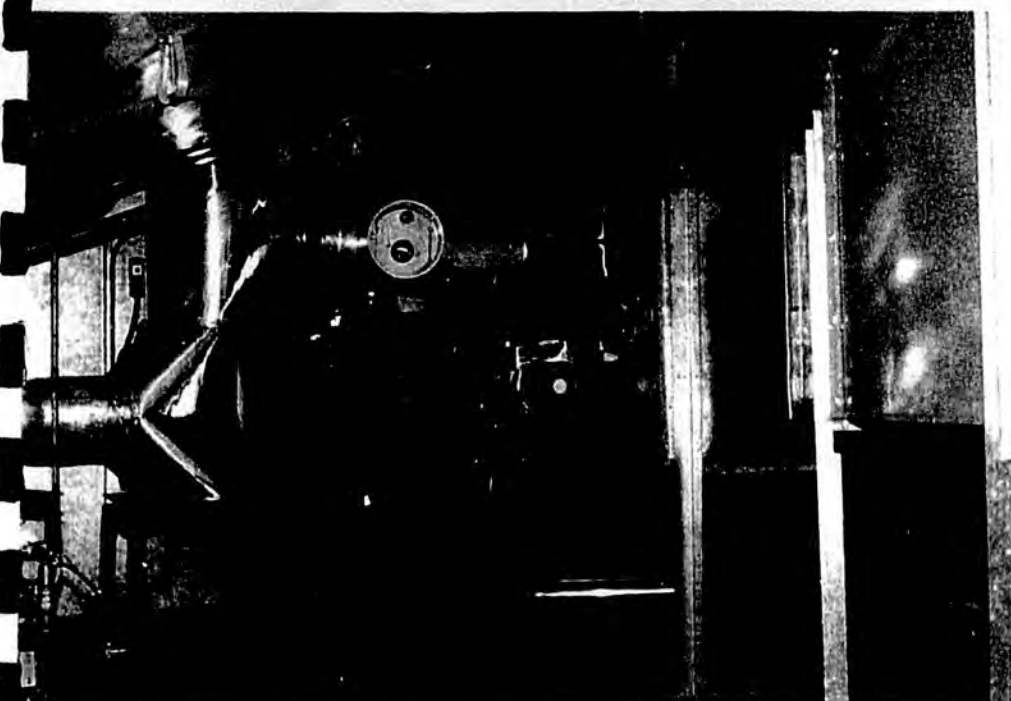
| <u>CODE VIOLATION</u> | <u>DESCRIPTION OF PROBLEM(S)</u> | <u>CODE No.</u> | <u>PHOTO No.</u> |
|---|---|---|---|
| | North exit - loose panic bar, needs weather strip & sweep | 3 | |

| <u>CODE VIOLATION</u> | <u>DESCRIPTION OF PROBLEM(S)</u> | <u>CODE No.</u> | <u>PHOTO No.</u> |
|---|---|---|---|
| | <b>THIRD/FOURTH GRADE CLASSROOM:</b> | 3 | |

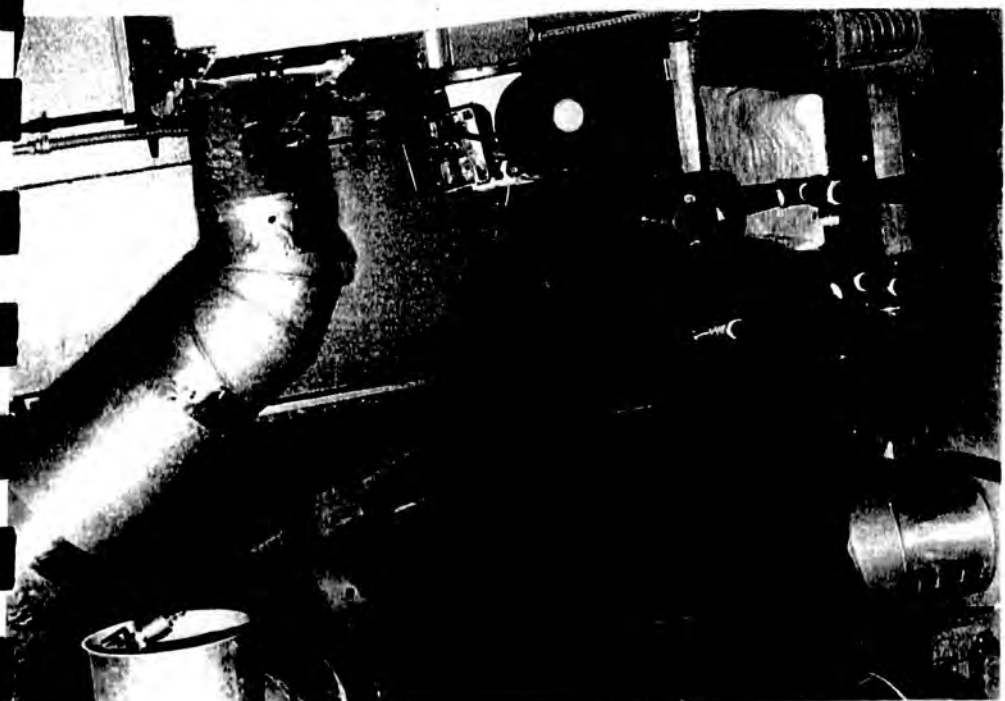
**PHOTO 3**

Plywood flooring and inadequate service access make for a dangerous installation.

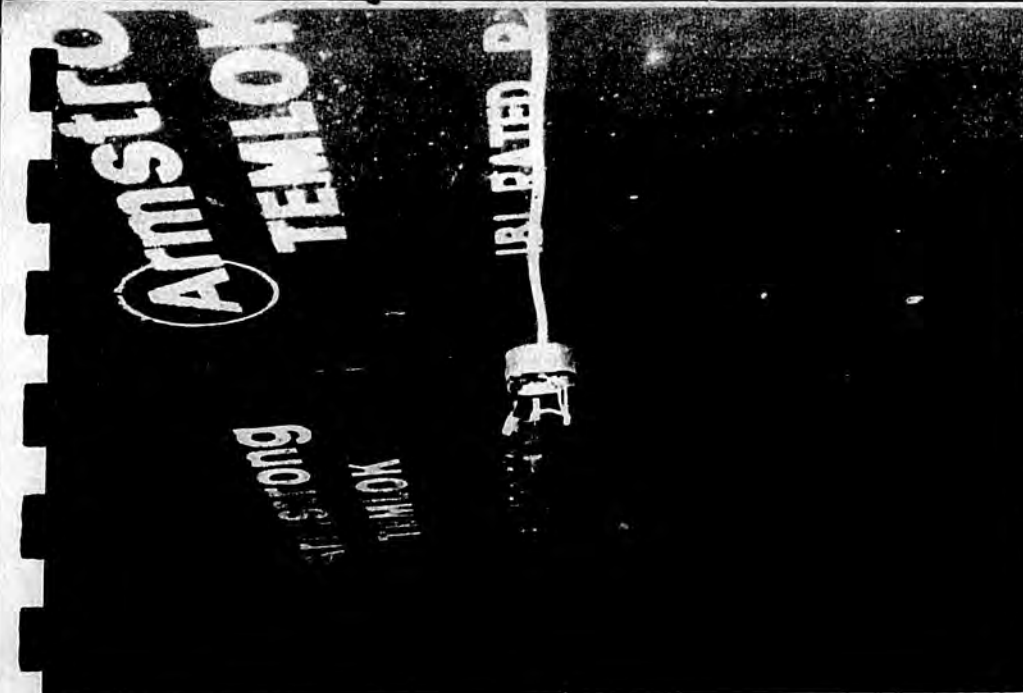
**PHOTO 4**

Improper and exposed wiring, broken lighting with no face cover for protection in the crawl space.

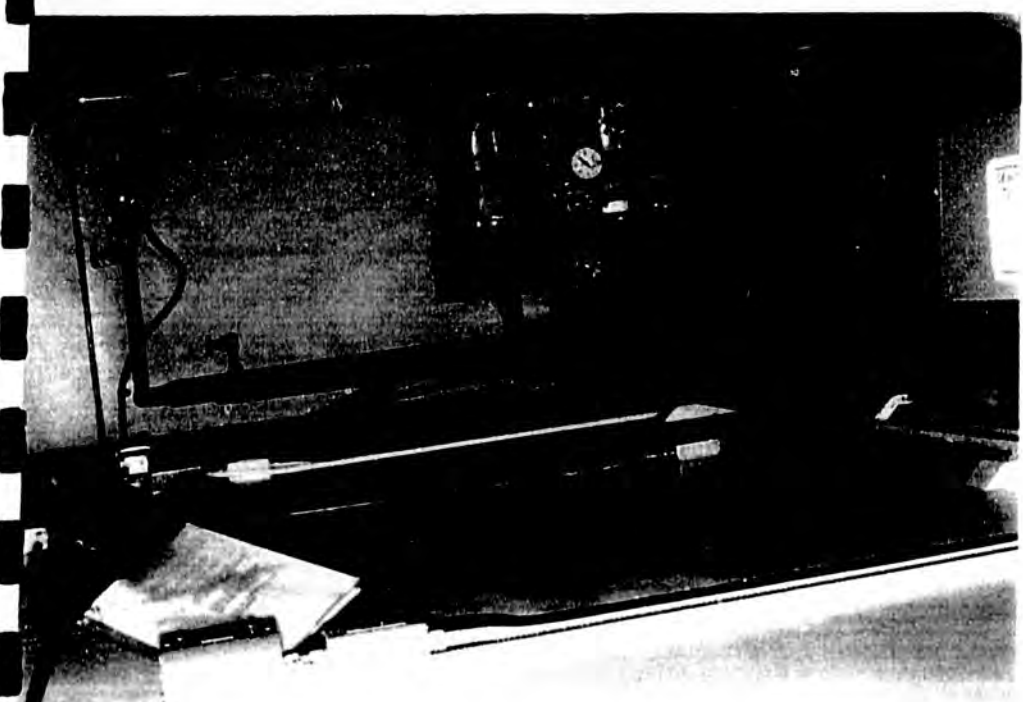
**PHOTO 6**

Wood plank flooring and limited access space for utilities.

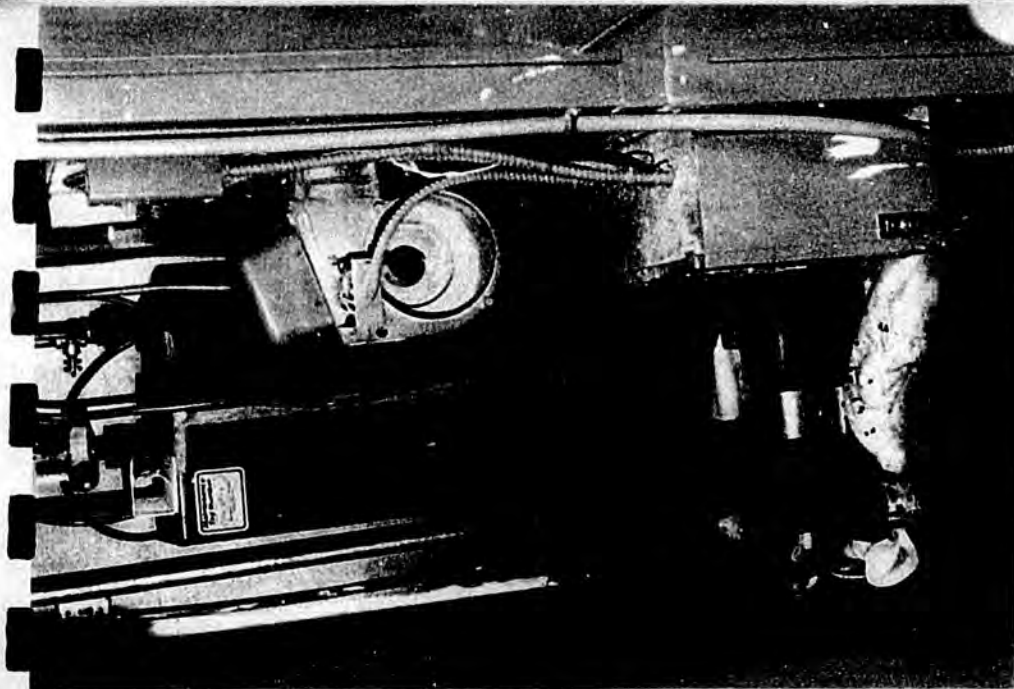
**PHOTO 7**

Plywood flooring, oil soaked rags and trash. Inadequate service access.

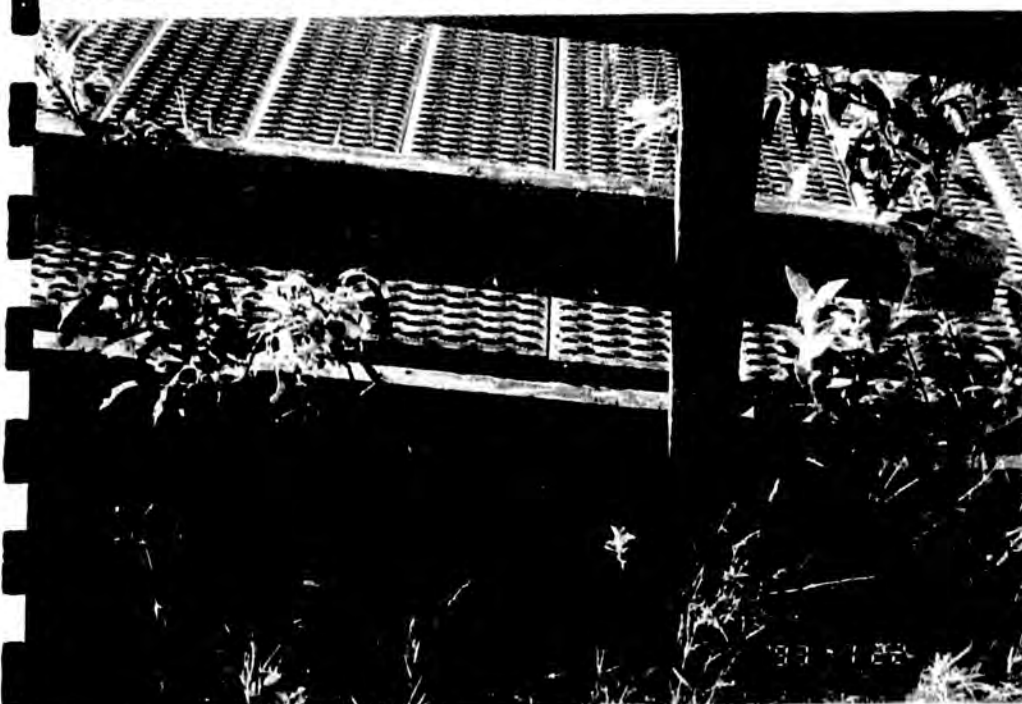
**PHOTO 9**

The ramp of the maintenance shop/storage building appears to be poorly designed. Some untreated timber members are in contact with the ground which will cause them to decay. In addition, framing appears inadequate.

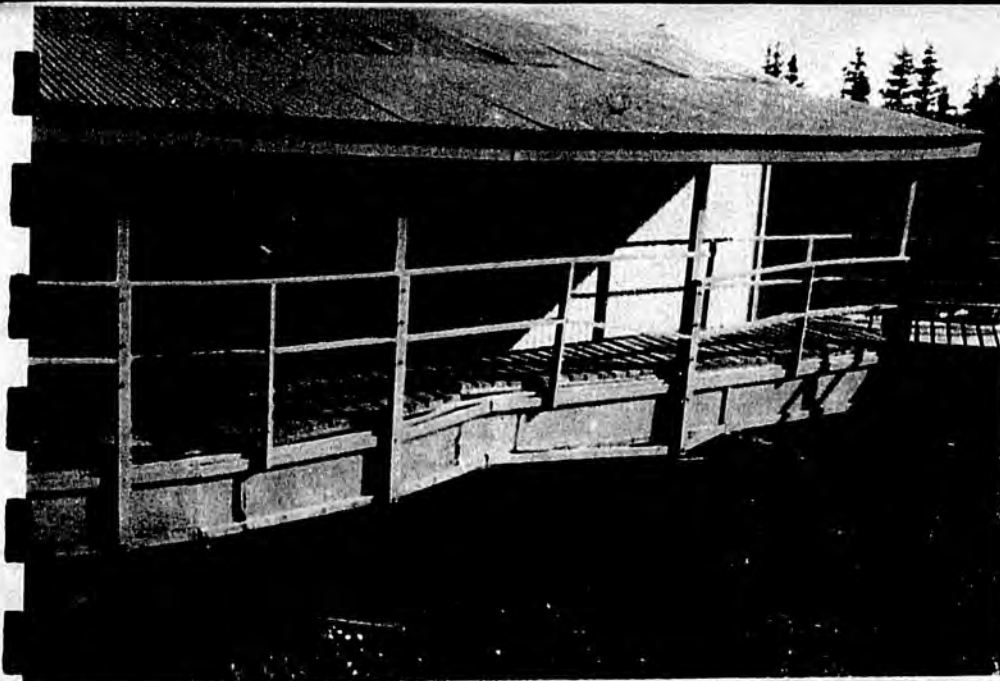
**PHOTO 10**

Apparent pile/frost jacking as shown by structural distress in the walkway in front of the mechanical building.
