**ALASKA LEGISLATURE SPECIAL COMMITTEE/SUBJECT FILES 8672**

**2534 SCOMM 111: DEFERRED MAINTENANCE TASK FORCE, 1997**

**NOORVIK SCHOOL  
INVENTORY & CONDITION  
SURVEY**

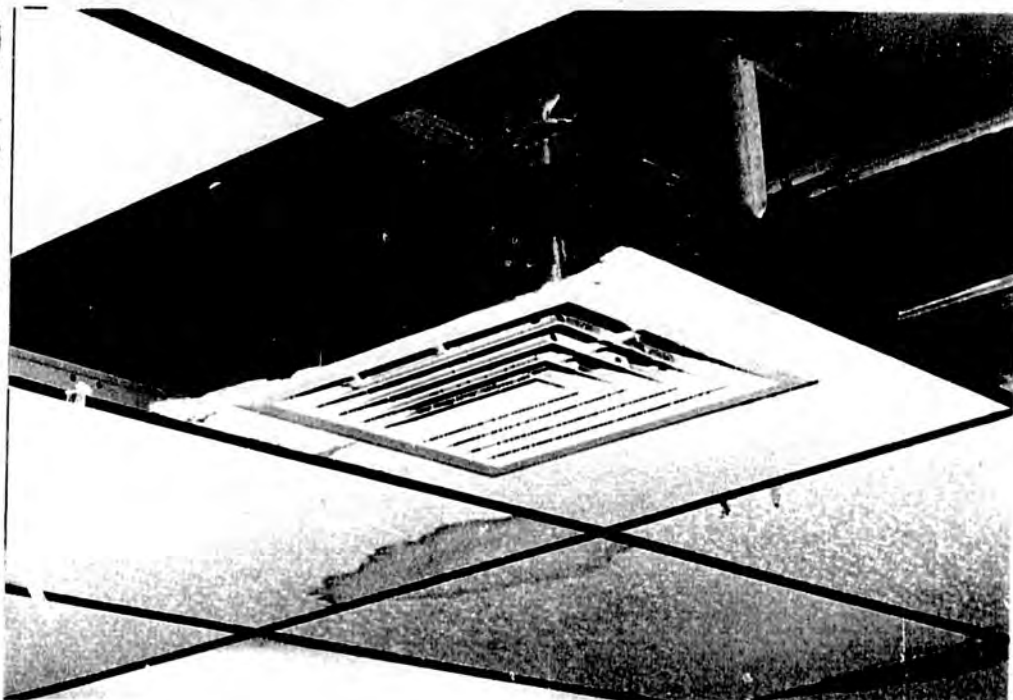
**PHOTO 11**

Roof leak causing deterioration in the ceiling structure.

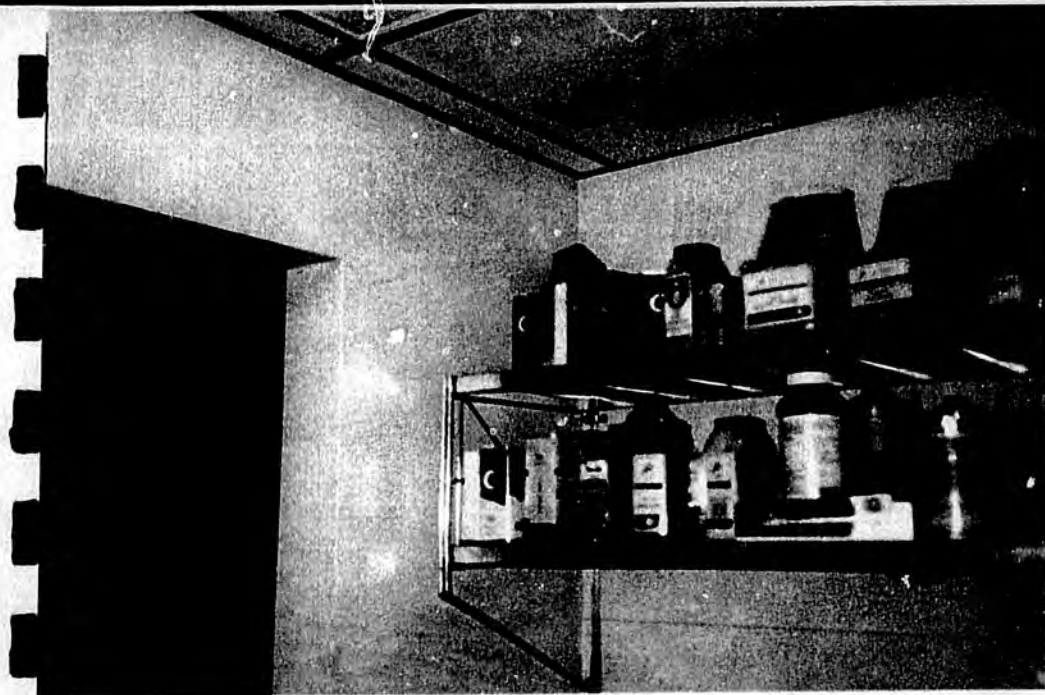
**PHOTO 13**

Structural damage to the gypsum wall board leading away from the corner of the cased opening.

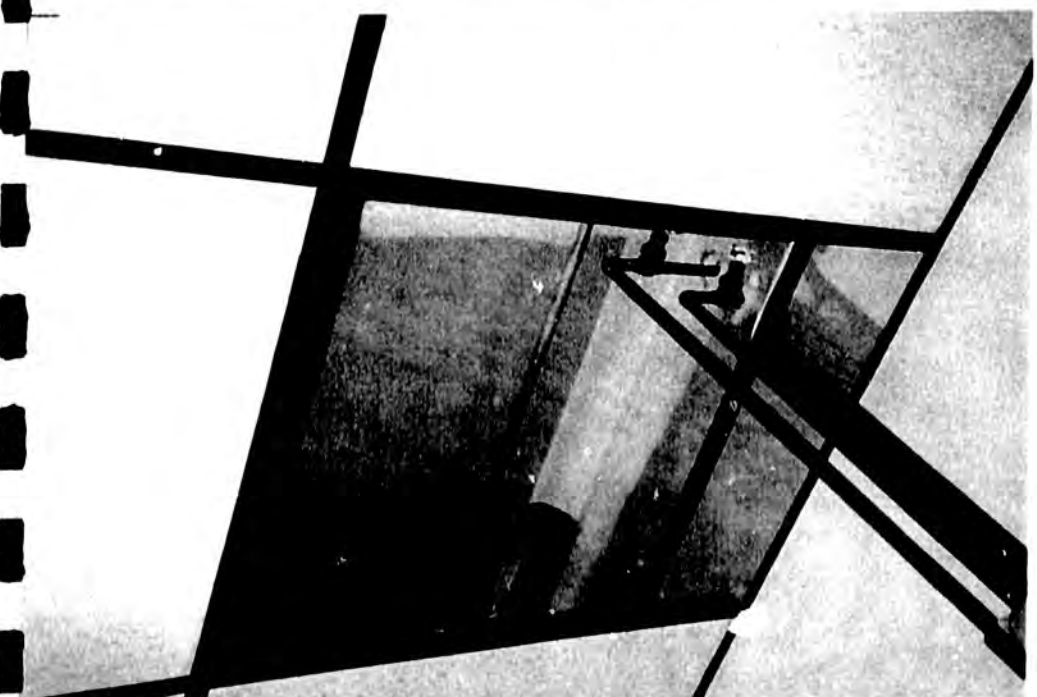
**PHOTO 15**

Combustibles stored on upper side of suspended ceiling.

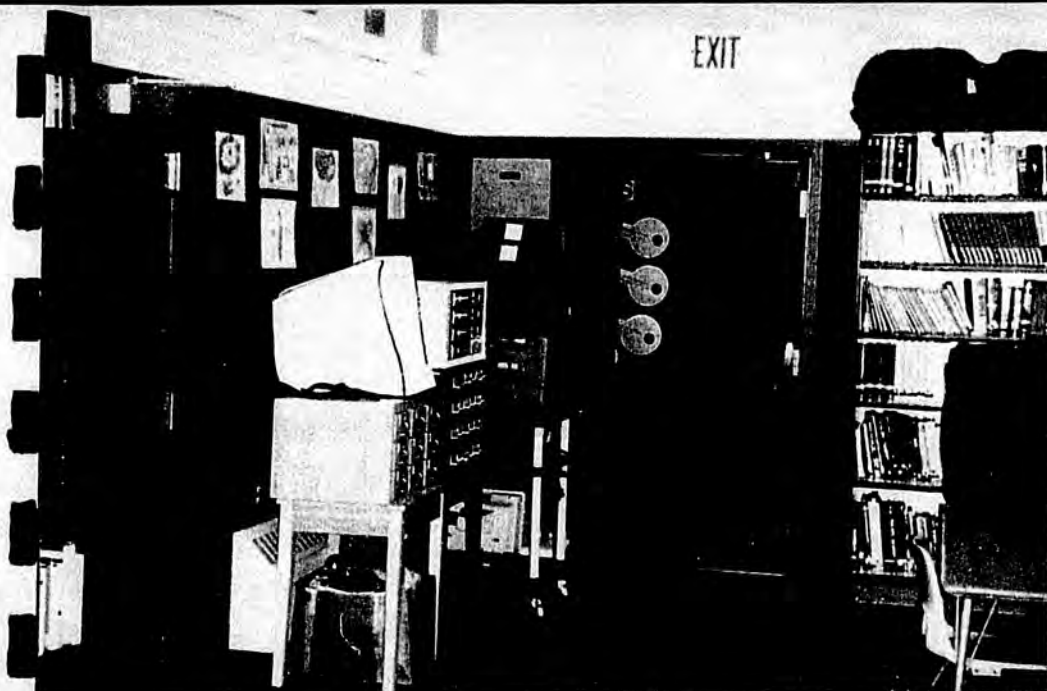
**PHOTO 16**

Carts and video equipment stored in the corridor. This blocks the electrical panel, wall switch, and encroaches on egress.

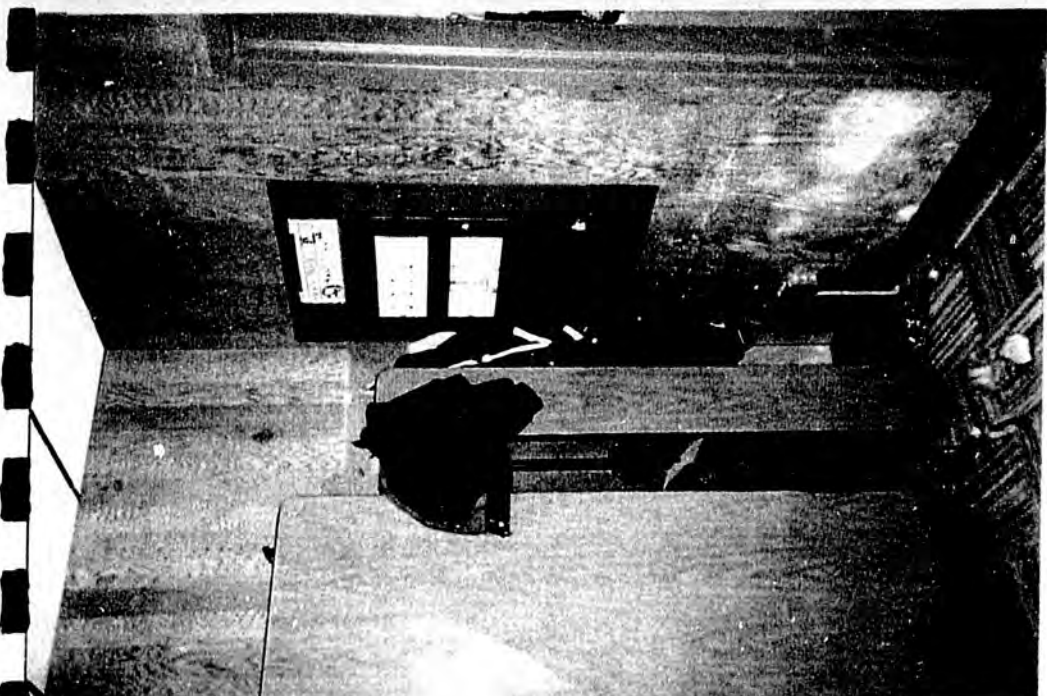
**PHOTO 17**

Food service table is stored in the hallway. It interferes with egress and in this case blocks access to an alarm panel. The multipurpose area should have a storage area specifically for these items.

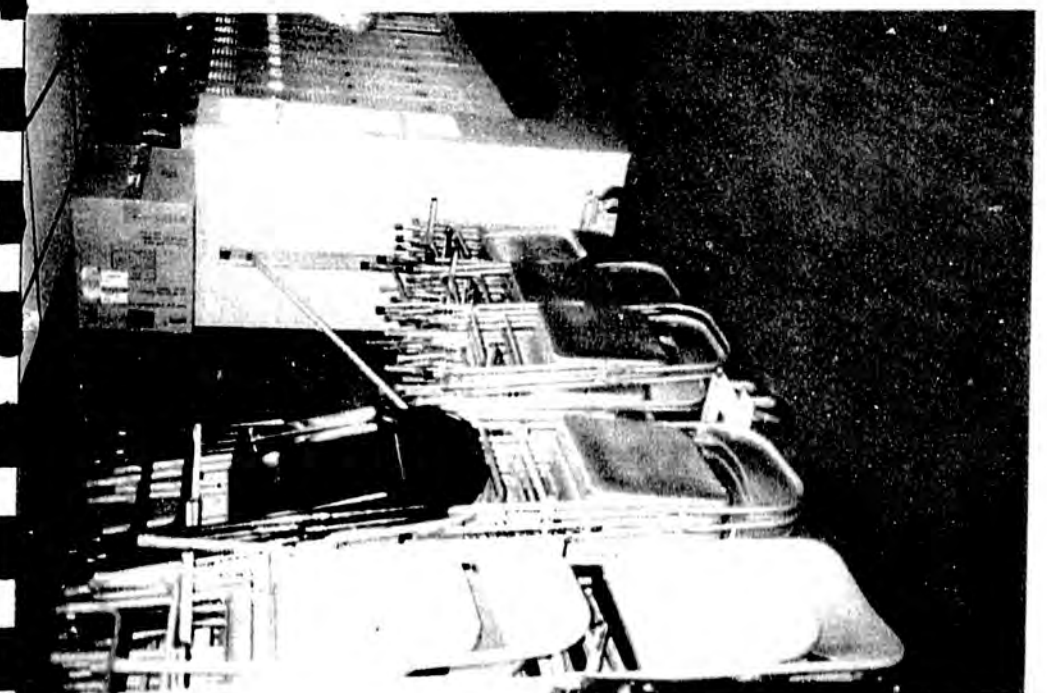
**PHOTO 18**

Chair storage for multipurpose room is in corridor. This creates a similar problem outlined in previous photo.

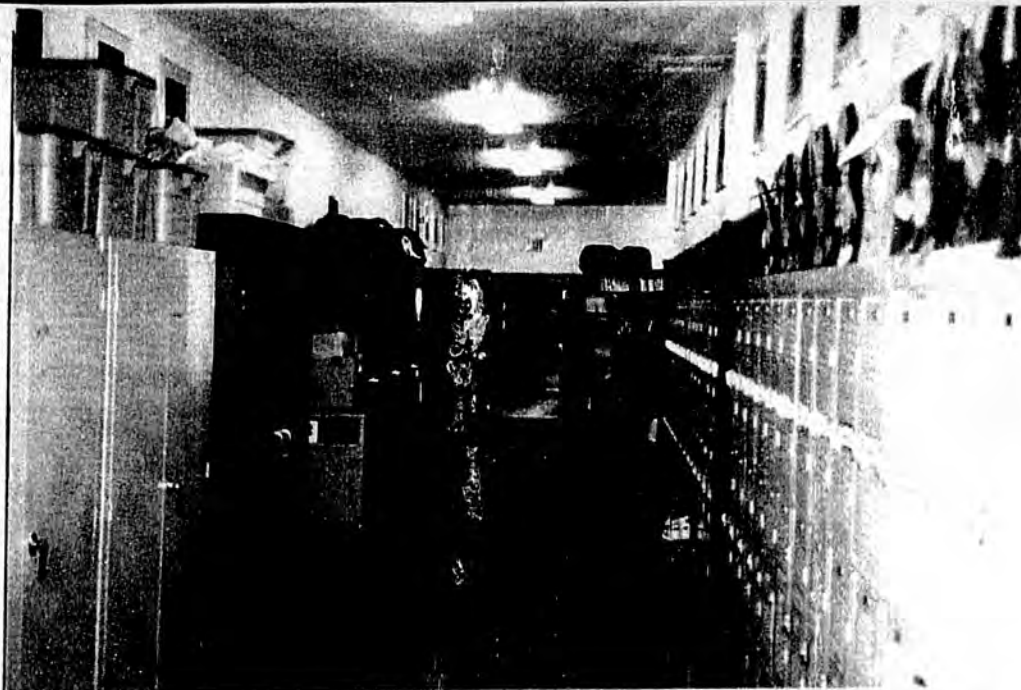
**PHOTO 19**

The corridor shows orderly storage. However, this is not the proper place for these materials. Egress codes are violated and housing combustibles in an exit.

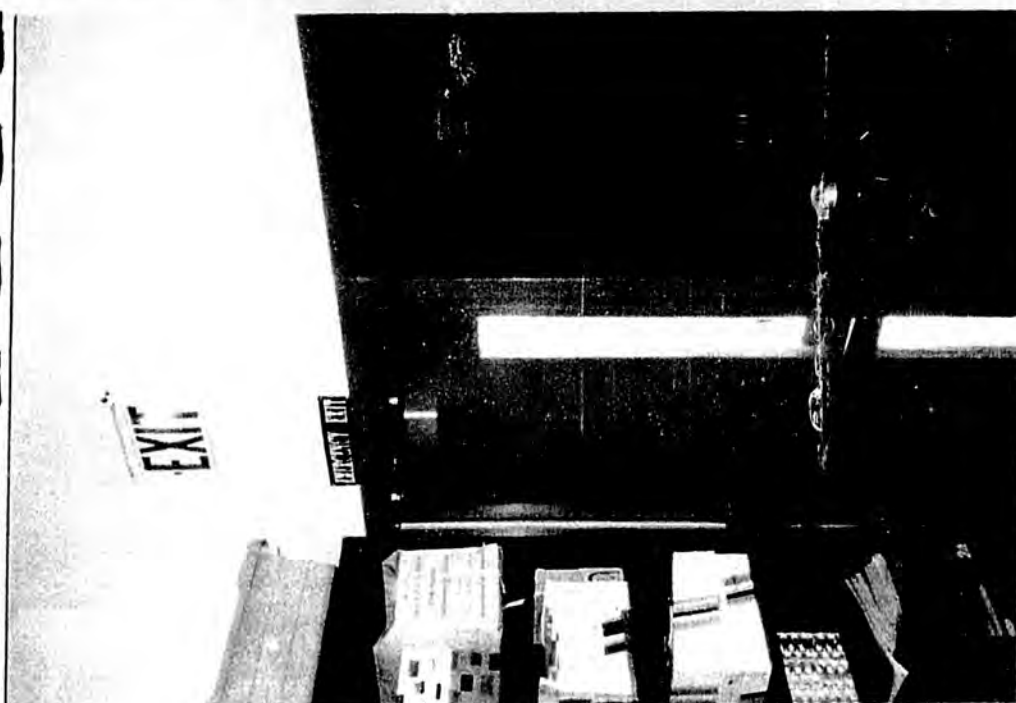
**PHOTO 20**

Emergency exit partially blocked by storage shelf unit.

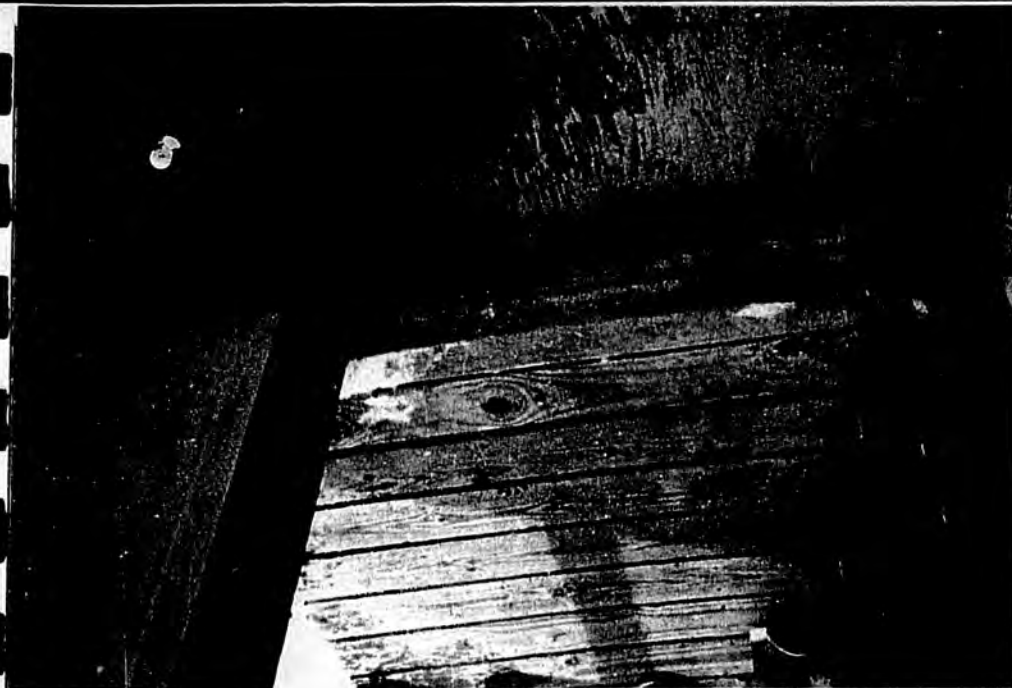
**PHOTO 22**

This change in elevation does not meet UBC exit requirements. Notice a fuel container is being stored in the exit vestibule. Also notice the overall dilapidated condition of the building.

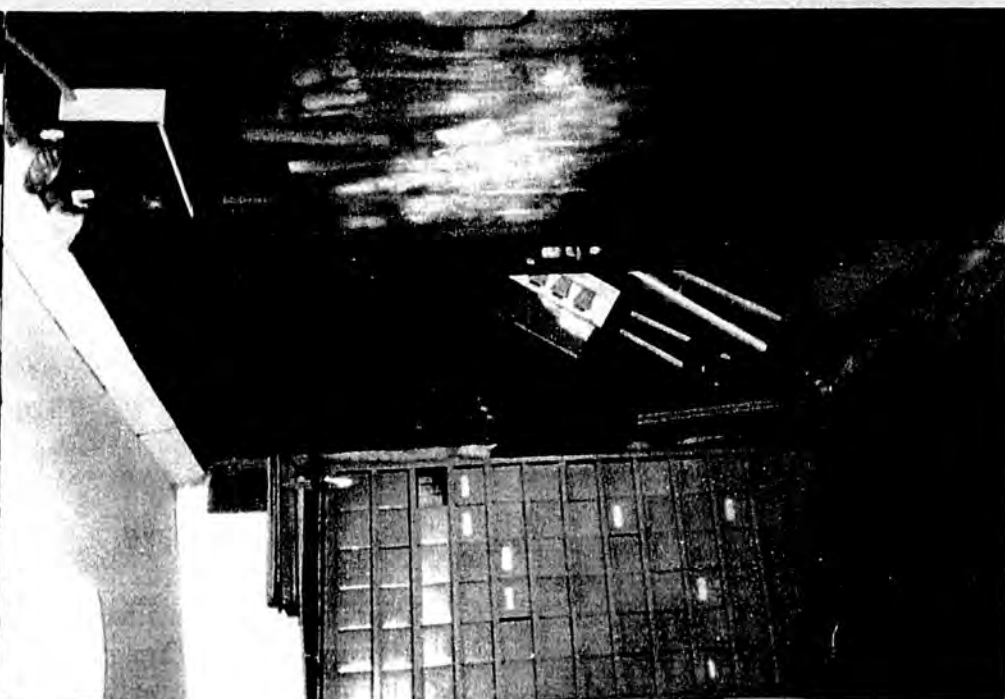
**PHOTO 23**

This is the exit passageway out of the shop building. There is approximately a 4-inch change in elevation in the exit passageway. This passageway does not meet code requirements.

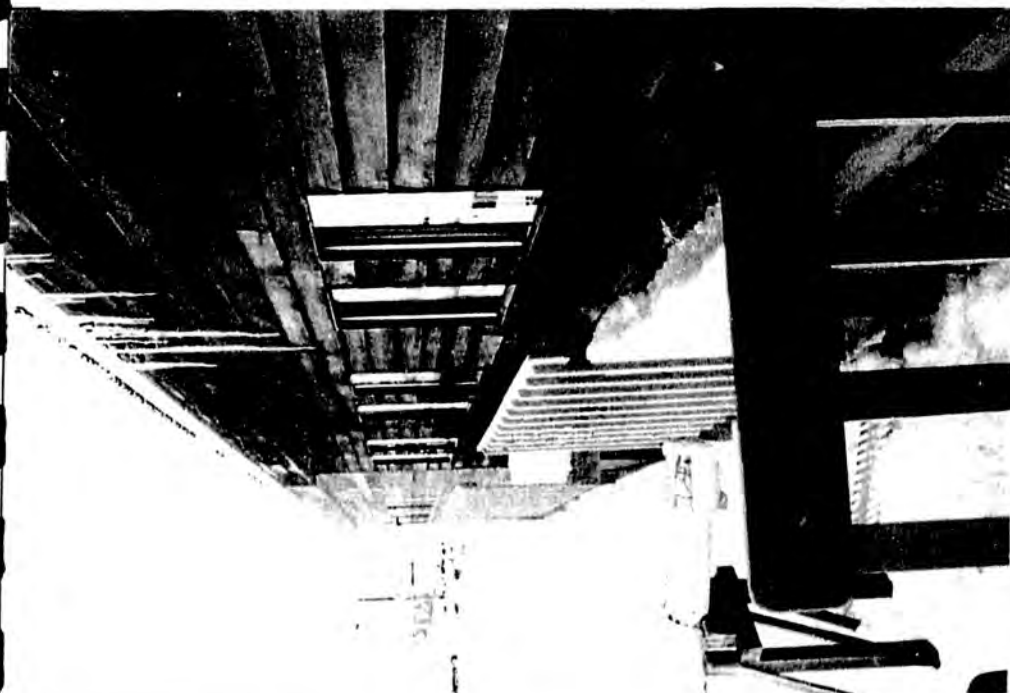
**PHOTO 24**

Egress is blocked by snow and rain runoff under the eave. There is no safe access to ground level from this platform; there are no handrails.
