2543 SCOMM 111: DEFERRED MAINTENANCE TASK FORCE, 1997

# **Deferred Maintenance**

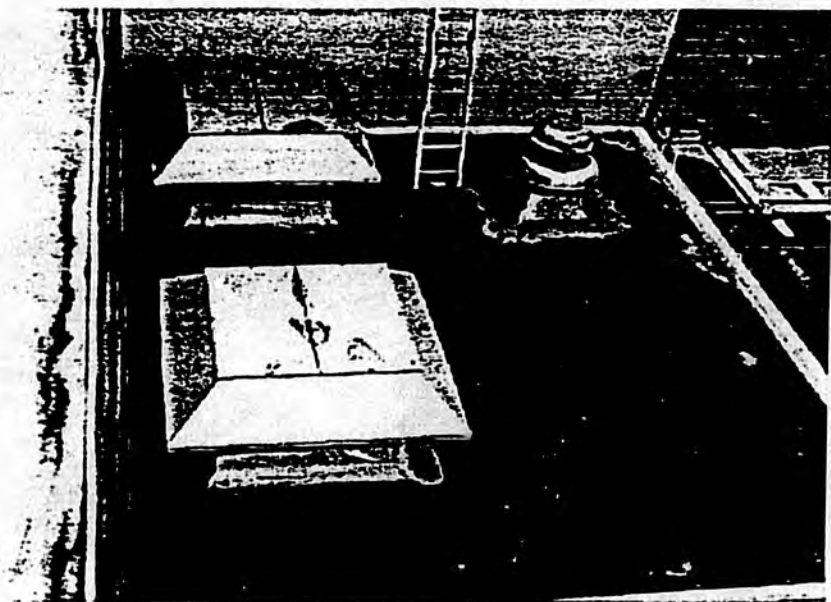
**Figure 1**  
Overview: Two Roof mounted air-intake hoods

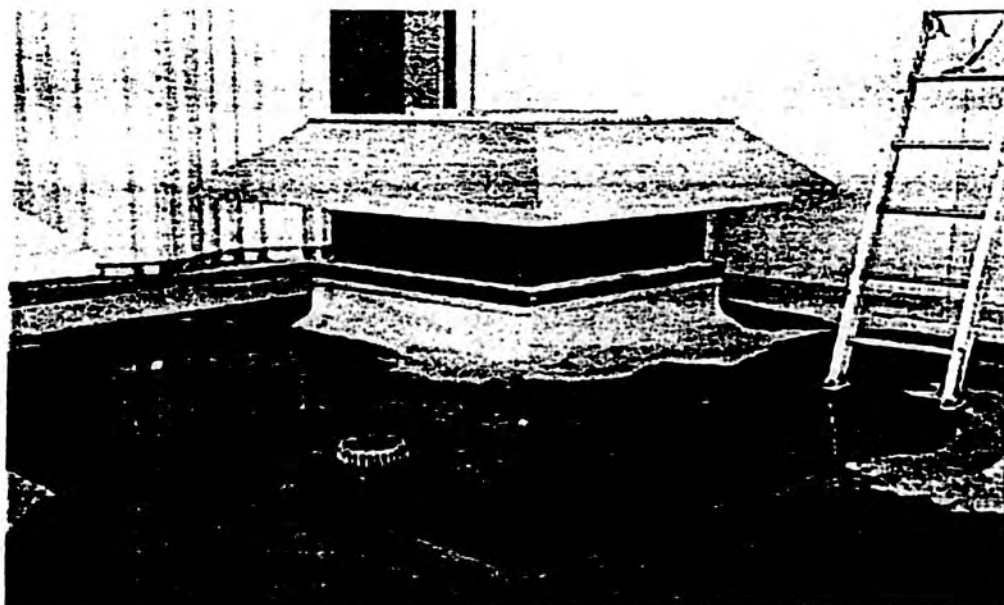
**Figure 2**  
Air-intake hood: Snow blows up under cap

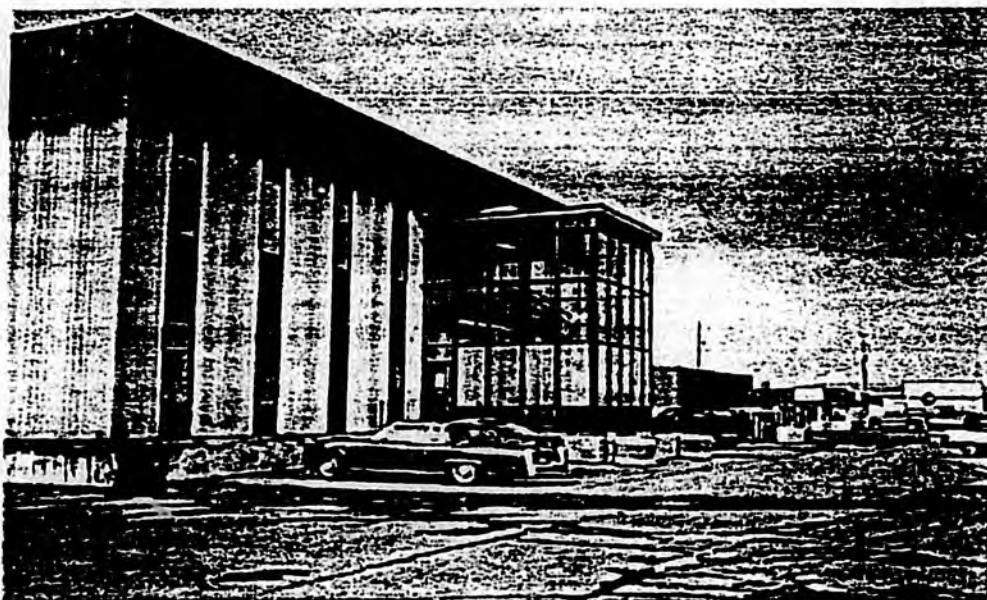
**Figure 3**  
Main entry vestibule

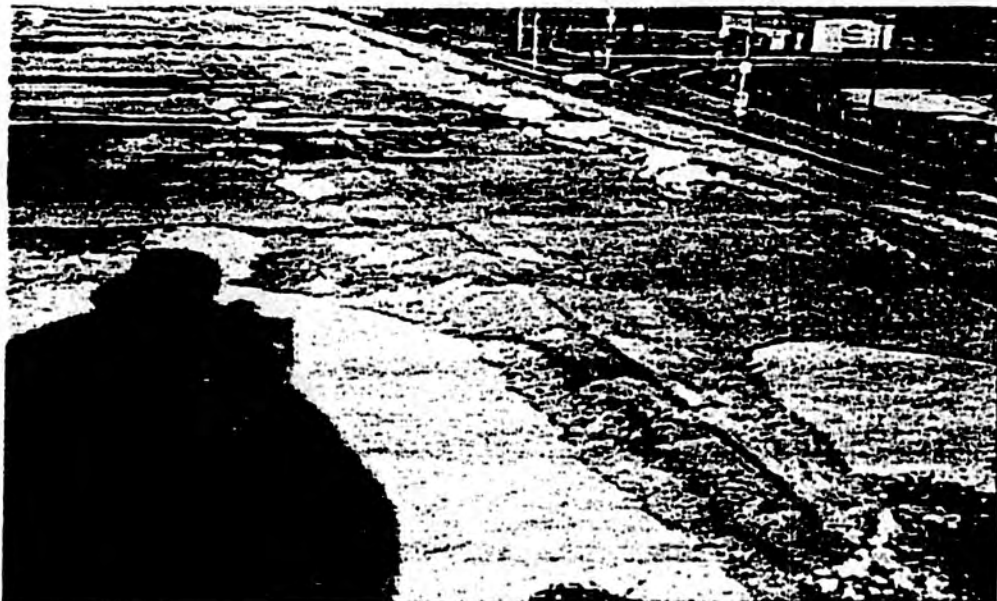
**Figure 6**  
Main building roof: Line of fasteners backing out

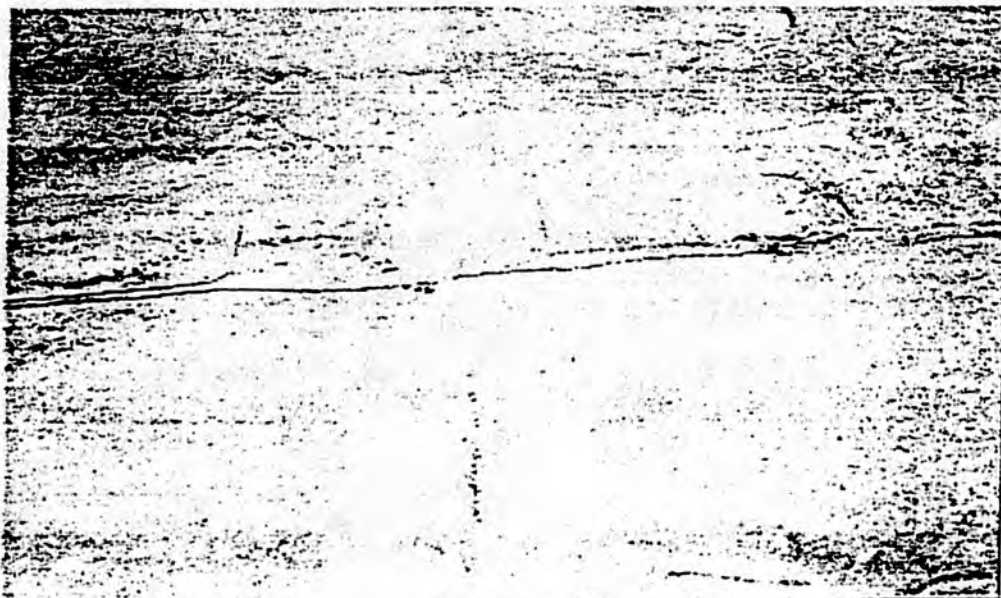
**Figure 7**

Main building roof: Previous patch over fastener which is, again, backing out

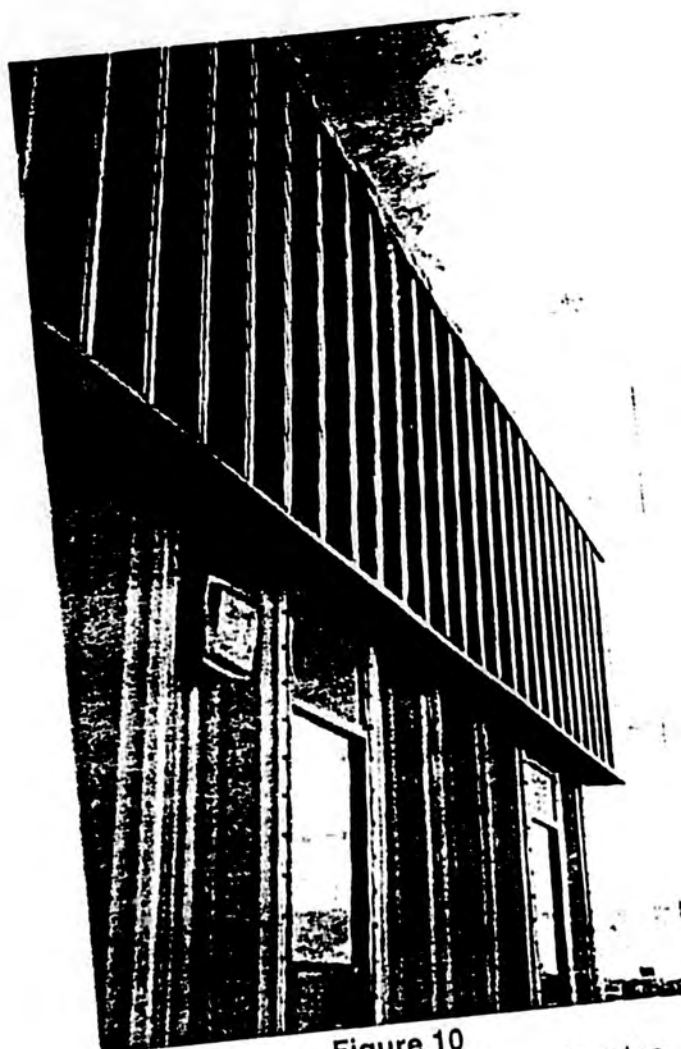
**Figure 10**  
Note water running through gap in edge  
metal down fascia
