2544 SCOMM 111: DEFERRED MAINTENANCE TASK FORCE, 1997 286

## E. ARCHITECTURAL

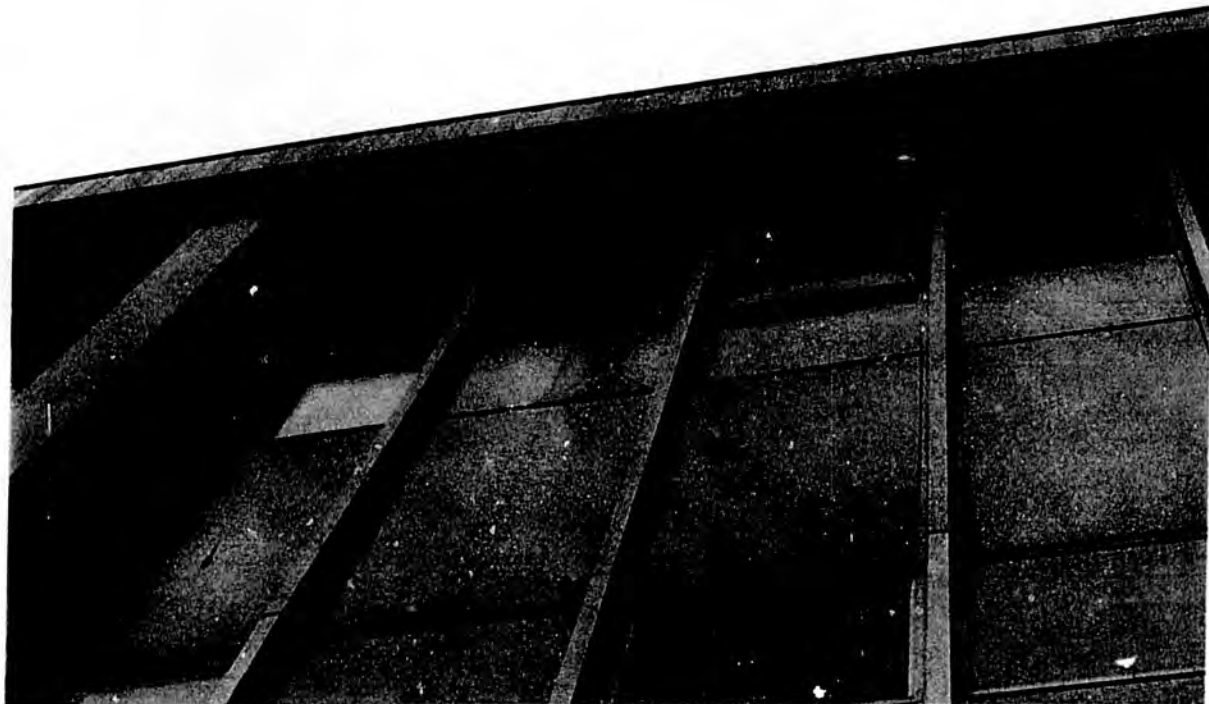
Photo #6

Delaminating Exterior Panels

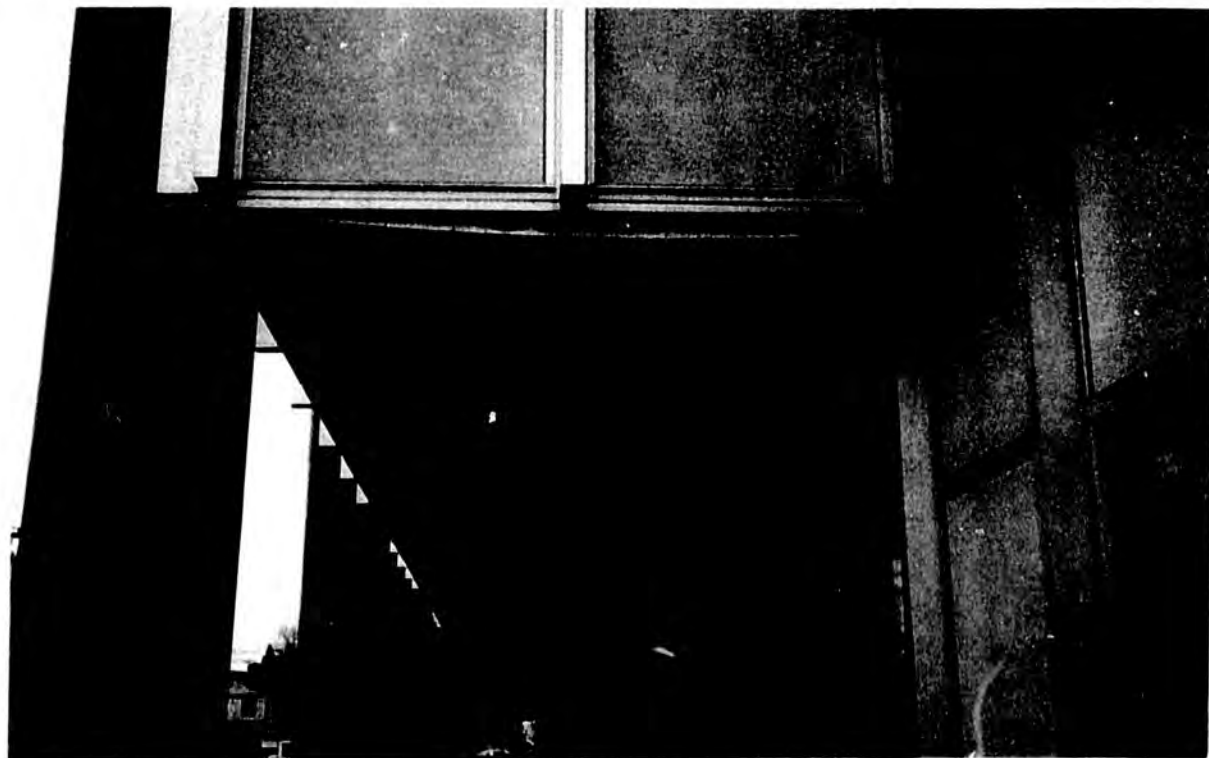
Photo #7

Failing South Soffit

A new soffit or EIFS system on the underside of the walkway ceiling will add insulation and provide a durable, low maintenance finish. If an EIFS finish is selected, spray foam insulation (4 inches thick minimum) could be applied directly to the underside of the steel decking to form an efficient insulative thermal break to reduce cold transmission to the office floor above.

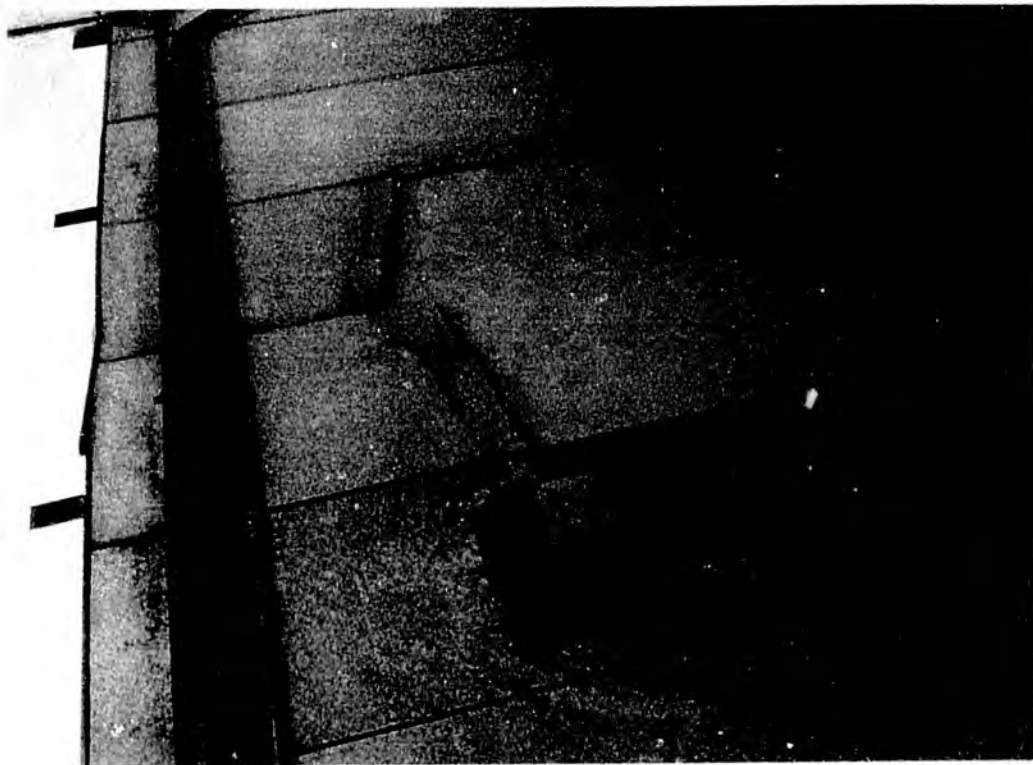
Photo #9

Detail of Soffit

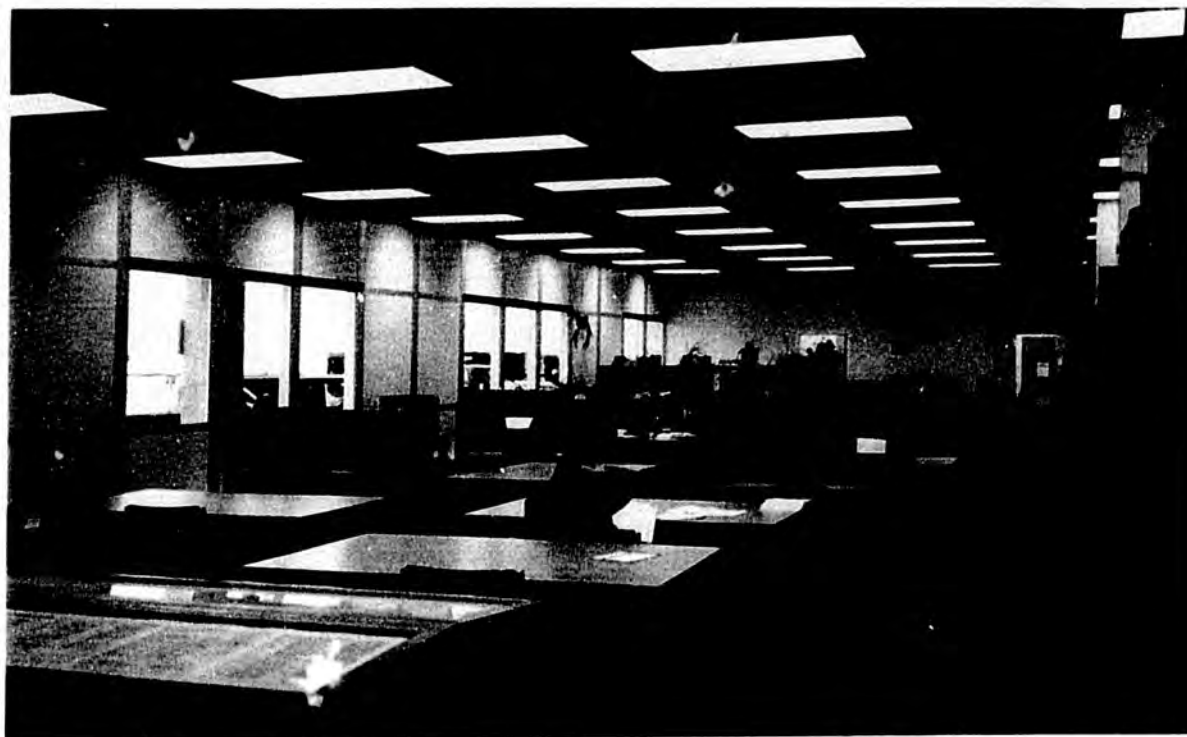
Photo #13

Law Library (A3)

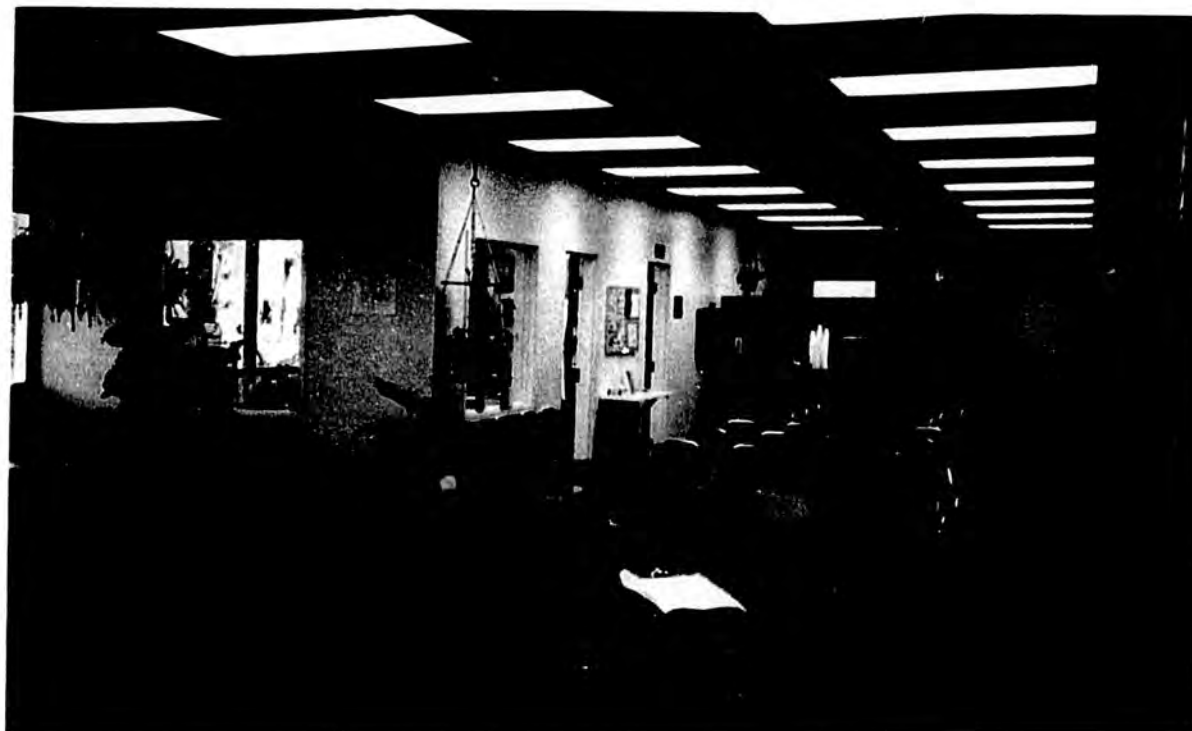
Photo #14

Jury Assembly (A3)

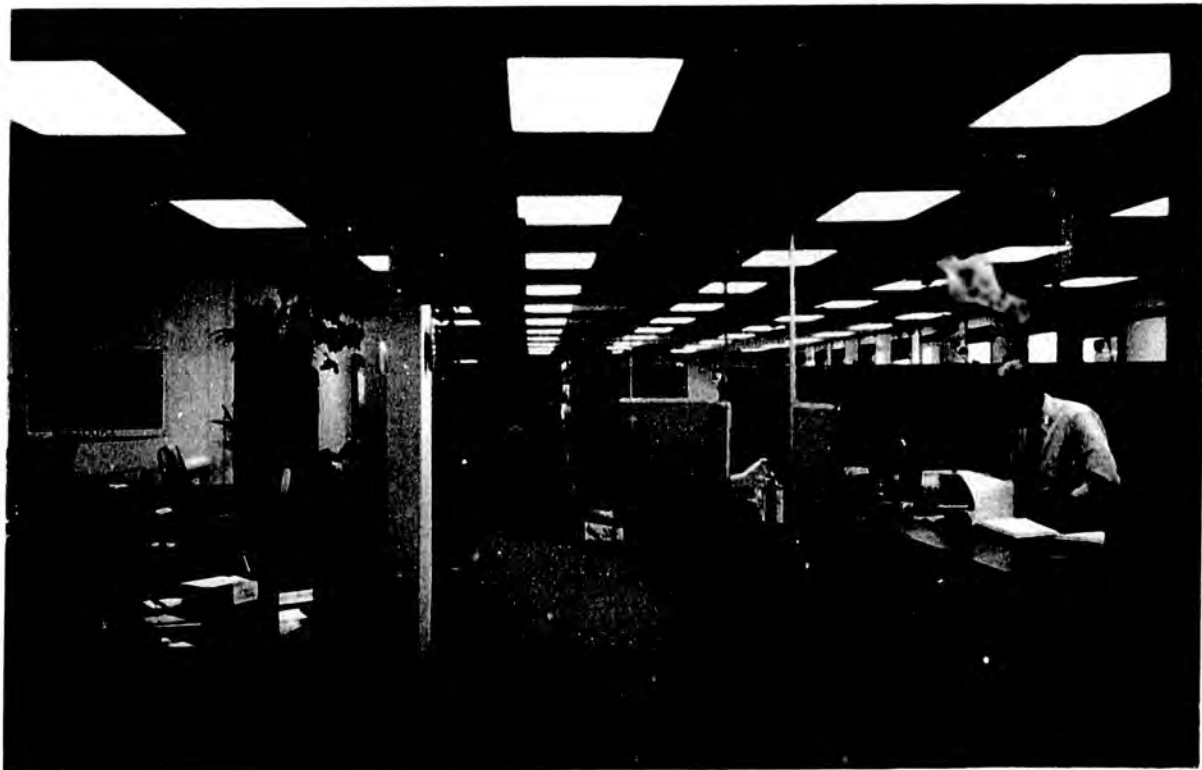
Photo #16

Clerk of the Courts (A3)

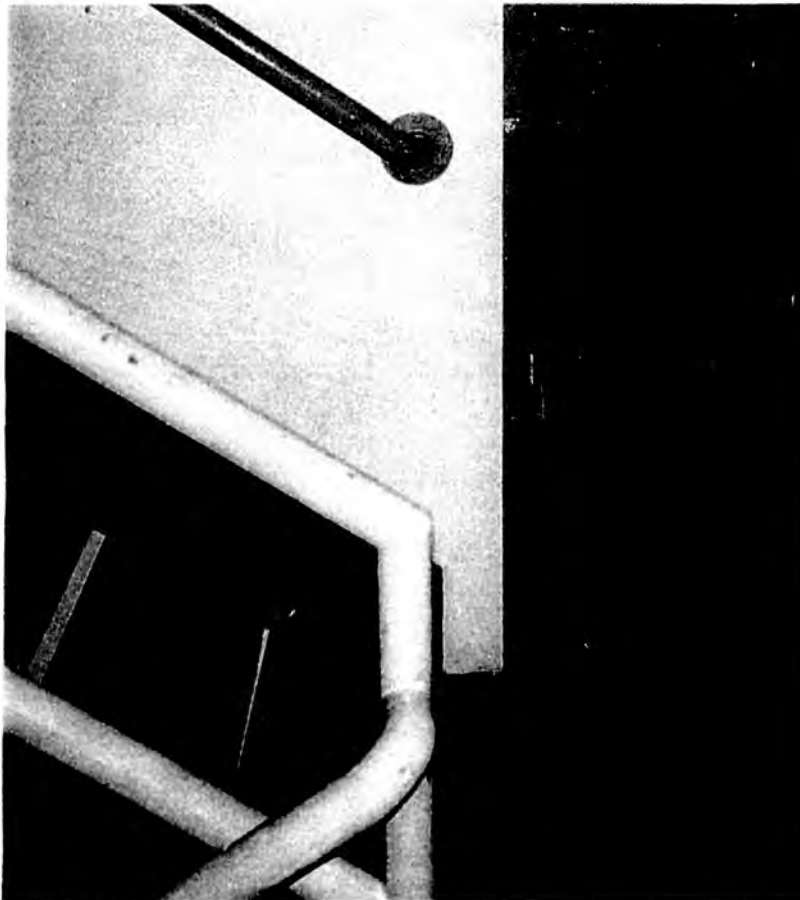
Photo #33  
Non-compliant  
Handrails  
at Exit Stairs

Handrails: Although the basic structure of the metal exit stairs complies with Code requirements for dimensions and materials, *risers must be added where they do not exist, and the handrail system must be replaced with an ADA and UBC compliant system.*

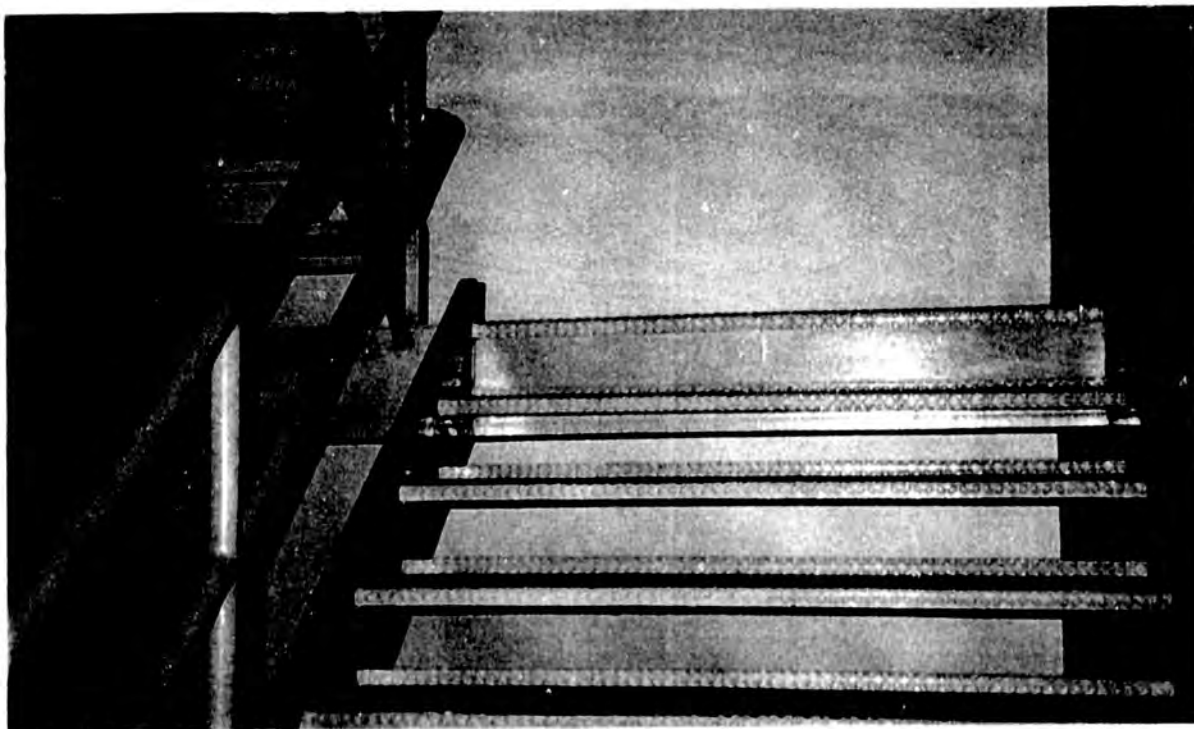
Photo #34

Open Risers at Exit Stairs

In lieu of completely demolishing the existing stair construction, new risers could be fastened to existing steel stair treads and stringers. The existing handrails will need to be removed and replaced with new metal pipe rails which meet code. Door openings onto the stairwell should be relocated to meet landing width and exit width requirements.

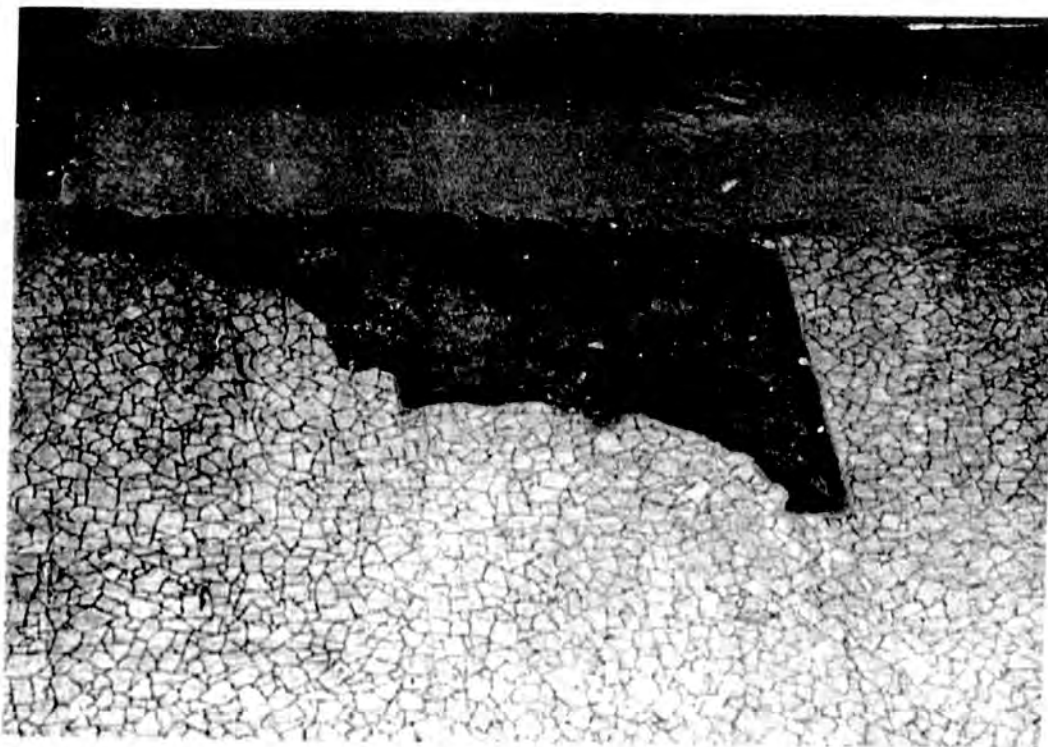
Photo #36

Damaged Floor Tile and Mastic

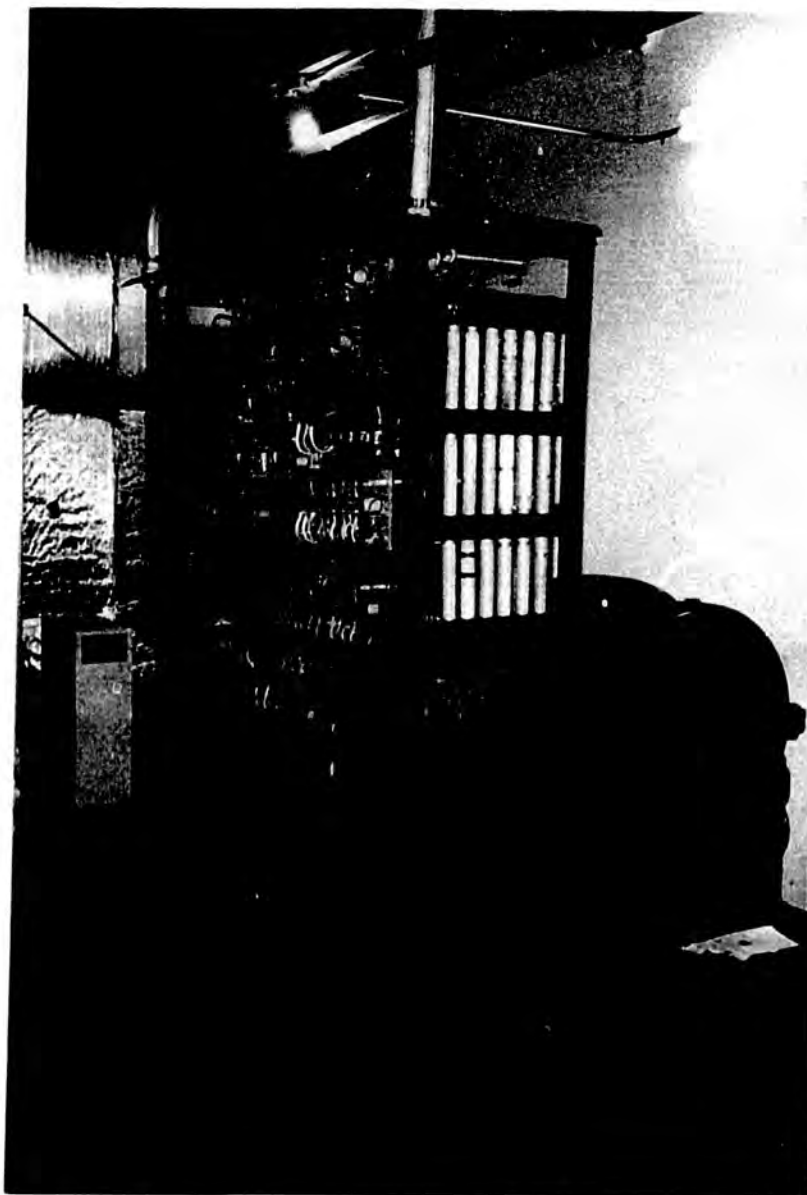
Photo #37

Original (Unenclosed)  
Elevator Machinery

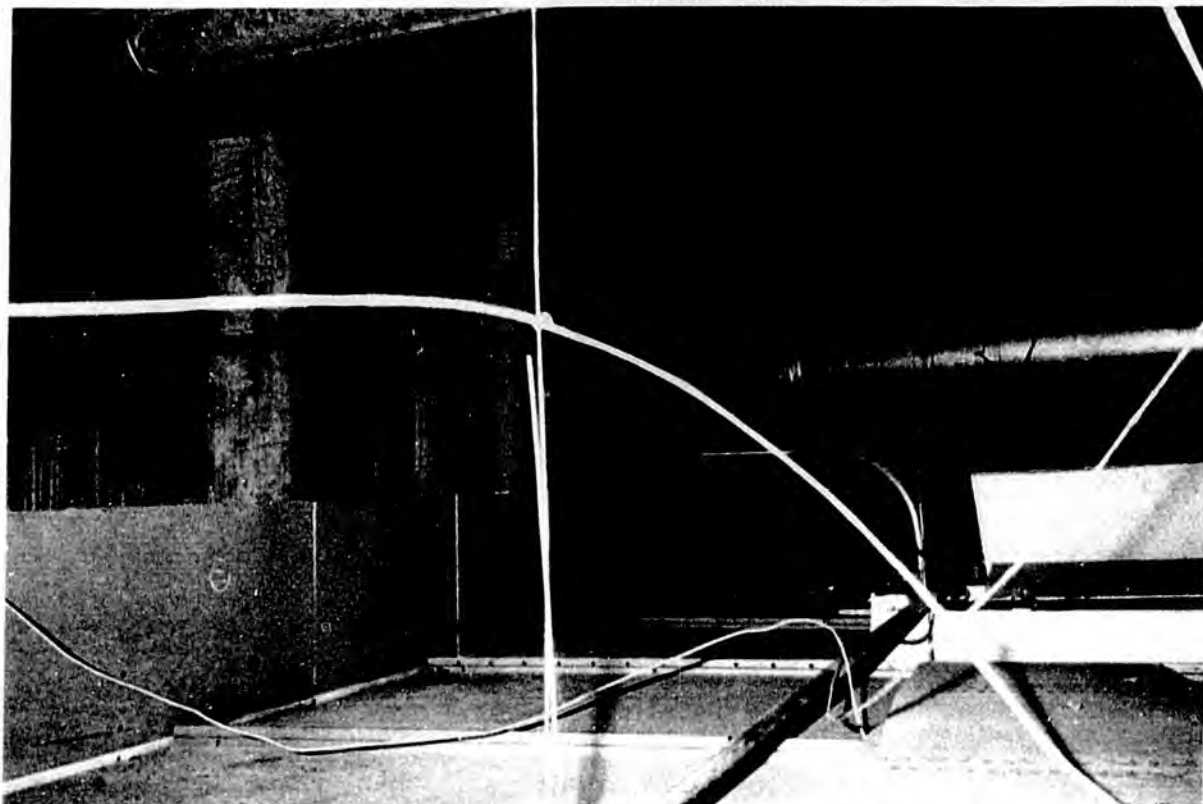
Photo #38

2. **Provide 1-hour fire resistive exit corridor system (per 1994 UBC 1005.7).** Current corridor construction does not extend to the underside of the floor deck above without openings, has exposed wood framing above the ceiling and the corridor ceiling does not meet 1-hour requirements.

Exposed Wood Stud Walls Above Ceiling

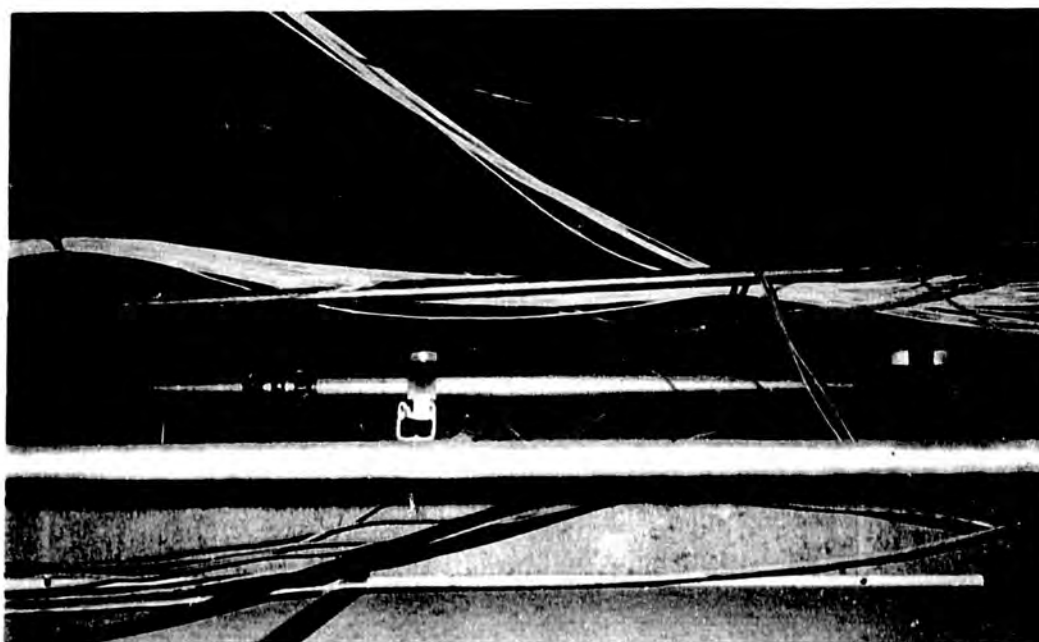
Photo #43

Wiring (non-rated) in Ceiling Plenum

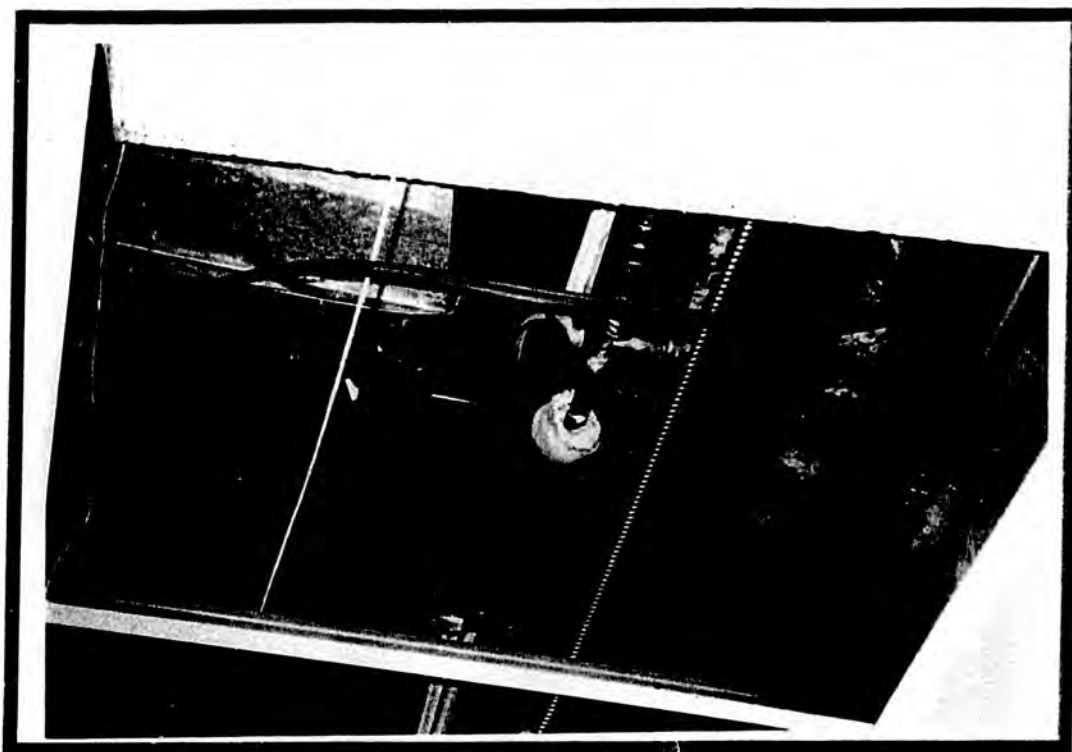
Description of Photo: Friable asbestos, north hallway ceiling, 3rd floor.

**Thermal System Insulation (TSI):** This friable ACM material is located throughout the building in ceilings and pipe chases and represents the ACM of greatest significance. It is recommended that all TSI be removed during the renovation project. In the event that all piping is to be replaced, removal of the ACM coated pipe is less expensive than removal of the insulation alone. Renovation cost estimates should include abatement of friable TSI.

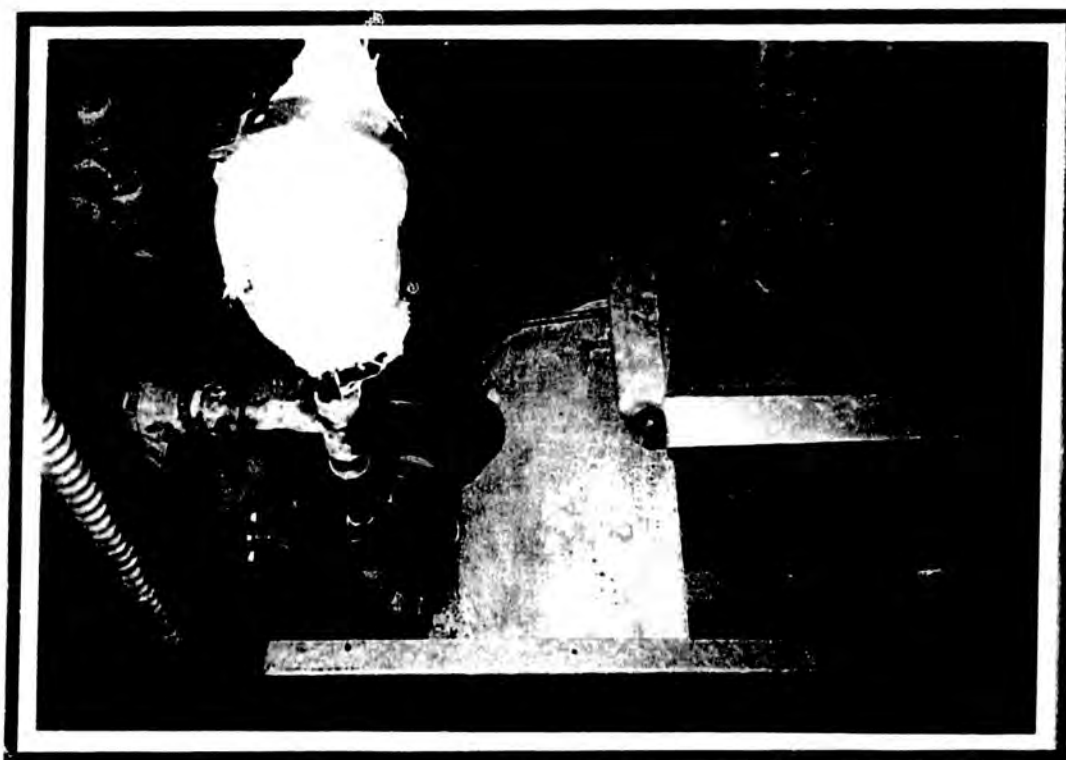
Description of Photo: Friable asbestos, north hall ceiling, 3rd floor.
