ALASKA LEGISLATURE SPECIAL COMMITTEE/SUBJECT FILES 8672

2552 SCOMM 111: DEFERRED MAINTENANCE TASK FORCE, 1997

Estimate to As-Built Condition

## Alaska Department of Transportation 1997 Pavement Condition Report

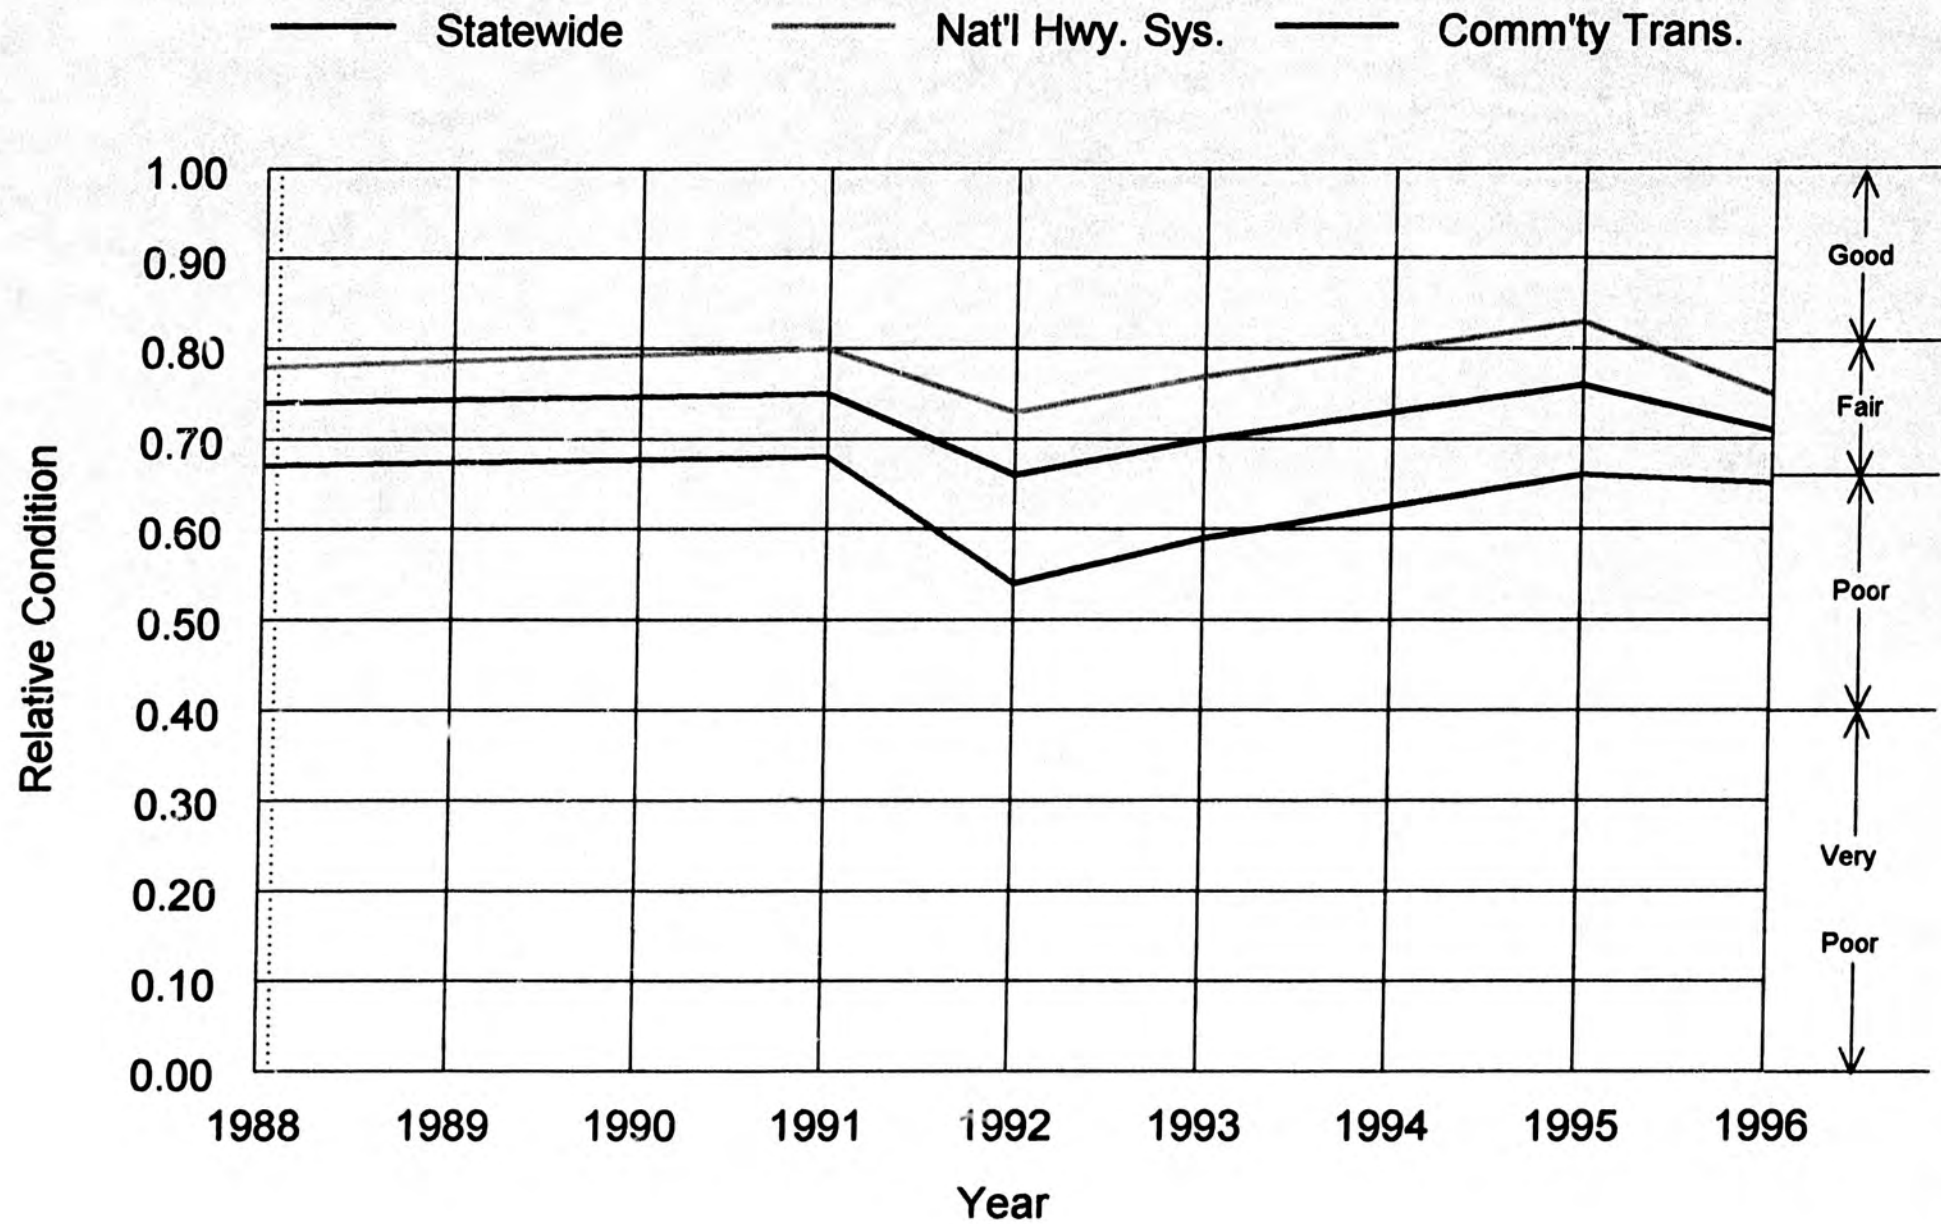
Figure 3: Overall Pavement Relative Conditions

Figure 3 shows overall (average) pavement conditions in Alaska from 1988 to 1996. In 1996, Statewide the overall condition of the paved roads surveyed was *fair* and starting to decline. Pavement management analysis generally recommends that the State invests approximately \$42 million in rehabilitation and

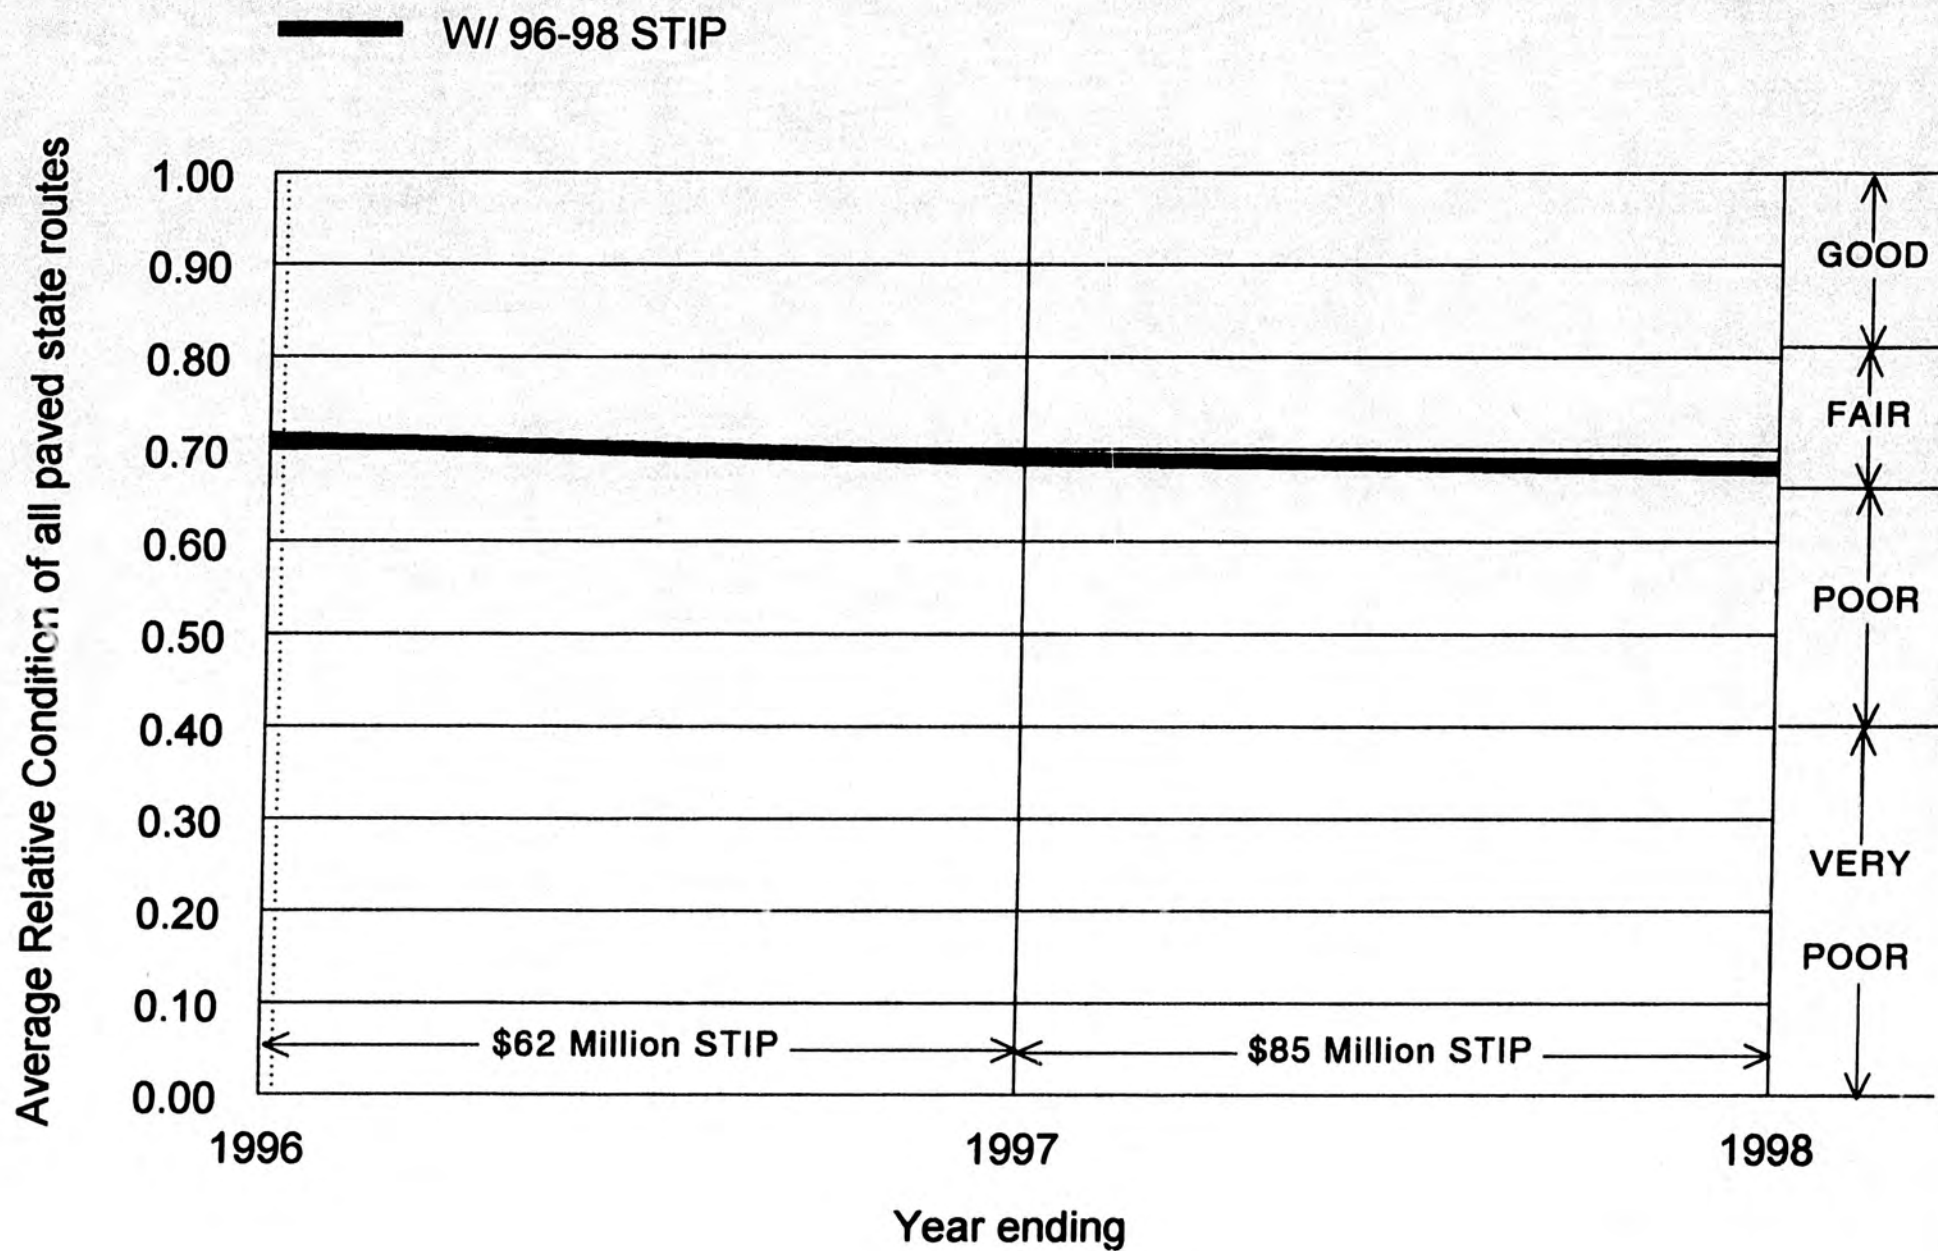
Figure 4: Predicted Statewide Pavement Relative Condition

It costs approximately \$100,000 on average to rehabilitate one lane mile of pavement that has degenerated to Poor condition. A lane mile is a stretch of pavement one mile long by 12 feet wide. Improvement costs vary widely depending on the severity of pavement damage. Pavements that have not degenerated to Poor condition can be asphalt surface treated for approximately \$30,000 per lane mile. Simple crack sealing projects can be done for \$2,000 per lane-mile. To completely rebuild the structural section with shoulders, a pavement from the foundation up can cost \$300,000 per lane-mile. At a minimum, routine maintenance should be performed on highways to keep pavements in good condition. Table 1 presents some typical pavement rehabilitation alternatives that are used in Alaska along with relative costs.

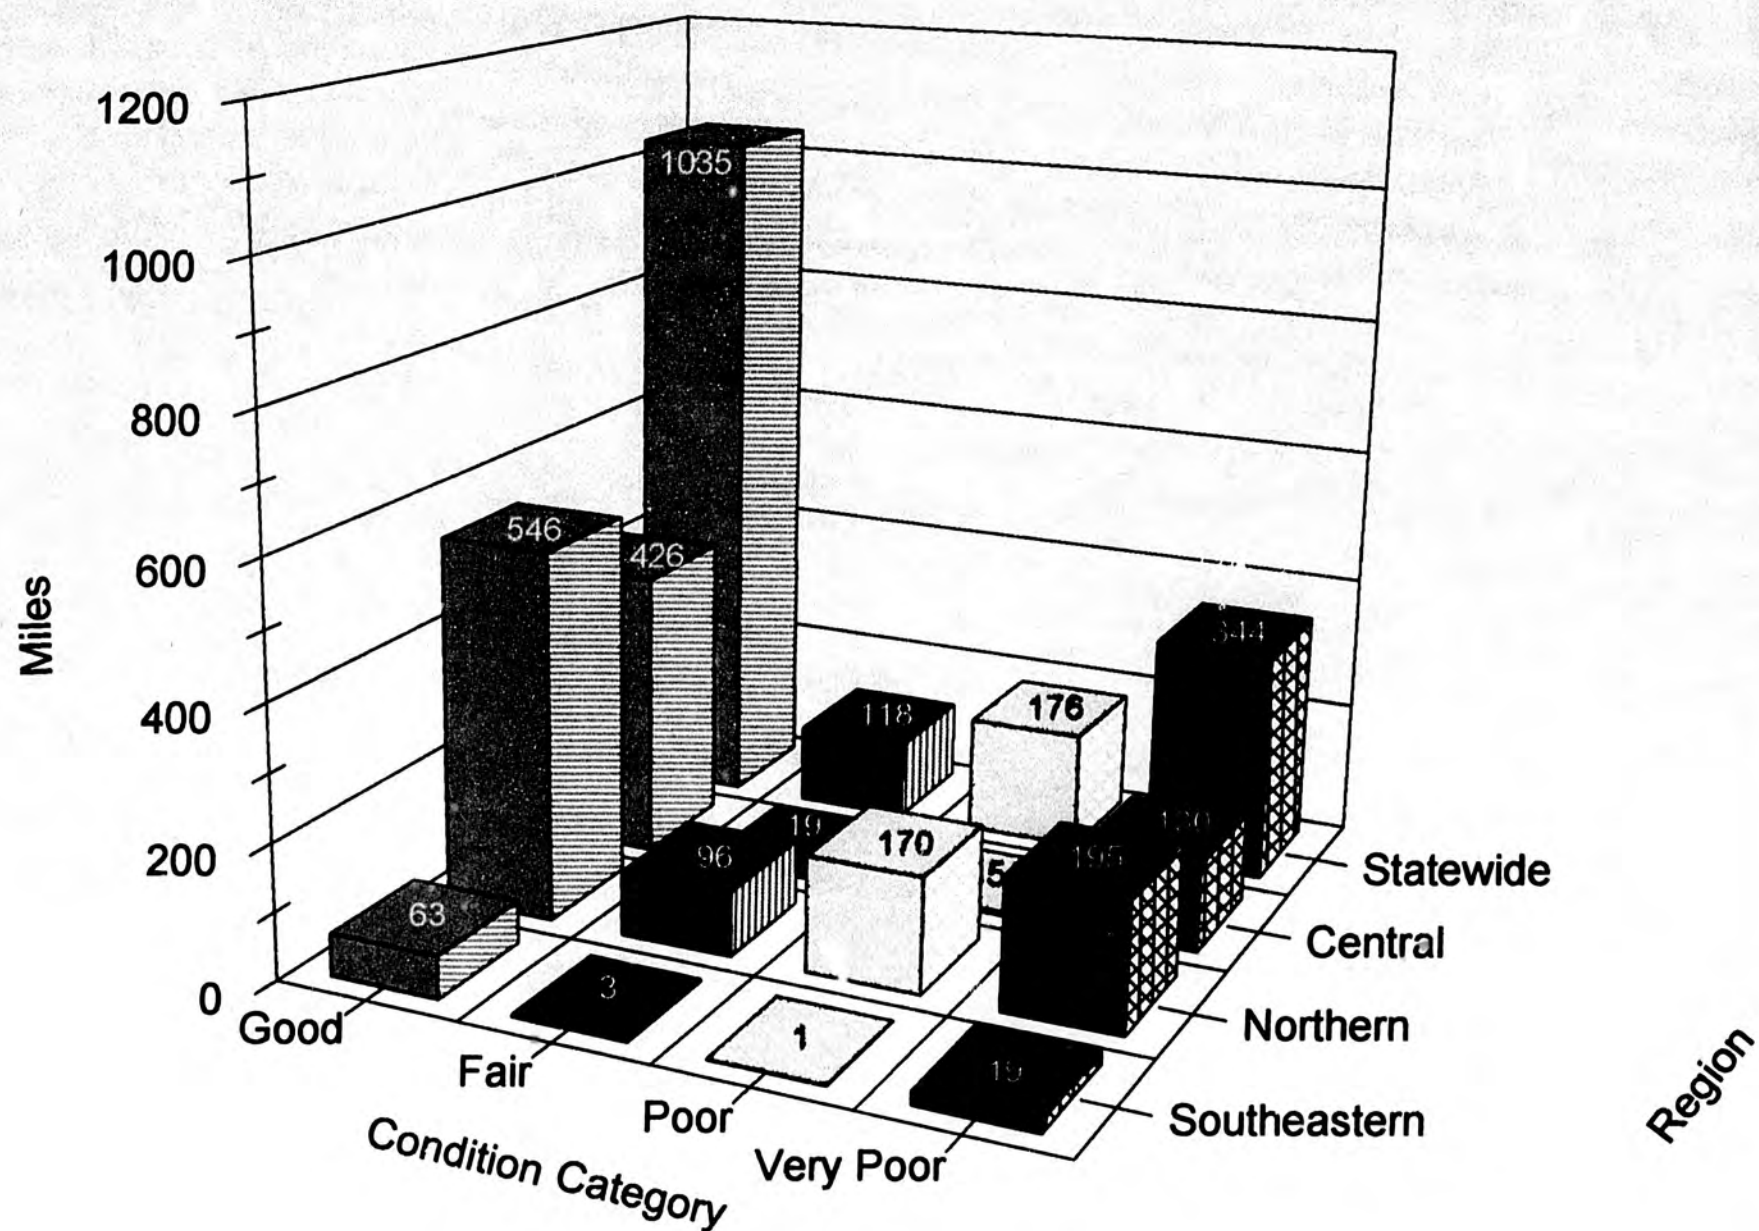
# Figure 6: National Highway System Pavement Conditions

Pavement conditions on the NHS are shown with Figure 6. There are 520 miles of a total 1,673 miles or 31% in poor and very poor condition. Again, the Northern Region has the highest portion in these condition categories with 365 miles or 36% of the NHS there. The Northern Region also has the most NHS miles in the state. The Central and Southeast Regions both have 23% of the NHS contained therein at this condition. That is, 135 miles in the Central Region and 20 miles in the Southeast Region.

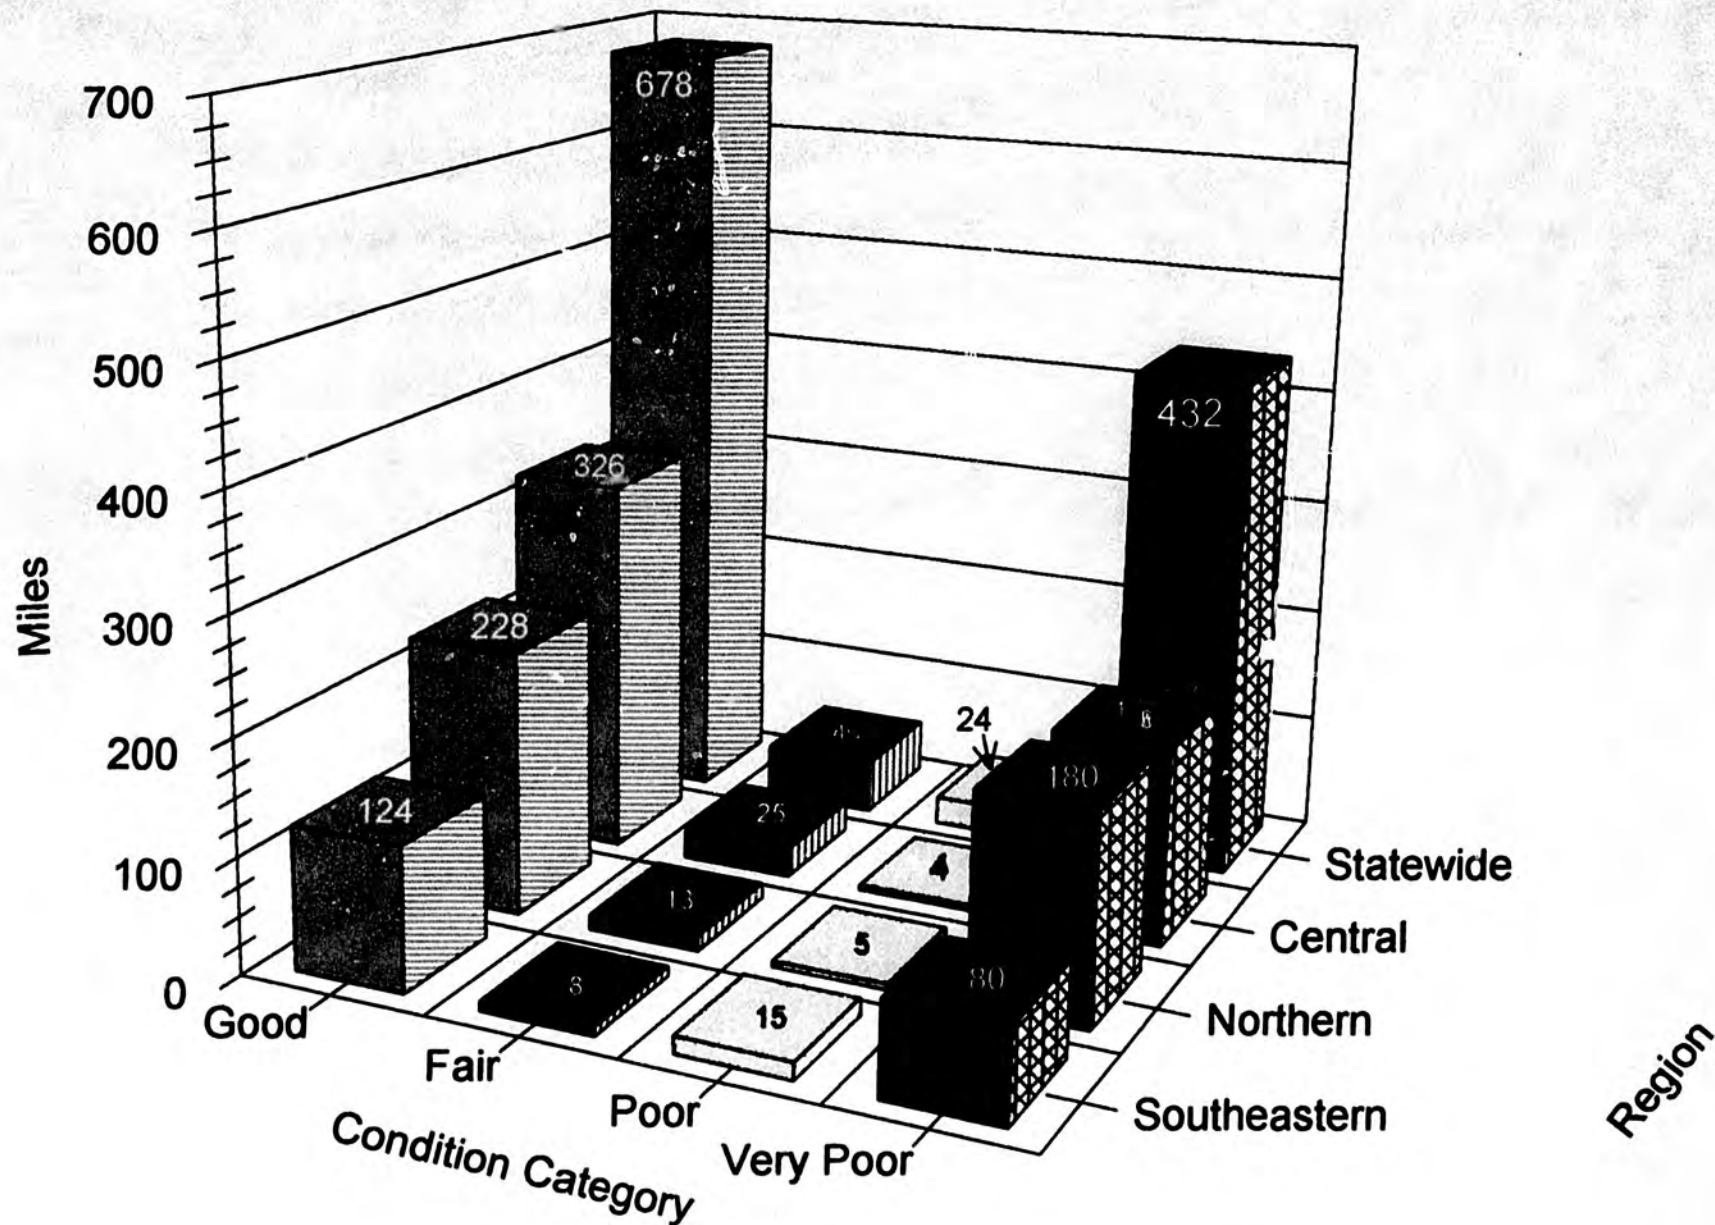
# Figure 7: Community Transportation Program Pavement Conditions

Figure 7 shows the pavement conditions on the CTP routes. Shown are 456 miles of 1,180 miles in poor and very poor condition statewide. That is 39% of the CTP routes centerline miles. The Central Region has the greatest number of paved CTP route miles. There are 176 miles of 527 total (33%) CTP miles in the Central Region in poor or worse condition. The Northern Region has about the same length in these condition categories at 185, but with a total of 426 CTP miles it amounts to 43%. The Southeastern Region has 95 miles or 42% of 227 CTP miles in poor and very poor condition.
