ALASKA LEGISLATURE SPECIAL COMMITTEE / SUBJECT FILE 8672  
1973 SCOMM 76: HOUSE SPEC. COMM. EXXON VALDEZ OIL SPILL. . 1991-92

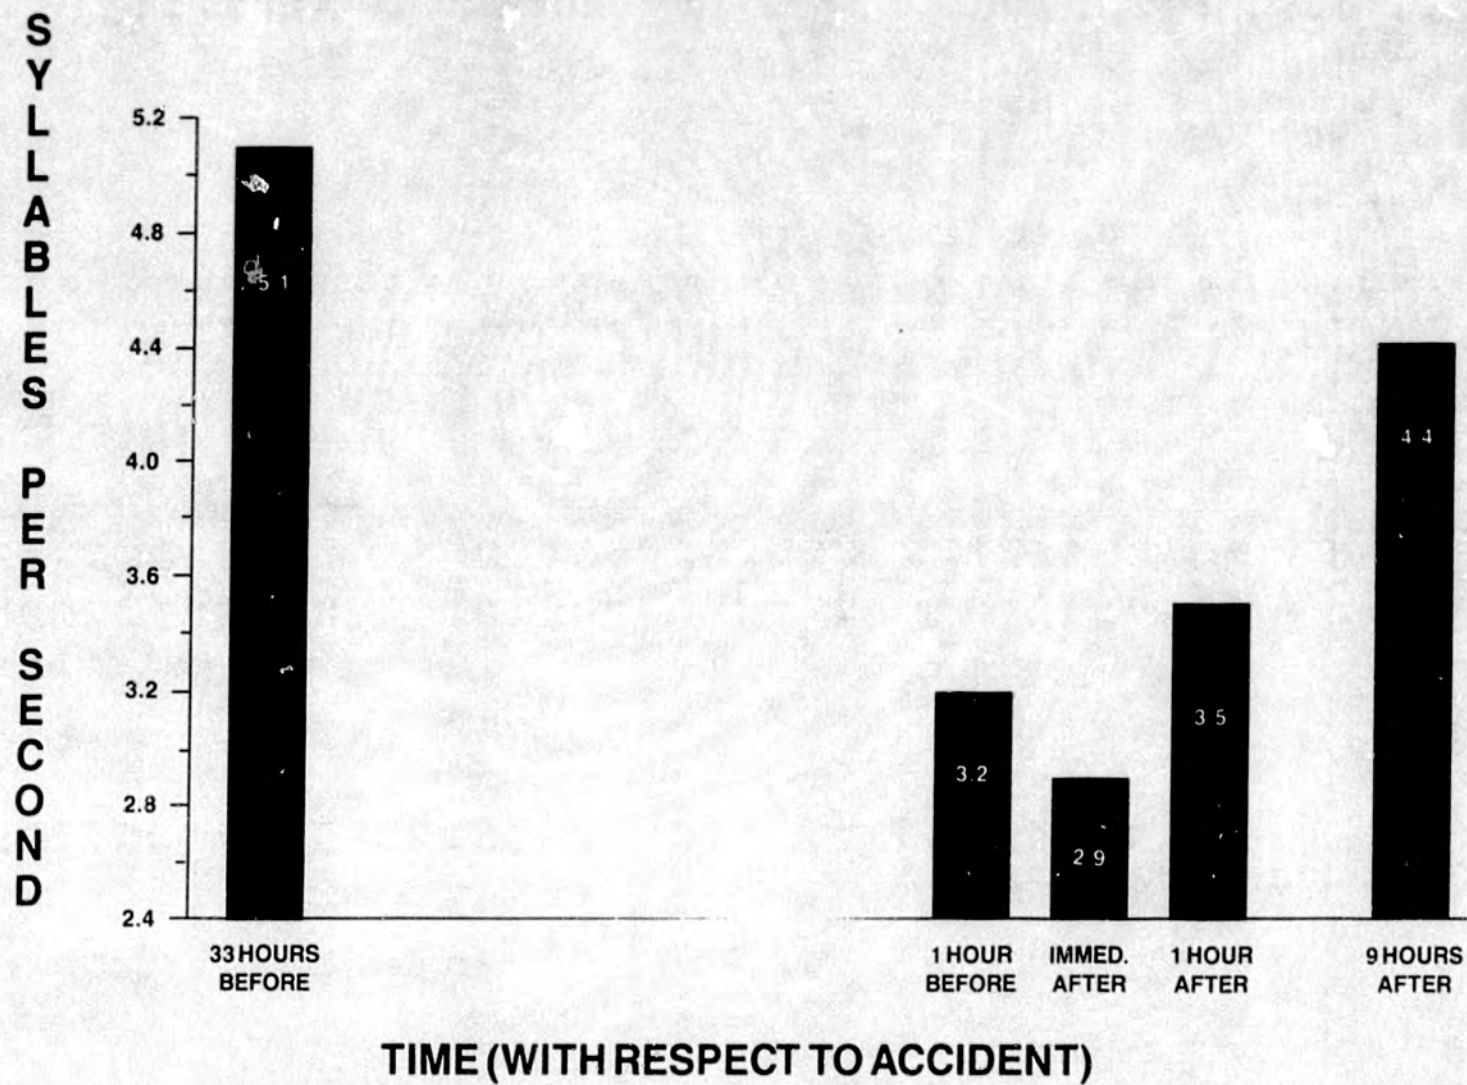
Figure 15.--Graph summarizing speaking rate.

## AVERAGE SPEAKING RATE OF THE EXXON VALDEZ MASTER

speech 9 hours after the accident and that it was significantly slower than his speech 33 hours before the accident.

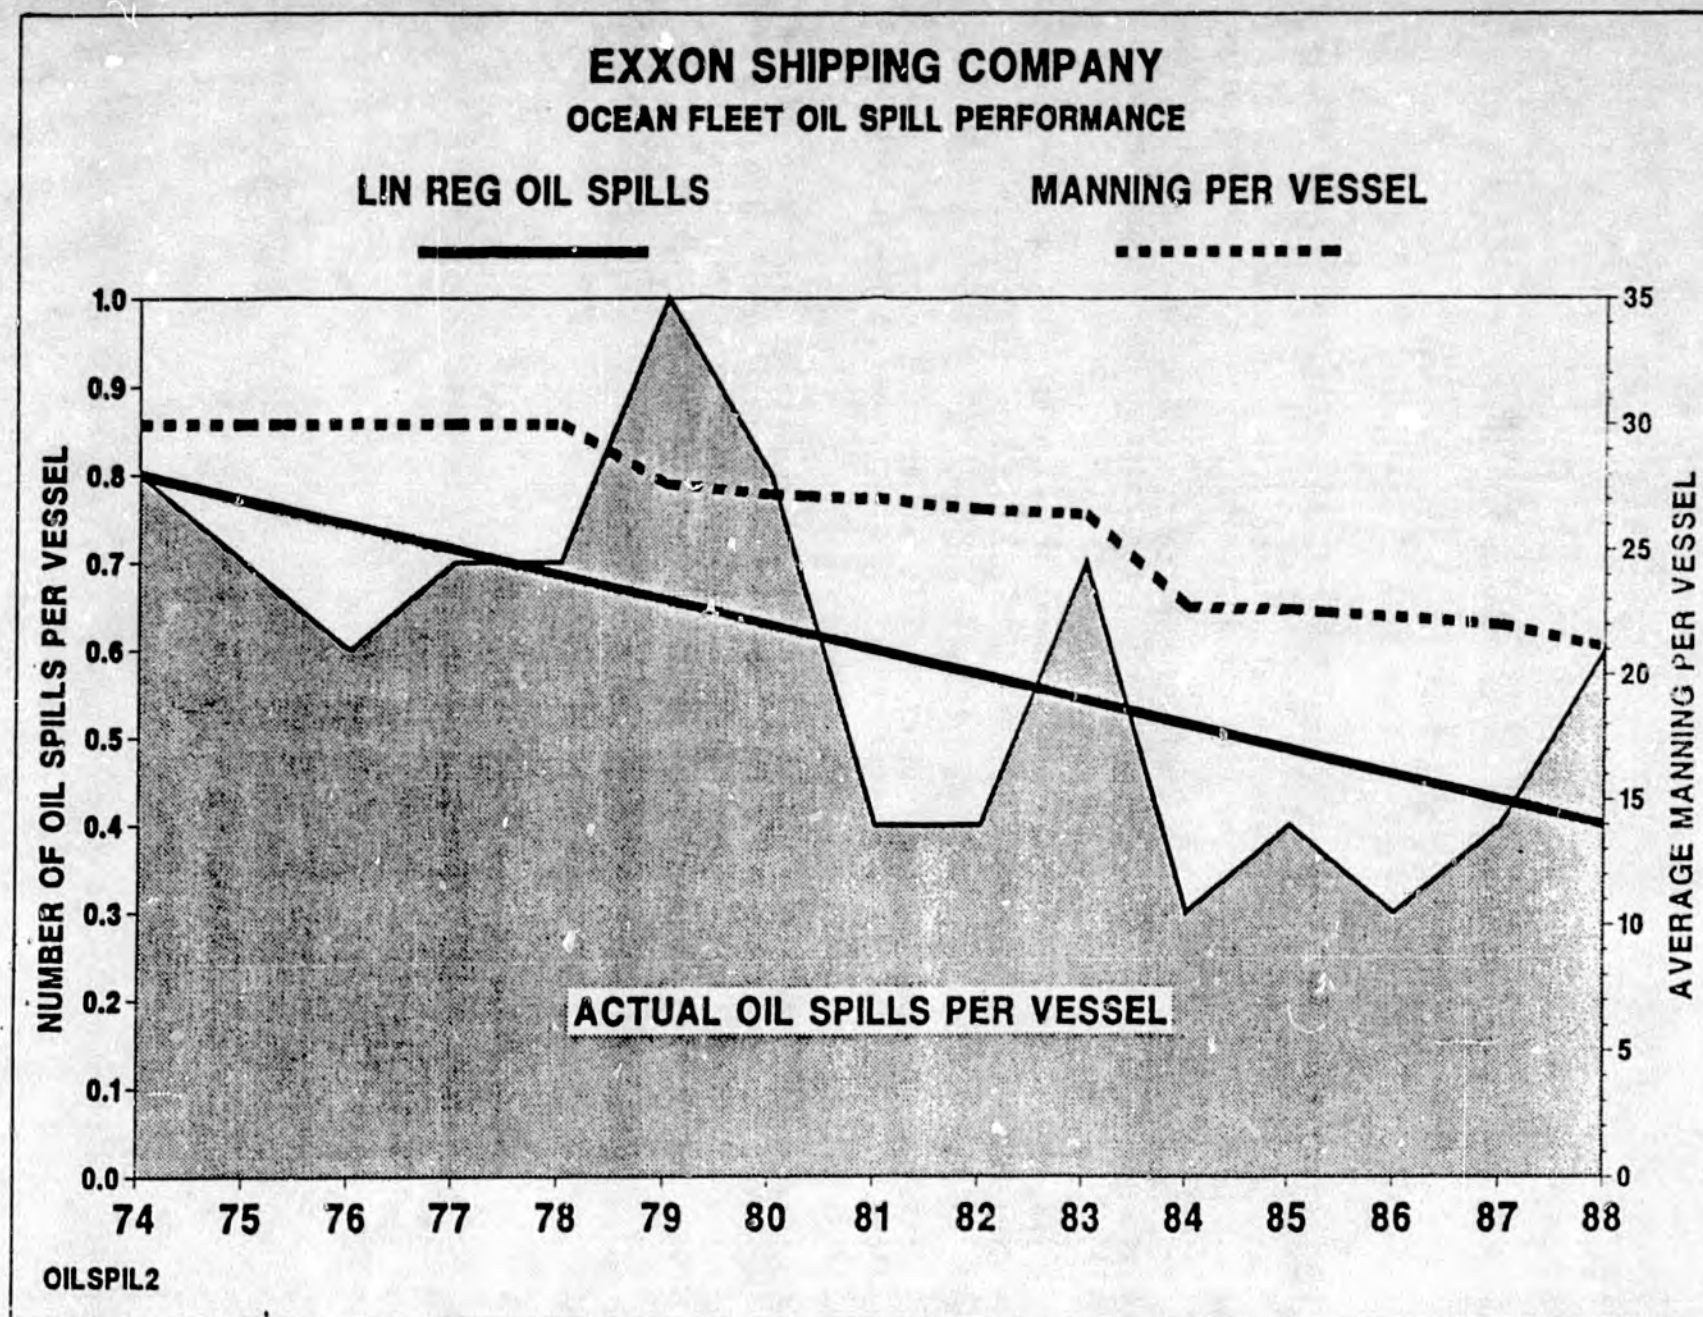
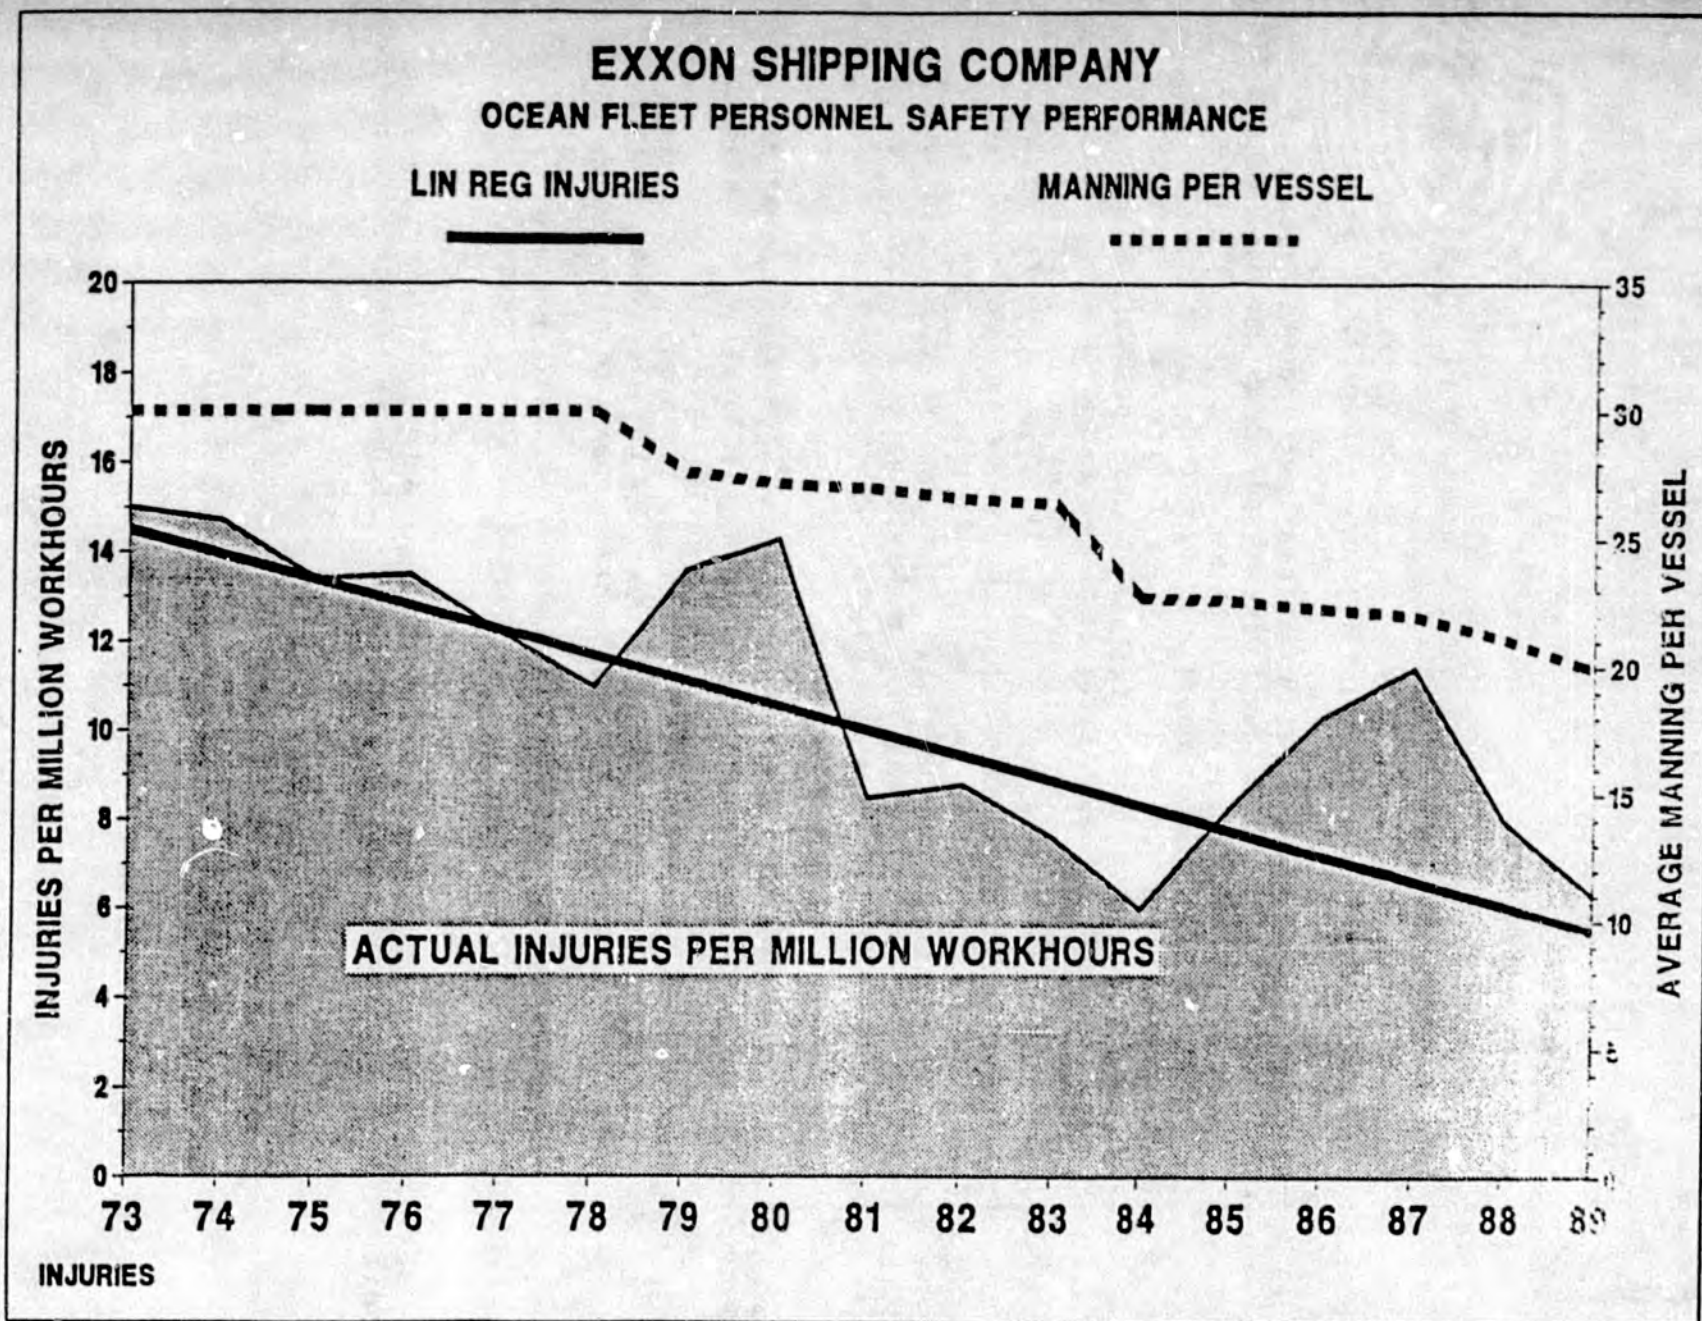
OCEAN FLEET  
PERSONNEL SAFETY PERFORMANCE  
1973 - 1989 (MAY)

From this data, it is clear that lower vessel complements have not resulted in a reduction in personnel safety or environmental conservation. On the contrary, the normalized ratios show a very pronounced improvement in both categories during a 15-year period when average crew size was reduced from 30 to 20.

- + Safety performance does not decline when the size of the crew is reduced; rather, our experience indicates that the rate of injury decreases when crew size is reduced.
