ALASKA LEGISLATURE

COMMITTEE FILES

HB 167 (file 1)

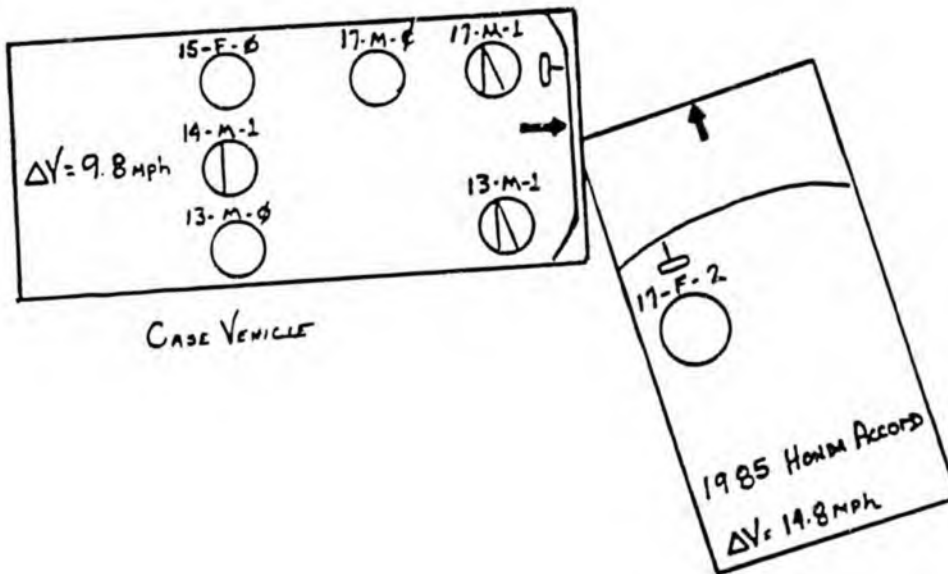
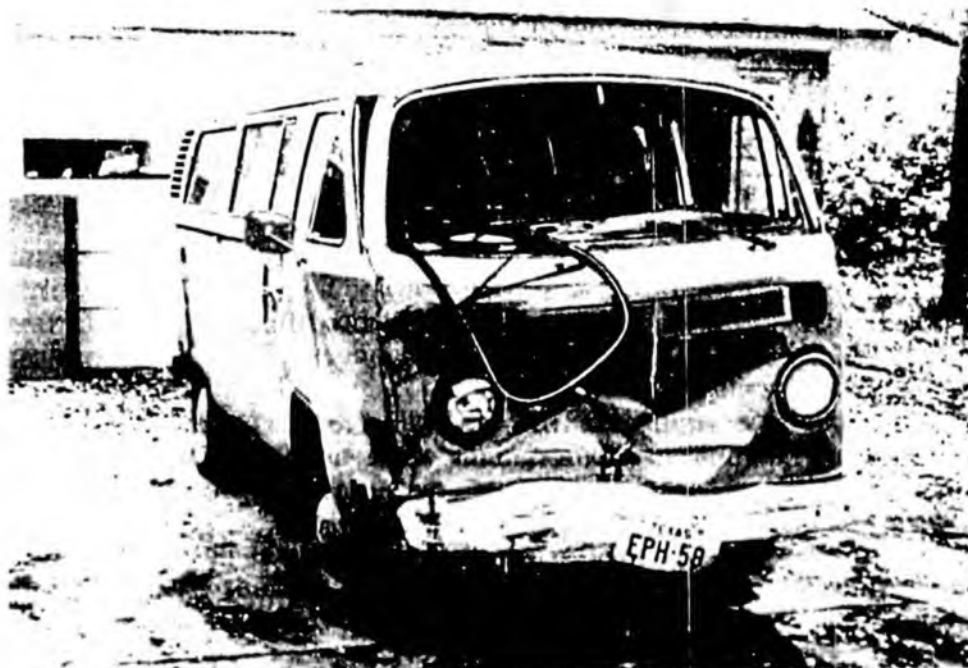
CASE 5 (FTW-85-H-OR31)

A 1976 VW Van struck, front center, a 1985 Honda Accord on the left front corner. The van was driven by a 17-year-old boy wearing the available static lap/shoulder belt. There were 5 other occupants of the van: a 13-year-old boy in the right front, restrained by a static lap/shoulder belt; a 15-year-old girl in the left rear, unrestrained; a 14-year-old boy in the center rear, with a static lap belt around him; a 13-year-old boy in the right rear, unrestrained; and a passenger riding on the cargo area floor of the van. Damage was substantial to both vehicles and both required towaway removal from the accident scene.

The collision resulted in moderate injuries to the unrestrained driver of the Honda. The restrained driver of the van, although misusing his restraint by wearing the shoulder belt portion routed under his left arm, sustained only minor injuries, as did the lap/shoulder belted right front passenger. The boy riding in the center rear seat with a lap belt received minor injuries also, apparently due to disconnection of the buckle at impact. The remaining occupants, all unrestrained, were not injured.

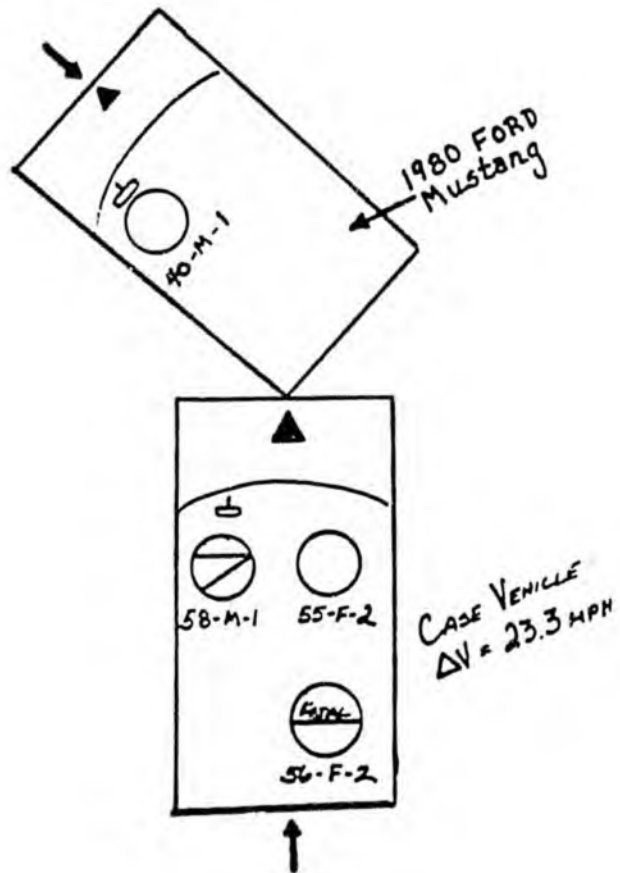
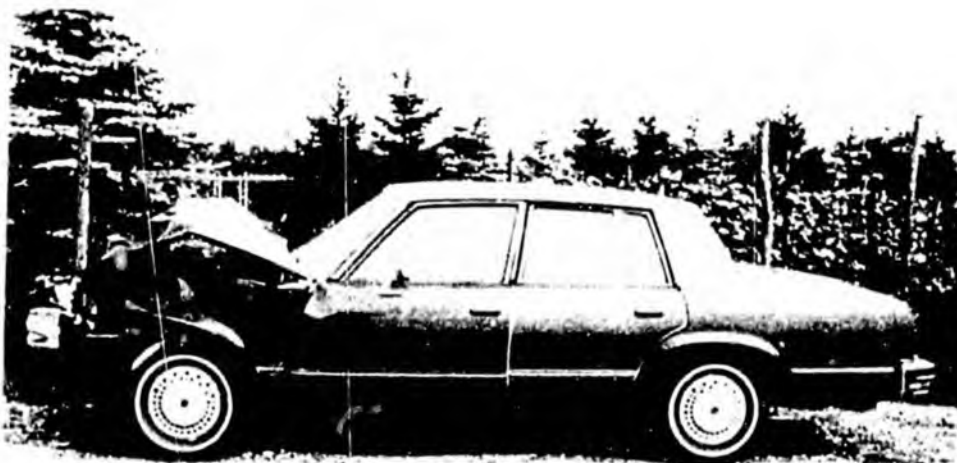
CASE 6 (NYC-84-H-OR05)

A 1983 Chevrolet Malibu was struck in the front center by the left rear corner of an out-of-control 1980 Ford Mustang. The Chevrolet was occupied by 3 adults, 2 of whom were wearing seat belts: the driver, a 58-year-old man, was wearing a lap/shoulder belt; the right rear passenger, a 56-year-old woman, was wearing a lapbelt. The right front passenger, a 55-year-old woman, was unrestrained.

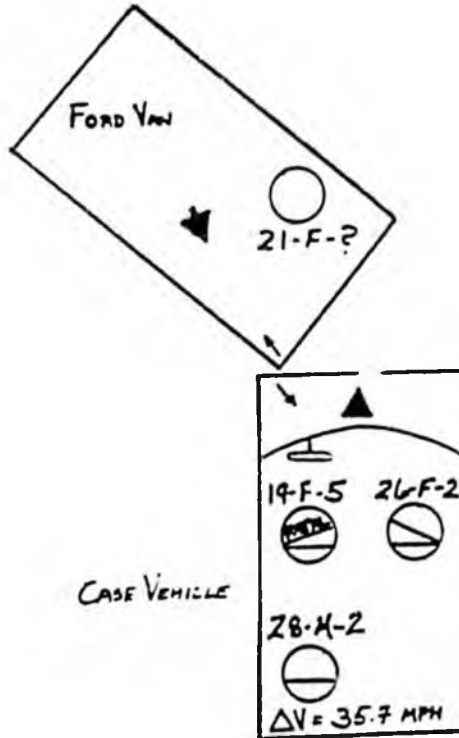
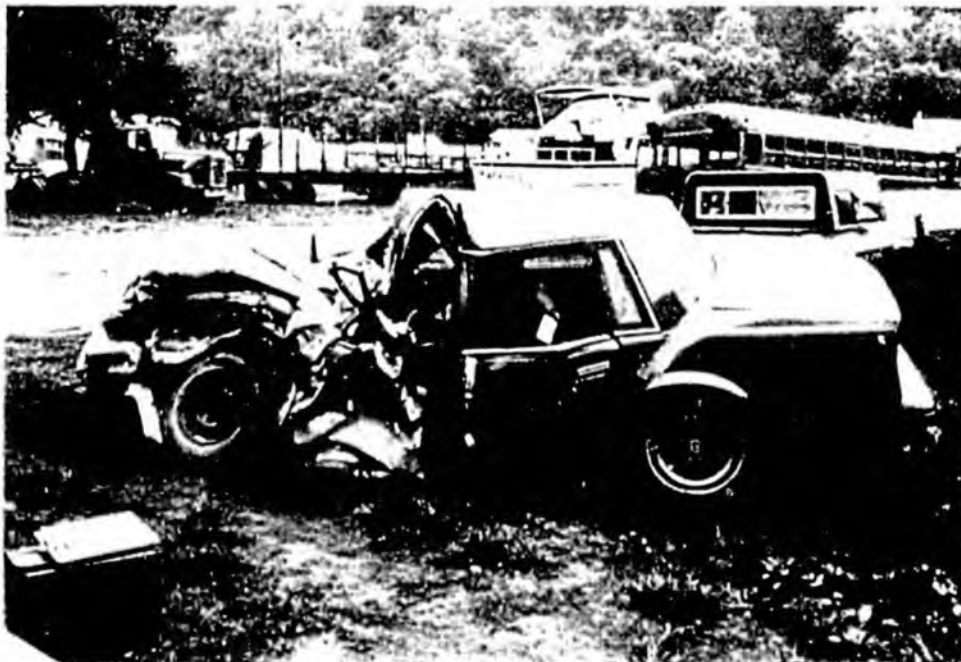
CASE 7 (CHI-85-H-OR02)

A 1984 Chevrolet Celebrity was struck on the left front corner by the right front corner of a 1984 Ford van. The Chevrolet was driven by a 19-year-old woman; a 26-year-old woman was in the right front, and a 28-year-old man was in the left rear. Both front seat occupants were restrained by 3-point lap/shoulder belts, while the rear seat passenger was wearing a lap belt. Both vehicles received substantial front structural damage.

The crash caused critical head injuries to the Chevrolet driver as the front structure collapsed rearward into the driver's space. The driver was pronounced dead 7 1/2 hours after the crash without regaining consciousness. The right front passenger and left rear passenger both sustained multiple moderate to serious injuries.

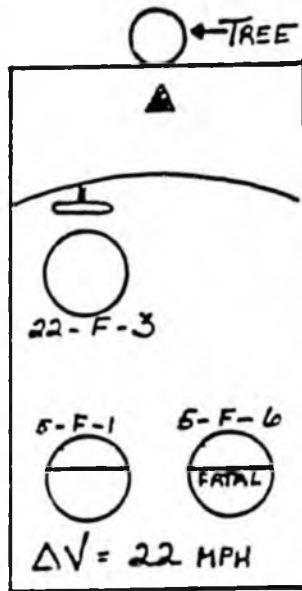
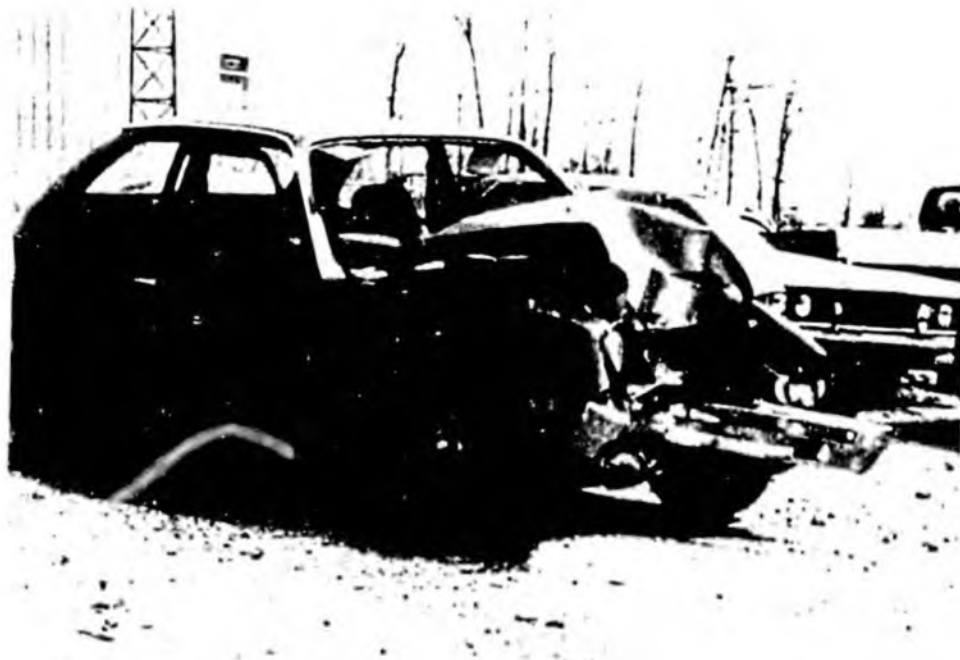
CASE 8 (CHI-85-H-OR19)

A 1977 Chevrolet Chevette sedan, driven by an unrestrained 22-year-old woman with two lap belted 5-year-old girls in the rear seat, ran off the road and hit a tree center front. Following this moderate crash, the three occupants were transported to a hospital by ambulance. The unrestrained driver received serious injuries, and the lap belted child in the left rear had minor injuries. The lap belted child in the right rear was fatally injured.

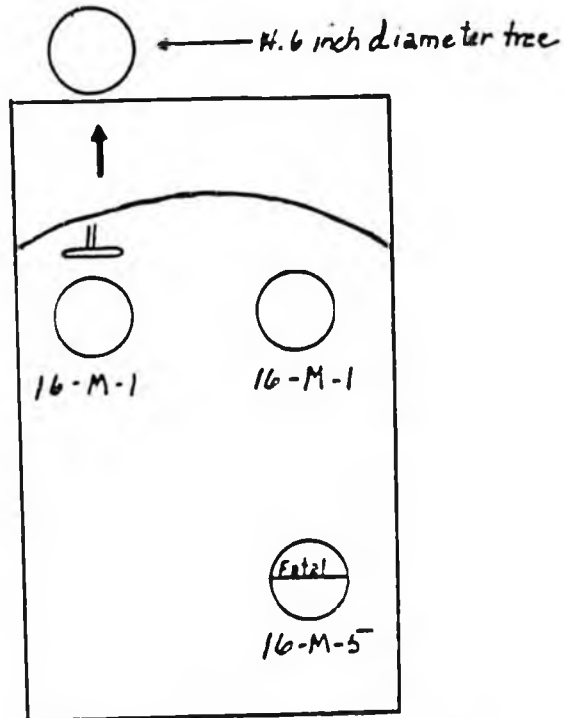
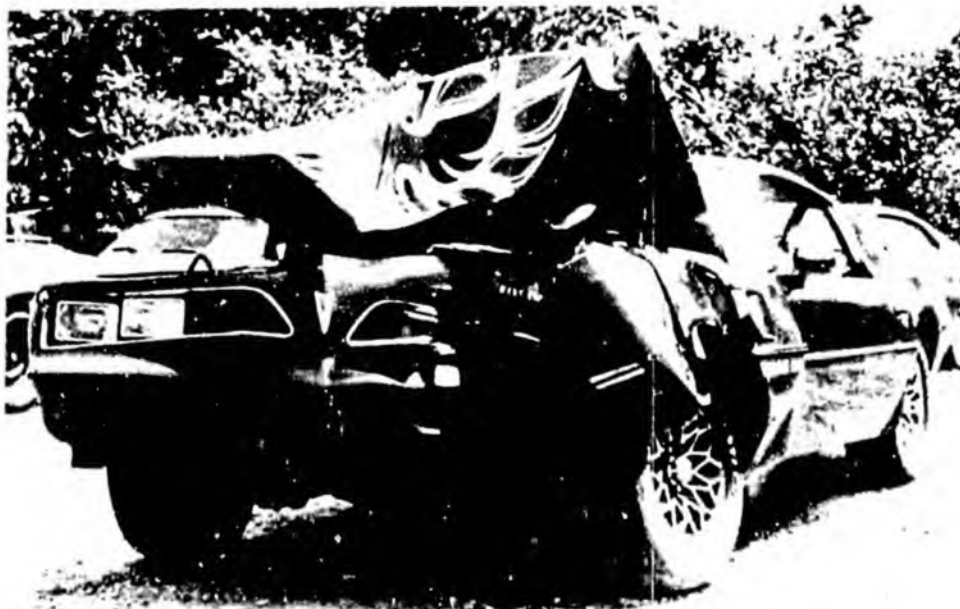
CASE 9 (ATL-84-H-OR29)

A 1977 Pontiac Trans Am struck a 14.6-inch-diameter tree head-on but left of center. The impact caused front structural collapse of 25 inches on the car. The car was occupied by an unrestrained 16-year-old male driver, an unrestrained 16-year-old boy in the right front, and a 16-year-old boy in the right rear. This boy was restrained by the latchplate webbing of his seating position coupled into the buckle assembly of the seat to his left.

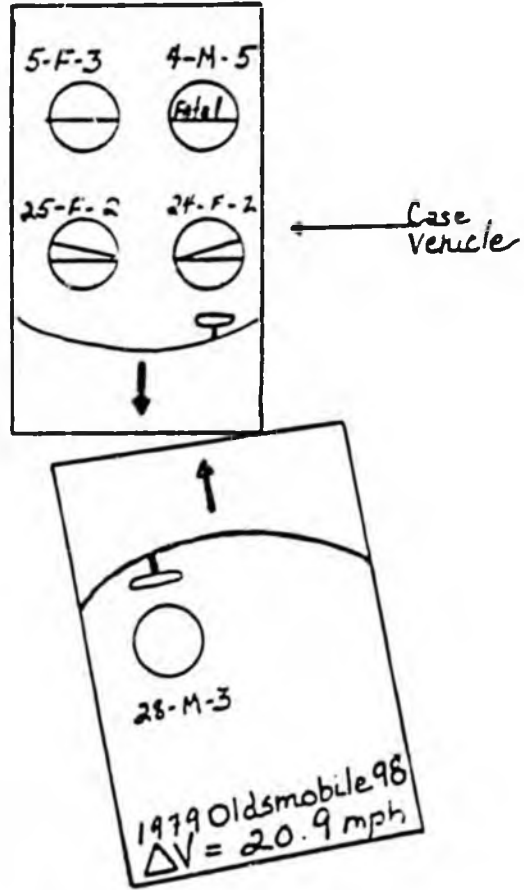
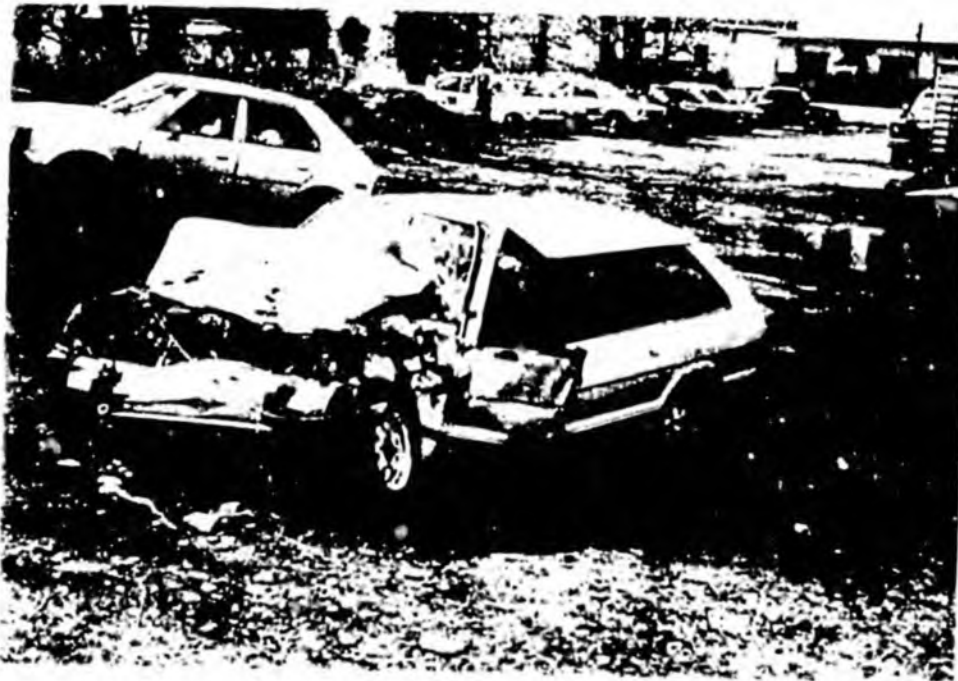
CASE 19 (NYC-85-H-OR09)

A 1982 Subaru station wagon was struck head-on by a 1979 Oldsmobile 98. At impact, the Subaru was stopped and pushed backward; the Delta V was 32.3 mph. The four Subaru occupants were restrained by seat belts. The two adults in the front seat (24-year-old woman driving and 25-year-old woman in right front) were wearing lap/shoulder belts. The two children in the rear seat (a 4-year-old boy in the left rear and a 5-year-old girl in the right rear) were both wearing lap belts.

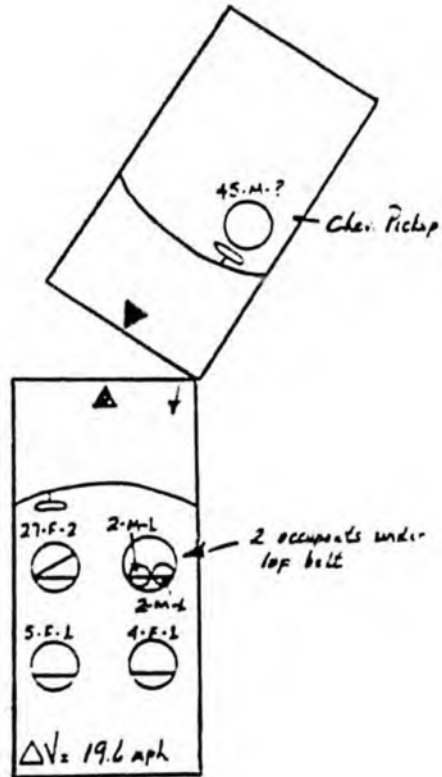
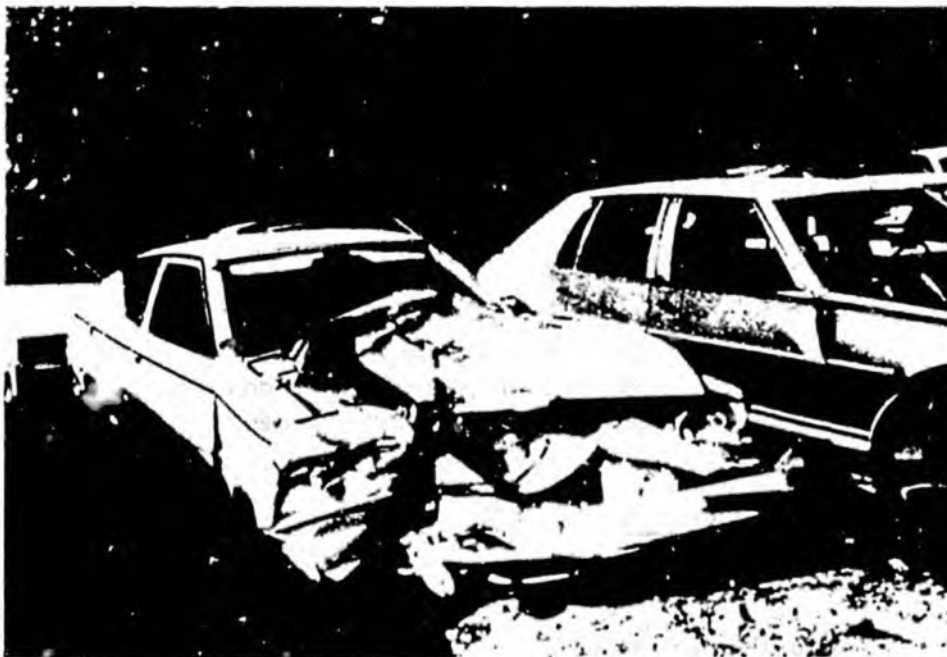
CASE 11 (ATL-85-H-OR14)

A 1977 Plymouth Arrow struck a 1985 Chevrolet S-10 pickup, right front into left front. The longitudinal Delta V for the car was 14 to 17 mph; the total Delta V was 19.6 mph. The car was occupied by a lap/shoulder belt restrained 27-year-old female driver, 4- and 5-year-old girls in the rear who were lap belt restrained, and two 2-year-old boys seated under a lap belt at the right front.

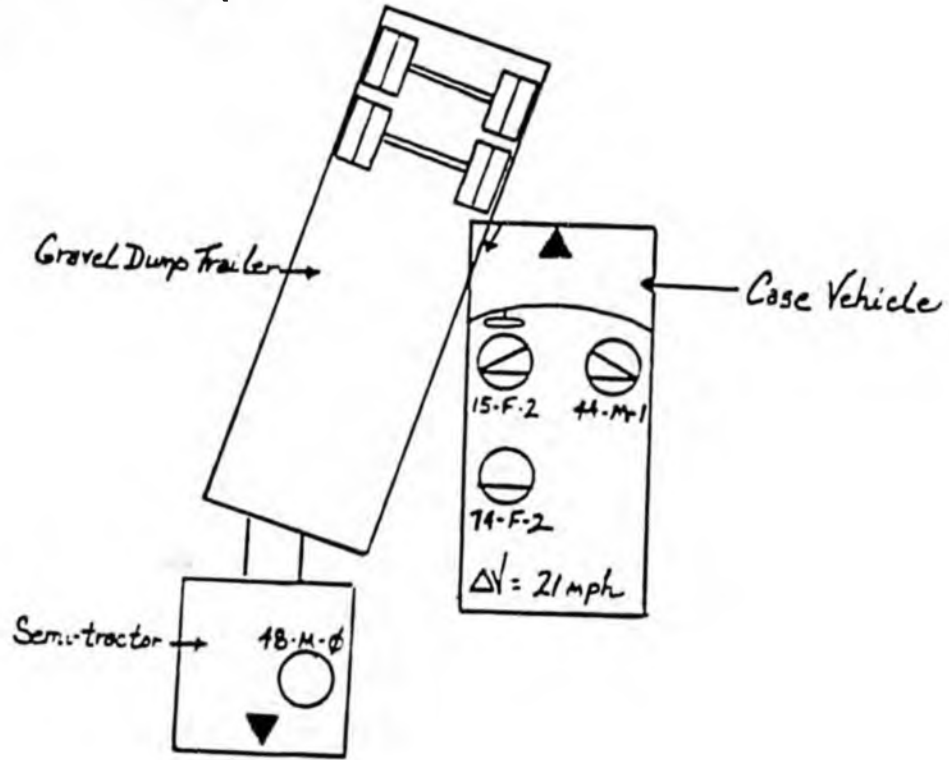
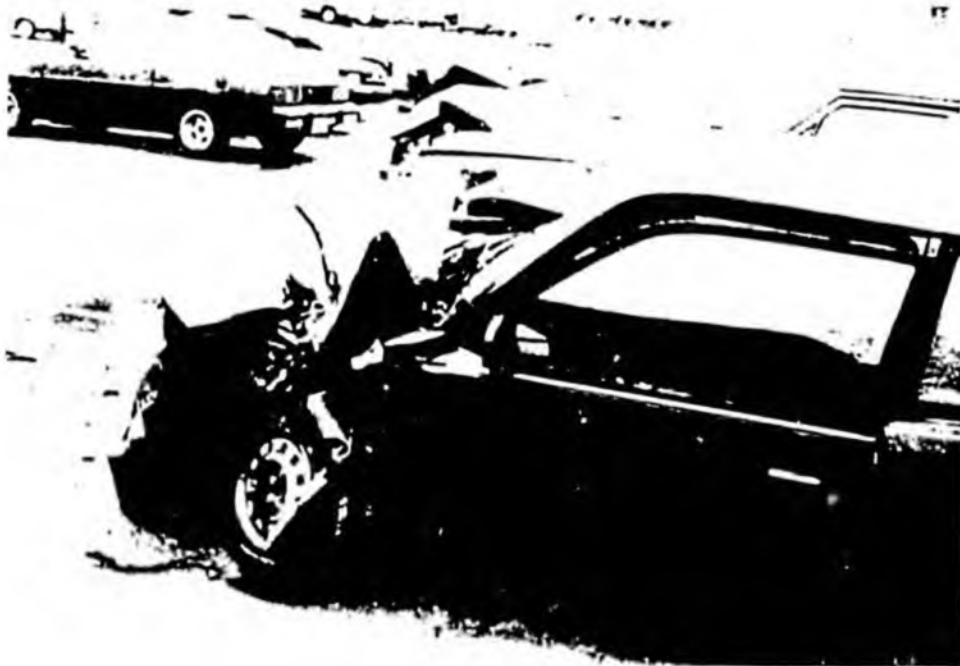
CASE 12 (FTW-85-H-OR17)

A 1984 Chevrolet Cavalier struck, left front corner first, the left leading dual tire assembly of a 42-foot dump trailer being pulled by a 1979 Ford semi-truck. The Chevrolet's left frontal structure was substantially damaged, with rearward displacement depths reaching 20 inches. The trailer unit received only minor damage and was not disabled.

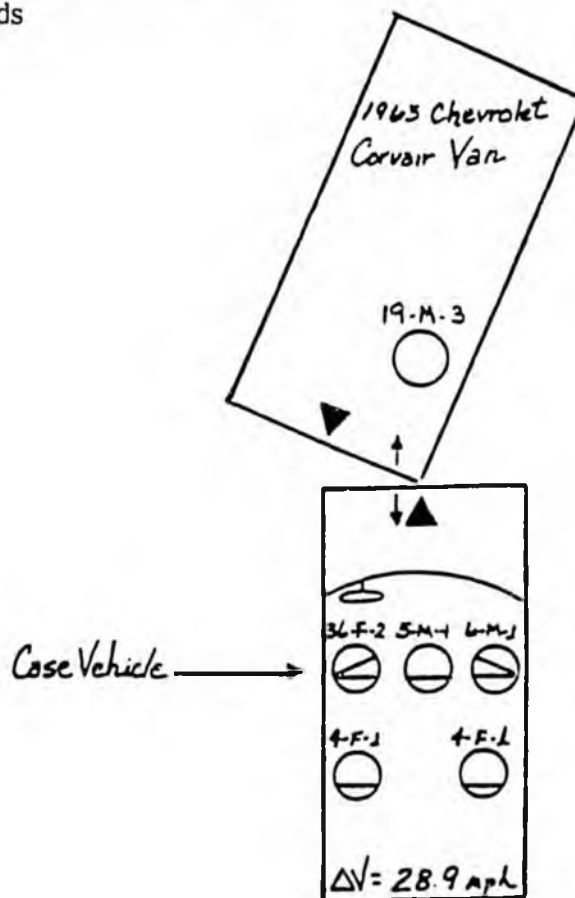
CASE 13 (SEA-85-H-OR20)

A 1978 Buick Estate station wagon was struck in the front, slightly left of center, by the left front corner of a 1963 Chevrolet van. The Buick was occupied by a lap/shoulder belted 36-year-old female driver, a lap belted 5-year-old boy at center front, a 6-year-old boy wearing a lap/shoulder belt at right front, and two 4-year-old girls seated in the left and right rear seats, restrained by lap belts. The force of this head-on collision destroyed the front structures of both vehicles.

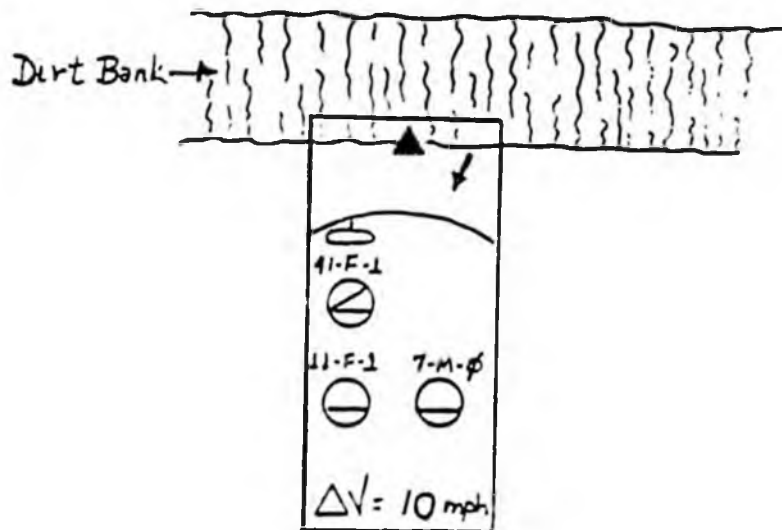
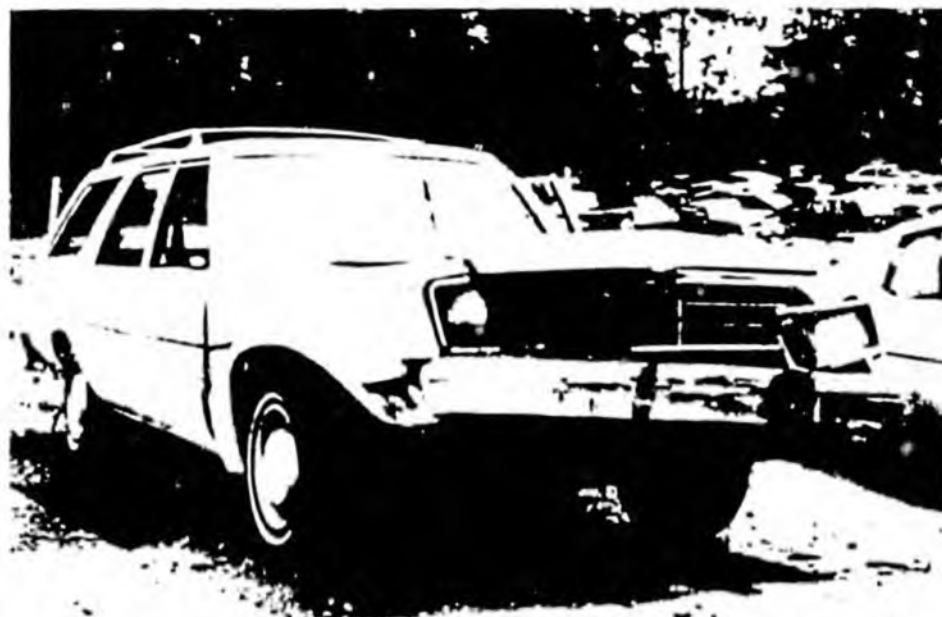
CASE 15 (ATL-84-H-OR28)

A 1980 Ford Fairmont station wagon struck a dirt embankment. Substantial damage resulted and towaway removal was required. The driver was a 41-year-old woman, restrained by a lap/shoulder belt; the left rear seat was occupied by an 11-year-old girl; a 7-year-old boy was seated right rear. Both rear seat occupants were restrained by lap belts.

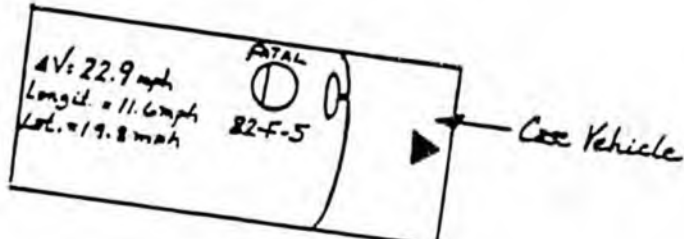
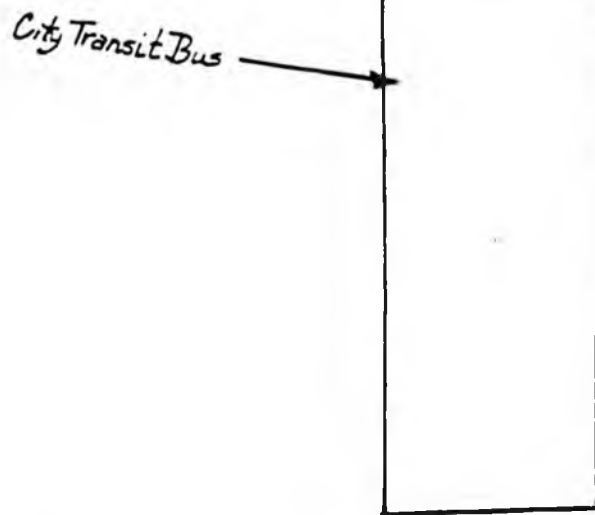
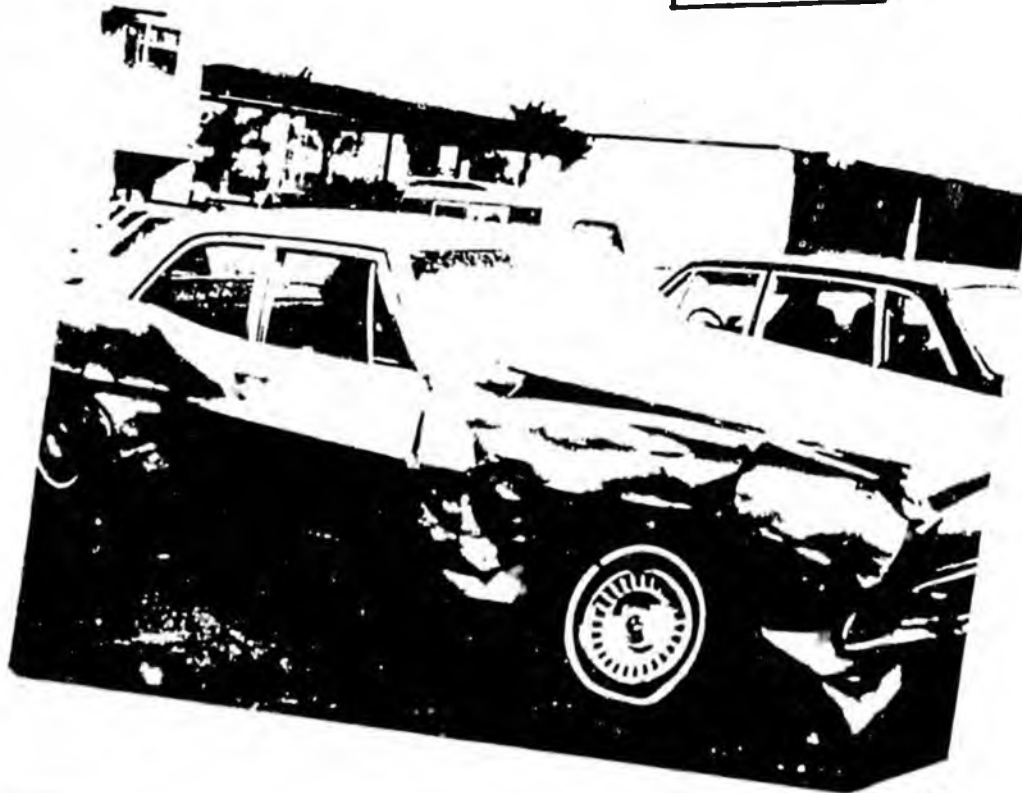
CASE 17 (LAX-85-H-OR18)

A 1967 Pontiac was struck on the right front side by a city bus. The Pontiac was being driven by an 82-year-old woman who was restrained by a static lap belt. The Pontiac received substantial structural damage along its right side; there was no apparent compartment distortion at the driver's position.

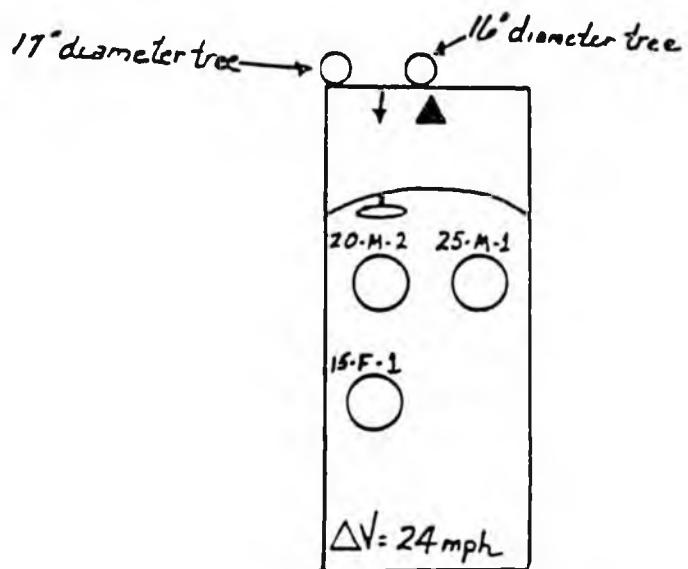
CASE 18 (SEA-85-H-OR25)

A 1980 Toyota Celica struck, head-on, two trees 16 to 17 inches in diameter. The impact resulted in substantial damage to the front structure of the vehicle, with rearward collapse reaching a depth of 26 inches at the front center point of impact. The vehicle was occupied by a 20-year-old male driver, a 25-year-old male right front passenger, and a 15-year-old female seated left rear. There were no restraints being used by these occupants.

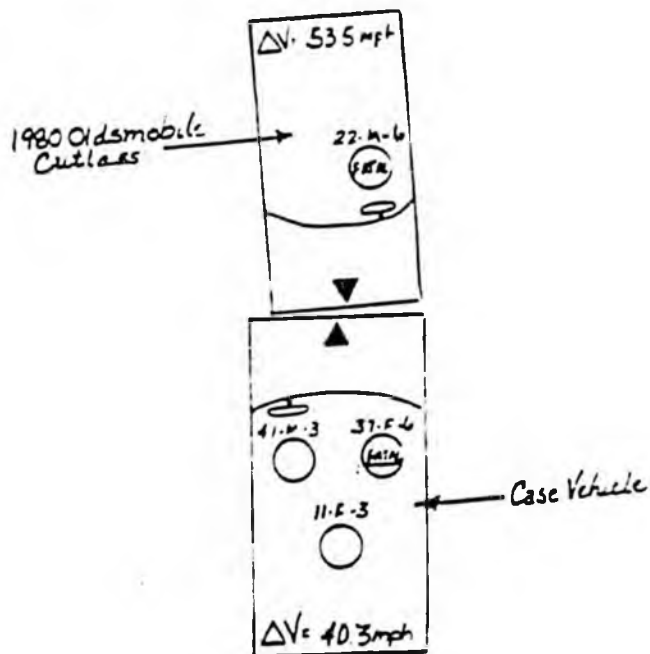
CASE 19 (CHI-85-H-OR27)

A 1979 Dodge Ramcharger was struck head-on by a 1980 Oldsmobile Cutlass, with a resulting Delta V of 40.3 mph to the Dodge and 53.3 mph to the Cutlass. Rearward structural collapse was more than 35 inches at the right front of the Dodge; deformation at the Oldsmobile's right front exceeded 50 inches.

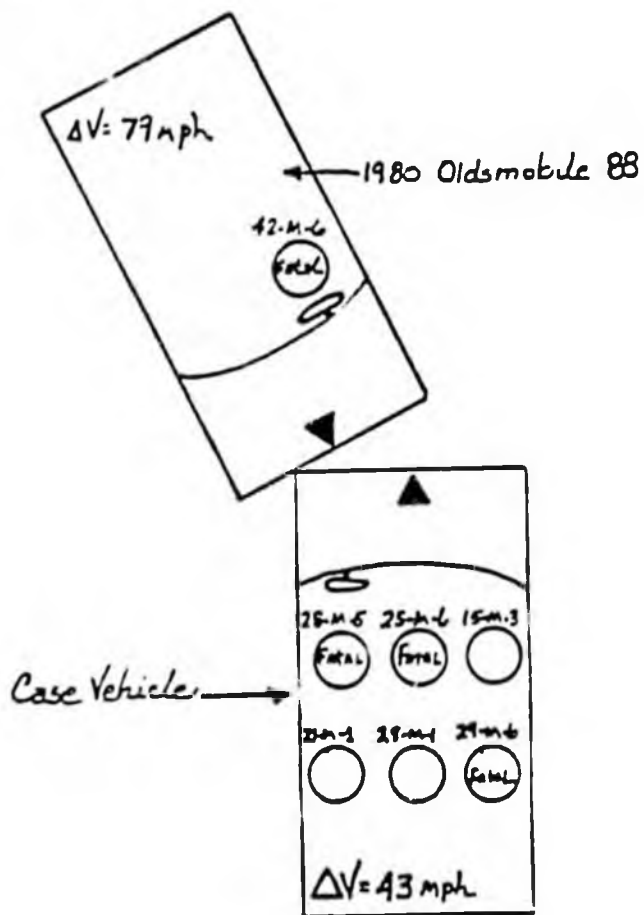
CASE 20 (FTW-85-H-OR39)

A 1973 Chevrolet Impala was struck head-on, right front to left front corner, by a 1980 Oldsmobile 88. From the area of impact, the Oldsmobile was deflected rearward approximately 14 feet from its original travel path. The Chevrolet rotated counterclockwise over 27 feet to its final resting position. Both vehicles were destroyed by the severe impact forces.

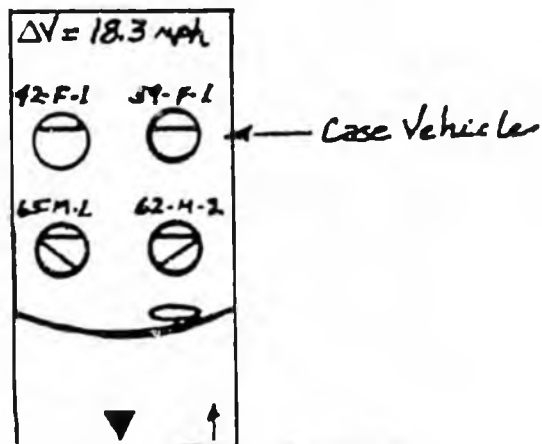
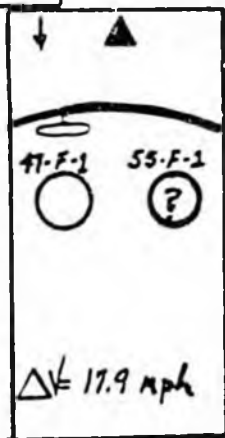
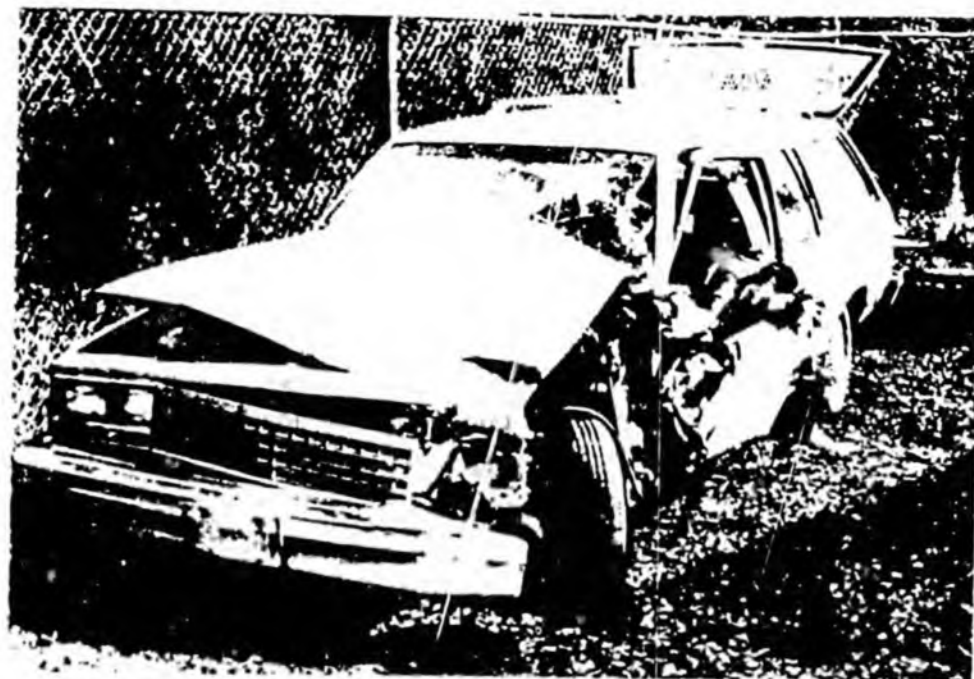
CASE 21 (SEA-85-H-OR26)

A 1983 Chevrolet Malibu station wagon was struck straight head-on, left front to left front, by a 1978 Ford Thunderbird. The Malibu was occupied by a lap/shoulder belt restrained 62-year-old male driver, a lap/shoulder belt restrained 65-year-old man seated right front, a lap belted 59-year-old woman seated left rear, and a lap belted 42-year-old woman seated right rear. The Thunderbird was driven by an unrestrained 47-year-old woman, accompanied by a 55-year-old woman in the right front, probably unrestrained. The Delta V for both vehicles was virtually identical at approximately 18 mph (longitudinal).

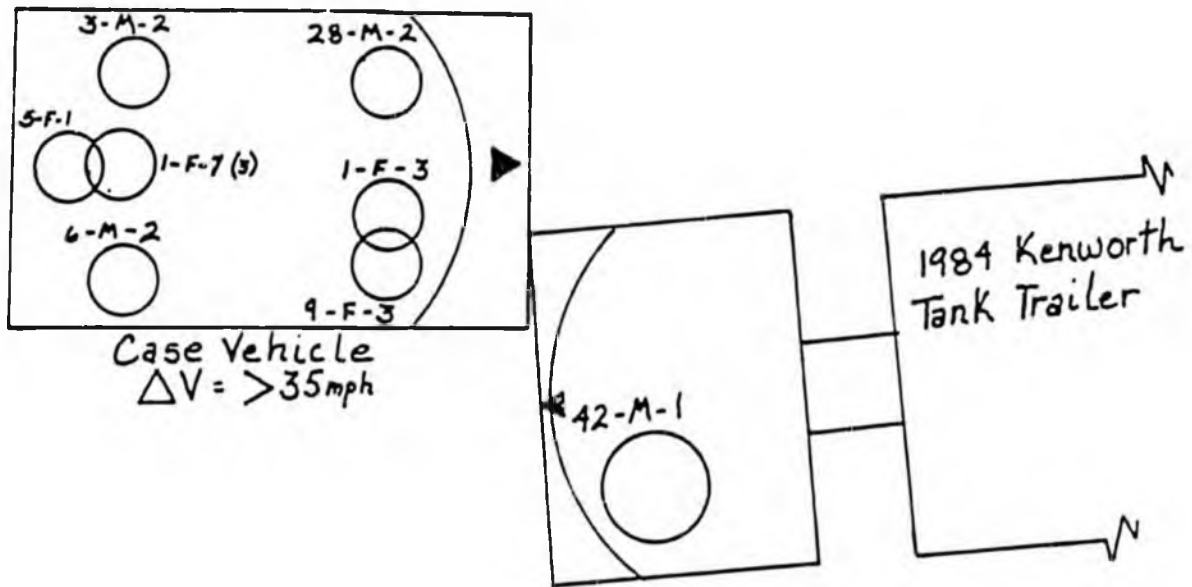
CASE 22 (FTW-86-H-OR02)

A 1979 Chevrolet Impala station wagon struck a 1984 Kenworth tractor-trailer (gasoline tanker) head-on, right front to right front. The station wagon was driven by a 28-year-old man accompanied by six other passengers who ranged in age from 10 months to 9 years. None of the stationwagon occupants were restrained.
