ALASKA LEGISLATURE COMMITTEES, 2003-2007

11957 SENATE RESOURCES

## Corrosion - 2002 Meet and Confer IV

**BP and State of Alaska Charter Agreement**  
**Corrosion Monitoring Review 2002**  
**Meet and Confer V**

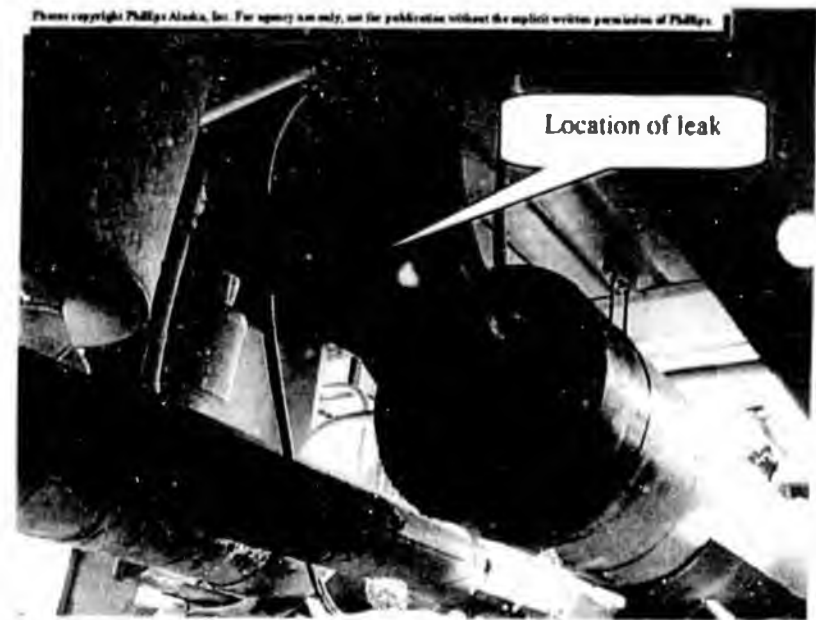
6" 2A-18 PO Well Line Leak 4/7/02

- Drill Site Operator discovered oil leaking from the flowline of Well 2A-18, which was immediately shut in
  - The spill occurred sometime between 0430 and 1030 hrs (last walkdown of area done by night operator @ 0430 hrs)
  - Due to the size of the hole, the pressure drop in the line was not enough to alarm or shut in the well
  - Leak area was a pinhole located just above the weld, where a thread-o-let used for Cosasco fitting access was located in a 90° elbow
  - The spill was estimated to be 1200 gallons of product (8% oil and 92% produced water) and covered approximately 1700 ft<sup>2</sup> of the pad
  - The spill was contained on the pad
  - With the C-sands perforations in 1999 the fluid rate in the well increased to 7000 bpd and continue to average 4000 to 6000 bpd.
- ⇒ Cause appears to be flow-assisted corrosion in flow disturbance area

- Erosion prone areas of this flowline ('S' riser and areas downstream of the choke) have been inspected seven times since 9/20/00. These inspections showed minor damage, but well within acceptable limits
- The last inspection downstream of the choke was done on 3/16/02 and showed minor damage, but was within acceptable limits
- This section of the flow line was thicker walled, 0.863", larger diameter and not where we have historically found erosion/corrosion concerns

- 23% wall loss by UT in the wellhead riser,
- 30% wall loss by RT due to erosion in the 4"x 6" reducer,
- Scattered corrosion pitting in the range of 8% to 15% wall loss throughout the majority of the 6" section of the flowline.
- The manifold piping exhibited erosion to the impingement areas in the range of 4% to 34% wall loss by RT & UT
- A total of 61 locations were inspected by (RT) Radiography and 11 locations by (UT) Ultrasonics.
- No locations on the well line needed to be repaired, other than leak area

- Inspect the rest of the 2A-18 flow line prior to putting it back into service  
- **Complete**
- Determine where other similar locations exist at Kuparuk on drill sites  
i.e. thread-o-lets with Cosasco fittings on well lines on the outside  
radius of 90° elbows – **Complete** (Approx. 220 locations)
- Inspect all the locations identified above using radiography to  
determine if there is a pattern of corrosion in these locations.
- Based on the inspection results, develop and implement a long-term  
inspection and repair plan for the identified problem areas.
- All Items to be completed by YE 2002

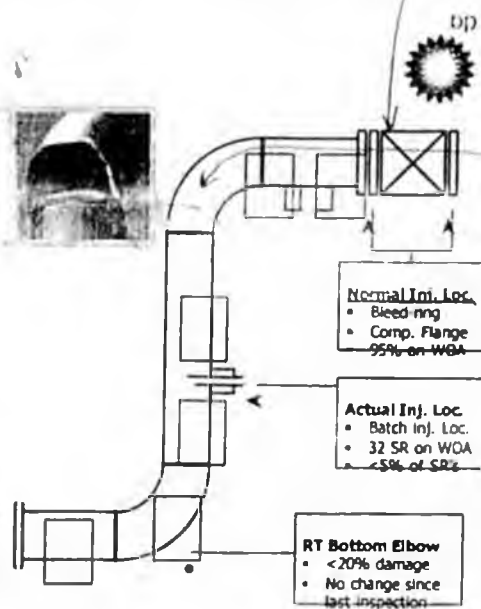
- » Prior Inspections
  - 6 locations by Radiography
  - No damage greater than 20%

- » Short term - complete
  - Inspected 347 GPB s-risers
  - 2 repairs identified
- » Long term - ongoing
  - Move corrosion inhibitor injection locations

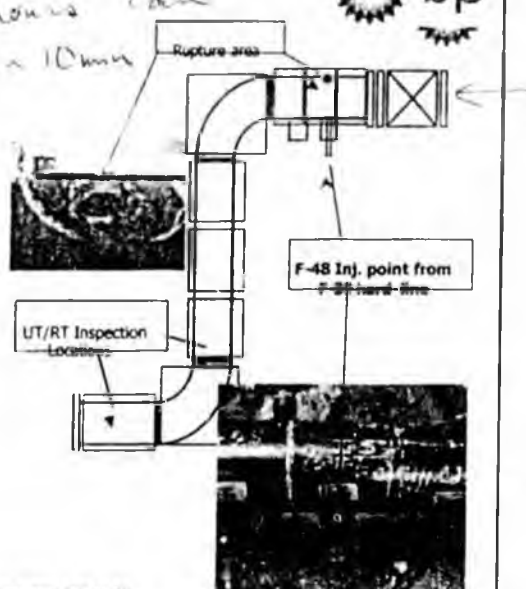
- ▶ May 31st small leak detected
- ▶ Line shut-in and insulation removed

- ▶ Failure caused by external corrosion
  - Weld pack in saddle
  - 7:00 to 10:00 clock position
  - 8" x 10" network with pinhole leak

- ▶ Complete line review performed
  - All insulation joints
- ▶ Sleeve repair leak location
  - No additional sleeves required

### ▶ Corrective Action Plan

- ▶ Inspection of adjacent piping
- ▶ Long term
  - Identify similar locations
  - Integrate into O&M program
- ▶ Interface with Operations

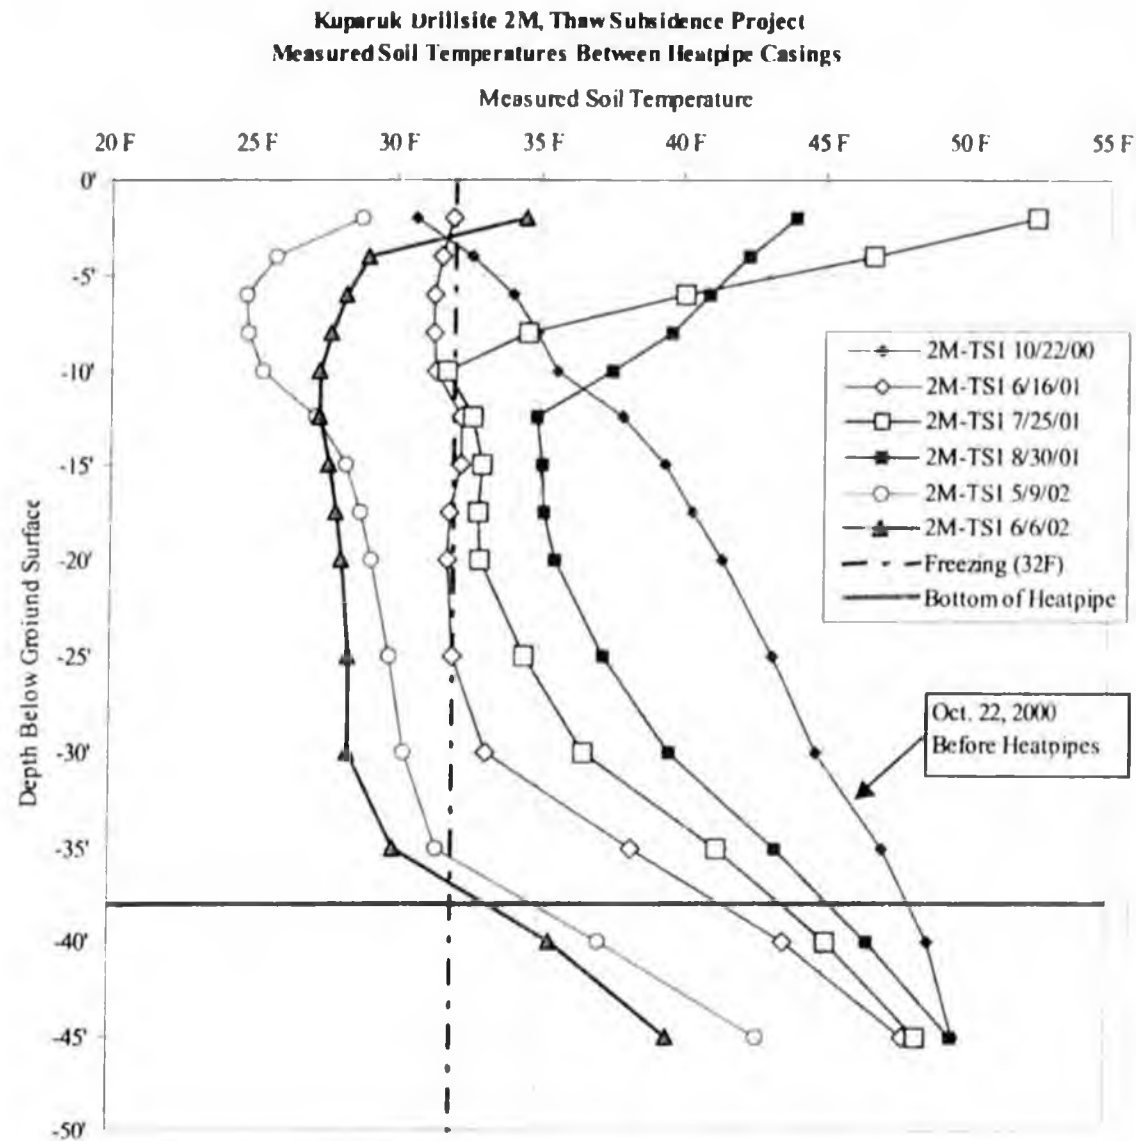
## Subsidence Mitigation at Drill Site 2M

- ✓ Periodic subsurface thermistor monitoring indicates the heat tubes are achieving the desired results, showing the expected thaw bulb contraction

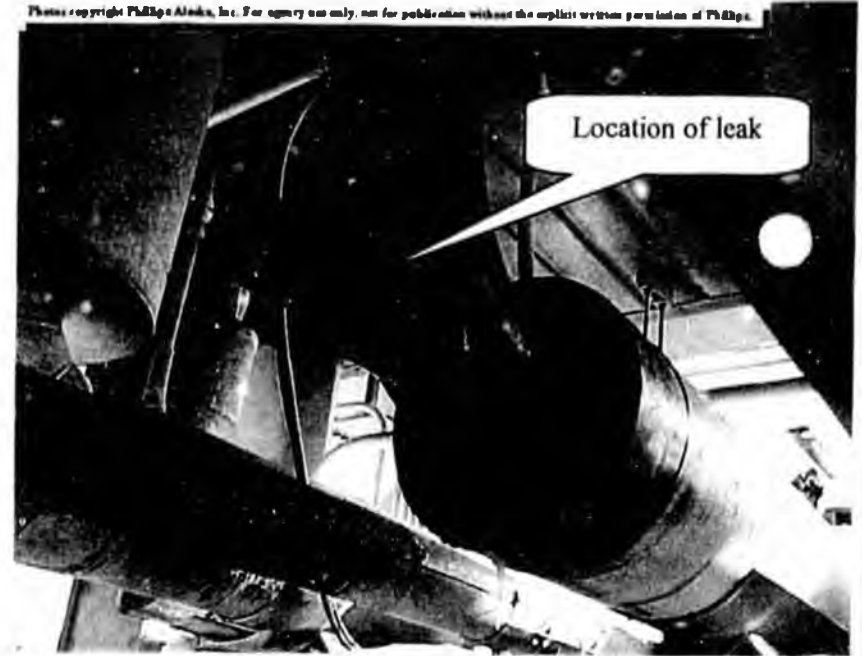
6" 2A-18 PO Well Line Leak

- Leak area was a pinhole located just above the weld, where a thread-o-let used for Cosasco fitting access was located in a 90° elbow
- 1200 gallons of product (8% oil and 92% produced water) on-pad
- ⇒ Cause appeared to be flow-assisted corrosion in flow disturbance area

## All Action Items Complete:

- ✓ Inspected remainder of 2A-18 well line prior to returning to service
  - Post-spill inspection of well line showed no areas required repair, other than leak location
- ✓ Completed survey for similar locations at all Drill Sites (283 locations)
- ✓ Completed RT inspections on all 283 similar locations on 6/22/02
  - No repairs required due to this corrosion mechanism
  - Two repairs due to other causes (questionable original weld, deteriorated threads)
- ⇒ Inspections confirm theory of isolated mechanism
- ✓ Added these locations to recurring interval survey for each well line
