**Greater Kuparuk Area (GKA)  
Western North Slope (WNS)  
Corrosion Programs Overview**

*Commitment to Corrosion Monitoring  
6<sup>th</sup> Annual Report to the Alaska Department of Environmental Conservation*

Prepared by  
**ConocoPhillips Corrosion Team**

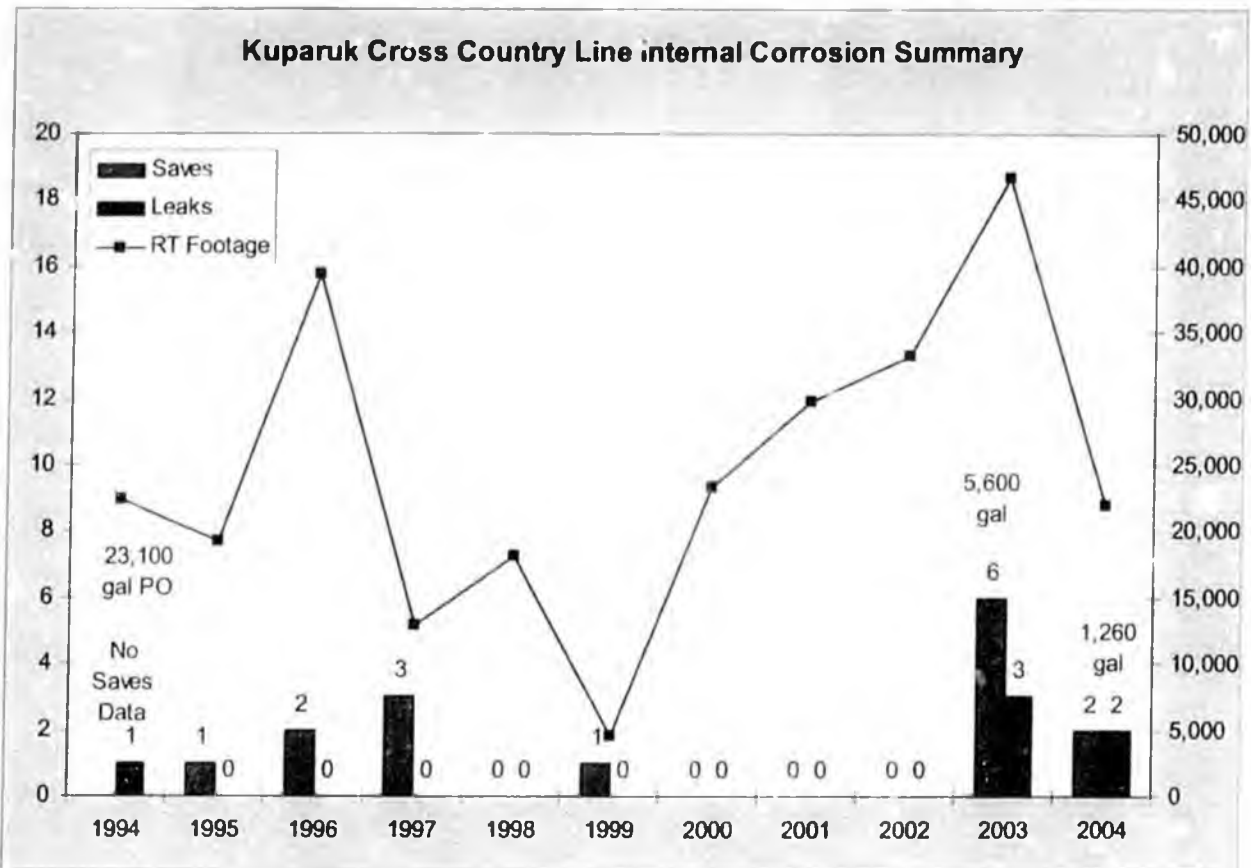
Figure 9. Summary of Cross-Country Line Internal Corrosion Inspections – RT footage, leaks, and saves as a function of time.

As indicated in Figure 9, four repair recommendations were initiated on cross-country lines (1 seawater injection, 3 production) because of internal corrosion damage in 2004. The corrosion mechanism for the three production lines was deadleg corrosion. The corrosion mechanism for the seawater injection line leak, determined not to be an ADEC-reportable spill, was microbiologically induced corrosion. More information on the leak can be found in section 3.1.g.

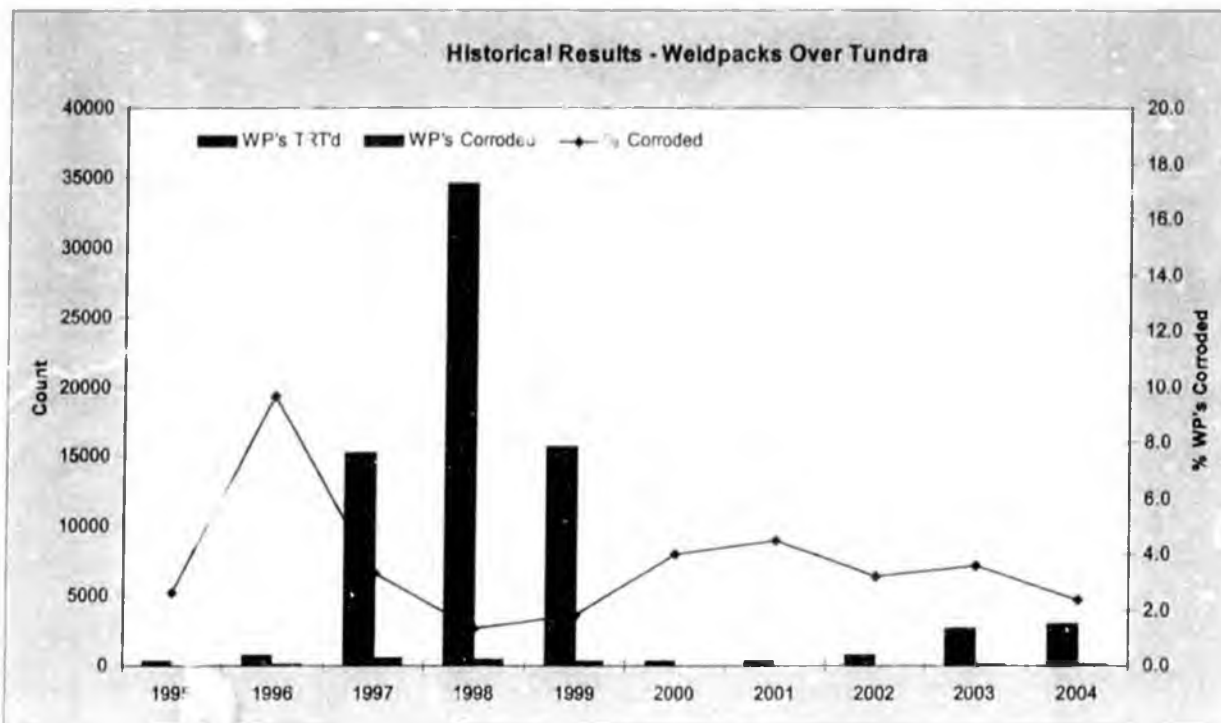
Figure 11. Summary of Weld Packs on Cross-Country Lines over Tundra (off-pad).

Figure 11 illustrates the most-complete external corrosion inspection program of the three external corrosion programs. 2002, 2003, and 2004 values include re-inspections and clean-up of locations missed or not properly documented during the original base line effort.

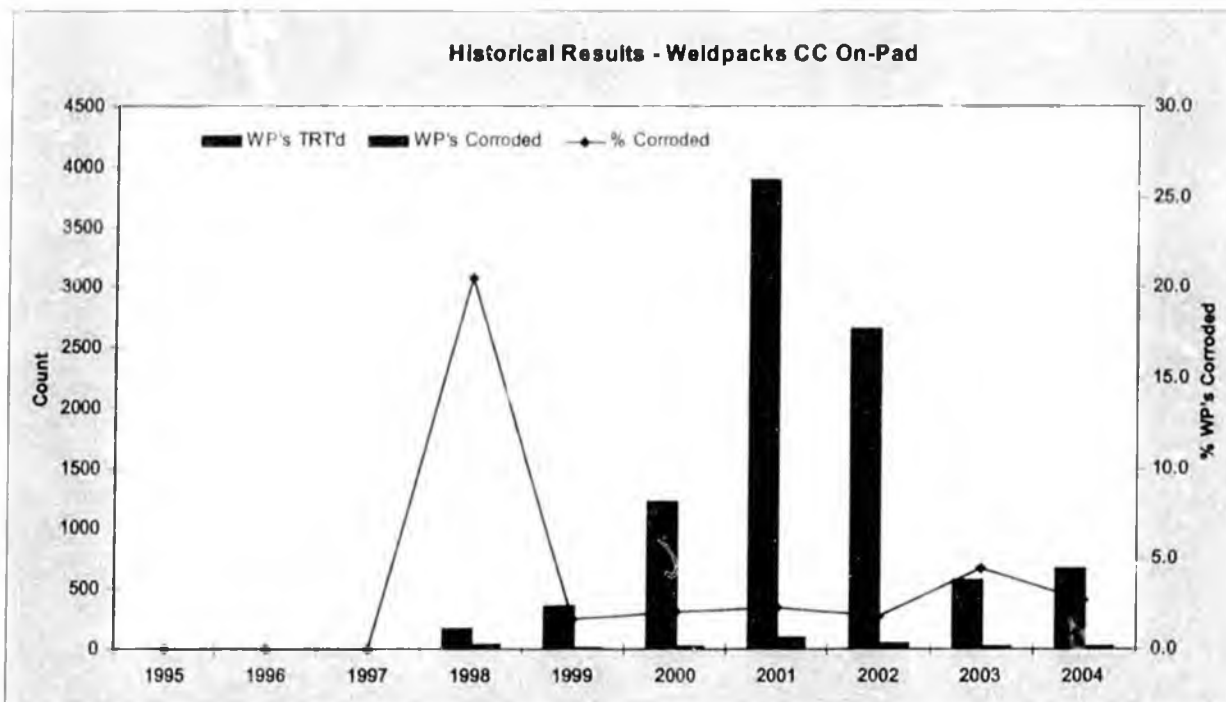
Figure 12. Summary of Weld Packs on Cross-Country Lines on Pads.

Figures 12 and 13 depict the results of the major focus of the external weld pack inspection program in 2004. The cross-country program and the well line weld pack program met milestones in 2004 by completing all of the baseline TRT inspections of all weld packs in their respective areas.

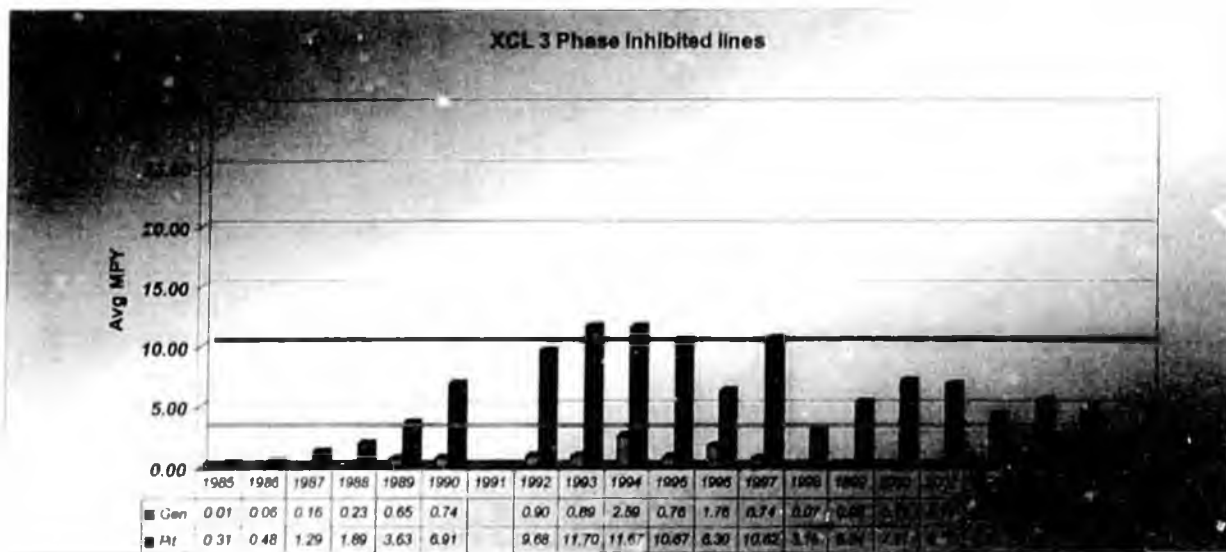
Figure 1. Three-phase Production Cross-Country Line Coupons – general and pitting corrosion rates as a function of time.

*Three-phase Production Cross-Country Lines:* The monitoring data summarized in Kuparuk Tables 1 and 2 and presented in Figure 1 suggest that general corrosion is under control. The data presented in Tables 1 and 2 and in Figure 1 include corrosion coupon data from the wet oil lines starting at CPF3 and going to CPF1 and CPF2.

Where corrosion rates exceeded targets, corrosion inhibitor concentrations were increased and/or the amount of inspection was increased. In 2005, coupon, probe or inspection-based corrosion rates exceeded targets or revealed increased damage on eight lines. In 2005, inspection results indicated minor corrosion had occurred in four of these eight lines. A complete listing of the lines with coupon/probe corrosion rates that exceeded targets and/or where inspection indicated increased damage is given in Table 3.

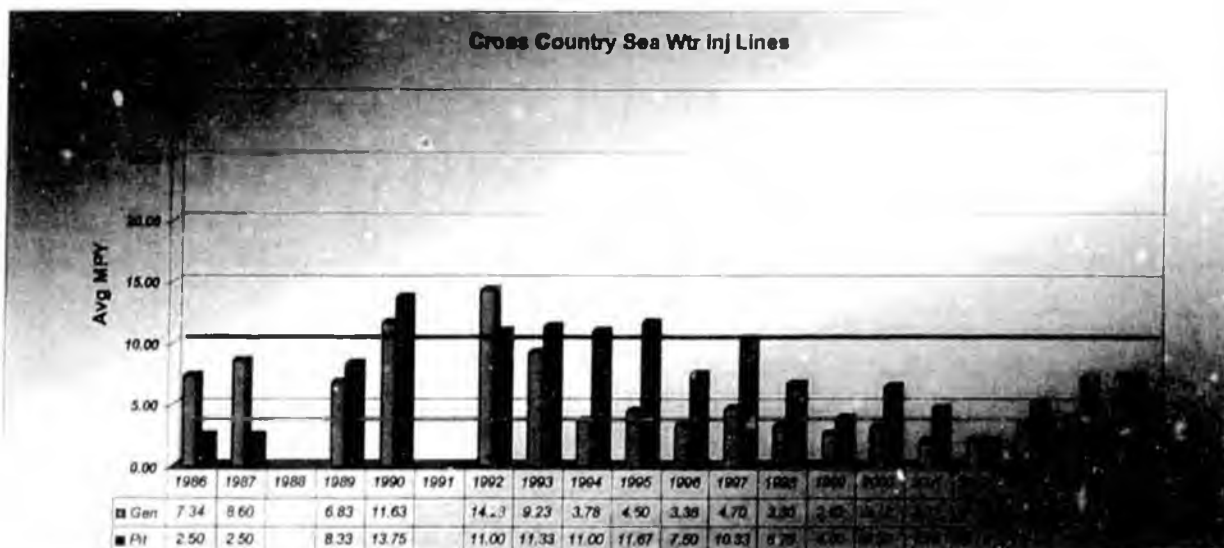
**Figure 2. Seawater Cross-Country Line Coupons – general and pitting corrosion rates as a function of time.**

*Sea Water Cross-Country Lines:* The monitoring data summarized in Kuparuk Tables 1 and 2 and presented in Figure 2 above, show the average corrosion rates for the sea water cross-country line coupons. Higher coupon corrosion rates were caused by higher dissolved oxygen concentrations seen during 2005 break-up and oxygen scavenger was added to decrease the dissolved oxygen concentration; these coupons are located near the exit of the sea water treatment plant (STP) and are not believed to be indicative of corrosion in the sea water injection system. Increased coupon corrosion rates detected are currently under review, with biocide concentration and pigging frequency increased in early 2006. Smart pigging of the 30-inch sea water line from the STP to the CW Skid is planned for 2006.

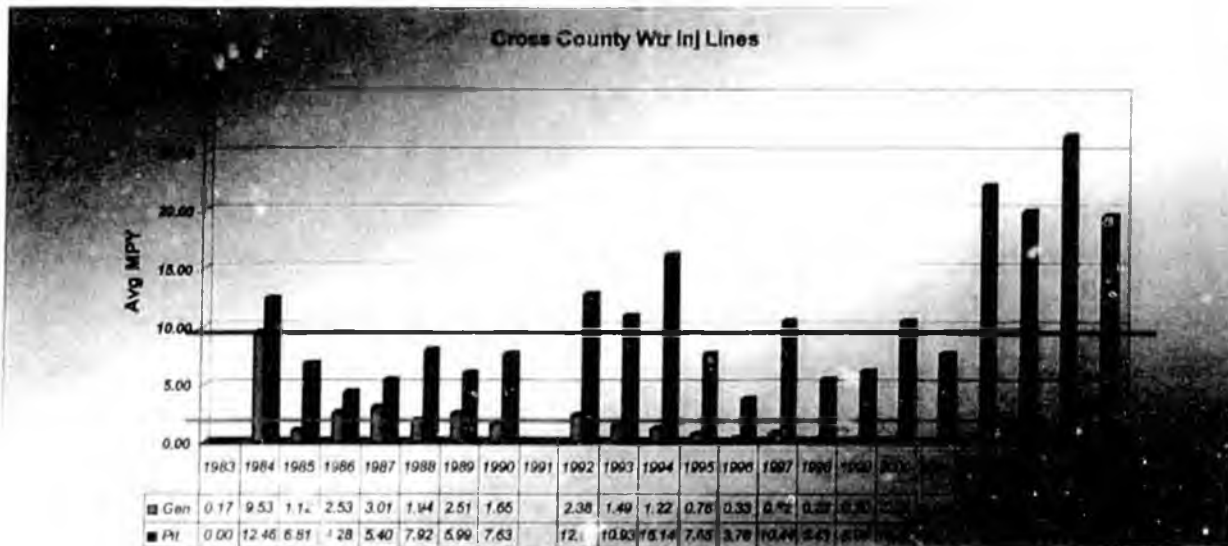
Figure 3. Water Injection Cross-Country Line Coupons – general and pitting corrosion rates as a function of time.

*Water Injection Cross-Country Lines:* The monitoring data summarized in Kuparuk Tables 1 and 2 and presented in Figure 3 show that average general corrosion rates are below the threshold, but that pitting rates for the field are above the threshold. Seawater and produced water commingling was suspended at CPF2 in August 2005 and coupons replaced then; coupons were retrieved from CPF2 in late November with pitting rates reduced markedly from previous pulls. Coupon results are used to prioritize inspection efforts. During 2005 additional equipment was installed and procedures were implemented to provide enhanced biocide treatments at CPF2. Cleaning pigs were upgraded to include brushes in addition to the disks and the pigging procedures changed to include multiple (three) pig runs per monthly cleaning cycle.

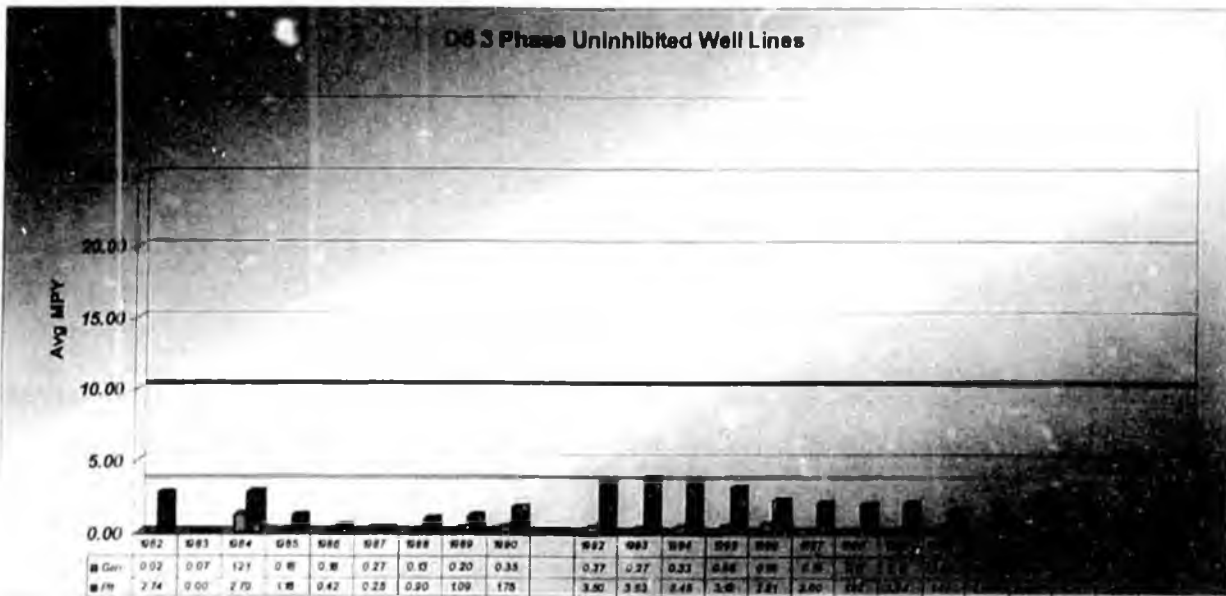
**Figure 4. Three-phase Production Well Line Coupons – general and pitting corrosion rates as a function of time.**

*Three-phase Production Well Flow Lines:* While the monitoring data summarized in Kuparuk Tables 1 and 2 and presented in Figures 4 and 5 suggest that corrosion rates are below targets, inspection data indicate that higher corrosion rates have been experienced historically. The well line inspection data are discussed in section 3.1.b below, and are a good example of why monitoring data alone cannot be relied upon to characterize corrosion in a given system. For three-phase production, coupons monitor free flowing fluid and have not shown the predominant, under-deposit corrosion mechanism.

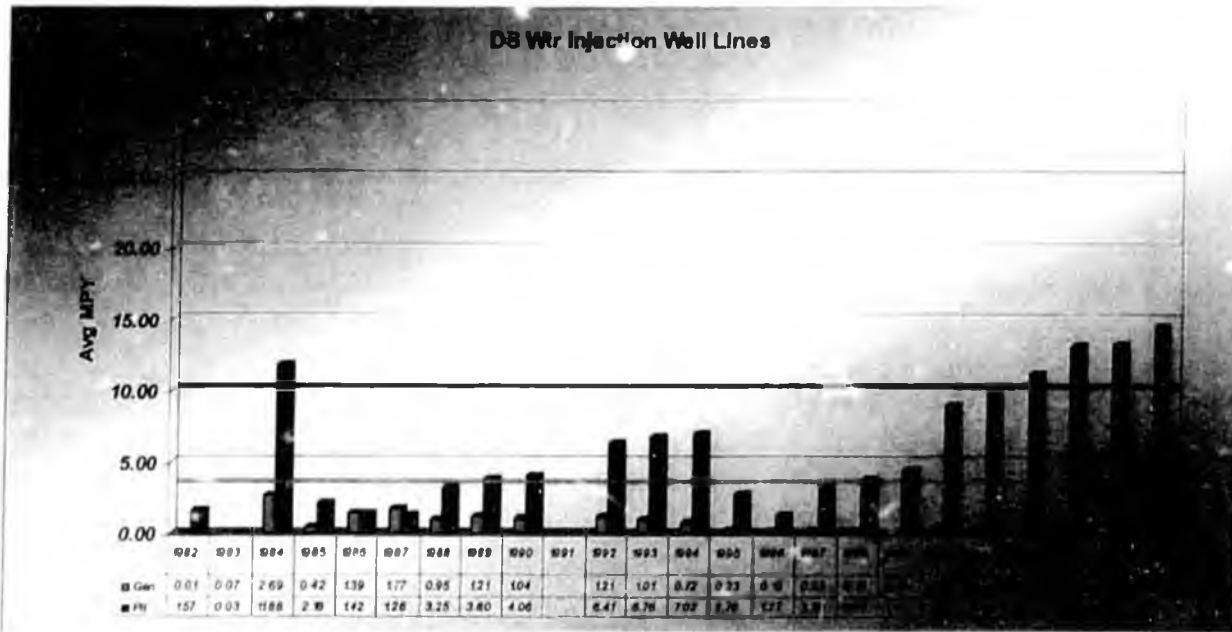
Figure 5. Water Injection Well Line Coupons – general and pitting corrosion rates as a function of time.

*Water Injection Well Flow Lines:* As discussed in section 3.1 b below, the well line inspection data on water injectors show that there are a significant number of corrosion related repairs. The water feeding this system is treated at the facilities with biocide and is discussed under Figure 3 - Water Injection Cross-Country Line Coupons. We believe that the increasing trend of coupon corrosion rates in the water injection well lines is caused by additional solids accumulating in the well lines because of low flow rates and improved pigging upstream of the well lines.

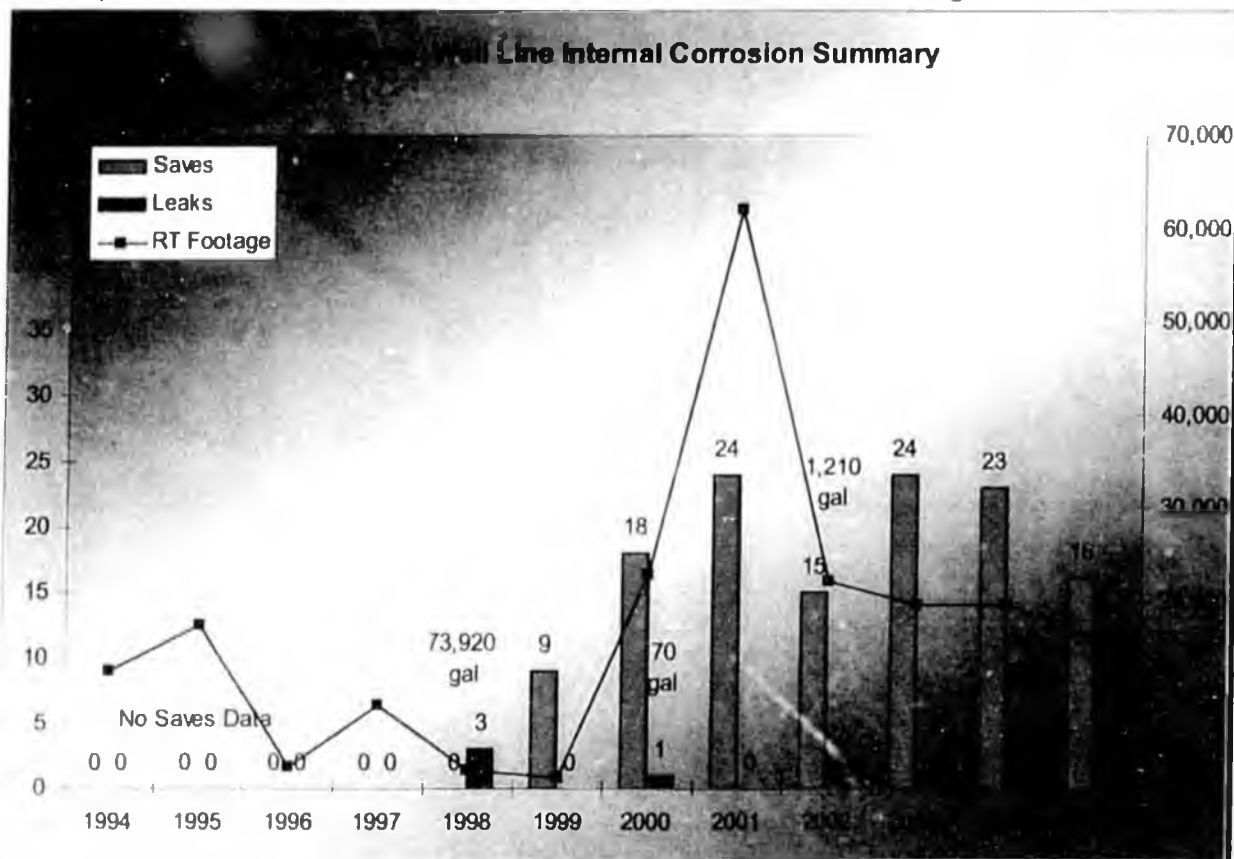
Figure 8. Summary of Well Line Internal Corrosion Inspections – RT footage, leaks, and saves as a function of time.

As indicated in Figure 8 below, repair recommendations were initiated on 18 well lines in 2005 because of internal corrosion or erosion damage (11 corroded water injection lines, 6 corroded production lines and 1 eroded production line). Except for the leak that was caused by erosion, the corrosion mechanisms were all underdeposit corrosion. More information on the leaks can be found in section 3.1.g.

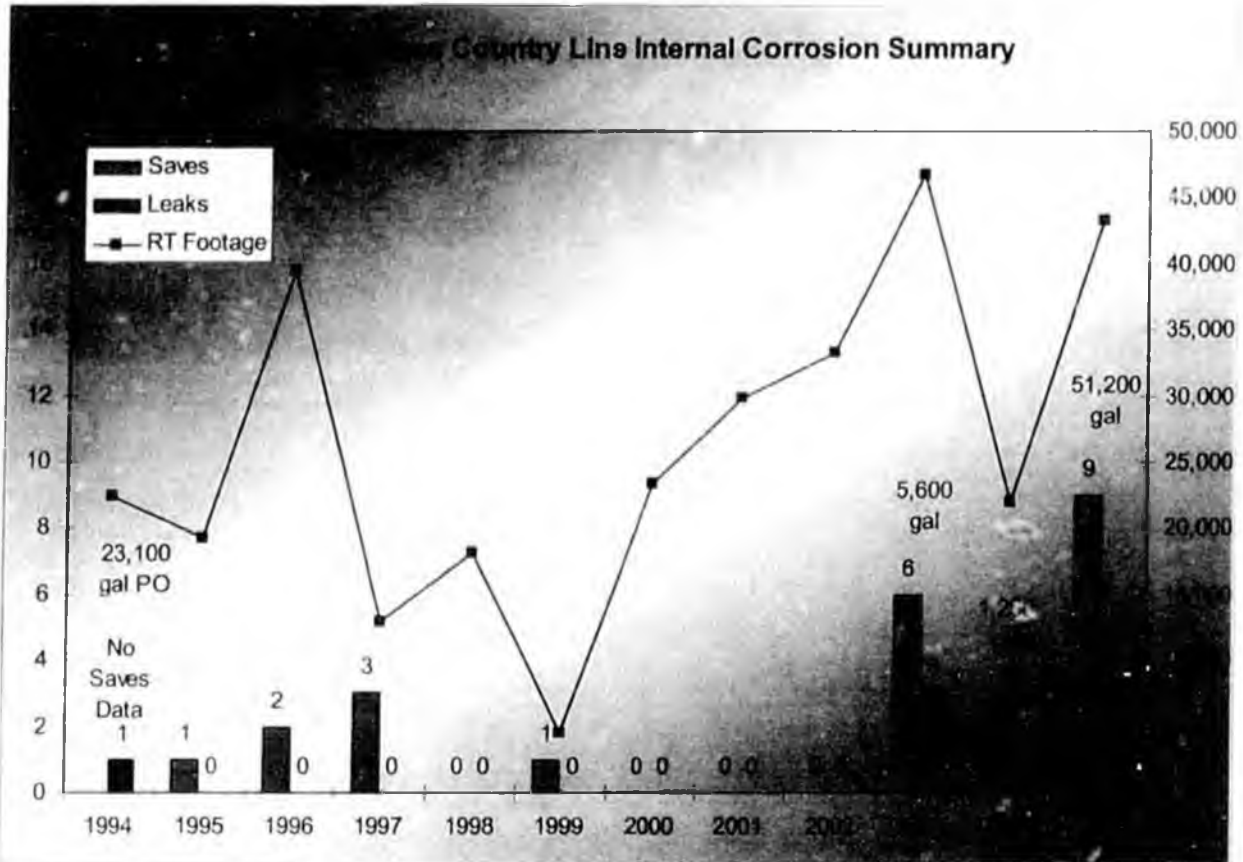
Figure 9. Summary of Cross-Country Line Internal Corrosion Inspections – RT footage, leaks, and saves as a function of time.

As indicated in Figure 9, 12 repair recommendations were initiated on cross-country lines (8 water injection, 4 production) because of internal corrosion damage in 2005. The corrosion mechanism for all repair recommendations was deadleg/underdeposit corrosion. All three leaks were in the water injection system. More information on the leaks can be found in section 3.1.g.

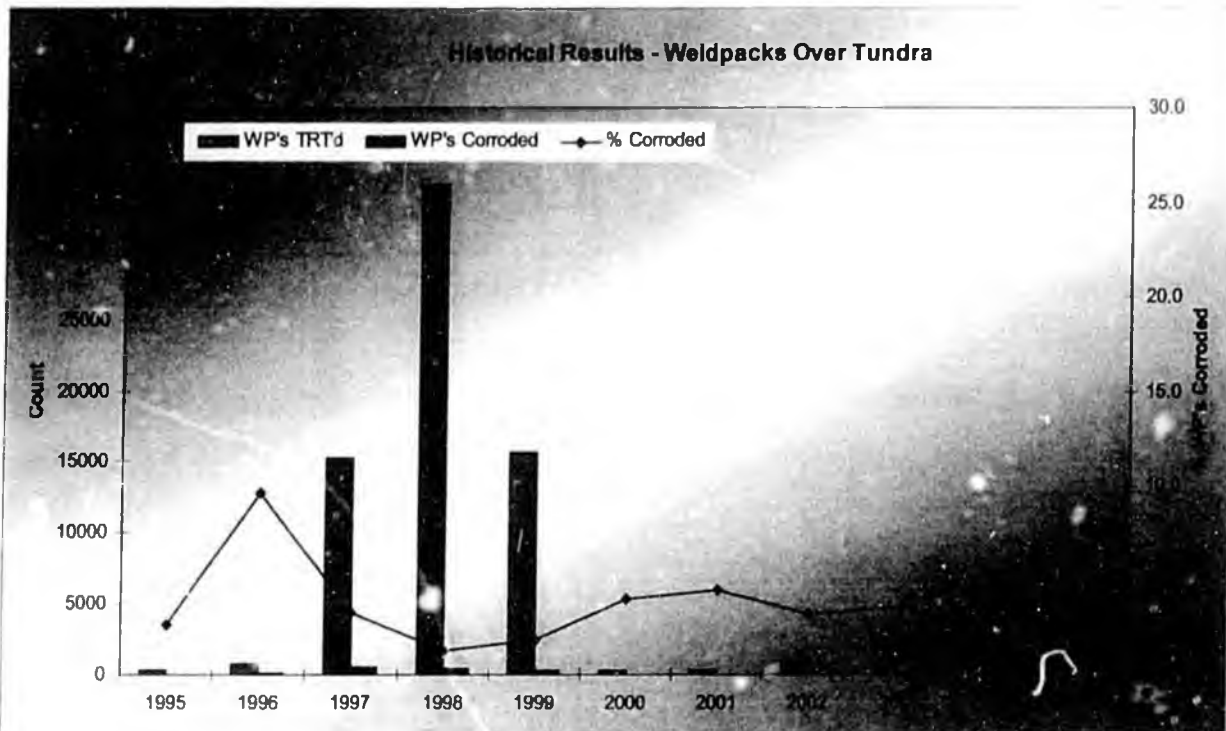
Figure 11. Summary of Weld Packs on Cross-Country Lines over Tundra (off-pad).

Figure 11 illustrates the most-complete external corrosion inspection program of the three external corrosion programs. 2002 through 2005 values include re-inspections and clean-up of locations missed or not properly documented during the original base line effort.
