Risks and Impacts from a Tailings Dam Failure at the Proposed Pebble Mine

April 1, 2019

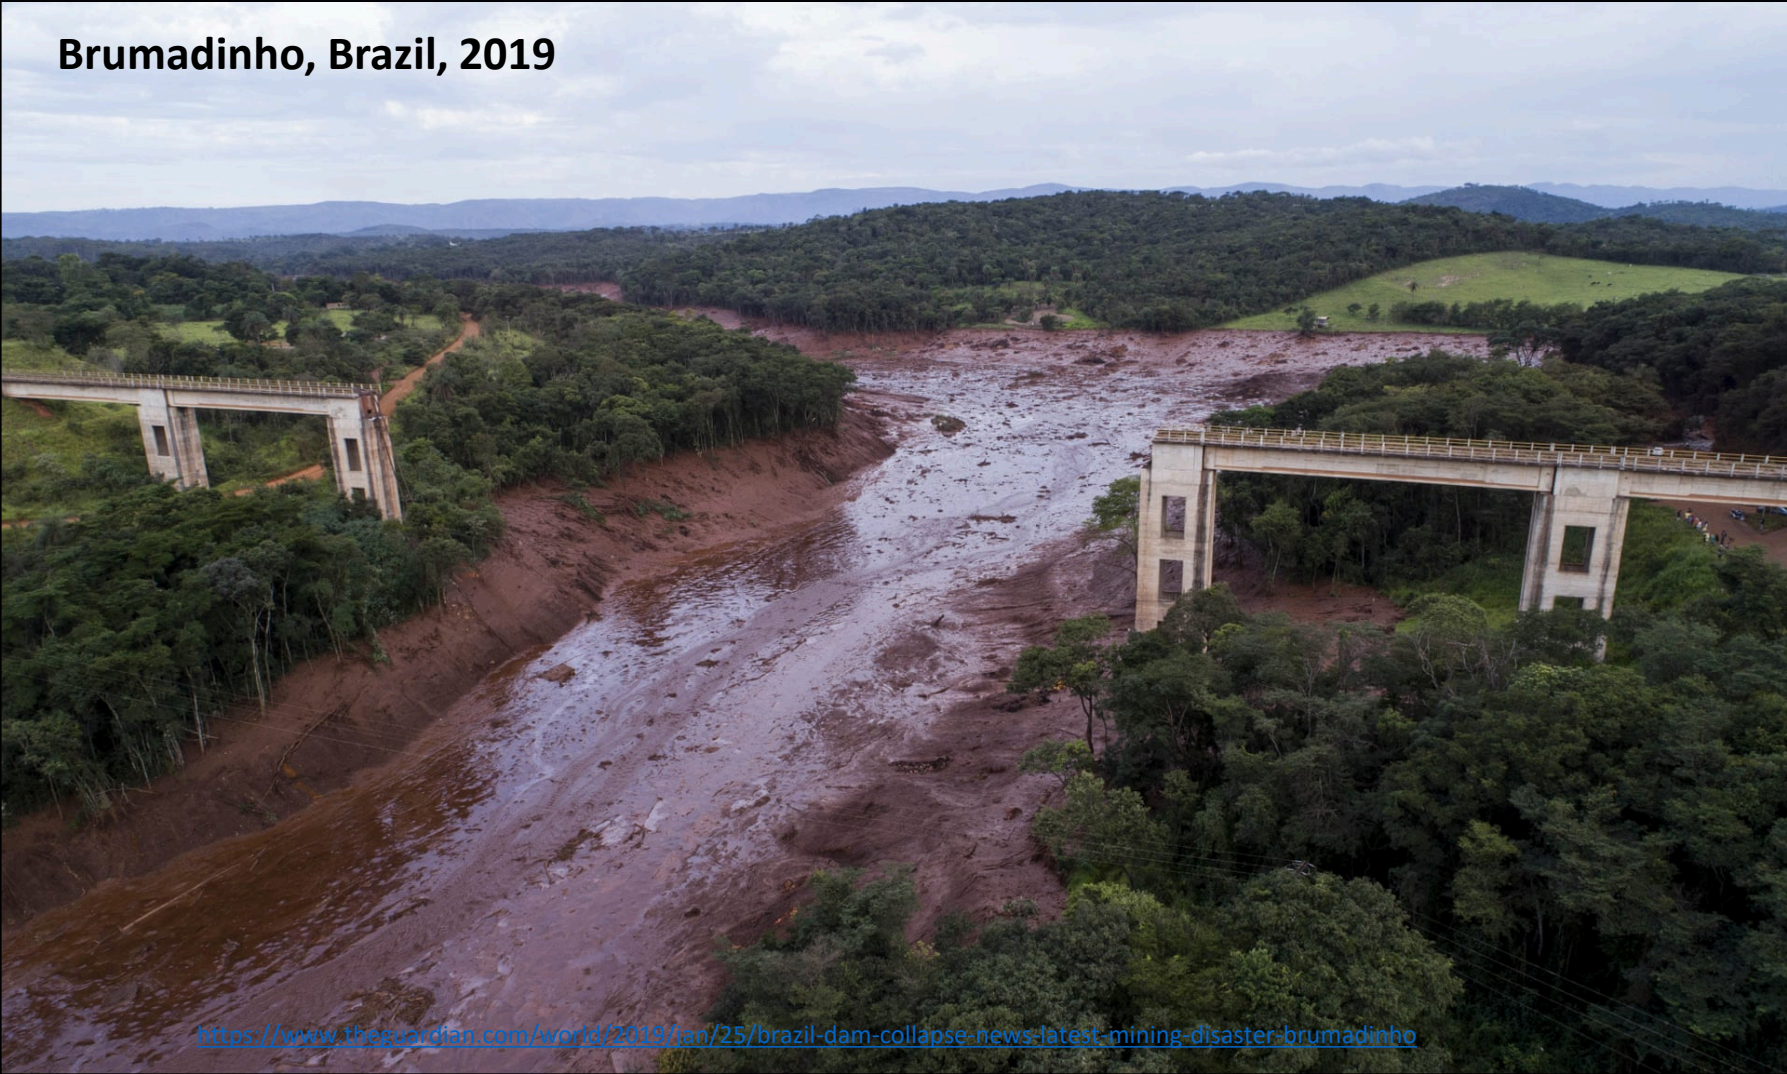
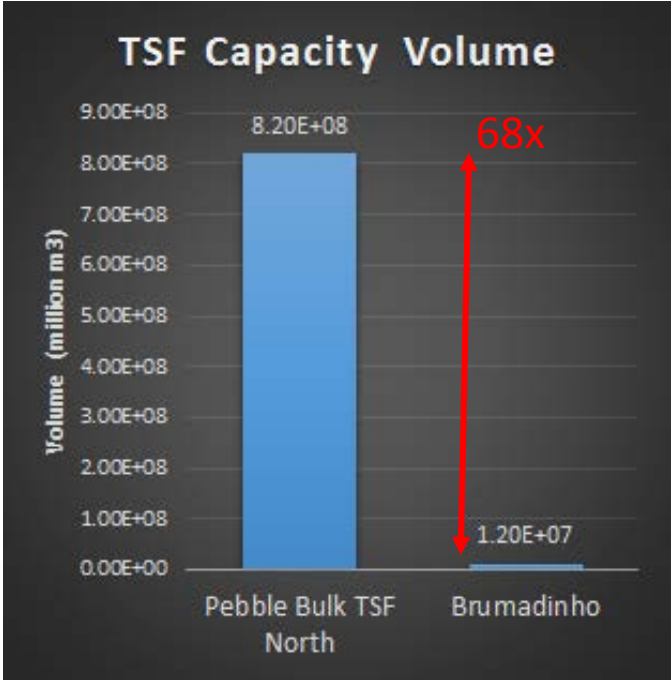
Brumadinho, Brazil, 2019

Recent Tailings Dam Failures

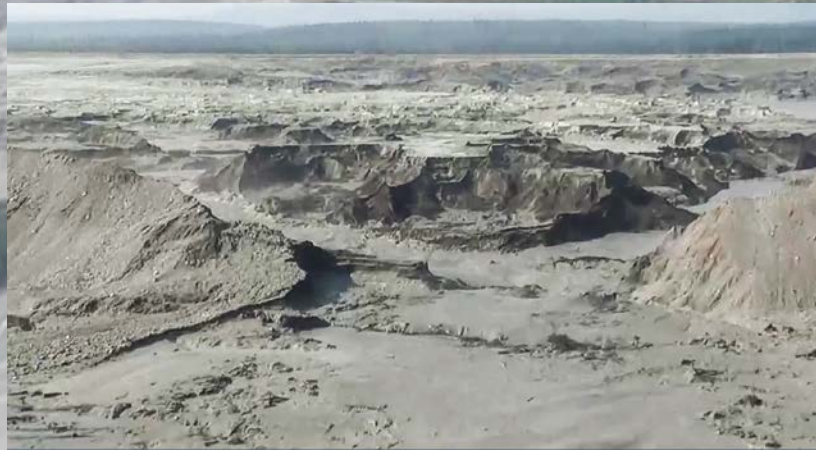
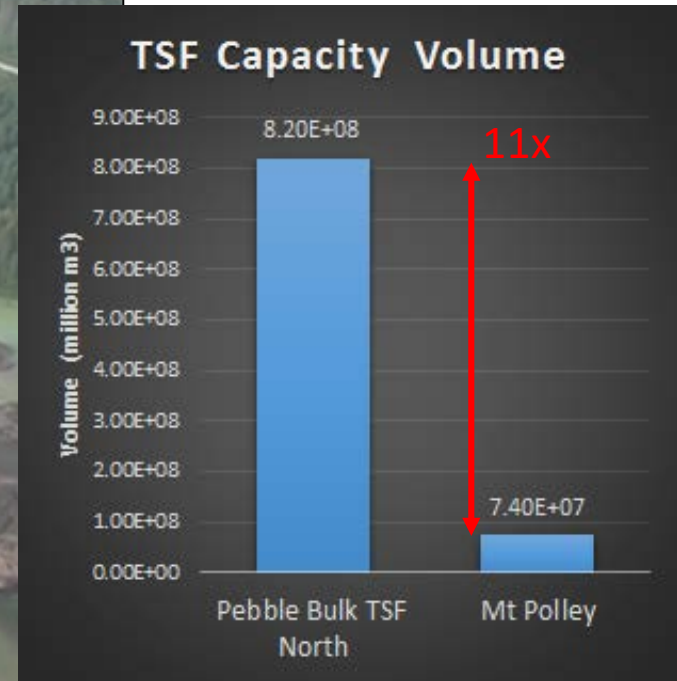
Mt. Polley, BC 2014

The Panel concluded that the dominant contribution to the failure resides in the design. The design did not take into account the complexity of the sub-glacial and pre-glacial geological environment associated with the Perimeter Embankment foundation. As a result, foundation investigations and associated site characterization failed to identify a continuous GLU layer in the vicinity of the breach and to recognize that it was susceptible to undrained failure when subject to the stresses associated with the embankment.

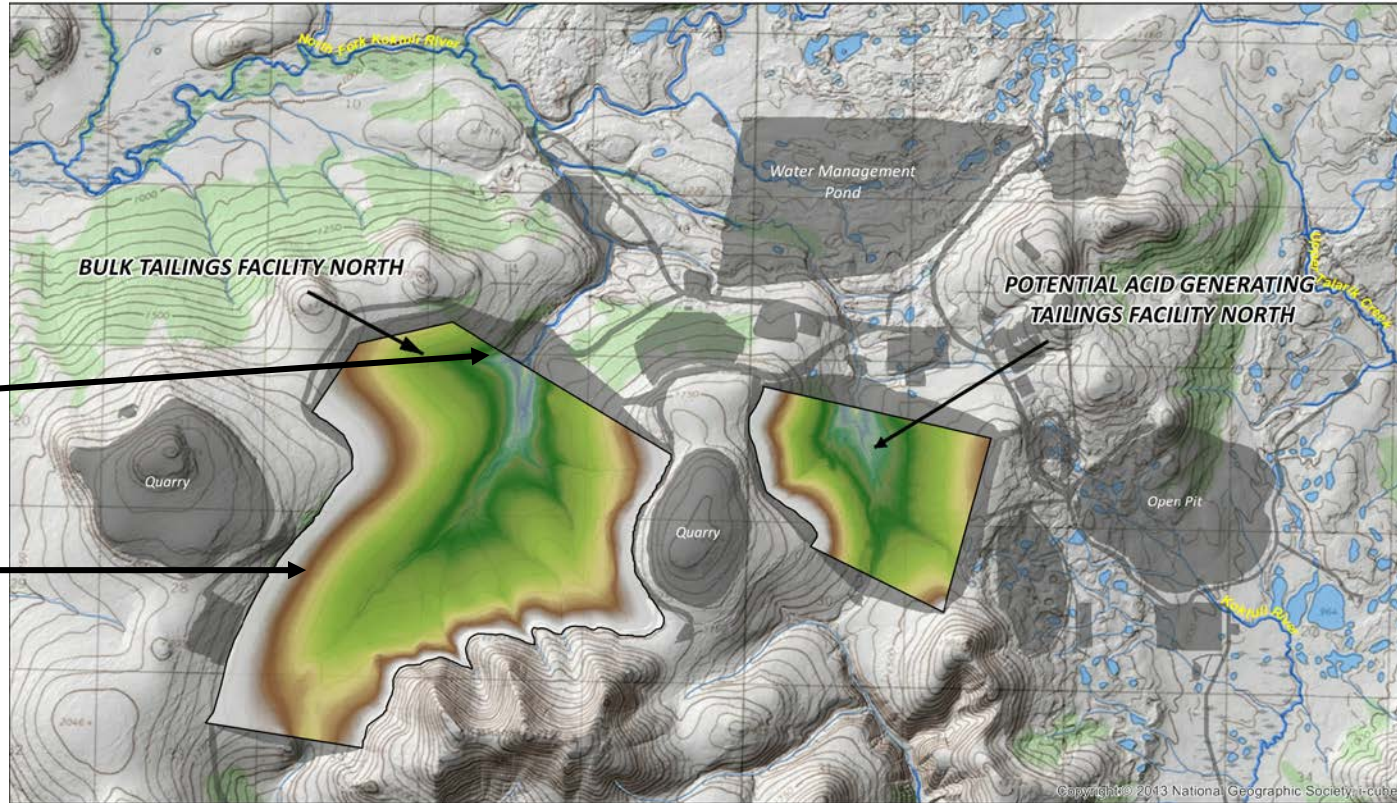
PROPOSED TAILINGS STORAGE FACILITIES FOR THE PEBBLE MINE - CURRENT PROPOSAL

Dam Height = 545ft

Capacity = ~328,000 Olympic swimming pools

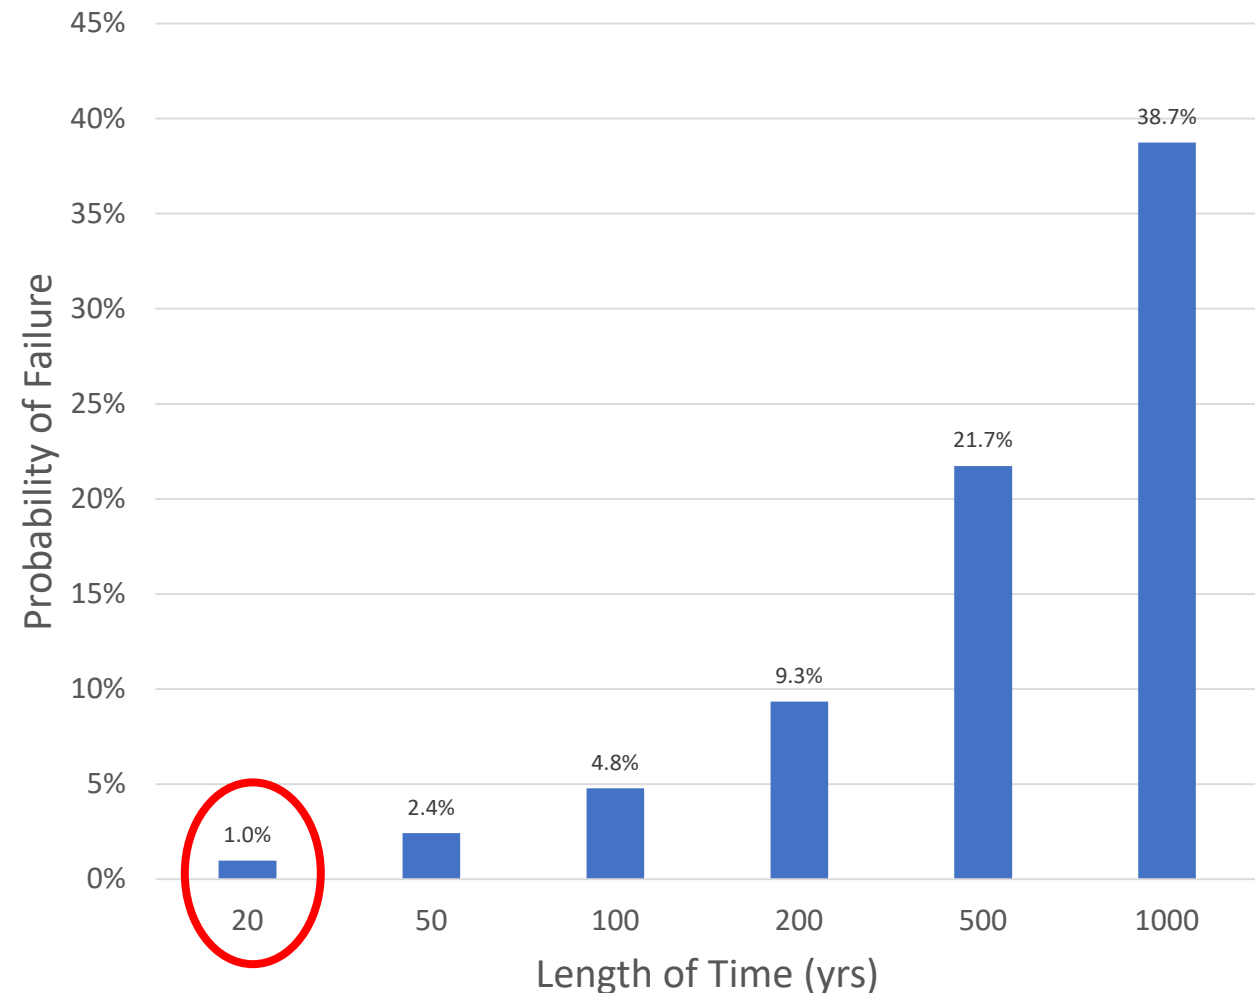
Probability of "1 in 2000" event over time

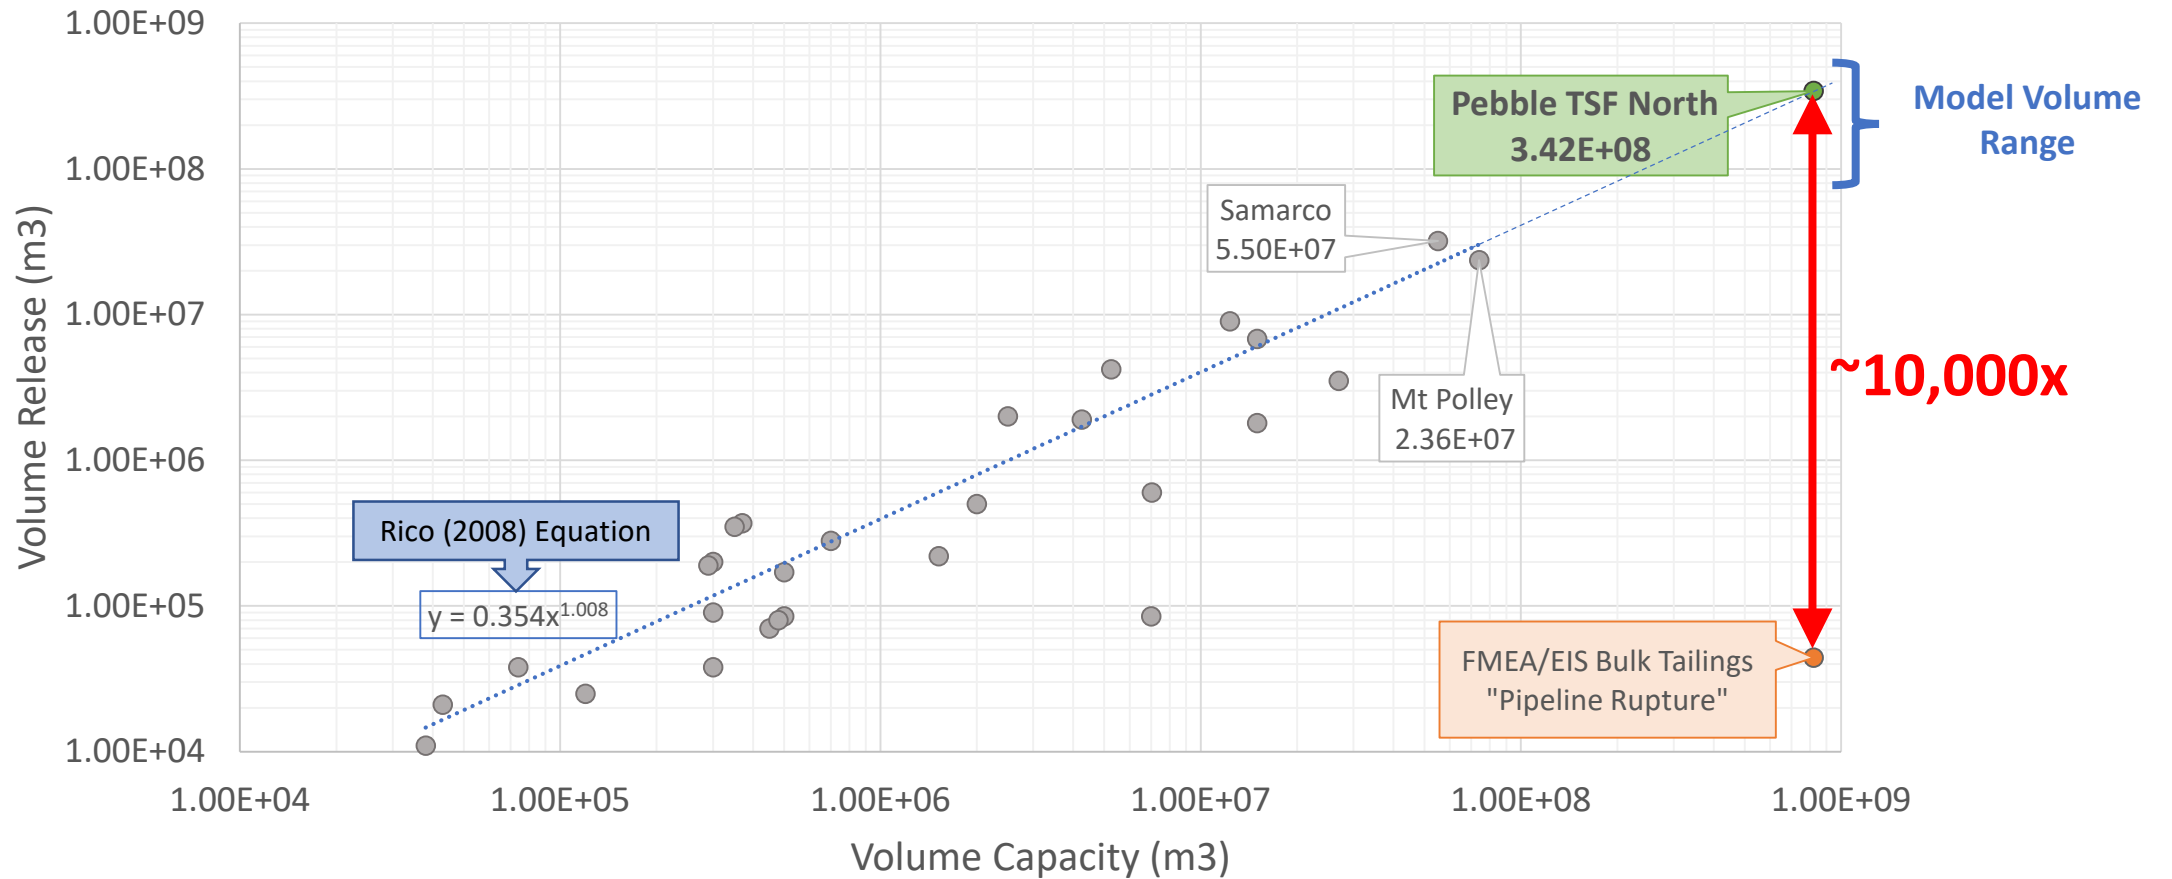
Breach Volume Released vs Tailings Storage Facility Capacity

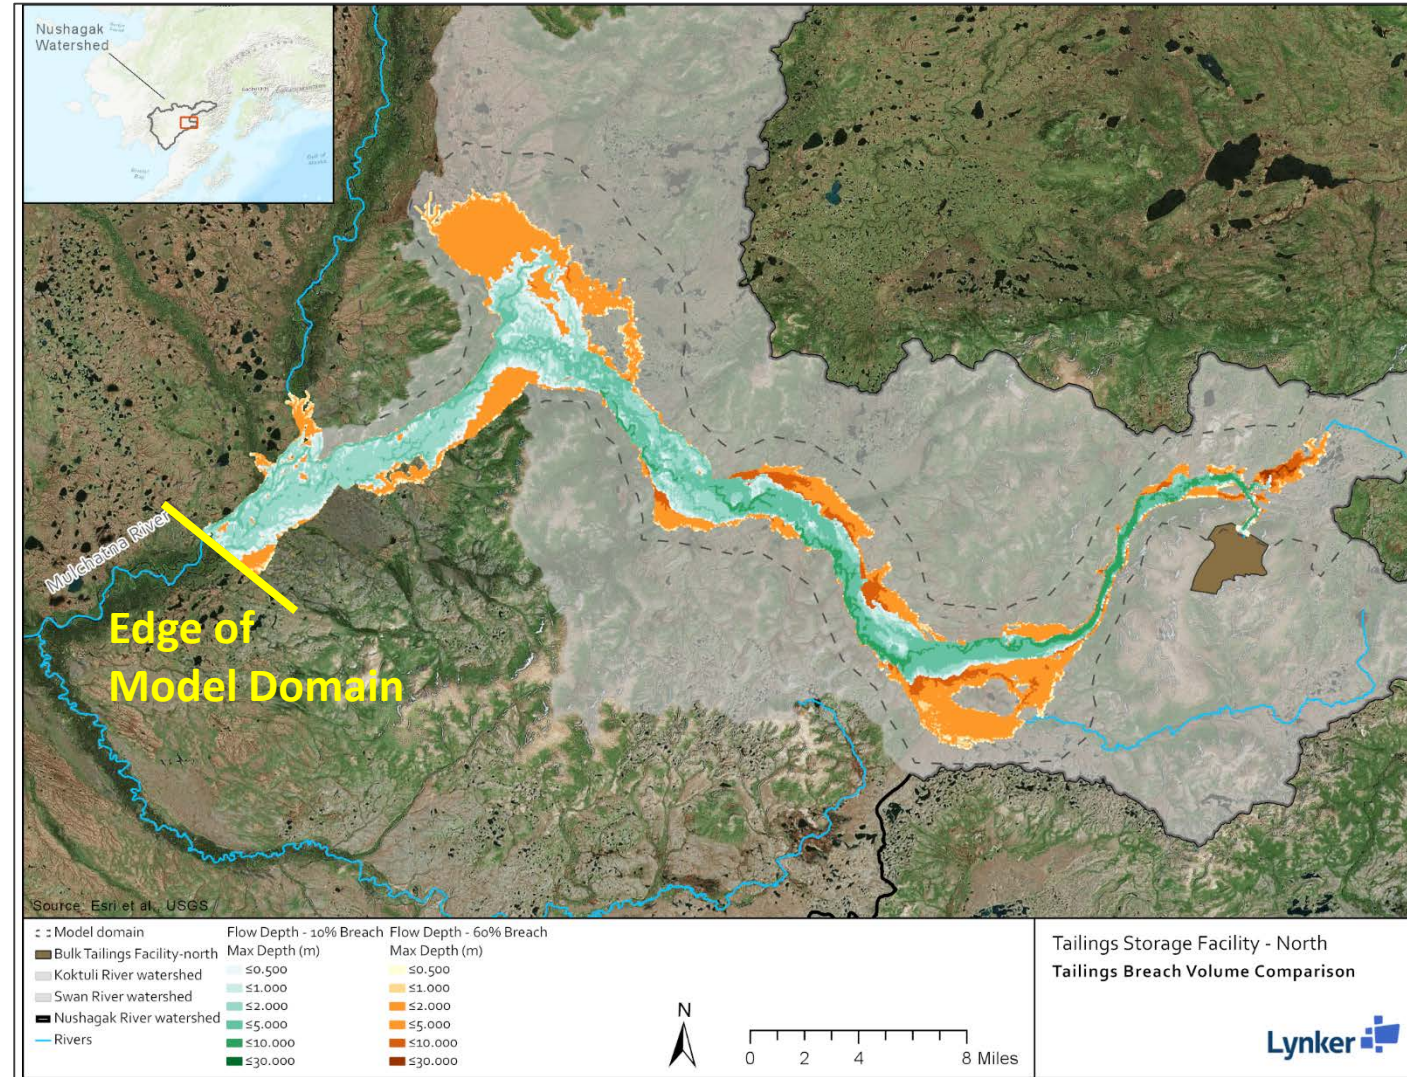
Breach Volume Comparison

10% breach volume (green)

- Inundated Area: 60.9 mi²

60% breach volume (orange)

- Inundated Area: 110.3 mi²

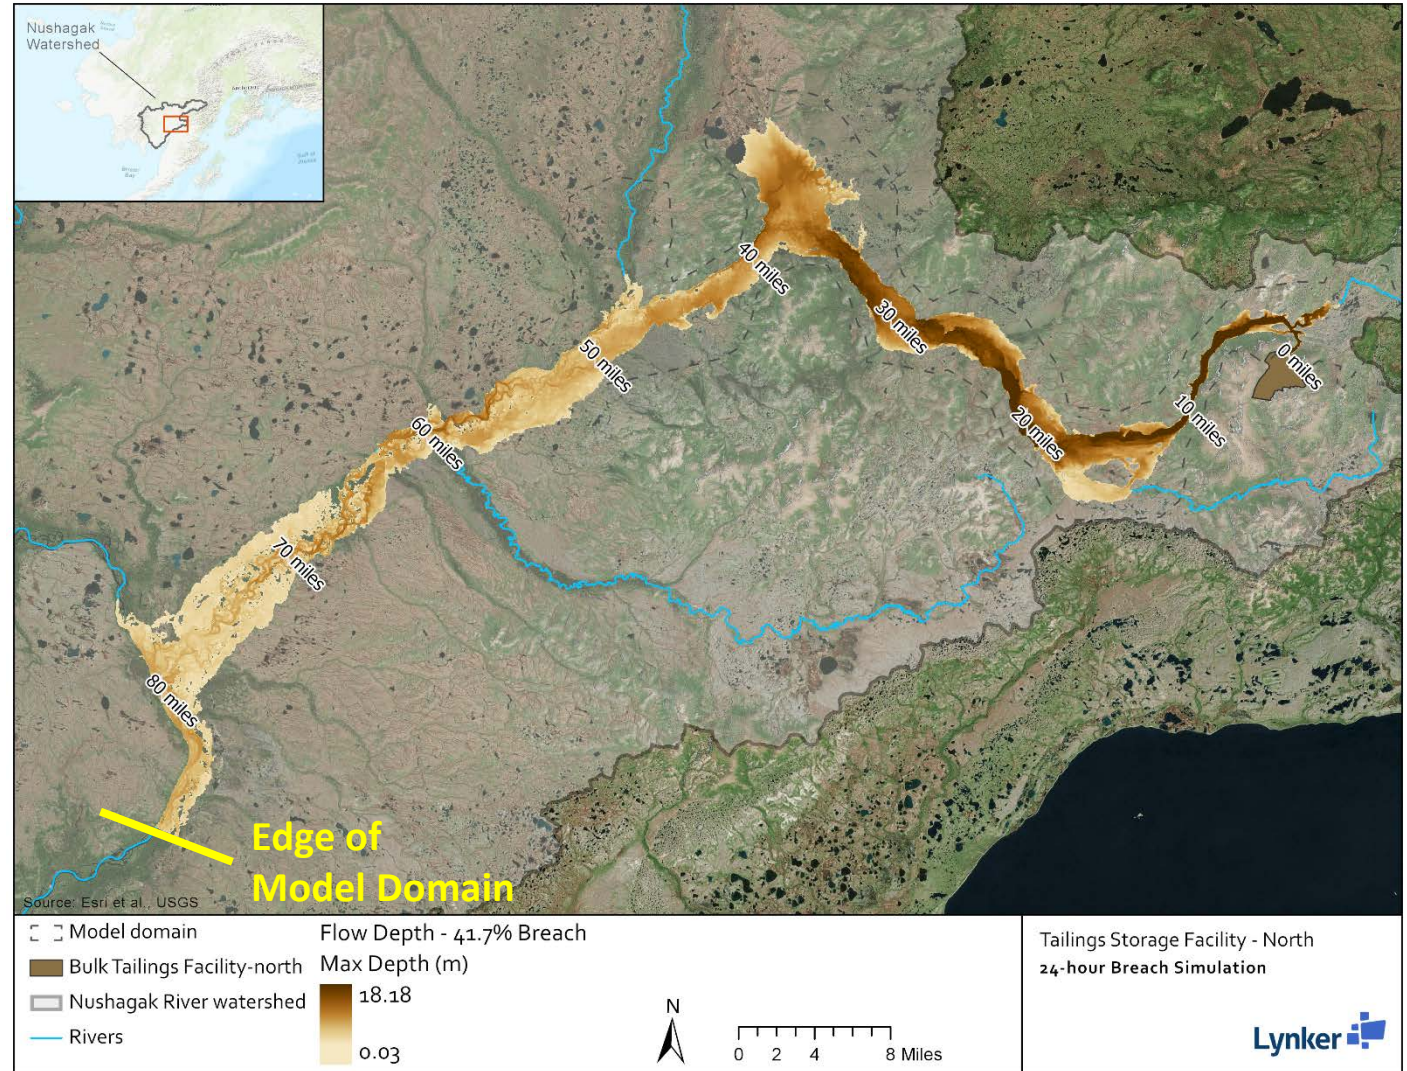
Larger Model Domain: 24-hour Breach

Model extends from TSF to Nushagak-Mulchatna Confluence

- ~45% of tailings are deposited within the model floodplain
- ~55% of tailings flow past the model boundary

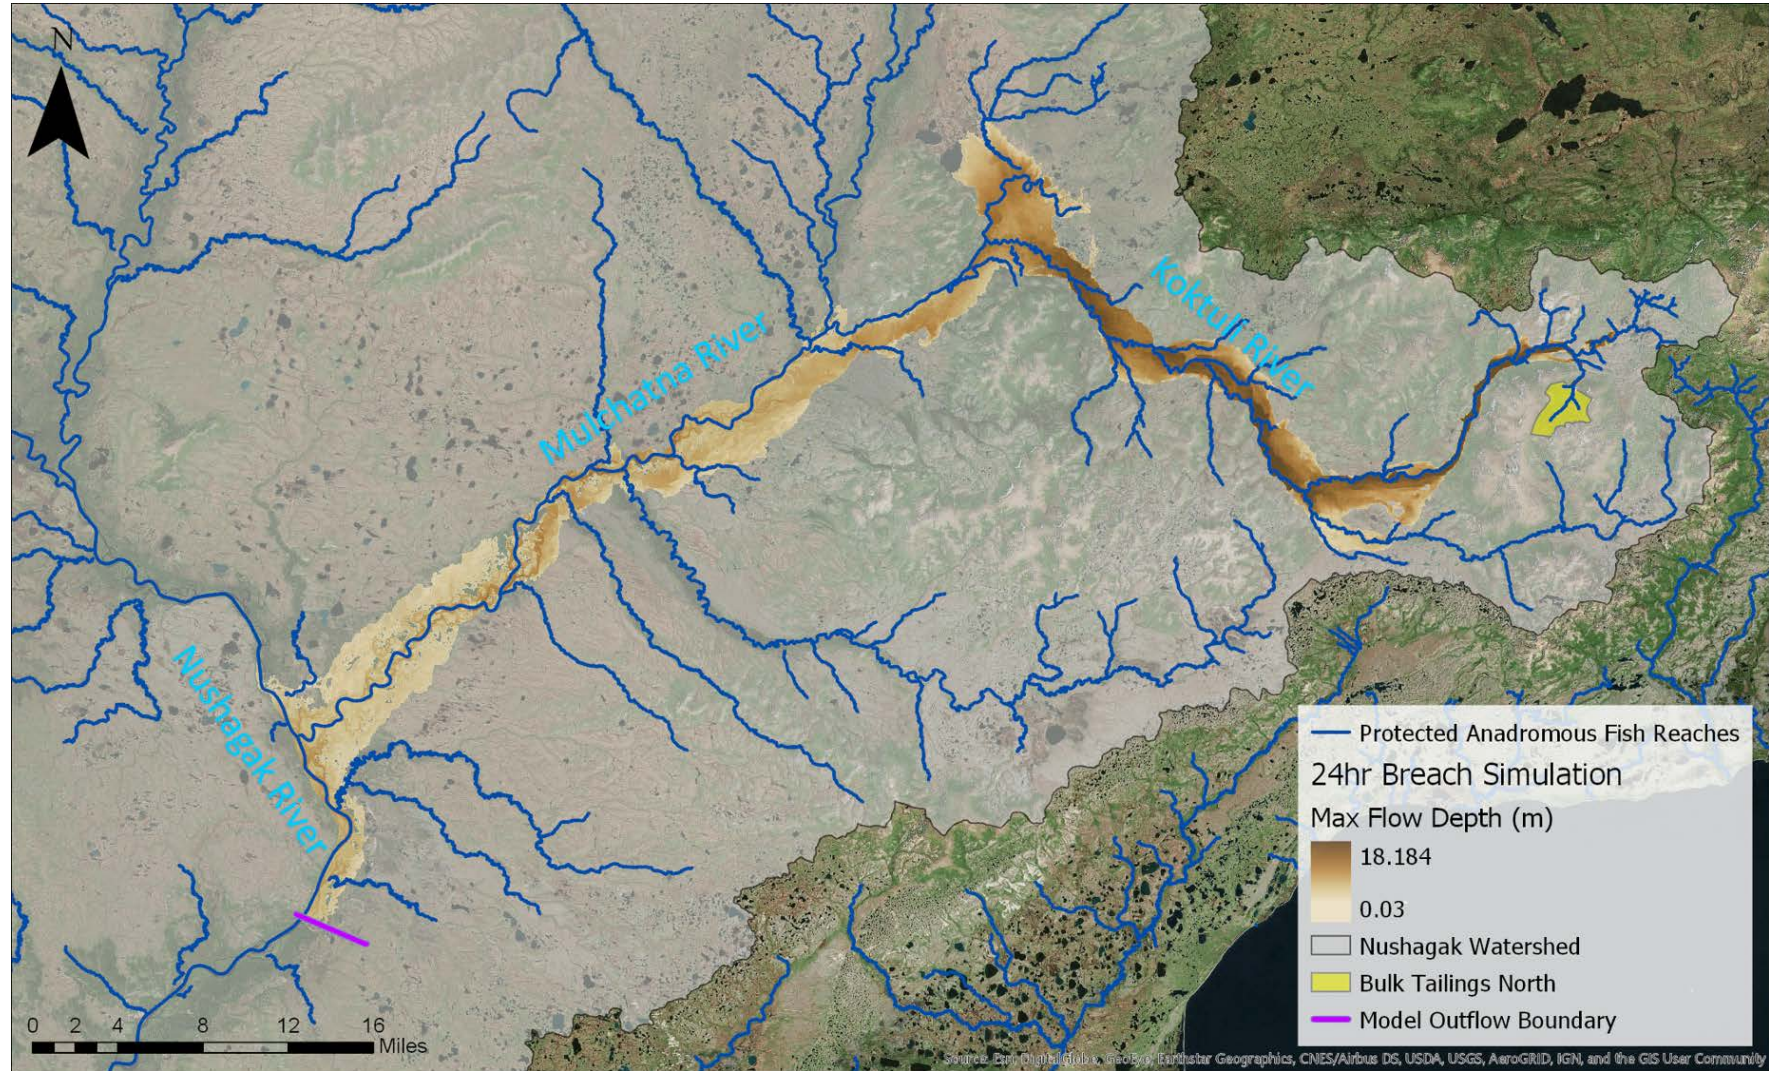
- Tailings would directly impact >219 miles of anadromous waters
