COMMITTEE REPORT
SENATE

The Committee on FINANCE has had SU 364

2 CS FOR SENATE BILL NO. 364 (Finance)

6 For an Act entitled: "An Act making special appropriations to certain
7 communities and municipalities for erosion control
8 projects; and providing for an effective date."

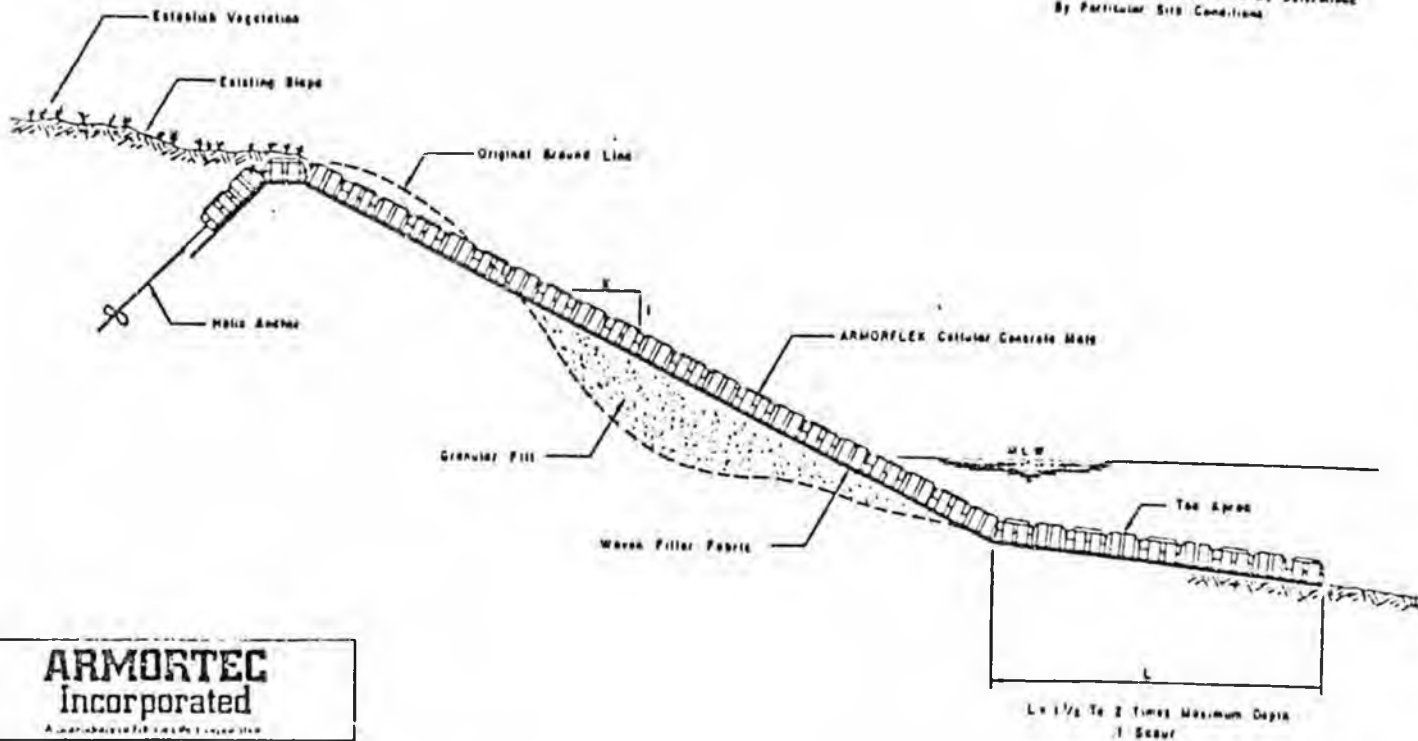
THE ABOVE DRAWING IS ONLY A CONCEPTUAL DRAWING OF ONE OF A NUMBER OF DIFFERENT DESIGNS WHICH ARE CURRENTLY ON THE MARKET. THIS REPORT IN NO WAY IS RECOMMENDING THIS DESIGN OVER SOME OTHER MANUFACTURERS. THE REPORT IS ONLY USING THIS DESIGN AS AN EXAMPLE OF ONE TYPE WHICH COULD BE USED FOR EROSION CONTROL IN THIS COMMUNITY.

PHASE I & II COSTS PER LINEAR FOOT = \$403.40

Dimensions And Details To Be Determined
By Particular Site Conditions

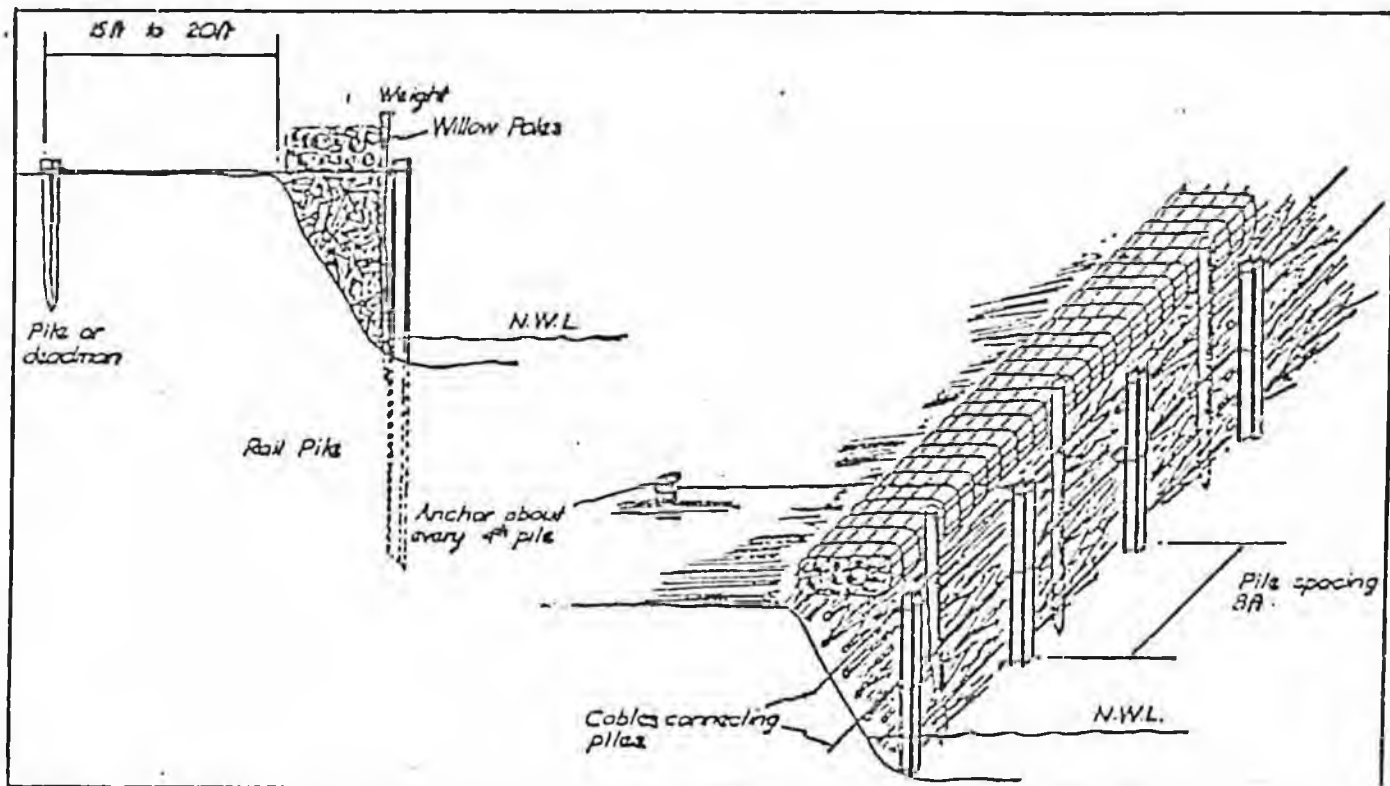
PILE AND FASCINE REVETMENT

ANOTHER VARIATION OF THE LIVE MATTRESS THERE IN WHICH EITHER TIMBER OR OLD RAIL PILES ARE DRIVEN IN FRONT OF AN ERODING BANK AND SPACED AT 6 FOOT CENTERS. PILES ARE DRIVEN BELOW THE ANTICIPATED SCOUR LEVEL WITH THEIR TOPS AT LEAST UP TO MODERATE FLOOD LEVEL.

FASCINES, BRUSH OR LARGE BRANCHES OF WILLOW, AND OTHER TREES ARE PLACED HORIZONTALLY BETWEEN THE PILES AND THE BANK, AND PUSHED OR WEIGHTED DOWN WITH INDIVIDUAL WEIGHTS, OR SAND BAGS. TOPS OF PILES ARE TIED BACK TO ANCHORAGE WITH WIRE OR LIGHT CABLE, AND THE TOPS OF THE PILES ARE INTERCONNECTED WITH CABLE. A CHAIN MESH NETTING AT THE BACK OF THE PILES CONNECTED TO THE TOP WADING OR WIRE ROPE. BATTERING OF THE BANK IS NOT NECESSARY. THIS TYPE OF WORK HAS NOT BEEN USED EXTENSIVELY AND WHEN IT HAS IT HAS BEEN MAINLY IN SMALL RIVERS WITH ACTIVELY ERODING BANKS. FASCINES AND BRANCHES WILL FOLLOW THE SCOUR DOWN TO A LIMITED EXTENT.

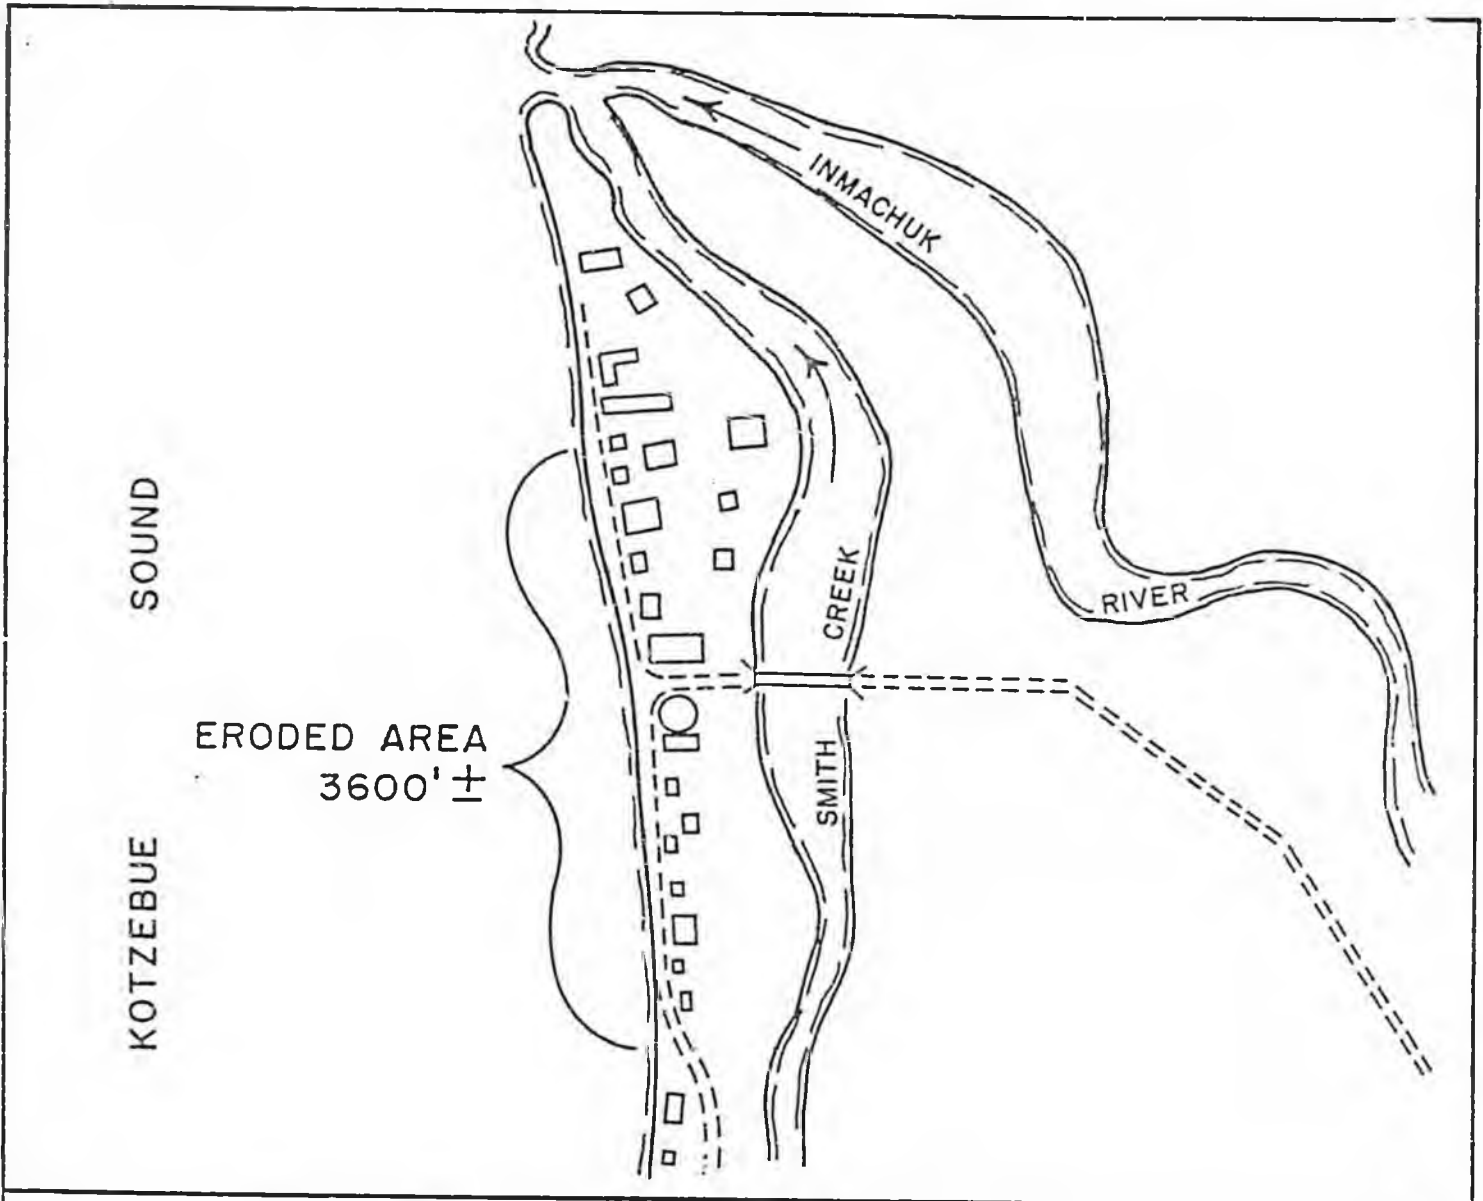
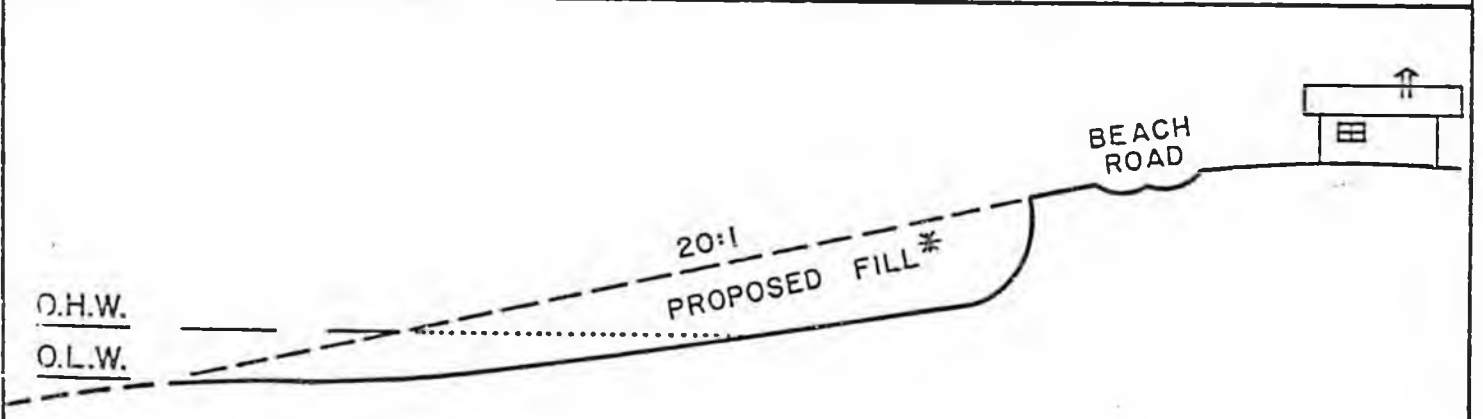
DEERING - TYPICAL SECTION

* FILL = Sand and Gravel from Inmachuk River, OR
 3" minus Rock from the Outcrop SE of Deering.

The most effective method of preventing major storms from attacking the steep bank adjacent to the roadway parallel to the houses at Deering is to replace the eroded material on a slope identical to the natural beach angle of 6 to 8 percent. Rock broken to gravel size (minus 3 inches) or pit-run gravel can be used in this work.

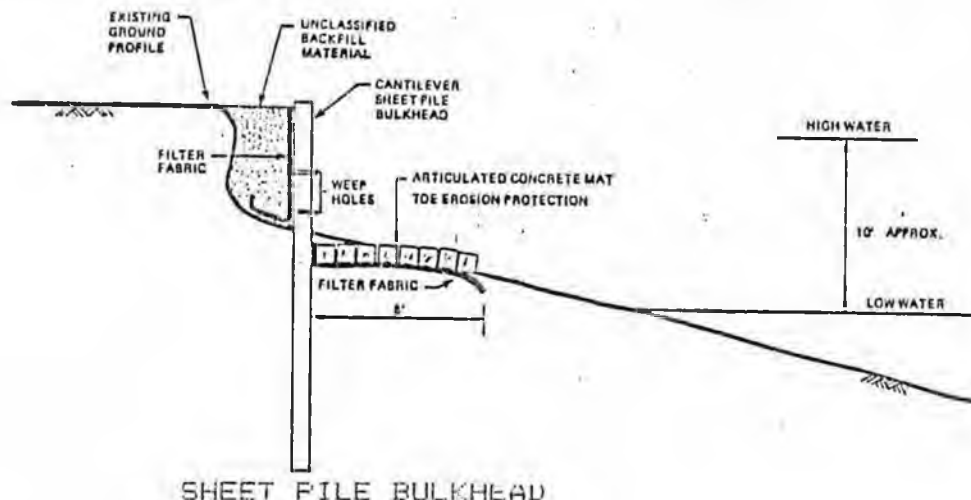
BASED ON OUR ON SITE EVALUATION OF THE PROBLEM IT IS ESTIMATED THAT THE AREA WHICH WILL NEED TO BE PROTECTED IS A MINIMUM OF 500 LINEAR FEET OF SHORE. THE METHODS WHICH WERE LOOKED AT WERE REINFORCED WALL, CANTILIVER SHEET PILE WALL.

THE FIRST POSSIBLE DESIGN WHICH WAS LOOKED AT WAS THE POSSIBILITY OF THE CONSTRUCTION OF A SHEET PILE BULKHEAD. THIS TYPE OF DESIGN WOULD PROVIDE VERTICAL FACE AND WOULD REQUIRE CONSIDERABLE FOUNDATION EVALUATION.
