**HOUSE COMMITTEE REPORT**

Date Referred to Committee: January 30, 2002

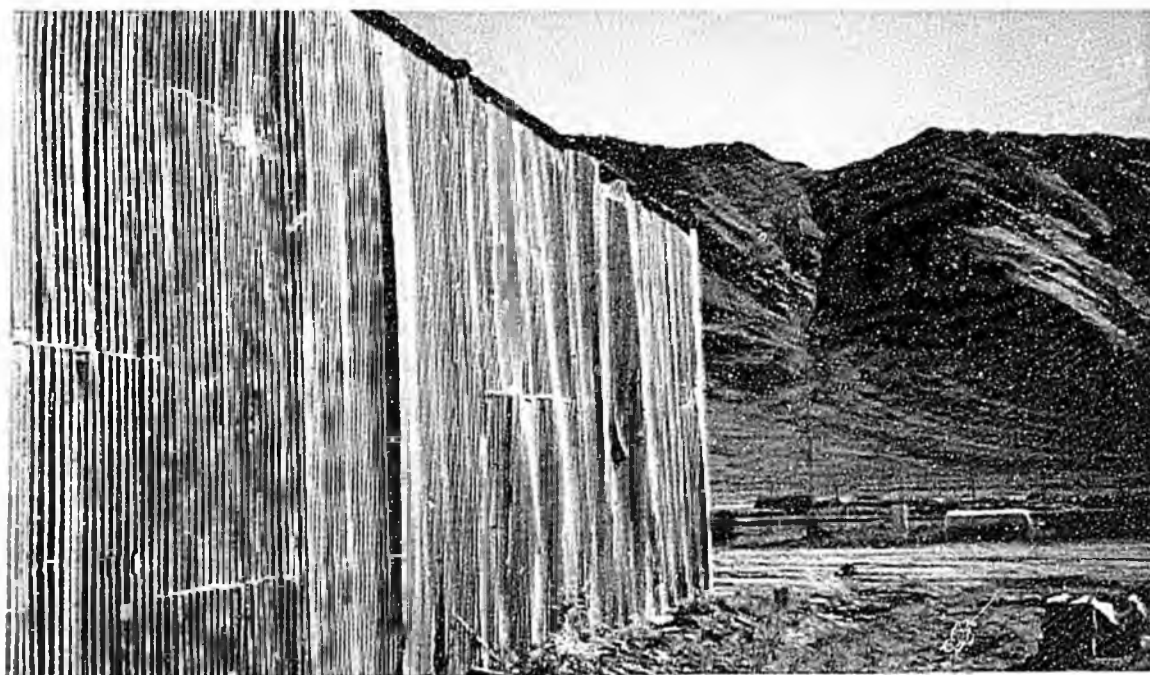
(Chandalar Maintenance Station on the Dalton Highway - South Wall Settlement Damage)

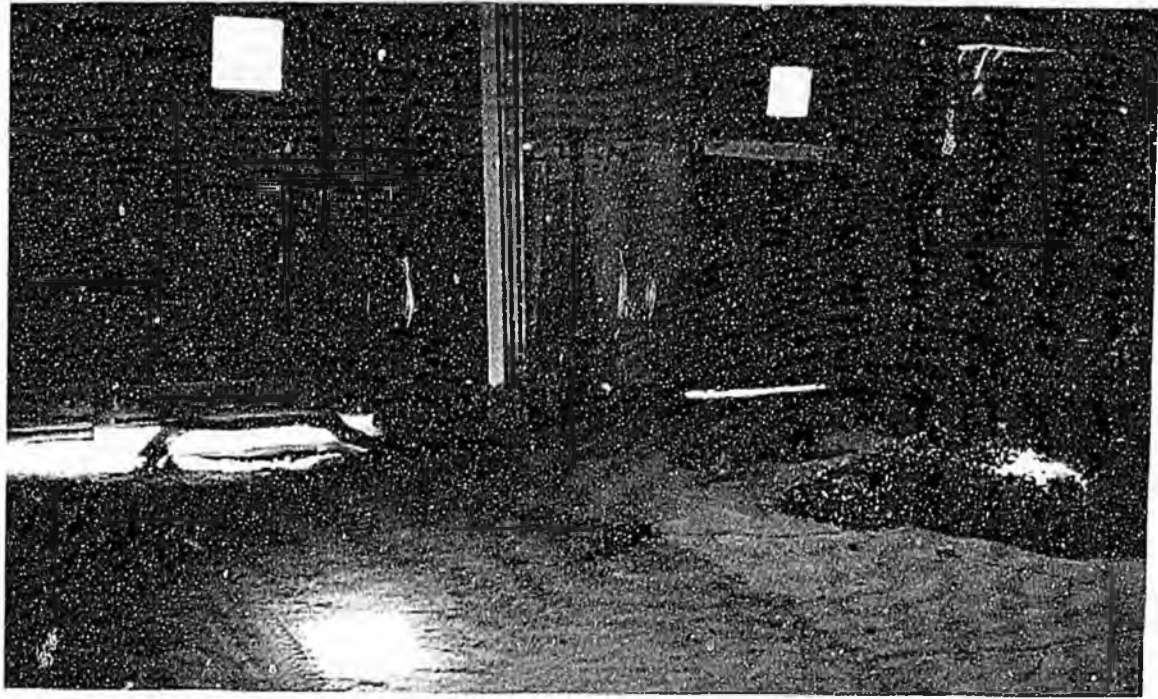
***Photograph Five: East End Foundation Settlement***

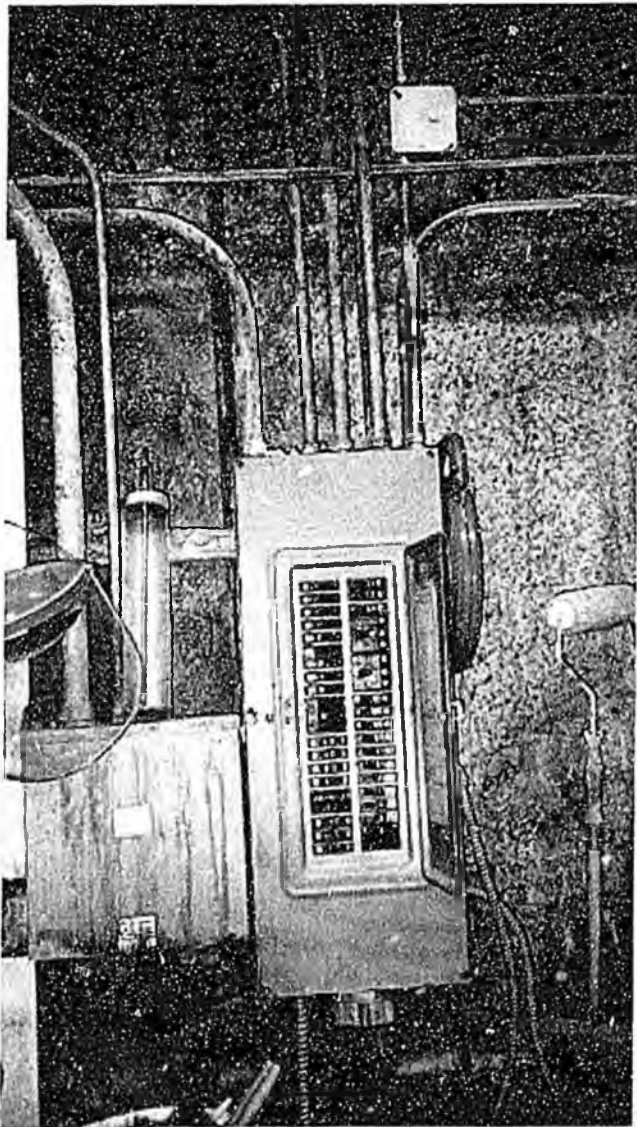
***Photograph Six: Water Stains on Wall and Electrical Panel***

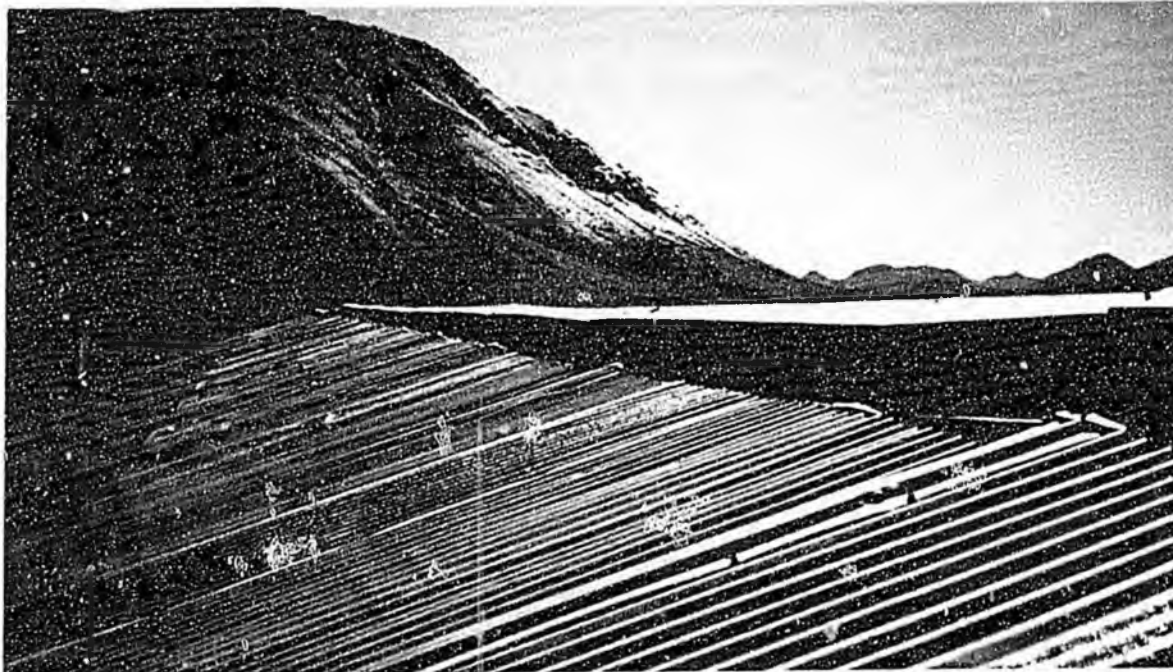
*Photograph Seven: Roof panel corrosion and separation.*

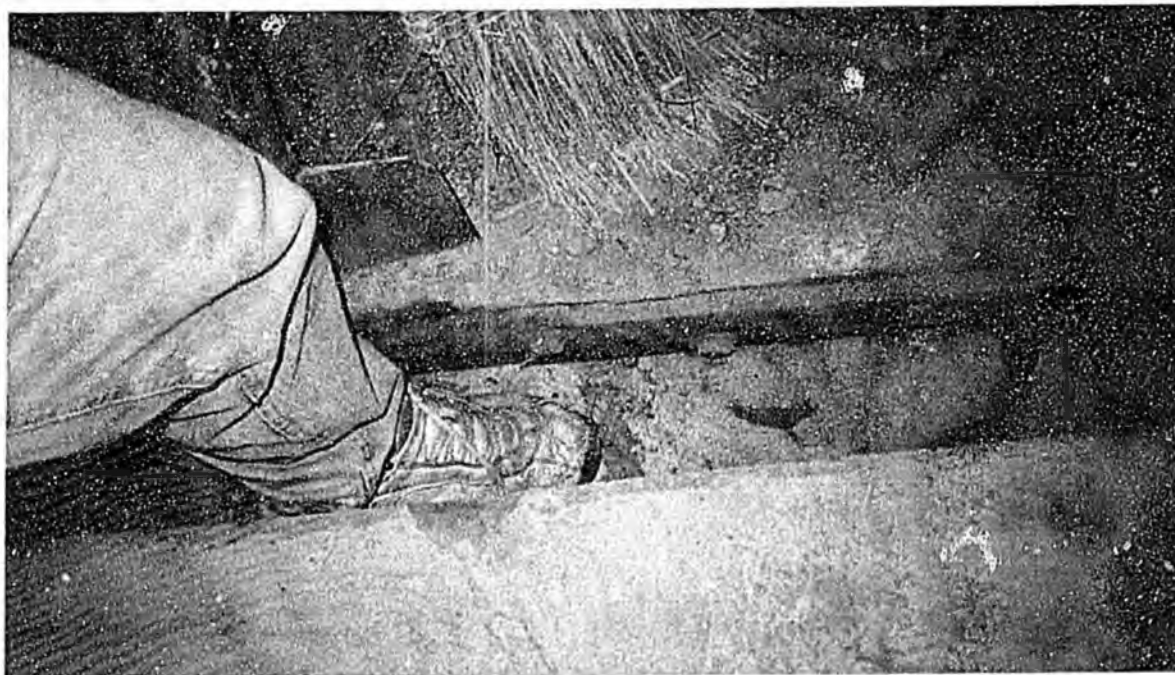
*Photograph Eight: Floor slab separation and settlement.*

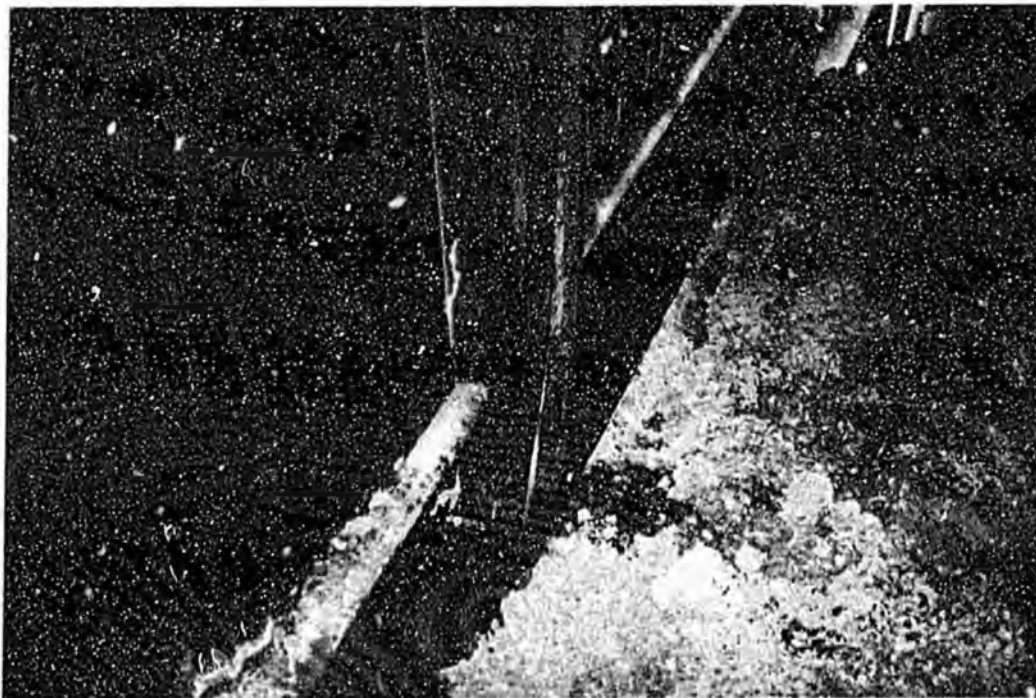
*Photograph Two: Settlement of Foundation*

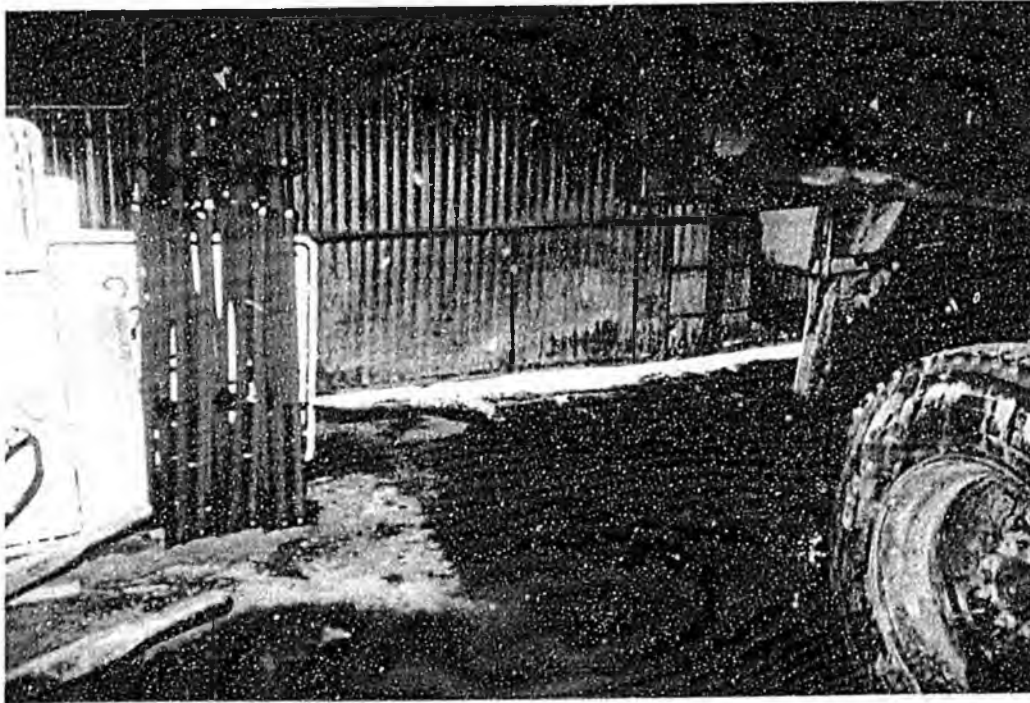
*Photograph Three: Settlement of Foundation*

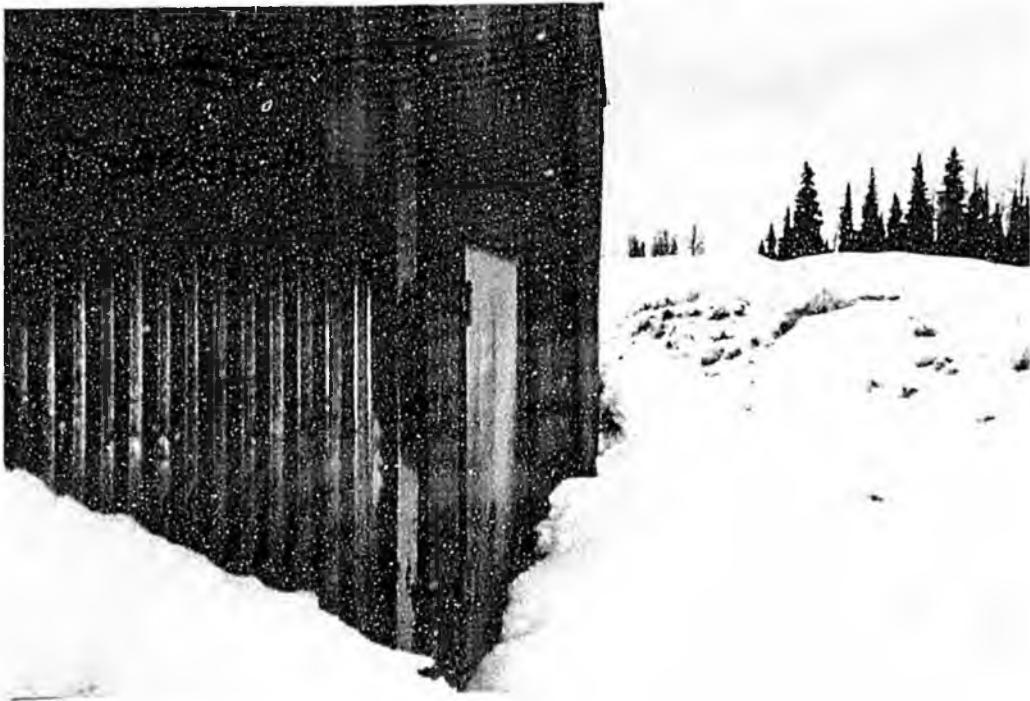
*Photograph Four: Corrosion of Building*

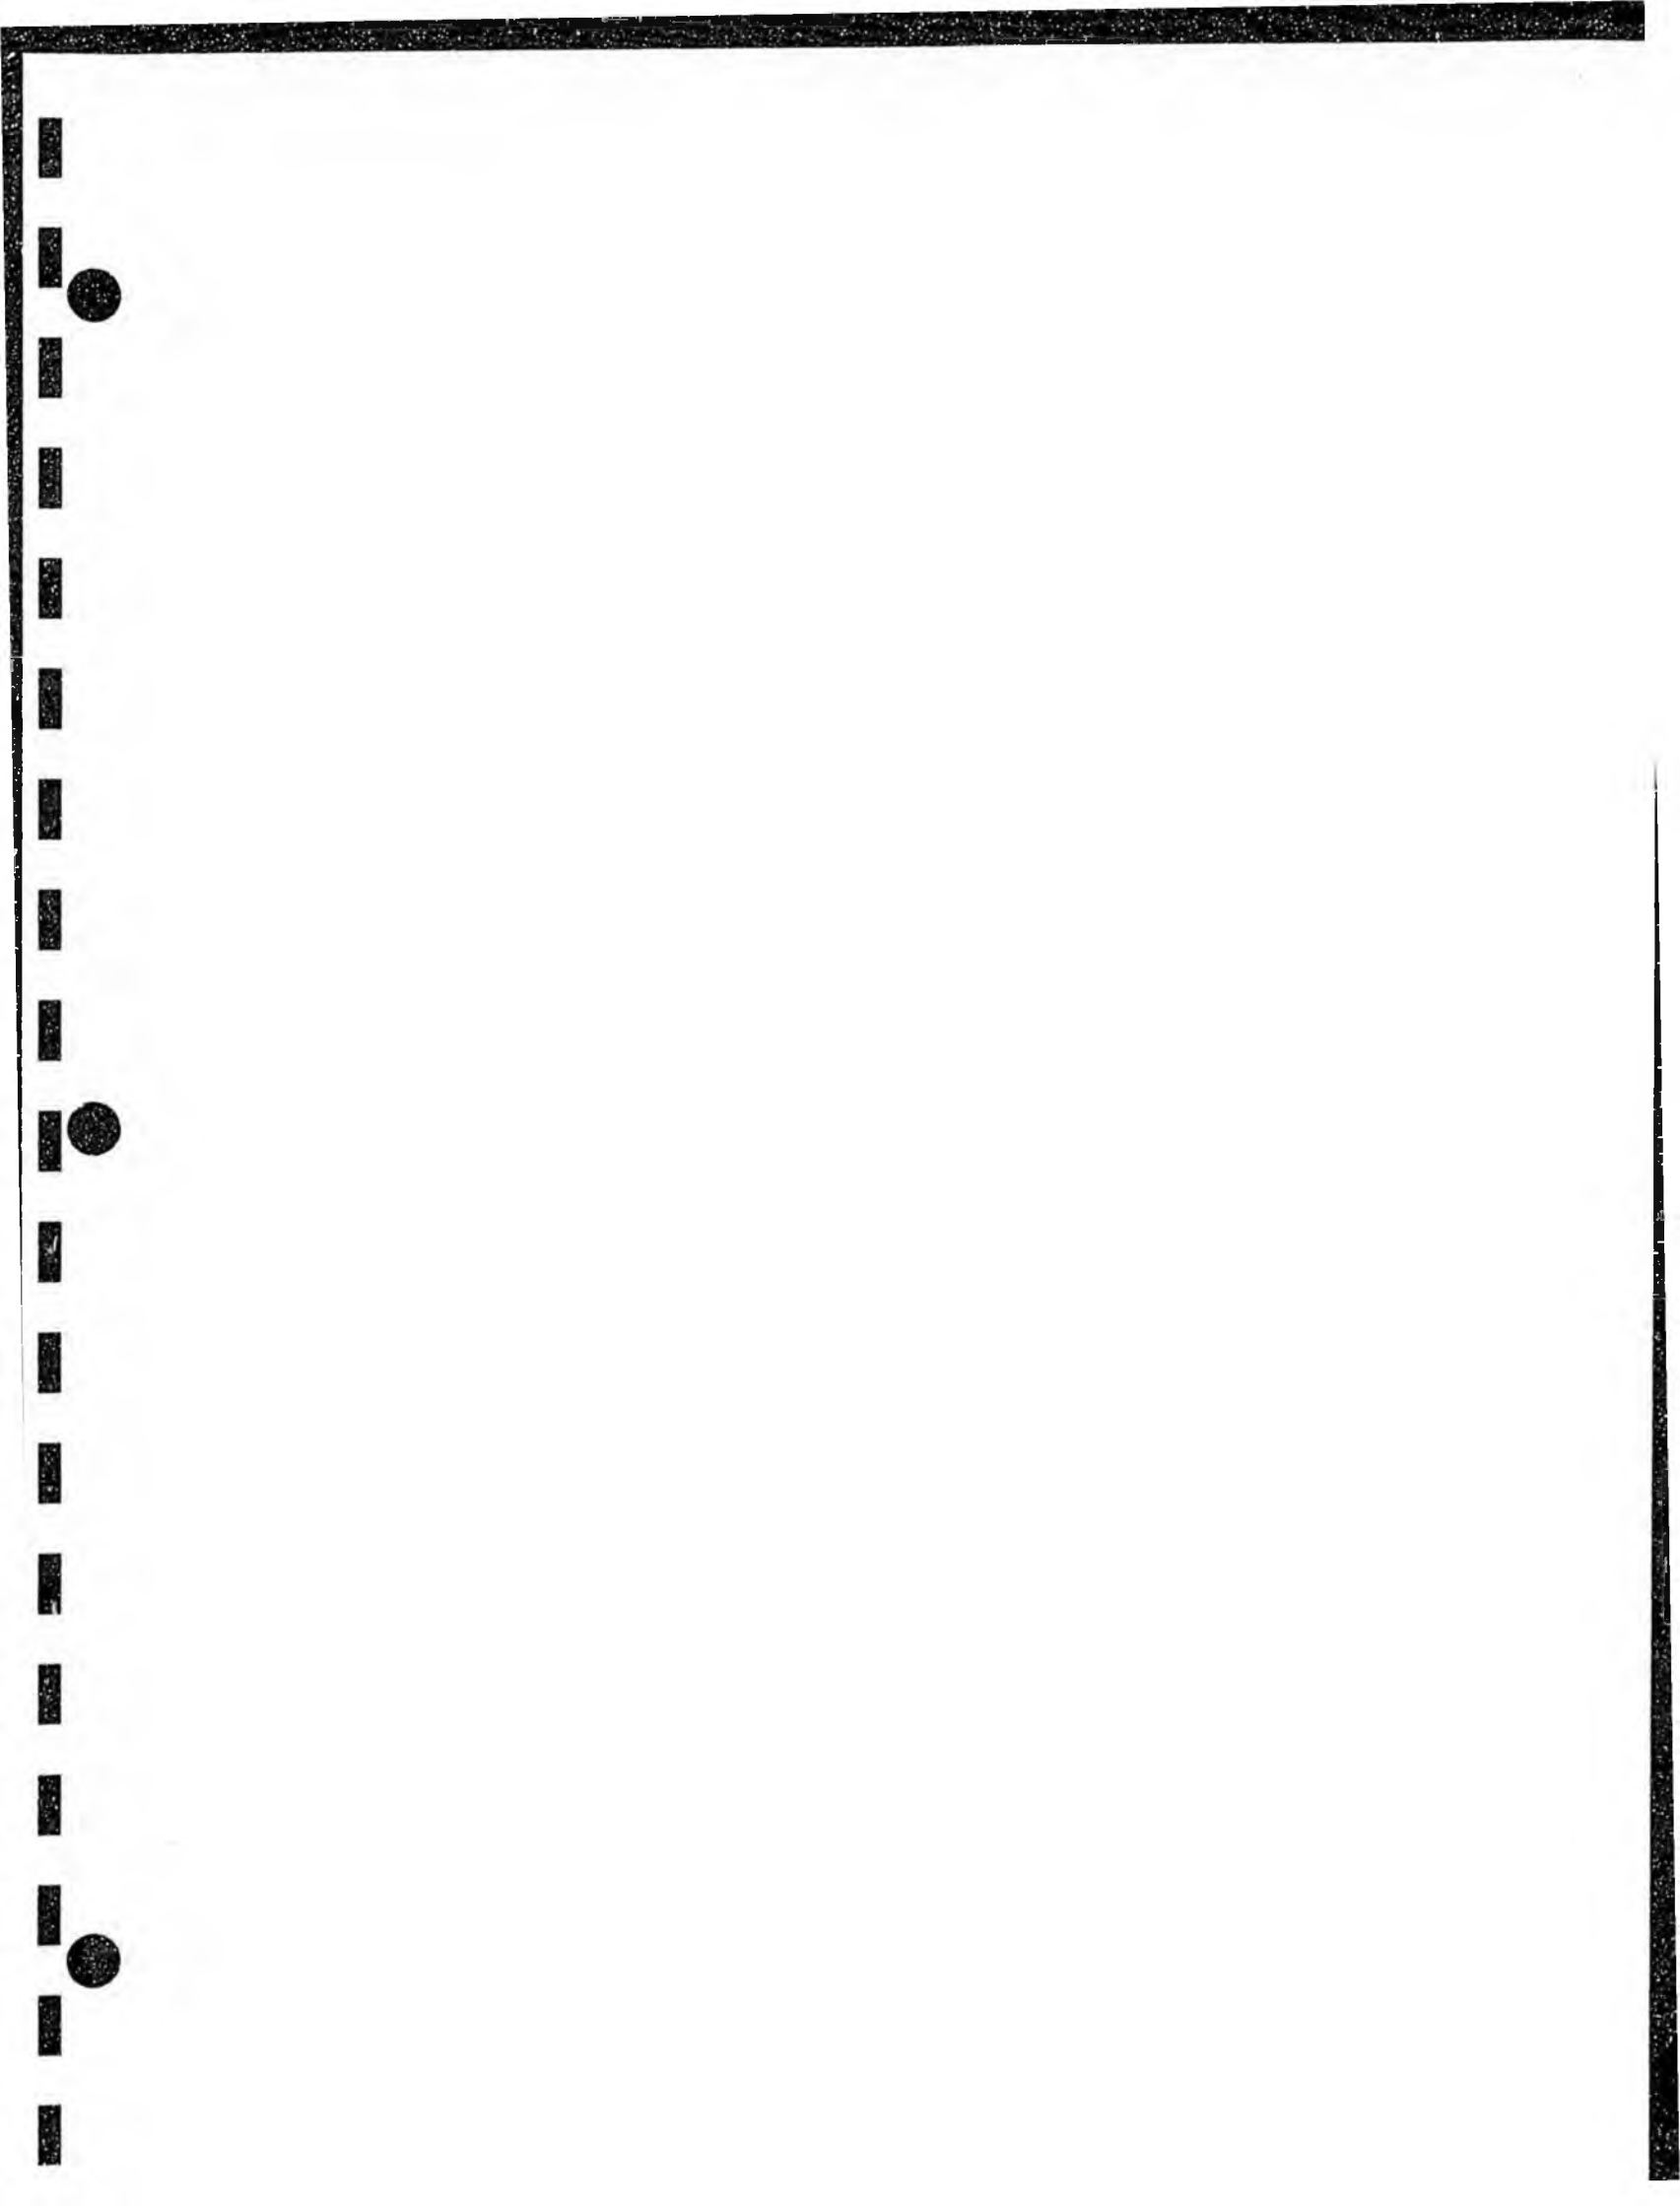
## **Willow Maintenance Station Executive Summary**

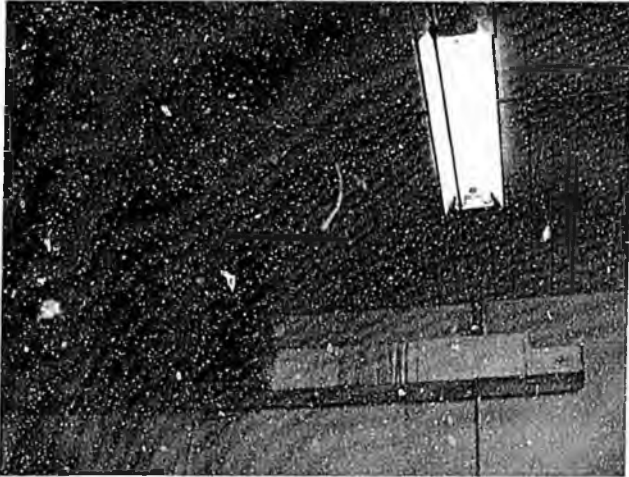
**Photo No. 7 – View showing underside of an area of highly deteriorated roof decking adjacent to furnace chimney passing through roof. Damaged area is just to the right of the center of the photograph. Roof in this area was noticeably “soft”.**

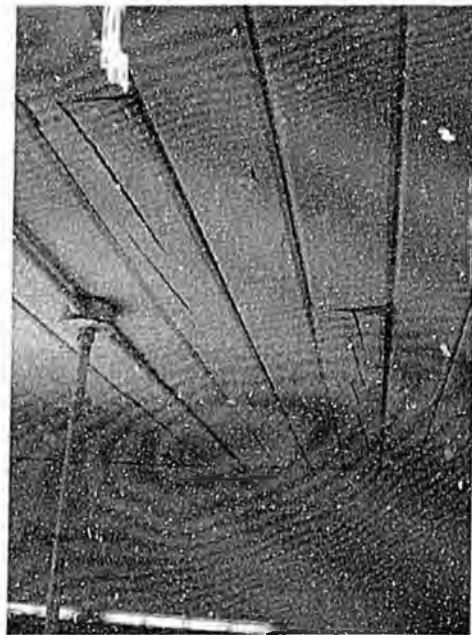
**Photo No. 8 – View showing another location where distress of roof decking is evident. A combination of high load and shrinkage appears to have dislodged the tongue-and-groove splines with resultant loss of strength.**

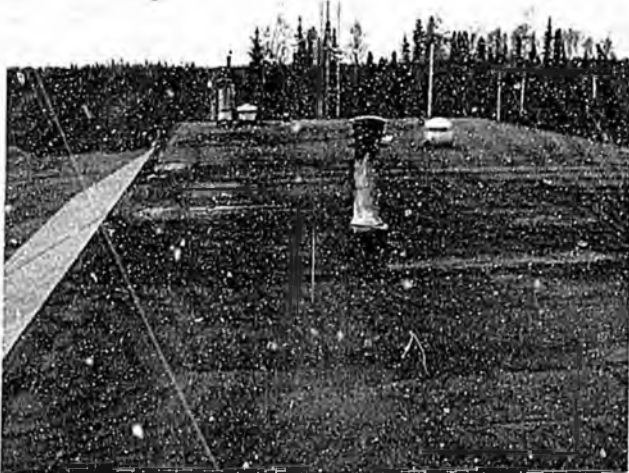
**Photo No. 9 – View showing extent of recent repairs to roof membrane, in vicinity of furnace chimney. Dark areas were coated with repair product.**

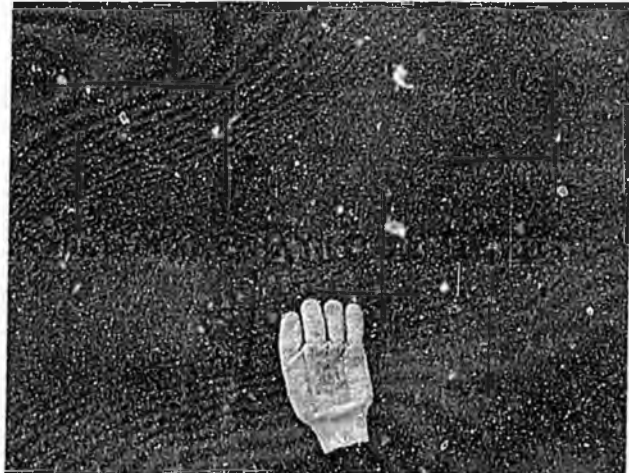
**Photo No. 10 – View showing cracked and weathered condition typical of roof membrane. Complete membrane replacement appears to be necessary soon.**

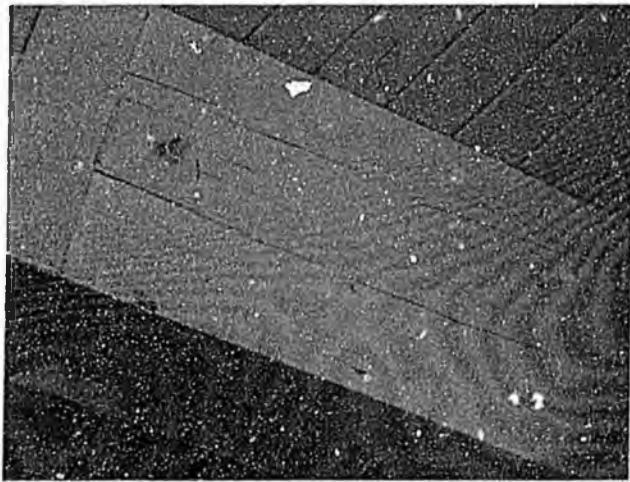
***Photo No. 11 – View showing cracks in glulam at cantilever that may be overstressed.***

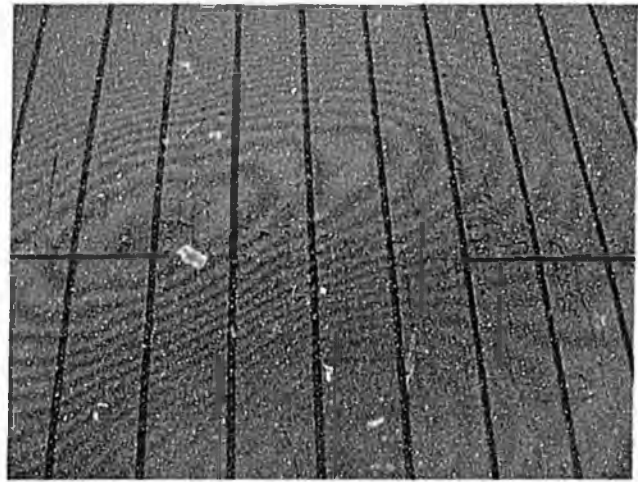
***Photo No. 12 – View showing weathered siding with grooves at 4 inch spacing, and nailing occurring only at stud spacing of 16 inches along the sheet edges.***
