Studded Tire Presentation

Lance Mearig, P.E., Chief Engineer

February 23, 2017

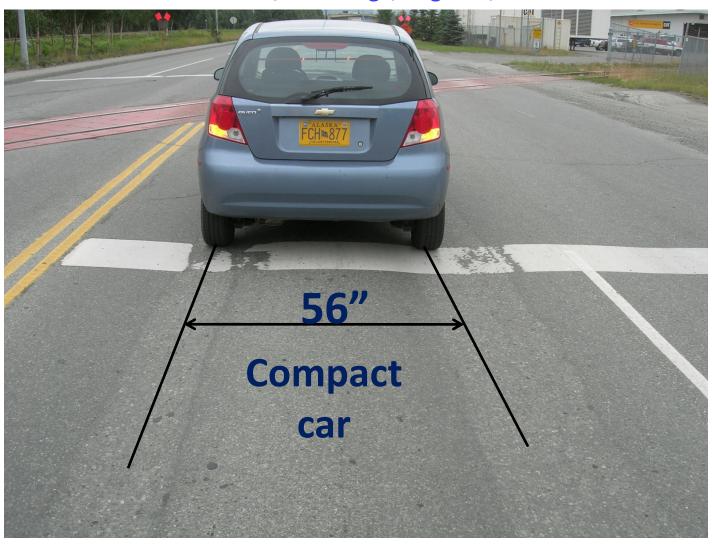
Arctic Blvd., Anchorage, August 5, 2008

Rutting Evidence caused by Studded Tire

Ruts fit wheel path of passenger vehicle

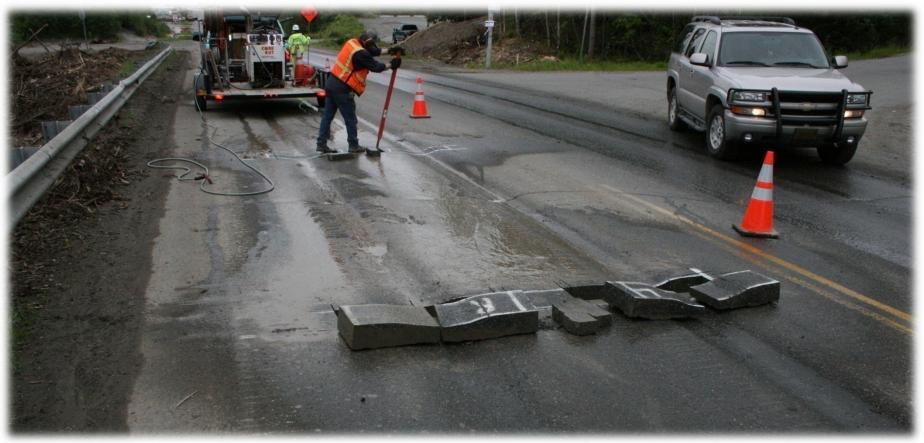
Pavement Sampling Eagle River Loop Road 13,000+ vehicles/day July 29, 2008

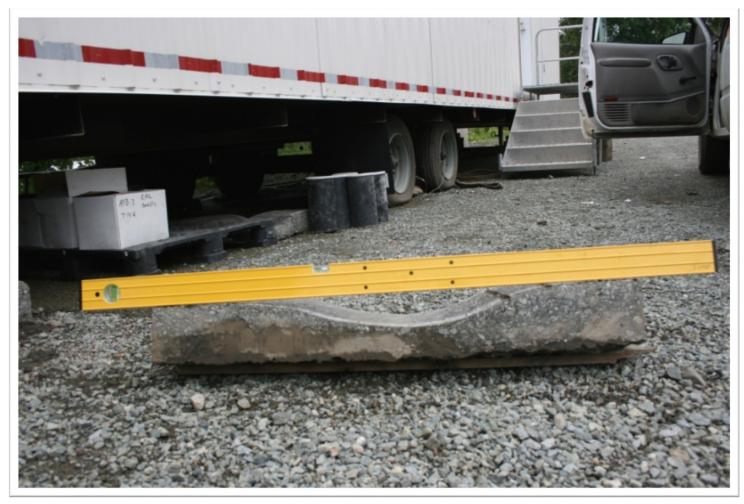
Eagle River Loop Road 13,000+ vehicles/day July 29, 2008
