# A White Paper on Energy Use in Alaska's Public Facilities

Published 11/7/2012 | Version 1

**Alaska**  
**Housing**  
FINANCE CORPORATION

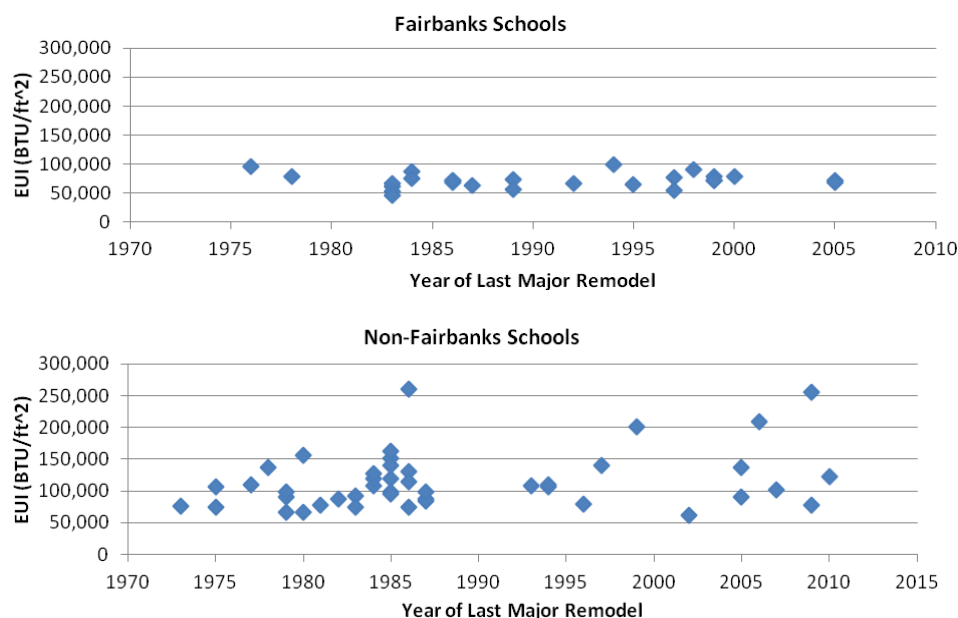
Preliminary benchmarking data and anecdotal experience led auditors to expect that EUIs are generally increasing over time due to potential over ventilation based on stricter minimum air and exhaust standards. Review of NORTECH’s audit data does not prove this hypothesis. None of the charts below show a clear relation between Energy Use Index (EUI) and the date built or last major remodel. The charts below compare EUI to year for Fairbanks schools and non-Fairbanks schools. The average EUI for Fairbanks schools appears consistent and low over time because of properly implemented maintenance and energy management programs along with trained personnel. The average for non-Fairbanks schools shows a much wider variability in EUI in schools of all ages.
