# MSBSD Earthquake

## Facilities Status (Feb 4, 2019)

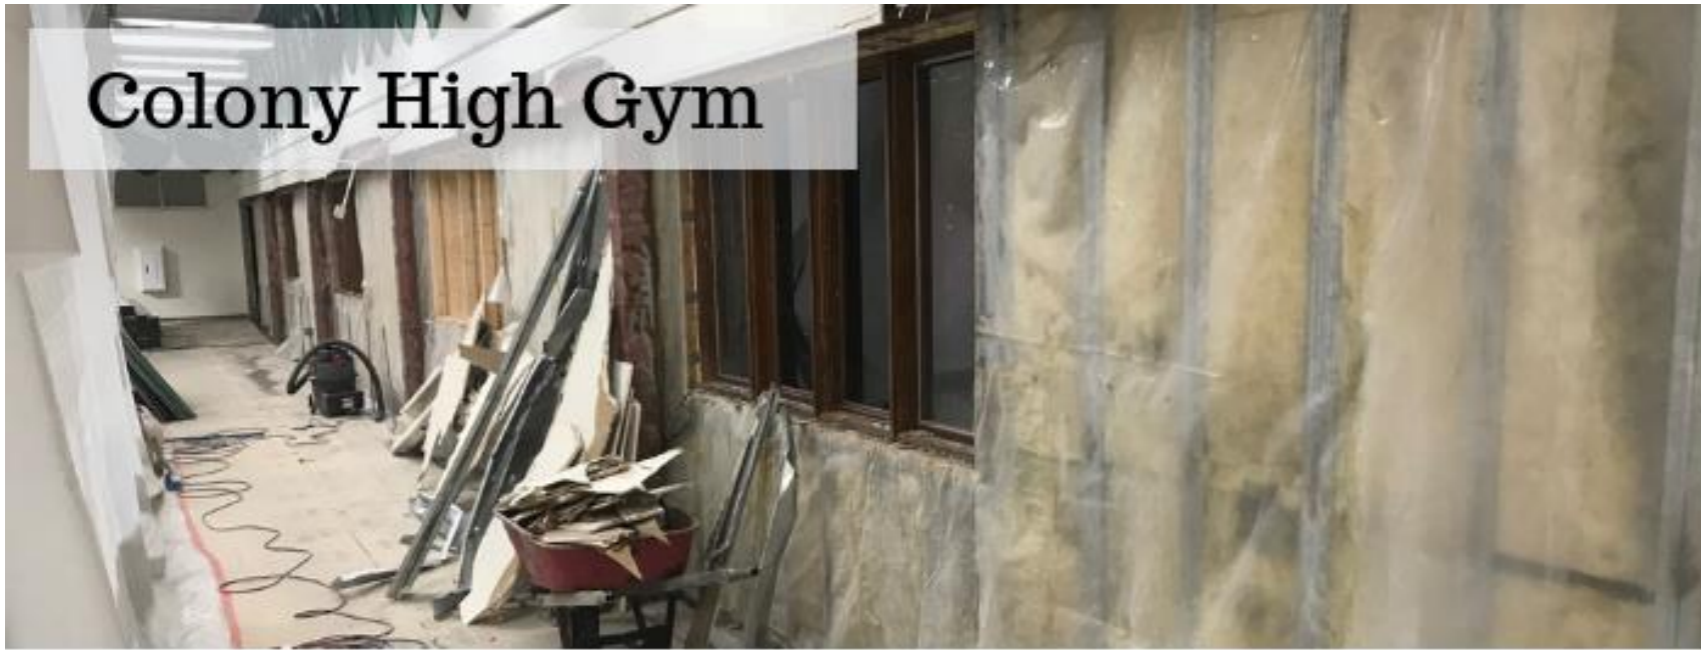
Colony High Gym

Colony High	Damage to north exterior wall and falling block from a non-bearing CMU partition in the northeast corner of the gym.	The north exterior concrete veneer wall above the track and northeast concrete block wall in the stairwell will be removed and replaced with a steel stud wall assembly along with the ceiling in the stairwell. Work will be complete by the end of February 2019.	\$90K
Wasilla Middle	Non-bearing CMU columns in the northeast wing were not tied into bearing walls.	Removed non-bearing columns and patched and painted walls in northeast wing during winter break (Dec 2018 – Jan 2019)	\$60K
Knik Elementary	Significant ceiling grid and tile failure in gym.	Remaining grid removed during winter break. Final work to be completed over spring break (March 2019).	\$90K

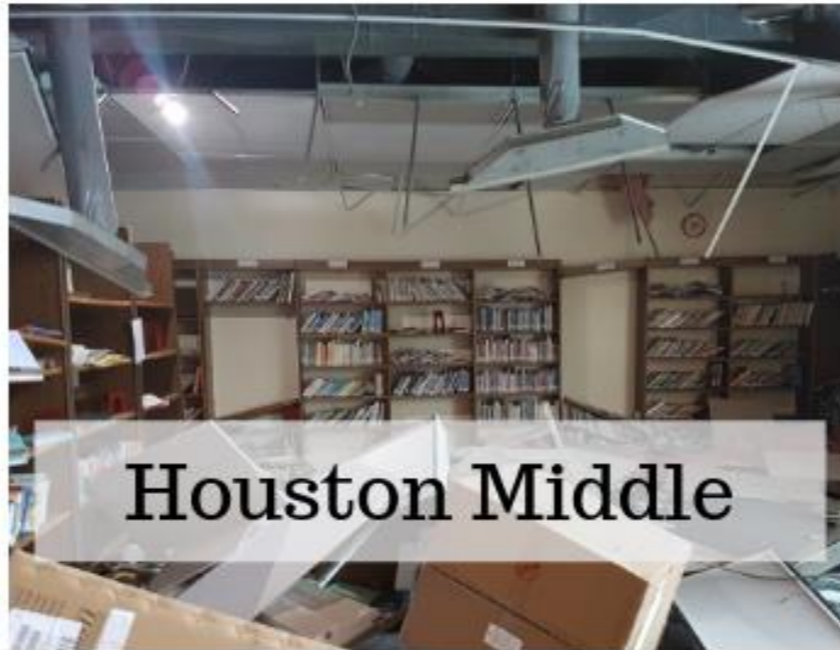
Site	Issue(s)	Ongoing Work	Costs
Houston Middle	Significant structural damage to the concrete masonry unit (CMU) especially in the second-story classroom wing and gym.	Burkhart Croft Architects (BCA), including PND Engineers, are developing a repair/replacement scope. Efforts to shore up specific areas has been completed. Expect the preliminary reports from the insurance company and BCA in mid to late February 2019. Follow-on structural engineering analysis likely to take an additional 2-3 weeks. Once these reports are received, we can expect to assess the extent of repair or replacement and associated costs.	TBD
Houston Jr/Sr High	Expand capacity of Houston High campus to meet demands of Houston Middle School.	Houston Middle and High Schools have been consolidated with the majority of middle school students occupying 13 portables recently moved on site. School opened with this new configuration January 7 <sup>th</sup> , 2019.	\$470K
