OPTIONS FOR REDUCING STUD-RELATED PAVEMENT WEAR

1. Report No. AK - RD - 96 - 1		2. Government Accession No.		3. Recipient's Catalog No.	
4. Title and Subtitle Options for Reducing Stud-Related Pavement Wear				5. Report Date August 30, 1996

CS FOR SENATE BILL NO. 156(TRA)
IN THE LEGISLATURE OF THE STATE OF ALASKA
TWENTIETH LEGISLATURE - FIRST SESSION

REPORT ON
ALASKA STUDDED TIRE STUDY

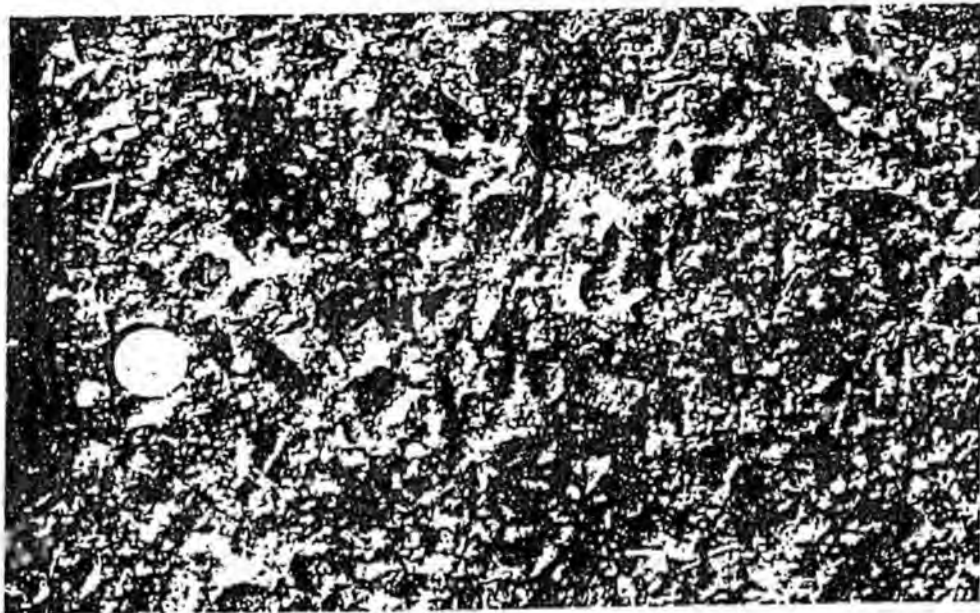
Exhibit 8

Intersection of Minnesota Drive and International Airport Road in Anchorage. (See Exhibit 14 for location.)
Top: Little used lane; note fines still visible in the surface.
Lower: Heavily used lane; note larger aggregate visible.

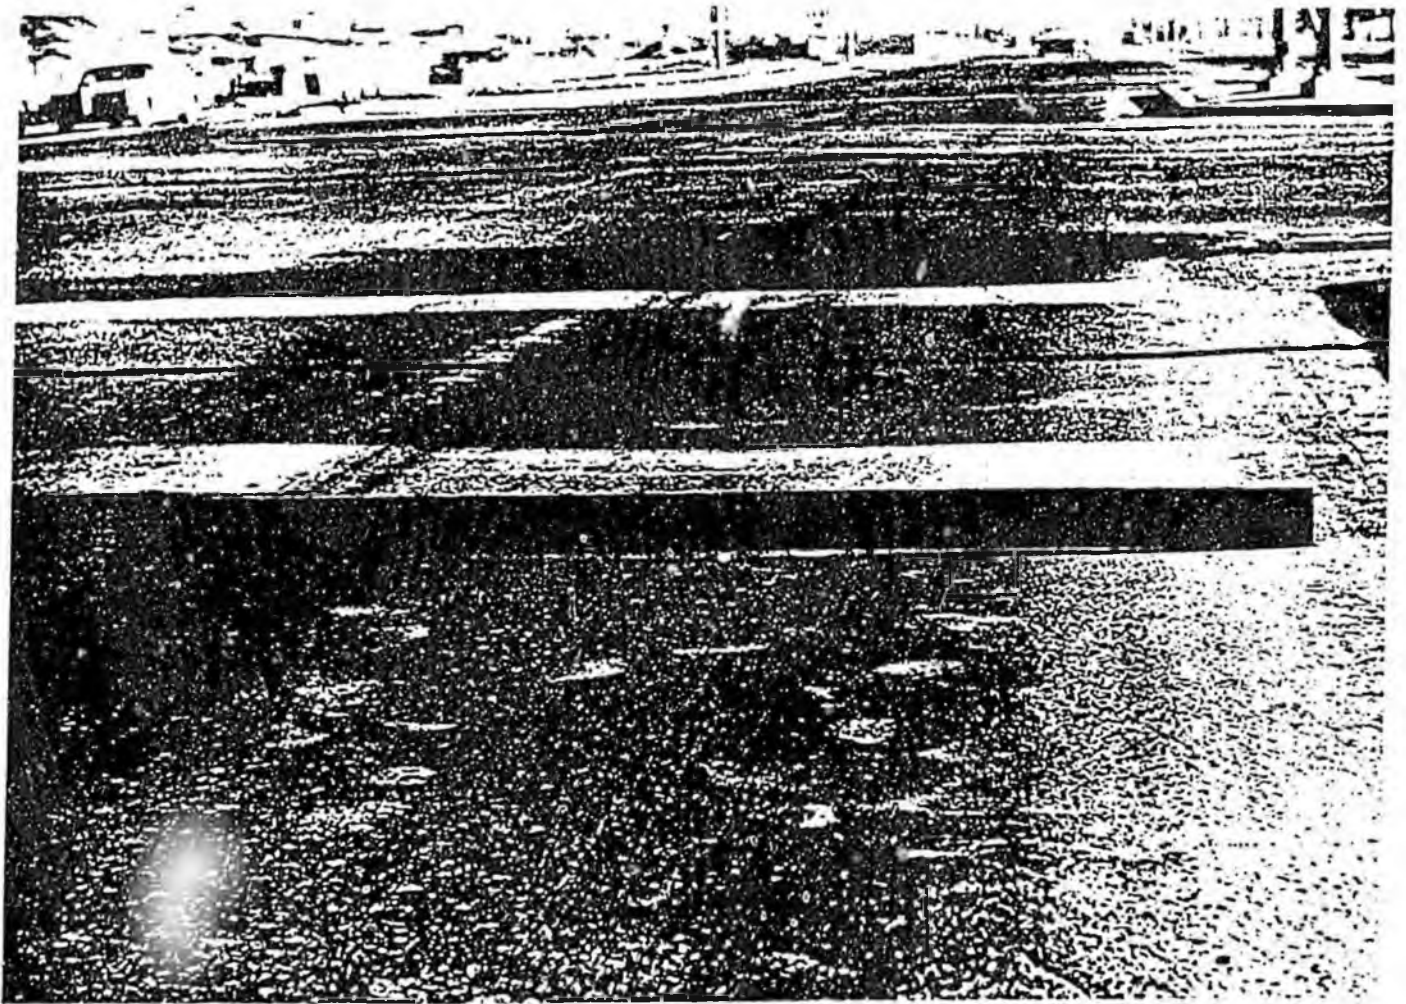
Exhibit 11

OBSERVATIONS IN ALASKA. The method used to measure pavement wear in Alaska was to place a straightedge across the wheel path and measure the maximum depth of the wheel track. For these tests a standard ten foot steel straightedge or screed was used throughout most of the survey. (See Exhibits 11 and 12) A small portion was tested with a six foot length of angle iron. A scale graduated in 50ths of an inch was used and measurements reported in hundredths of an inch. For this survey the depth was taken to the top of the exposed aggregate as this was assumed to be the riding surface.

This photograph was taken in July, 1971 at the intersection of East 5th Avenue and Bragaw Street in Anchorage and shows typical wheel-path wear caused by studded tires. Note the dime in the wheel path under the straightedge.

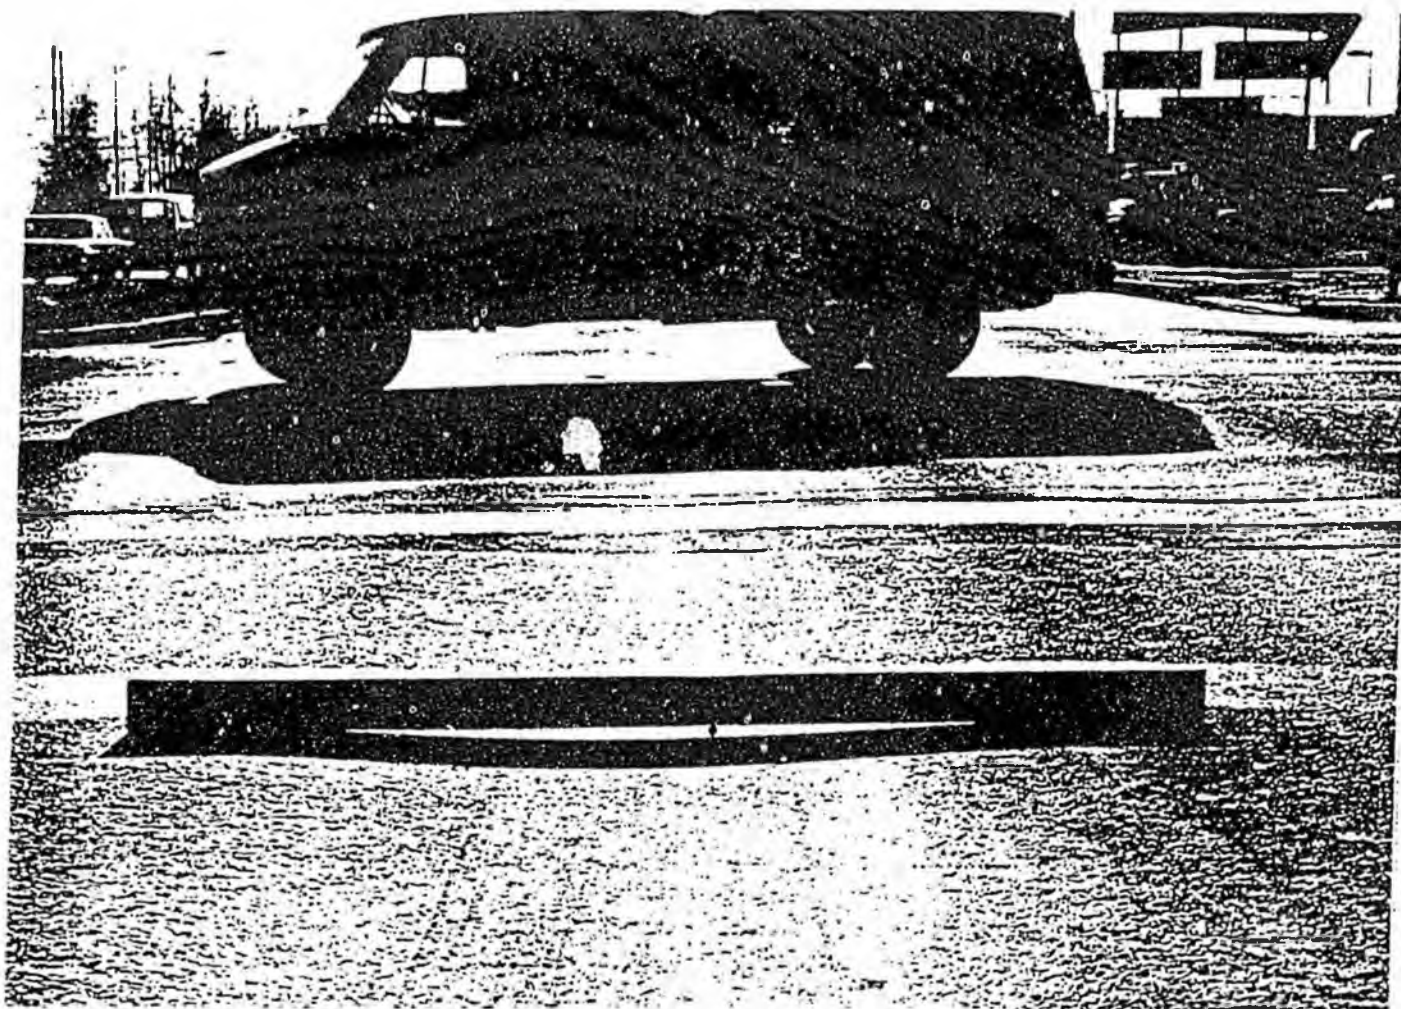
Exhibit 12

This photo taken on the Seward Highway at the Fireweed Lane intersection in Anchorage shows typical wheelpath wear at a heavily traveled intersection. Note the dime in the wheelpath under the straightedge.
