**PRUDHOE
BAY
CORROSION
CRISIS,
8/18/06
(FILE 1)**

SENATE & HOUSE JOINT RESOURCES PACKET

RE: Joint Senate and House Resources Committee Meeting
August 18, 2006

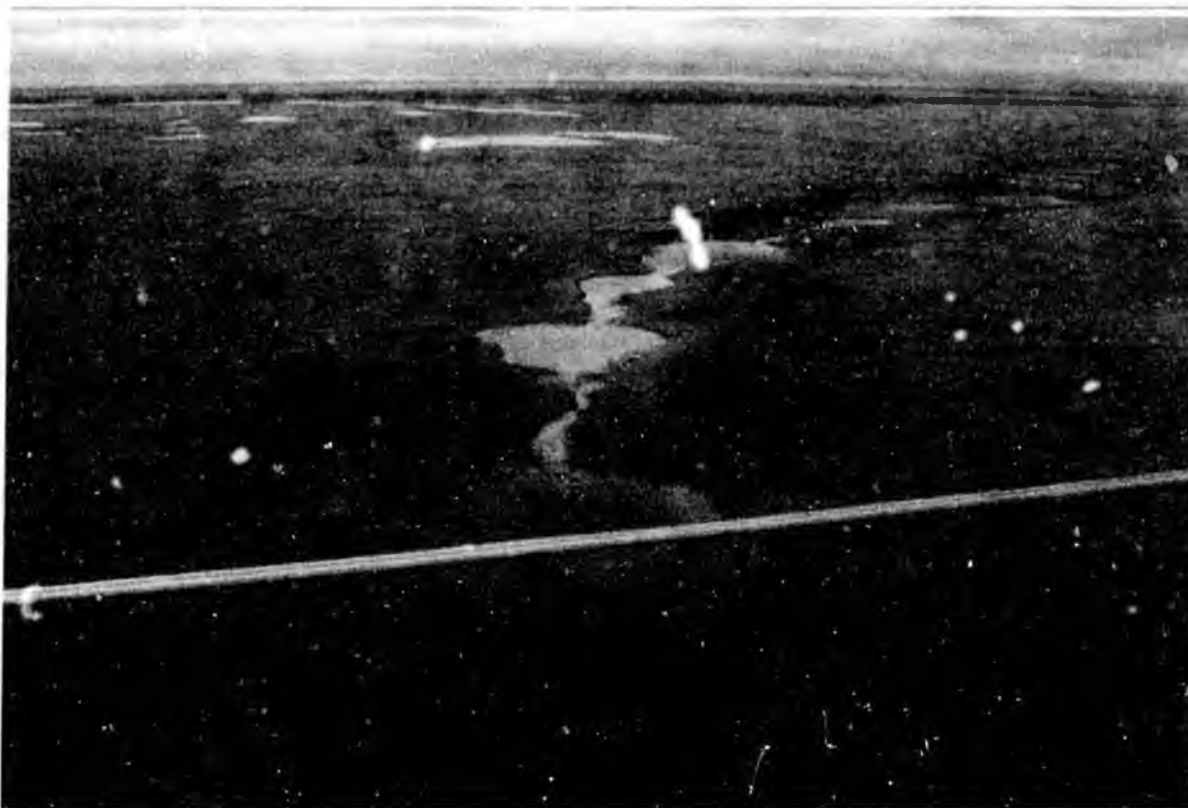
The Alpine Pipelines (oil, diesel, and utility) connect the Alpine Development on the Western North Slope to infrastructure in the Kuparuk River Unit.

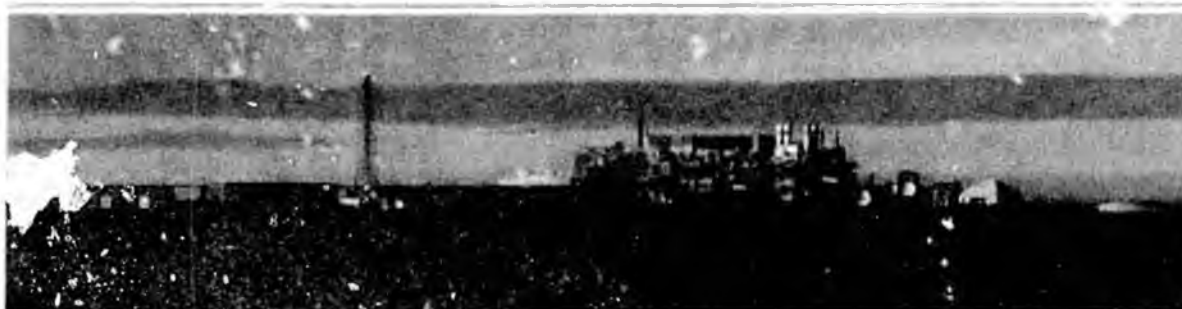
The Endicott Pipeline connects BP's Endicott Development to TAPS. Endicott is developed on man-made islands in the Beaufort Sea connected by a causeway with breaching structures.

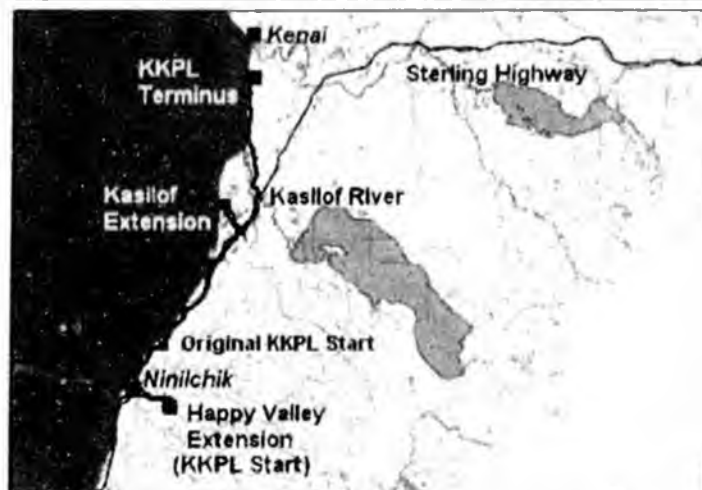
The Kenai Kachemak Pipeline transports natural gas on the Kenai Peninsula.

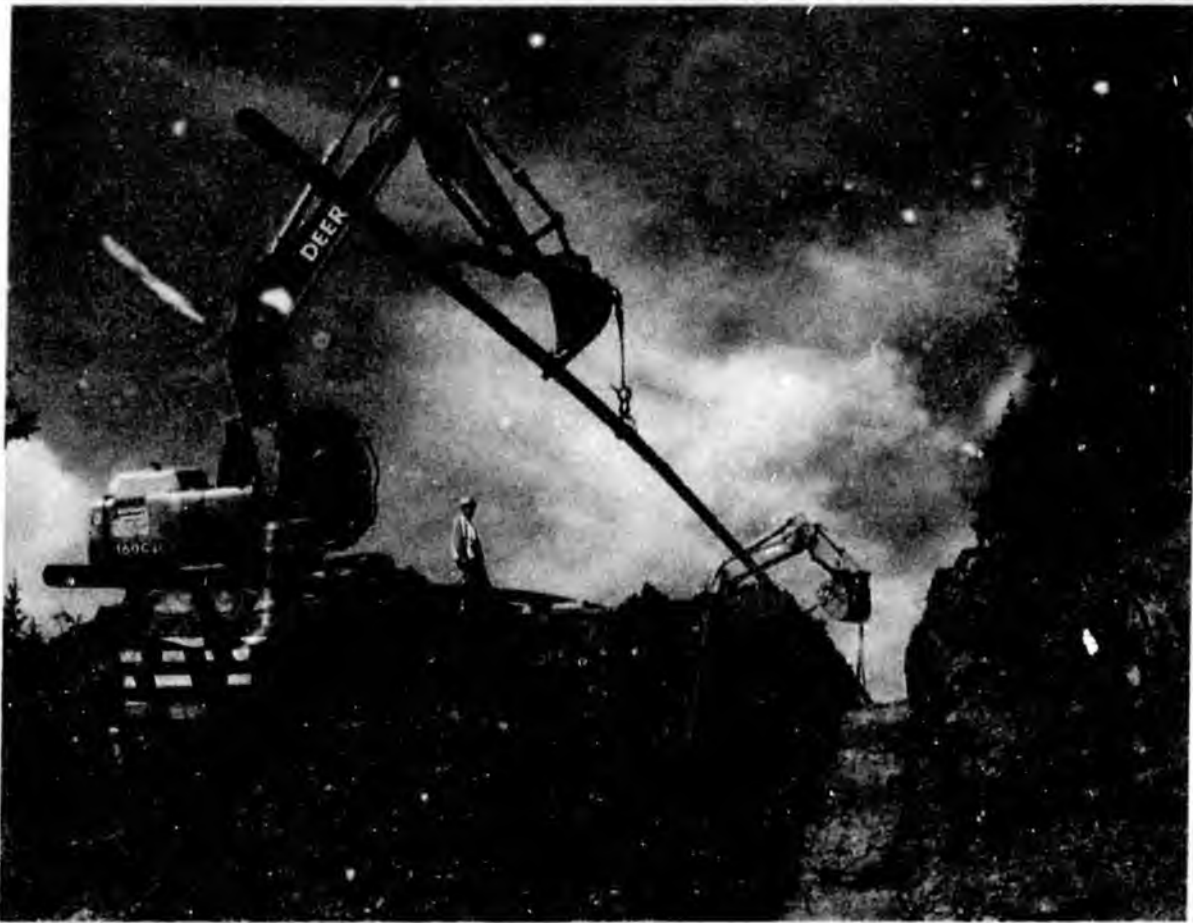
In summer 2006, construction is in progress on the 4.2-mile Kasilof Extension to the KKPL. This picture shows a segment of pipeline being placed in the newly-dug trench.

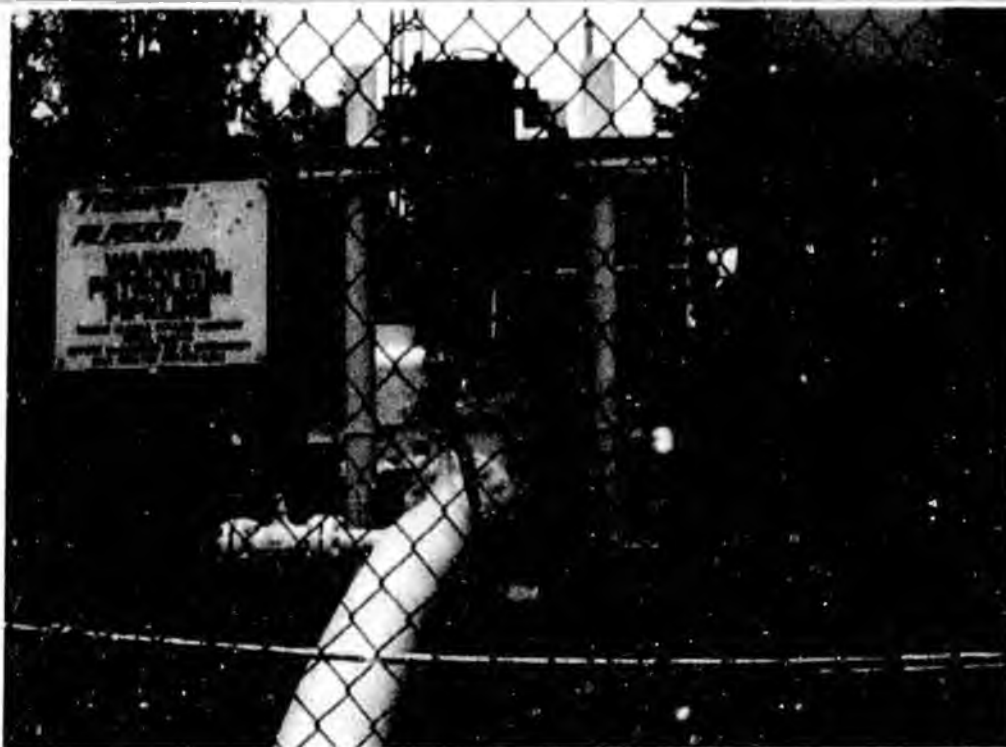
This photo is of a remotely-operated valve on the Nikiski Alaska Pipeline near Point Possession. Solar panels and propane provide energy for the valve and cathodic protection system.

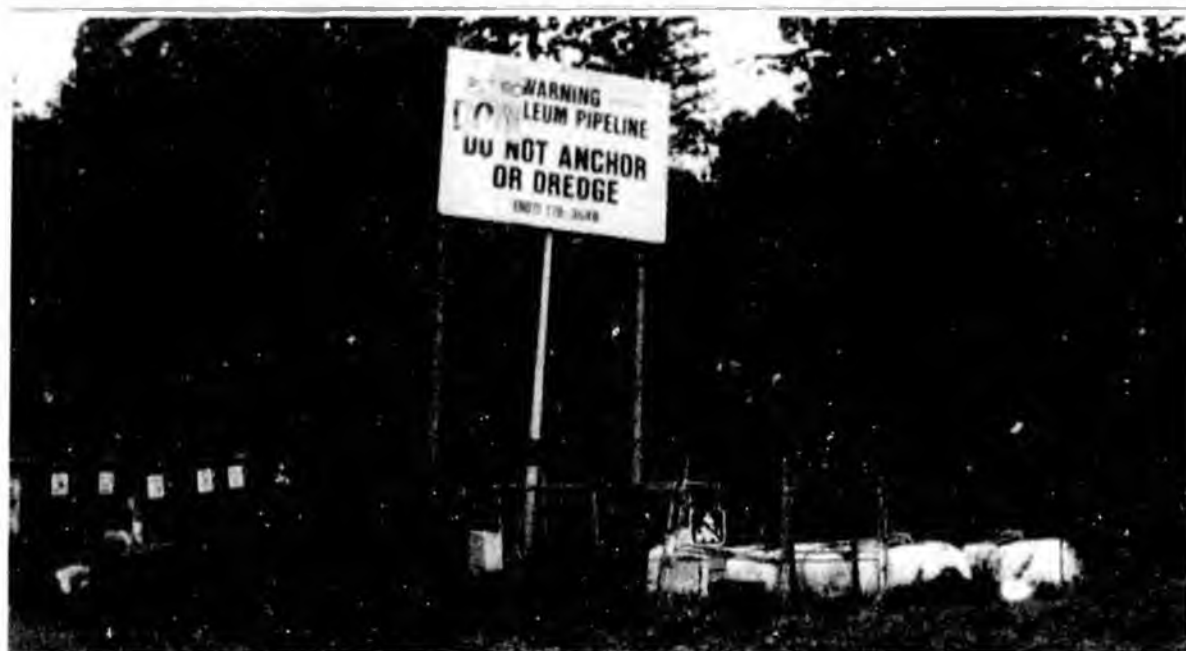
This sign, a piece of which has fallen off, marks the pipeline's transition to sub-sea at Point Possession on the Kenai Peninsula. The propane tanks to the right are part of the impressed current cathodic protection system for the sub-sea line. The site was accessed by four-wheeler during June 2006 SPCO surveillance.

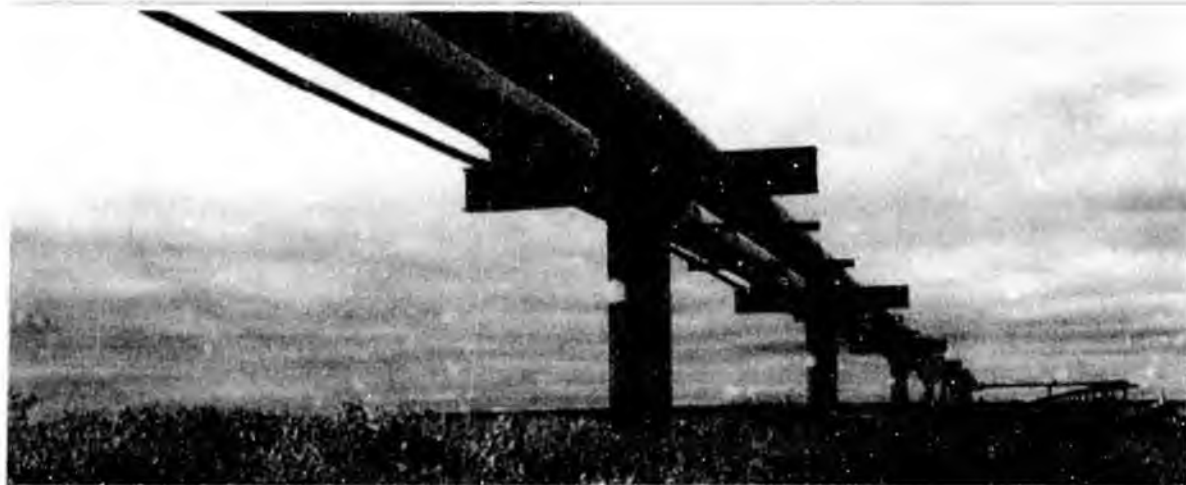
VSMs for the Alpine pipelines are marked with reflector tape for public safety.

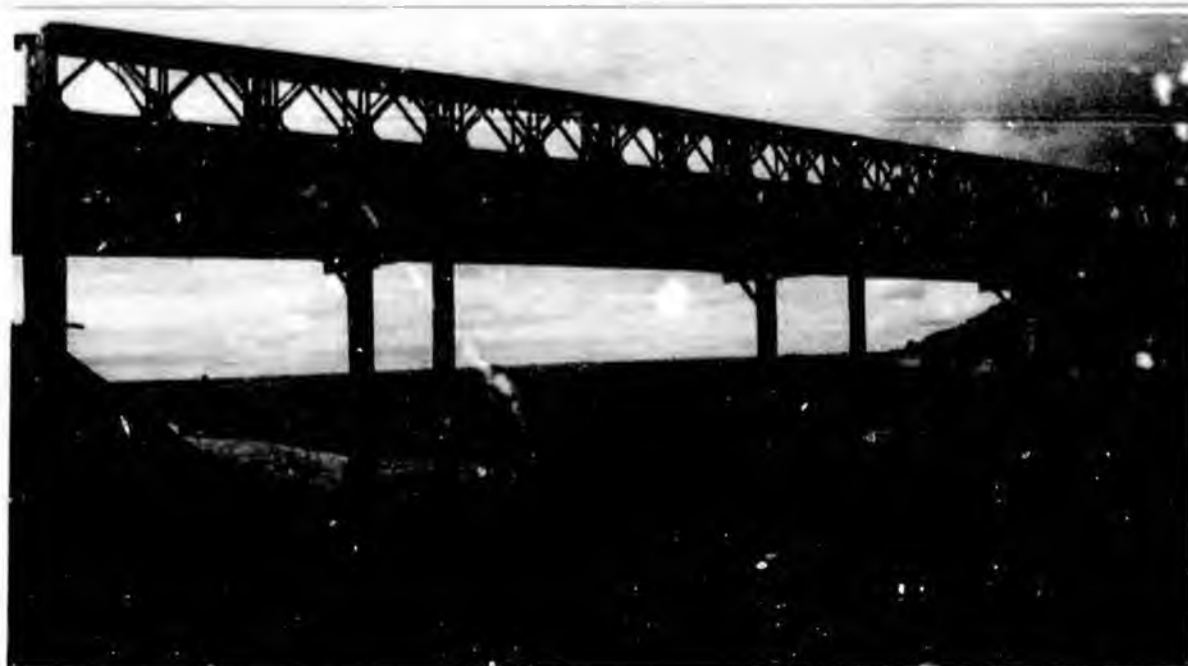
The KPL and OPL cross over Smith Creek, a Kuparuk River tributary, on the Bailey Bridge. CPAI also maintains the Hamilton Bridge as part of the KPL/OPL access road.

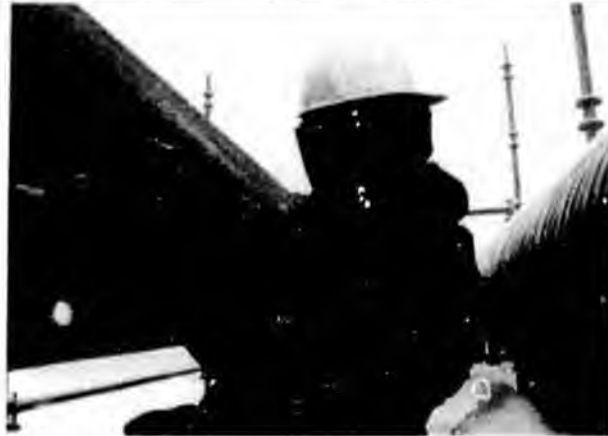
During field surveillance of the KPL and OPL in November 2005, an SPCO surveillant observed inspection work being performed on the KPL. The technician drew a white line around the potentially corroded area to be inspected. The location had previously been stripped of insulation and prepped for inspection.

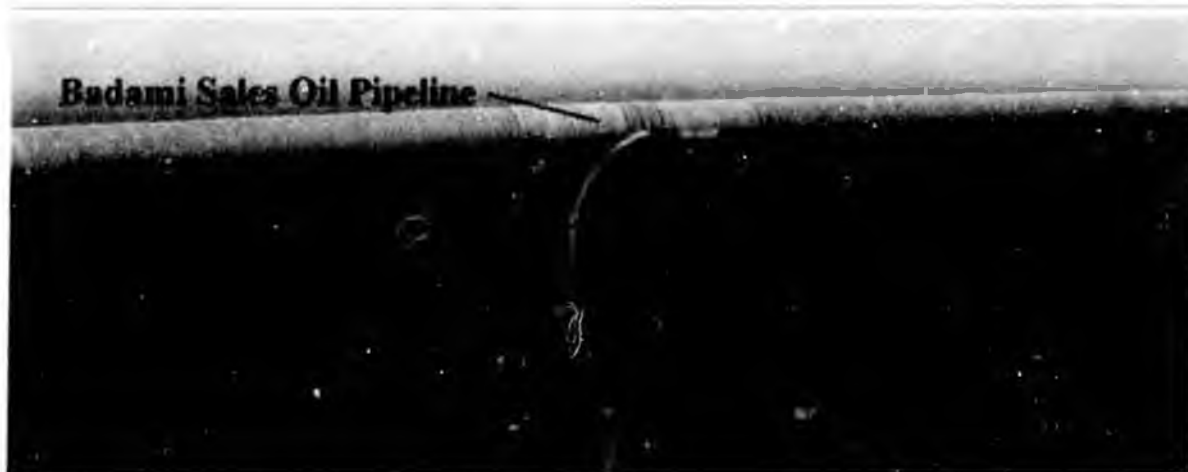
This diagram shows the configuration of the Badami pipelines with vibration dampeners.

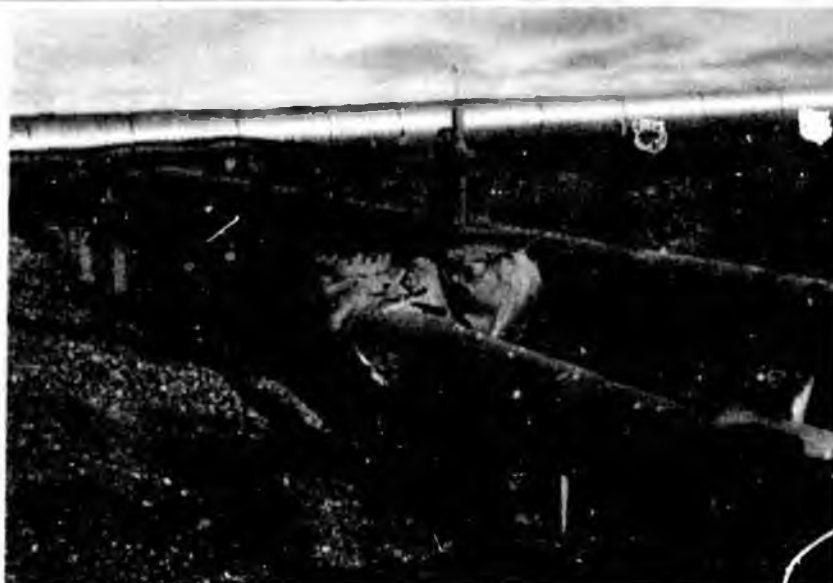
This photo shows the location where the Badami Oil Pipeline (above) ties into the Endicott Pipeline. The Badami pig receiver is visible just left of the Endicott Pipeline (right).

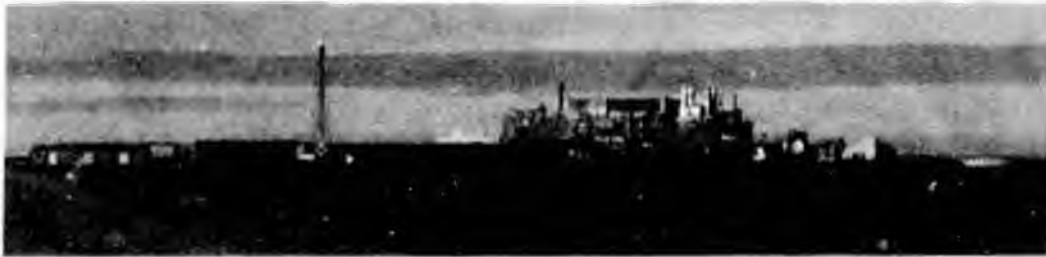
The Endicott Main Production Island is a man-made drilling island in 14-foot deep water connected to shore by a causeway with breaching structures. Endicott was the world's first arctic offshore production facility and the first model of the oil industry's "reduced footprint." Endicott's footprint was 70% smaller than the traditional pad at the time. Current daily production from Endicott is approximately 25,000 barrels per day, compared to the peak production of 115,000 bpd in late 1987. (Source: BP Alaska website, accessed October 2005.)

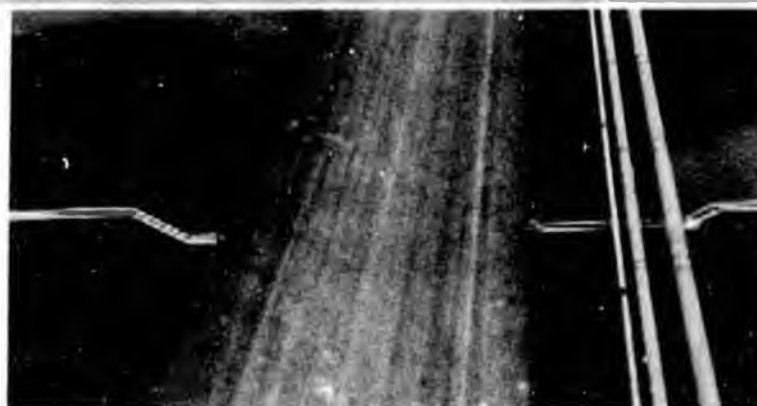
At road crossings, the Northstar pipelines are located in steel culverts covered with gravel. This picture was taken from a helicopter during an SPCO compliance oversight visit in 2004.

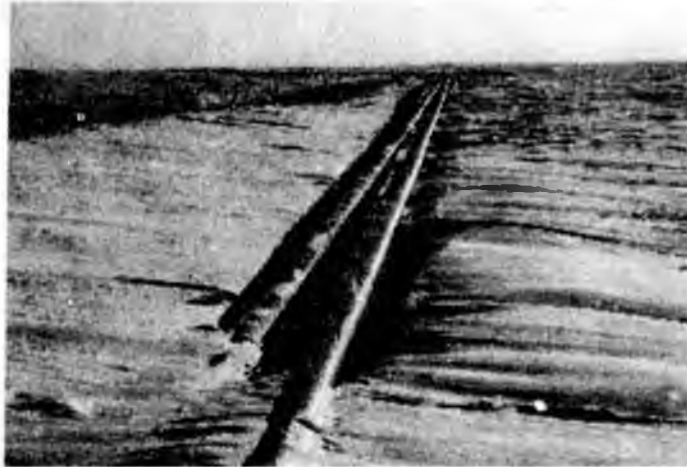
Winter view of the Milne Point Pipelines looking South from the "S" Pad intersection.

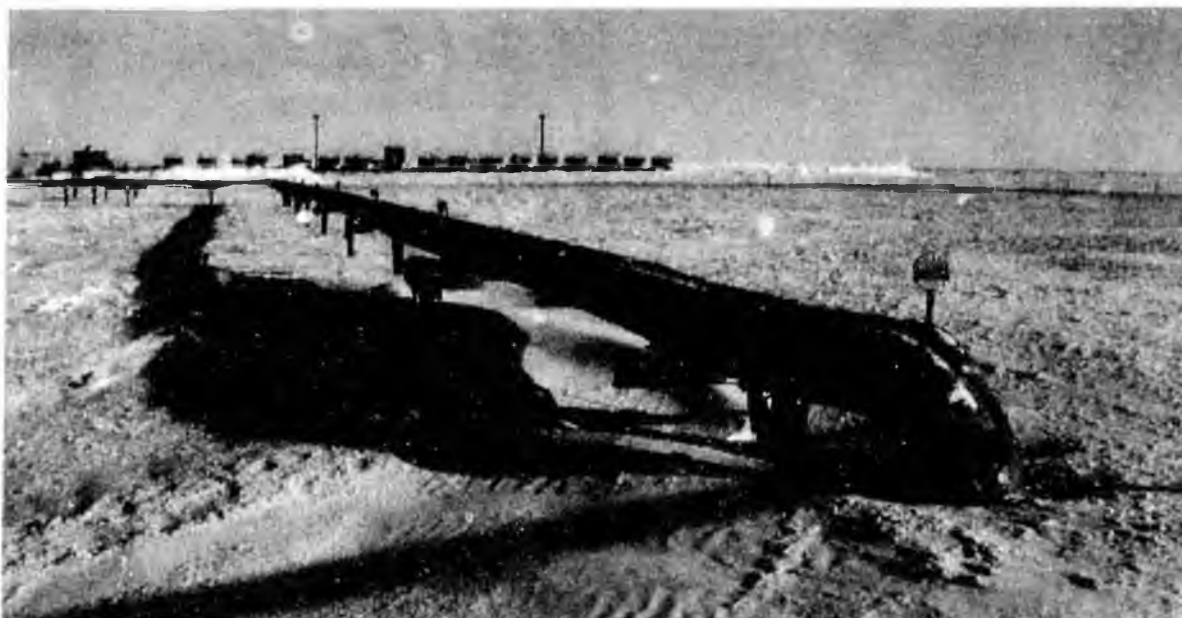
View of the Milne Point Pipelines looking east from Milne Point Road. The pipelines transition to a buried road crossing. In the background is Milne Central Facilities Pad.

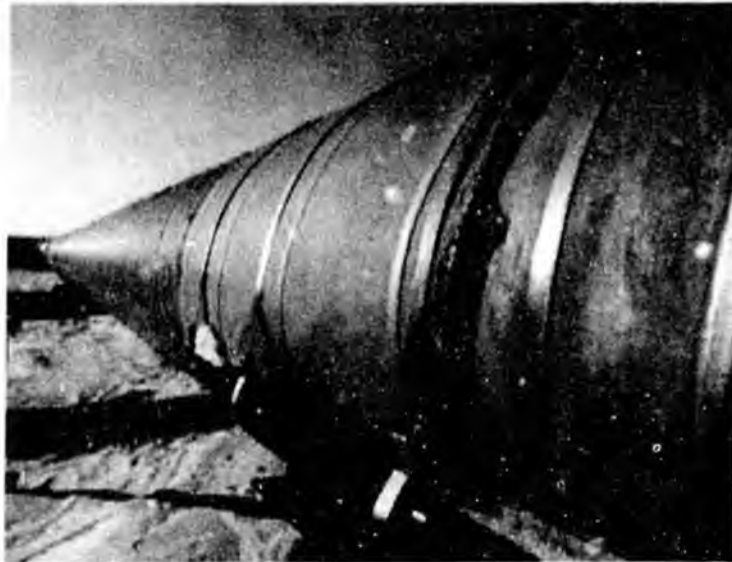
This is a Milne Point Oil Pipeline saddle location near Milne Central Facilities Pad. During March 2006 surveillance, a compliance oversight team member noticed this gap at the joint between two sections of casing. Information about the problem was forwarded to Milne Point personnel.

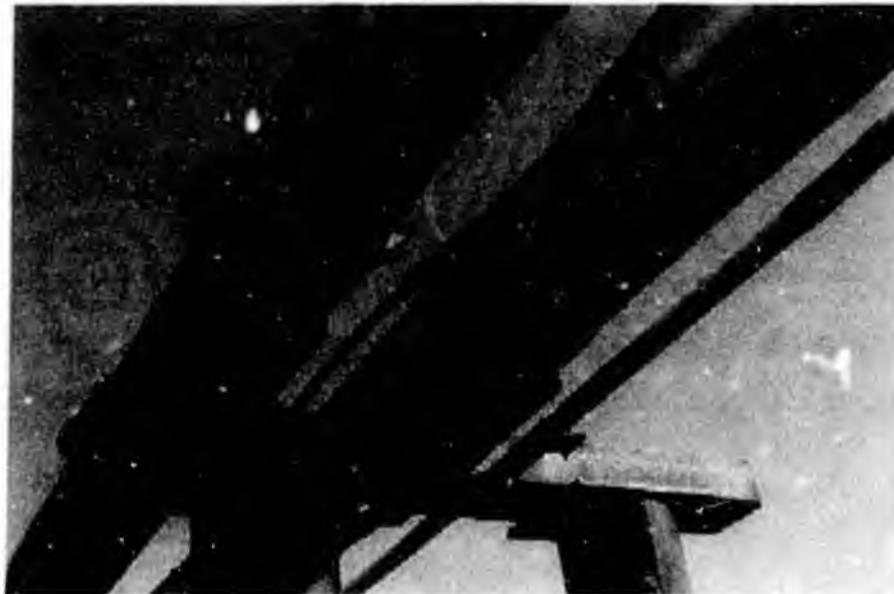
This photo depicts the Alpine and Nuiqsut Pipelines sharing vertical and horizontal supports. From left to right: Alpine Diesel, Utility, Sales Oil, and NNGP (yellow). A fiber optic cable associated with the Alpine Development is in the center.
