**PRUDHOE
BAY
CORROSION
CRISIS,
8/18/06
(FILE 11)**

*Lease Compliance
Monitoring Report
2006*

ALASKA DEPARTMENT OF
NATURAL RESOURCES

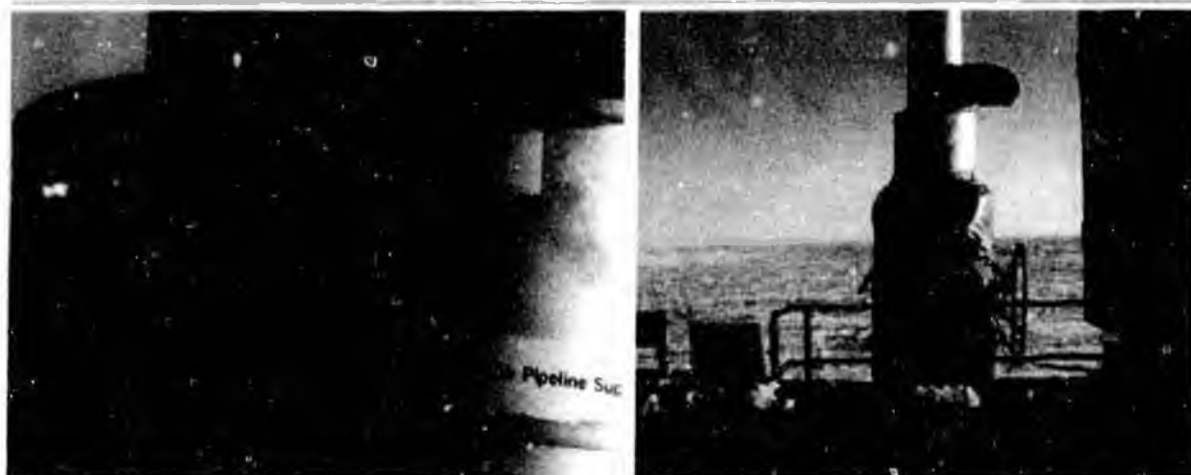
The SPCO surveillant observed that the sign marking the Oliktok tie-in valve did not match the sign described in BPTA's incident report. Details are in surveillance report #ANC-06-S-033.

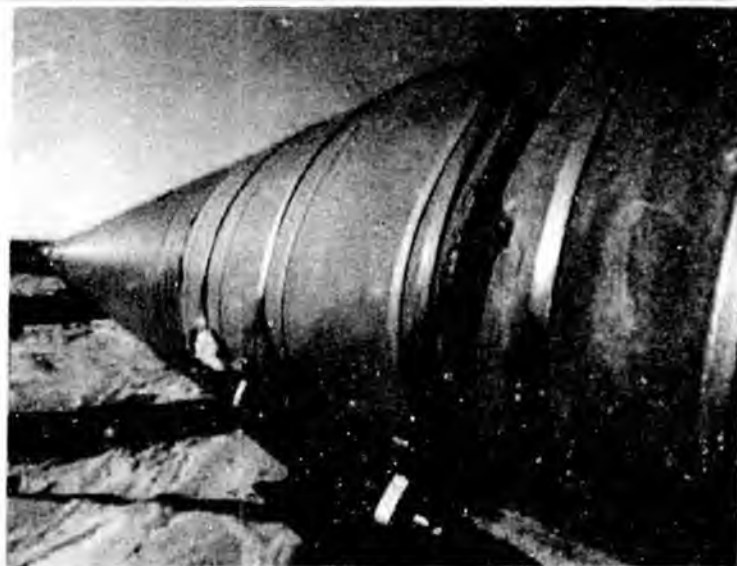
This is a Milne Point Oil Pipeline saddle location near Milne Central Facilities Pad. During March 2006 surveillance, a compliance oversight team member noticed this gap at the joint between two sections of casing. Information about the problem was forwarded to Milne Point personnel.
