**PRUDHOE
BAY
CORROSION
CRISIS,
8/18/06
(FILE 7)**

Annual Report to Alaska Department of Environmental Conservation

Commitment to Corrosion Monitoring

Corrosion, Inspection and Chemicals (CIC) Group
BP Exploration (Alaska) Inc.

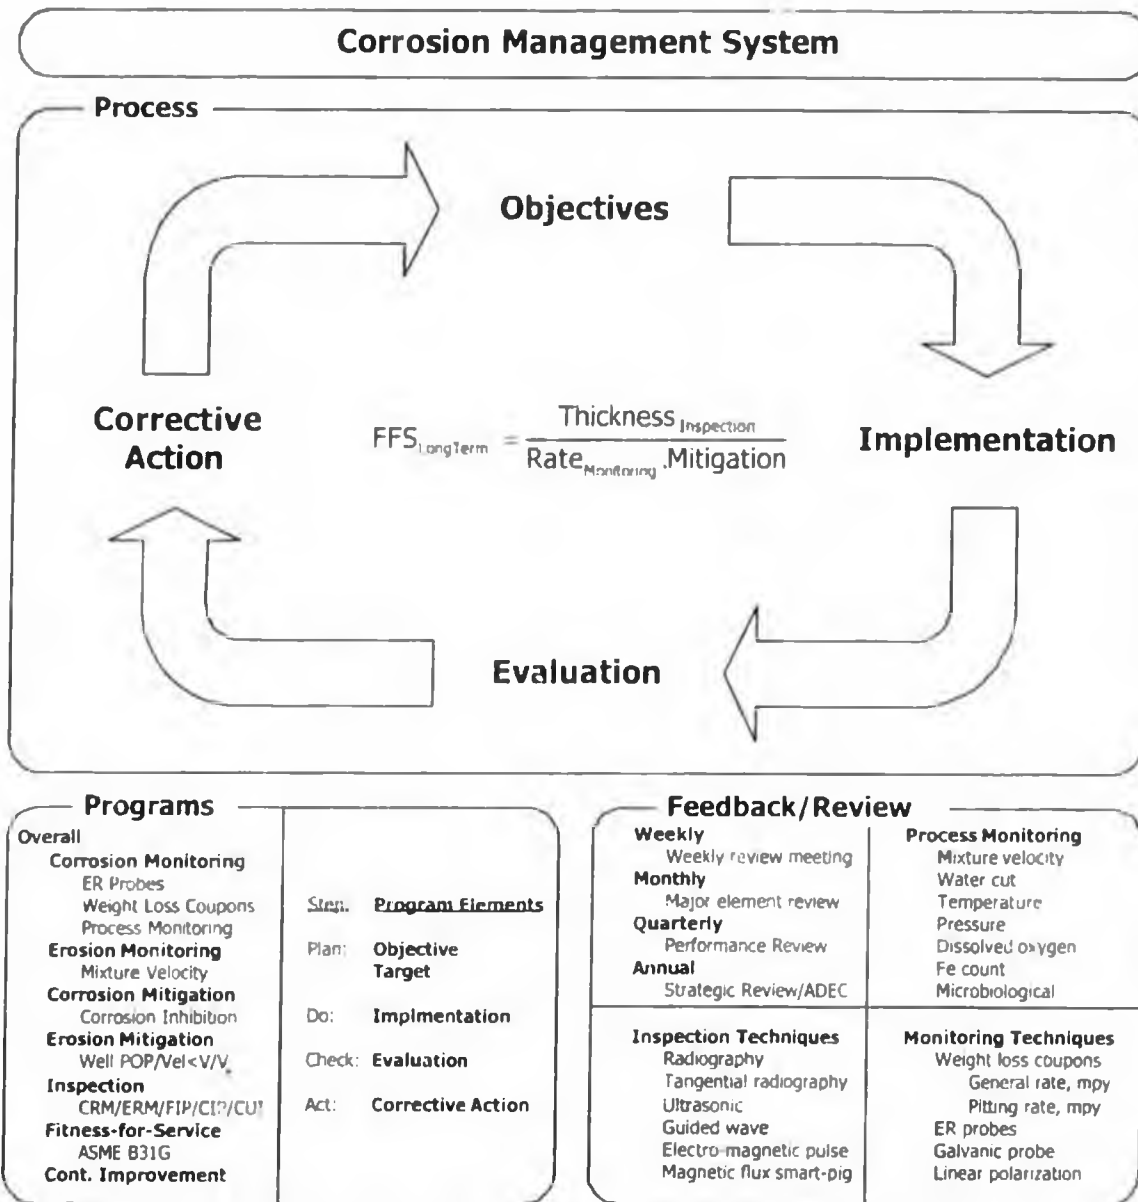
Figure B.1 Overview of the Corrosion Management Process

The Corrosion Management System consists of a number of major program elements, which follow a simple management process. The overall system is shown in Figure B.1.

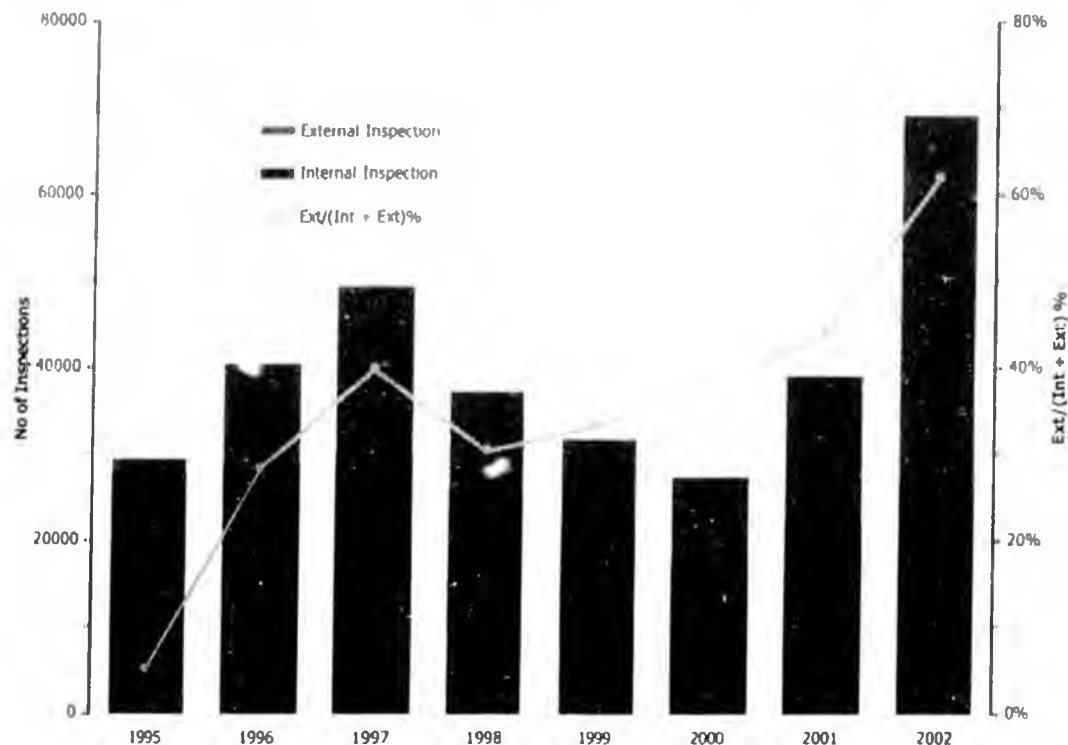
Figure B.4 Breakdown of Inspection Activity Between Internal and External for Field Piping

Table B.5 provides the details of inspection activity for the internal and external programs. The level of external corrosion inspection activity has been ramped-up from a broadly flat level of 10-15,000 in 1995 to over 43,000 external inspection items in 2002. Based on the results of the data generated in the 1996-2001 external corrosion inspection surveys, the 2002 program was expanded to reduce the risk of a leak because of the external corrosion. This is discussed in detail in Section E. The average activity level for the program from 1996-2001 was ~13,000 items per year, in comparison the 2002 program achieved ~43,000 items which is over 3 times the average for the prior five years.

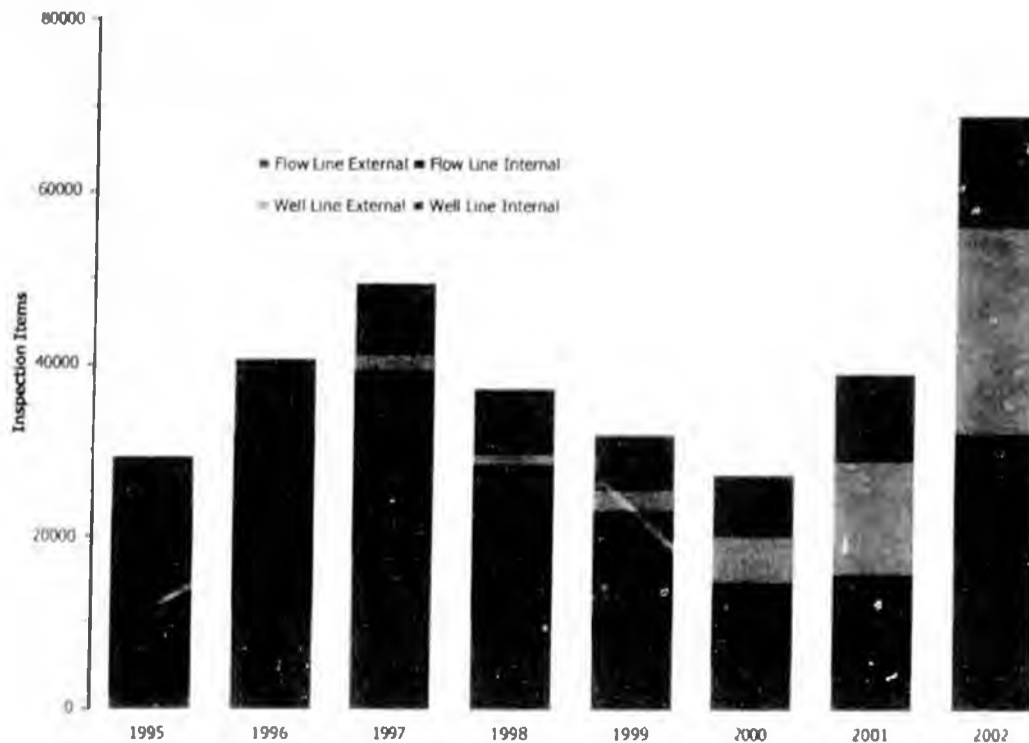
Figure B.7 Internal and External Inspection Activity Summary by Flow/Well Line

For the year 2002, the level of internal inspection activity for the well lines and the flow lines was approximately equal at ~13,200 items. Similarly, the external corrosion inspection program activity was approximately equally distributed between the well line and flow lines at ~20,000 items for each. The split between internal and external inspection for the flow lines and well lines is summarized in Figure B.7

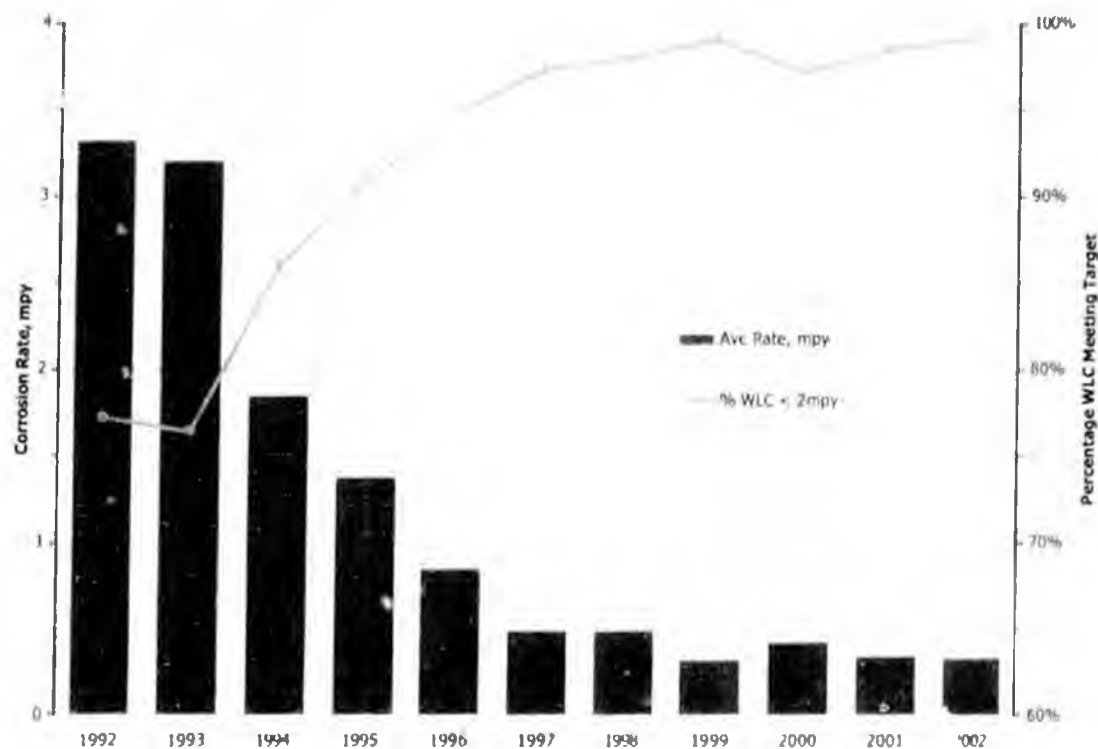
Figure C.1 Flow Line Corrosion Rate Trend 1992 to 2002

expected, there is a very strong correlation between these two metrics. However these two metrics should be viewed as being complementary. The percentage less than 2 mpy target has the advantage of highlighting non-conformances that would otherwise be lost in the calculation of the average.

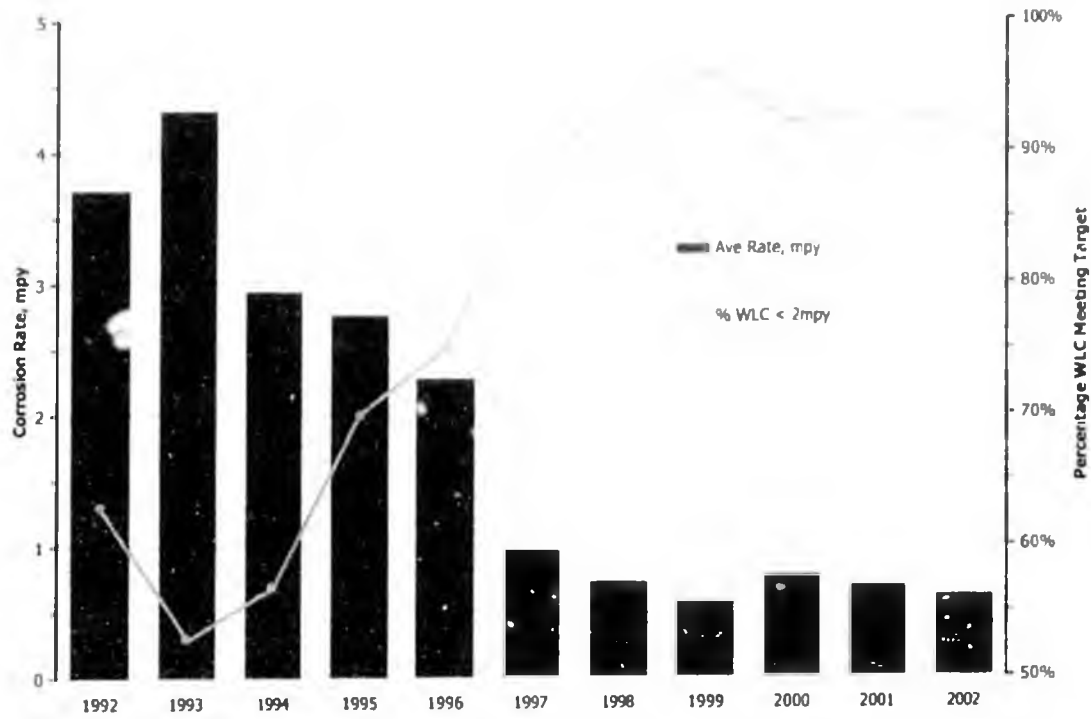
Figure C.3 Well Line Oil Service Corrosion Rate Trend 1992 to 2002

The long term corrosion control improvement in the well lines is of the same magnitude as that seen in the flow lines with corrosion rates being reduced from an average of 3-4 mpy in 1992/3 down to an average of ~0.6 mpy for 2002.

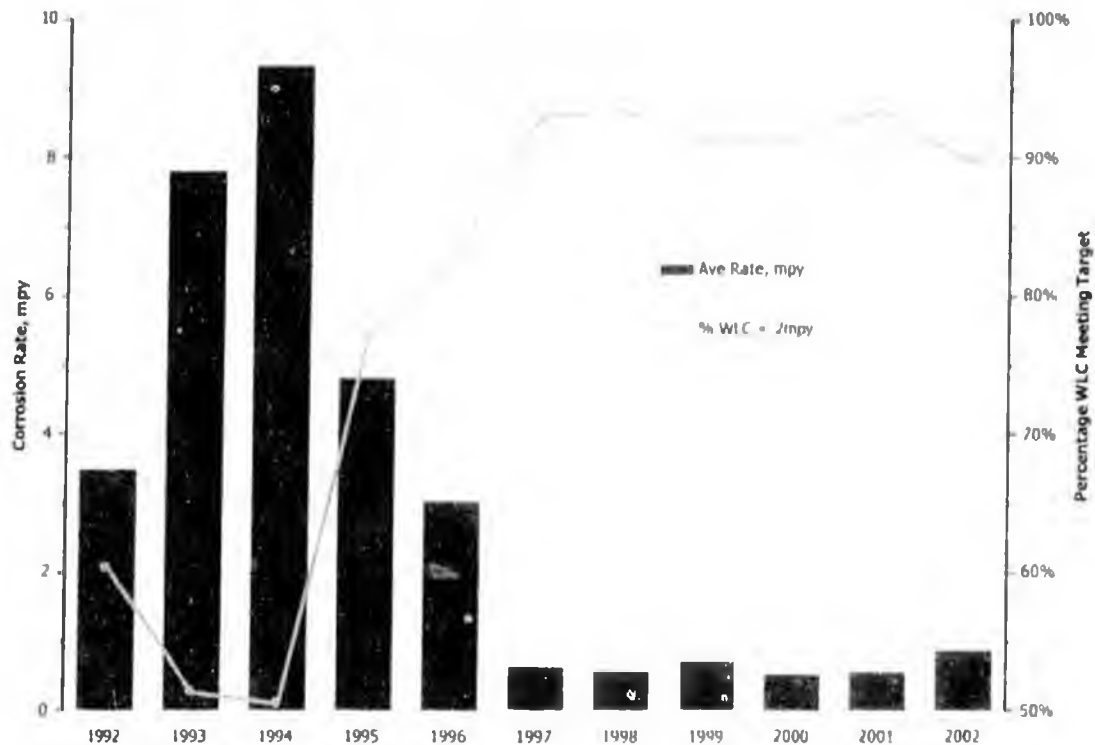
Figure C.5 Flow Line PW/SW Service Corrosion Rate Trend 1992 to 2002

The period, 1993-1996, of increased in corrosion rate is the last time there were significant issues within the SW system. Although there are on-going issues in the SW system, see Section C.5, SW service flow lines now constitute a lower percentage of the overall injection service system and therefore have a less significant impact on the aggregate flow line statistics presented in this report.

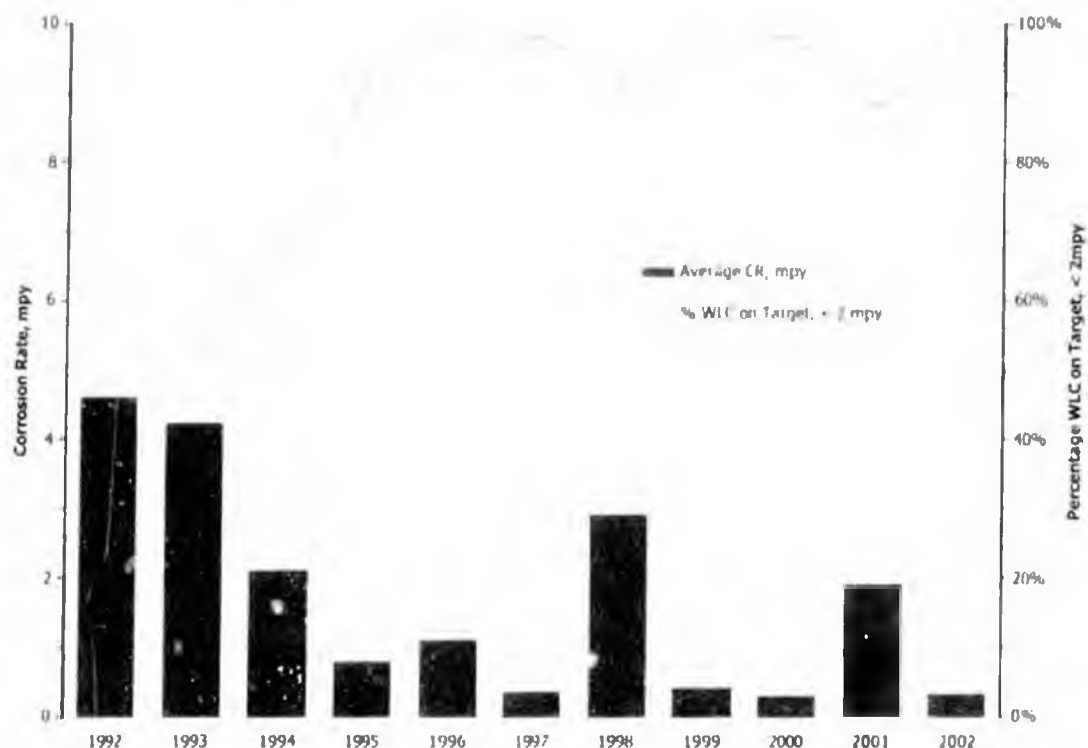
Figure C.6 (a) Corrosion Rates for 100% PW System 1995 to 2002

The trend for 100% produced water service is summarized in Figure C.6 (a). For 2002 the average corrosion rate in the well lines in produced water service was 0.3 mpy with 97% of the well lines falling below the target corrosion rate of 2 mpy.

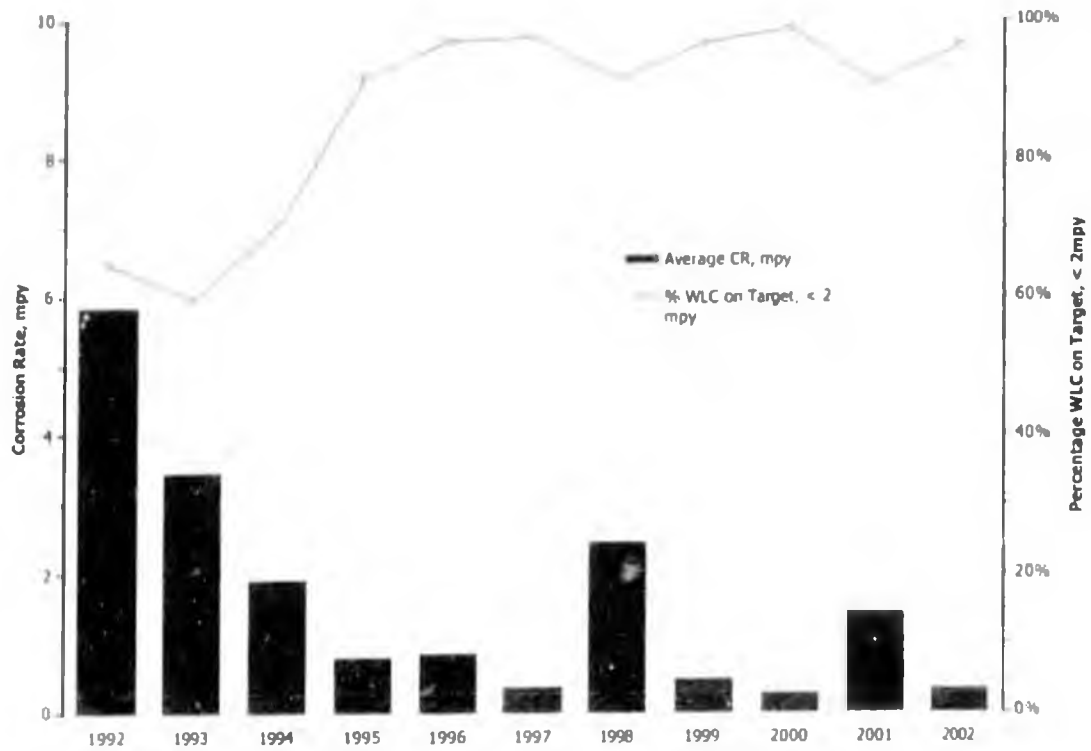
Figure C.6 (b) Corrosion Rates for Majority PW System 1992 to 2002

For those coupons where the produced water was the majority service, Figure C.6 (b) shows that the corrosion rate trends were very similar to that seen for 100% produced water service. The average corrosion rate for 2002 was 0.3 mpy and approximately 96% of the coupons met the corrosion control target of 2 mpy.

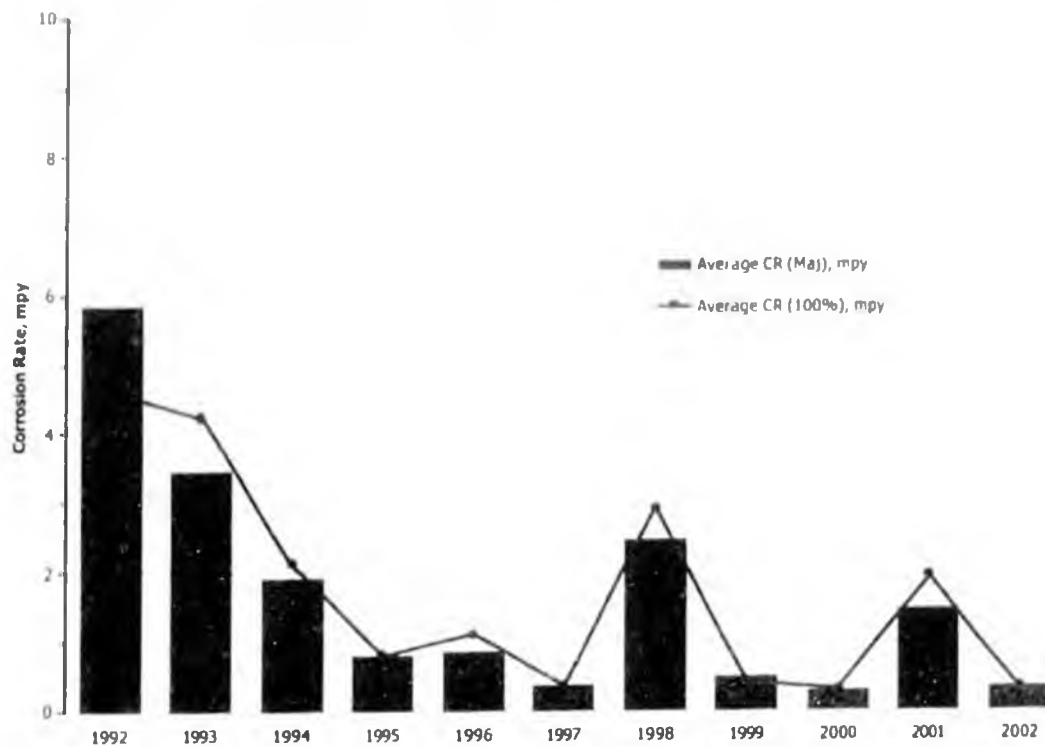
Figure C.6 (c) Comparison of Corrosion Rates for 100% and Majority PW System 1992 to 2002

A comparison of the corrosion rate trends for produced water between the 100% service and majority service is provided in Figure C.6 (c). The figure shows there is little or no difference between the two trends.

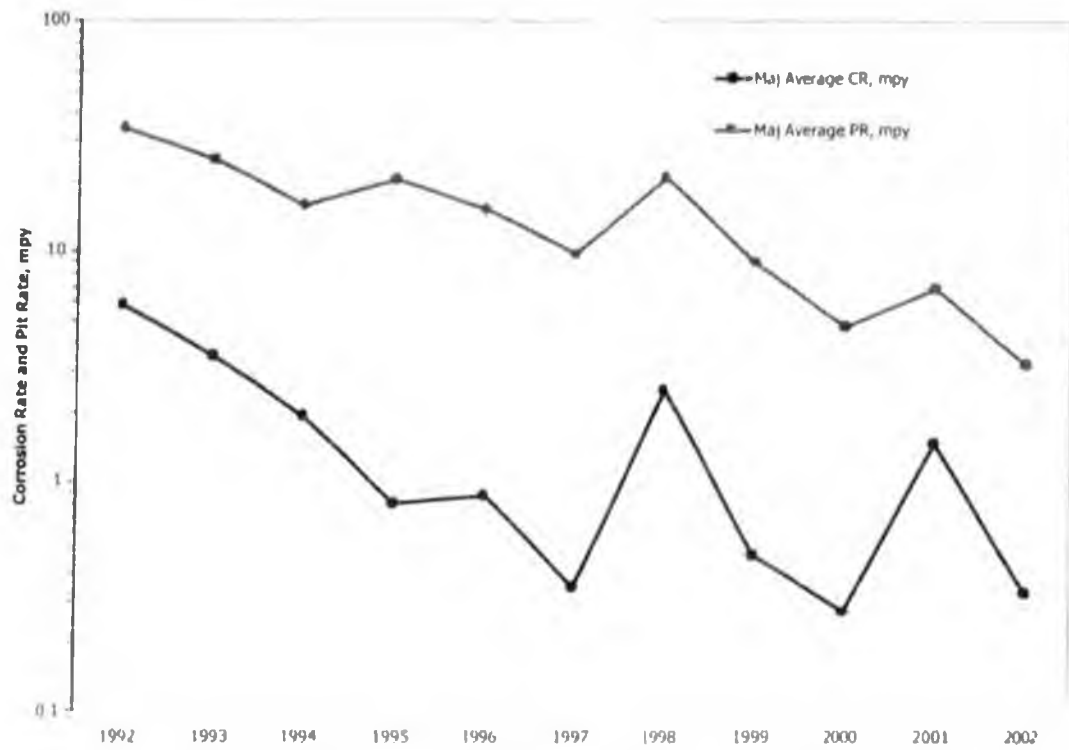
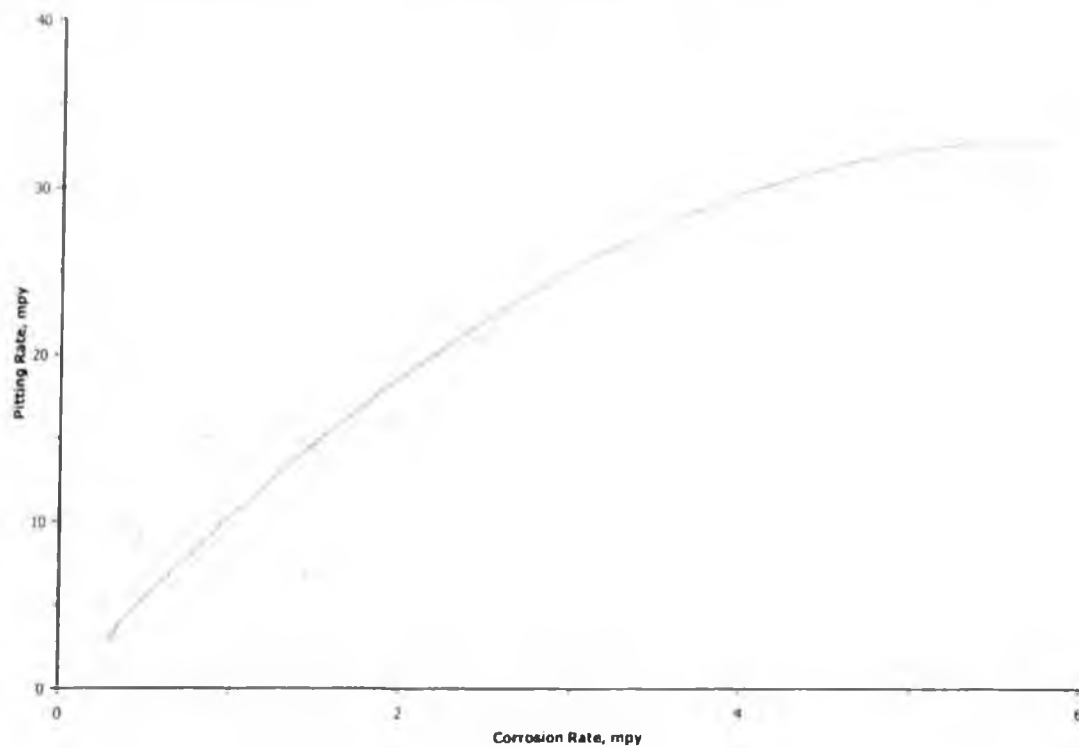
Figure C.6 (d) and (e) are a comparison between the general corrosion rate and the pitting rates for the produced water system. From both figures it is clear that there is a correlation between the two trends with the pitting rate being approximately 10-fold higher than the general corrosion rate.

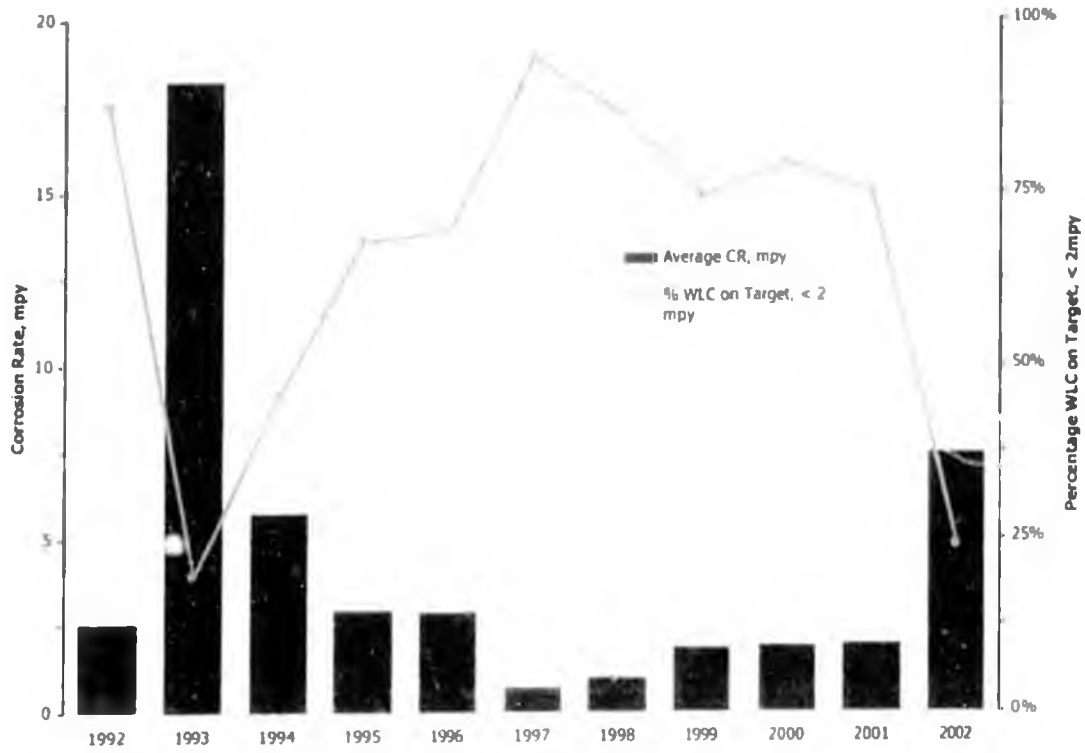
Figure C.7 (a) Corrosion Rate for 100% Seawater System 1992 to 2002

As a consequence of the increasing corrosion rate trends in the seawater system, and as discussed in the 2001, and again at the 2nd 2002 Meet and Confer session with ADEC, a number of corrective actions have been taken to reverse this trend.

- Maintenance pigging frequency has been doubled along with an improved disc/brush pig design
- Biocide treatment frequency was doubled, from once every 2 weeks to once a week

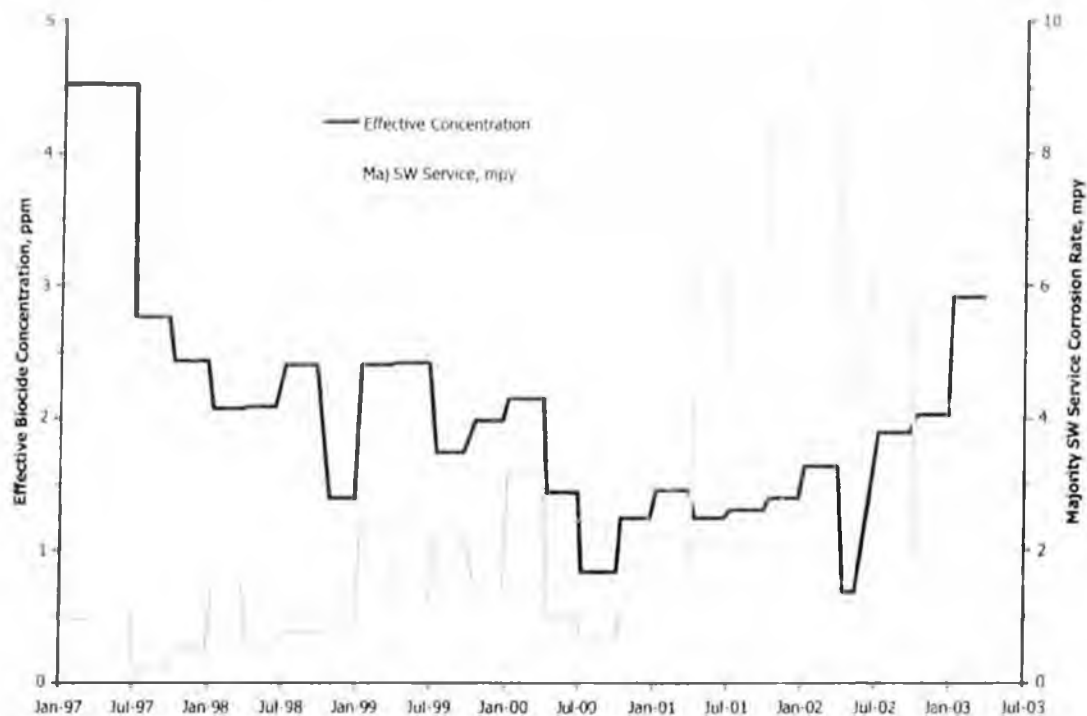
Figure C.11 Biocide Treatment Concentration and Corrosion Rate

While Figure C.11 contains only preliminary information, and no long-term trend has been established, the data does suggest that the increase in biocide

additions and the changes in the biocide treatment regime are beginning to have an impact. The data for the second half of 2002 at least shows that the problem is getting no worse and potentially indicates that corrosion rates are declining if not yet at or below target rate. Clearly this data is still preliminary and continued effort will be required in 2003 to assure that full control of the seawater system has been established and implementation of the long-term treatment regime.

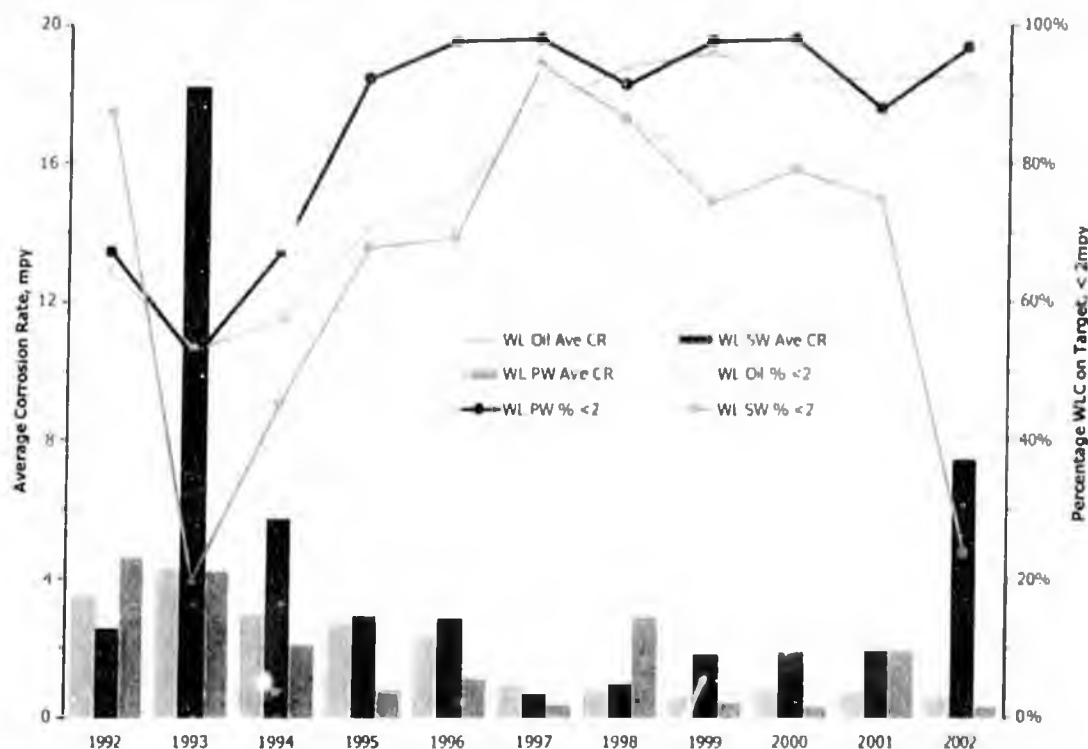
Figure C.13 Well Line Summary by Equipment and Service for Corrosion Coupon Data

Figure C.13 shows the corrosion rate and corrosion conformance for the well lines. The well line 3-phase system has remained essentially constant between 2001 and 2002. For the produced water well lines there has been a significant improvement between 2001 and 2002, however, this improvement has only returned the system to the levels seen in 1999 and 2001.

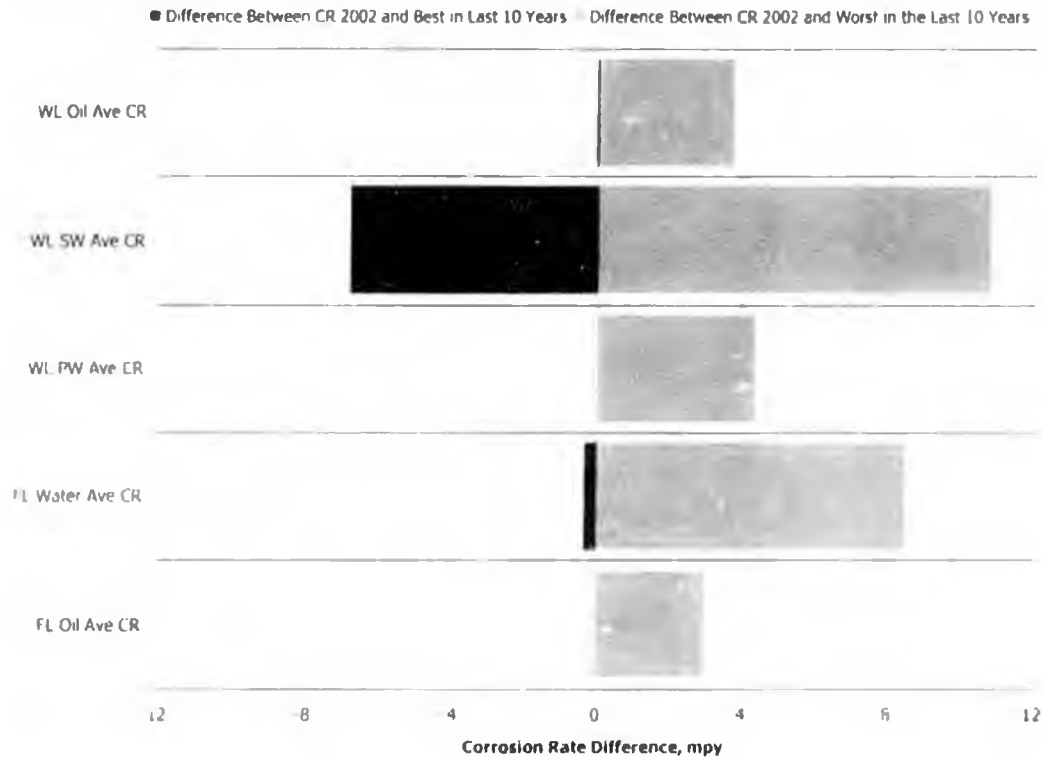
Figure C.14 Corrosion Rate Difference by Service and Type

In order to assess the relative performance of the corrosion management program today versus that of the last 10 years, Figure C.14 was generated as a summary. The data shows the difference between the 2002 corrosion rate for each of the systems and the best, or lowest, corrosion rate seen in the prior 10 years and the worst, or highest, corrosion rate seen in the prior 10 years. This is an approximate measure of the successes and/or shortcomings of the program today versus the 10-year history and highlights areas for attention.

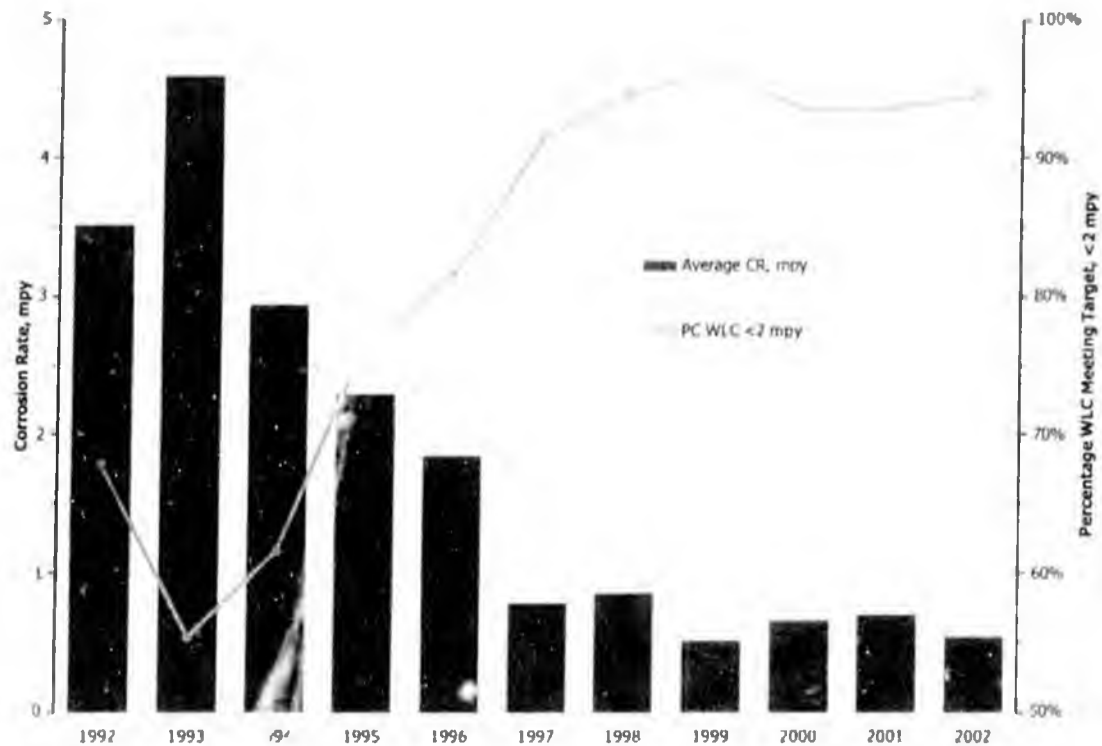
Figure C.16 GPB Aggregate Performance

Electrical Resistance (ER) probes are installed in various locations to monitor corrosion rates in flow lines throughout the GPB field piping systems. ER probes show increases due to material loss from corrosion and the measurements are converted to provide corrosion rates in mils per year (mpy). Field ER probes are equipped with remote data collectors (RDC), which measure and record the metal loss data at specified time intervals. The RDC units throughout GPB are set

to record metal loss data every 3 hours. This provides an adequate number of data points to assess corrosion rates while maximizing battery life in the units.

The type of ER probe used is a T-10 that has 5 mils of metal thickness available for use. All flow line probes are replaced based on 1-year service, or when one half the usable metal thickness has been used. This reduces false negative and false positive readings as a result of a bad, used up, or unresponsive probe.

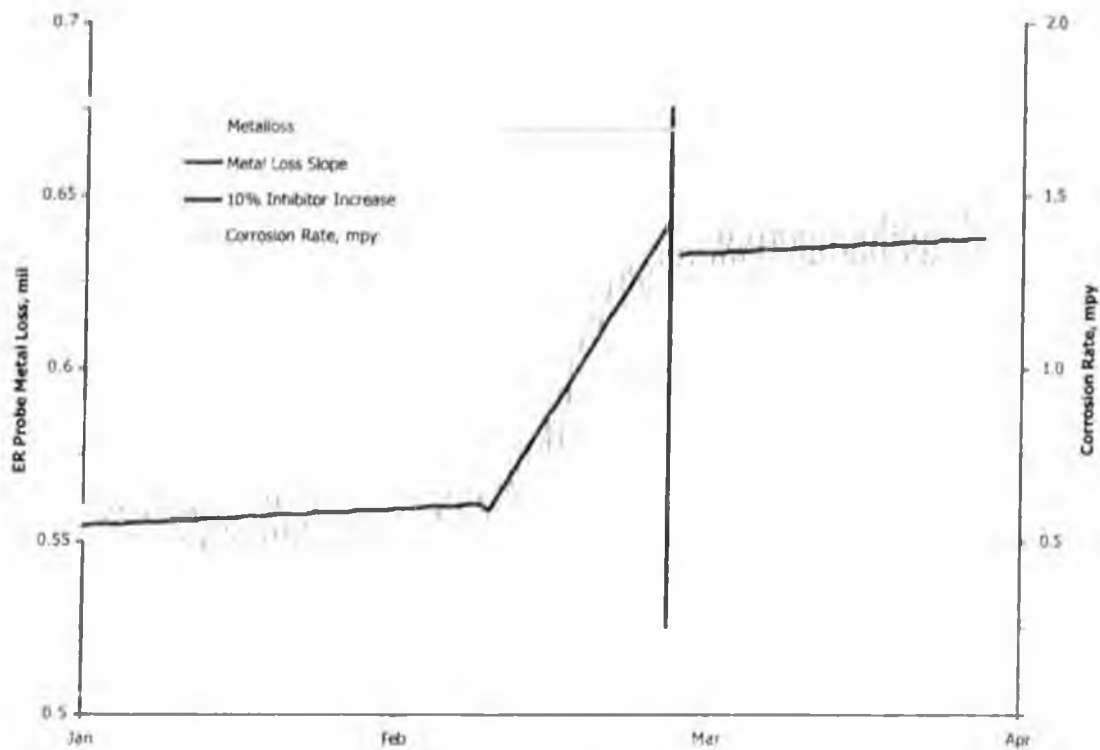
Figure C.17 ER Probe Inhibitor Change Example

ER probe data is collected in the field and uploaded to the corrosion and inspection database once per week. More frequent readings can be made to closely monitor suspect locations/readings. The data is then reviewed and analyzed to identify any negative trends that need to be addressed. After verifying an increase in corrosion rates based on the probe data, a corrosion inhibitor increase may be recommended, as discussed in Section D and shown in the example given in Figure C.17.

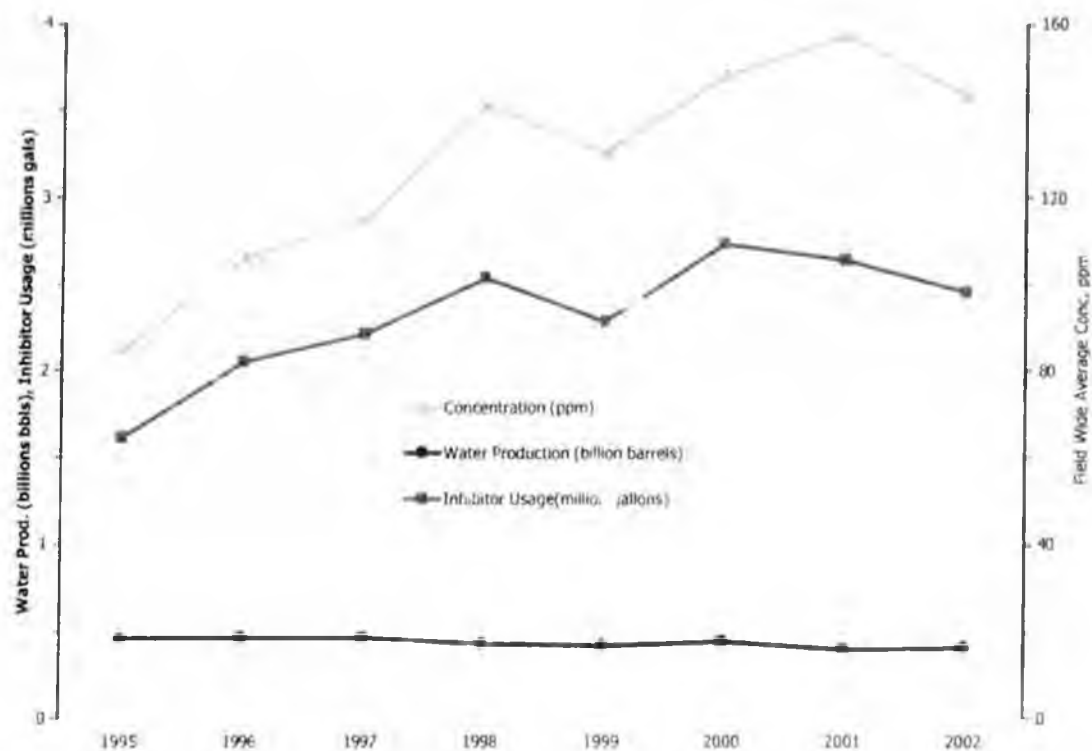
Figure D.9 Field Wide Chemical Usage

The metrics in Figure D.9 deal with chemical usage at the field level but much of the chemical optimization activity focuses on injecting the correct amount of corrosion inhibitor to each piece of equipment. The inhibitor requirement is driven by factors such as water cut, water volume, flow regime, and condition of the equipment and varies over a wide range, from a few parts per million (ppm) to several hundred ppm.

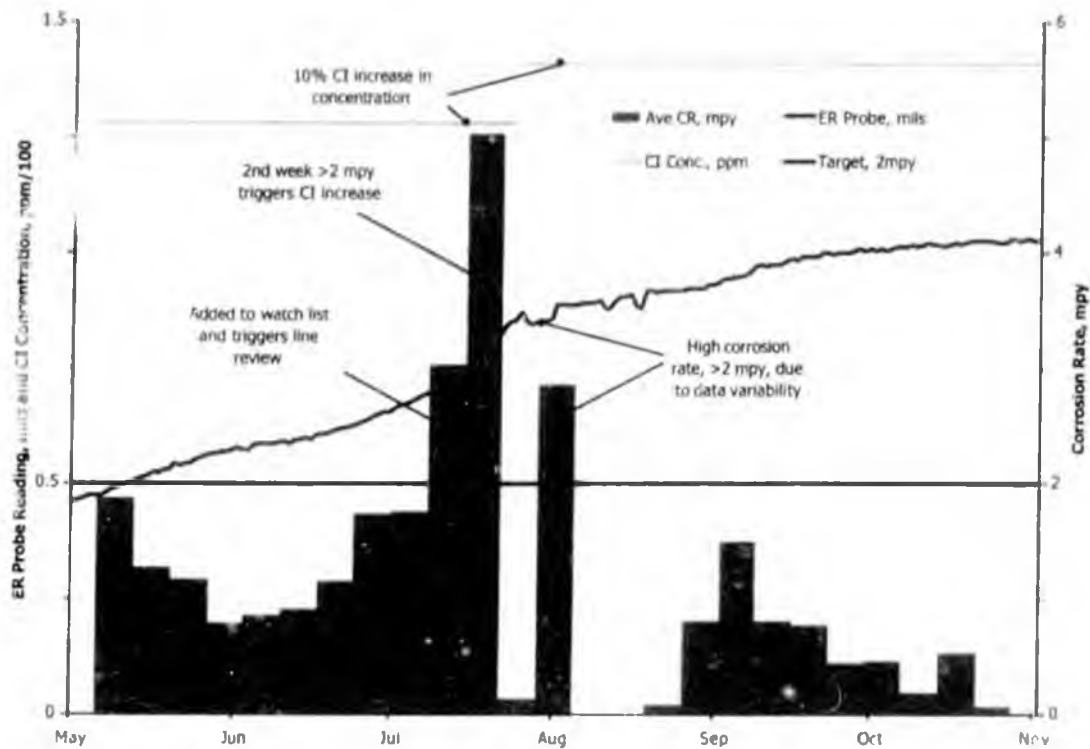
Figure D.12 (a) Corrosion Inhibitor Concentration vs. Corrosion Rate

The data in Table D.13 clearly shows the long-term effectiveness of the corrosion inhibitor increase with the corrosion rate in the flow line remaining below 1 mpy for the 4-month period following the 10% inhibitor concentration increase.

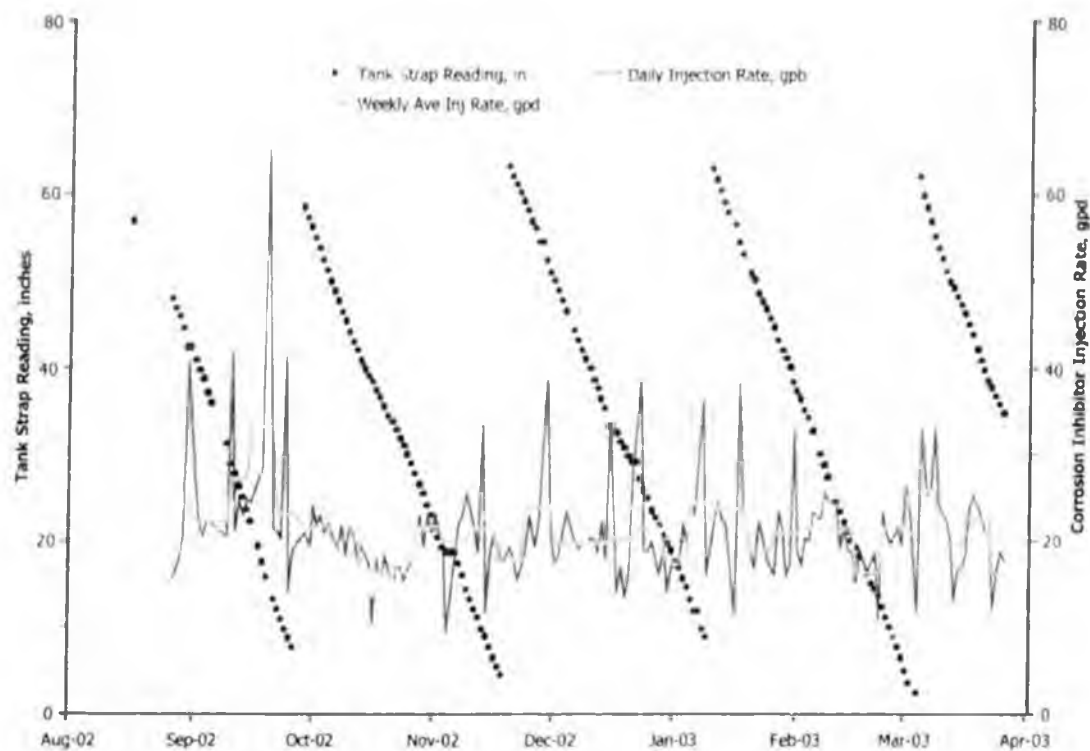
Figure D.14 Tank Strap Reading and Inhibitor Usage

An example of the data that is now available is given in Figure D.14. The figure shows the tank strap reading history for C-Pad fluids that flow into GC-3 via a 24" diameter flow line. This and similar data sets will allow for much improved and consistent levels of corrosion inhibitor injection for the future.

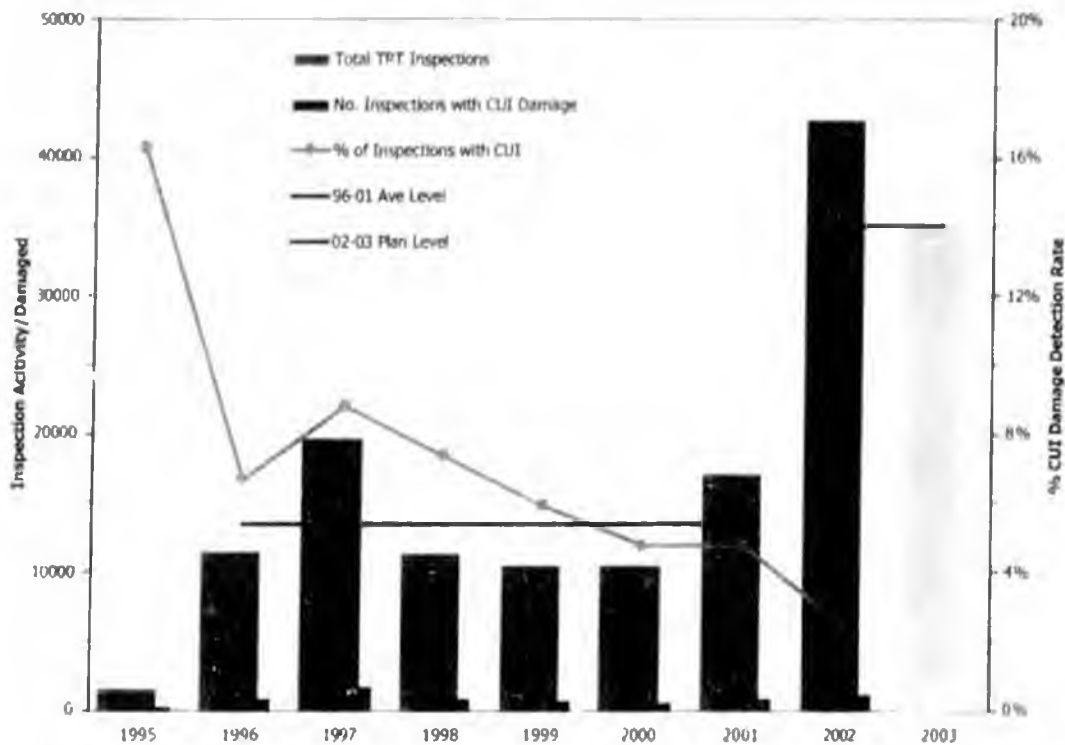
Figure E.2 External Corrosion Activity and Detection Summary

Table E.1 and Figure E.2 summarize the annual level of CUI inspection activity, the number of damaged locations found through the inspection program, and the percentage of inspected locations that exhibited damage. In general, the inspection levels over the period 1996 to 2001 remained relatively constant at an average of ~13,000 per year. The inspection level in 2002 was greater than three times the historical average and ~43,000 inspections were completed. In contrast, the percentage of locations found with damage has fallen from an initial high of >15% to a field-wide average of ~2%.

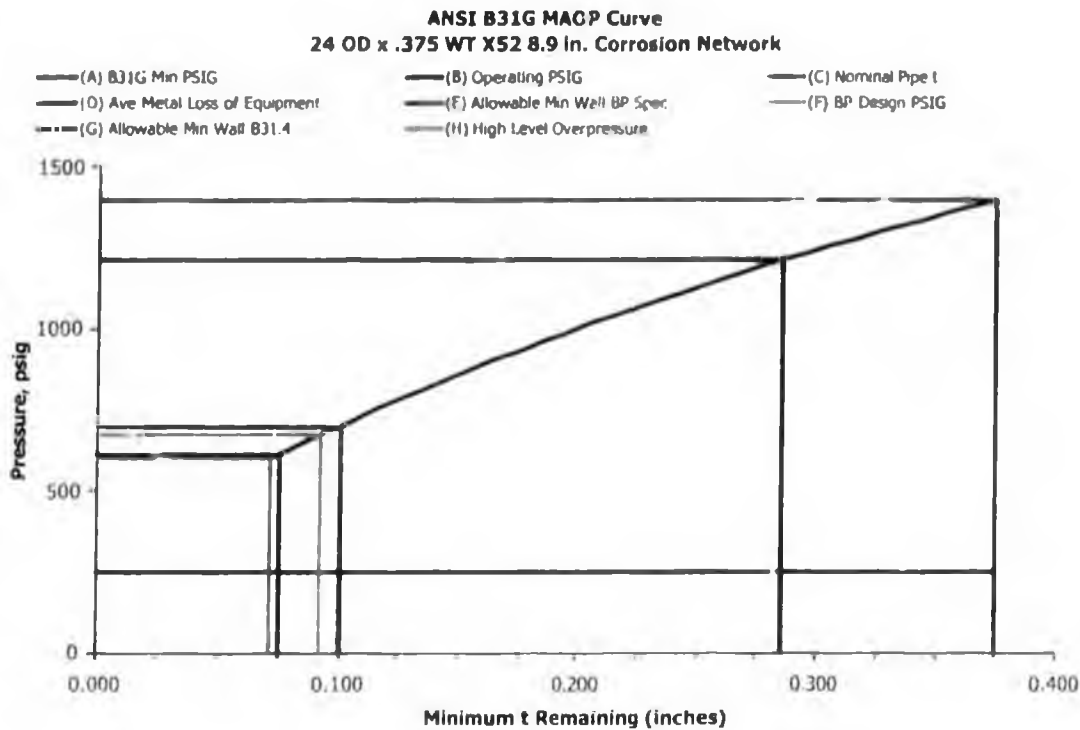
Figure E.12 (a) MAOP versus Remaining Wall Thickness

Figure E.12 and the subsequent explanation are intended to show the multiple-layers of protection to the environment provided by the current fitness-for-service criteria. At the original wall thickness of 375 mils, a typical flow line has a B31G calculated MAOP of ~1400 psi. As the wall thickness is reduced by corrosion, this pressure containment capacity is reduced.

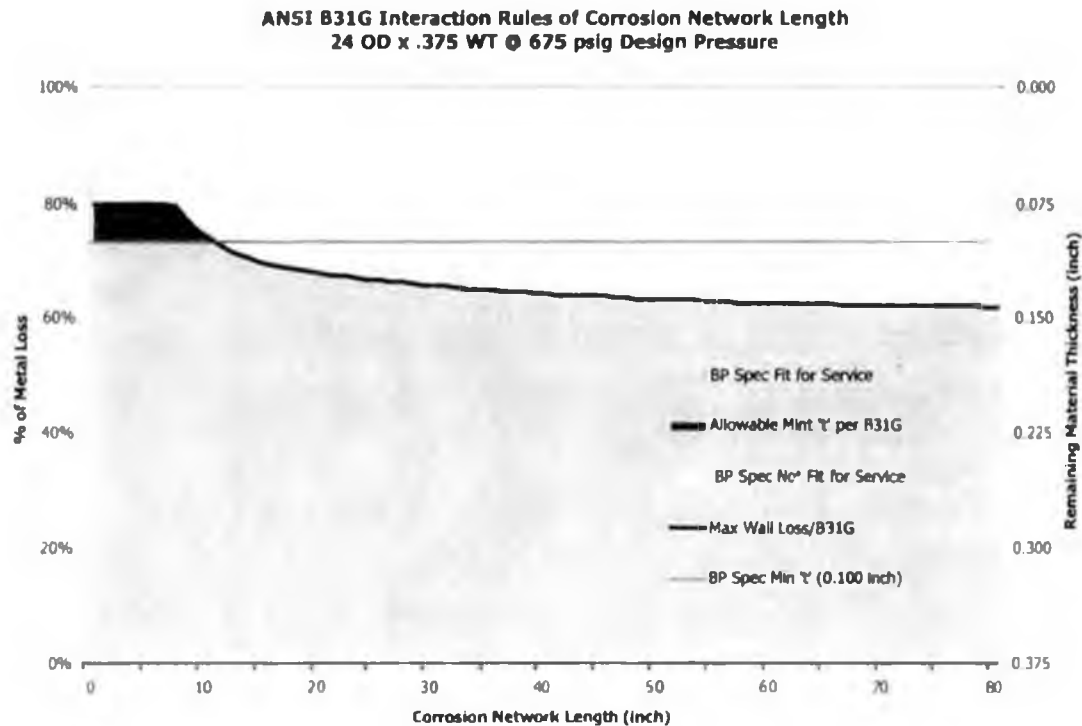
Figure E.14 illustrates the FFS envelop for a combination of depth and length of defect as defined in BP Specification SPC-PP-00090. As can be seen from the curve, the criteria for allowable operating service condition is more conservative than the industry standard at the low end of the remaining wall thickness. This conservatism reflects two issues, (a) the need to provide a margin for error in the determination of wall thickness and corrosion rate, and hence remaining life, and (b) the decreased accuracy of the NDE techniques in use at a wall thickness of less 100 mils.

In addition, repairs are typically scheduled when the corrosion damage has reached 105% of the repair criteria. This additional conservatism is in order to allow repairs to be planned rather than requiring an immediate plant shutdown.

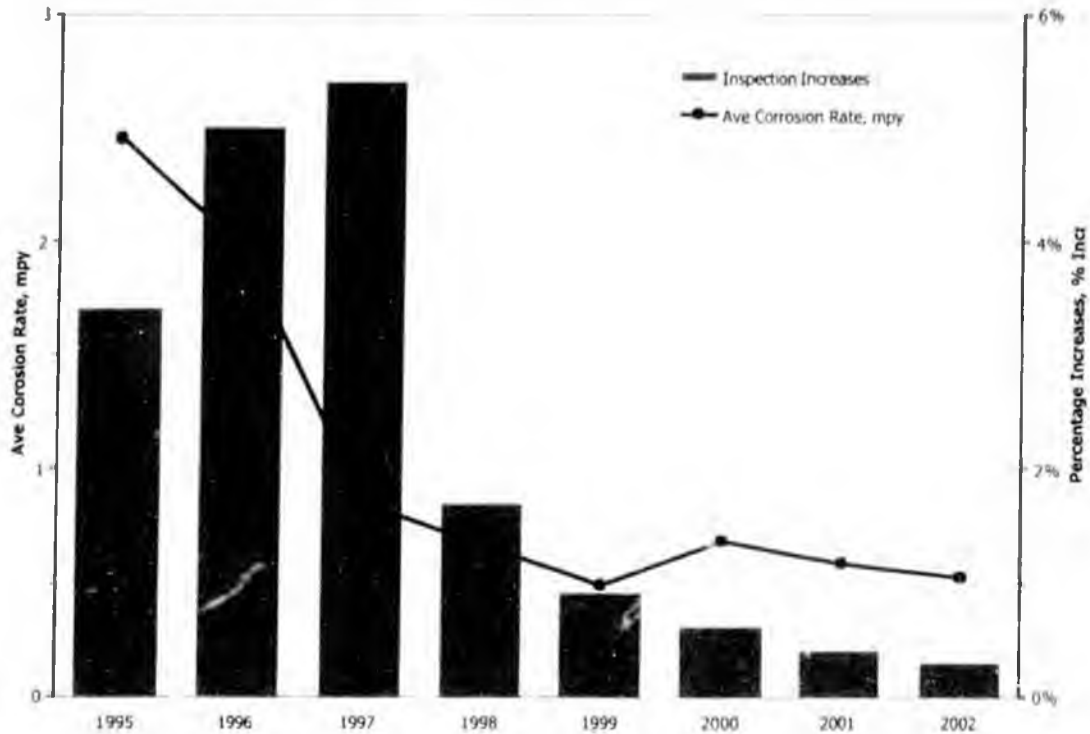
Figure E.15 Correlation of Corrosion Rate and %Increases

- Because of the lower sensitivity of the techniques used in the inspection program, the corrosion rates in the 3-phase flow lines are below the detection limits for inspection; therefore corrosion rate monitoring becomes a function of the coupon program leaving inspection as a confirmation and integrity assessment tool
