**PRUDHOE
BAY
CORROSION
CRISIS,
8/18/06
(FILE 7)**

Annual Report to Alaska Department of Environmental Conservation

Commitment to Corrosion Monitoring

Corrosion, Inspection and Chemicals (CIC) Group
BP Exploration (Alaska) Inc.

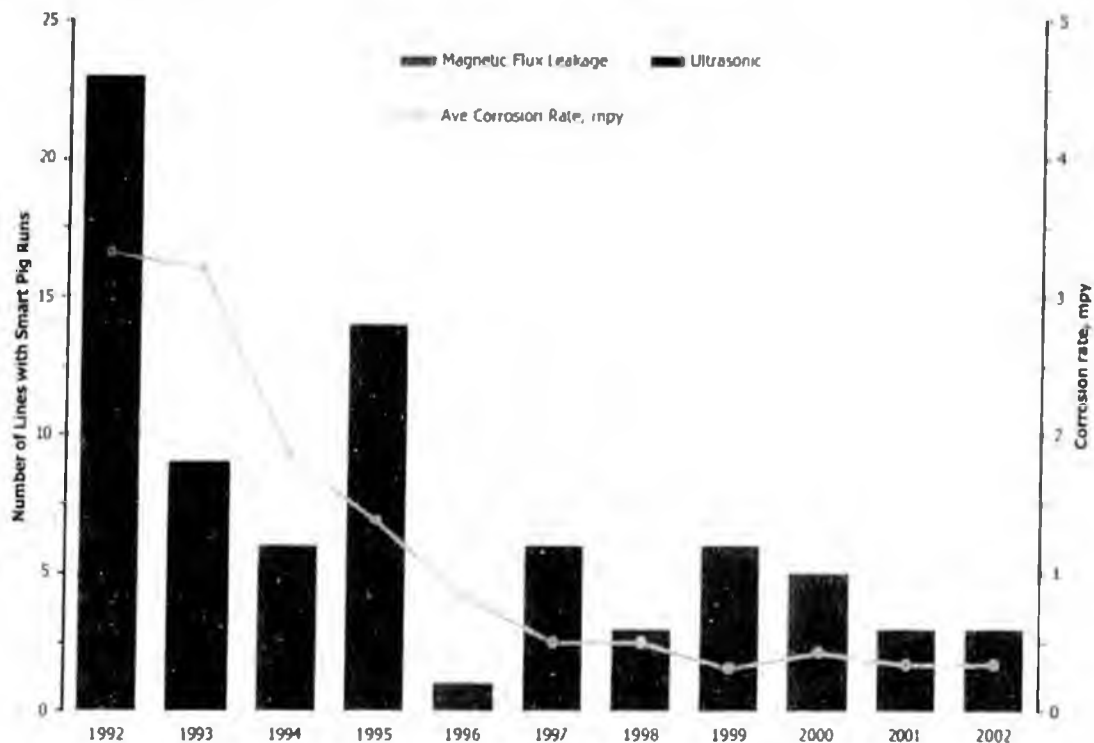
Figure E.18 Smart Pig Activity and Corrosion Rate 1992 to 2002

year in 1992 to the 3 runs completed in 2002. In addition to the smart pigging activity level, the chart also shows the average corrosion rate for the oil service flows lines. The reduction in smart pigging activity level coincides with the decline in corrosion rate and reflects the change in emphasis of the program. As the corrosion rates have fallen, then the immediate concern of the program has shifted from the short-term integrity of the flowline, which is focused on condition, to the long-term integrity of the flow line, which has a dual focus of condition and corrosion rate. This long-term integrity is better managed through higher resolution methods such as corrosion monitoring and manual radiographic and ultrasonic NDE.

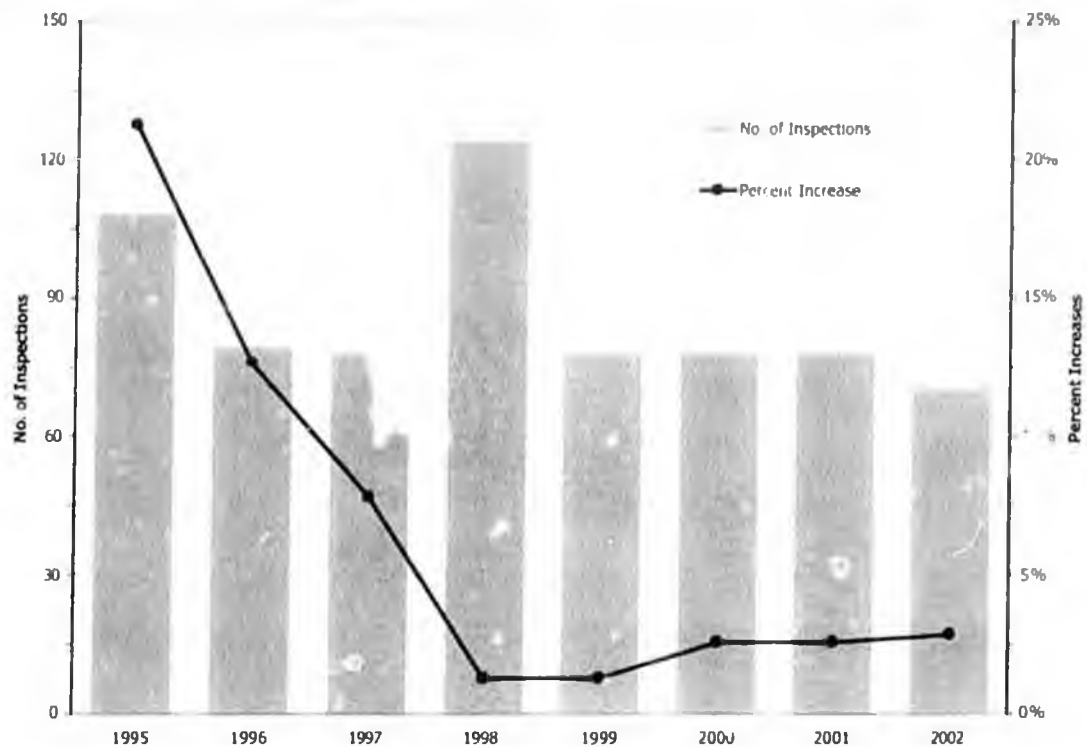
Figure D.1 Endicott IIWL Quarterly UT Readings Through 2002

Corrosion mitigation at Endicott has concentrated on a three-pronged approach of maintenance pigging for line cleanliness, biociding to control bacterial activity and continuous injection of a corrosion inhibitor for corrosion control. As noted earlier, the primary monitoring tool for effectiveness is the quarterly UT inspection of 25 locations along the IIWL. These inspections indicate there is currently slight corrosion activity in the IIWL, but down significantly from the 1995-1997 timeframe. A historical perspective of the reduction in corrosion activity since this three-pronged approach was implemented is shown in Figure D.1. The number of locations showing corrosion increases has been fairly constant over the past three years, indicating slight corrosion activity. The maintenance pigging program was suspended for approximately two months in 2002 for repairs to the launcher. Also, a slight inhibitor modification was made in 2002, however the inhibitor formulation is virtually unchanged from the previous version. Treatment volumes vary dependant upon operational swings in injection rates and reservoir optimization efforts. The current treatment concentration is 17 ppm. Optimization efforts prior to 2003 had concentrated on the biocide program. The line is currently under review to modify the corrosion inhibitor treatment type and/or rate.

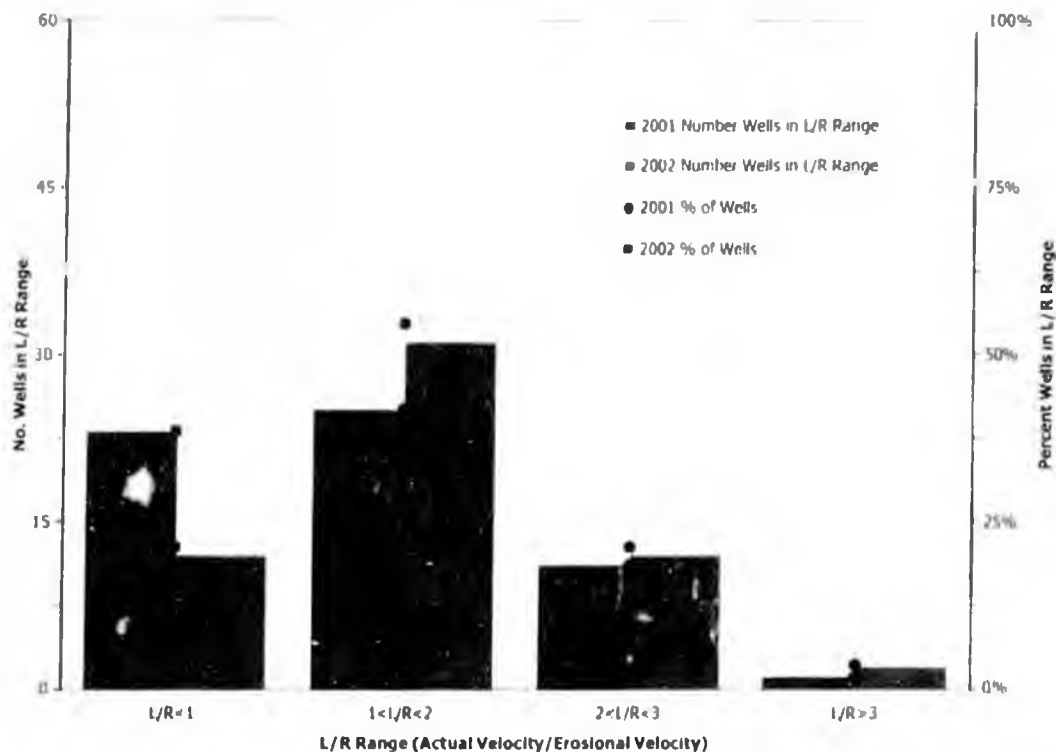
Figure D.2 Endicott Velocity Monitoring 2001-2002

In the production system, the primary damage mechanism is erosion. The erosion rate, in this mainly duplex stainless steel system, is mitigated through inspection and velocity management. Wells are risk ranked by mixture velocity approximately once per month. This information is used to determine inspection frequency, and is also used by the operating personnel to determine if production rate, and hence fluid velocity, for the well should be reduced. Figure D.2 is an overview of the velocity data for Endicott for 2001 and 2002. Shown are the numbers of wells within L/R ratio ranges, where L is the mixture velocity and R is the allowable erosion velocity as defined by API RP 14E.

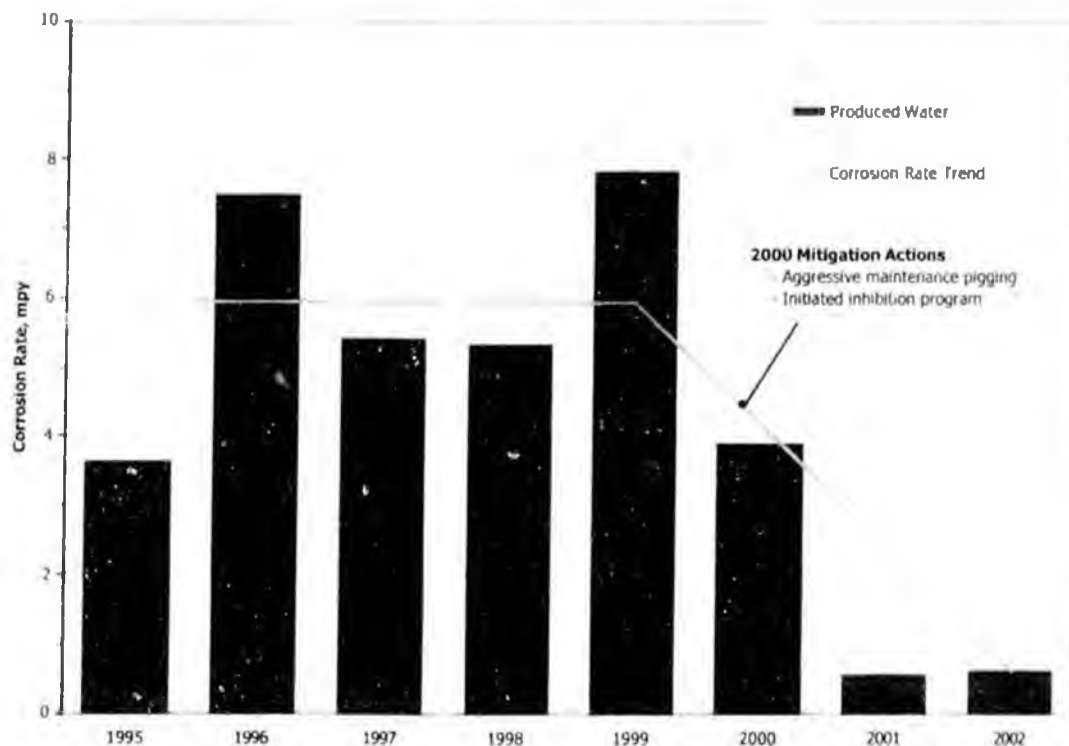
Figure D.3 Milne Point Produced Water Corrosion Rate Trend

Corrosion inhibition of the water injection system began in mid-2000, along with a more frequent maintenance pigging program. Weight loss coupon data indicates the system is coming under control as the corrosion rates have averaged less than 2 mpy since mid-2000. This represents a significant reduction from previous years and can be seen in Figure D.3.

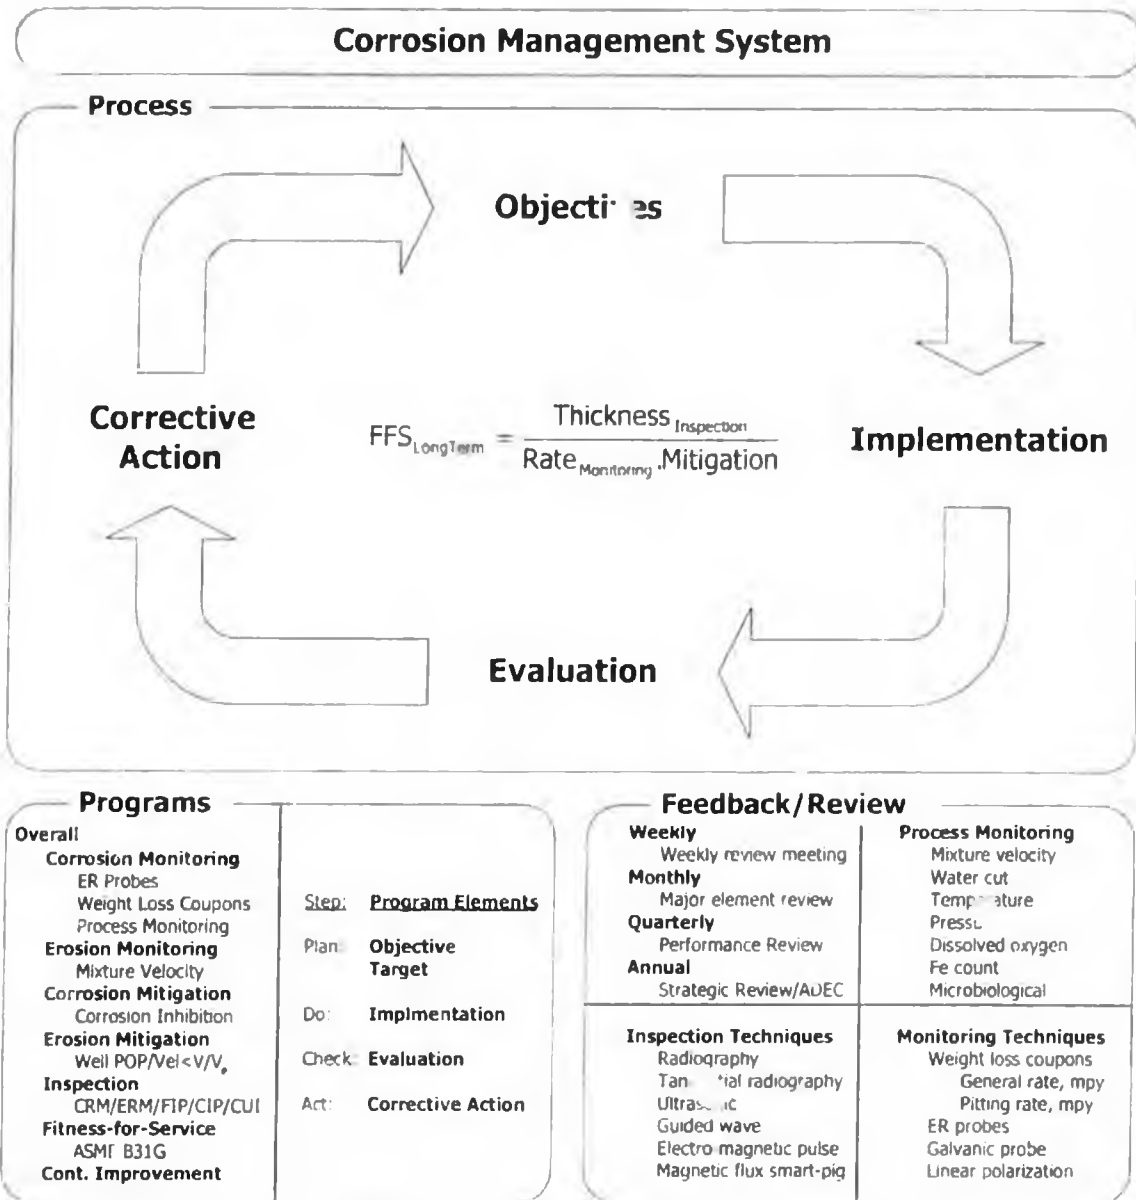
GPB Figure B.1 Overview of the Corrosion Management Process

These overall goals and objectives are achieved through a comprehensive Corrosion Management System that consists of an integrated system of strategy, processes and programs.

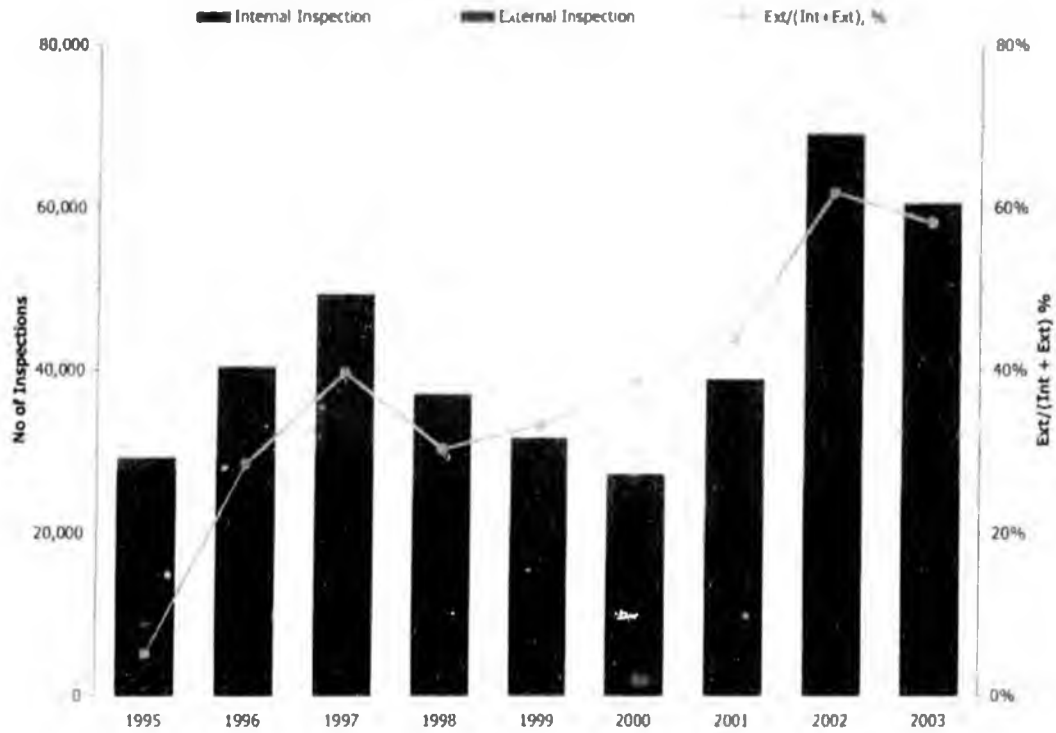
GPB Figure B.2 Internal and External Inspection Activity for Flow and Well Lines

Year	1995	1996	1997	1998	1999	2000	2001	2002	2003
External	1,508	11,498	19,546	11,235	10,512	10,437	17,037	42,676	35,079
Internal	27,804	28,997	29,860	25,934	21,304	16,861	21,929	26,410	25,382
Total	29,312	40,495	49,406	37,169	31,816	27,298	38,966	69,086	60,461
$\frac{\text{Ext}}{\text{Ext} + \text{Int}} \%$	5%	28%	40%	30%	33%	38%	44%	62%	58%

GPB Table B.4 illustrates the increased level of external corrosion inspection activity established in 2002 was maintained through 2003. This level is up from the 6-year average (1996 to 2001) of ~13,000 inspections to the 2002/03 target of 35,000 inspections. This is discussed in detail in Section E.1.

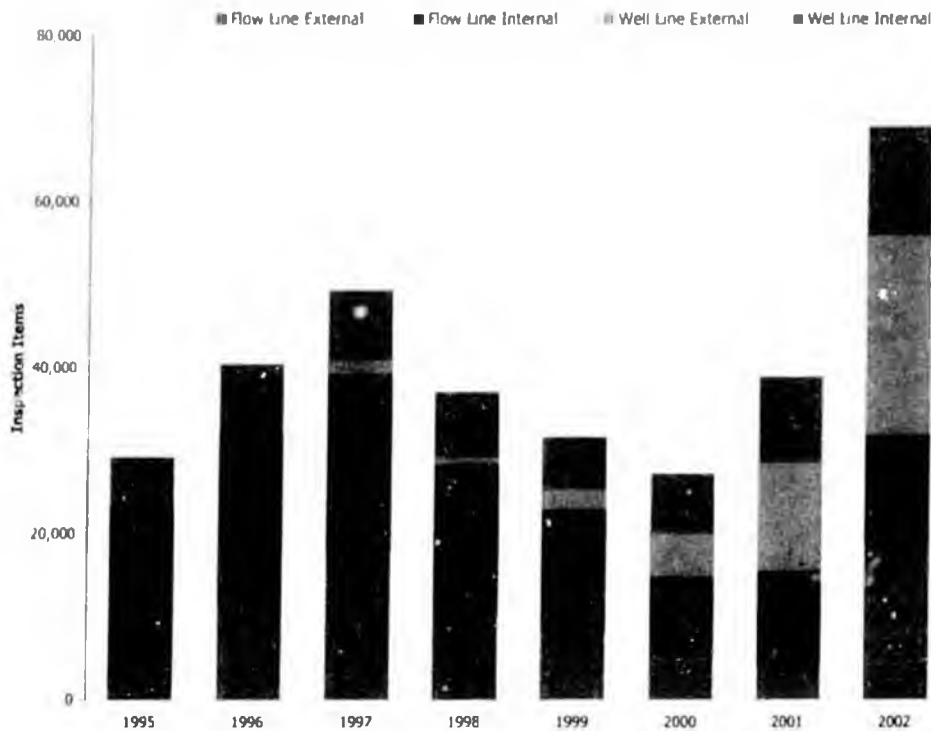
GPB Figure B.3 Internal and External Inspection Activity Summary by Flow/Well Line

Year		1995	1996	1997	1998	1999	2000	2001	2002	2003
Flow Line	External	1,508	11,462	17,866	10,289	8,136	5,180	3,966	18,727	24,258
	Internal	21,733	20,509	21,329	18,180	14,965	9,612	11,618	13,234	14,131
Total		23,241	31,971	39,195	28,469	23,101	14,792	15,584	31,961	38,389
$\frac{\text{Ext}}{\text{(Ext + Int)}}\%$		6%	36%	46%	36%	35%	35%	25%	59%	63%
Well Line	External	-	36	1,680	946	2,376	5,257	13,071	23,949	10,821
	Internal	6,071	8,488	8,531	7,754	6,339	7,249	10,311	13,176	11,251
Total		6,071	8,524	10,211	8,700	8,715	12,506	23,382	37,125	22,072
$\frac{\text{Ext}}{\text{(Ext + Int)}}\%$		0%	0%	16%	11%	27%	42%	56%	65%	49%
Grand Total		29,312	40,495	49,406	37,169	31,816	27,298	38,966	69,086	60,461
$\frac{\text{FL}}{\text{(FL + WL)}}\%$		79%	79%	79%	77%	73%	54%	40%	46%	63%

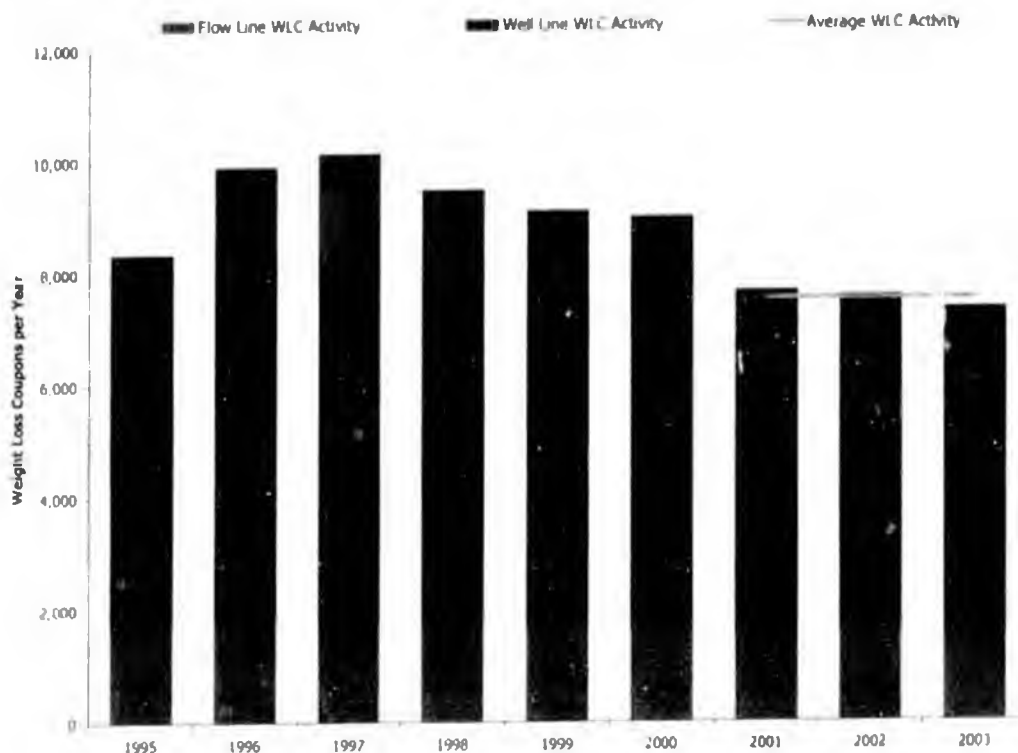
GPB Figure B.4 Corrosion Monitoring Activity Statistics by Equipment

The number of weight loss coupons reported for 2003 reflects the inventory of coupons that are installed in the system at year-end that are still to be 'processed.' The reduction in 2003 coupon numbers therefore represents a timing effect and not a reduction in the program scope or activity level.

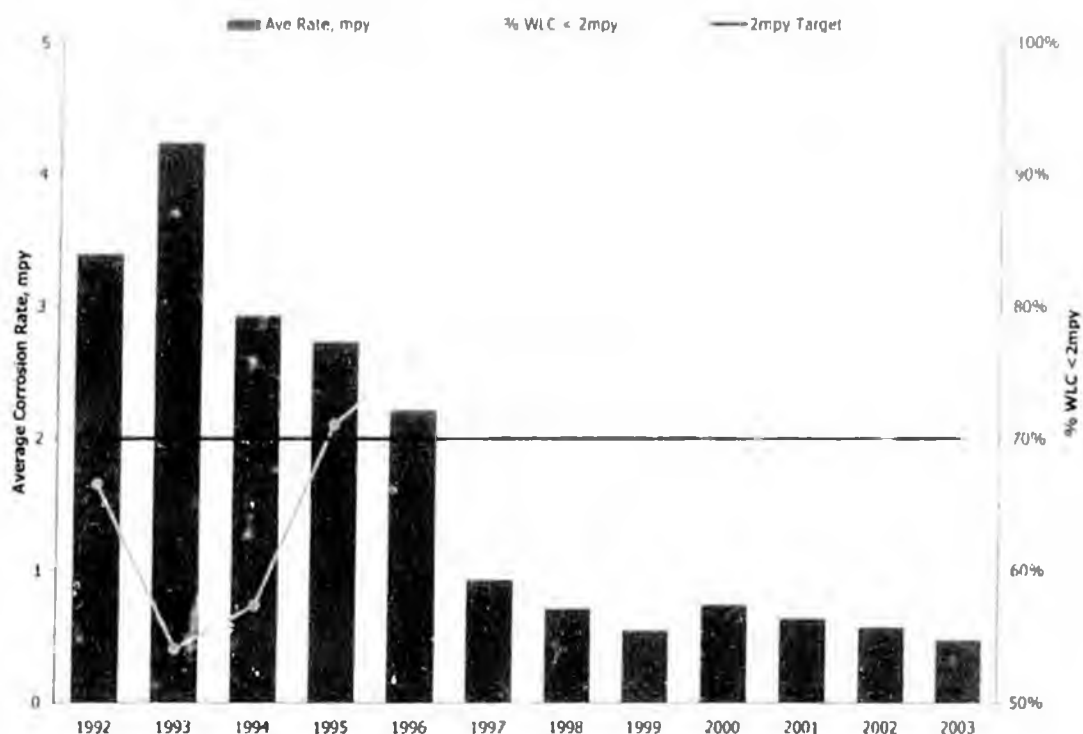
GPB Figure C.3 Well Line Oil Service Corrosion Rate Trend

GPB Figure C.3 shows the average corrosion rate and percentage of WLC \leq 2 mpy since 1992. The trends are very similar to those seen in the cross-country oil flow lines, showing a long-term improvement in the level of control from early 1990's to the present day. The corrosion rate is at its lowest value and the percentage of coupons \leq 2 mpy is at the highest value since 1992.

The long term corrosion control improvement in the well lines is of the same magnitude as that seen in the flow lines with corrosion rates being reduced from an average >4 mpy in 1993 down to an average of 0.5 mpy for 2003.

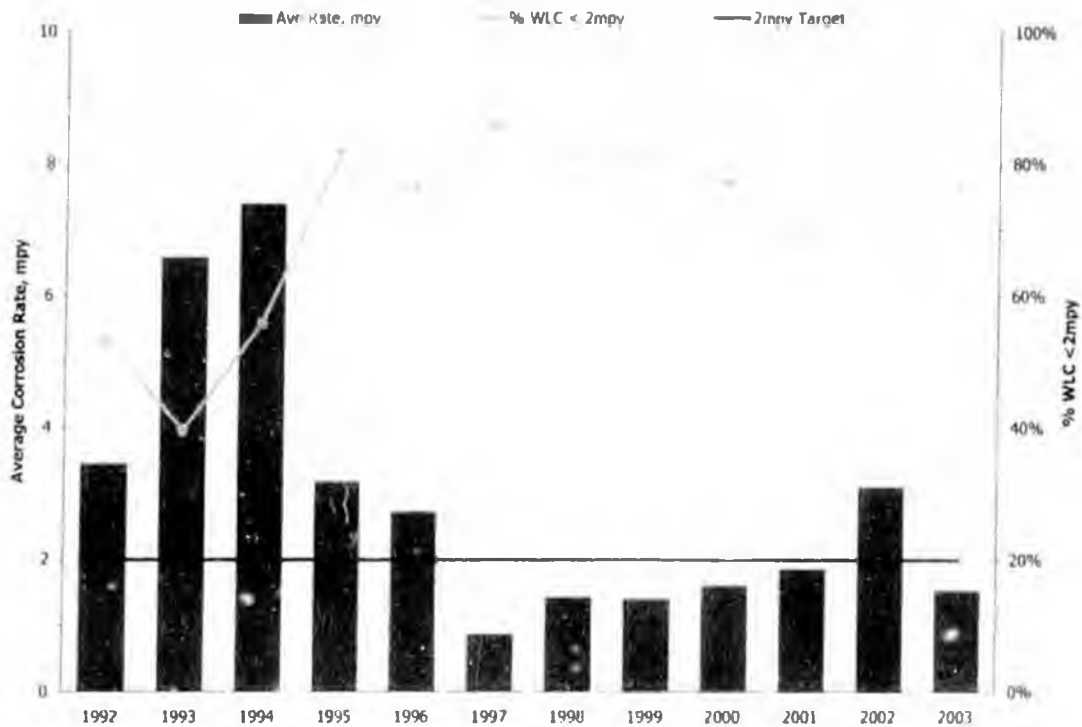
GPB Figure C.4 Flow Line PW/SW Service Corrosion Rate Trend

The data set for 2003 has been expanded from previous years. Additional monitoring locations, from the facility piping, have been added to the data set to provide increased insight into the performance of the water injection flow lines.

These locations are exposed to mainline flow but are physically located inside the facility module walls.

In summary, the average WLC corrosion rates for the aggregate water injection service improved in 2003, reversing a negative 5-year trend. This improvement is attributable to corrosion mitigation actions in the seawater system over the recent years.

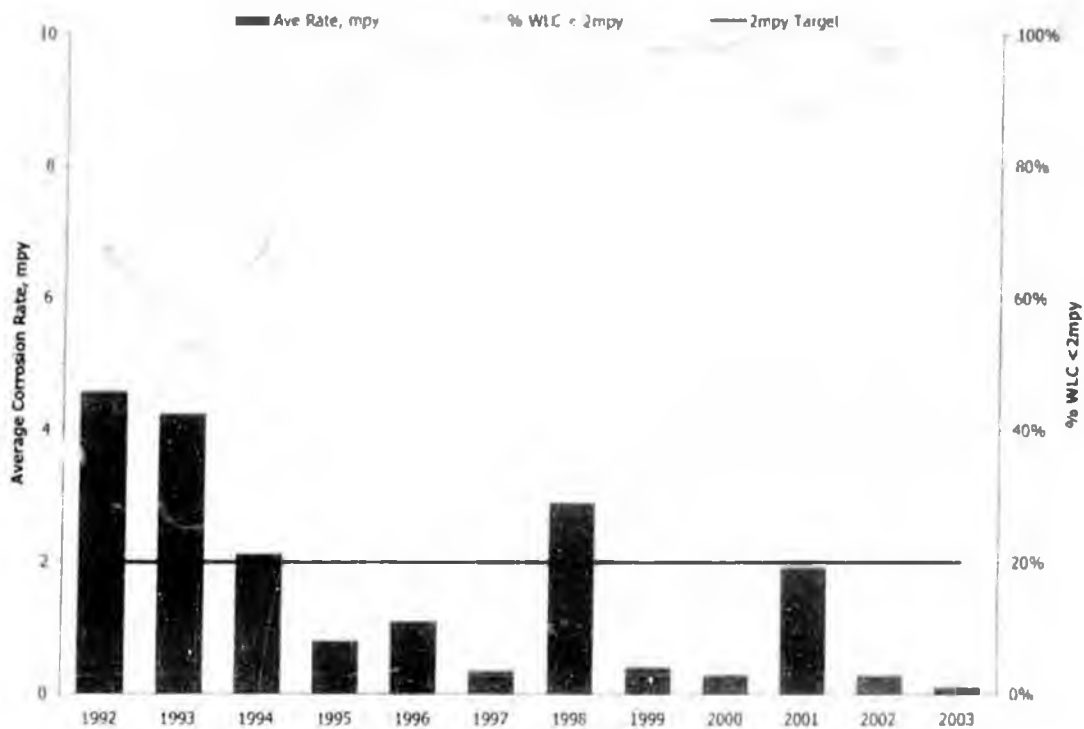
GPB Figure C.5 Corrosion Rates for 100% PW System

GPB Figure C.5 shows the performance for 100% produced water service. The 2003 levels reached a system best with average corrosion rates at ~0.1 mpy and 100% WLC \leq 2 mpy. This initial evaluation of the new treatment is encouraging, but caution is warranted as the data set is limited and long-term trend has not been established.

GPB Figure C.5 through GPB Figure C.7 summarize the historical corrosion rate data for produced water well lines. The data show the general corrosion rates in the produced water system have fallen as the level of inhibition in the 3-phase system was increased and supplemental produced water corrosion inhibitor injection was initiated.

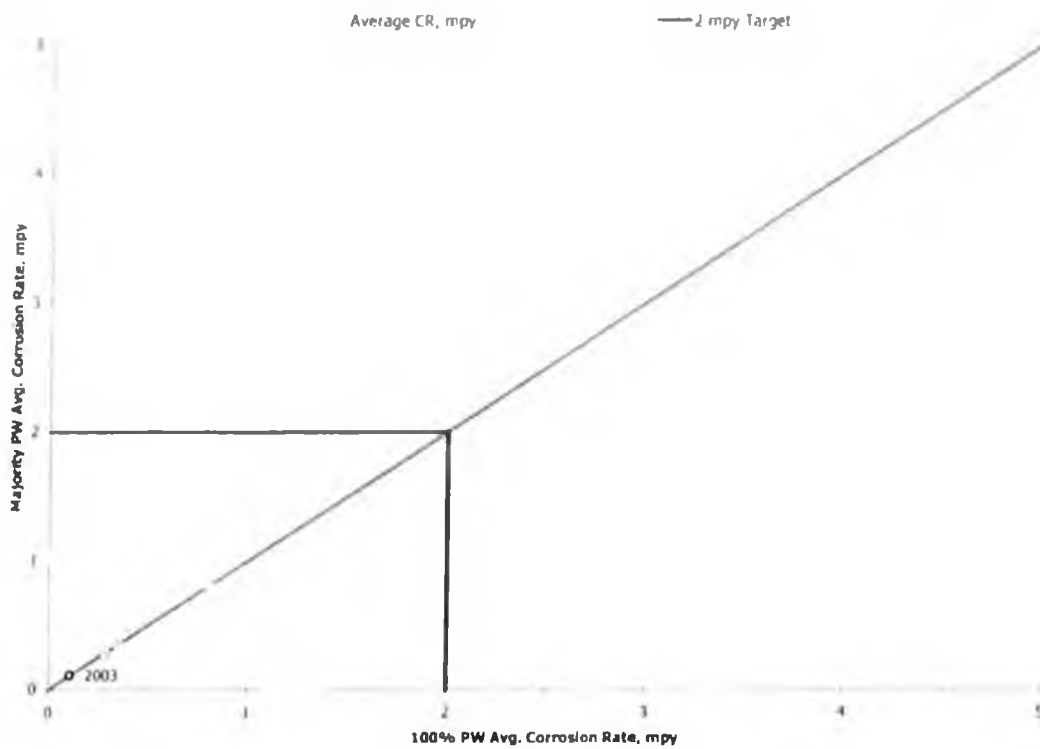
GPB Figure C.7 Comparison of Corrosion Rates for 100% and Majority PW

A comparison of the average corrosion rate for produced water between the 100% service and majority service is provided in GPB Figure C.7. The figure shows little difference between the data.

The overall improvement in the performance of the PW system from 2001 to date can be attributed primarily to two factors. First, there was a change in the upstream 3-phase continuous corrosion inhibitor in 2002 that gave more favorable partitioning characteristics to the water phase than the prior product. This had the effect of increasing the levels of corrosion inhibitor carried from the upstream system into the produced water distribution network. The second contributor was the expansion of corrosion mitigation programs specific to the PW system started in 2002. The program now includes limited inhibitor injection in the PW system at FS-1, FS-3, GC-1, GC-2 and GC-3.

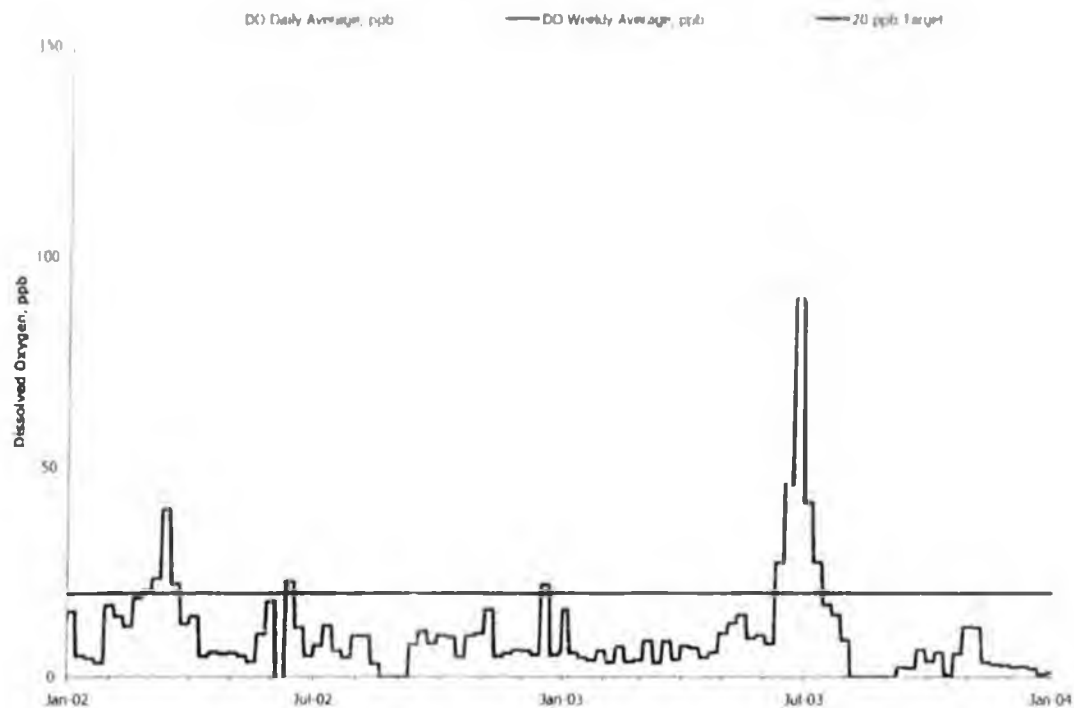
GPB Figure C.11 Dissolved Oxygen Control Performance for the Seawater System

GPB Figure C.11 shows the daily and weekly average level of dissolved oxygen control in the seawater system through 2003. The DO excursion in summer 2003 was due to seasonal decreases in rates of the chemical oxygen scavenging reactions during periods of spring runoff and seawater turbidity. This was followed by a ~1 month shutdown to complete system upgrades for increased capacity. DO control improved markedly in the latter part of 2003, and diligent plant operation continues to deliver good DO control.

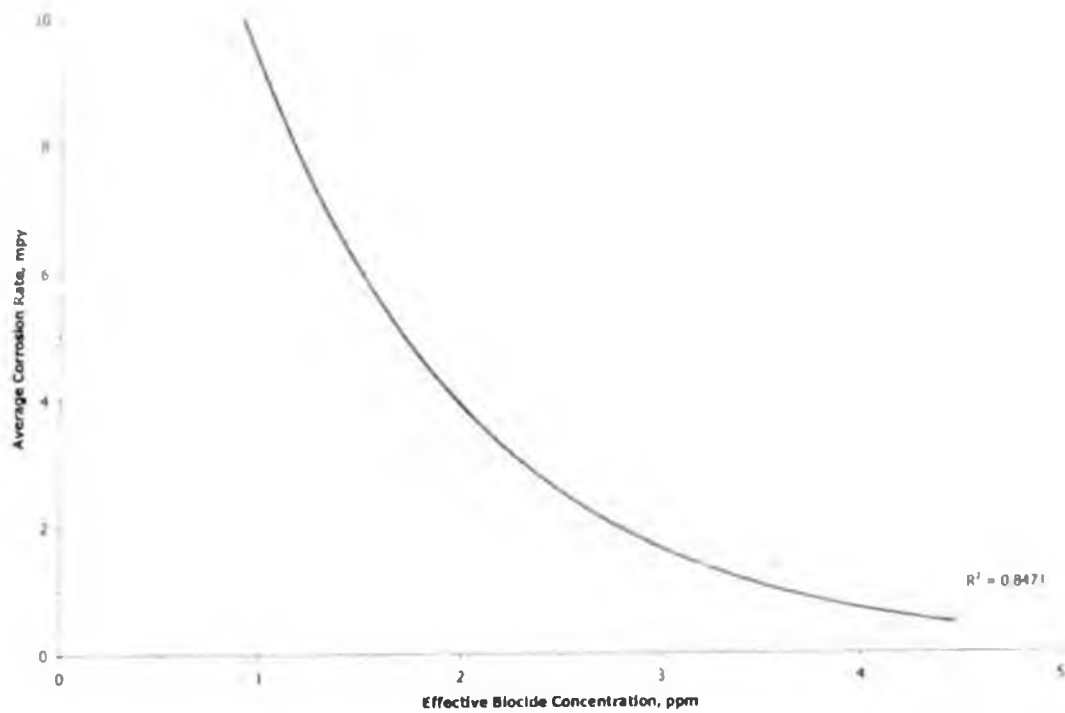
GPB Figure C.13 Average Corrosion Rate vs. Effective Concentration, 2001 - 2003

The effect of increasing biocide on the corrosion rates in the SW system are more clearly shown in GPB Figure C.13, which shows the correlation between the average corrosion rate and effective biocide concentration for 2001 through 2003.

In summary, improvements made from 2000 to 2003 in DO control and increased biocide injection rate have reduced corrosion rates in the seawater system. The data suggest progress has been made in returning the seawater system to control; however as with the produced water system, caution is warranted. Therefore, there will be an on-going effort in 2004 to assure that this trend is confirmed and continued. Should a long-term trend of reduced corrosion rates not be established then further corrective actions will be implemented.

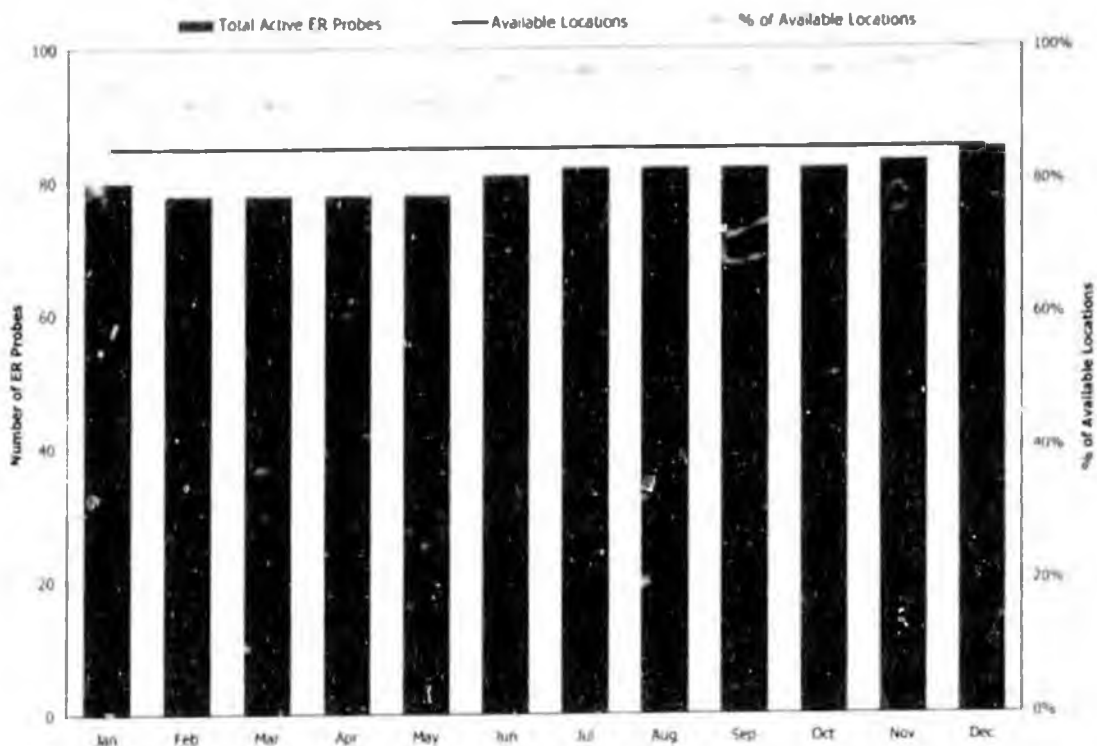
GPB Figure C.14 Equipment Monitored Using ER Probes

GPB Figure C.14 shows the number of ER probes and the percentage of time the ER probes were providing data. The number of flow lines monitored with ER probes has increased due to the addition of new probe locations and an increased emphasis on equipment maintenance.

^ significant effort was made in 2003 to improve reliability of data provided by the ER probe monitoring equipment. Equipment availability improved during 2003, from 95% at the beginning to 100% at year-end.

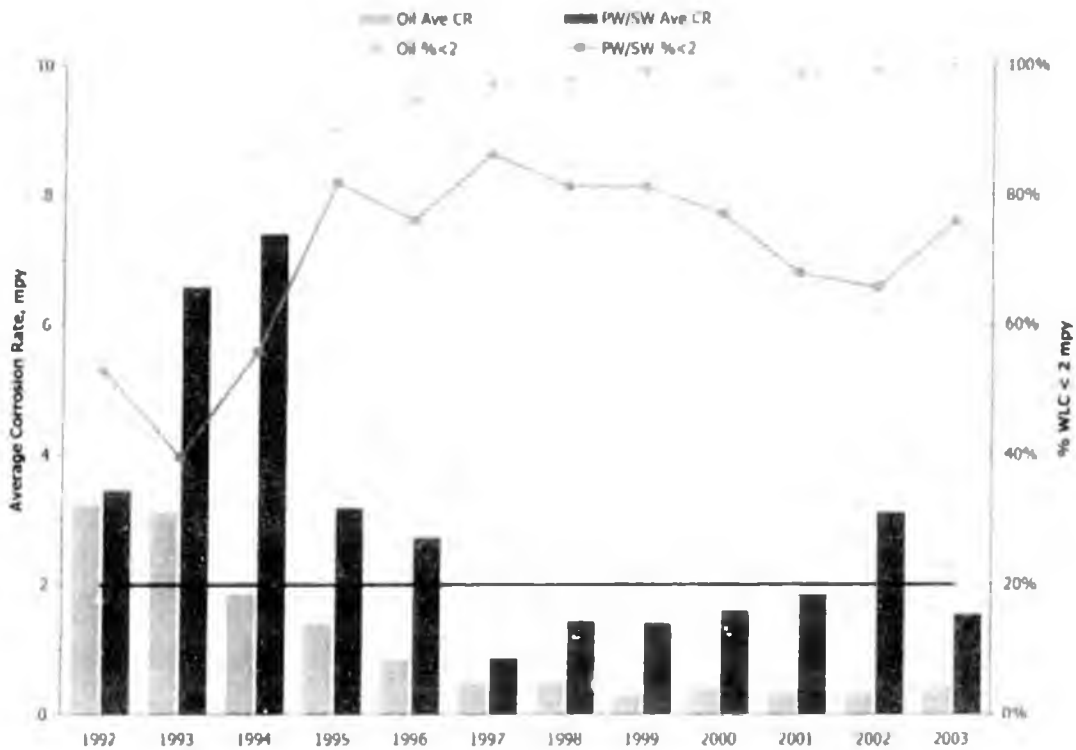
GPB Figure C.15 Flow Line Corrosion Coupon Summary by Equipment and Service

This section provides system-by-system summary since 1992 for the major systems at GPB. GPB Figure C.15 shows the corrosion rate and corrosion target conformance since 1992. The performance in the 3-phase production system has improved slightly from 2002. The data set for water injection flow lines has been updated to include additional monitoring locations. The improvement from 2002 to 2003 is a result of the on-going corrective actions being implemented in the SW injection system.

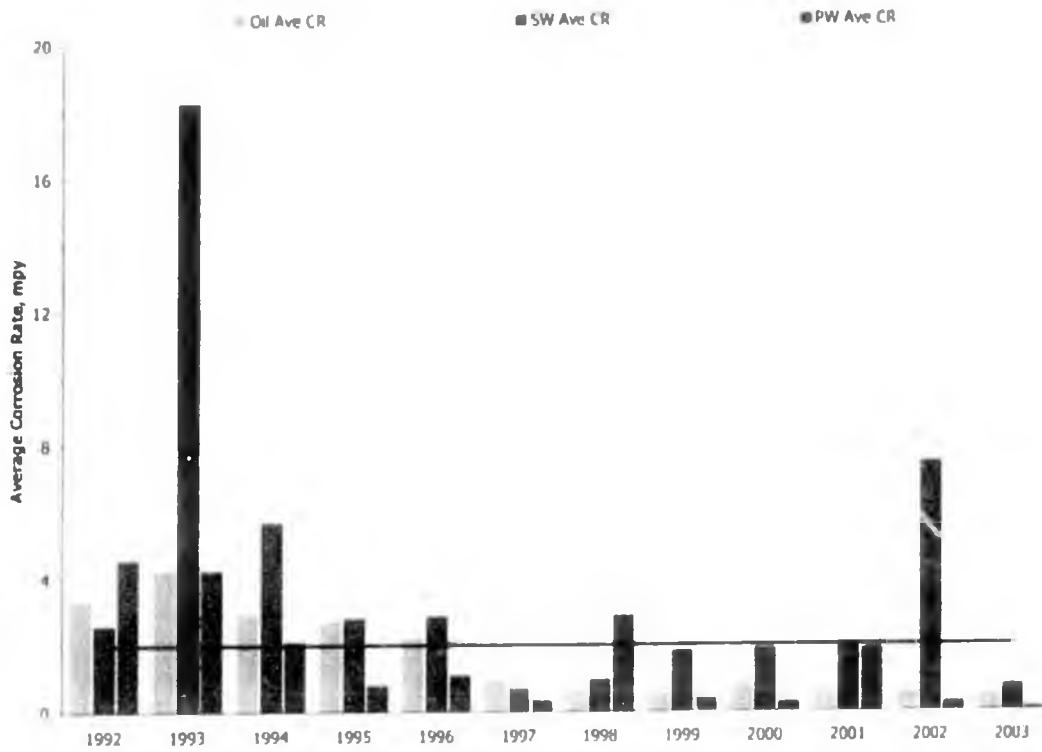
GPB Figure C.16 Well Line Average Corrosion Rate Summary by Equipment and Service

GPB Figure C.16 shows the corrosion rate and GPB Figure C.17 shows corrosion conformance for well lines. The well line 3-phase system has improved between 2002 and 2003. The produced water well lines corrosion performance continues to improve and corrosion rates decreased to their lowest level since 1992. The well lines in seawater service show a marked improvement in performance and in the level of conformance to the 2 mpy target. As previously discussed, there have been a number of changes made to the mitigation programs in the SW system.

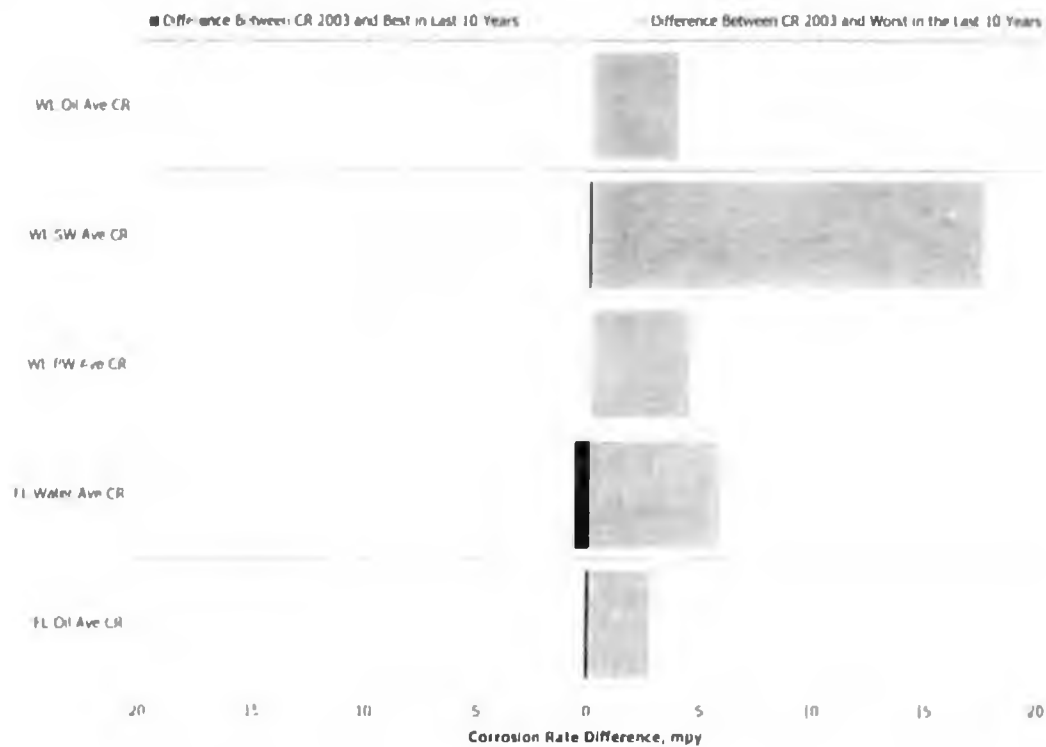
GPB Figure C.18 WLC Corrosion Rate Difference by Service and Type

In order to assess the relative performance of the corrosion management program today versus that of the last 11 years, GPB Table C.3 and GPB Figure C.18 were generated as a summary. The data show the difference between the 2003 WLC corrosion rate for each of the systems and the best, or lowest, WLC corrosion rate and the worst, or highest, WLC corrosion rate observed since 1992. This is an approximate measure of the successes and/or shortcomings of the program today versus the ~11-year history and highlights areas for attention. The results indicate the current level of corrosion control, as determined by weight loss coupons, is at or near the best levels of control in the last 11 years for each system.

Well Line Oil Service – Significant improvements in performance occurred from 1992 to 1997 when the average corrosion rate (CR) was reduced from 3.6 to 1.0 mpy (~70% improvement) and conformance to the 2 mpy target was increased from 64% to 88% (~40% improvement). Since then, CR and target conformance performance has increased to the 2003 values of 0.5 mpy and 96% respectively. Continued improvements are expected due to corrosion inhibitor distribution optimization (individual target rates and expansion of continuous injection systems).

Flow Line Oil Service - Consistent with historical best performance, 99% of coupons pulled in 2003 were less than or equal to the corrosion control target of 2 mpy. Significant improvements in performance occurred from 1992 to 1997 when the average CR was reduced from 3.3 to 0.5 mpy (~85% improvement) and conformance to the 2 mpy target was increased from 77 to 97% (~25% improvement). Since then, CR and target conformance performance has improved to the 2003 values of 0.4 mpy and 99%, respectively.

Well Line PW Service – Average CR and percent conformance with the 2 mpy target achieved historical best performance at 0.1 mpy and 100%. The two excursions, 1998 and 2001, were likely the result of reduced system velocities and oil system corrosion inhibitor changes. Work continues in the evaluation of new the corrosion control techniques designed specifically for the PW system.

Well Line SW Service – Performance deteriorated from 1997 through 2002 with the average CR increased from 0.7 to 7.5 mpy. Average CR and percent conformance with the 2 mpy target rebounded in 2003 to 0.7 mpy and 94% respectively. This is a direct result of specific corrective actions that were implemented in 2001 and 2002. While these initial data are encouraging, it is probably too soon to be assured that the corrosion trend has been reversed. SW system corrosion control will continue to be a focus in 2004.

Flow Line PW/SW Service – Performance deteriorated from 1992 to 1994 when average CR increased from 3.5 to 7.4 mpy. However, significant improvements occurred from 1994 to 1997 when the average CR was reduced to 0.8 mpy. Since then, CR and target conformance degraded until 2003 when performance improved to 1.5 mpy and 76% respectively.

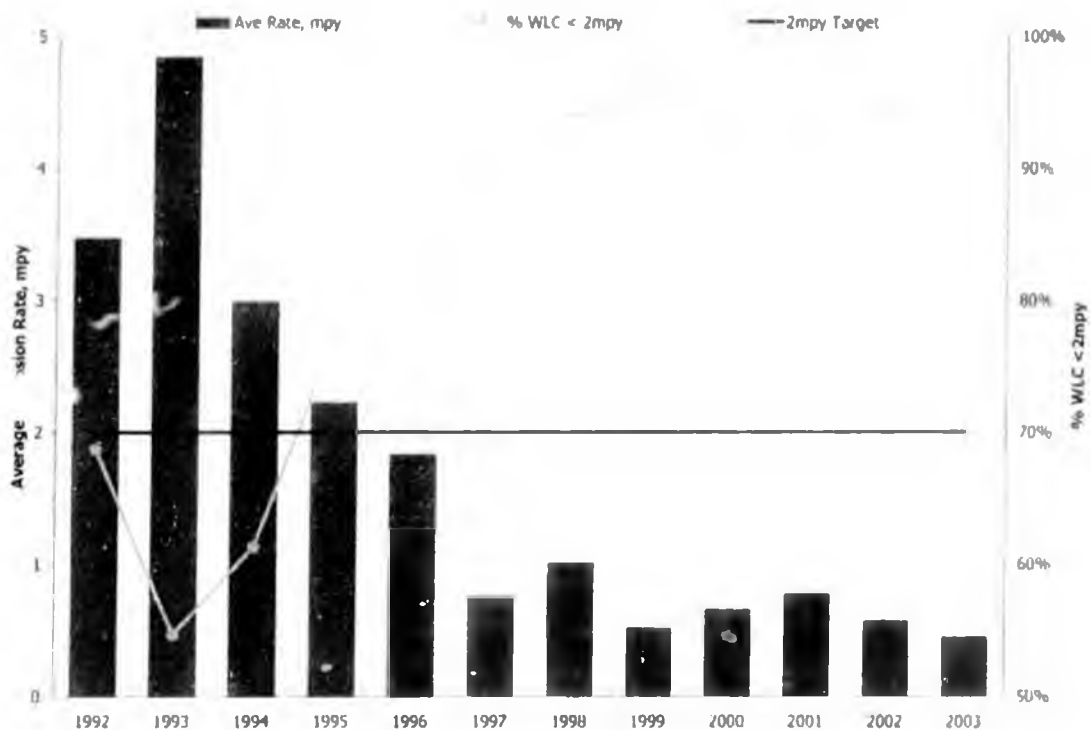
GPB Figure C.19 GPB Aggregate Performance

As an overall representation of the progress of improving corrosion control, GPB Figure C.19 shows the aggregate performance for all equipment and all services discussed in this report. The average corrosion rates have fallen by 80% from 2.3 mpy in 1995 to 0.5 mpy in 2003 and that the number of coupons meeting or beating the 2 mpy target has increased from 76% in 1995 to 97% in 2003.

It should be noted that the majority of the pipelines are in 3-phase service and hence these aggregate data are dominated by the performance of the 3-phase system.

For the GPB systems in aggregate, 2003 represents the best ever performance both in terms of average corrosion rates and percentage of WLC \leq 2 mpy target.

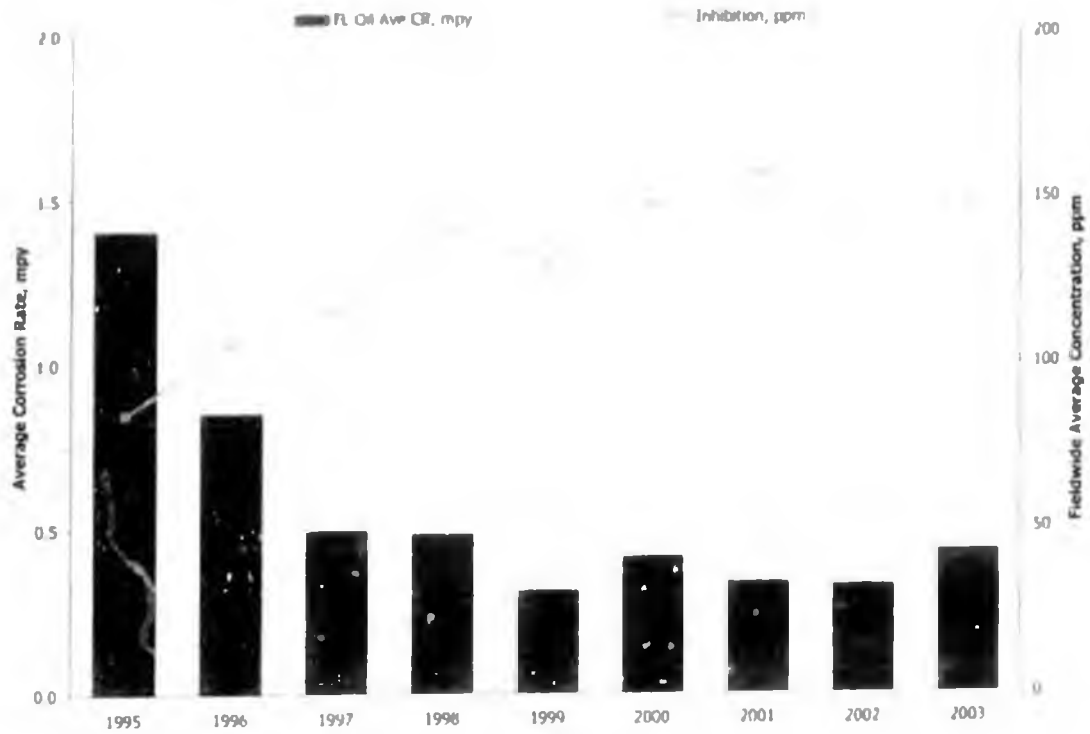
GPB Figure D.5 Average Corrosion Rate Versus Inhibitor Concentration

GPB Figure D.5 shows the correlation between the increased level of corrosion inhibitor and the reduction in average corrosion rate from 1995. As might be expected, the decline in average corrosion rate correlates with the increase in corrosion inhibition levels over time. The inhibition levels have increased approximately 70% from 1995 to 2003, with a field-wide average concentration of 85 ppm to 147 ppm. As a result the corrosion rates have fallen from 1.4 mpy in 1995 to 0.4 mpy in 2003.

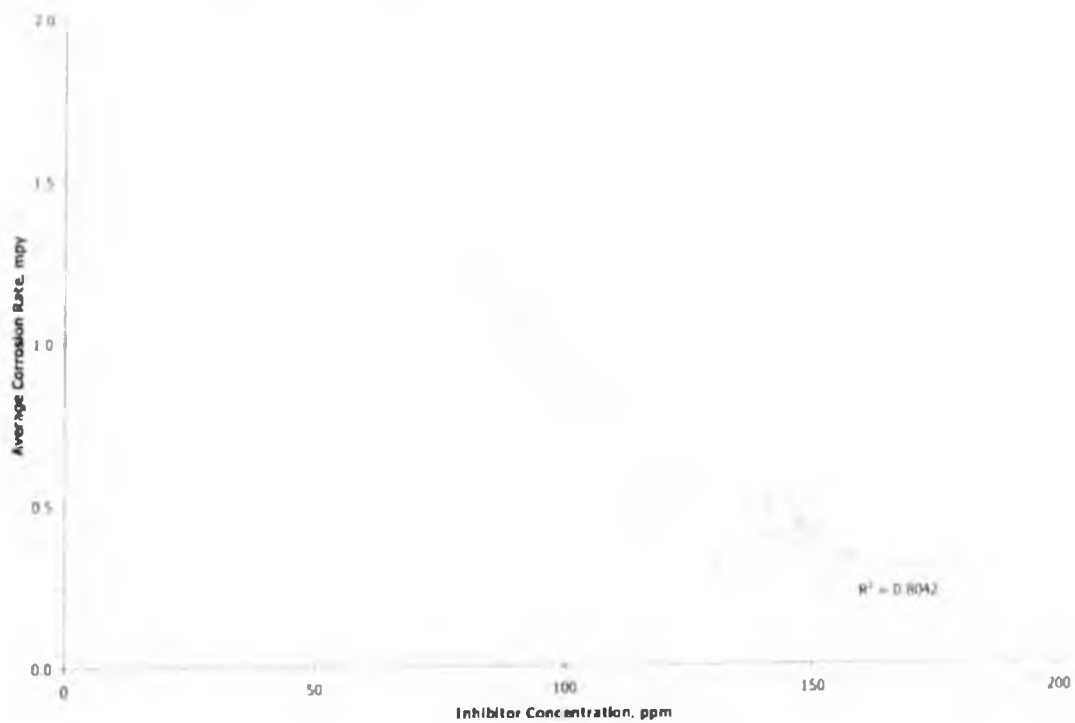
GPB Figure D.6 Corrosion Inhibitor Concentration vs. Average Corrosion Rate

GPB Figure D.6 shows the annual field-wide average corrosion inhibitor concentrations versus annual average corrosion rates for 3-phase production flow lines. The figure shows how additional corrosion inhibitor has reduced the average corrosion rate through time, but also shows an inherent limitation of corrosion inhibition as the minimum corrosion rate (or maximum corrosion inhibitor efficiency) is approaching an asymptote of ~0.25 mpy.

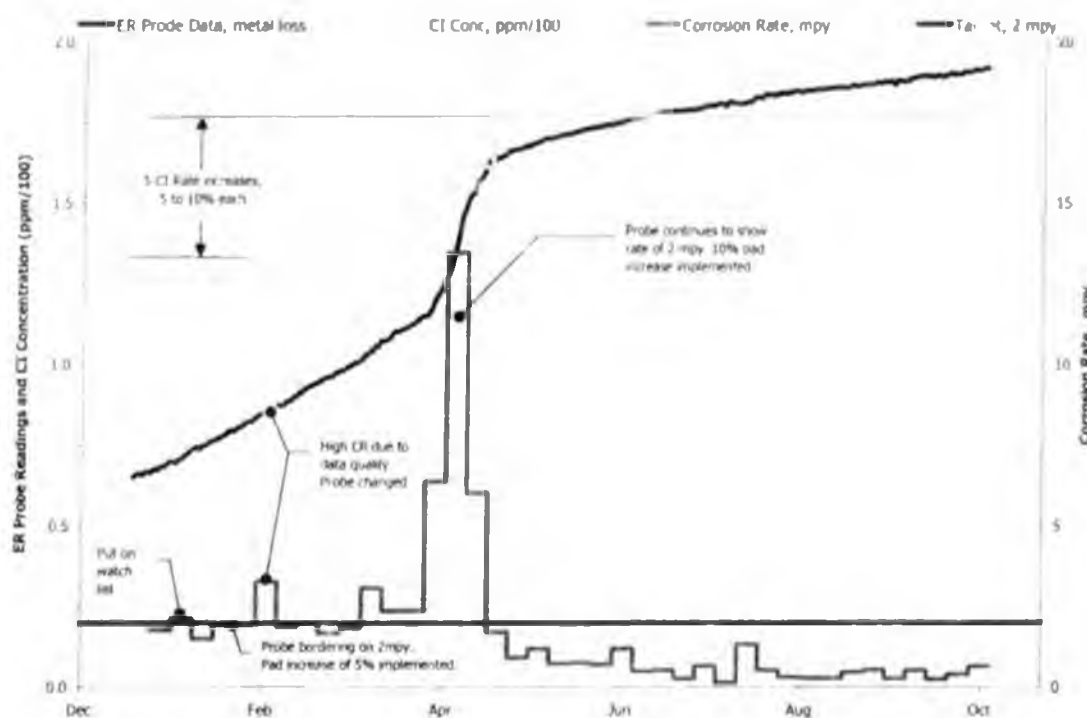
GPB Figure D.7 Corrosion Inhibitor Concentration vs. Corrosion Rate

GPB Figure D.7 and GPB Table D.5 illustrate the use of ER probes in managing changing corrosion conditions in a large diameter flow lines. GPB Figure D.7 shows the ER probe readings and derived corrosion rates, over a period of approximately 10 months in 2003. For the first 10 weeks the measured corrosion rate is bordering on 2 mpy and a 5% increase in CI is implemented. In early February the existing ER probe was replaced due to data quality issues. In mid-March another increase of CI was implemented based on ER probe corrosion rate. During April and part of May, the CR still exceeded the target and two additional CI increases were implemented. Finally in mid-May, the CR falls below the 2 mpy target and the CI remains at the increased concentration.

Time Period	Comments
14-Jan	Probe placed on watch list
14-Jan to Feb 11	Probe at or near 2 mpy, 5% increase in pad CI target
14-Feb	Poor data quality, ER probe replaced.
18-Feb to 21-Mar	Probe continues to show rate >2mpy, 10% increase in pad CI target
21-Mar to 30 Apr	Probe continues to show rate >2mpy, 10% increase in pad CI target
01-May to 01-Oct	Probe shows rate <2mpy, No adjustments to CI target
