**PRUDHOE
BAY
CORROSION
CRISIS,
8/18/06
(FILE 7)**

Annual Report to Alaska Department of Environmental Conservation

Commitment to Corrosion Monitoring

Corrosion, Inspection and Chemicals (CIC) Group
BP Exploration (Alaska) Inc.

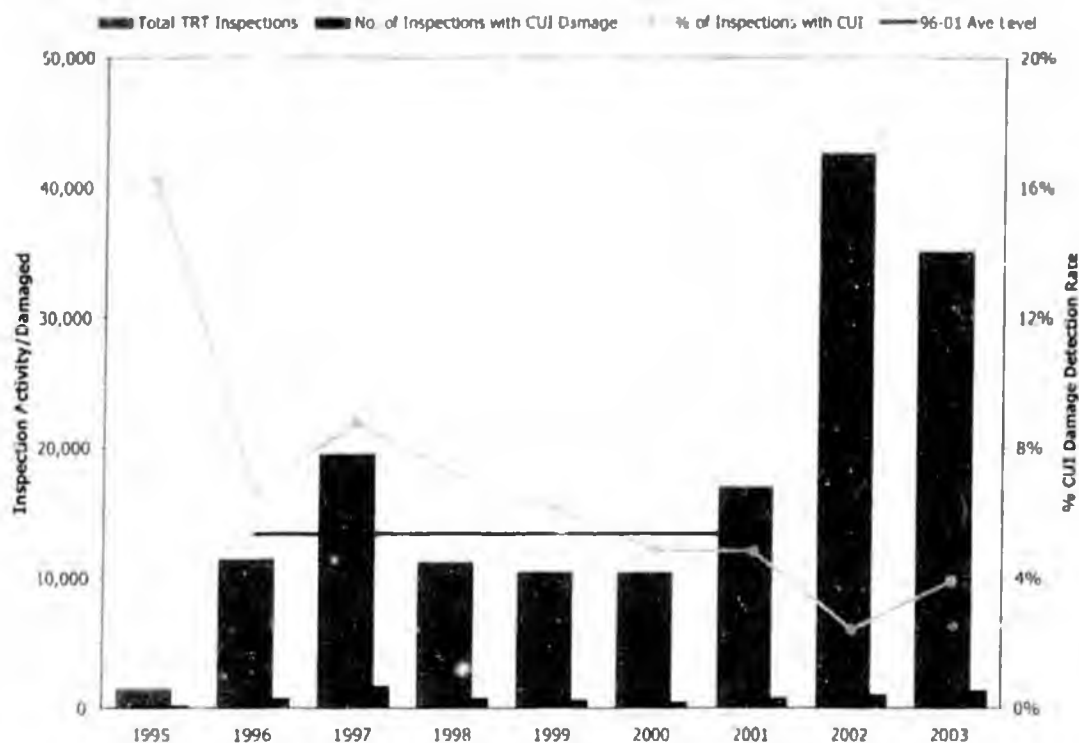
GPB Figure E.1 External Corrosion Activity and Detection Summary

In general, the inspection levels over the period 1996 to 2001 remained relatively constant at an average of ~13,000 per year. In 2002 the activity level was increased substantially, targeting 35,000 inspections per year. In 2003 the activity level was slightly over the target of 35,000 inspections. The difference between 2002 and 2003 is the result of ease of access for performing external corrosion inspections. A significant amount of time was spent in the 1Q03 performing off-road inspections, specifically the pipelines over the Kuparuk River and pipelines over tundra without road access from Y Well Pad to P Well Pad. Additionally, activities following the May Y-36 spill and lessons learned directed activities across GPB on equipment with similar configurations as the Y-36 caribou crossing.

There was a slight increase in CUI damage detected in 2003 as compared to 2002. Overall, the percentage of locations found with damage has fallen from an initial high of >15% to a field-wide average of 4% in 2003.

GPB Table E.3 and GPB Figure E.1 show the number and results of the external corrosion inspections performed from 1995 through 2003. The data includes all

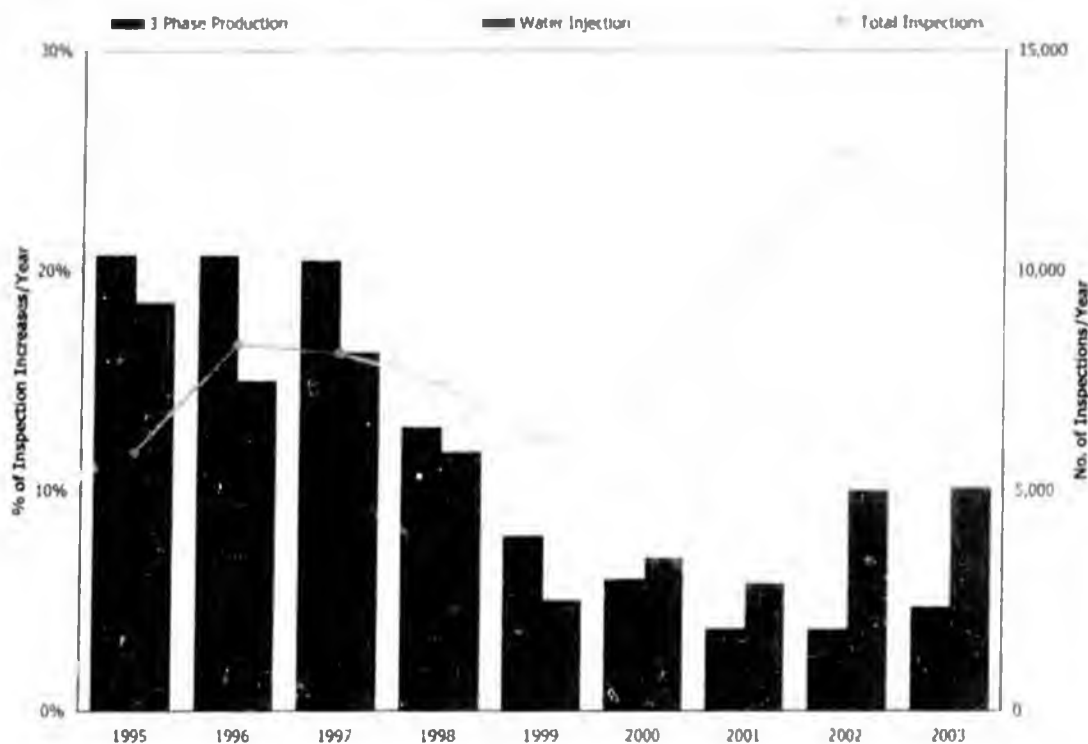
GPB Figure E.5 Well Line Internal Inspection Increase by Service

GPB Figure E.5 shows the inspection increases trend and the number of inspections per year for the well lines.

For the 3-phase well lines in the long term, there is a decrease in corrosion activity as measured by the percentage of inspection increases. This is the same trend as seen in the flow lines. In the short term, the slight increase in corrosion activity seen in the flow lines is similarly reflected in the well line data.

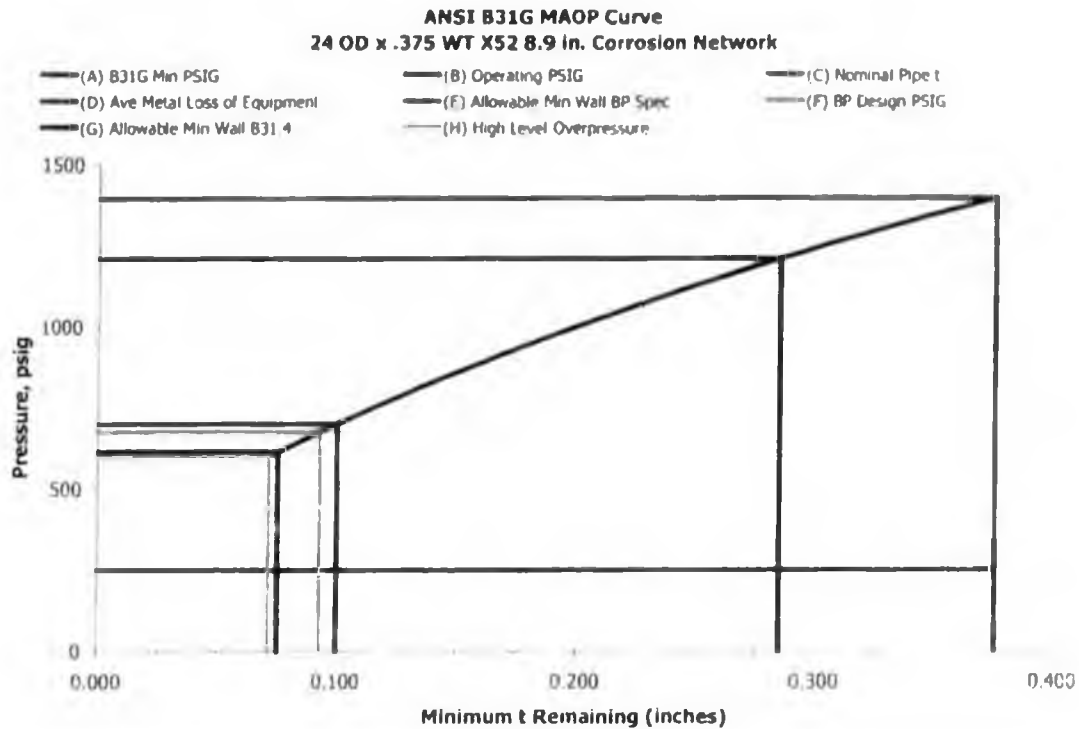
Legend	Description/Comments
(A) B31G Min PSIG	The relationship between maximum allowable operating pressure, MAOP, as given by B31G and the remaining wall thickness

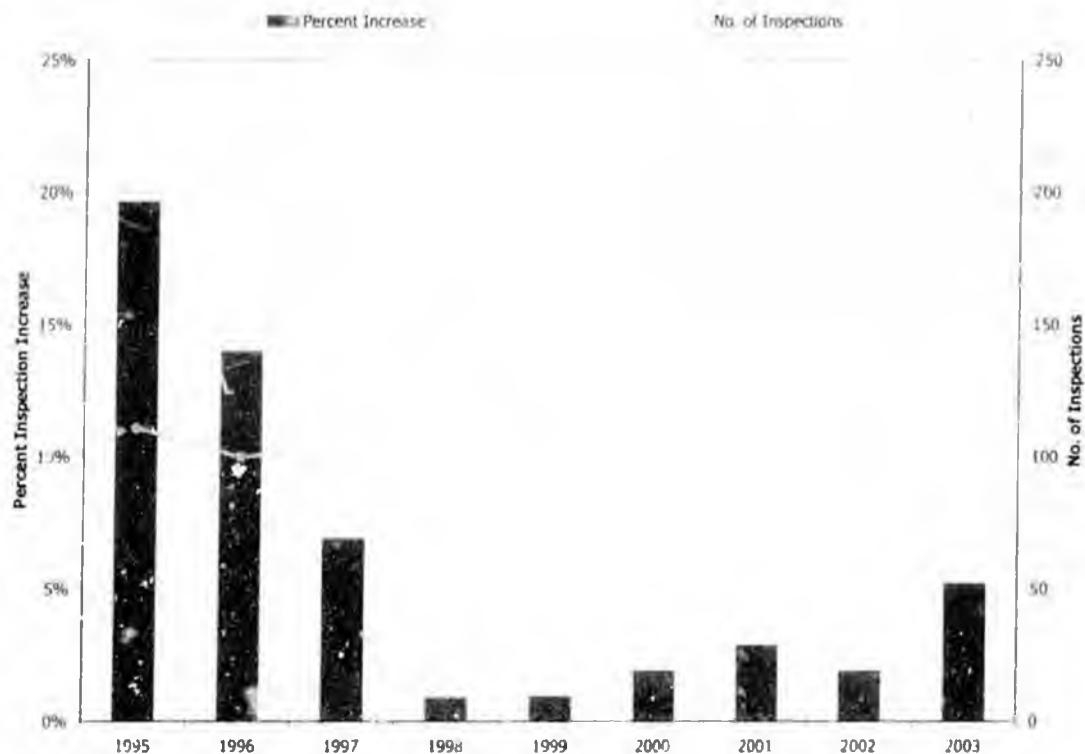
ACT Figure D.1 Endicott IIWL UT Readings Through 2003

ACT Figure D.1 shows there is an increase in corrosion activity in the IIWL in 2003 compared with 1998 to 2002. While the 2003 results are cause for concern, the results are still below the levels seen prior to 1997. The number of locations showing corrosion increases has been fairly constant over the previous three years, indicating slight corrosion activity. Unfortunately the maintenance pigging program was suspended for approximately 12 weeks in 2003 for repairs to the launcher. As a result of the pigging suspension, the IIWL experienced an increase in corrosion activity. To monitor the corrosion activity, the inspection frequency was changed from quarterly to monthly until control is once again assured. Pigging was resumed in late 2003 and current inspection data indicate corrosion is under control.

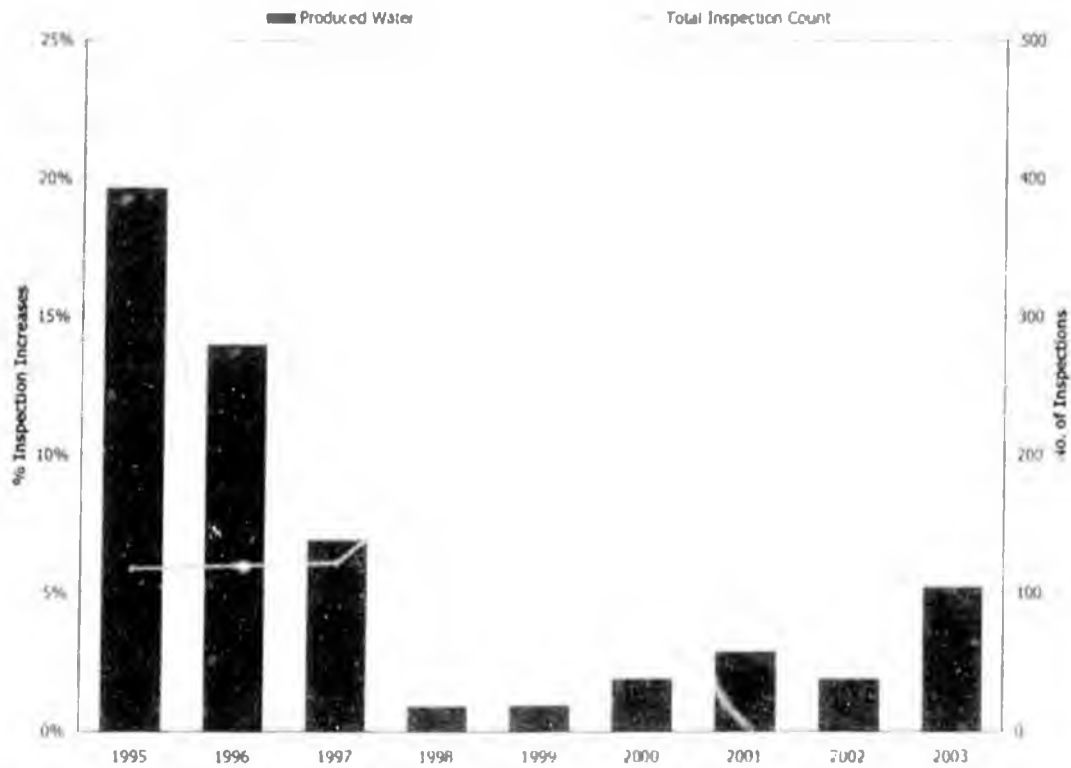
ACT Figure E.2 Detection of internal corrosion of flow line by inspection at Endicott 2003

ACT Figure E.2 shows a significant decline of inspection increases from 1995 through 1998 for the IIWL at Endicott. There has been a gradual increase in inspection increases since 1998. As discussed in Section D.1, the increase in corrosion activity in the IIWL was exacerbated by the temporary suspension in the pigging program and addressed by an increase in corrosion inhibition in 2003.

It should be noted that the corrosion increases in the 3-phase production are in carbon steel C-Spools that are managed through planned replacement at the FFS criteria discussed in Section E.3.

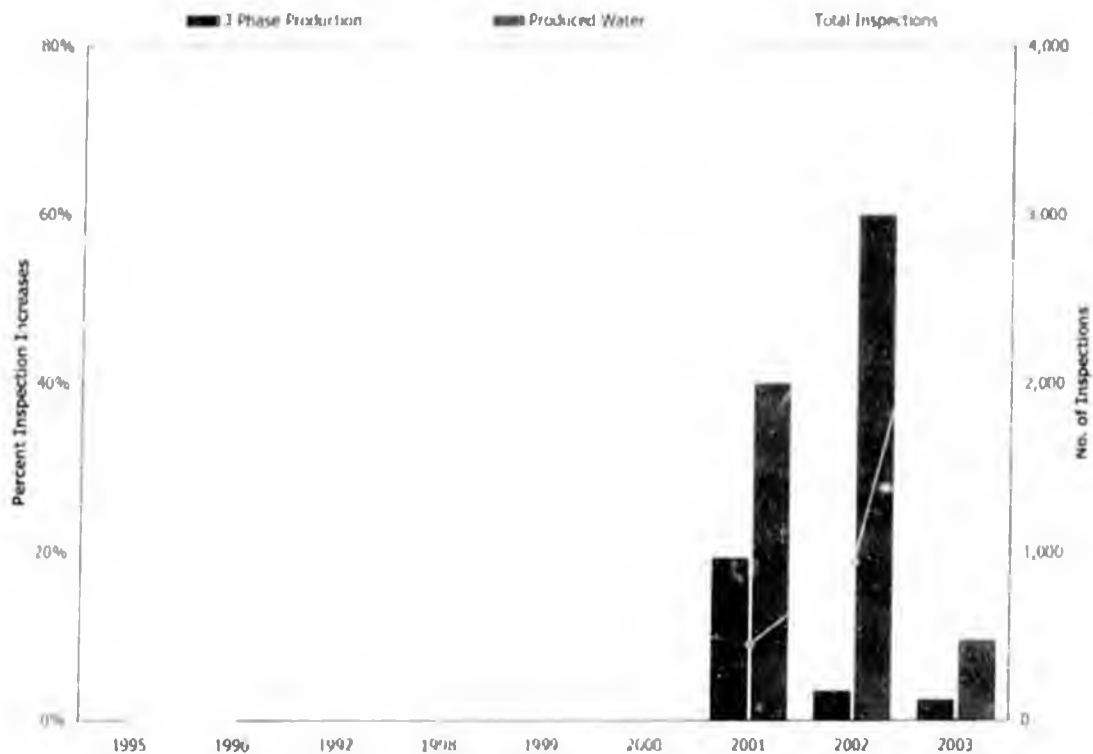
ACT Figure E.4 Detection of internal corrosion of well lines by inspection

ACT Figure E.4 shows the historical detection of internal corrosion of well lines by inspection and the progress made in expanding the inspection program. There has been a significant decrease in the number of repeat locations showing active corrosion from 2002 to 2003. As noted in the discussion above, this represents a more consistent repeat inspection basis from prior years, as the majority of repeat locations were at approximately a year apart, whereas in previous years the time difference between repeat inspections was several years.
