**PRUDHOE  
BAY  
CORROSION  
CRISIS,  
8/18/06  
(FILE 8)**

Annual Report to Alaska Department of Environmental Conservation

**Commitment to Corrosion Monitoring  
Year 2004**

Corrosion, Inspection and Chemicals (CIC) Group  
BP Exploration (Alaska), Inc.

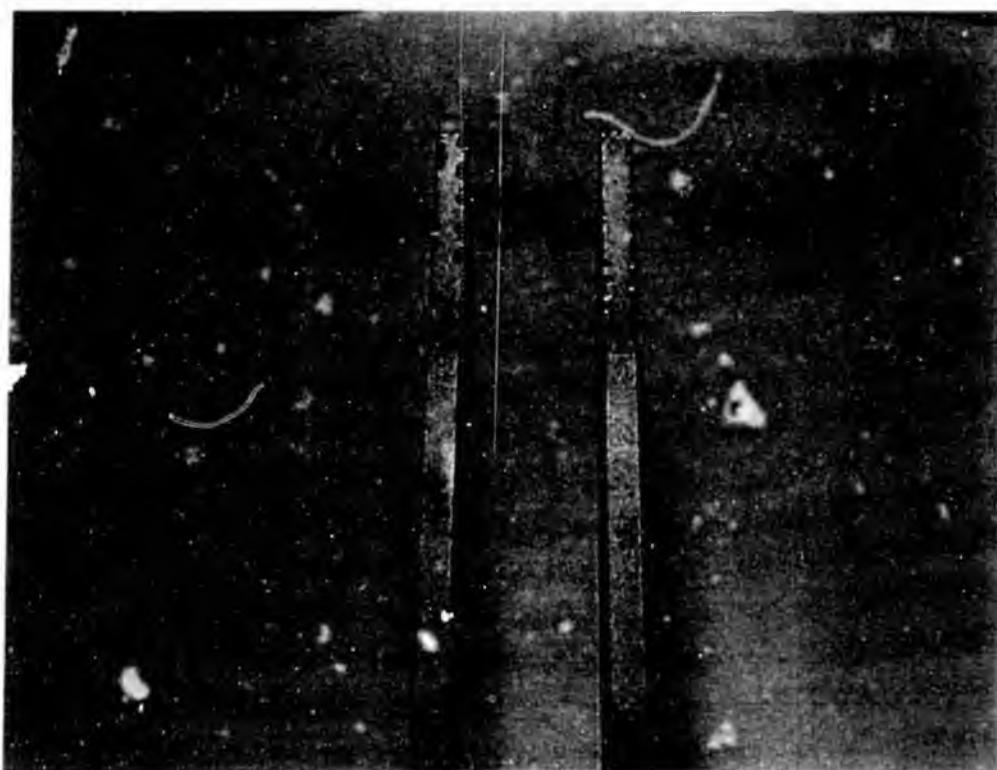
A second example, utilizes the output from the weight loss coupon program. This example from a test performed in 2001, demonstrates the need/value of multiple monitoring techniques when evaluating corrosion inhibitor performance. The trial product was tested for a 90-day period with no negative response observed by the ER probes. However, after the 90-day test period the corrosion coupons were pulled and showed relatively high general corrosion and pitting rates - see Figure 4. The product evaluated was a failure and the incumbent product was re-instated based on the coupon results. Corrosion inhibitor tests use all the monitoring tools available such as corrosion probes, coupons, and inspection data to determine corrosion control performance. In addition, the corrosion inhibitor is evaluated for plant production performance to show compatibility with the separation process.

Figure 4 Corrosion coupons pulled after an 'unsuccessful' chemical trial

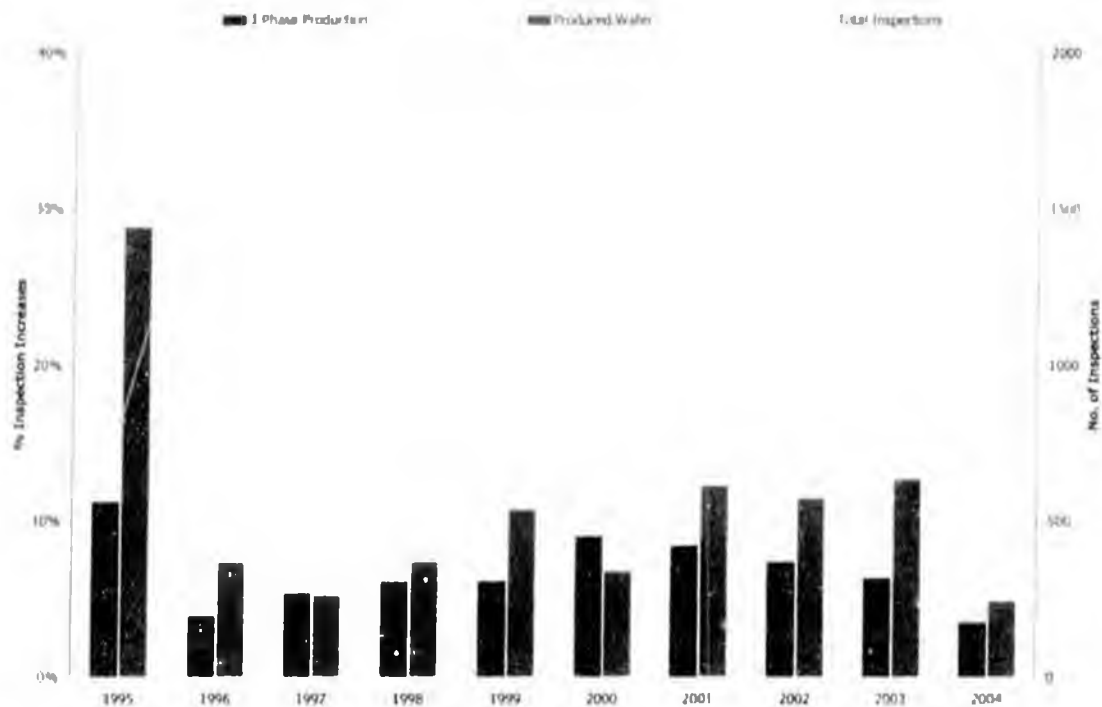
Corrosion activity in the water injection well lines had been increasing since 2000 and was addressed by increasing the corrosion inhibitor concentration by ~18% in 2003 and then by another 50% in late 2004 to 30 ppm. The additional corrosion inhibitor has reversed the increasing trend.

ACT Figure E.1 Endicott Well Line Internal Inspection Increases

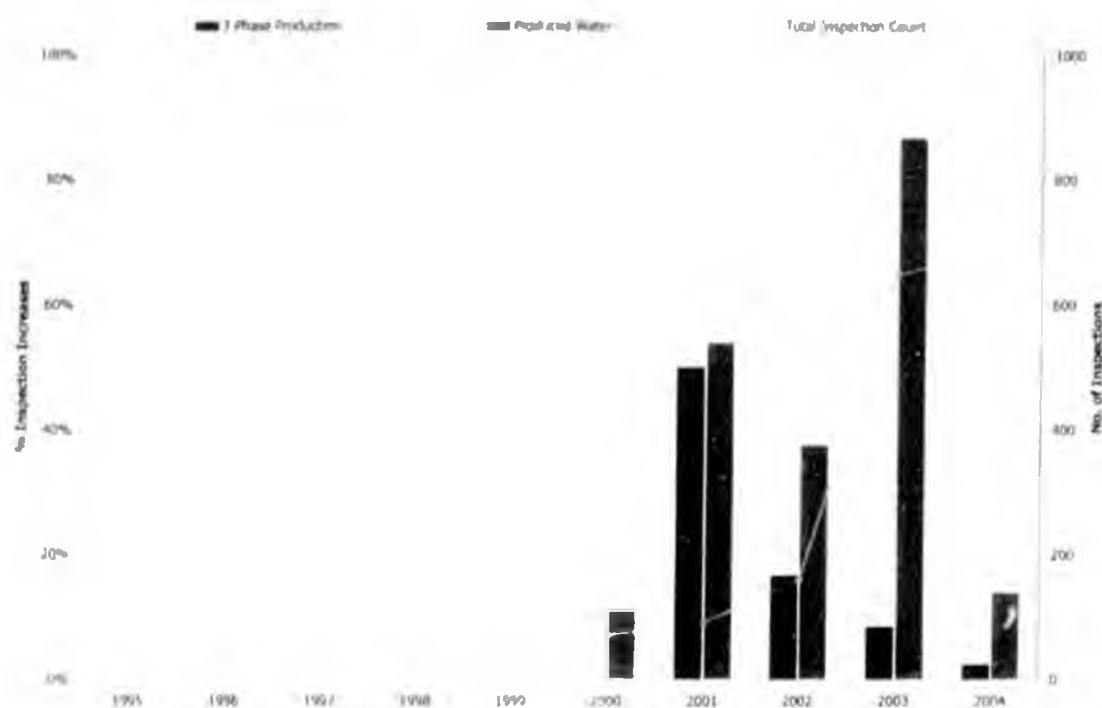
BPXA became operator at Milne Point in 1994, and from this date to 2000 the inspection program was aimed at establishing the baseline condition in the MPU systems. It is only with the 2000 data and beyond that trending of inspection increases has been possible. The results of this comparative data can be seen in ACT Figure E.3. The figure shows the total number of inspection items has consistently increased since 1998.

ACT Figure E.3 MPU Flow Line Internal Inspection Increases

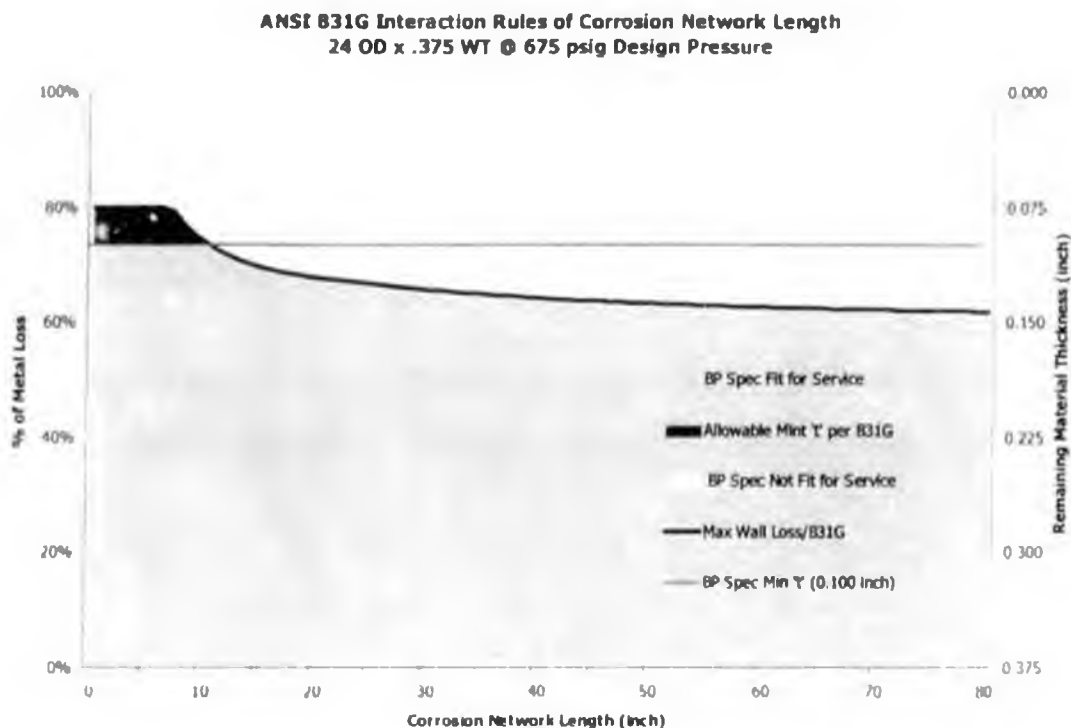
Figure 6 illustrates the FFS envelop for a combination of depth and length of defect as defined in BP Specification SPC-PP-00090. As can be seen from the curve, the criteria for allowable operating service condition is more conservative than the industry standard at the low end of the remaining wall thickness. This conservatism reflects two issues, (a) the need to provide a margin for error in the determination of wall thickness and corrosion rate, and hence remaining life, and (b) the decreased accuracy of the NDE techniques in use at a wall thickness of less 100 mils.

**Figure 6 Fitness-for-Service Envelope Based on BP SPC-PP-00090**

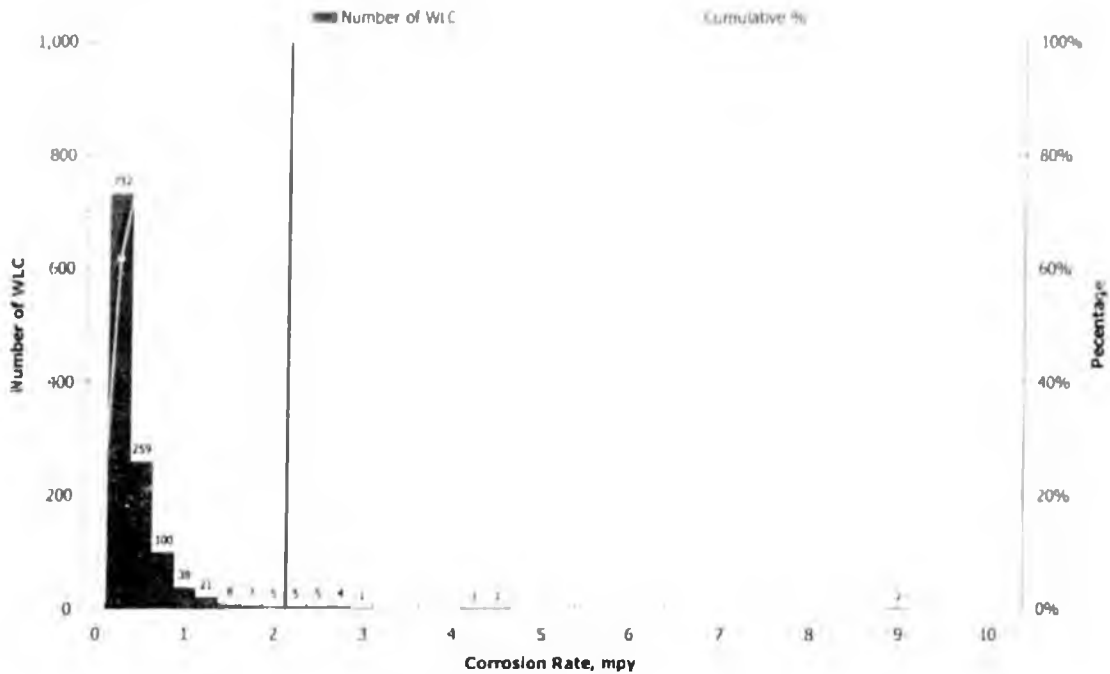
GPB Figure C.4 shows a distribution of corrosion rate for WLC in flow line oil service. There were 19 WLC greater than the 2 mpy target. Refer to Section H.1.5 for details and corrective actions.

GPB Figure C.4 Flow Line Oil Service WLC Histogram
