**HB**

### Sponsor Statement – House Bill 341

**A White Paper on  
Energy Use in Alaska's  
Public Facilities**

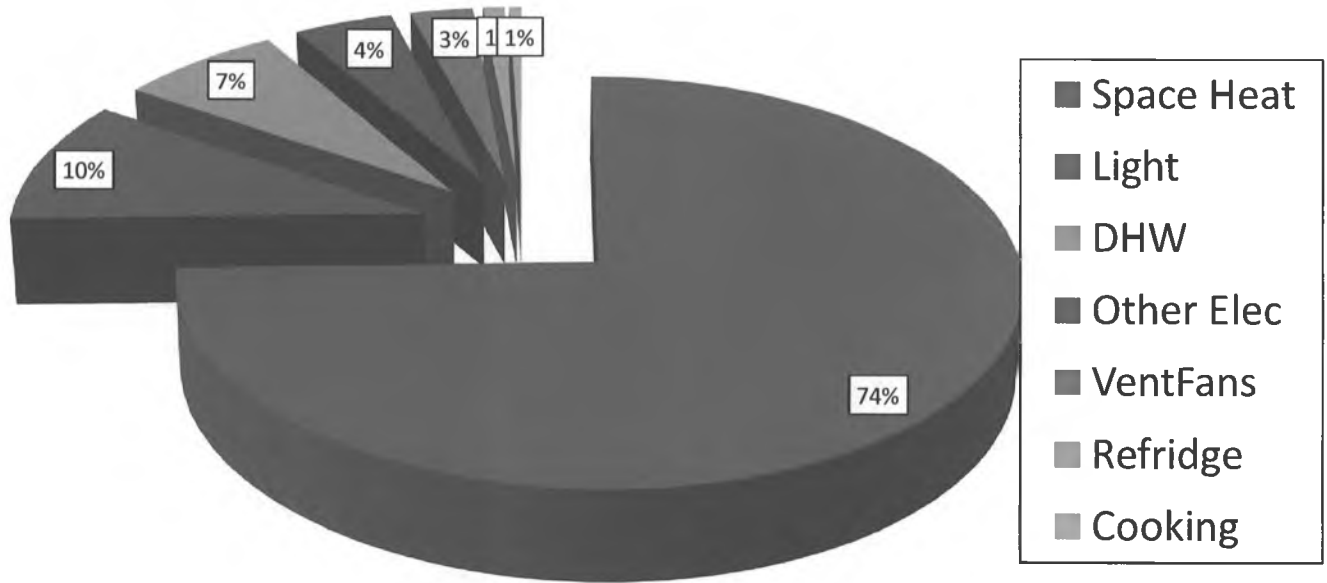
Energy End-Use for Public Schools in Alaska

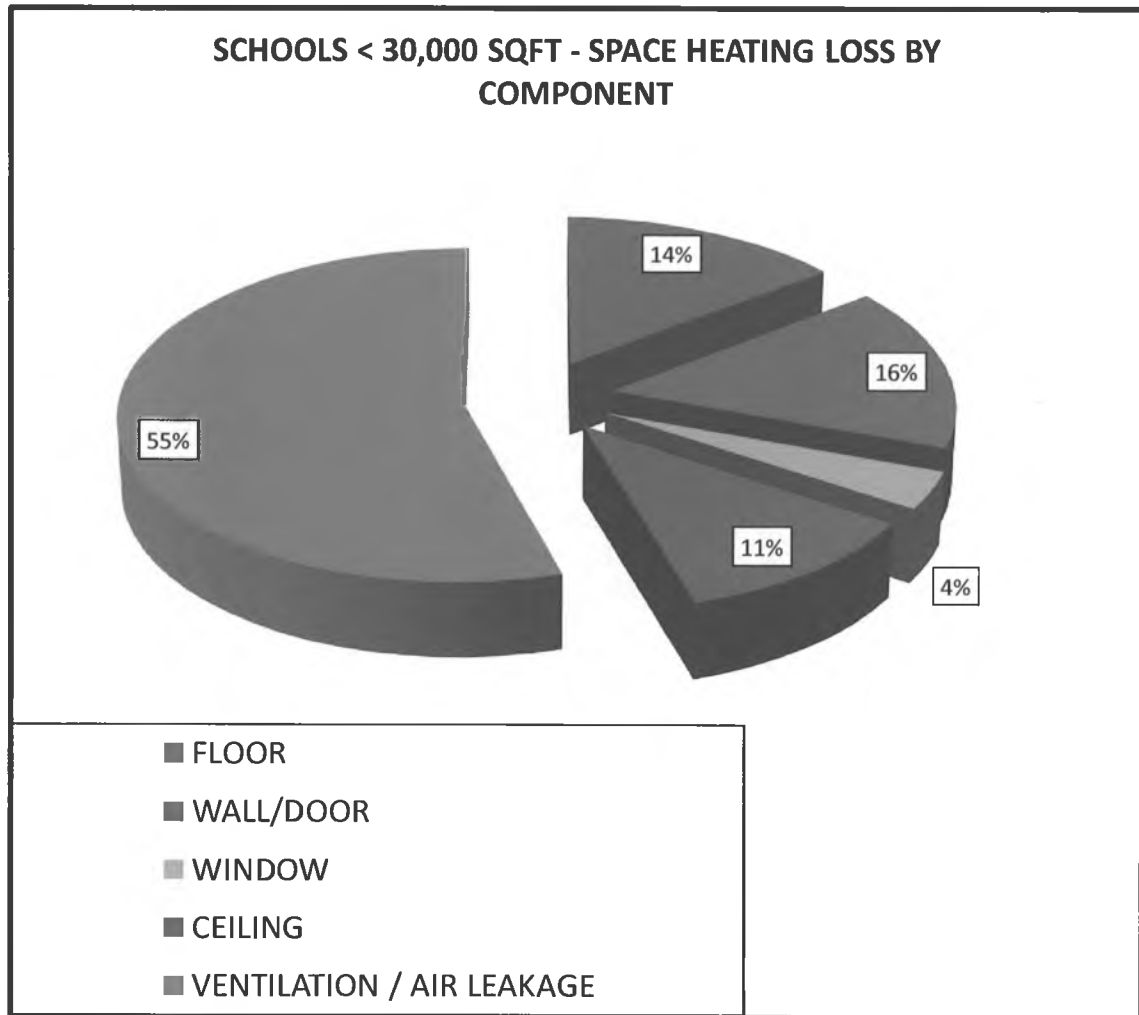
### Source of Heat Loss in Public Schools

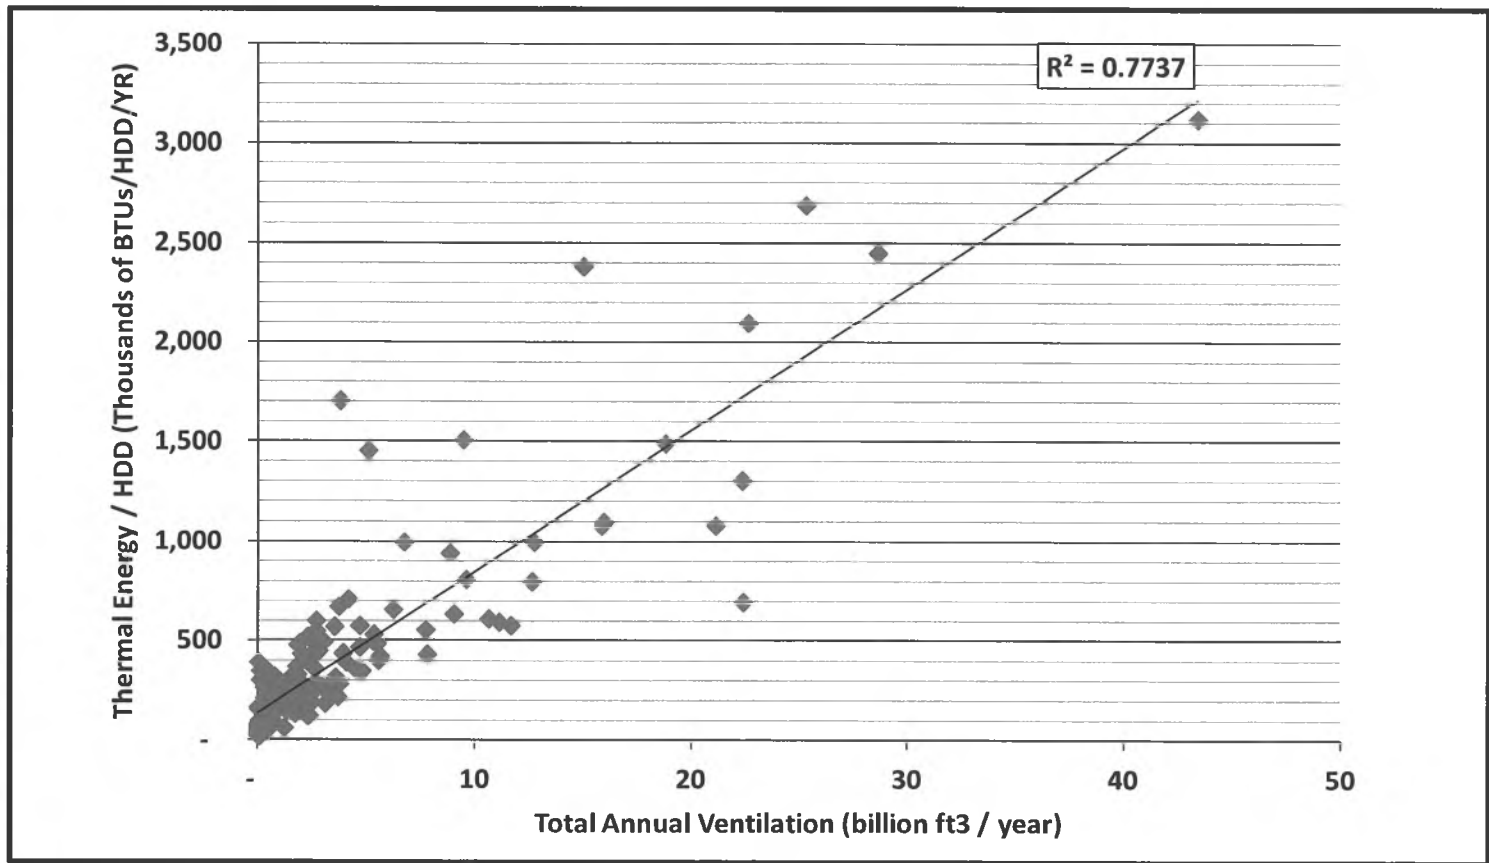
Ventilation is a Key Driver of Energy Use

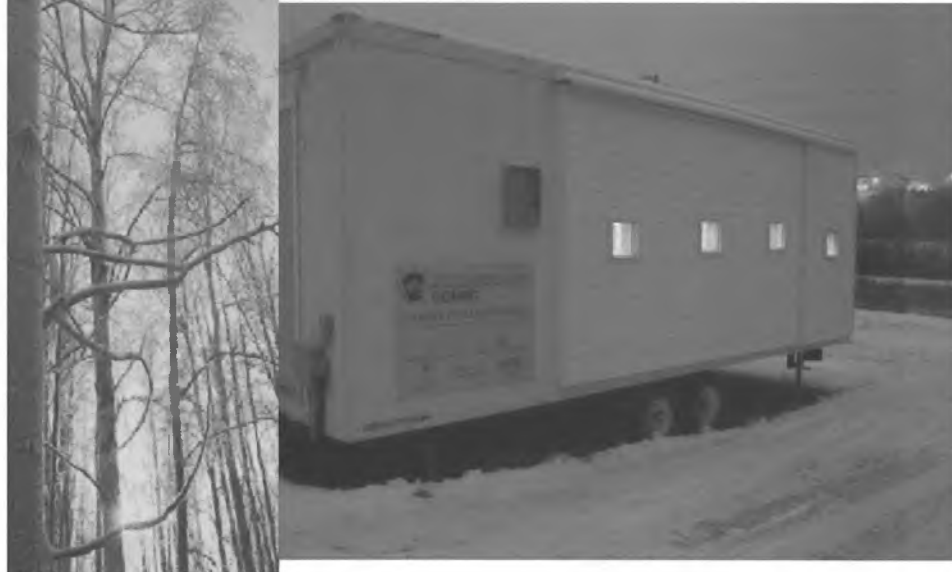
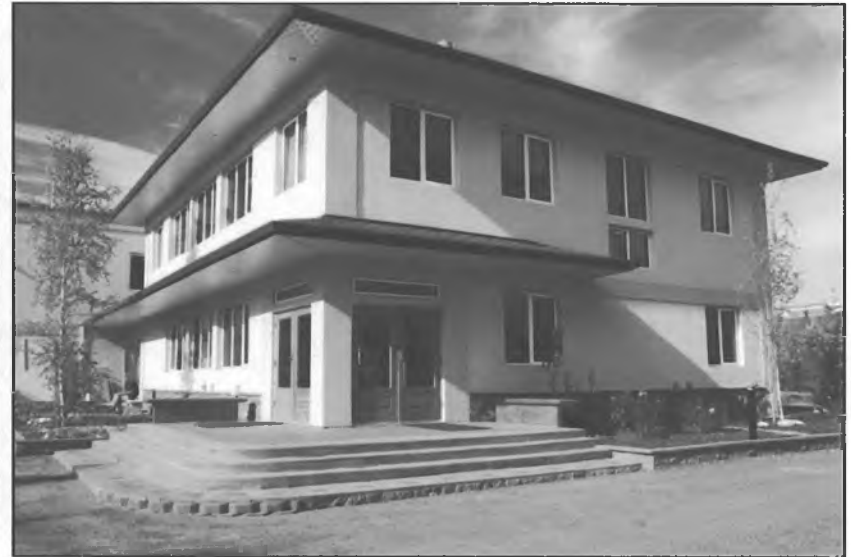
Scenario A	Scenario C	Scenario D
Fairbanks, AK Winter Temperature: 36.5°F 12% MC <sup>(1)</sup> Level Soil, 8% MC <sup>(2)</sup> 100% Snowfall,			
	<b>No Exterior Insulation</b>	<b>Vertical Exterior Insulation (2" XPS R-10 Foam Board)</b>	<b>Vertical Exterior Insulation with Horizontal Wing (2" XPS R-10 Foam Board, 48" Total Length)</b>

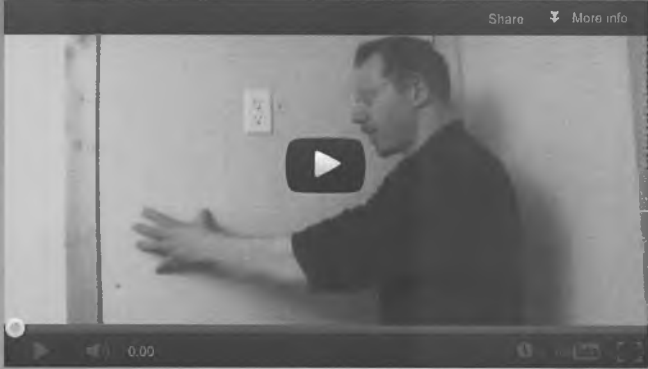
Walls typically represent the largest exterior surface area of a home. As a result, from an energy stand point, the wall system is a major component of the building envelope, particularly in extreme cold climates. When it comes to improving thermal performance, there are many ways to construct a wall, and the details of sealing, sheathing and insulating are even more numerous.

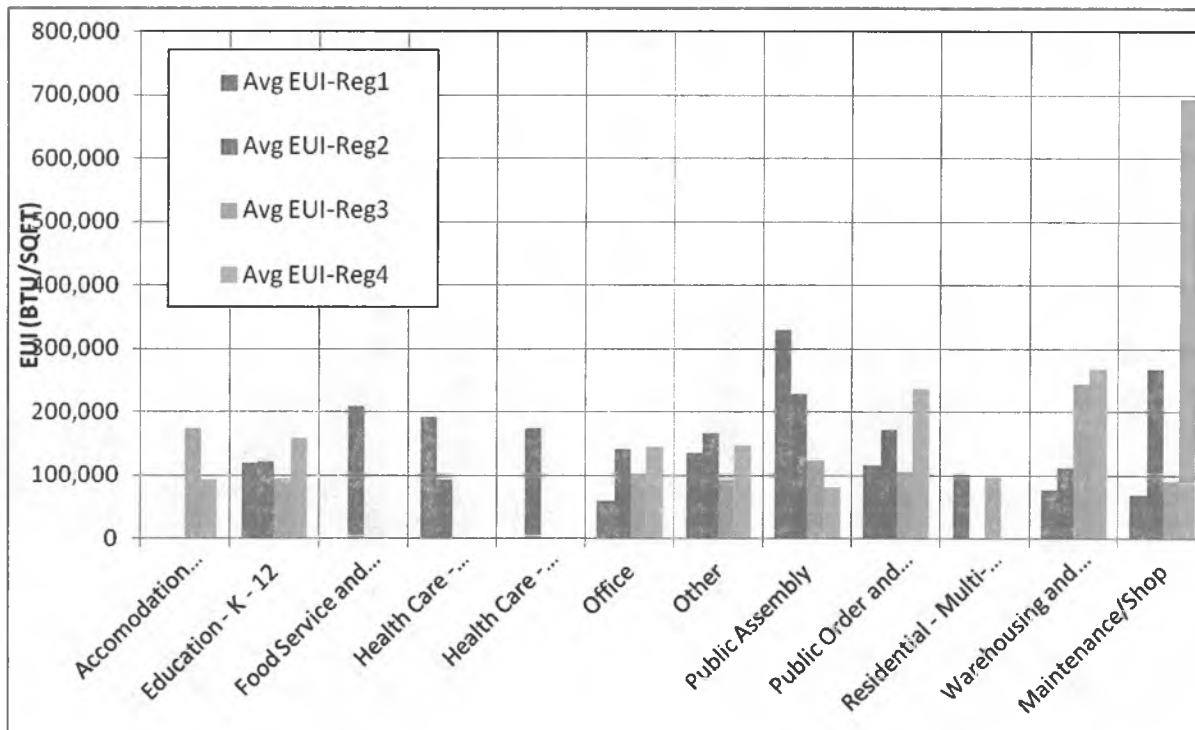
Figure 4: EUI by auditor region by building function

- b. **Auditor Region Energy Characteristics:** Figure 5 illustrates patterns that begin to emerge when going beyond the statewide level and looking at the Auditor Region's level. Figure 5 breaks out the regional data by usage type for EUI. As this graph shows, the much higher EUIs of Maintenance and Shop buildings at the statewide level are being driven primarily by the extremely high energy usage of shops in Region 4, the Northern Region (see Figure 9 for a pictorial depiction). This makes sense since shops typically are bringing in equipment to be worked on that is very cold and very heavy. Also, the equipment has to be heated with electric heaters for the engine, battery, and hydraulics in order to start them so that they can be brought into the shop for maintenance. Lastly, shops in the arctic are located in a darker winter area driving the need for more exterior lighting operation over the course of the year.

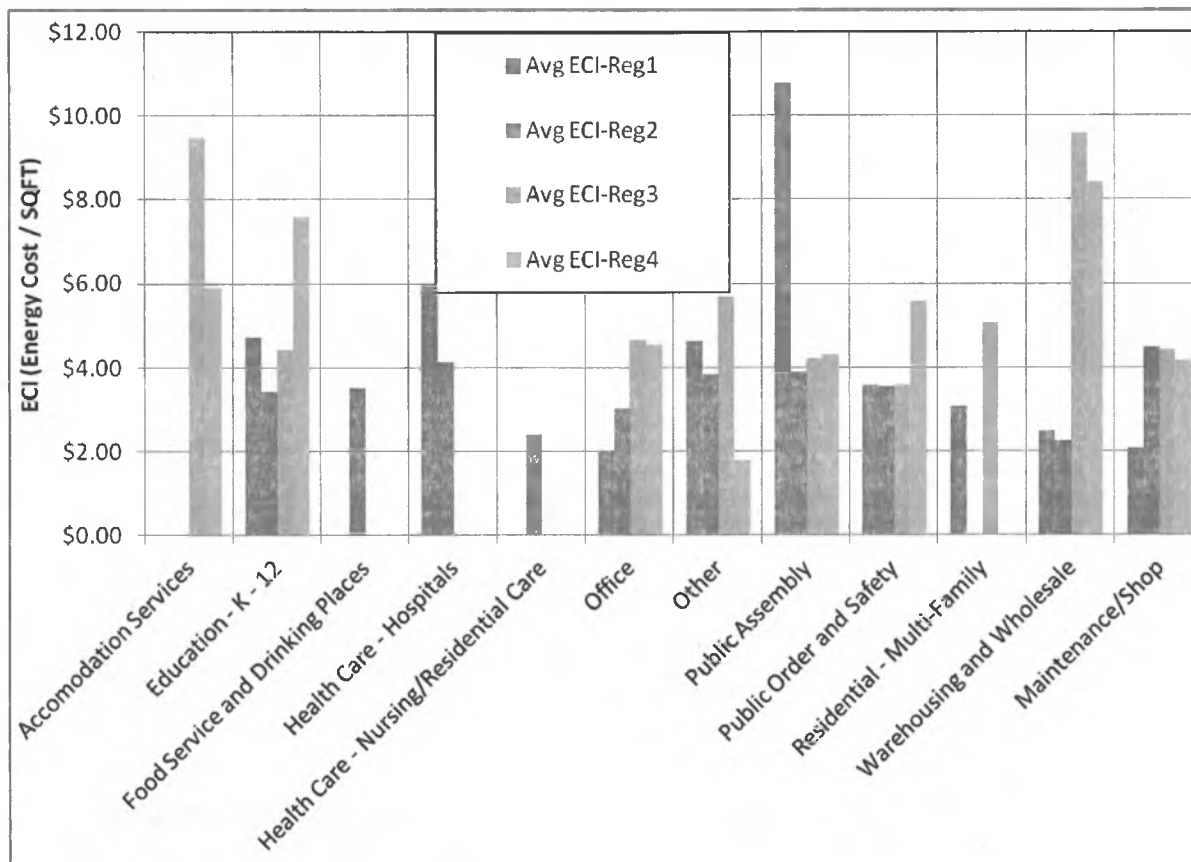
Figure 5: ECI by auditor region by building function

- c. As can be seen in Figure 6, Region 1 has the highest ECI for **Public Assembly usage** in the state, primarily due to a very inefficient pool heated to a high temperature with electric boilers. This figure has not been normalized by climate, which explains why in some categories such as **Warehousing and Wholesale** the ECI increases progressively from Southeast to the Arctic Slope. Also, fuel prices vary significantly between and sometimes within regions; this, combined with the small number of records of a particular usage type in some regions, leads to some of the fluctuations, such as those found in Warehousing and Wholesale buildings in Regions 3 and 4.

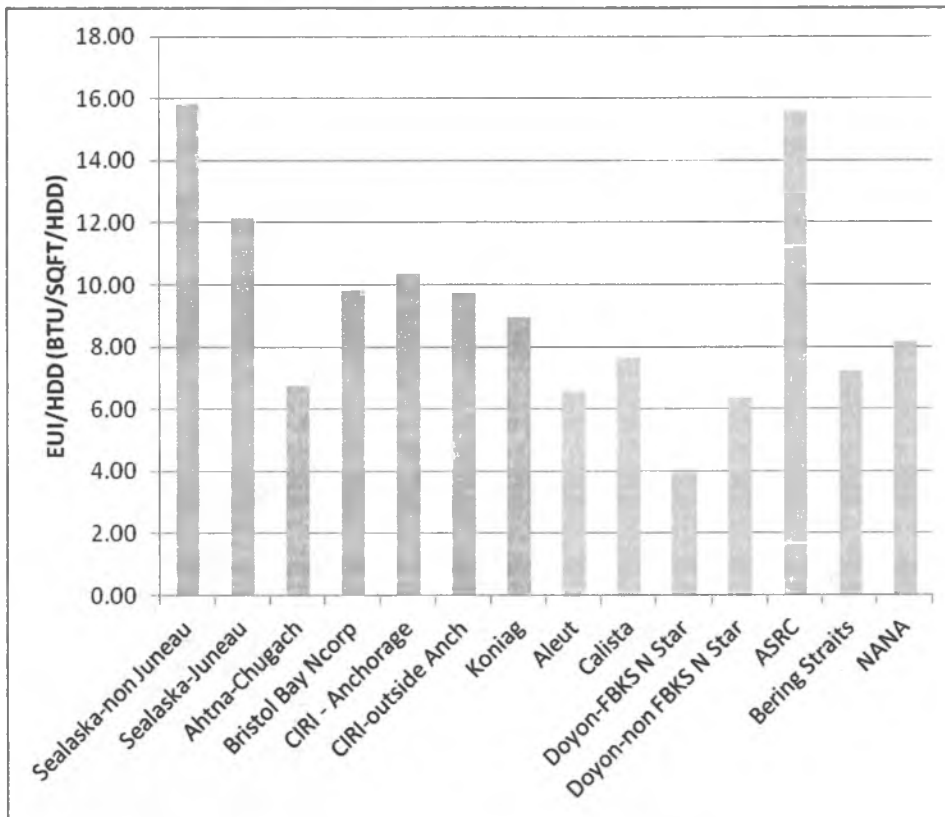
Figure 7: Average Thermal EUI per HDD, by ANCSA Region, all audited buildings

The data in Figure 7 suggest that ASRC buildings use more energy than in many regions. This may be at least partially accounted for in the longer darkness period in the Arctic and the impact of extreme cold on equipment and engines that drive the need for electric head bolt heater operation, which drives up the cost of energy significantly. The data in Figure 10 looks solely at energy consumed for space heating. Note that even after accounting for the colder climate ASRC buildings continue to have the highest average thermal EUI/HDD. It also suggests that buildings in the Sealaska geographic area outside of Juneau are roughly equally energy inefficient. A further conclusion might be that in places with cheap energy, there is less pressure to construct efficient structures. However, there is a fairly low correlation statewide between EUI per HDD and energy price<sup>7</sup>. Another factor is that similar buildings have the same lighting and equipment energy use, but this is weighted differently when the HDD correction is applied.

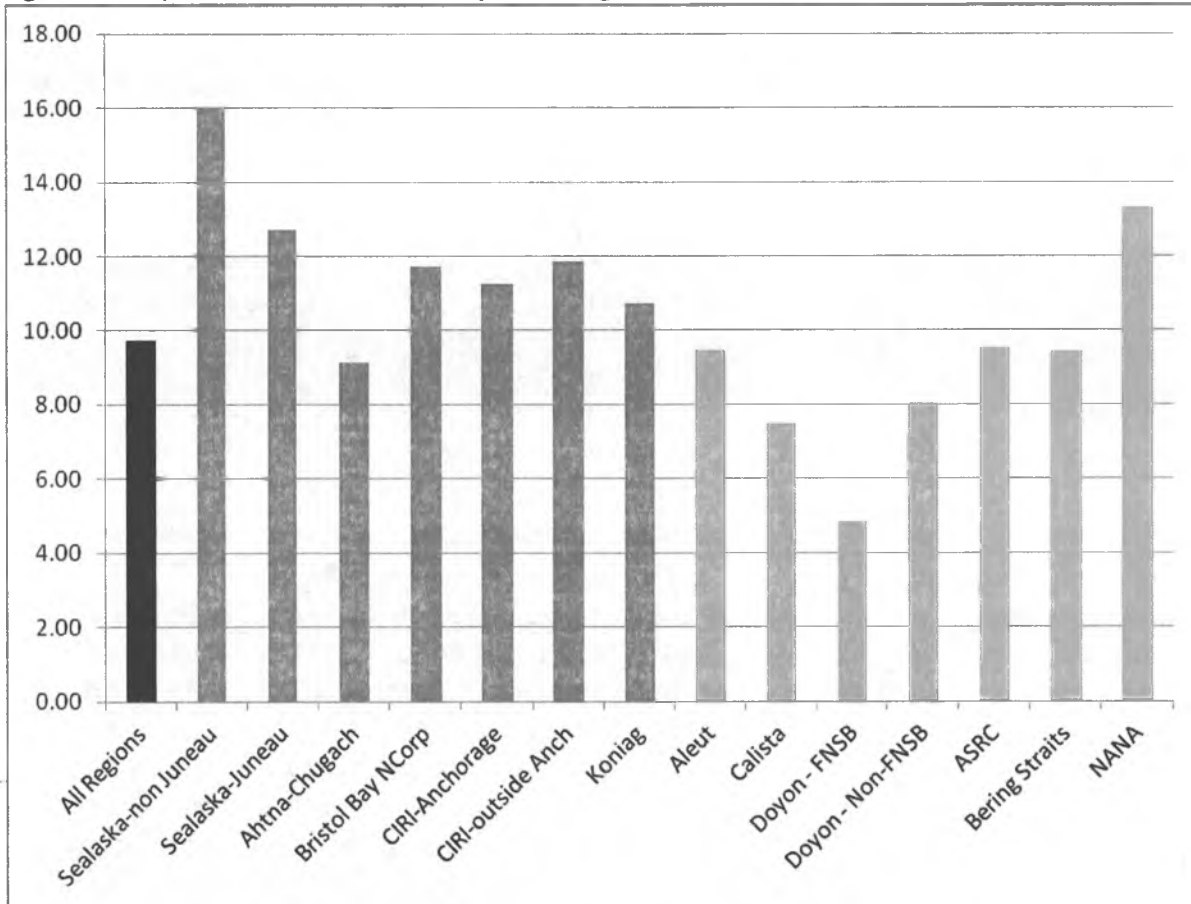
Figure 13: EUI per HDD of Audited Schools by ANCSA region

This chart indicates significant differences by ANCSA region, with schools in the Fairbanks North Star Borough on average using less than half of the energy per HDD of an equal sized building in the Sealaska Bristol Bay, NANA and CIRI regions. In order to narrow down the possible causes of this difference, building age and building size were analyzed to determine if there was a significant correlation between high energy use and older buildings or increased energy use with smaller building size. The variables were not found to have significant correlation with EUI or EUI per HDD<sup>11</sup>.

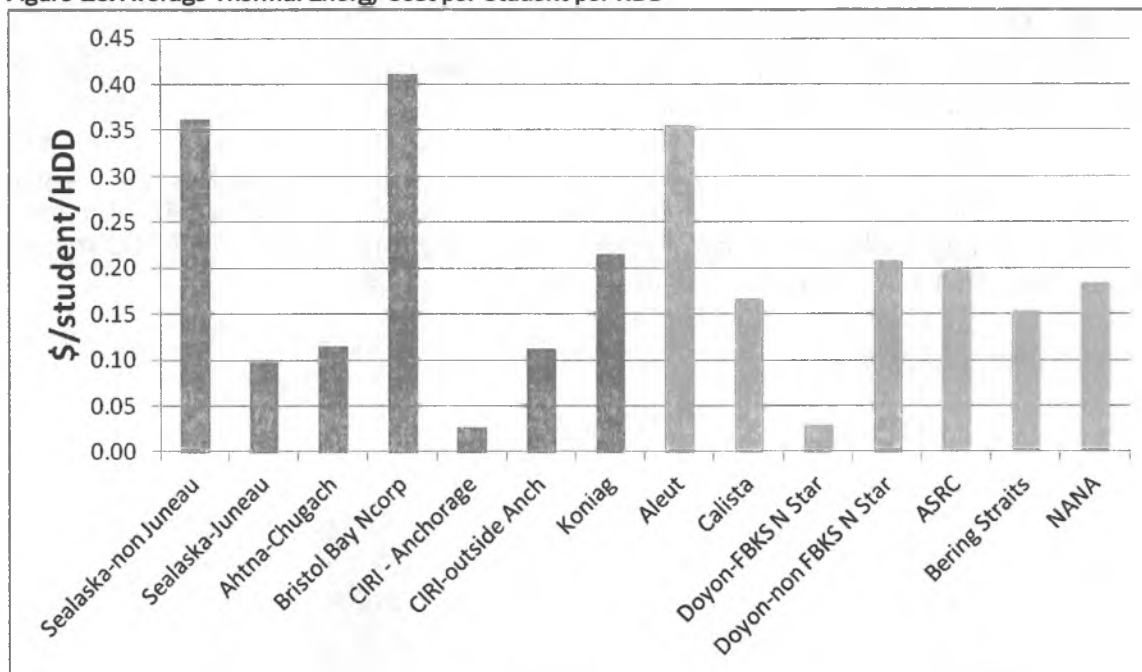
Figure 16: Average Thermal Energy Cost per Student per HDD

By normalizing the data using HDDs, the above graph shows particular ANCSA geographic regions that have much higher annual energy costs per student than are explainable by their climate alone to be identified.

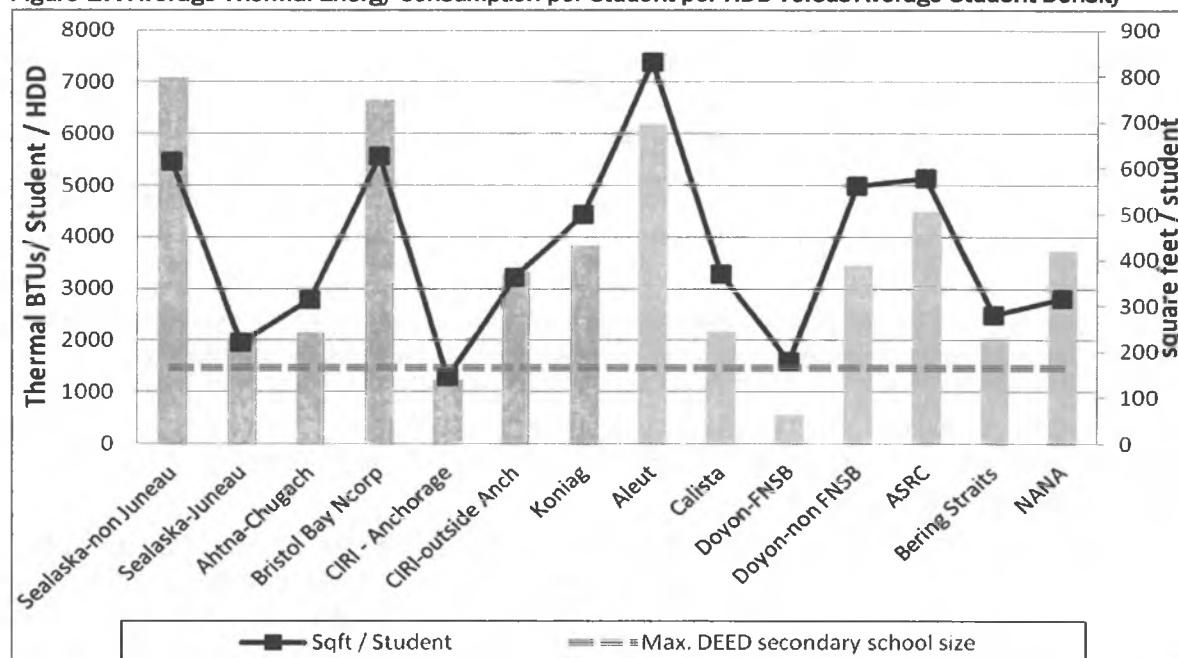
Figure 17: Average Thermal Energy Consumption per Student per HDD versus Average Student Density

It should be noted that DEED has a space allocation guideline that recommends a maximum limit on the gross square feet per student that can be built. As of 2005, the maximum square footage per student was 165 for secondary schools, and 114 for elementary schools<sup>18</sup>. Only audited schools in Anchorage and the Fairbanks North Star Borough meet these criteria, and the rest of the schools in the State have too large a school compared to the number of students—sometimes by a factor of 450 percent in excess of the standards.

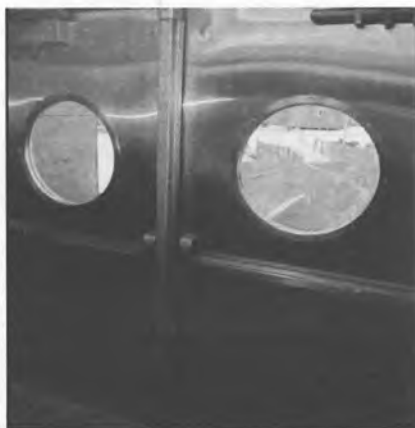
School B

- 7.25" Rigid Insulation
- Hot, sealed roof
- Well insulated metal doors with small windows.
- Arctic Entry

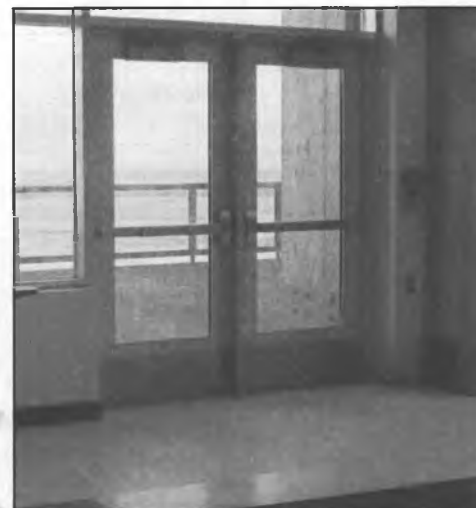
- 5.5" rigid insulation
- Cold, vented roof
- Full glass metal doors
- No arctic entry

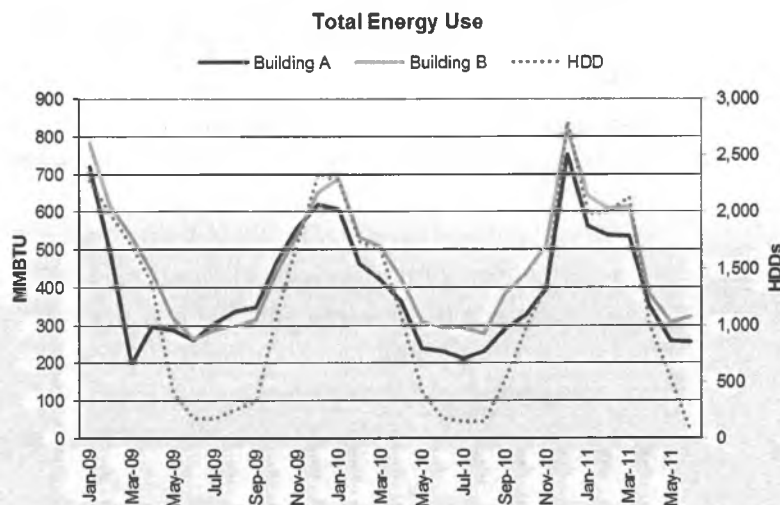
The graph below shows how energy use in the two buildings is affected by heating degree day (HDDs). The energy use trend almost perfectly follows the HDD trend in the winter months. The graph shows none of the apparent fluctuations of energy use that are normally seen from varying occupancy, building uses or schedules in normal buildings. This correlation of energy use and HDDs is an indication that primary energy use in these building is directly related to heating OSA that makes up for the excessive exhaust rates.

**Cause** Excessive levels of OSA are a byproduct of the buildings' designs that use constant exhaust volumes as if each building were fully utilized on a 24/7 schedule. The designed exhaust rates require a high amount of OSA in

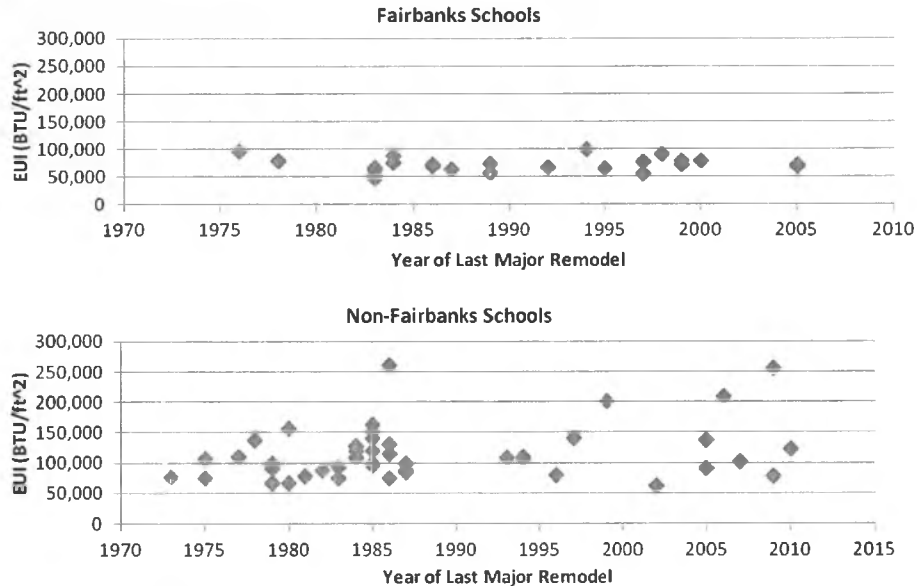
Preliminary benchmarking data and anecdotal experience led auditors to expect that EUIs are generally increasing over time due to potential over ventilation based on stricter minimum air and exhaust standards. Review of NORTECH's audit data does not prove this hypothesis. None of the charts below show a clear relation between Energy Use Index (EUI) and the date built or last major remodel. The charts below compare EUI to year for Fairbanks schools and non-Fairbanks schools. The average EUI for Fairbanks schools appears consistent and low over time because of properly implemented maintenance and energy management programs along with trained personnel. The average for non-Fairbanks schools shows a much wider variability in EUI in schools of all ages.

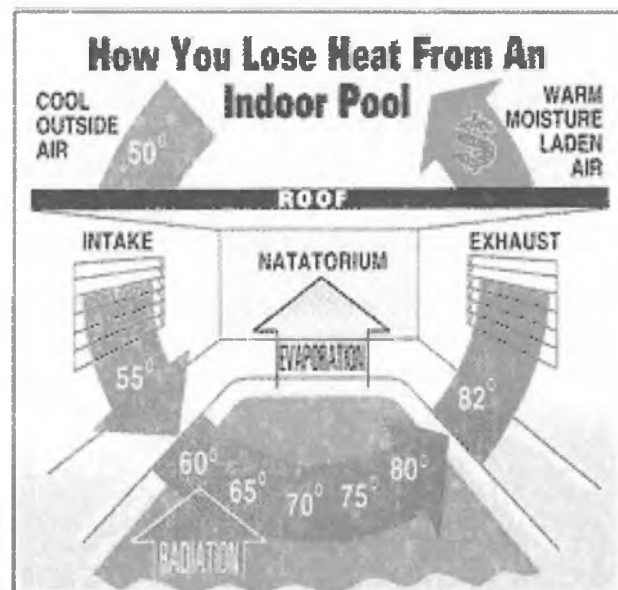
Figure 1.0: Indoor Pool Energy Loss Example

**Recommended Change** It is recommended that indoor pools be provided with pool covers and these covers be used during times when the pool is closed or unoccupied. According to the U.S. DOE, "Covering a pool when it is not in use is the single most effective means of reducing pool heating costs. Savings of 50 percent–70 percent are possible. Pool covers on indoor pools not only can reduce evaporation but also the need to ventilate indoor air and

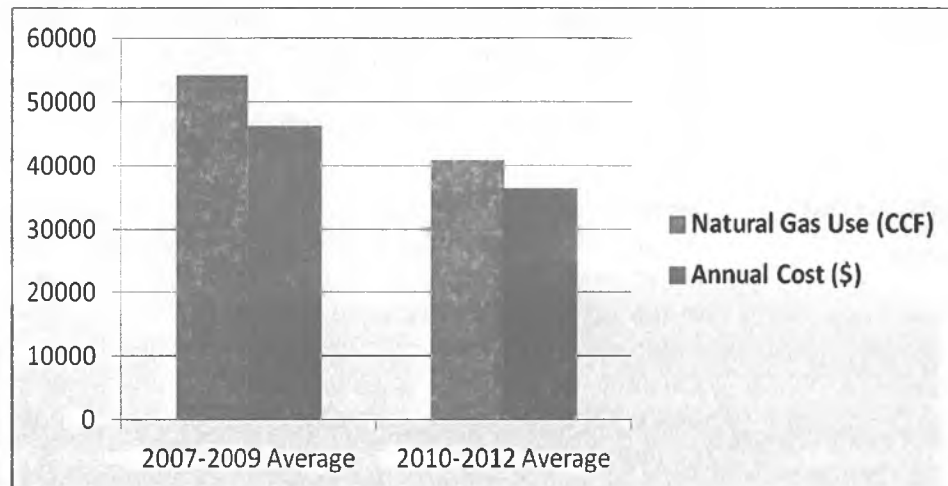
Figure 1.0: Average Annual Energy Use and Cost Comparison

**Impact** Klatt Elementary was provided with modern high-efficiency condensing gas boilers as a flagship project for ASD replacing 26 year old gas fired Weil McLain sectional boilers. From the utility data provided, the installation of these boilers and the degree of control provided by the DDC system has reduced the annual natural gas use of this building by 24.6 percent, based on the average annual consumption over the three-year periods of 2007-2009 and 2010-2012. Figure 1.0 shows the difference in natural gas used in Hundreds of Cubic Feet (CCF) and Annual Cost for Klatt Elementary's natural gas usage over the three-year averages mentioned earlier. Cost savings over this period were shown to be \$9,945 annually, corresponding to a 21.5 percent reduction in actual cost paid for the natural gas used.

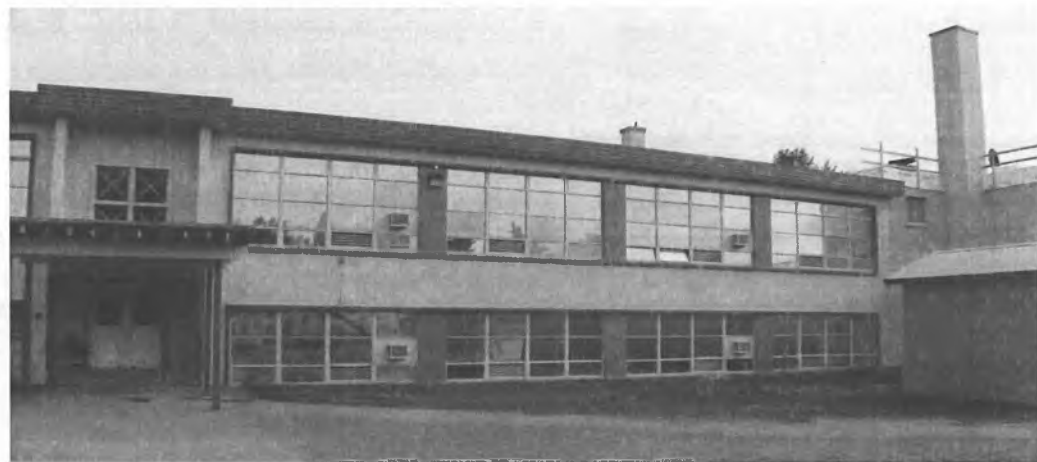
Figure 1: View of South Facing Windows with A-C Units

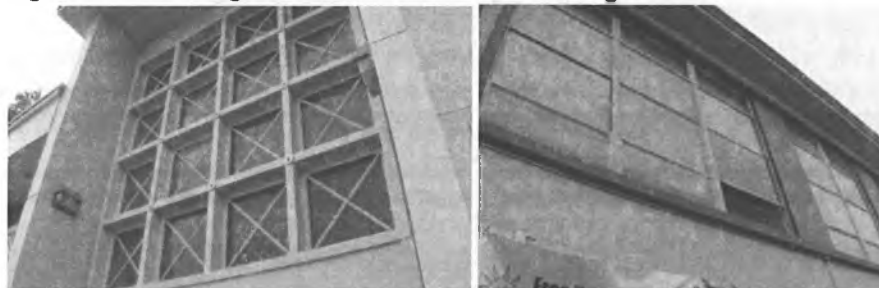
Figure 2: View of Single Pane Windows and North Facing Windows

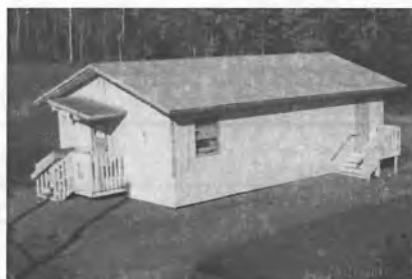
Figure 1: View of Chinook Elementary Relocatable Classroom

Electrical use data was provided by the ASD so that the average electrical use could be determined for the Relocatable Classrooms which are sub-metered. It can be concluded that these units are estimated to consume 17,450 kWh annually on average and can be entered as a stand-alone plug-load in AkWarm-C

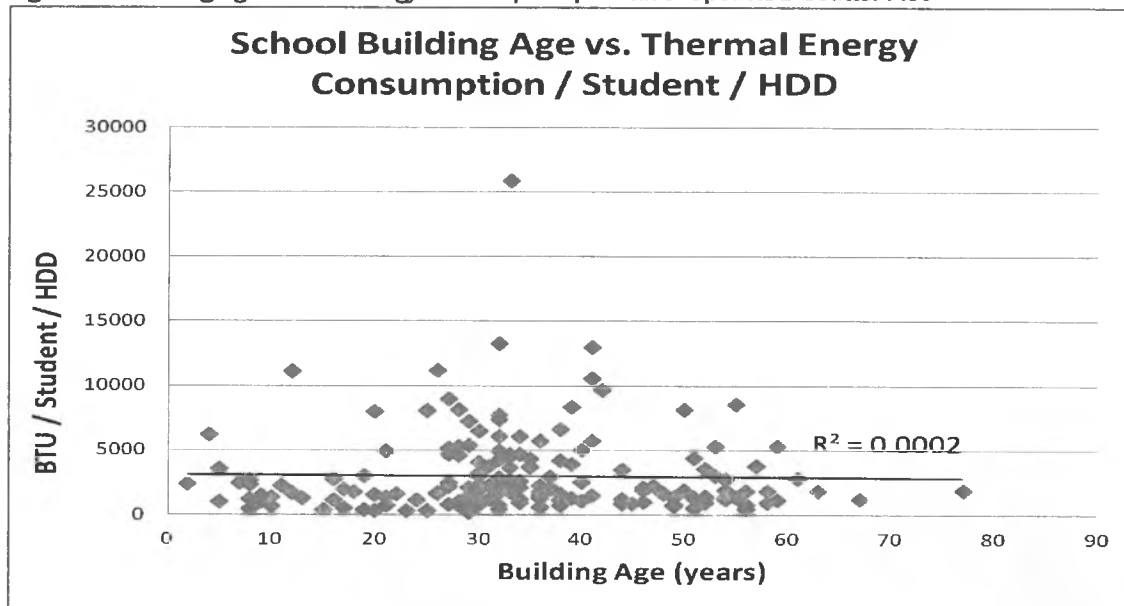
Figure 22: Building Age versus Energy Consumption per student per HDD Scatter Plot

Each data point represents one school. Upper bound outlier audit data points have been thoroughly reviewed and validated.

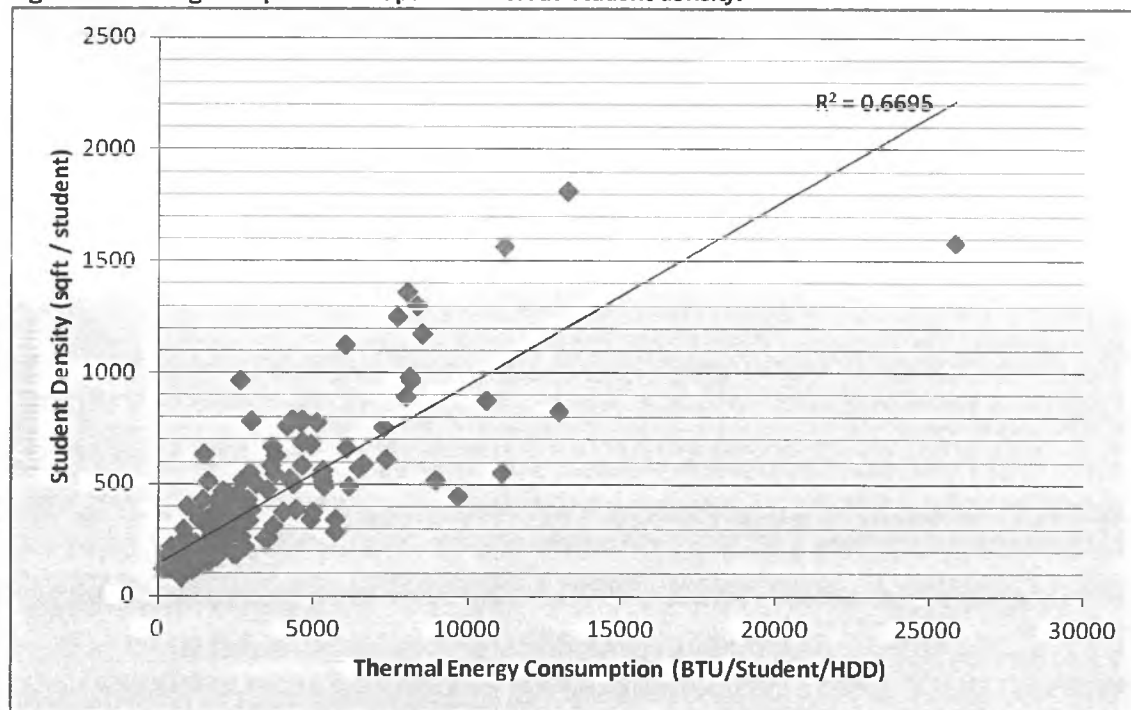
Figure 23: Average EUI per student per HDD versus student density.

Each data point represents one school. Upper bound outlier audit data points have been thoroughly reviewed and validated.

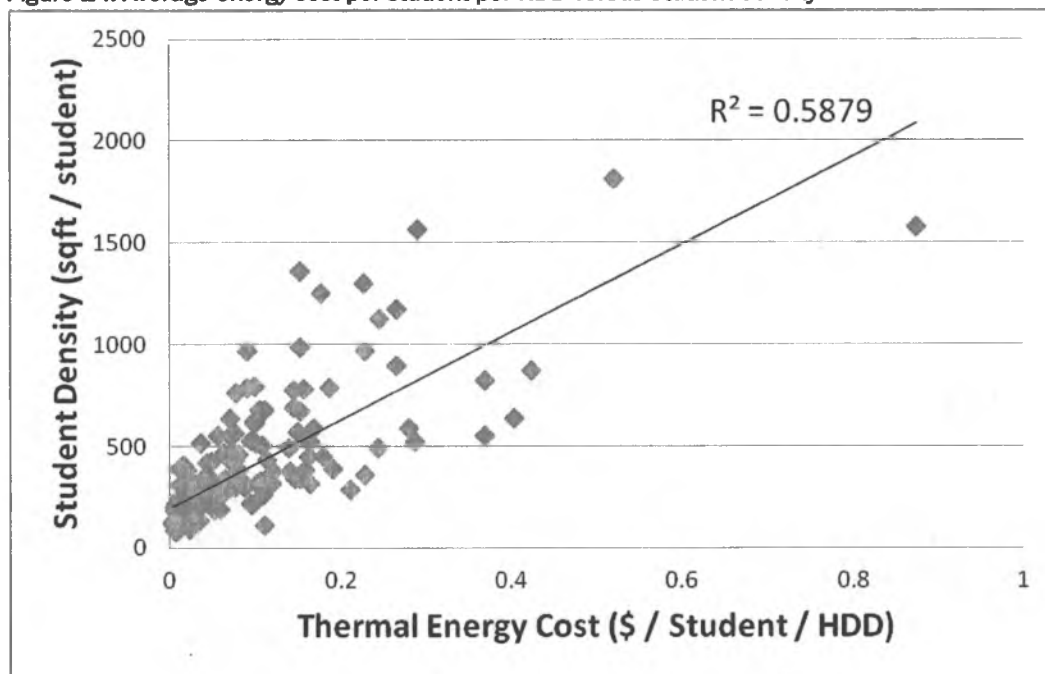
Figure 24: Average energy cost per student per HDD versus student density

Each data point represents one school. Upper bound outlier audit data points have been thoroughly reviewed and validated.

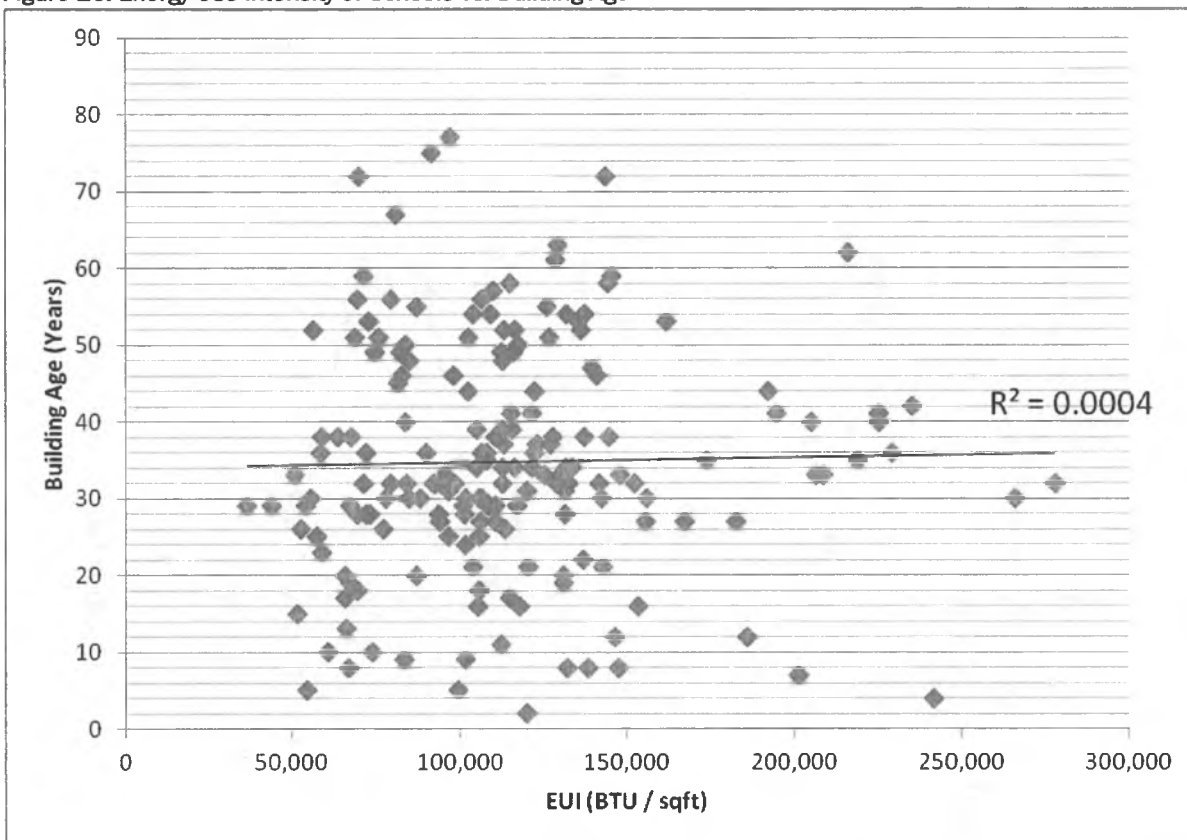
Figure 26: Energy Use Intensity of Schools vs. Building Age

An  $R^2$  value of 1 indicates perfect correlation. In this case, the  $R^2$  value of 0.0004 indicates very little correlation.

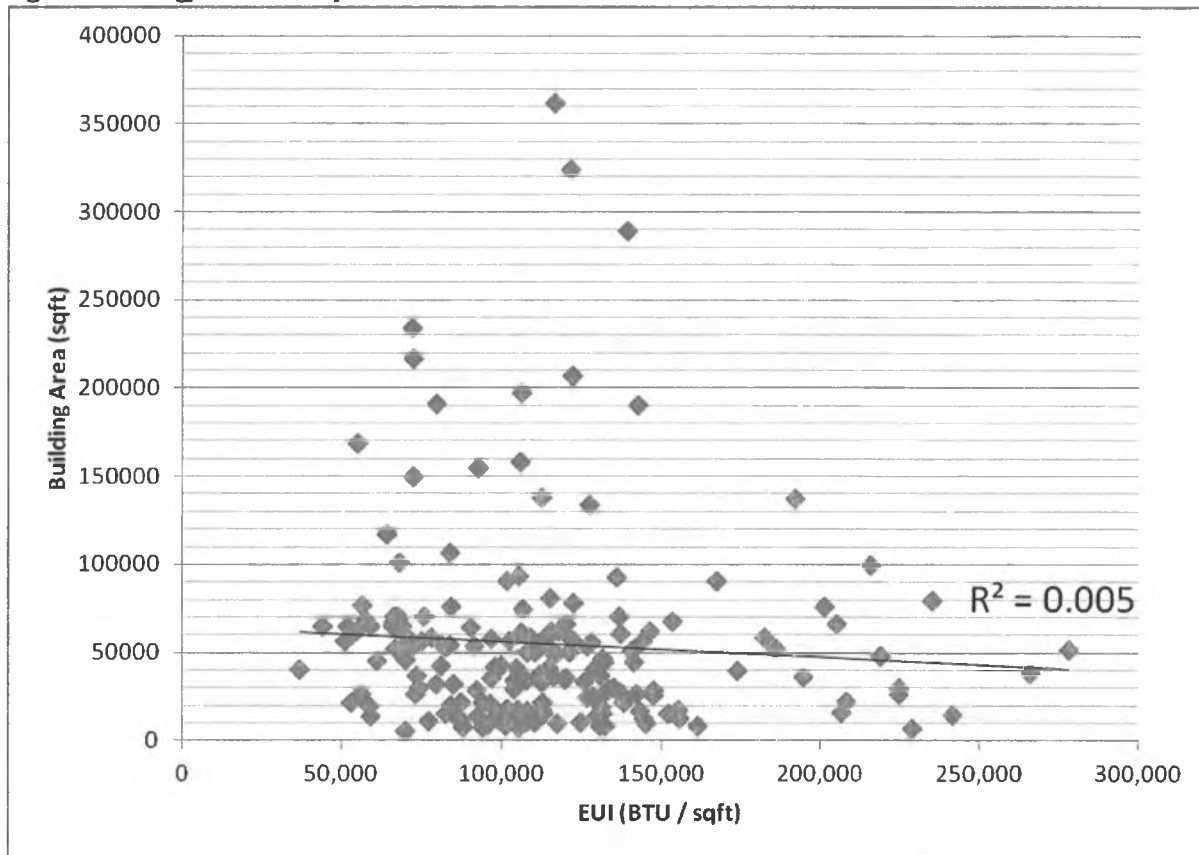
Figure 27: Energy Use Intensity of Schools vs. School Size

An  $R^2$  value of 1 indicates perfect correlation. In this case, the  $R^2$  value of 0.005 indicates very little correlation.

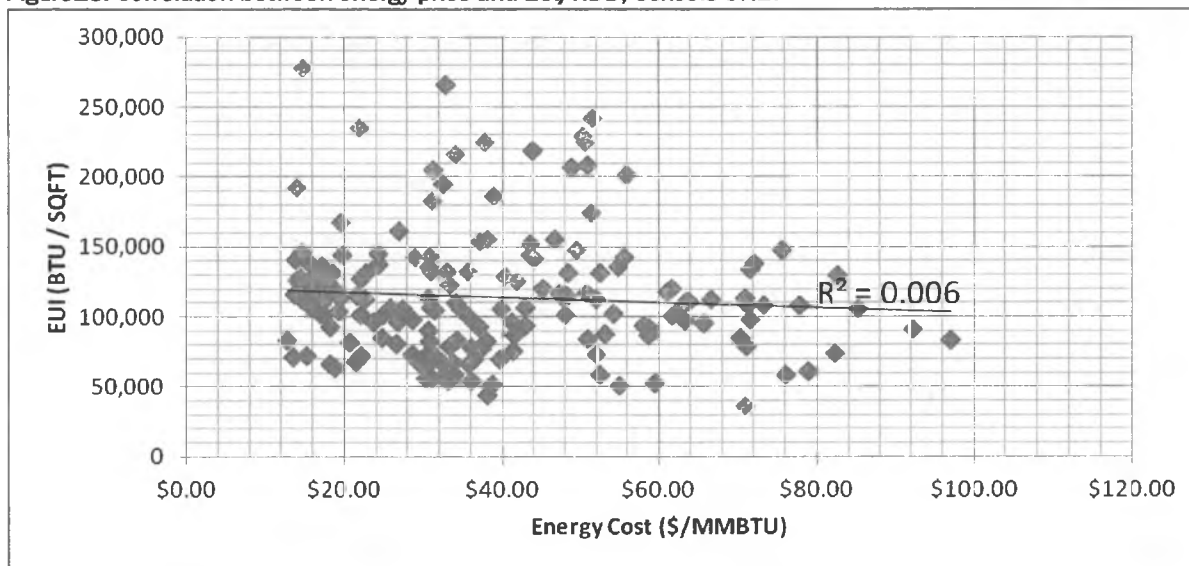
Figure 28: Correlation between energy price and EUI/HDD, Schools ONLY

Each point represents one of the audited buildings. An  $R^2$  value of 1 indicates perfect correlation. In this case, the  $R^2$  value of 0.006 indicates very little correlation.

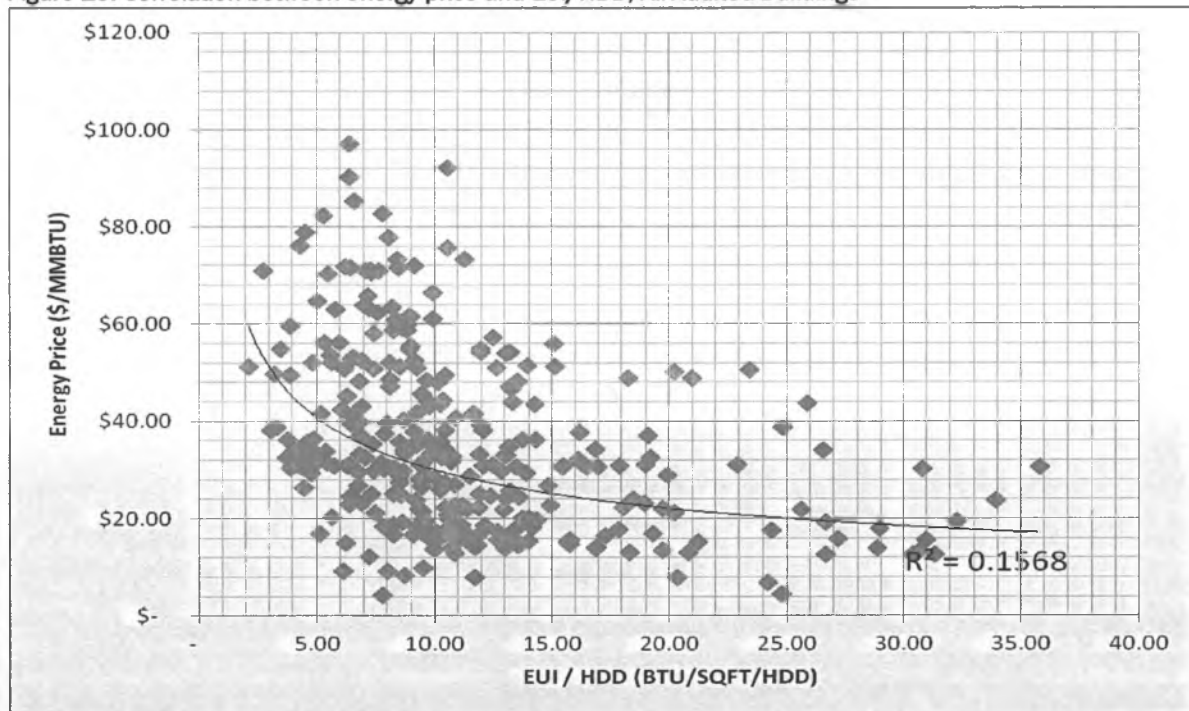
Figure 29: Correlation between energy price and EUI/HDD, All Audited Buildings

Each point represents one of the audited buildings. An  $R^2$  value of 1 indicates perfect correlation. In this case, the  $R^2$  value of 0.1568 indicates only a slight correlation. Outlier data was cleaned from this graph, and an exponential line of best fit was used as it appeared to model the data better than a linear line.
