WICKERSHAM HOUSE REPORT

Prepared in Response  
to  
Legislative Resolve No. 30, 1981

Condition Survey Report

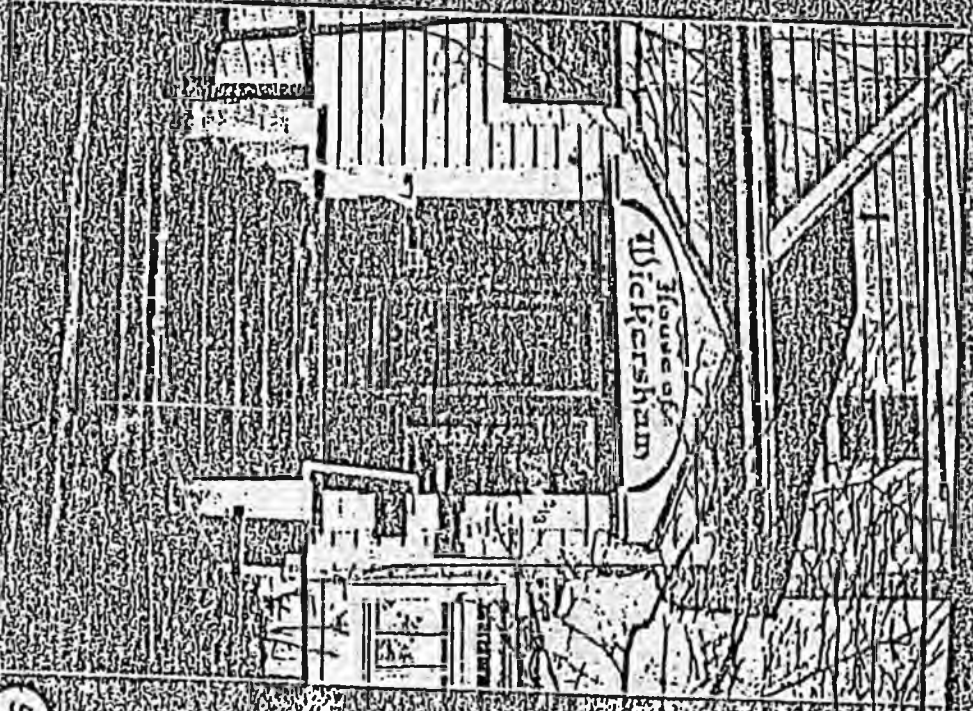
59

Entrance stair #1, concrete, is in relatively good condition. One minor crack requires adhesive/sealant repair. However, the walkway and curb leading to it are badly deteriorated and heaved. See photo #59. These need repair/rebedding/replacement. Service stair #3 is in good condition and does not require work, but the sidewalk to stair #3 requires repair. Stair #2, at the southwest porch, is in good condition, but sidewalk requires repair.

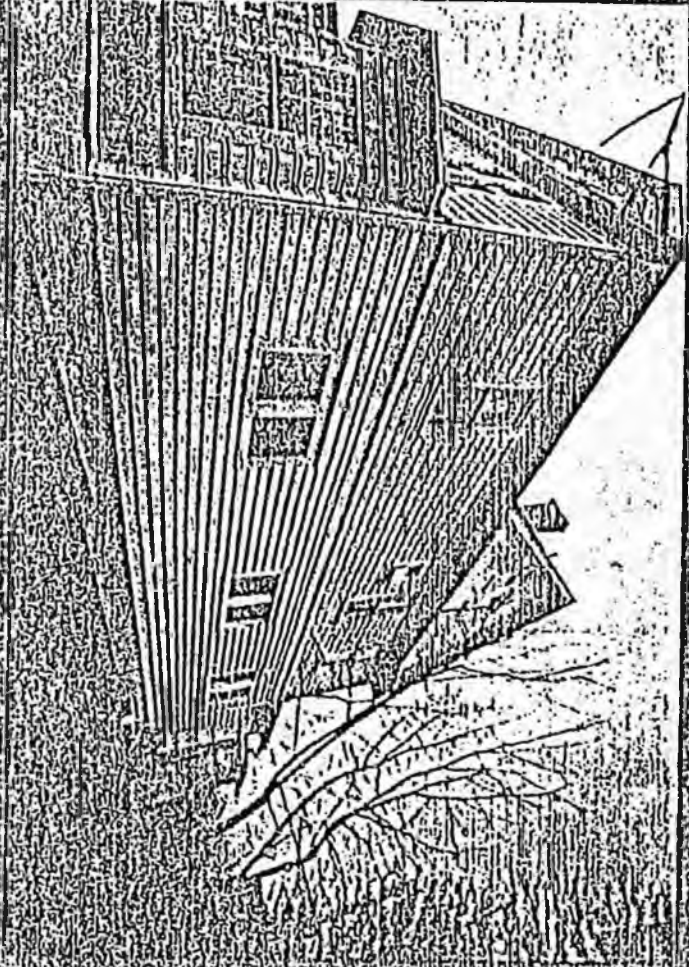
61

The roof consists of square-butt, mineral-surfaced asphalt shingles, laid approximately 5 inches to the weather on a wood substrate with 12:12 pitch. The roofing is deteriorated as indicated in photos #61 & 69, and requires complete replacement with best grade fire retardant shingles of same appearance. All flashings need replacement at that time also, and such work should not be done until all foundation stabilization and framing realignments are completed.

Brick chimney is deteriorated and needs attention. See photos #61 & 69.

Loose or rotten brick should be reset or replaced with matching material as appropriate. Flue liner needs to be thoroughly inspected, cleaned, and repaired if required.

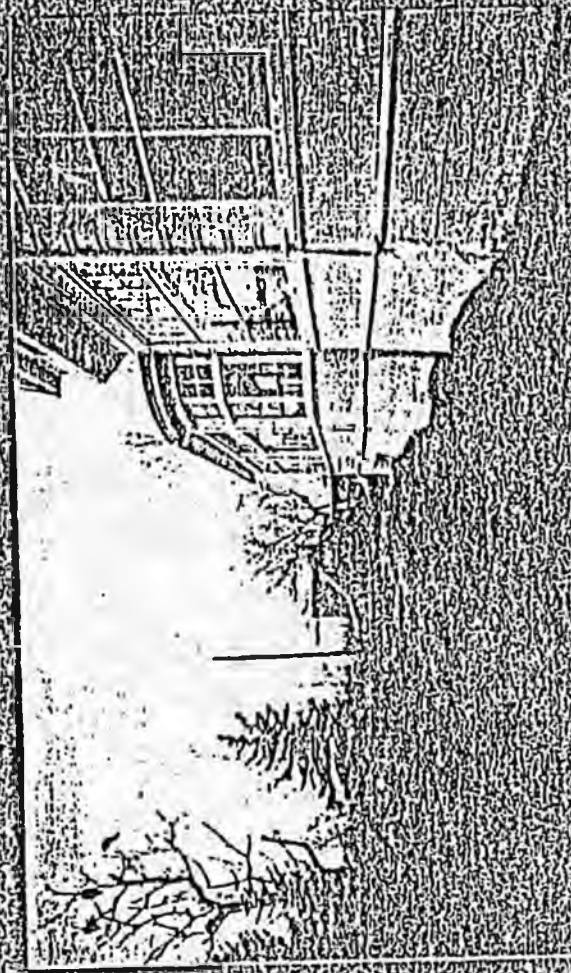
63

There are no readily apparent problems with the principal foundation line, although the inner foundation under porch #112 and under the bay window group #115-117 of study #109 will require detailed examination when the outer foundations are opened. Severe settlement problems have occurred affecting the outer foundation under porch #112 and under the bay window. See photos #63-66, 73, 74. It is not known whether this set-

tlement is due to inadequate footing design, improper preparation of the soil bearing surface when footings were installed, or whether due to possible soil drift or subsidence down the slope to the south.

Analysis of soil stability in the south third of this property should be obtained, and the outer foundations of the porch and bay window removed and reconstructed. It will be necessary to examine the inner foundation wall line at that time to confirm condition. Levelling of first floor over the crawl space and rework of piers on that area should take place after soil analysis is obtained. Crawl space minimum clearance is about 1½ feet. It may prove desirable to excavate the crawl space to full basement depth and develop full finished basement at that time.

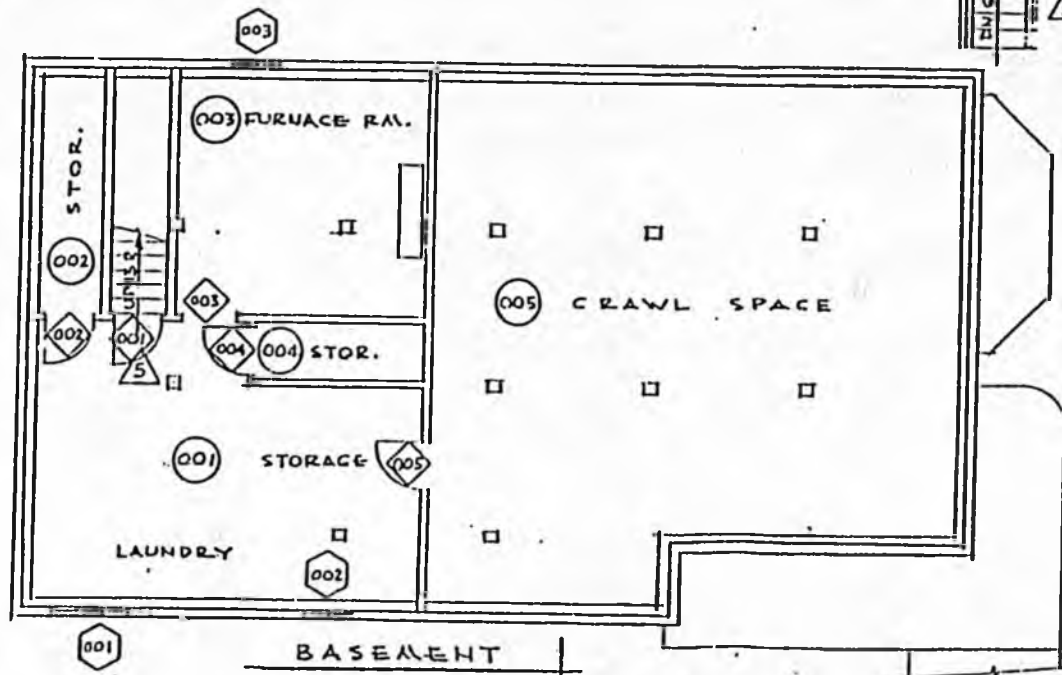
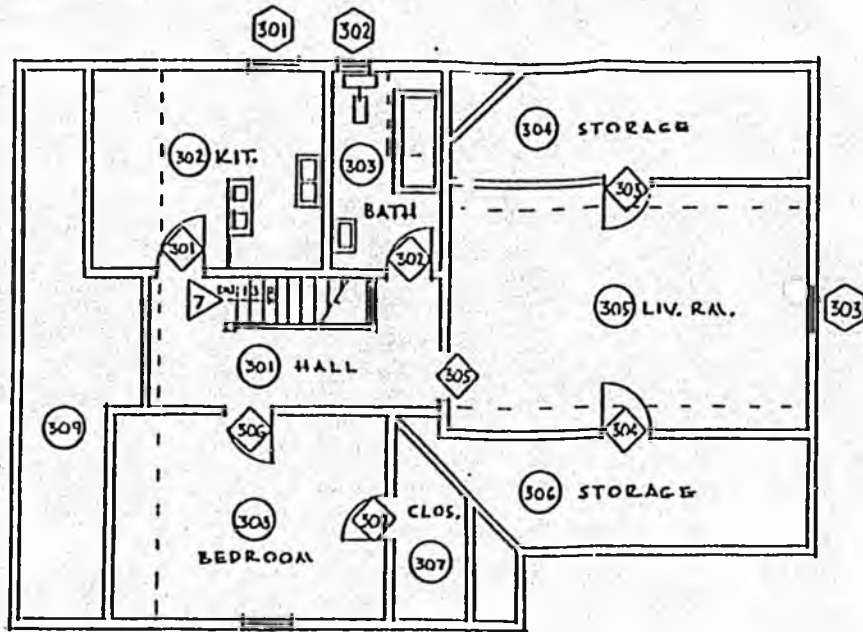
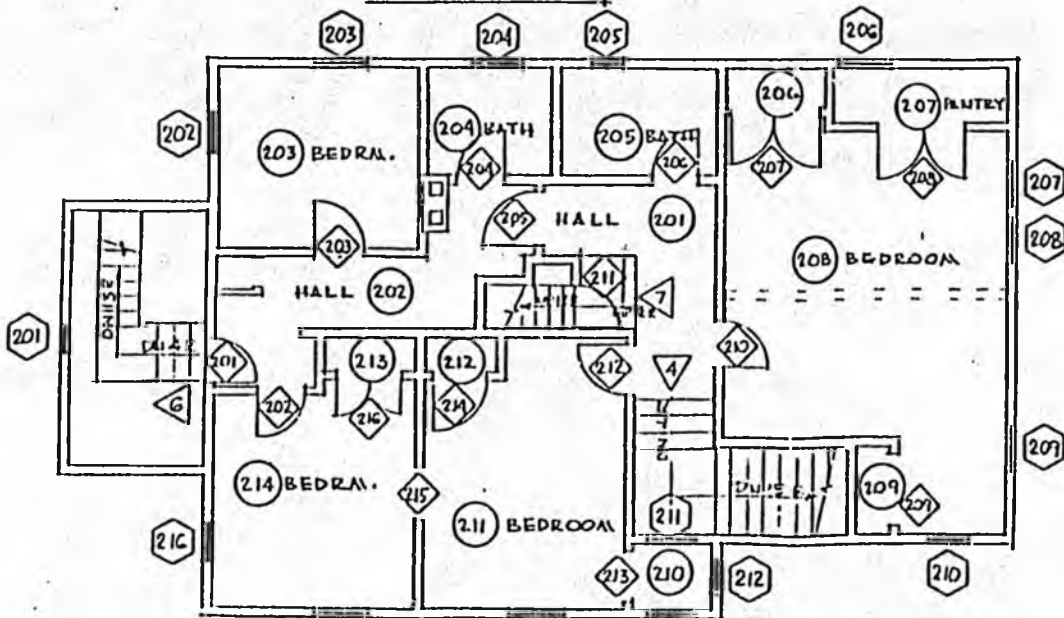
FLOOR PLANS  
(PRESENT CONFIGURATION)

Stair #2 enclosure. The partition separating bathroom #204 and hallway #202 appeared since 1912, as did doorway #205 separating hallway #202 from #201. The doorway, hall partition and landing at bottom of stair #7 are departures from the 1912 condition, and appear to have been in place for quite a while.

As dwelling space:  $640 \text{ net sq ft} / 300 = 2.13$ . Allowable occupant load = 2; second stair not required. Stair minimum width required is 30 inches, rise/run = 8 inches/9 inches. Existing stair #7 is 27 inches wide, less than minimum width; rise of 8 inches ok; tread run of  $8\frac{1}{2}$ " is less than required minimum. There is insufficient space to modify this stair to meet minimums, without severely impacting other aspects of the space. Recommend requesting waiver of requirement, with proviso of installing automatic fire suppression system.

Since modifications to door #201 and stair #6 would need to be extensive to achieve conformity, recommendation is to limit second floor occupancy to not more than 8 persons, and third floor to not more than 2 persons. These loads will not affect first floor at all, since egress is direct to porch via door #114.

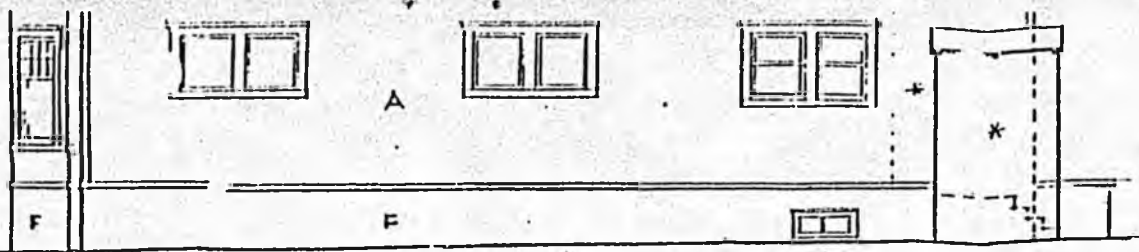
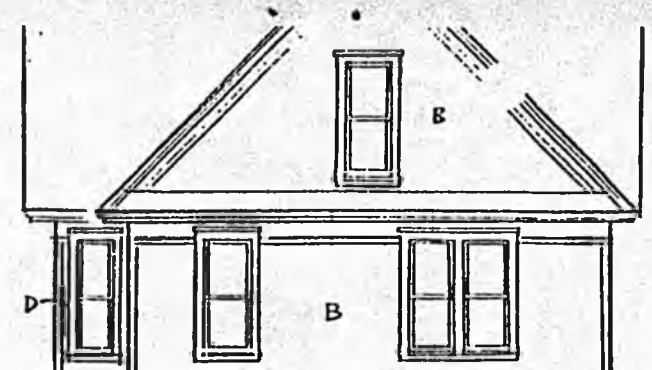
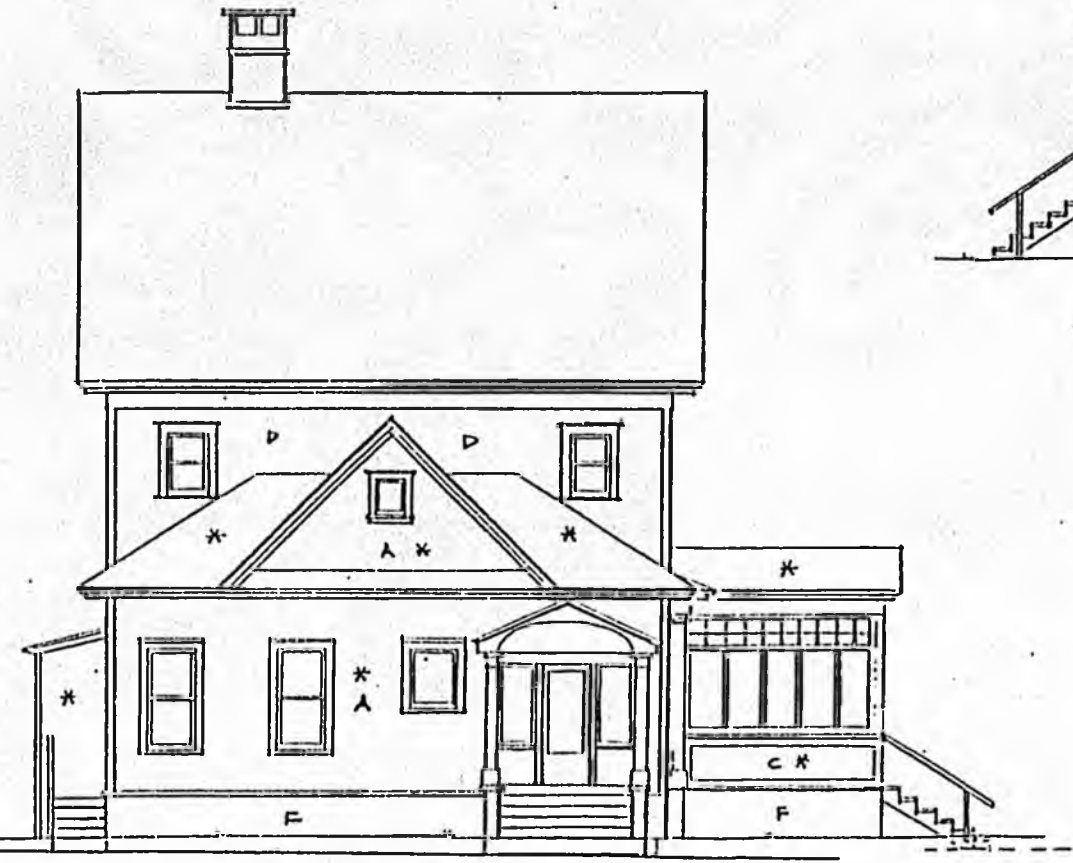
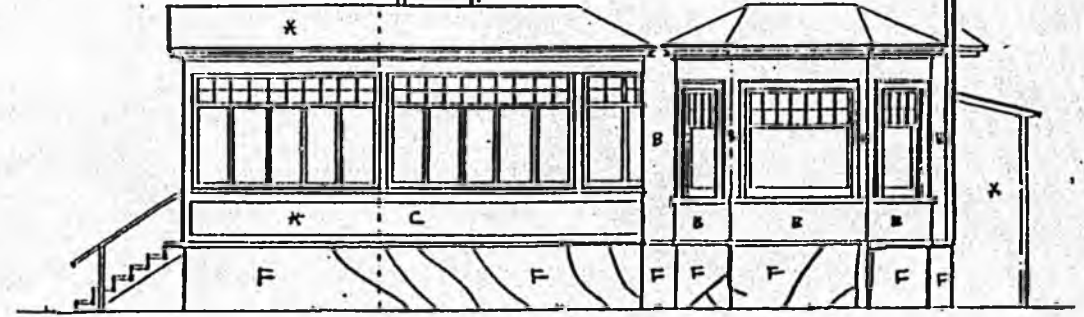
EXTERIOR ELEVATIONS  
(PRESENT CONFIGURATION)

Exterior siding is an assortment of lines and textures - original wood shingles in various patterns, original wood horizontal siding in bevelled shiplap pattern, and horizontal clapboard siding which is not original on north wall and probably not original on east or west walls. However, the north addition, dated ca. 1928, has probably acquired historical value of its own. Siding and exterior trim appear to be in very good condition, and no work in this area is anticipated.
