ALASKA LEGISLATURE COMMITTEE FILES 1987-1988 8672

5562 SSTA HB 167 (file 1)

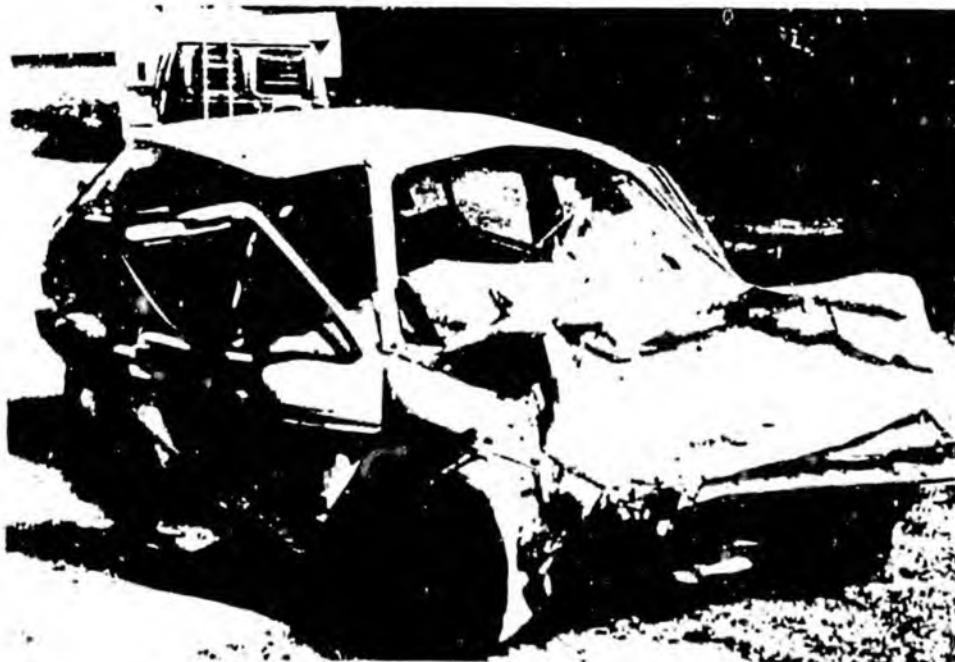
A 1979 VW Rabbit struck a 1977 Chevrolet Impala head-on. The Delta V for the VW was 35.5 mph, and for the Impala, about 23 mph. Both vehicles were substantially damaged, with rearward structural collapse reaching depths of 26 inches on the VW and 34 inches on the Chevrolet.

The unrestrained driver of the VW sustained fatal injuries. His lap/shoulder belted right front passenger escaped with only minor 1/ injuries. The lap belted right rear passenger received critical internal injuries, including ruptures of the aorta and colon, along with a fracture of his 3rd lumbar vertebra. The aorta damage required a 3-inch graft repair and the colon injury necessitated removal of more than 1 1/2 feet of damaged intestine. Injuries to the remaining three occupants of the VW's rear seat, all unbelted, were minor to moderate.

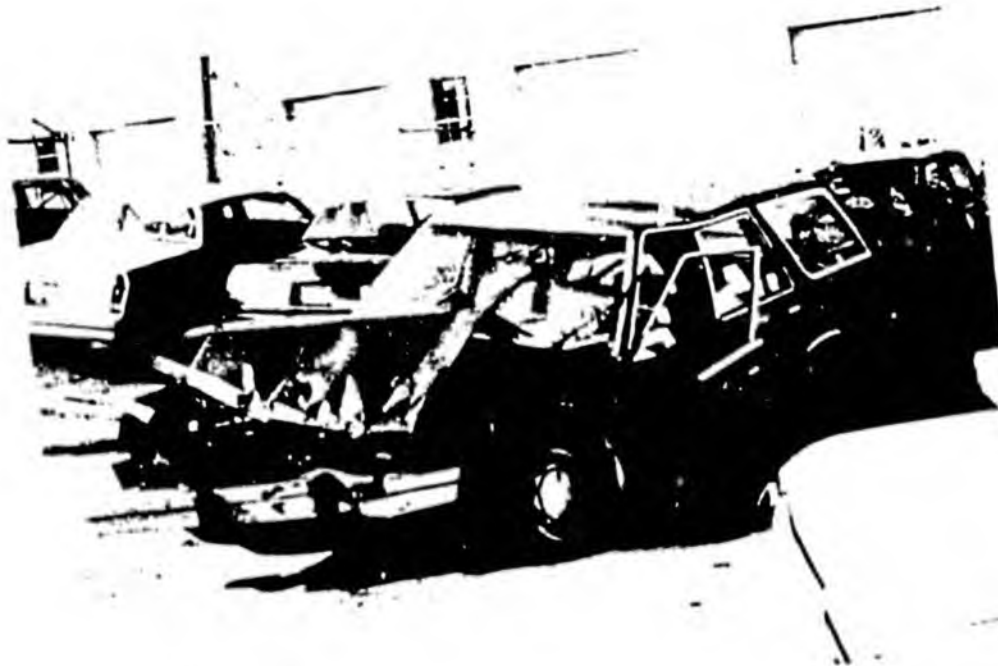
A 1981 Ford Fairmont station wagon was struck on the left front corner by the center front of a 1985 Buick Somerset Regal. Both vehicles received substantial front structural damage, with rearward collapse reaching over 30 inches at the Ford's left front and over 23 inches at the left side front of the Buick.

The collision resulted in moderate injuries to the Ford's driver and right front passenger. The lap belted left rear Ford occupant sustained serious injuries, including a severely avulsed small bowel mesentery which required a resection of more than 30 inches, due to multiple areas of torn mesentery. The right rear occupant suffered multiple fractures of the lumbar vertebrae. Injuries sustained by the Buick driver were moderate.

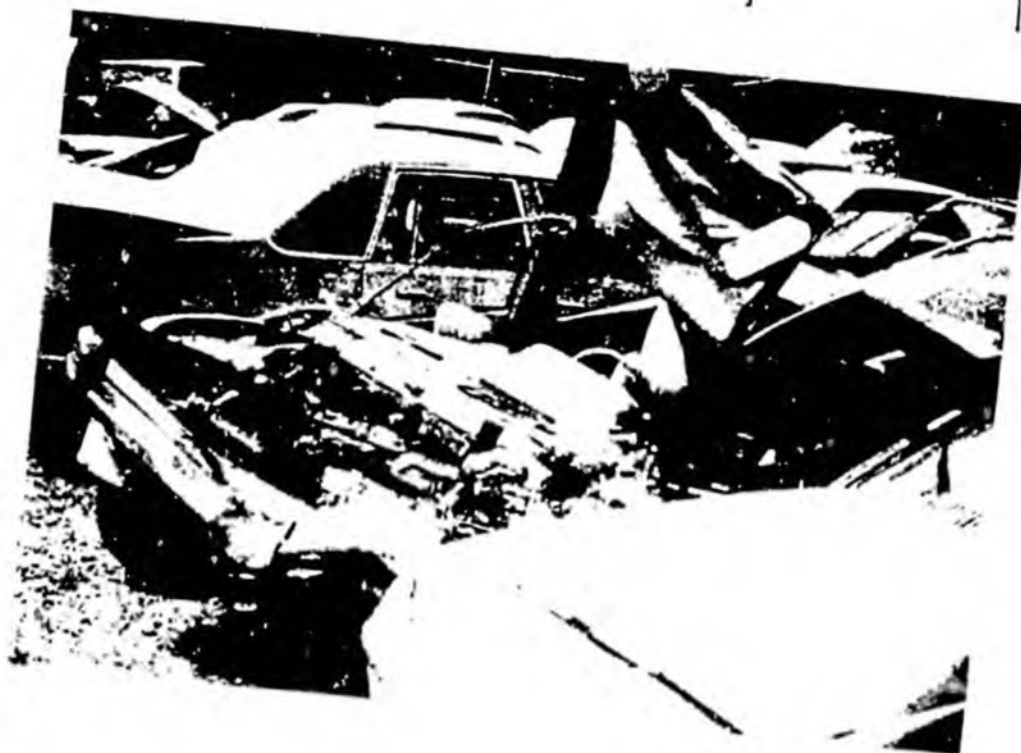
1974 IH tractor-trailer

A 1985 Ford Escort struck, center front to left front corner, a 1974 International Harvester semi-truck and trailer. The collision forces completely destroyed the front structure of the Escort, with rearward structural collapse reaching 29 inches at the left front.

The Ford Escort was driven by an unrestrained 16-year-old girl. An unrestrained 15-year-old girl was the right front passenger, a 14-year-old boy was lap belted left rear, and an 11-year-old boy was lap belted in the right rear position. The driver sustained minor abrasions, lacerations, and contusions, deep lacerations of the lower extremities, and an open fracture of the left femur. The right front occupant sustained similar injuries. Both lap belted rear seat passengers sustained massive internal injuries, including torn and avulsed mesentery, avulsed and ruptured intestines, and substantial blood loss. In addition, the 11-year-old boy in the right rear received a lap belt induced fracture of the spinal column, which rendered him paraplegic. The 14-year-old boy in the left rear seat died as a result of his lap belt induced internal injuries before medical treatment could provide repair.

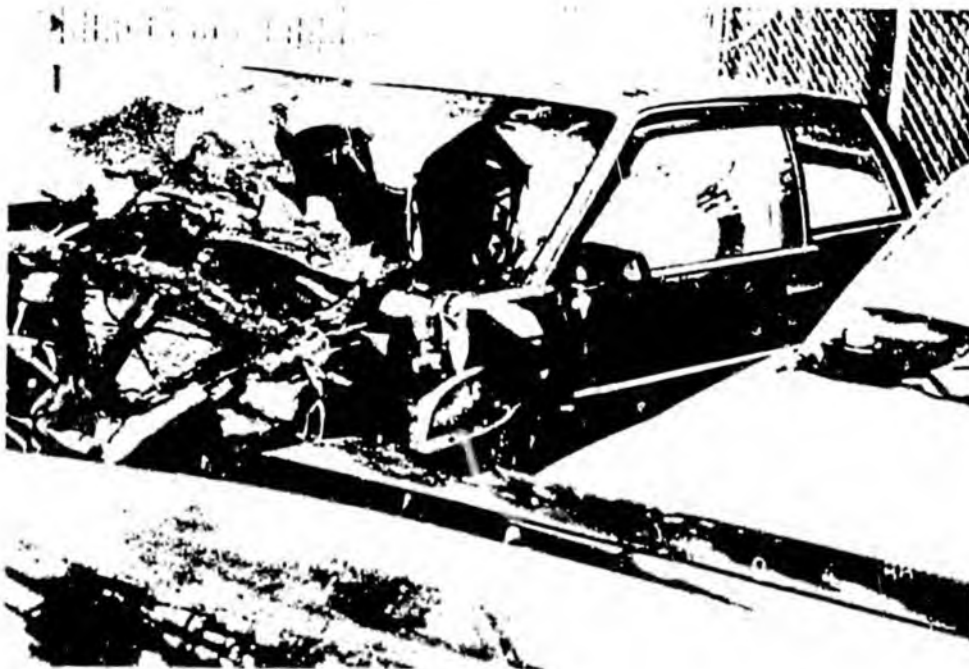
CASE 28 (SEA-86-H-OR04)

A 1982 Buick Century struck front first into the left front of a GMC delivery truck. The Buick was driven by a 72-year-old man wearing a lap/shoulder belt. The right front passenger was a 76-year-old man also wearing a lap/shoulder belt; the left rear passenger was a 75-year-old woman wearing a lap belt; and the right passenger was a 64-year-old woman, also wearing a lap belt.

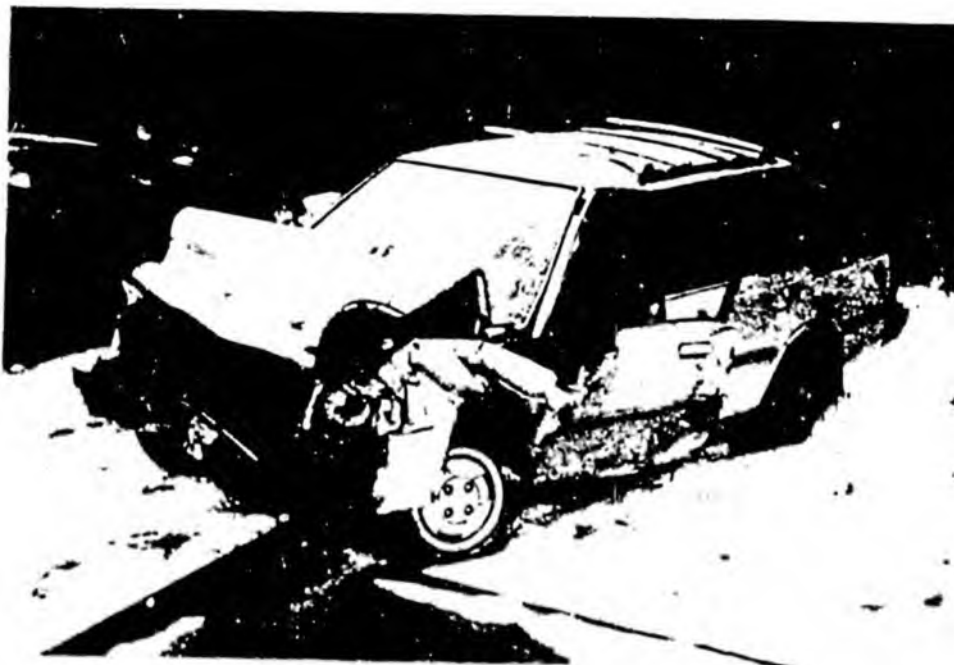
CASE 30 (NYC-85-H-OR04)

A 1985 Dodge Daytona 2-door sedan slid broadside into the front of a 1984 Nissan Sentra station wagon. The Dodge was driven by an unrestrained 20-year-old man; in the right front seat was an unrestrained 19-year-old man. The Nissan was occupied by a 33-year-old male driver and his 29-year-old wife, both of whom were using 3-point lap/shoulder belts; in the rear center seat was their 5-month-old boy in a child safety seat, and in the right rear seat was their 6-year-old daughter, using a lap belt.
