ALASKA LEGISLATIVE COMMITTEES, 2009-2010 / 2009-2010  
11951 SENATE RESOURCES

**Comments by Steve Marshall  
President, BP Exploration (Alaska) Inc.  
To the Joint Alaska Senate and House Resources Committee  
August 18, 2006**

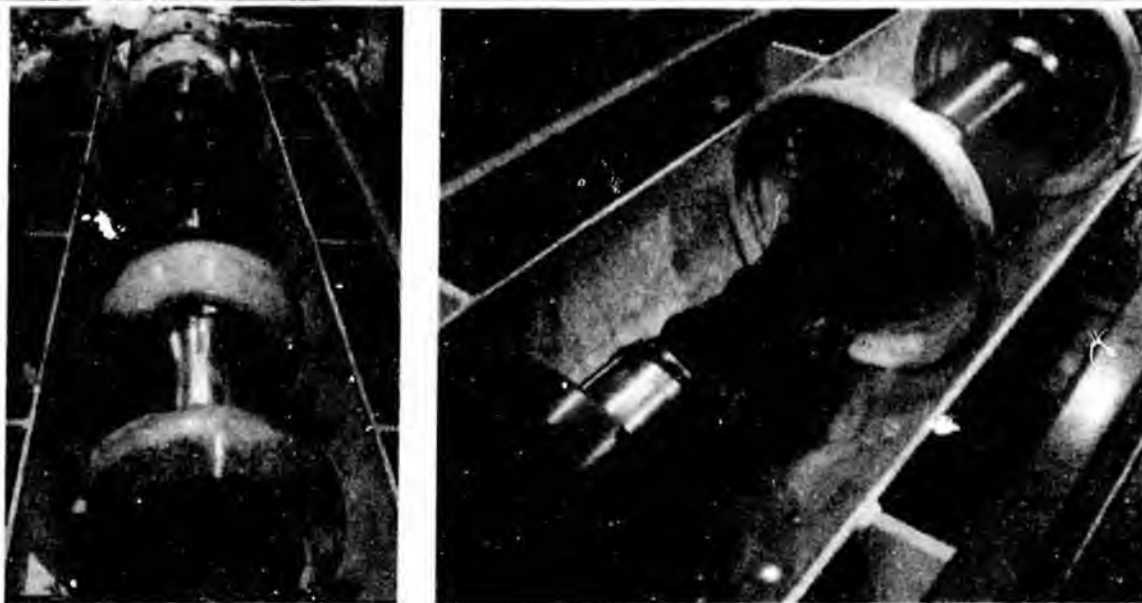
*In-line inspection tools known as smart pigs are used to detect pipeline defects such as metal loss due to corrosion. The compliance oversight team lead observed smart pigging operations using this smart pig in the Alpine Oil Pipeline in June 2005.*

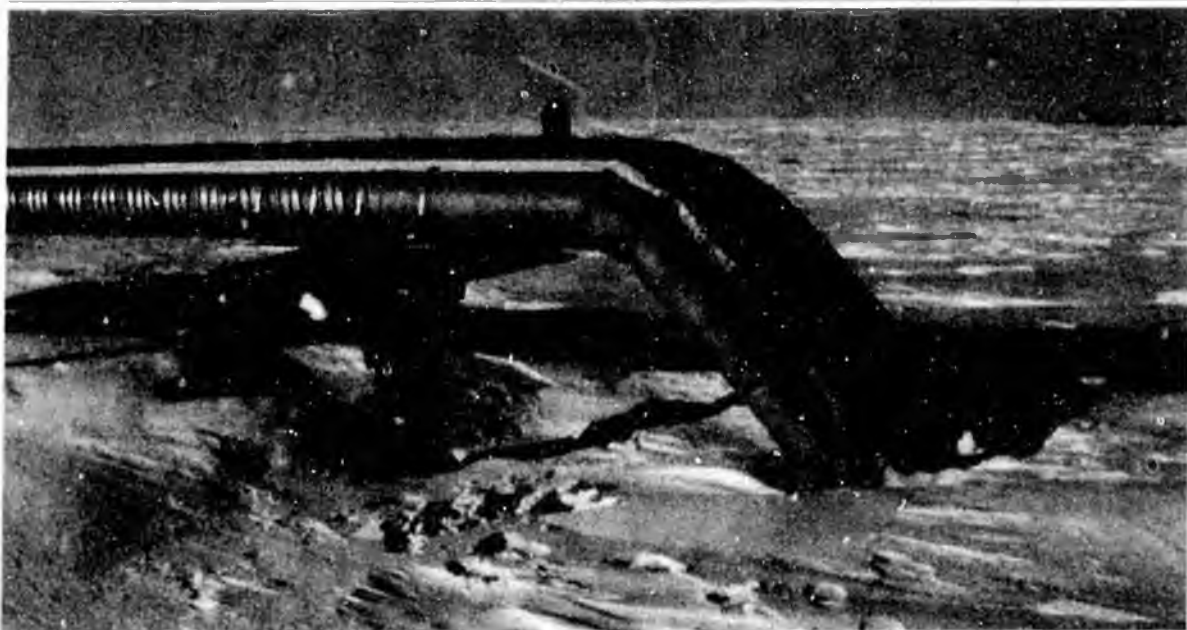
*The Milne Point Oil (rear) and Products (front) pipelines connect the Milne Point Development, east of Prudhoe Bay, to the Kuparuk and Oliktok Pipeline Systems, respectively, approximately 10 miles to the south.*

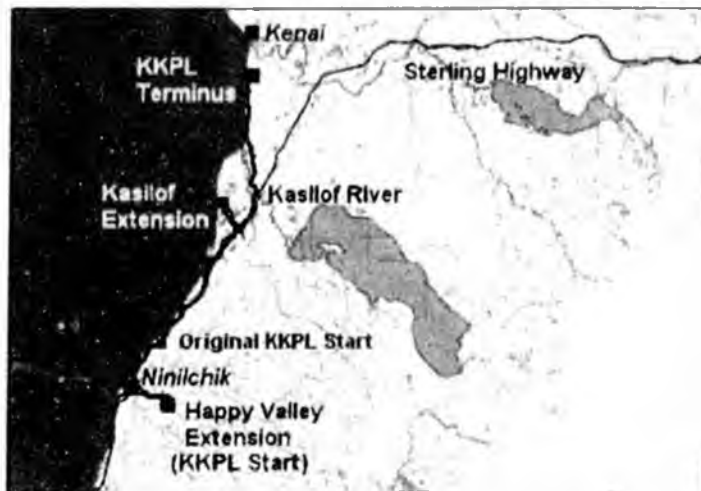
*The Kenai Kachemak Pipeline transports natural gas on the Kenai Peninsula.*

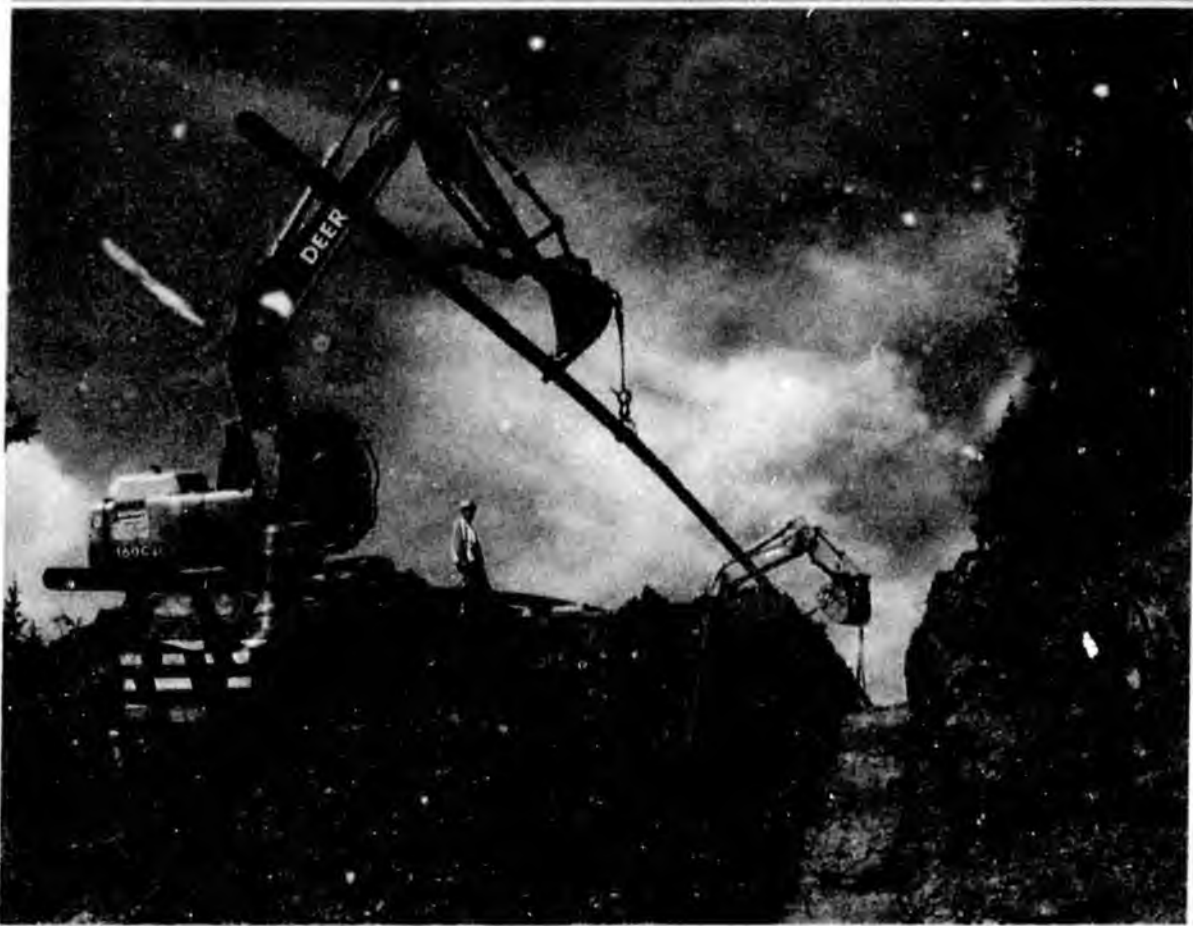
*In summer 2006, construction is in progress on the 4.2-mile Kasilof Extension to the KKPL. This picture shows a segment of pipeline being placed in the newly-dug trench.*

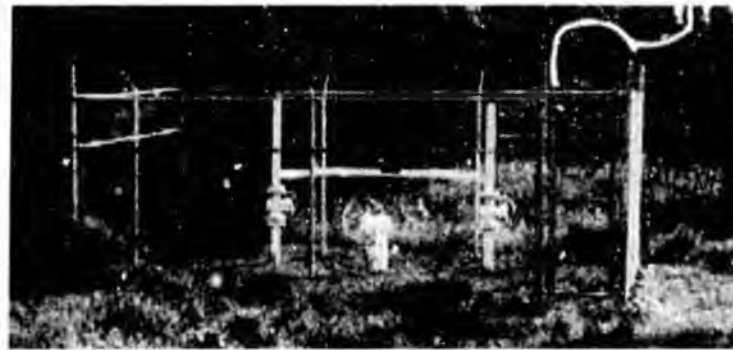
*The KKPL valves are enclosed in fencing, locked, and marked with warning signs to inform the public and protect equipment.*

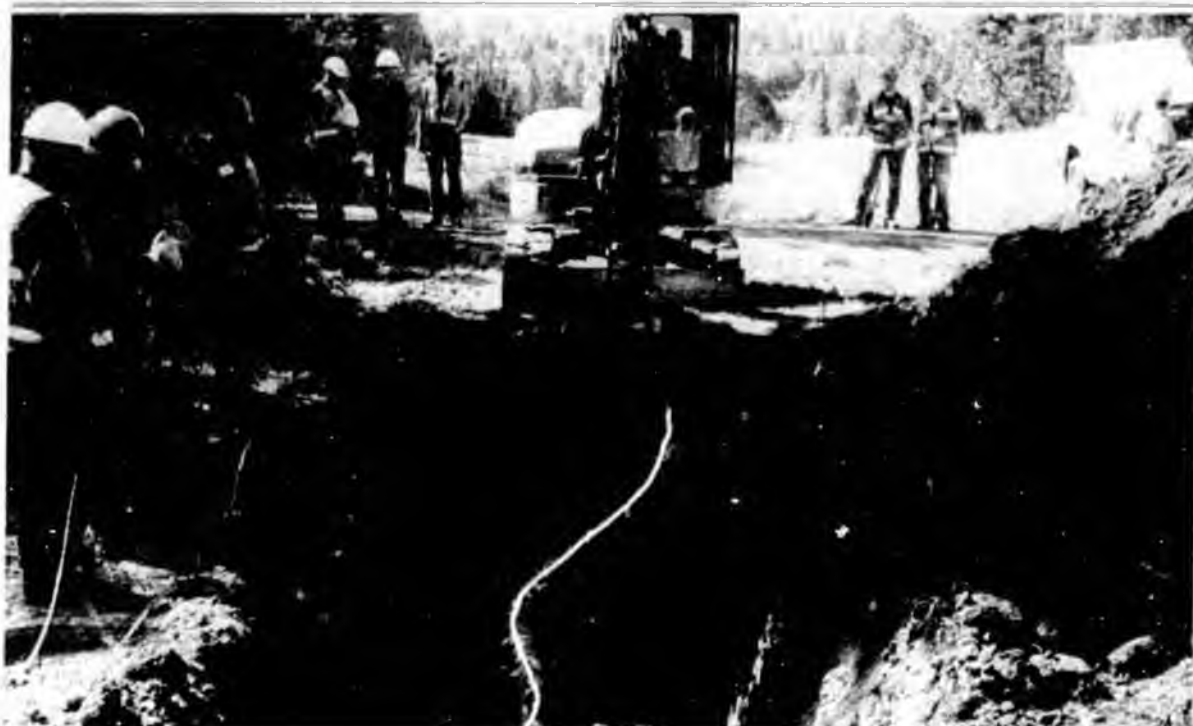
*In July, 2005, the compliance oversight team observed a pipeline integrity dig at a potential external wall loss location identified in an in-line inspection run. No anomaly was found*

*Anomaly Dig:* On June 15, 2005, the team observed a pipeline excavation taking place east of the Sterling Highway and south of Fleetwood Avenue. A magnetic flux leakage in-line inspection had identified an anomaly described as external wall loss of approximately 19%, with a potential instrument error of + or - 10%. Due to the error in ILI measurements and the potential to recover contractor warranty costs, KKPL decided to excavate and examine the anomaly location. When the surveillance team arrived on site, a contractor had largely completed the excavation process. The team reported that an excavator dug a 45-foot by 6-foot trench and workers used hand shovels to complete final exposure of the pipe. The surveillance team observed contractors searching for the anomaly location on a five-foot section of pipe. No anomaly was found. Upon completion of the inspection, the pipe was re-coated and re-buried. To follow up, the pipeline operator sent the SPCO a "KKPL Anomaly Inspection Report" on July 22, 2005. The surveillance team completed reports ANC-05-S-049 through 052, all of which noted satisfactory conditions.

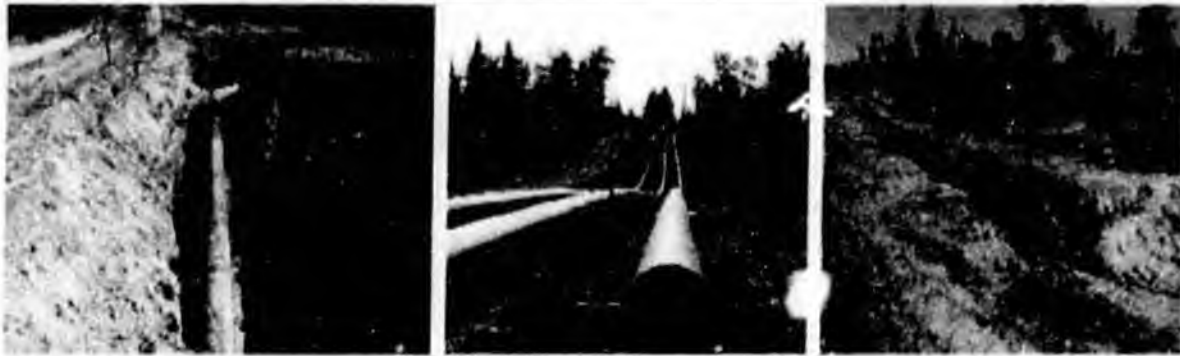
These three photos were taken on SPCO surveillance during 2004 construction of the Happy Valley Extension. From left to right: pipe laid in trench; pipe welded together for placement in trench; pipe ready for placement in trench.

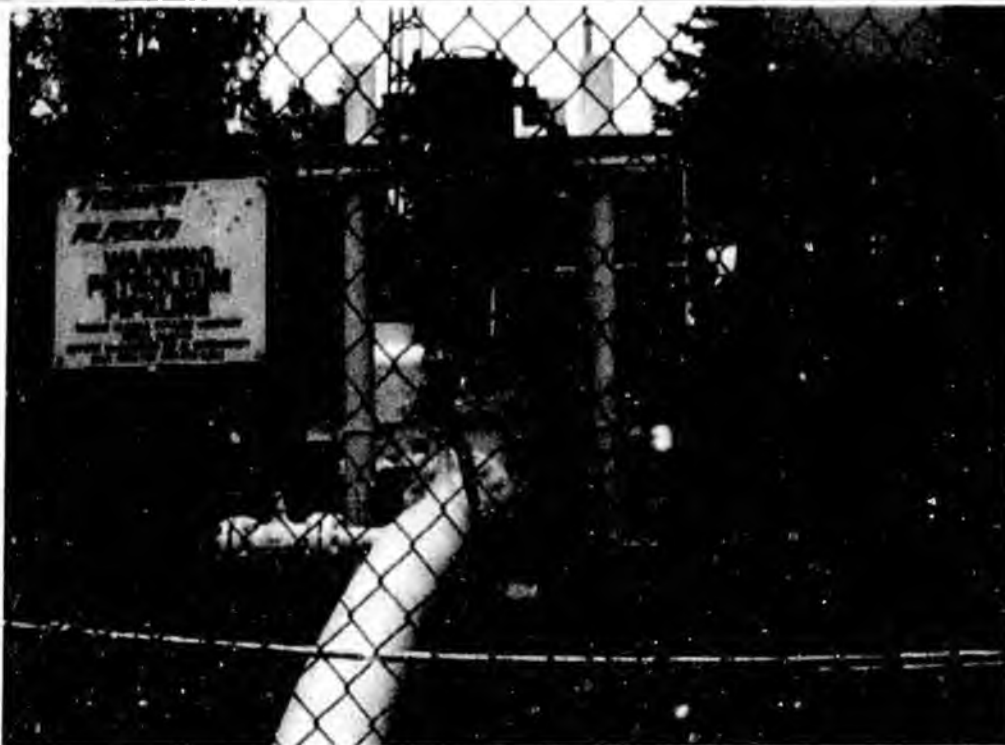
*This photo is of a remotely-operated valve on the Nikiski Alaska Pipeline near Point Possession. Solar panels and propane provide energy for the valve and cathodic protection system.*

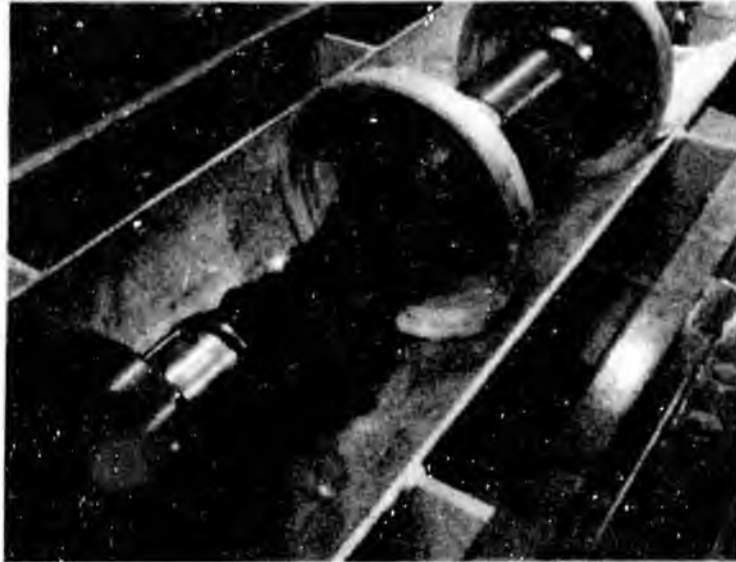
*This smart pig was used in June 2005 to detect pipeline conditions in the Alpine Oil Pipeline. The lease compliance oversight team witnessed retrieval of the pig at Kuparuk.*

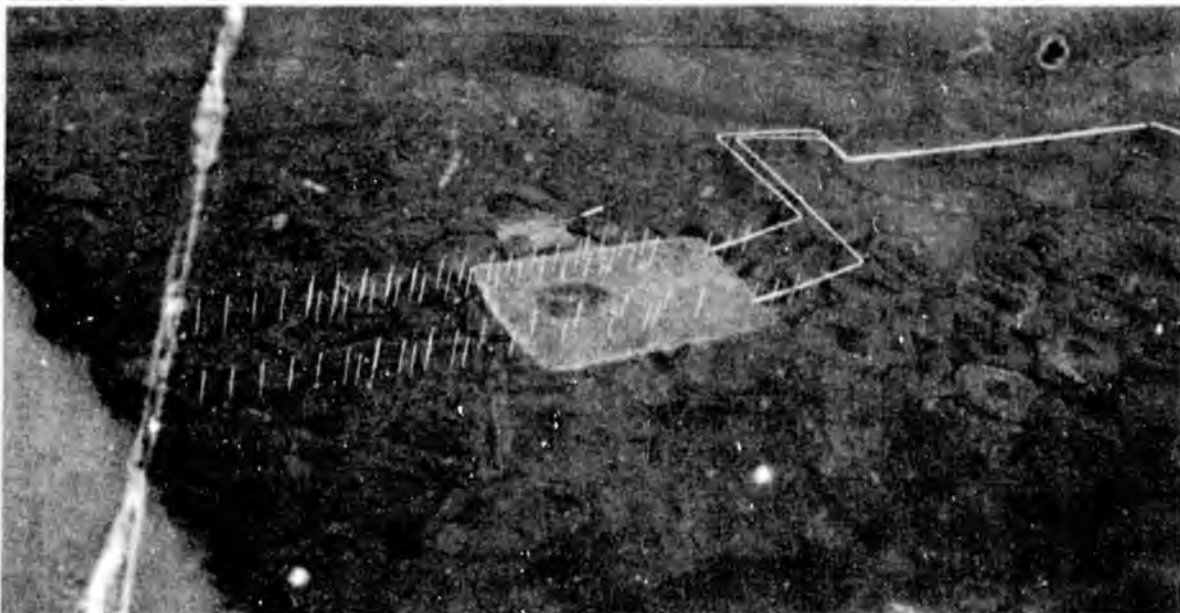
*Aerial photo of the transition between below-ground pipe (in steel casing) and above-ground pipe at the East Bank of the Colville River HDD site.*

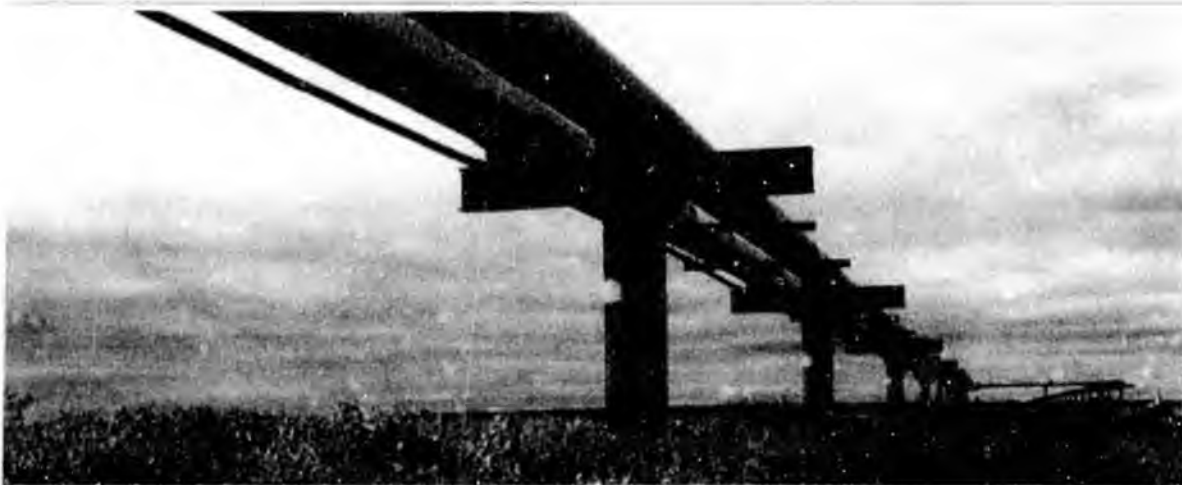
*VSMs for the Alpine pipelines are marked with reflector tape for public safety.*

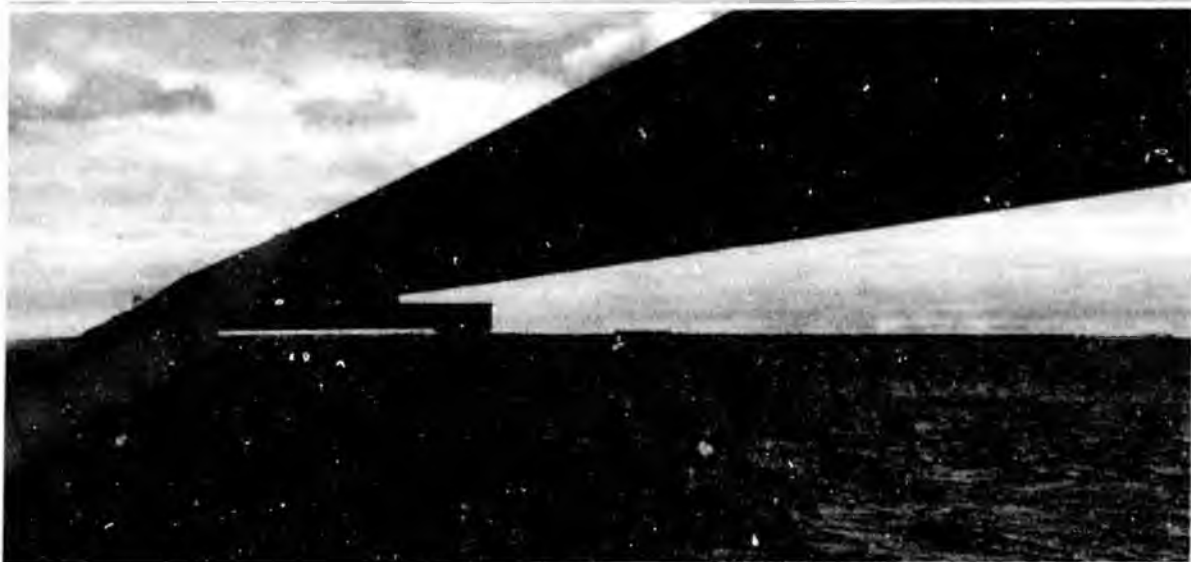
*Here the Kuparuk and Oliktok Pipelines are depicted crossing tundra. The Kuparuk and Oliktok ROWs parallel Spine Road (out of frame) through this area.*
