ALASKA STATE LIBRARY COMMISSION, 2005-2006 00/2

11952 SENATE RESOURCES

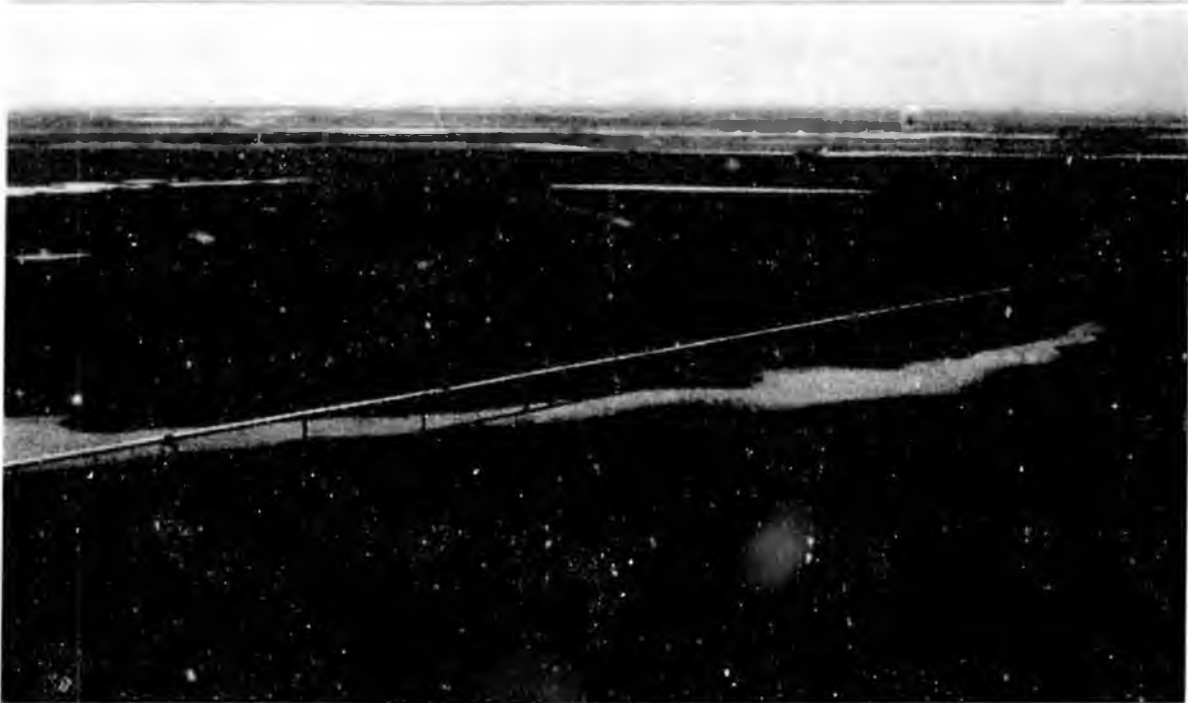
The Badami pipelines cross were built "roadless" to prevent damage to tundra.

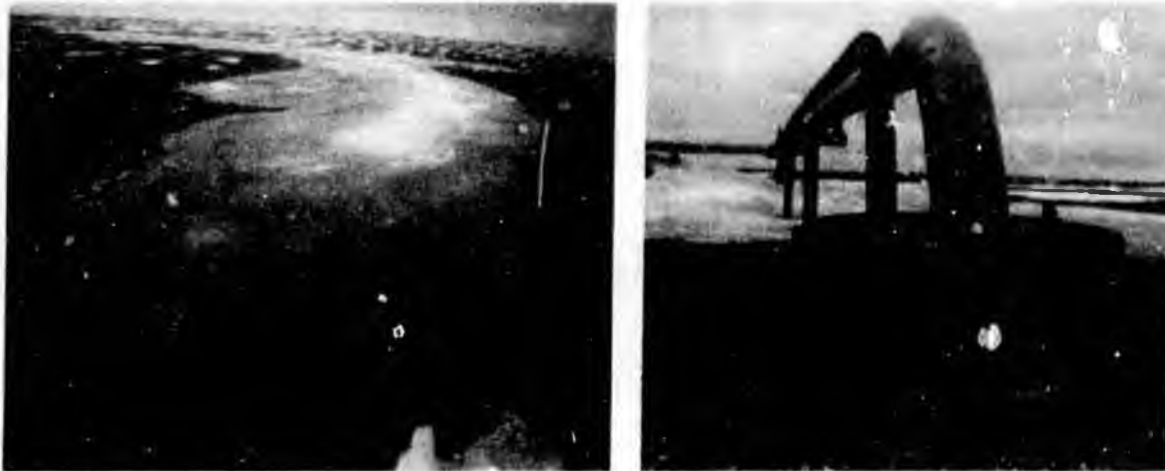
Left: Aerial view of the oxbow lake that the Badami weir protects. This lake is connected to a wetland system which extends for at least one mile to the south. Right: the Badami pipelines transition underground approximately 30 feet west of the weir.

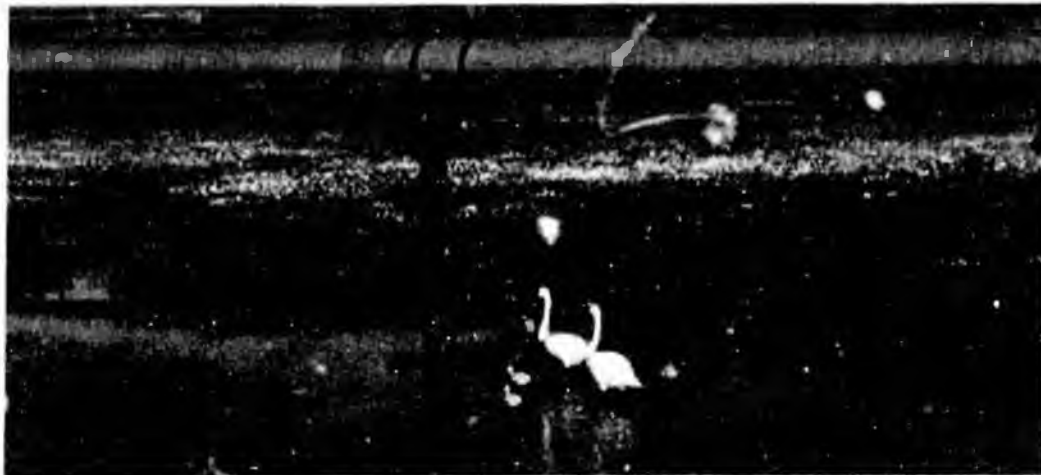
The Endicott Pipeline passes through important tundra and wetland habitats. Here a pair of swans and their three young are using wetlands next to the pipeline. The smaller pipeline in front is the Badami Utility Pipeline, which is on the same supports as the Endicott Pipeline from Endicott to the Badami/Endicott tie-in.

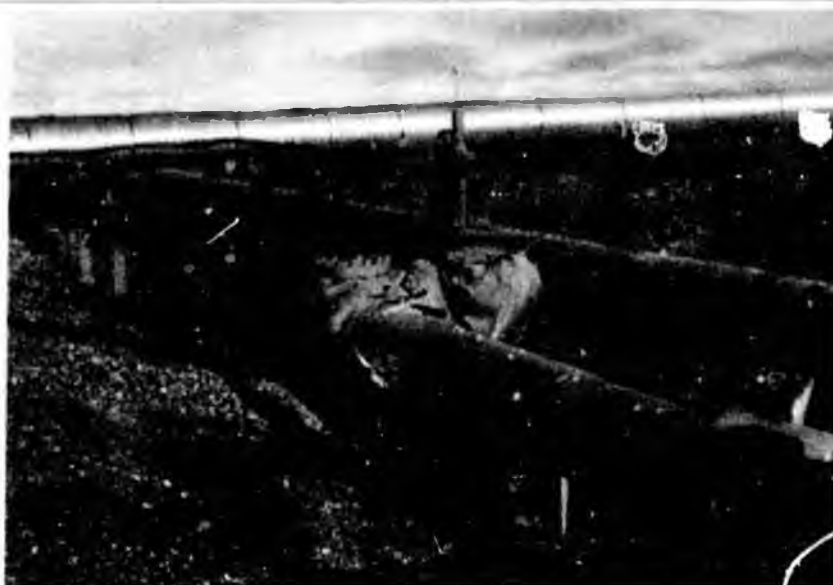
This photo shows the location where the Badami Oil Pipeline (above) ties into the Endicott Pipeline. The Badami pig receiver is visible just left of the Endicott Pipeline (right).

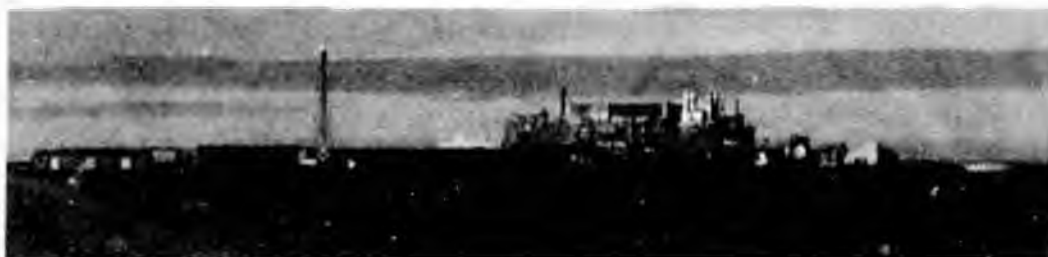
The Endicott Main Production Island is a man-made drilling island in 14-foot deep water connected to shore by a causeway with breaching structures. Endicott was the world's first arctic offshore production facility and the first model of the oil industry's "reduced footprint." Endicott's footprint was 70% smaller than the traditional pad at the time. Current daily production from Endicott is approximately 25,000 barrels per day, compared to the peak production of 115,000 bpd in late 1987. (Source: BP Alaska website, accessed October 2005.)

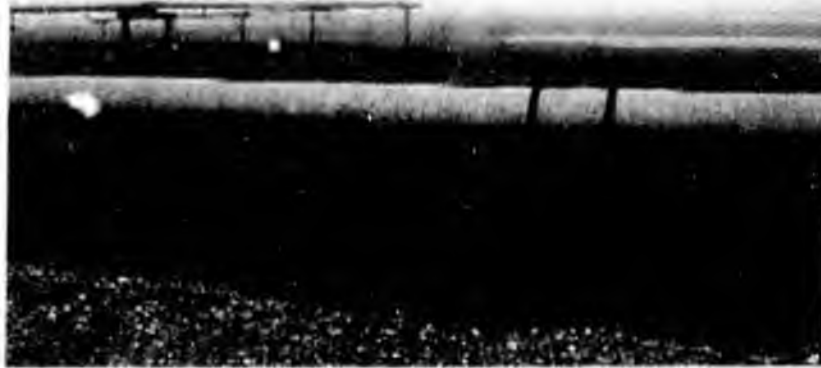
View of typical Endicott Pipeline ROW. In the foreground, there is a saddle location (where the pipeline is held by the horizontal and vertical supports).

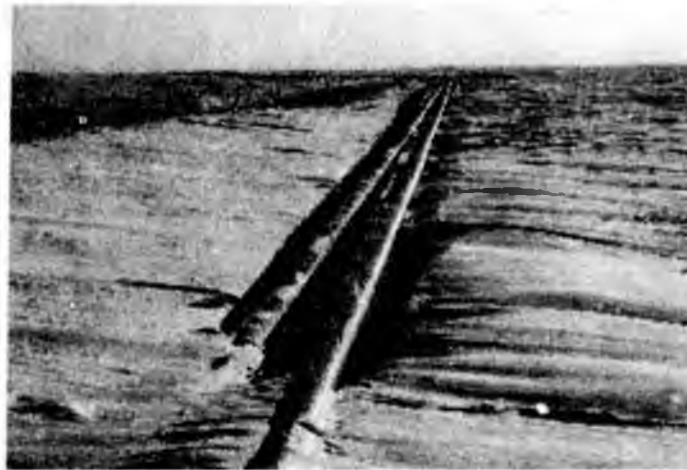
Winter view of the Milne Point Pipelines looking South from the "S" Pad intersection.

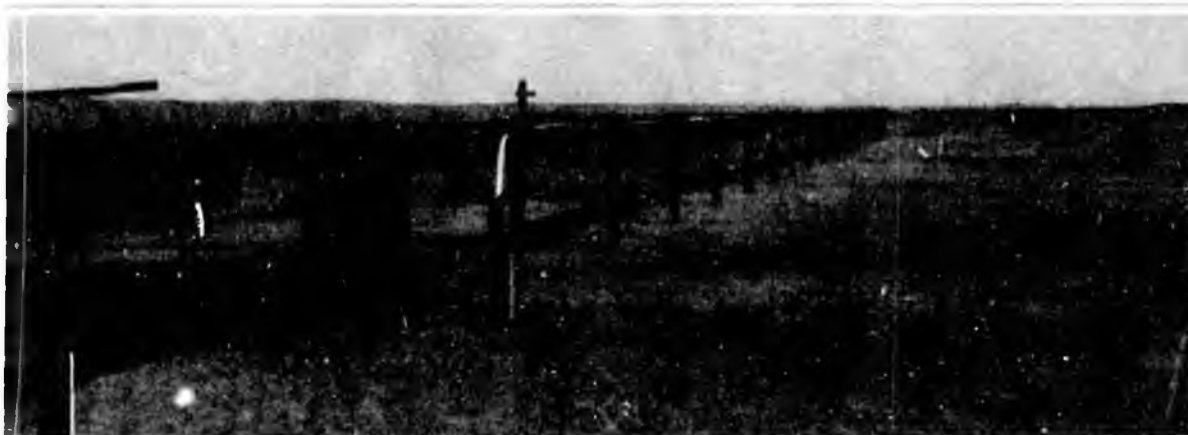
This photo was taken from the west bank of the main channel of the Colville River. Here the NNGP (yellow) diverges from the Alpine Pipelines and transitions underground towards Nuiqsut.

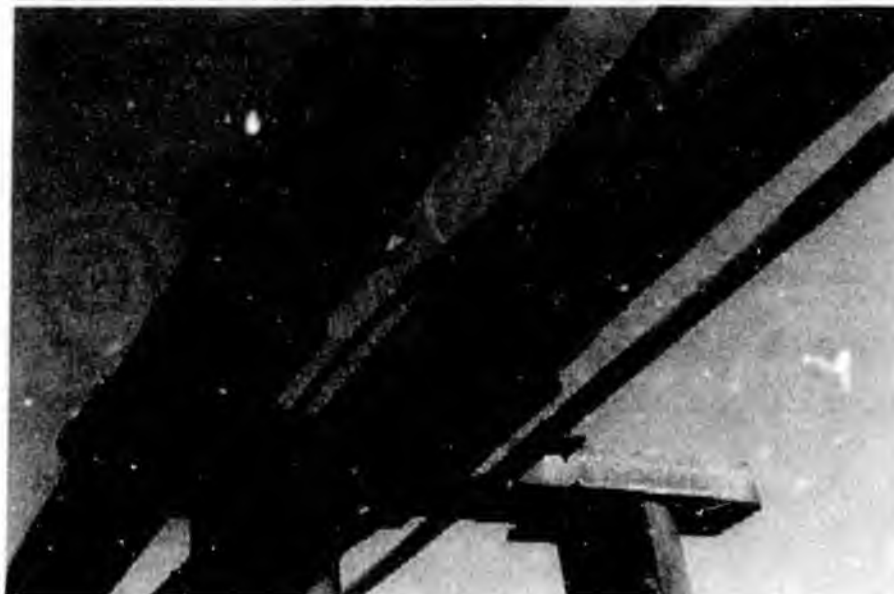
This photo depicts the Alpine and Nuiqsut Pipelines sharing vertical and horizontal supports. From left to right: Alpine Diesel, Utility, Sales Oil, and NNGP (yellow). A fiber optic cable associated with the Alpine Development is in the center.
