11960 SENATE RESOURCES

## Commitment to Corrosion Monitoring Year 2004

## Commitment to Corrosion Monitoring Year 2005

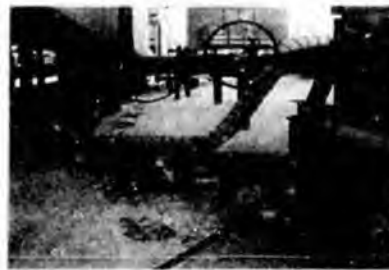
### ▶ Well line 17-14

- ▶▶ Apr-04 leak detected
- ▶▶ 3-phase production
- ▶▶ External corrosion (CUI)
- ▶▶ 5 gallon spill
- ▶▶ Section Replaced

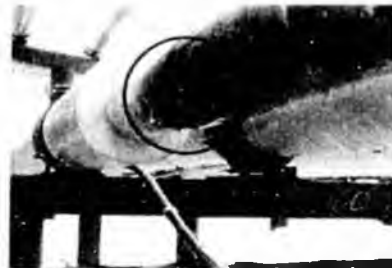
### ▶ Well Line M-13

- ▶▶ May-04 leak detected
- ▶▶ Produced Water
- ▶▶ Freeze rupture
- ▶▶ 20 gallon spill
- ▶▶ Currently not in service

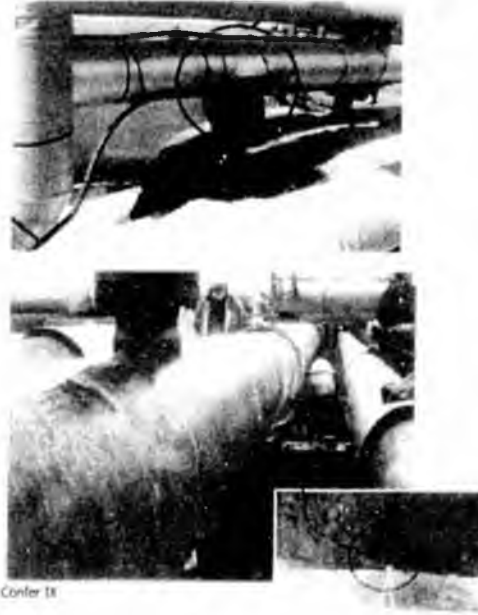
- ▶ **DS04 PW Divert**
  - ▶▶ Jun-04 leak detected
  - ▶▶ Internal corrosion (D/L)
  - ▶▶ 30 gallon spill
  - ▶▶ Section Replaced

- ▶ **Flow line 06C/13B**
  - ▶▶ Sep-04 leak detected
  - ▶▶ 3-phase production
  - ▶▶ External Corrosion (CUI)
  - ▶▶ 153 gallon spill
  - ▶▶ Sleeve Repair

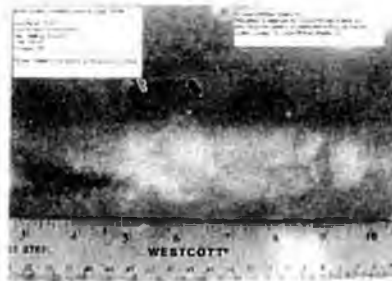
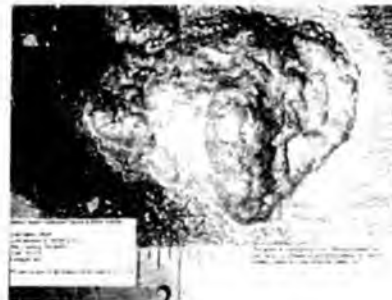
6" 2KWI Injection water Line Leak 3/26/2005

- On 3/26/05 At ~10:45 AM, a leak from a  $\frac{1}{8}$  inch X  $\frac{1}{4}$  hole was discovered on the below-grade section of a six-inch Cross-Country Water Injection line located at the DS2H pad.
- The leak was discovered during a routine corrosion survey.
- Estimated 1,219 Bbl of a mixture of produced water and sea water was spilled, contacting an area of tundra approximately two acres in size.

- After commencing operation of this line in 1989, the initial inspection of this line took place in 2001 when a 5% RTR inspection (463') was completed. Nine of the twelve segments inspected had no damage. Widely scattered internal pitting was noted in three segments. Worst case damage was 17% wall loss. A below grade piping long range inspection for external corrosion on this line was completed by Profile Technology Inc. (PTI) in July of 2001. No indications were reported.
- In the period between 2001 and the time of the leak, seven recurring manual inspections (at three locations) were performed on this line with minor increases and worst case damage of 35% wall loss by RT.
- In 2005, another 5% RTR inspection (614') was conducted. Widely scattered internal pitting was discovered in all 16 segments inspected with a worst case damage of 29% wall loss.

- All below grade pipe at 2H pad has been recovered and replaced.
- Spill clean up is complete.
- 100% inspection of the line between 2H and 2K is in progress. Estimated completion date is May 5th, 2005. To date, four areas have been identified for sleeve repairs.
- A Root Cause Failure Analysis (RCFA) commenced April 27<sup>th</sup> and is expected to take 8-10 weeks to complete.

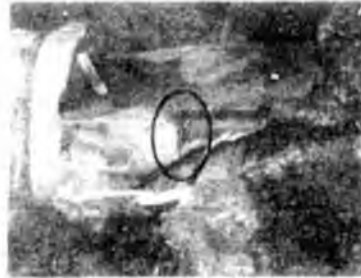
### ▶ DS14 – 6" Warm-up gas

- ▶ Leak detected - April
- ▶ SW Injector
- ▶ Low cycle fatigue @ weld
- ▶ 500 – 1,000 gallon spill
- ▶ Segment isolated
  - Cut-out and blinded

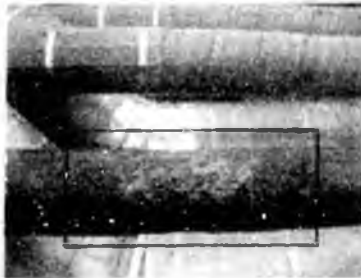
### ▶ DS16 – 3" 16/17AL

- ▶ Leak detected - July
- ▶ Gas lift
- ▶ External corrosion @ weld pack
- ▶ Small gas release
  - Isolated – No repair to date
