**ADEC Corrosion Charter  
Meet & Confer - Field Visit 2005  
September 27 – 29, 2004**

## Commitment to Corrosion Monitoring Year 2005

**BP Exploration Alaska  
Commitment to Corrosion Monitoring  
Annual Reports 2000 – 2005**

**Commitment to Corrosion Monitoring  
Year 2000**

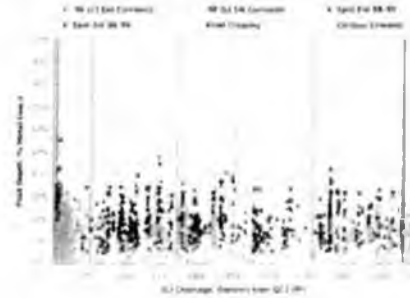
### OT-21, 1998 ILI & Verification

- ▶ Corrosion degradation after ~21 years
  - Moderate internal and external corrosion damage. Pipe FFS

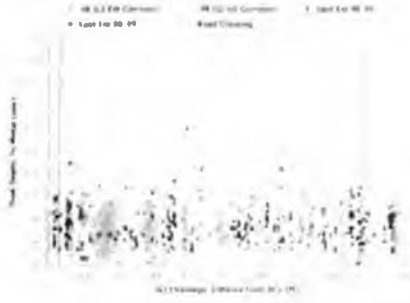
### OT-13, 1998 ILI & Verification

- ▶ Corrosion degradation after ~21 years
  - Moderate internal and external, slightly better than 2.1 segment

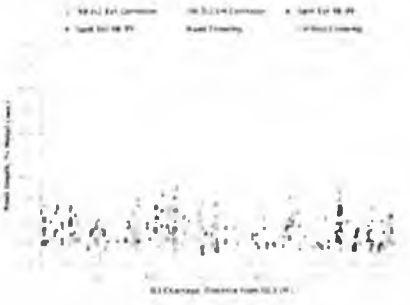
### OT-31, 1998 ILI & Verification

- ▶ Corrosion degradation after ~21 years
  - Moderate corrosion, progressively less than upstream

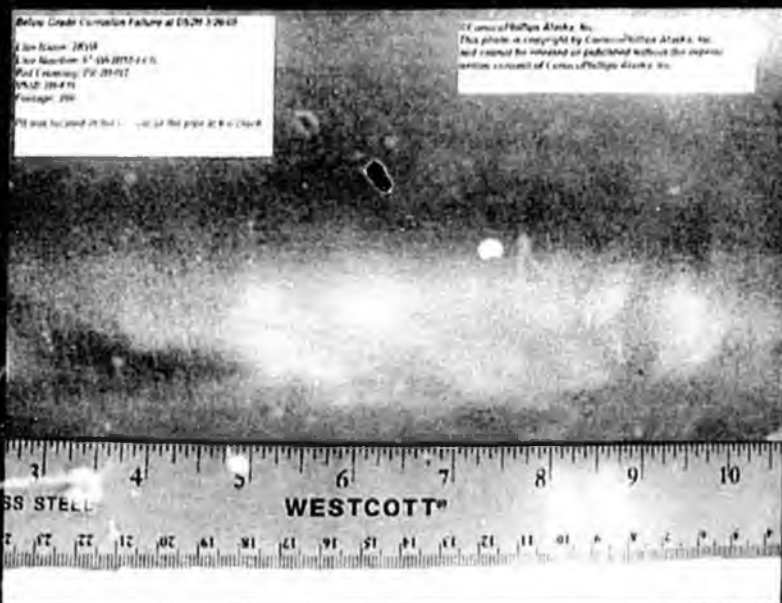
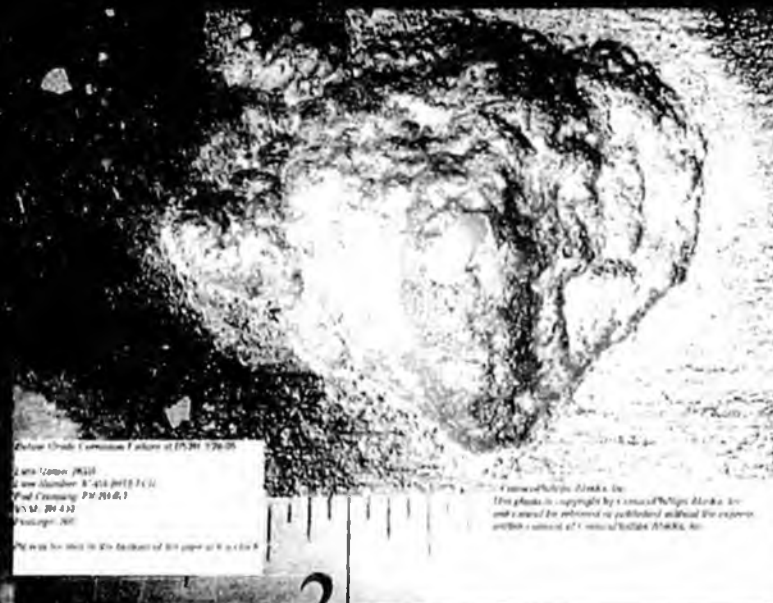
- On 3/26/05 At ~10:45 AM, a leak from a 1/4 inch X 1/4 hole was discovered on the below-grade section of a 6" CC WI line at DS2H pad.
- The leak was discovered during a routine corrosion survey.
- Original estimate of **113,000 gallons**, eventually revised to 51,198 gallons. The approx. 2-acre spill was a mixture of PW and SW.

- Line put in WI service in 1989
- Initial inspection in 2001 w/ 5% RTR (463') showed 9 of 12 segments had no damage. Scattered internal pitting in 3 segments - 17% wall loss max.
- Below grade long range inspection for external corrosion on this line by Profile Technology Inc. (PTI) in July of 2001; no indications.
- Between 2001 and the time of the leak, 7 recurs by manual inspections at 3 locations showed minor increases and 35% max. wall loss by RT.
- In 2005, another 5% RTR inspection (614') showed widely scattered internal pitting in all 16 segments inspected with 29% max. wall loss.

- Commingling of PW & SW caused additional solids deposition and rendered corrosion inhibition less effective
- Coupon mpy rates increased post 2000 due to the above
- Under-deposit/MIC corrosion accelerated due to nutrients from SW/PW
- Maintenance pigging ineffective in removing solids
- The line was subject to low flow velocities

- Fourteen Near, Medium and Long-term recommendations from Physical Cause Analysis under various stages of implementation
- Commingling of PW & SW at CPF2 is suspended; plans to commingle at CPF3 is now on HOLD
- More aggressive maintenance pigging with disk-brush-disk combo in operation; pigging returns (TSS) monitored
- Risk-based inspection protocols further strengthened with more frequent interval inspections
- TWI technique for internal & external long range inspection prioritized field-wide
- Recent data indicate lines are 'cleaning up' and corrosion rates have receded

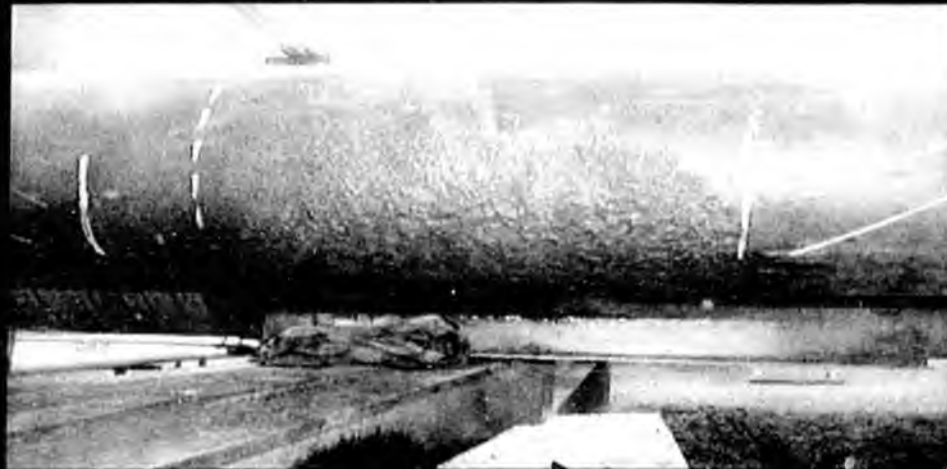
- 3JPO 12" CC line leaked on 10/26/2005 at saddle weld-pack - external corrosion
- Leaks at 10 O'clock position on line – corrosion was 360 degrees around
- Weld-pack previously inspected 12/2001 - no corrosion or water detected
- This weld-pack was not scheduled for re-inspection under the existing CC line interval inspection program.
- TRT Program Guidelines changed – Require Top and Bottom inspection over entire CUI length when medium wet or damaged insulation – An increased CUI inspection frequency has been proposed

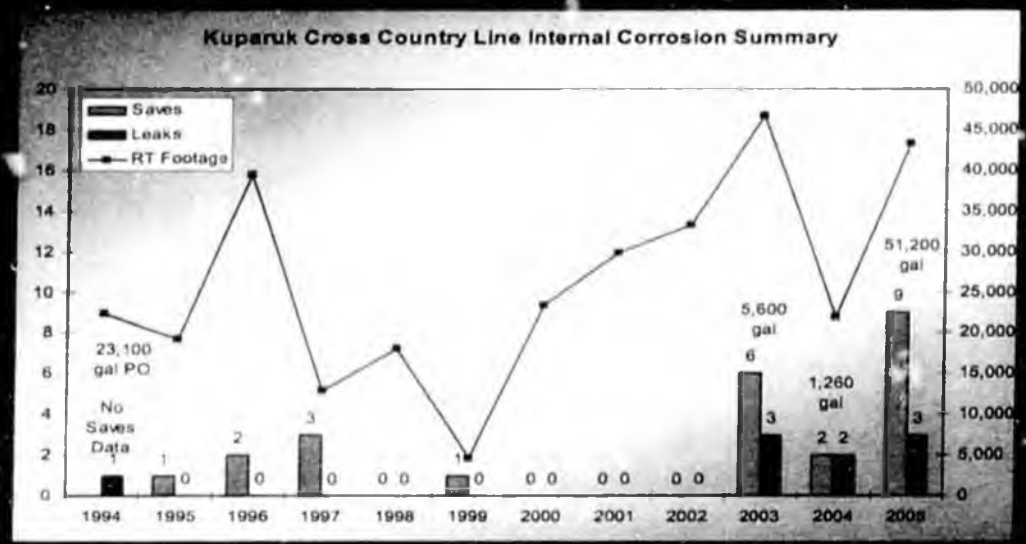
Number of Leaks & Saves

- ✓ Completed all 2005 goals except for 30" SWI Line Smart Pig.
- ✓ Over 43,000 ft over 160 lines inspected (RTR and RT)
- ✓ Completed baseline survey of on-pad deadlegs.
- ✓ 3 Leaks (1 water injection, 2 production), 9 Saves (5 WI, 4 PO). WI leak caused by MIC.

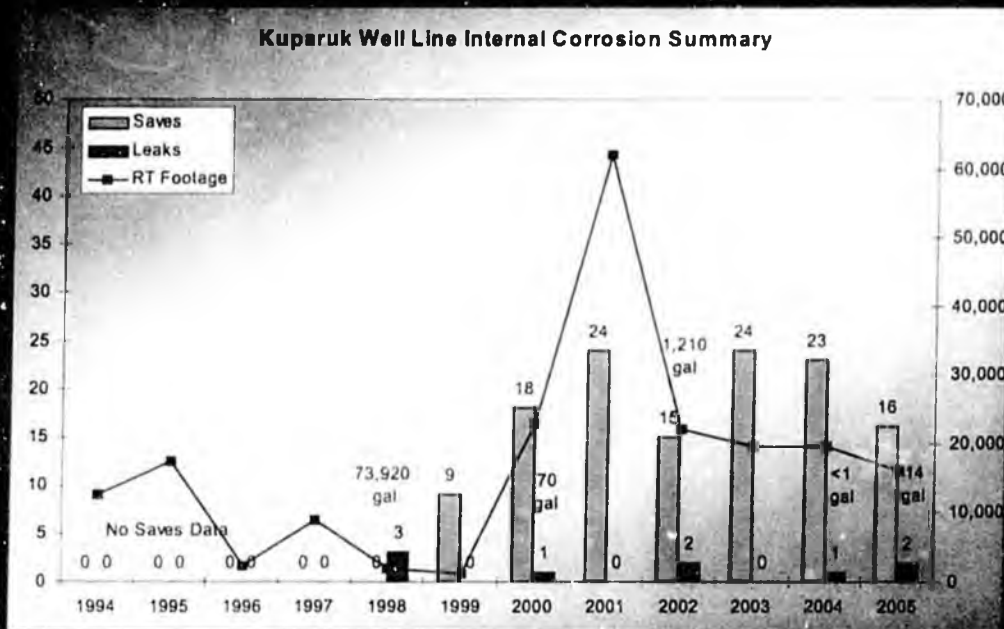
Number of Leaks & Saves

- ✓ Completed all 2005 goals.
- ✓ Roughly 16,000 ft of over 300 lines inspected (RTR and RT).
- ✓ 18 lines required repair (11 injection, 7 production).
- ✓ 2 Leaks, 16 Saves. Leaks due to under-deposit corrosion and erosion.

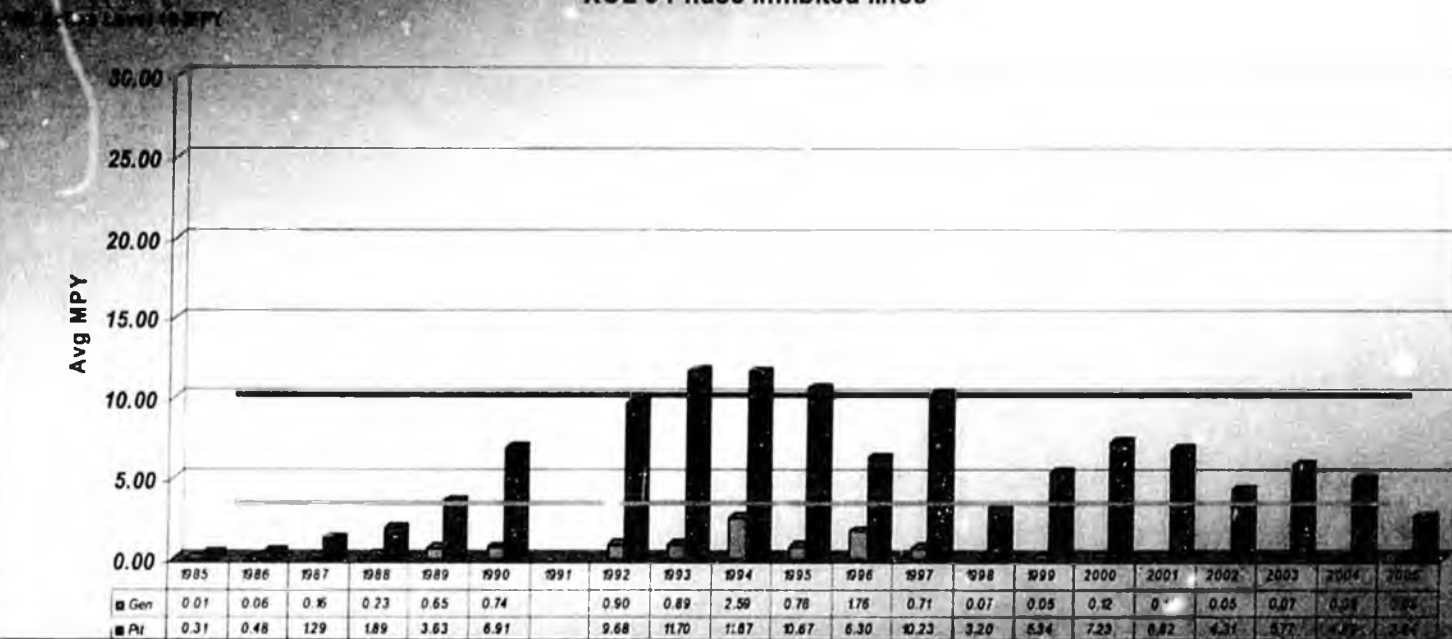
XCL 3 Phase Inhibited lines

- ✓ Coupon average rates remain below thresholds.
- ✓ 96% of 3-Phase Production CC lines have ER probe rates < 2 mpy.
- ✓ Inspection continues to support monitoring with 419 corrosion-rate monitoring (CRM) inspections conducted, with one minor increase found
- ✓ All 3-Phase Production CC lines with probe, coupon, or inspection corrosion rates above thresholds had corrective action taken.

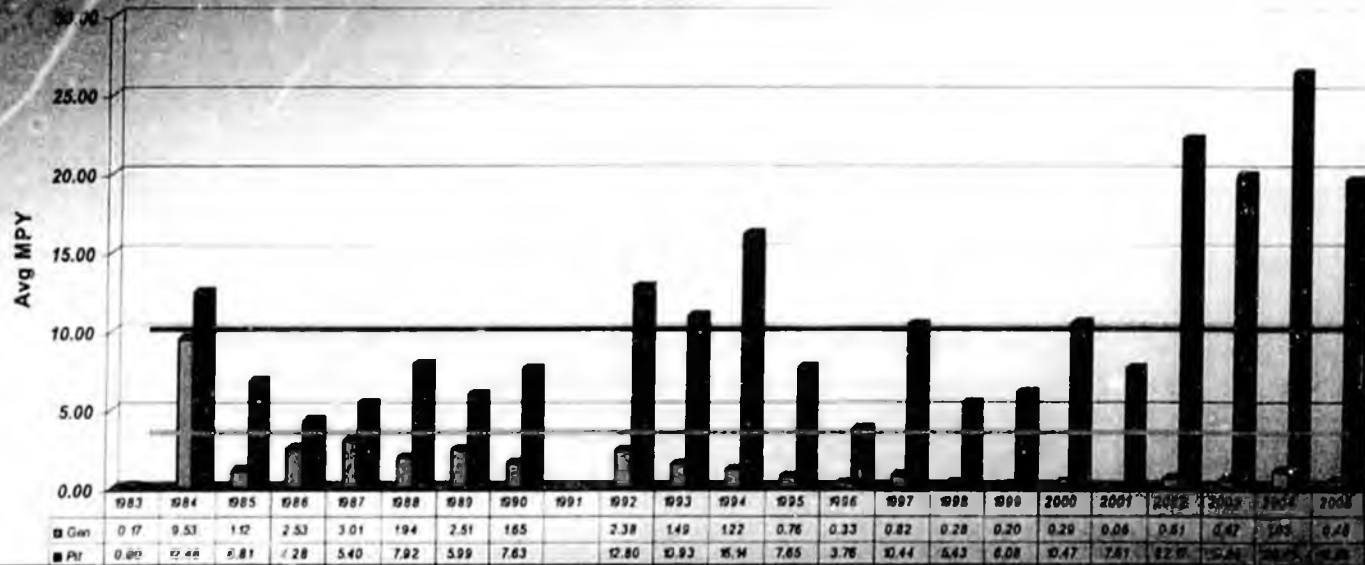
Cross County Wtr Inj Lines

- ✓ Coupons changed after CPF<sub>2</sub> split the SW & PW, were pulled 3 months later with pitting rates dropping on all header coupon locations from a high of 185 mpy to a high of 18 mpy.
- ✓ Inspection continues to corroborate monitoring data
- ✓ Continuing to adjust and analyze mitigation program with adjustments to pigging at all facilities and additional adjustment to STP biocide treatment.

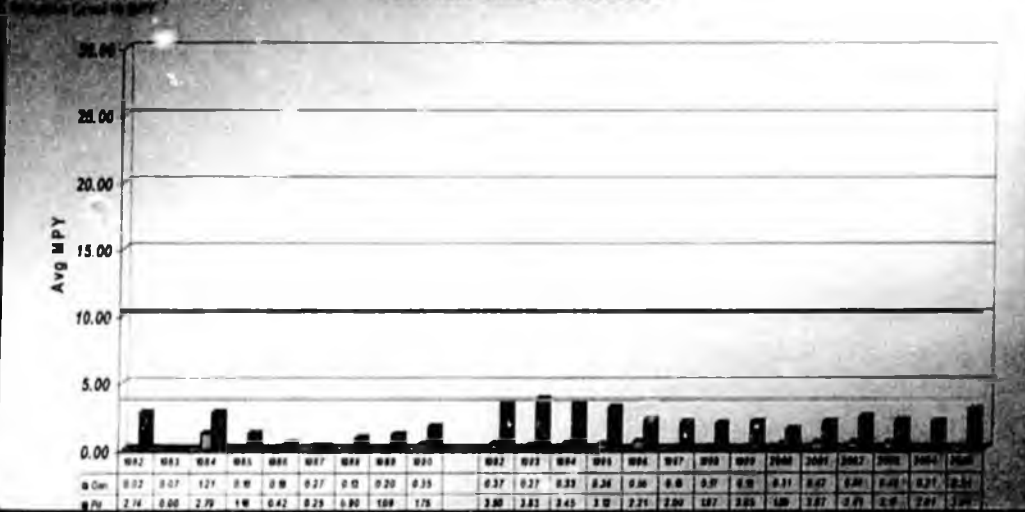
DS 3 Phase Uninhibited Well Lines

- ✓ Coupon average corrosion rates remain below threshold levels
- ✓ Inspection supports lower 3 phase system corrosion rate with lower number of repairs identified in this system

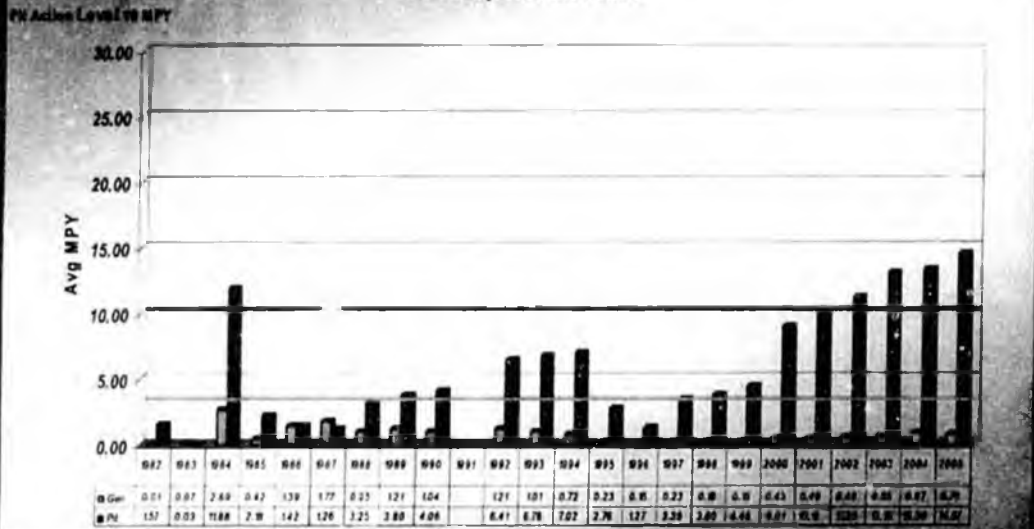
DS Wtr Injection Well Lines

- ✓ Inspection continues to identify lines requiring repair / replacement.

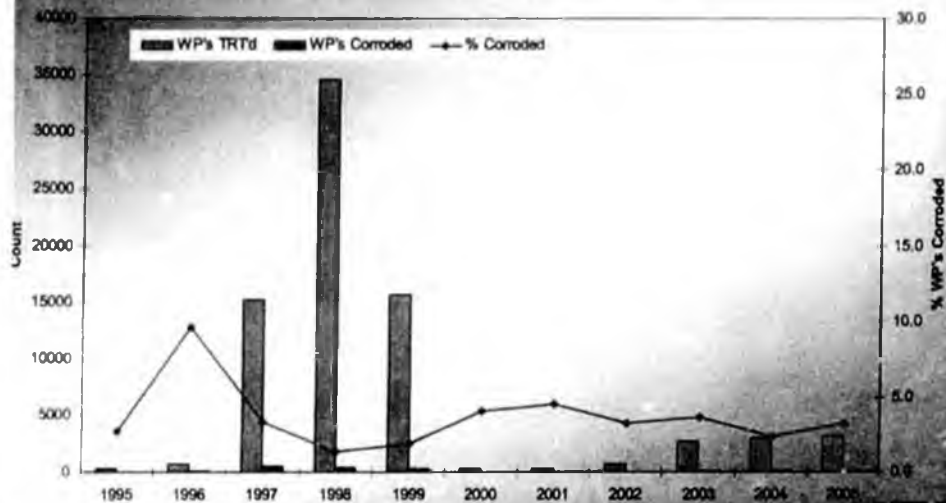
Historical Results - Weldpacks Over Landra

- ✓ 3205 weld packs TRT inspected.
- ✓ 102 (~3.2%) had corrosion. One location required a temporary sleeve (DS3KPO).

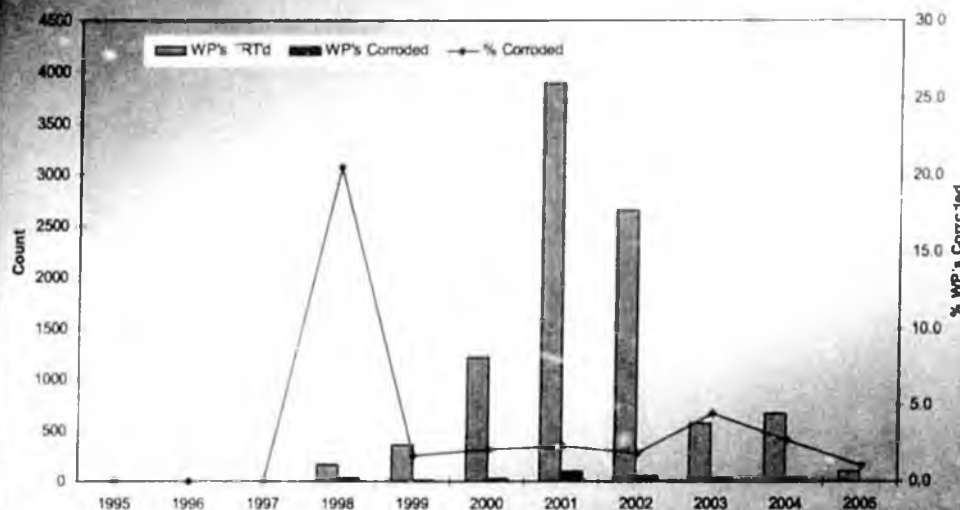
Historical Results - Weldpacks CC On-Pad

- ✓ 94 weld packs TRT inspected.
- ✓ Only one location was found to have corrosion (~1.0%). No repairs required.

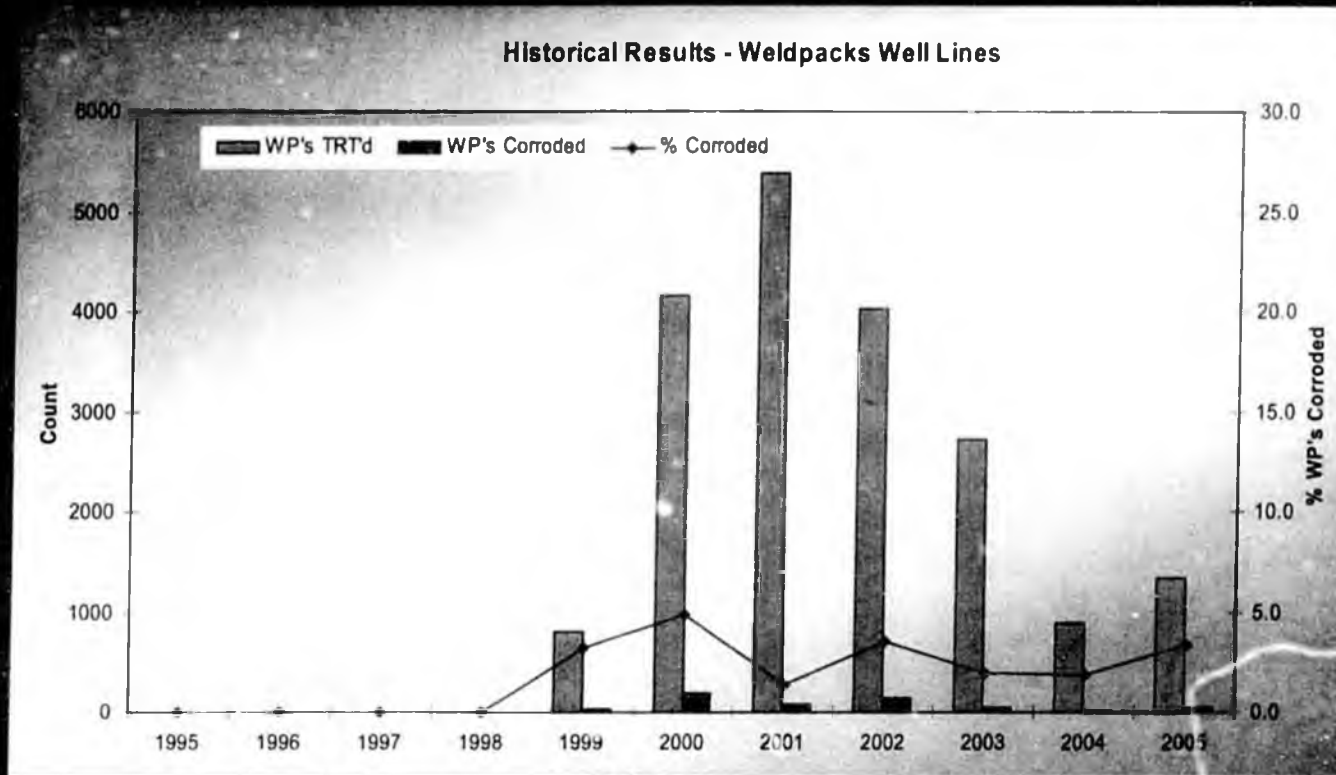
- ✓ 1347 weld packs TRT'd. Baseline inspections were completed in 2004. 2005 was the first year of our recur inspection program.
- ✓ 46 (~3.4%) were corroded. No repairs were required. The corroded weld packs were refurbished.

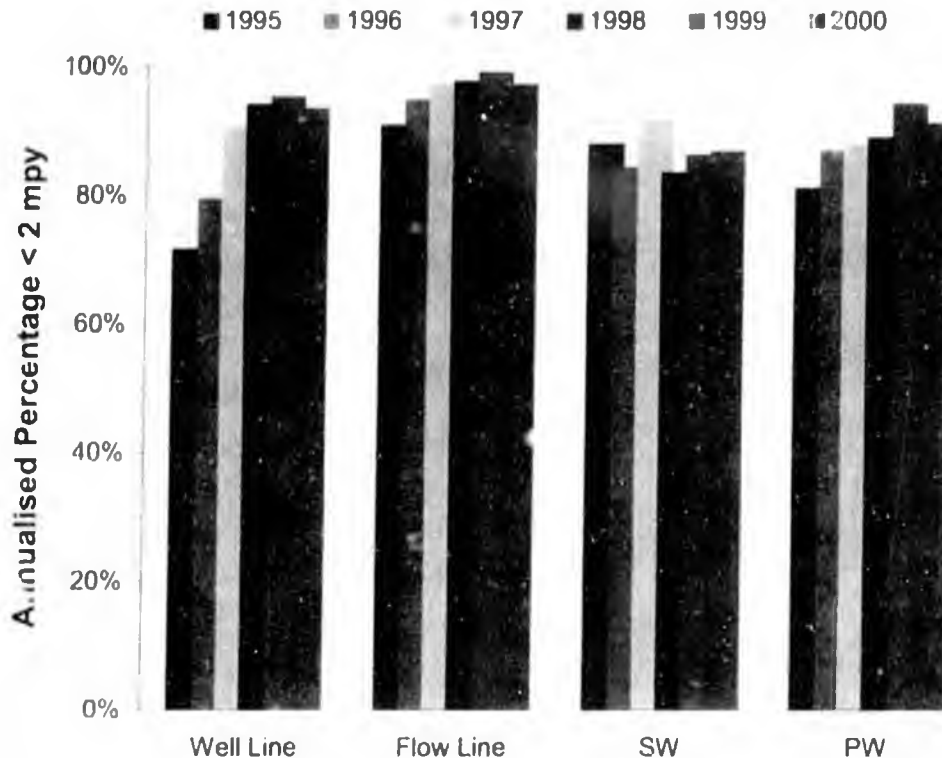
Figure 1: Summary of corrosion coupon data 1995 to 2000

For the three data sets relating to produced fluids (well lines, cross country pipelines, and produced water) 2000 showed the first reversal in a trend of continuous improvement in corrosion control since 1995. This trend of continuous improvement with a reversal in 2000 is also seen in Figures 4 and 6. It is believed that there are separate reasons for the reduced corrosion control in the 3 classes of equipment (well lines, cross country pipelines, and produced water).

For well lines it is believed that a lessening in the ability to achieve target corrosion inhibitor injection rates at the well head is the cause. This is covered in more detail in Section E.2 but has resulted in a wide ranging but moderate increase in corrosion rates of well lines. This is not assumed to be the case for the cross country pipelines as they receive the flow from numerous wells and therefore variations in chemical allocations to individual wells are smoothed out.

Unlike well lines, the reduction in corrosion control of cross country pipelines is not wide ranging and Figures 5 and 6 demonstrate that overall, the trend of continuous improvement in corrosion control was maintained. The reduction in corrosion control for this equipment was highly specific, in particular the corrosion rate in N-74 (24" pipeline from N-pad to GC-2) increased markedly during 2000. In response, the target concentration of corrosion inhibitor was increased in several steps from 100 ppm to 300 ppm. Also, an unsuccessful chemical trial at drill site 14 resulted in elevated corrosion rates.

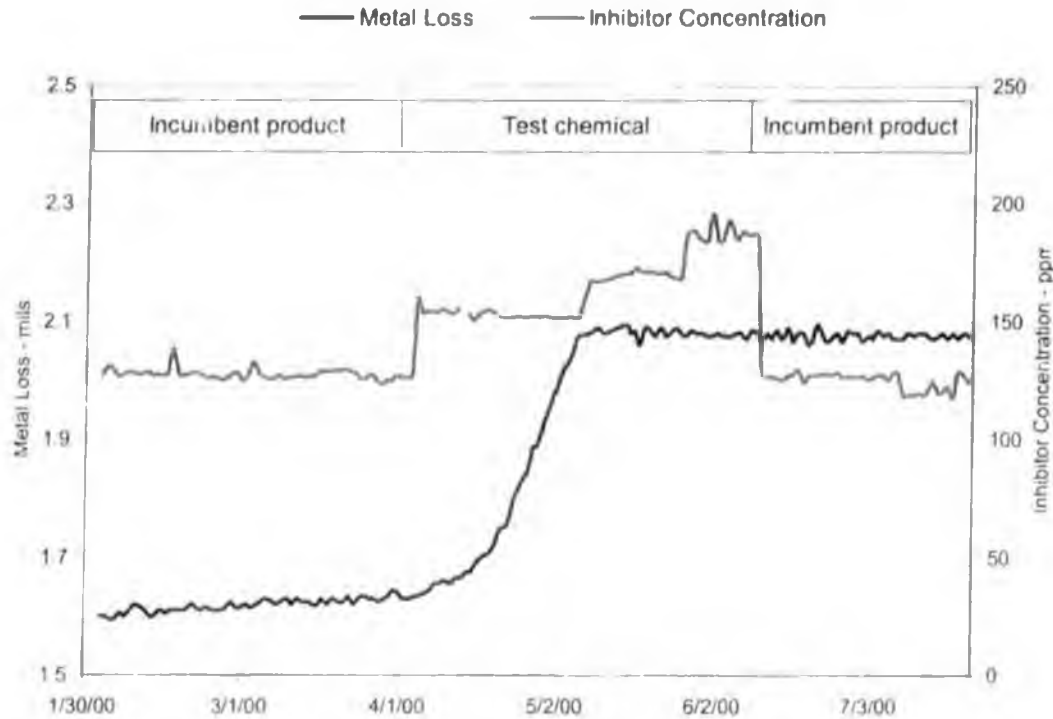
Figure 2: Chemical optimization in response to corrosion probe data

The metrics above deal with chemical usage at the field level but a lot of the chemical optimization activity concentrates on getting the correct amount of corrosion inhibitor to each piece of equipment. The inhibitor requirement is driven by factors such as water cut, water volume, flow regime, and condition of the equipment and varies over a wide range, from a few parts per million (ppm) to several hundred ppm. By way of example, Figure 2 shows corrosion probe data for a cross country pipeline during a chemical test. Soon after the test started, the corrosion rate increased and the concentration of inhibitor was increased to reduce the corrosion rate – see highlighted area. The required

increase in dose rate made the test chemical uneconomic and therefore the test was halted and the incumbent chemical was re-used at the original target dose rate. This type of optimization is done in response to probe, coupon, and inspection data, while testing new chemicals, as well as during normal operations as the amount of corrosion inhibitor required changes due to production variables such as water cut, water volume, or flow rates.

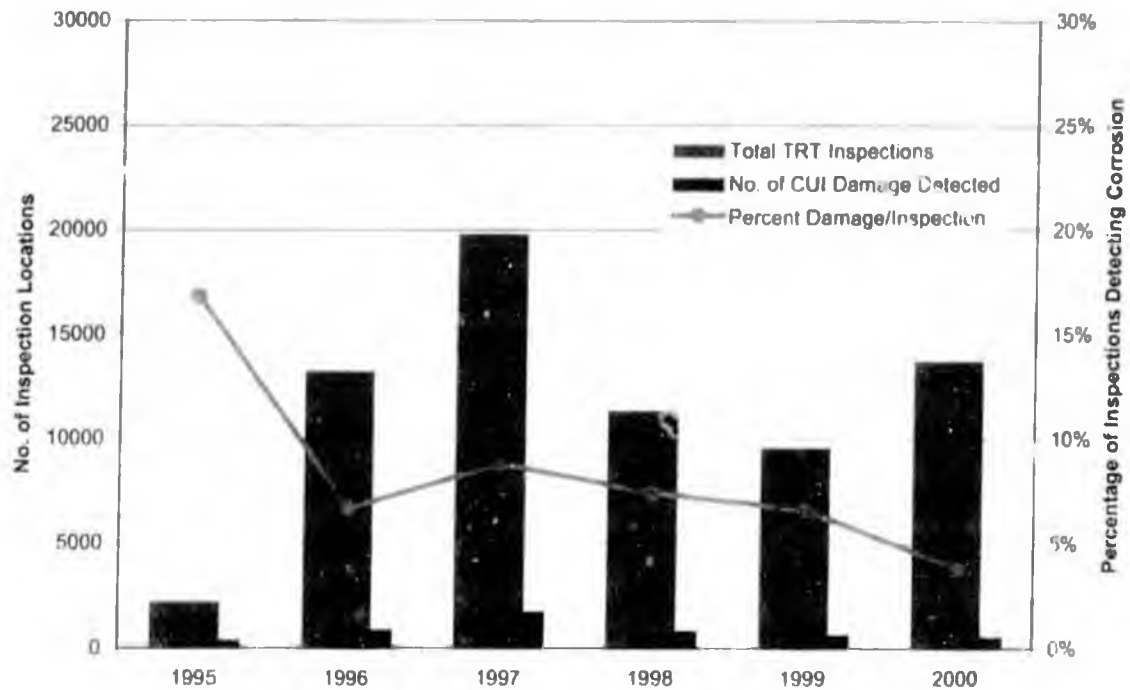
Figure 3: External inspection using Tangential Radiographic Testing

Figure 3 shows the number of TRT inspections performed to detect external corrosion, 1995 to 2000. It includes all tangential radiographic methods (TRT, ATRT, C-arm X-ray). It also shows the number of locations where corrosion is detected as a total and as a percentage of the number of inspections. The Figure shows that the total number of inspections per year has been fairly constant since 1996 but the number of new locations where corrosion is detected has been reducing. This reflects the random nature of CUI as once damage is located and mitigated, the probability of finding active CUI decreases.
