Corrosion, Inspection and Chemicals (CIC) Group
BP Exploration (Alaska), Inc.

Commitment to Corrosion Monitoring

Year 2005

This is the sixth annual report that meets the commitment made by BPXA to the State of Alaska to provide a regular review of BPXA's corrosion monitoring and management practices for non-common carrier pipelines on the North Slope. The contents of this report reflect the Work Plan¹ agreed jointly between BPXA, Phillips and ADEC, the Guide for Performance Metric Reporting², and feedback from previous ADEC reports. The report is divided into 2 main parts.

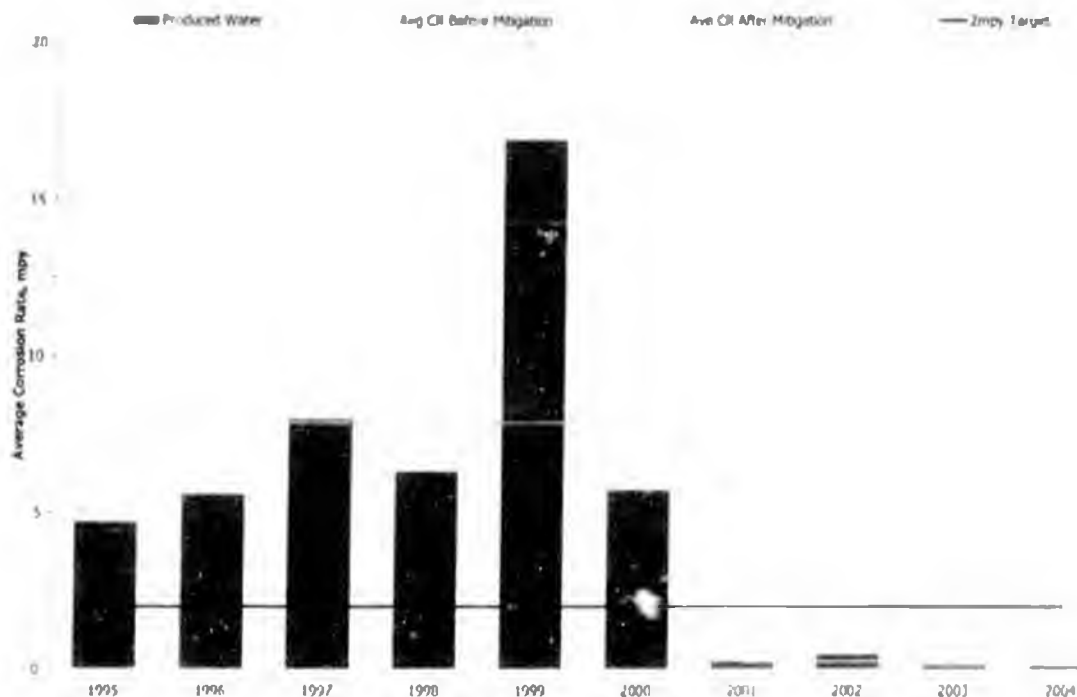
ACT Figure D.2 Milne Point Produced Water Corrosion Rate Trend

Corrosion inhibition of the water injection system began in mid-2000, in addition to a more frequent maintenance pigging program. Corrosion inhibitor concentration is at 40 ppm. Weight loss coupon data indicate the system is under control as the WLC corrosion rates have averaged <2 mpy since mid-2000. This represents a significant reduction from previous years as can be seen in ACT Figure D.2. For the period 1996-2000, the average corrosion rate was ~7 mpy. Since the enhancement of the corrosion management program in 2000, the average WLC corrosion rate for the PW system has been reduced to <1 mpy.

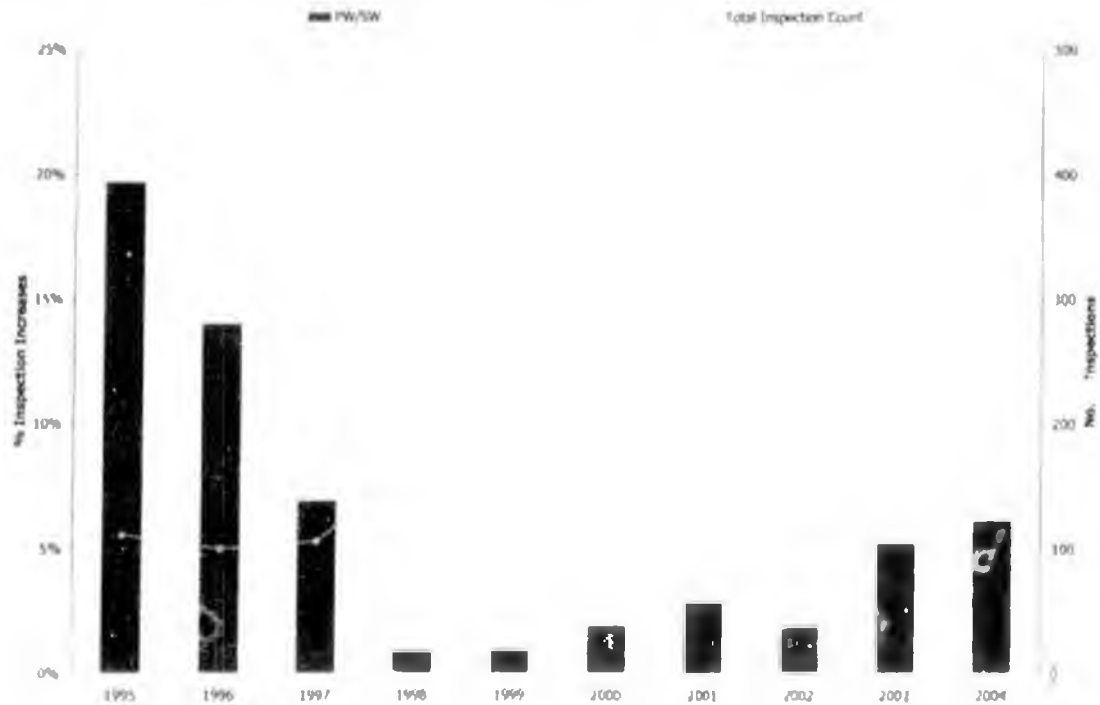
ACT Figure E.2 Endicott Flow Line Internal Inspection Increases

ACT Figure E.2 shows a significant decline of inspection increases from 1995 through 1998 for the IIWL at Endicott. There has been an increasing trend in %I's from 1998 through 2004, however these data include the addition of inspection locations that have not been inspected in several years. These additional locations confirm that corrosion was occurring in the line; however the time period between inspections makes it difficult to determine when the corrosion actually occurred. A more accurate representation of corrosion activity through time was shown previously in ACT Figure D.1 which includes

only data from inspections performed on a frequent basis. The frequently monitored locations show a decrease in corrosion activity during 2004.

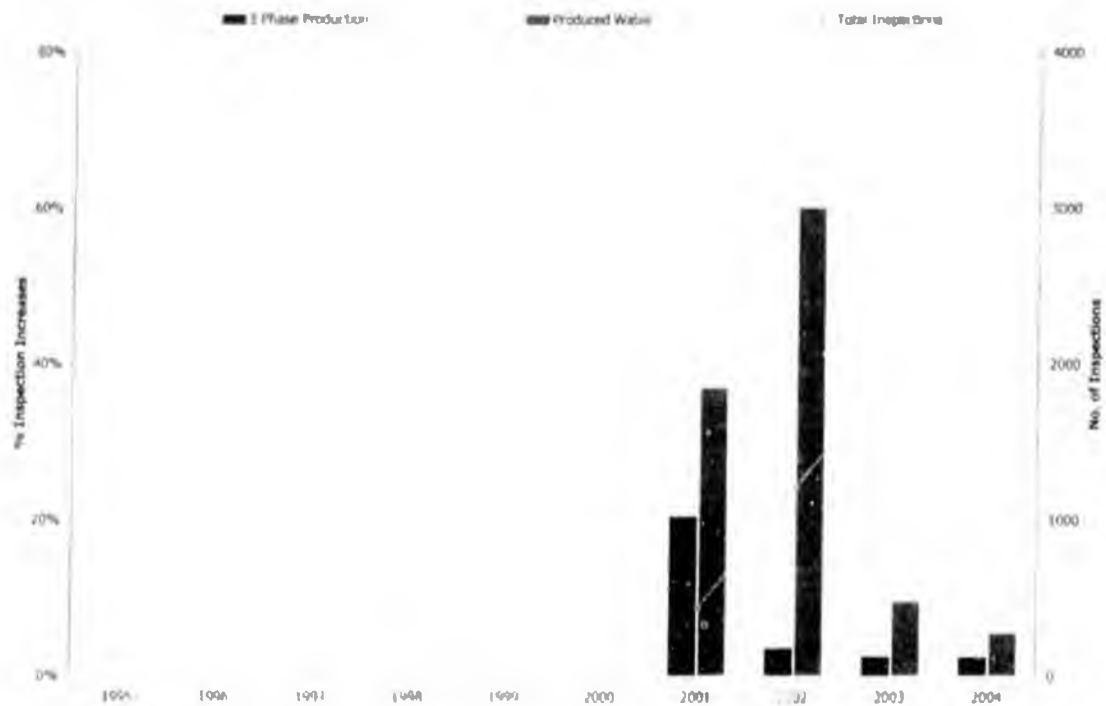
ACT Figure E.4 MPU Well Line Internal Inspection Increases

ACT Figure E.4 shows the %I's and number of inspections on well lines. There has been a significant decrease in the number of repeat locations showing active corrosion since 2002. As noted in the discussion above, this represents a more consistent repeat inspection basis from prior years, as the majority of repeat locations were ~1-year apart, whereas in previous years the time difference between repeat inspections was several years.

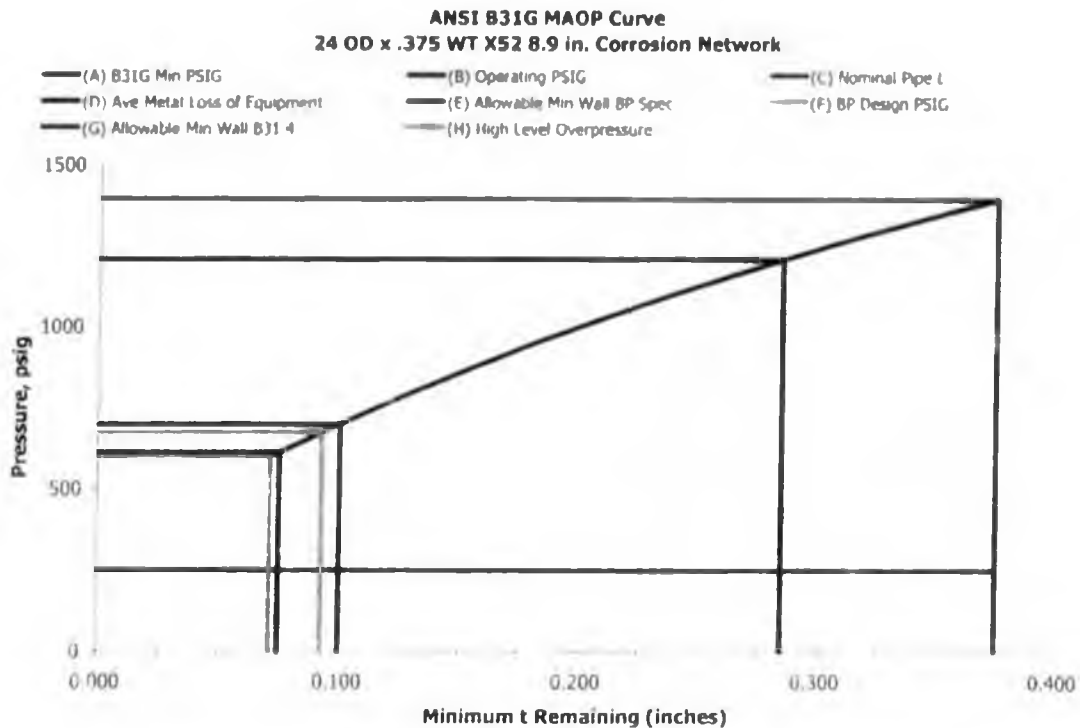
Legend	Description/Comments
(A) B31G Min PSIG	The relationship between maximum allowable operating pressure, MAOP, as given by B31G and the remaining wall thickness

(B) Operating PSIG	The normal operating pressure for a typical low pressure common line or flow line (CL/LDF)
(C) Nominal Pipe t	The original nominal pipe wall thickness which for this example is 0.375" (375 mils) as is the case for many of the flow lines at GPB

(D) Ave metal loss	From the inspection data an average pit depth or depth of damage across the field for the 24" LP OIL flow lines
(E) Min Wall BP Spec	The minimum wall thickness, 0.100", which is permitted under BP specification SPC-PP-00090 for the management of corroded pipe-work. Any location at or below this level is actioned regardless of the calculated MAOP

(F) BPXA Design PSIG	The original design pressure that the pipe wall thickness was designed to retain
(G) Allowable Min Wall	Allowable minimum wall thickness under B31 below which a repair is mandated by code

Step	t, mils	MAOP	Curve	Description
1	375	1395	(C)	As constructed pipe condition with no corrosion or degradation of wall thickness
2	285	1209	(D)	After 25+ years of service the average wall loss for the flow line system is 24% or 90 mils and has a MAOP of 1209 psi. This is an equivalent corrosion rate of ~4 mpy. At the average corrosion rate seen to date, in approximately 50 years the wall loss will be such that it reaches the repair criteria in Step 3. Note that the target corrosion rate is 2 mpy to provide additional protection and scope for extended field life
3	100	700	(E)	The BP repair criterion from BP Specification SPC-PP-00090 is 100 mils with an MAOP of 700 psi. This repair criterion is 25 psi above the design pressure and 25 mils or 33% above minimum wall thickness defined by code B31G giving significant level of additional protection
4	35	675	(F)	The original system design pressure

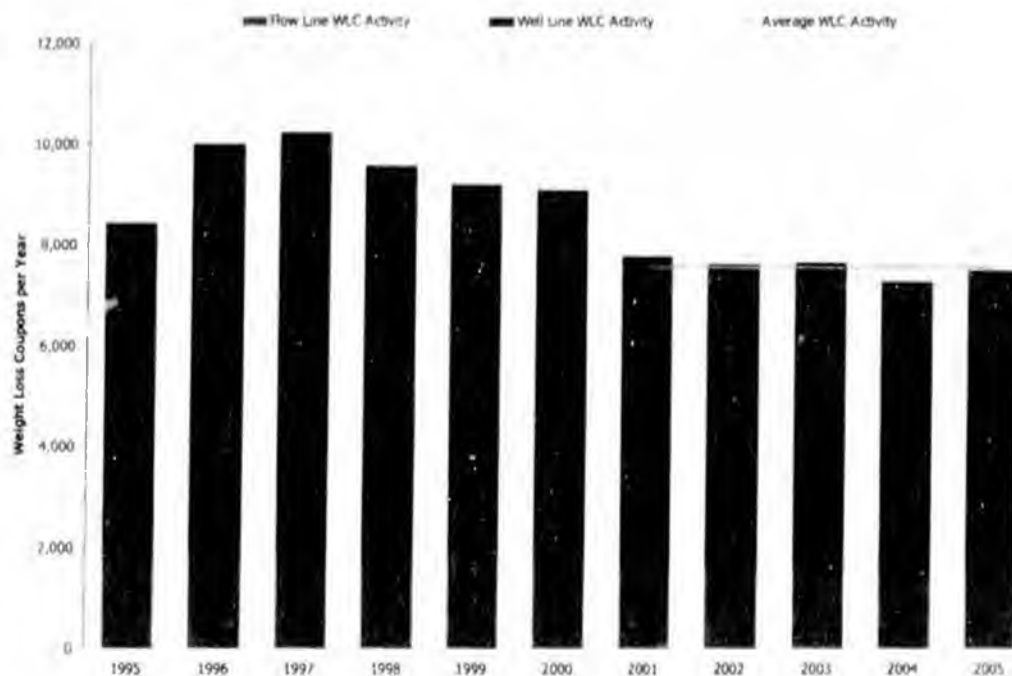
GPB Figure C.1 Corrosion Monitoring Activity Statistics by Equipment

Two corrosion coupons are typically recovered for each WLC pull with the exception of those lines that are regularly maintenance pigged where single flush mounted coupons are installed. The number of coupons, coupons per pull, and pull frequency continue to be adjusted through time to gain greater value from the data obtained by the program.

As discussed in prior reports, there has been a gradual reduction in the number of weight loss coupons being evaluated, which reflects the on-going effort to optimize the program. Following the rationalization in 2000/01, the level of WLC activity has stabilized at ~7,500 coupons per year. The number of weight loss coupons reported for 2005 does not reflect the inventory of coupons that are installed in the system at year-end and still to be 'processed.' The reduction in 2005 coupon numbers therefore represents a timing effect and not a reduction in the program scope or activity level.

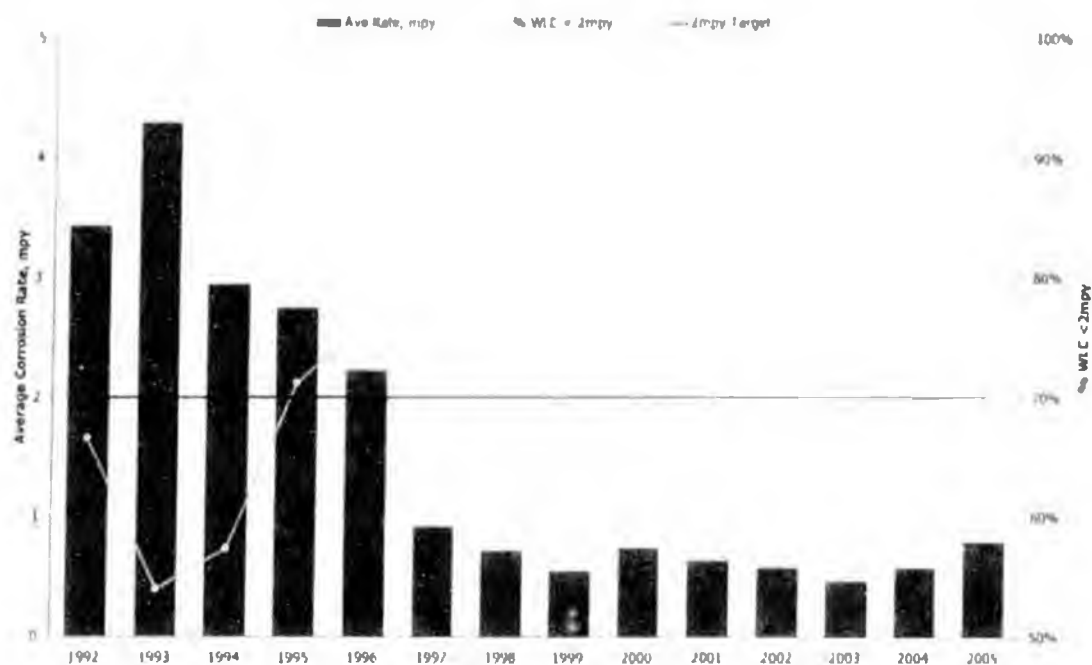
GPB Figure C.5 Well Line Oil Service Corrosion Rate Trend

GPB Figure C.5 shows the average corrosion rate and percentage of WLC ≤ 2 mpy since 1992. The trends are very similar to those seen in the cross-country 3-phase oil flow lines, showing a long-term improvement in the level of control from early 1990's to the present day with a slight decrease in performance from 2003 to 2005. This decrease in performance is largely due to two reasons; first there were precipitation problems with the winter corrosion inhibitor that lead to plugging of several continuous injection systems, and second, there was an incompatible test corrosion inhibitor which required the shutdown of the injection system in early 2005.

The long term corrosion control improvement in the well lines is of the same magnitude as that seen in the flow lines with corrosion rates being reduced from an average >4 mpy in 1993 down to an average of 0.5 to 0.8 mpy over the past six years.

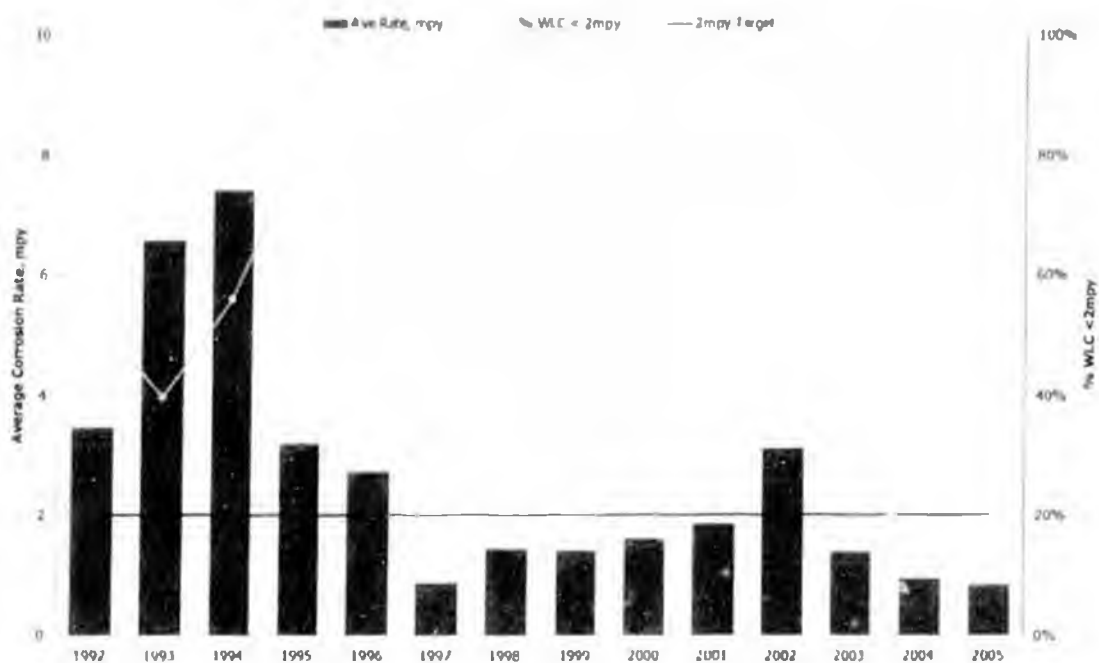
GPB Figure C.6 Flow Line PW/SW Service Corrosion Rate Trend

GPB Figure C.6 is a summary of aggregate data for produced water and seawater flow lines. The data show the 2005 WLC corrosion rates at the lowest level since 1997 and demonstrate improved corrosion control over the past three years.

In summary, the average WLC corrosion rates for the aggregate water injection service continued to improve in 2005. This improvement is attributable to several different activities outlined in Section C.2.2 and Section C.2.3.

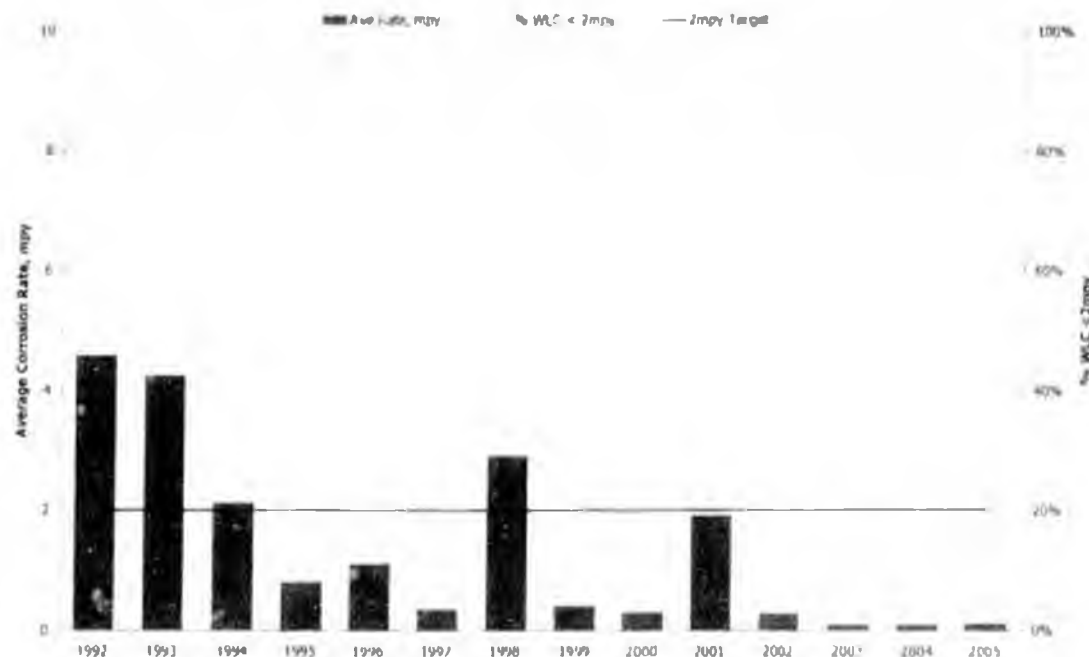
GPB Figure C.7 Corrosion Rates for 100% PW System

GPB Figure C.7 through GPB Figure C.9 summarizes the historical corrosion rate data for produced water well lines. The data show general corrosion rates in the produced water system have fallen as the level of inhibition in the 3-phase system was increased and supplemental produced water corrosion inhibitor injection was initiated.

GPB Figure C.7 shows the performance for 100% produced water service. The 2005 levels maintained average corrosion rates at ~ 0.1 mpy and $\sim 100\%$ WLC ≤ 2 mpy.

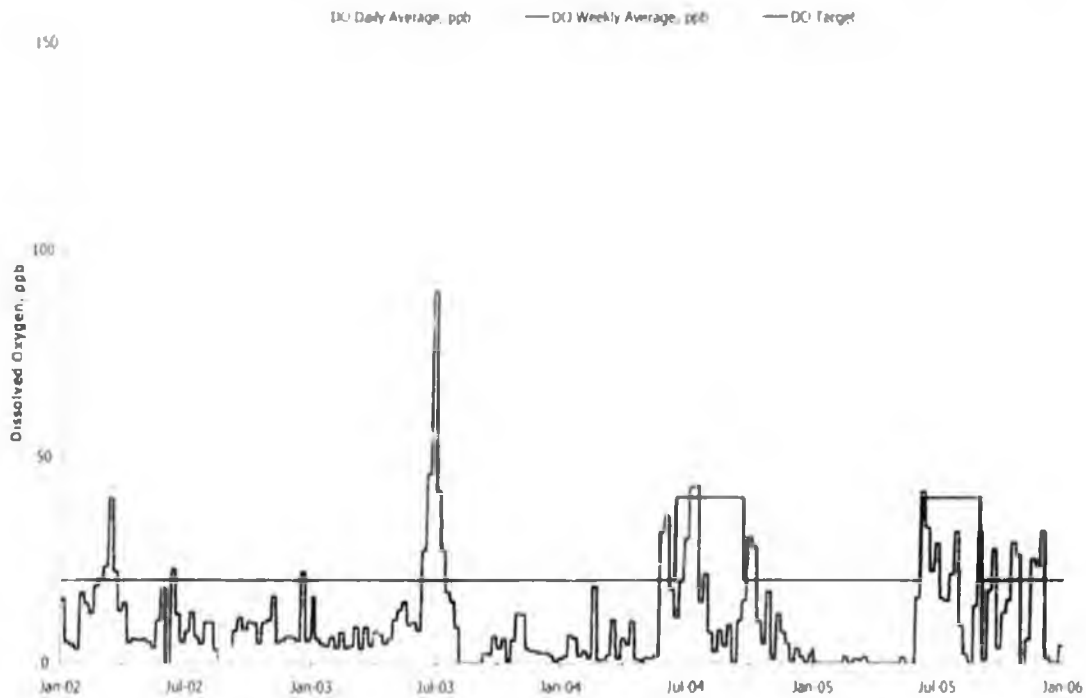
GPB Figure C.13 Dissolved Oxygen Control Performance for the Seawater System

GPB Figure C.13 shows the daily and weekly average level of dissolved oxygen control in the seawater system from 2002 through 2005. The DO excursion during the summers is

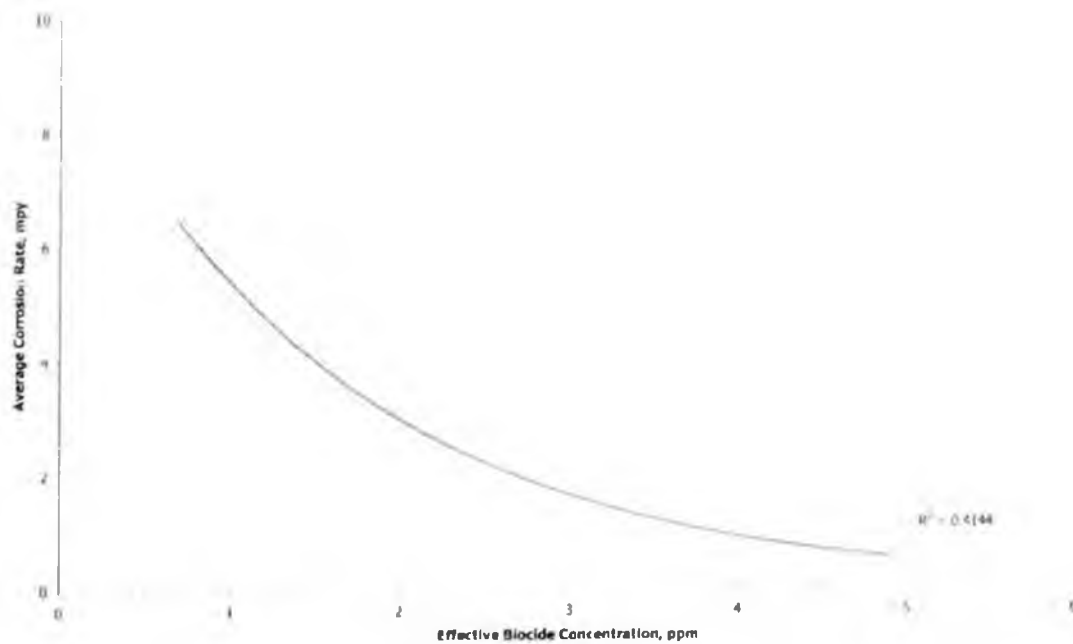
GPB Figure C.15 Average Corrosion Rate vs. Effective Concentration, 2001 - 2005

GPB Figure C.15 shows the correlation between the average corrosion rate and effective biocide concentration for 2001 through 2005.

In summary, the corrosion monitoring data suggest progress has been made in returning the seawater system to control. However as with the produced water system, the data are limited and caution is warranted. Therefore, there will be an on-going effort in 2006 to correlate the corrosion monitoring trend with inspection data and identify program improvements.

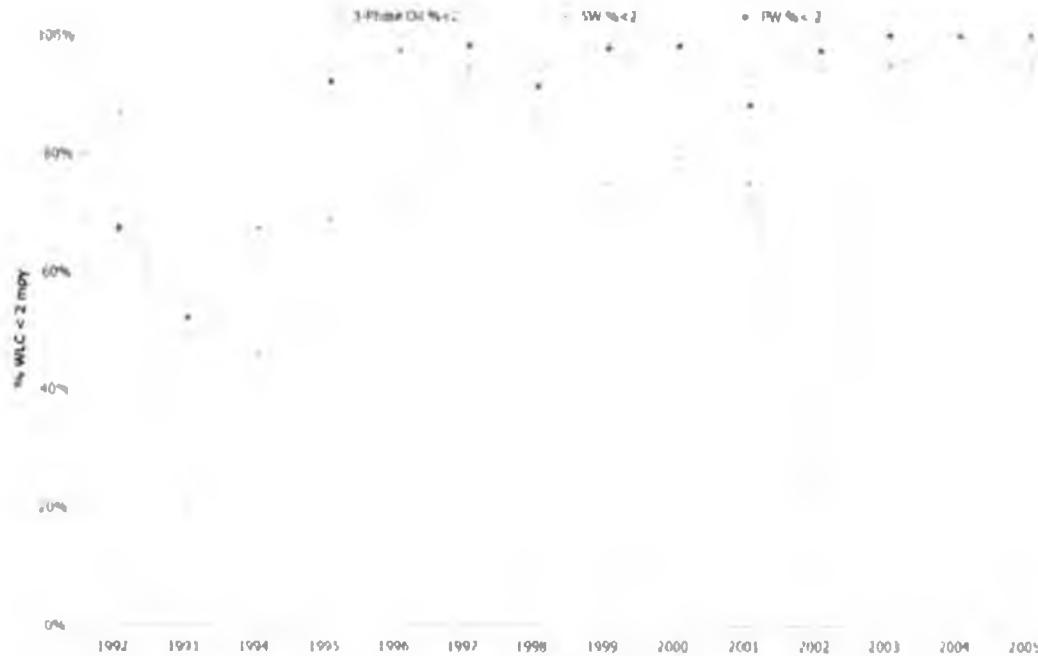
GPB Figure C.17 Well Line Average Corrosion Rate Summary by Equipment and Service

GPB Figure C.17 shows the corrosion rate and GPB Figure C.18 shows corrosion conformance for well lines. The well line 3-phase system performance has remained essentially unchanged since 2000. The produced water and seawater well lines corrosion performance has remained essentially consistent since 2002.

Well Line 3-Phase Oil Service – Significant improvements in performance occurred from 1992 to 1997 when the average corrosion rate (CR) was reduced from 3.6 to 1.0 mpy (~70% improvement) and conformance to the 2 mpy target was increased from 64% to 88% (~40% improvement). Since then, average CR has been <1 mpy, and target conformance performance has been >90%. In 2005, values were 0.79 mpy and 92% respectively.

Well Line SW Service – Performance deteriorated from 1997 through 2002 with the average CR increased from 0.7 to 7.5 mpy. Average CR and percent conformance with the 2 mpy target rebounded in 2003 to 0.7 mpy and 95% respectively. For the 100% SW service, the average CR of 0.63 mpy and percent conformance of 94% <2 mpy. For the Majority SW service, there was an increase in 2005 with 0.60mpy and 95% <2 mpy.

Well Line PW Service – Average CR and percent conformance with the 2 mpy target was just under the historical best performance, with 0.12 mpy and 100%. The two excursions, 1998 and 2001, were likely the result of reduced system velocities and oil system corrosion inhibitor changes. Work continues in the evaluation of new corrosion control techniques designed specifically for the PW system.

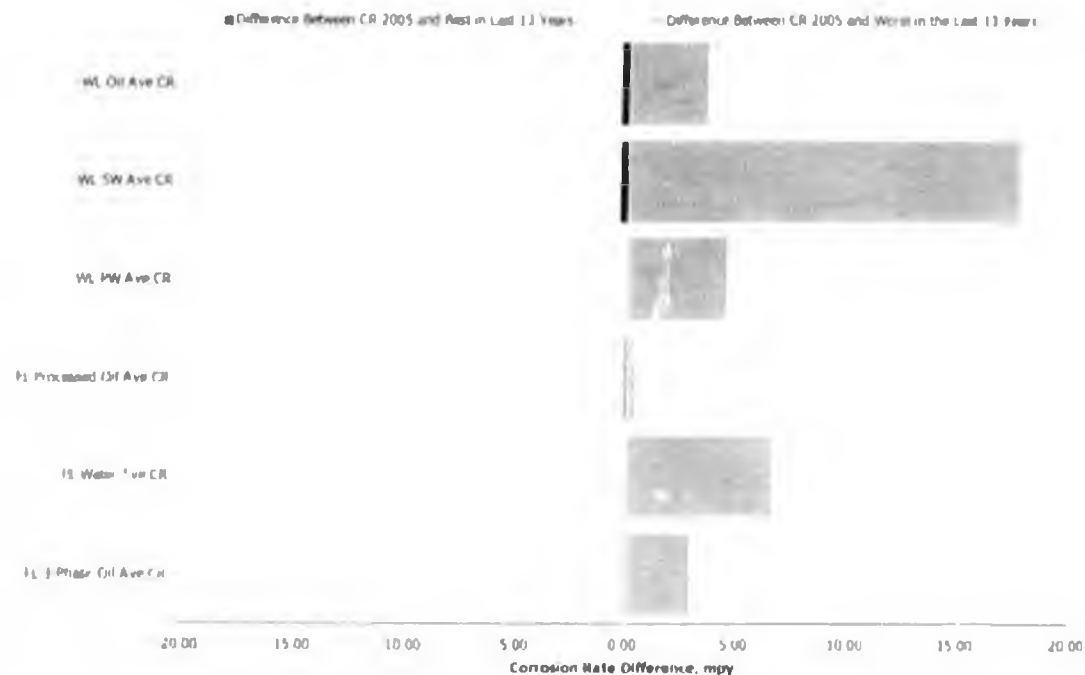
GPB Figure C.19 WLC Corrosion Rate Difference by Service and Type

In order to assess the relative performance of the corrosion management program today versus that of the last 13 years, GPB Table C.5 and GPB Figure C 19 were generated as a summary. The data show the difference between the 2005 WLC corrosion rate for each of the systems and the best, or lowest, WLC corrosion rate and the worst, or highest, WLC corrosion rate observed since 1992. This is an approximate measure of the successes and/or shortcomings of the program today versus the ~13-year history and highlights areas for attention. The results indicate the current level of corrosion control, as determined by weight loss coupons, is at or near the best levels of control for each system.

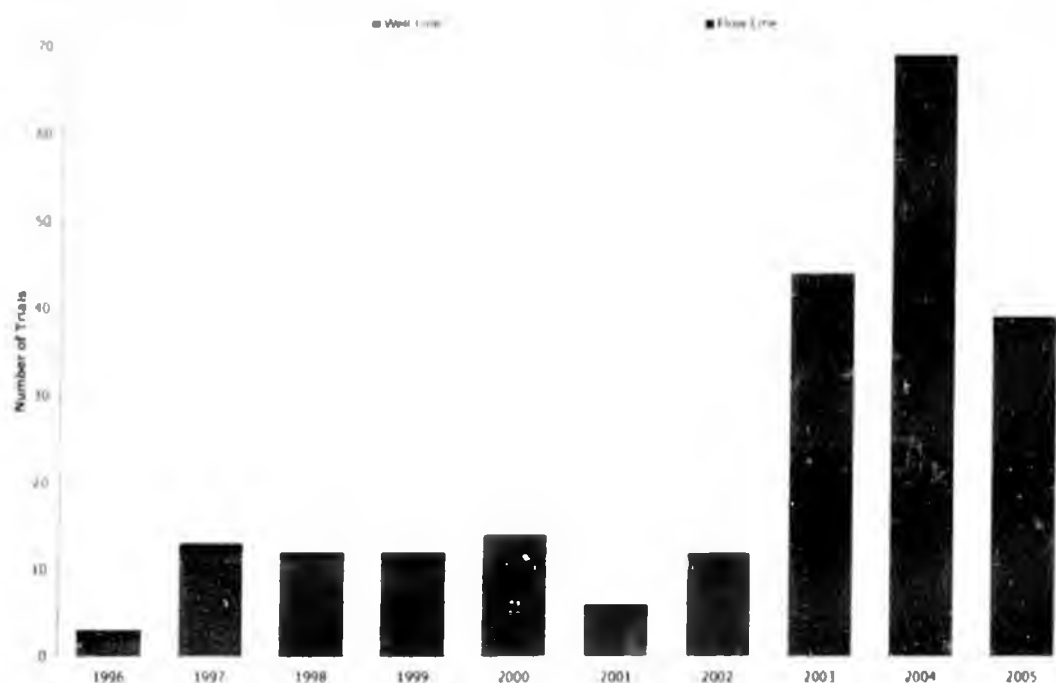
GPB Figure D.1 Number of Well Line and Flow line Tests

GPB Figure D.1 summarizes the number of well line and flow line tests which have been completed since 1996. The level of well line test activity increased beginning in 2003 due to a change in the screening protocol, which reduced the time required per test. The combined number of well line and flow line tests has increased from ~10-14 per year⁷ to more than 35 during 2005. This level of activity represents a substantial investment of resources towards the development of new and more effective corrosion inhibitors.

Two test chemical were advanced from the well line test program to large scale flow line testing. However, neither chemical met the technical performance requirements to advance further.
