11976 SENATE RESOURCES

### 3) 2006 Annual SPCO Compliance Oversight Report

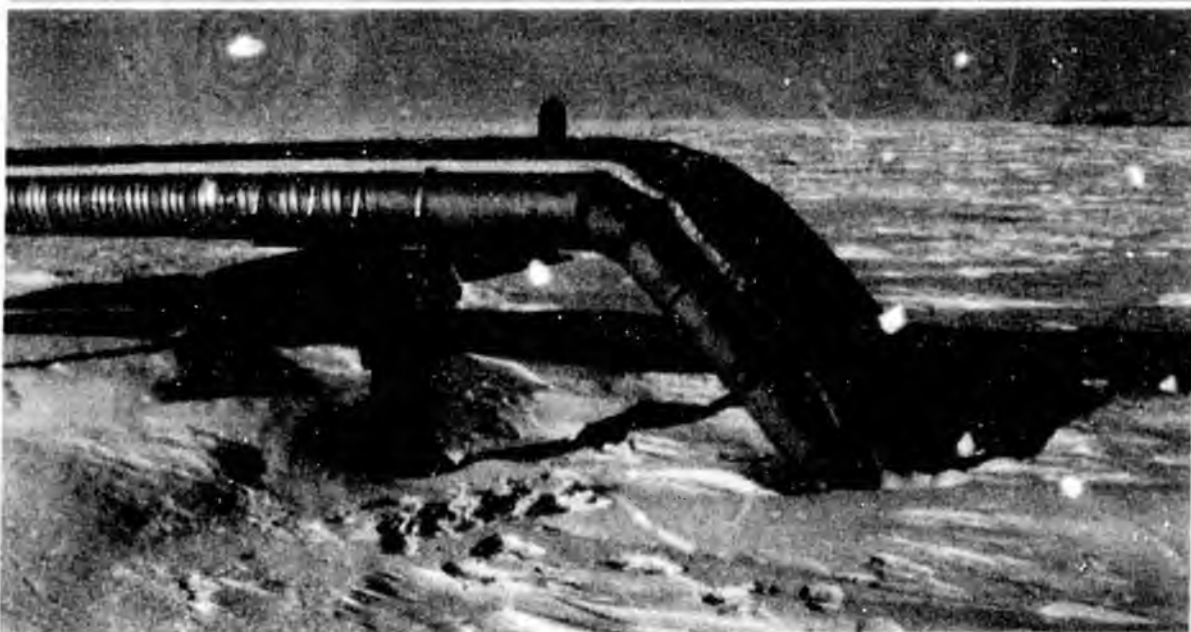
*The Milne Point Oil (rear) and Products (front) pipelines connect the Milne Point Development, east of Prudhoe Bay, to the Kuparuk and Oliktok Pipeline Systems, respectively, approximately 10 miles to the south.*

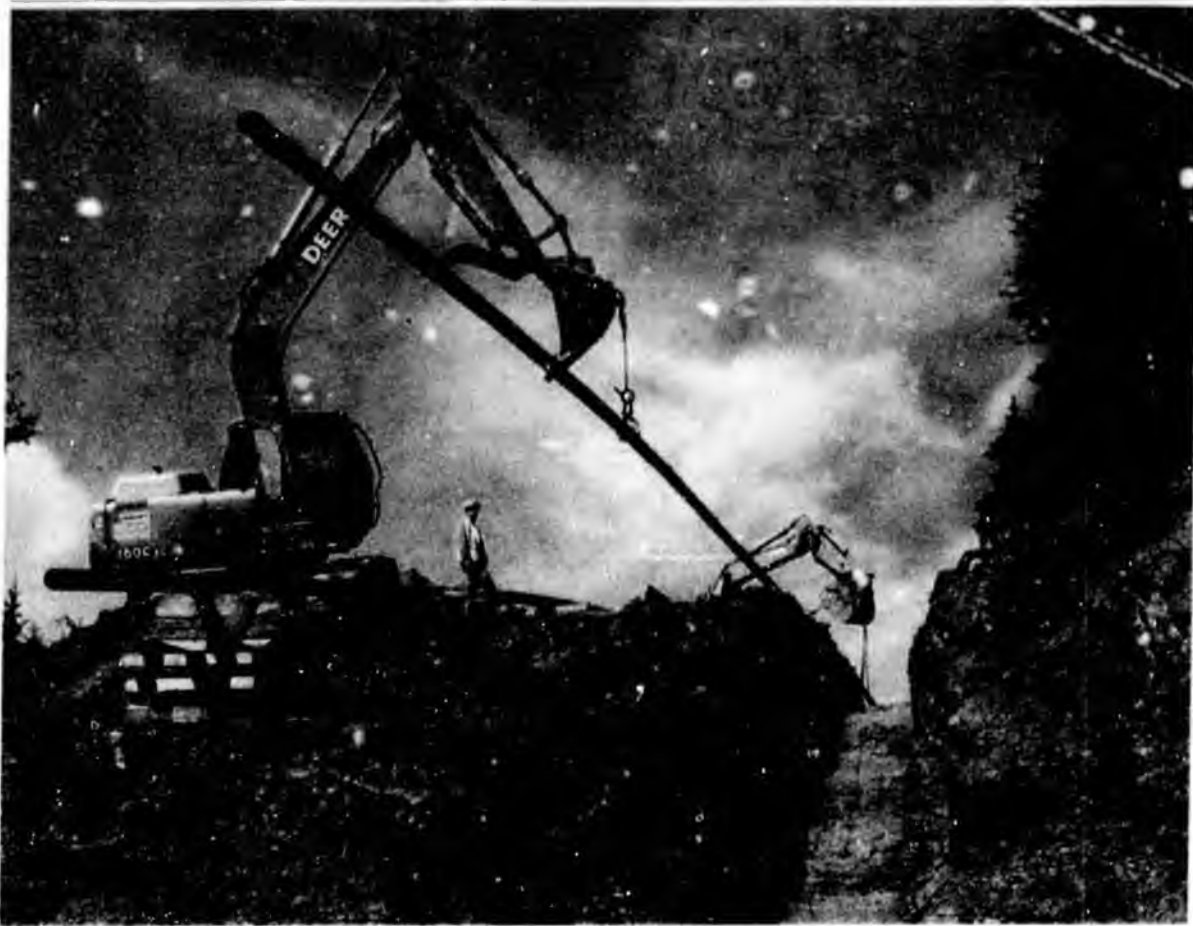
*In summer 2006, construction is in progress on the 4.2-mile Kasilof Extension to the KKPL. This picture shows a segment of pipeline being placed in the newly-dug trench.*

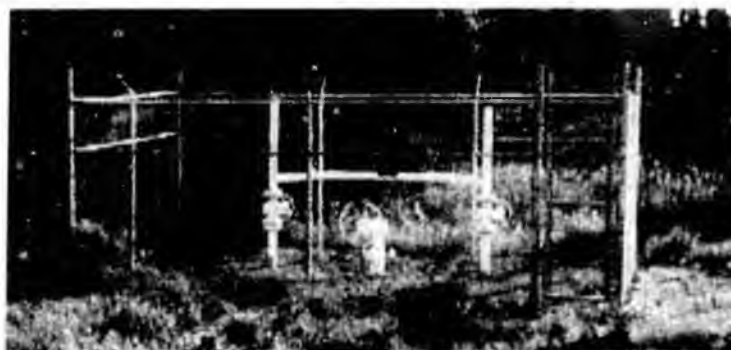
*The KKPL valves are enclosed in fencing, locked, and marked with warning signs to inform the public and protect equipment.*

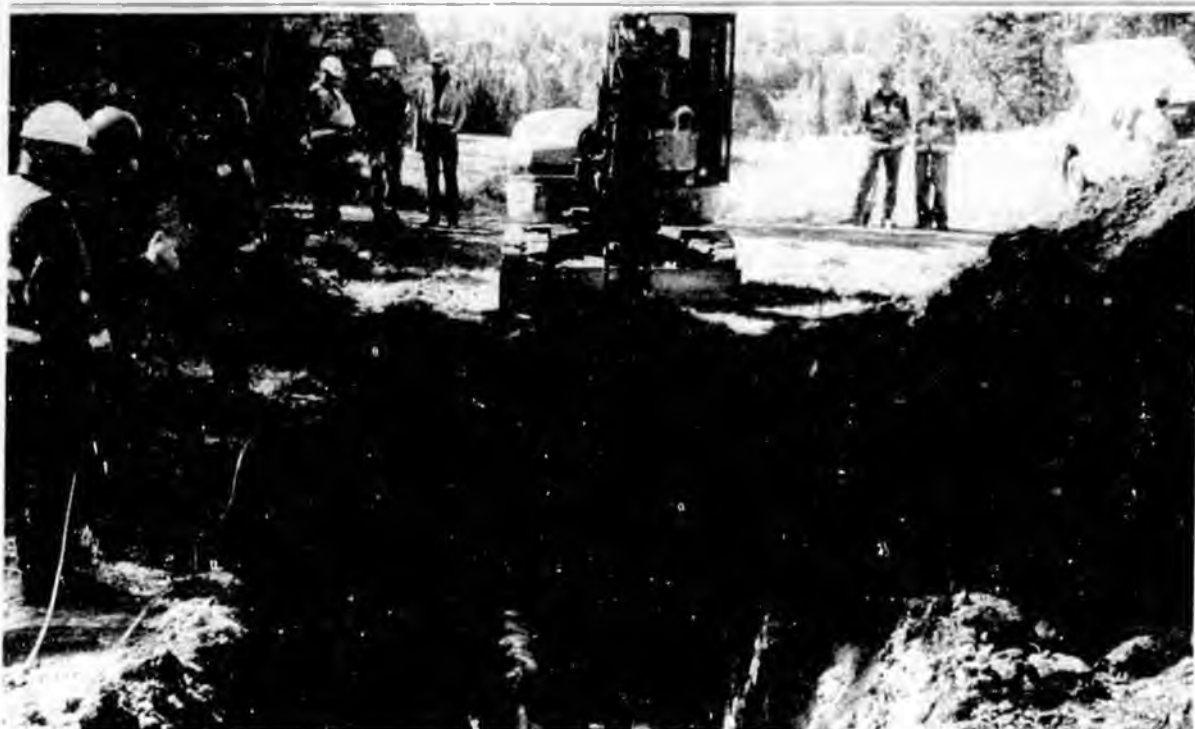
*Anomaly Dig:* On June 15, 2005, the team observed a pipeline excavation taking place east of the Sterling Highway and south of Fleetwood Avenue. A magnetic flux leakage in-line inspection had identified an anomaly described as external wall loss of approximately 19%, with a potential instrument error of + or – 10%. Due to the error in ILI measurements and the potential to recover contractor warranty costs, KKPL decided to excavate and examine the anomaly location. When the surveillance team arrived on site, a contractor had largely completed the excavation process. The team reported that an excavator dug a 45-foot by 6-foot trench and workers used hand shovels to complete final exposure of the pipe. The surveillance team observed contractors searching for the anomaly location on a five-foot section of pipe. No anomaly was found. Upon completion of the inspection, the pipe was re-coated and re-buried. To follow up, the pipeline operator sent the SPCO a "KKPL Anomaly Inspection Report" on July 22, 2005. The surveillance team completed reports ANC-05-S-049 through 052, all of which noted satisfactory conditions.

*In July, 2005, the compliance oversight team observed a pipeline integrity dig at a potential external wall loss location identified in an in-line inspection run. No anomaly was found.*

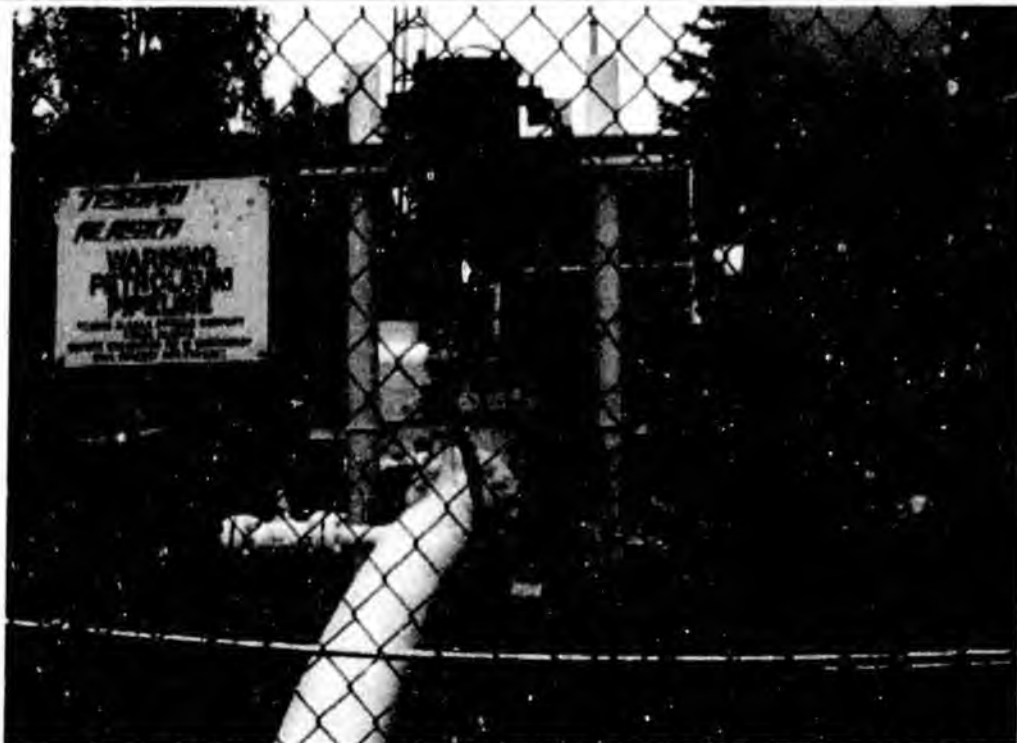
*This photo is of a remotely-operated valve on the Nikiski Alaska Pipeline near Point Possession. Solar panels and propane provide energy for the valve and cathodic protection system.*

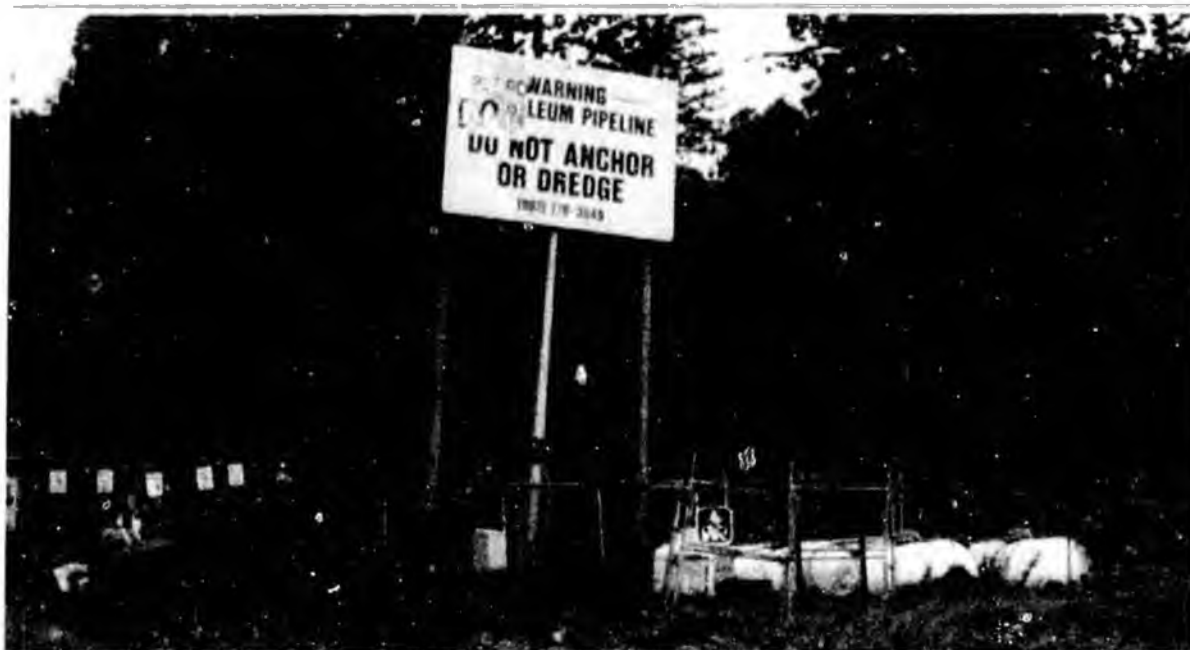
*This sign, a piece of which has fallen off, marks the pipeline's transition to sub-sea at Point Possession on the Kenai Peninsula. The propane tanks to the right are part of the impressed current cathodic protection system for the sub-sea line. The site was accessed by four-wheeler during June 2006 SPCO surveillance.*

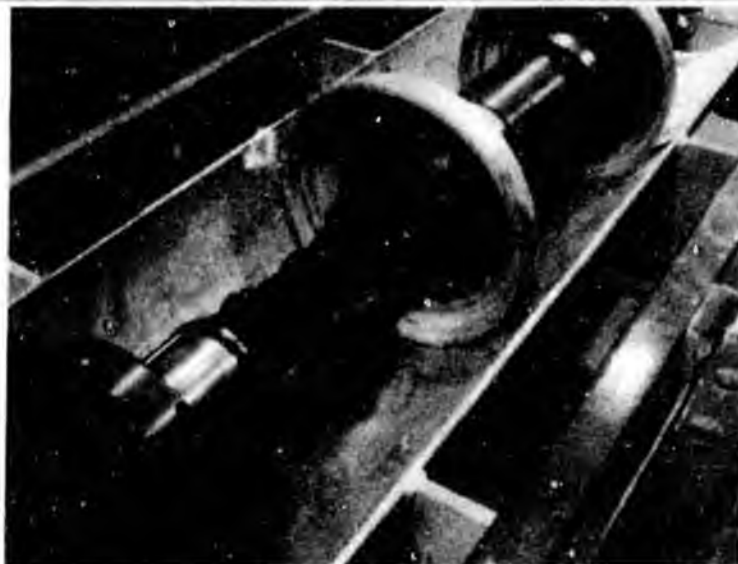
*This smart pig was used in June 2005 to detect pipeline conditions in the Alpine Oil Pipeline. The lease compliance oversight team witnessed retrieval of the pig at Kuparuk.*

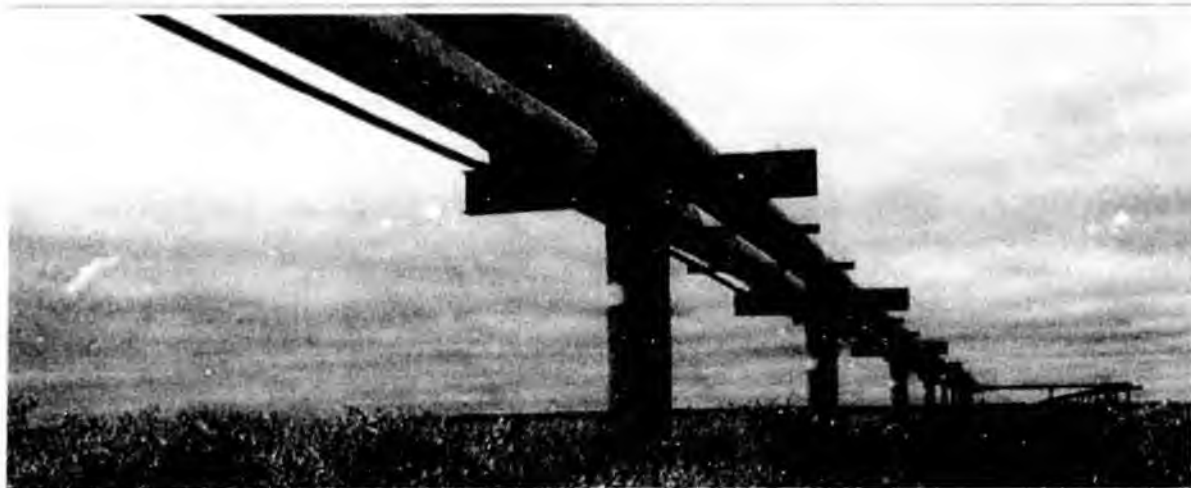
*VSMs for the Alpine pipelines are marked with reflector tape for public safety.*

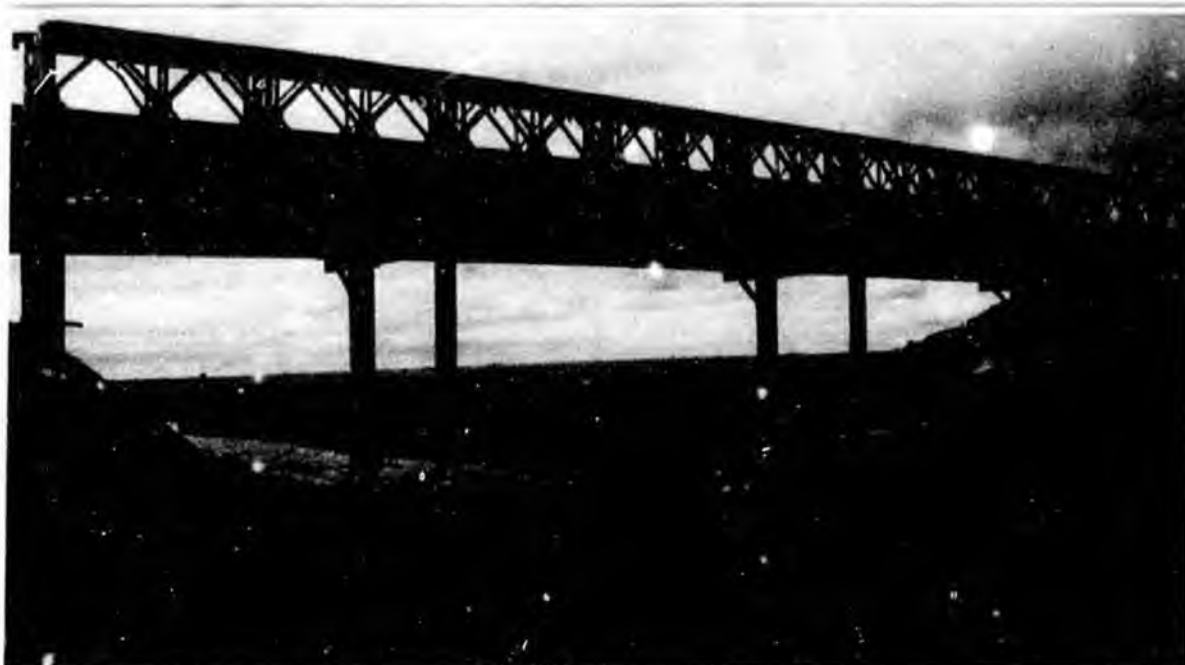
*The KPL and OPL cross over Smith Creek, a Kuparuk River tributary, on the Bailey Bridge. CPAI also maintains the Hamilton Bridge as part of the KPL/OPL access road.*

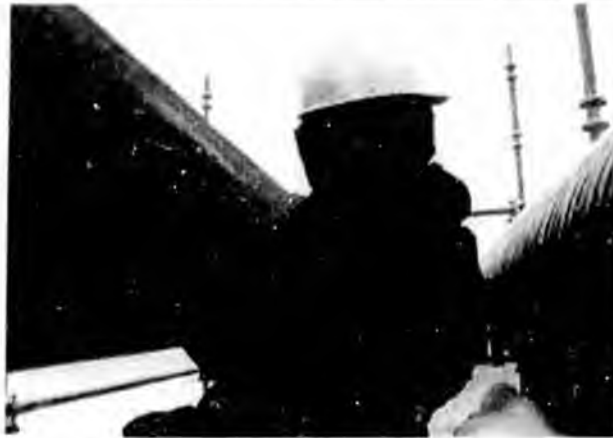
*During field surveillance of the KPL and OPL in November 2005, an SPCO surveillant observed inspection work being performed on the KPL. The technician drew a white line around the potentially corroded area to be inspected. The location had previously been stripped of insulation and prepped for inspection.*

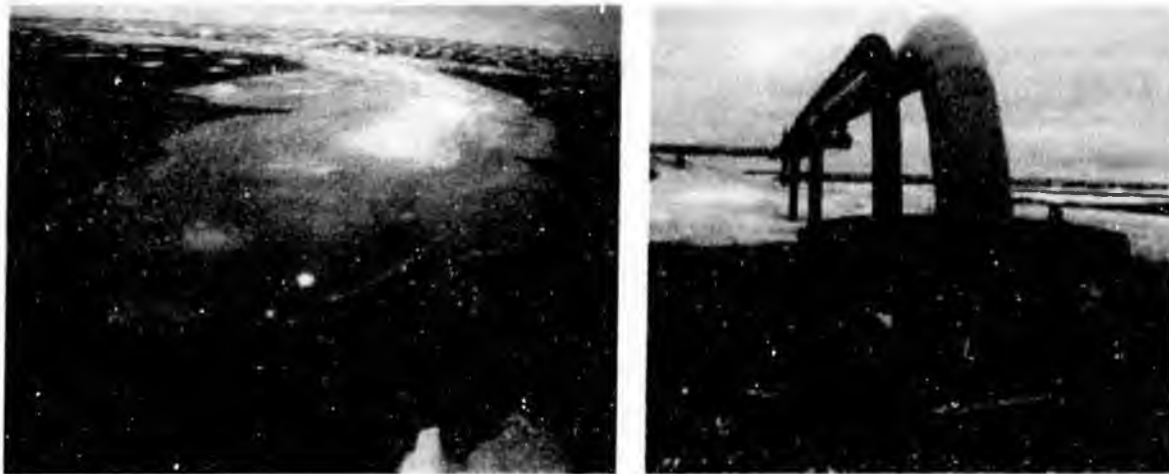
Left: Aerial view of the oxbow lake that the Badami weir protects. This lake is connected to a wetland system which extends for at least one mile to the south. Right: the Badami pipelines transition underground approximately 30 feet west of the weir.

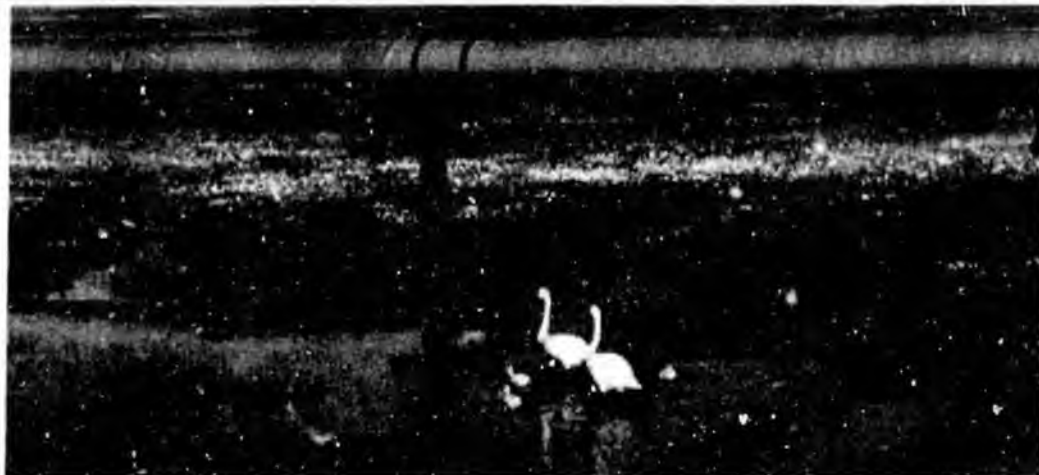
*The Endicott Pipeline passes through important tundra and wetland habitats. Here a pair of swans and their three young are using wetlands next to the pipeline. The smaller pipeline in front is the Badami Utility Pipeline, which is on the same supports as the Endicott Pipeline from Endicott to the Badami/Endicott tie-in.*

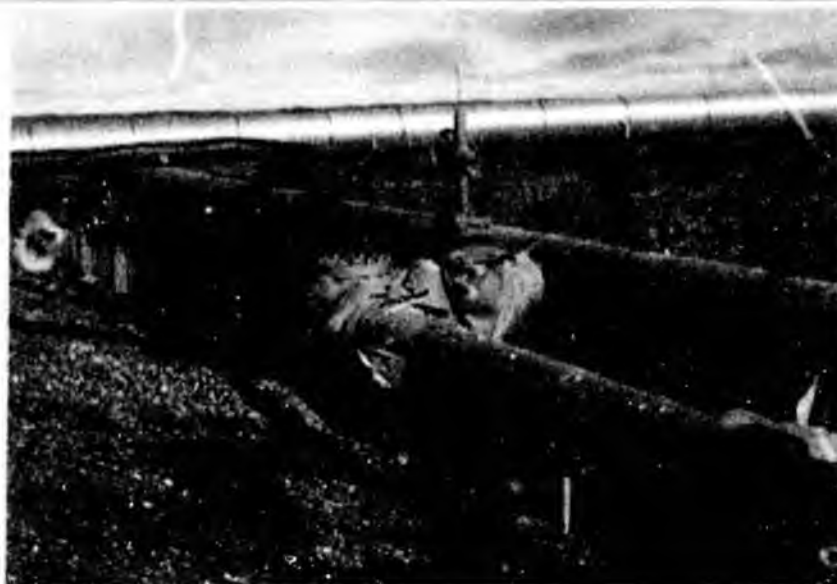
*This photo shows the location where the Badami Oil Pipeline (above) ties into the Endicott Pipeline. The Badami pig receiver is visible just left of the Endicott Pipeline (right).*

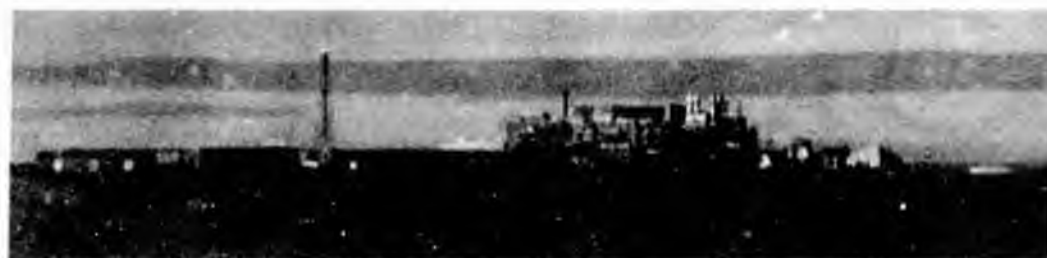
*The Endicott Main Production Island is a man-made drilling island in 14-foot deep water connected to shore by a causeway with breaching structures. Endicott was the world's first arctic offshore production facility and the first model of the oil industry's "reduced footprint." Endicott's footprint was 70% smaller than the traditional pad at the time. Current daily production from Endicott is approximately 25,000 barrels per day, compared to the peak production of 115,000 bpd in late 1987. (Source: BP Alaska website, accessed October 2005.)*
